BEFORE THE ILLINOIS POLLUTION CONTROL BOARD
ADMINISTRATIVE CITATION

AC 12-36
(IEPA No. 64-12-AC)

Open Dump Inspection Checklist

SUBJECT: LPC #0838005003 – Jersey County
Elsah / Hagen (f.k.a. Robinson, & Herrmann)
C-05-006-C
FOS File

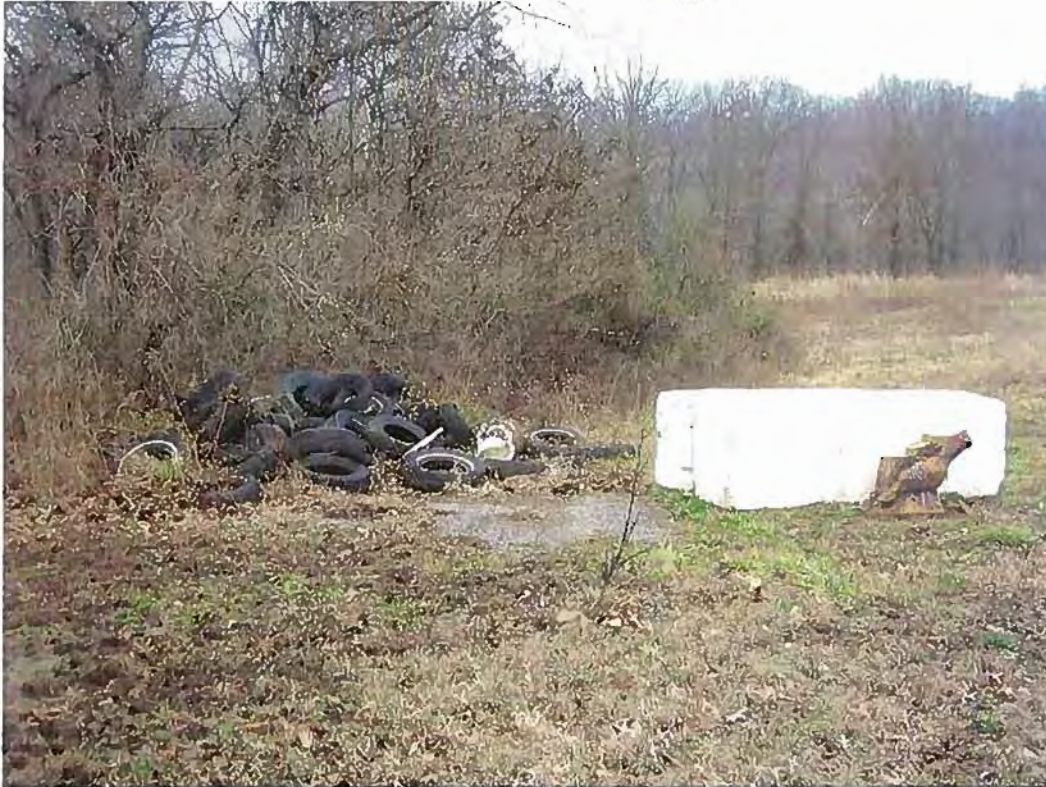
The Illinois EPA inspector arrived at the site and knocked on both of the front doors to the pole building. There were no vehicles in the driveway. I left my business card between the door and the weather stripping. I started walking over to the used tire pile that was easily visible from the street and driveway. I took Photograph 001 that shows approximately fifty (50) used tires east of the driveway. There were also two large Styrofoam blocks nearby that roughly measured 2ft by 3ft by 8 ft (each).

Date: February 16, 2012
Time: 11:30 AM
Direction: SE
Photo by: Eisenbrandt
Exposure #: 001
Comments: Approximately 50 used tires east of the driveway. There were also two large Styrofoam blocks nearby. The Styrofoam blocks were approximately 2ft x 3ft x 8ft each.

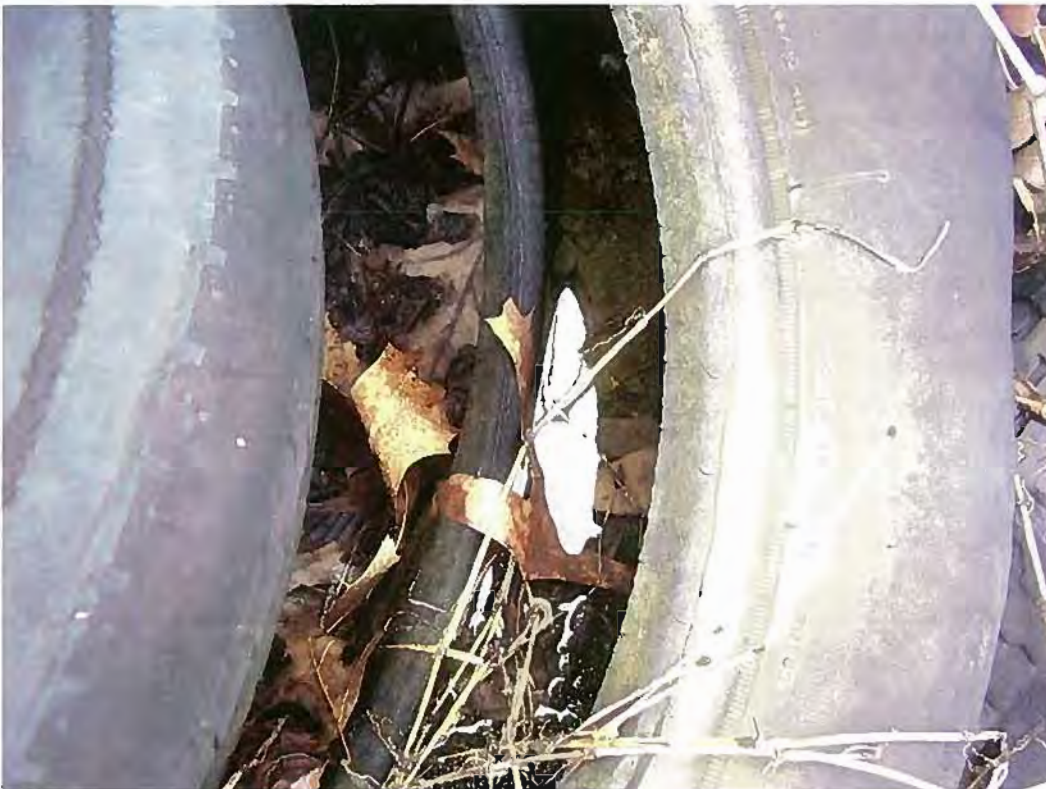
Photographs 002 and 003 show two the off-rim tires that contained stagnant water, green algae, and leaf debris. Photograph 002 also shows aluminum cans, an amber beer bottle, a rusty tin can, and asphalt debris intermixed with the used tires. Photograph 004 shows an alternate view of the estimated 50 used tire pile. Four (4) of the used tires were on-rim, and more have been on-rim lower in the pile. The majority of the exposed waste tires were off-rim. The photograph also

Date: February 16, 2012
Time: 11:31 AM
Direction: E
Photo by: Eisenbrandt
Exposure #: 002
Comments: Stagnant water, algae, and leaf debris in an off-rim used tire.

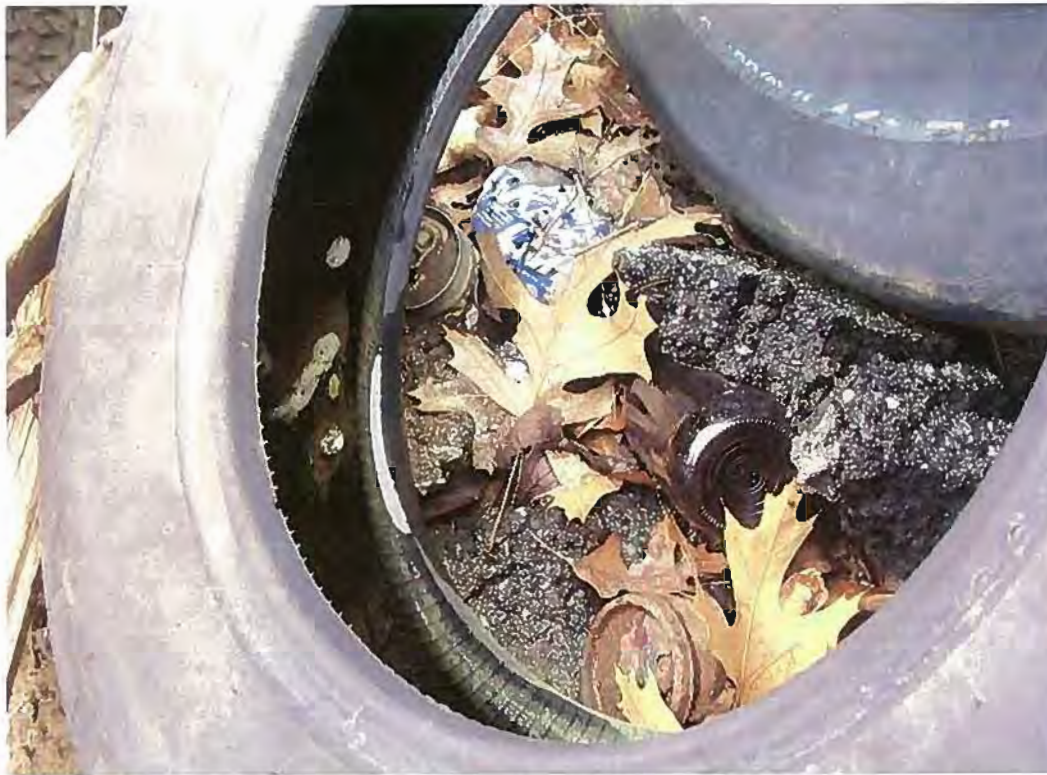
Date: February 16, 2012
Time: 11:31 AM
Direction: N
Photo by: Eisenbrandt
Exposure #: 003
Comments: Stagnant water, algae, and leaf debris in another off-rim used tire. Aluminum cans, an amber bottle, a rusty can, and asphalt debris intermixed with the used tire pile.

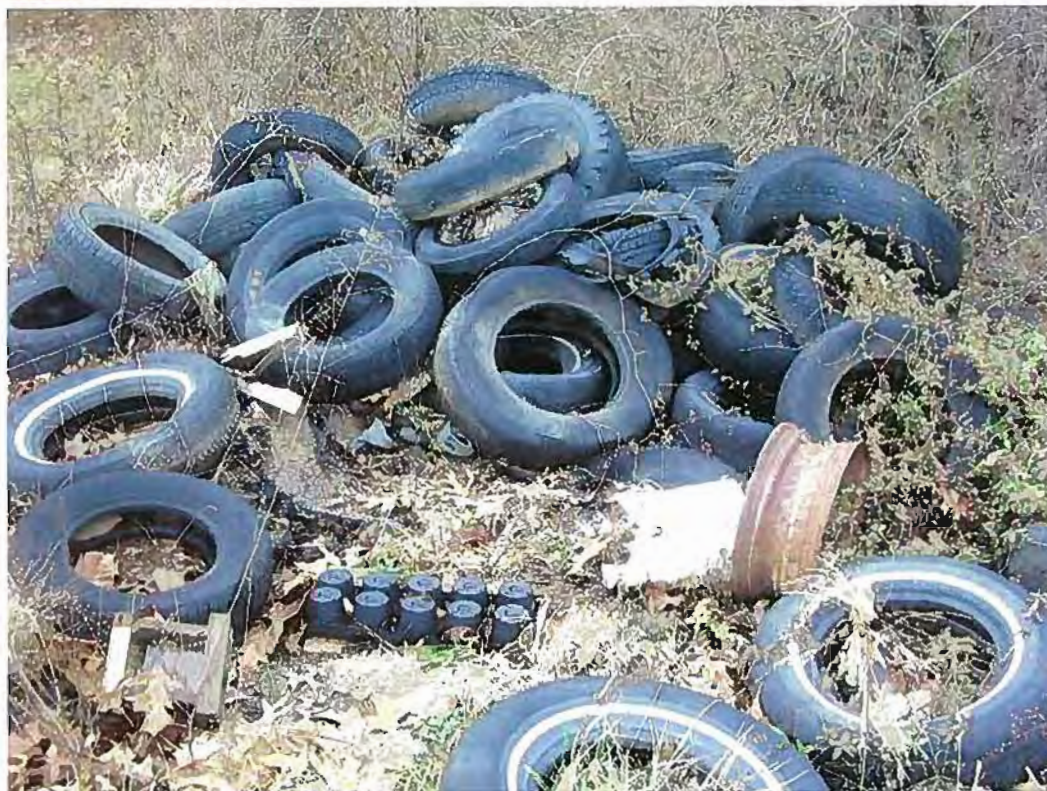
shows a rusty wheel rim, lumber scrap, a broken plastic bucket, a bird feeder, and a black plastic flat for seedlings. The dried vegetation partially covering the used tires indicates long term deposition.

Date: February 16, 2012
Time: 11:35 AM
Direction: N
Photo by: Eisenbrandt
Exposure #: 004
Comments: Alternate view of the 50 used tires, of which 4 were on-rim), a rusty wheel rim, lumber scrap, a broken plastic bucket, a bird feeder, and a black plastic flat for seedlings.

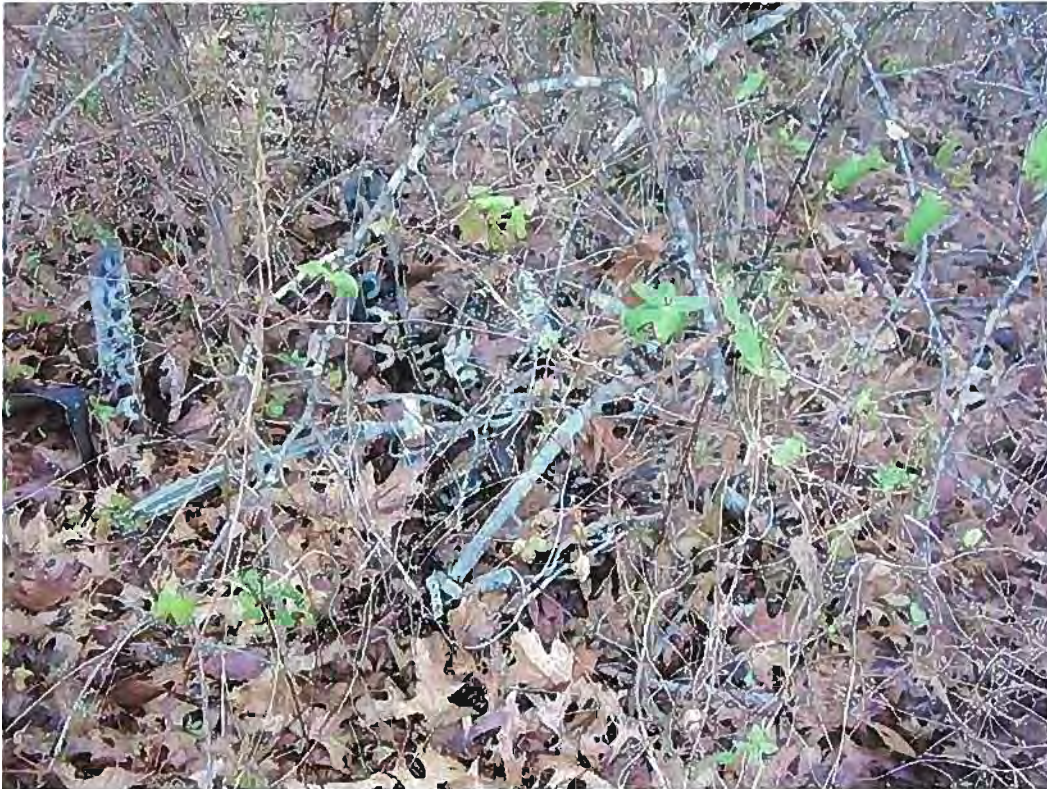
I walked southeast along the tree and occasionally crossing over to the edge of the ravine (that runs along the east property line). Photograph 005 shows some radiator coils and copper wire in the weeds on the bank of the ravine. Refer to the attached Site Sketch for the approximate photograph locations. I walk south and observed an off-rim used tire with a small caliper tree growing through it (see Photograph 006).

Date: February 16, 2012
Time: 11:37 AM
Direction: E
Photo by: Eisenbrandt
Exposure #: 005
Comments: Radiator coils and copper wire in the weeds.

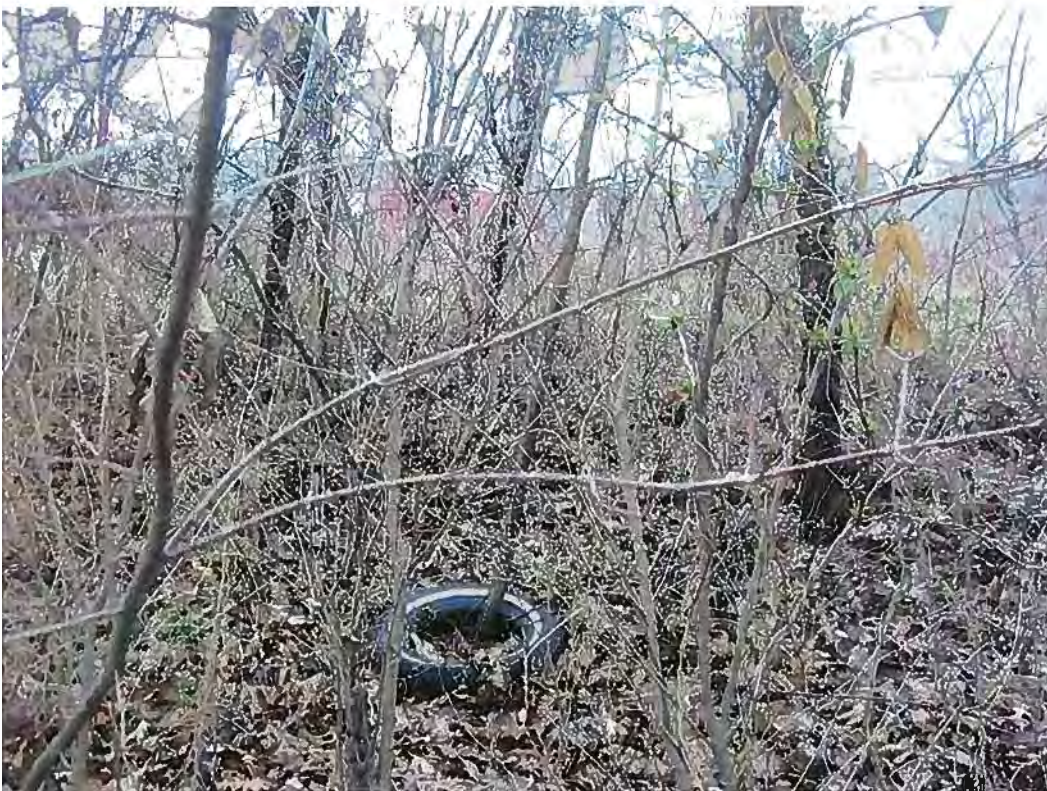
Date: February 16, 2012
Time: 11:40 AM
Direction: NW
Photo by: Eisenbrandt
Exposure #: 006
Comments: A whitewall off-rim used tire with a small caliper tree growing through it.

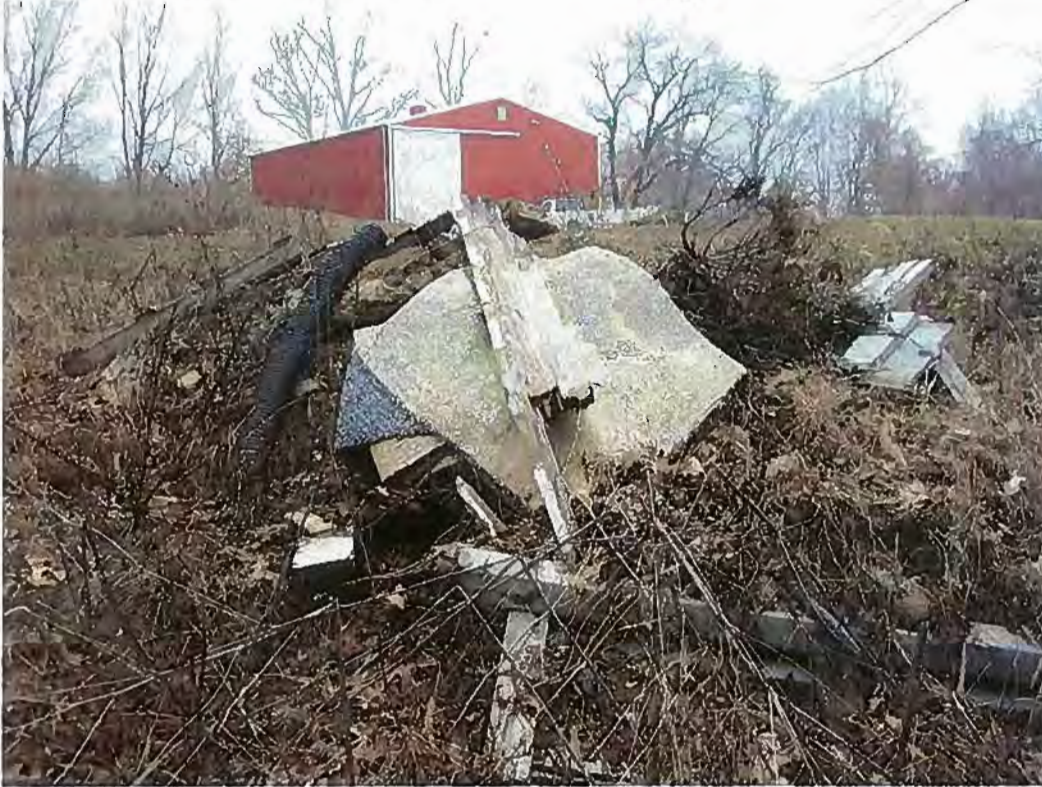
I followed a new path cut along the western side of the property. I walked north and could see the red and white pole building at a higher elevation in the distance. I climbed the hill and discovered a 15 ft by 15 ft debris pile (see Photographs 007 and 008). I observed carpeting scrap, landscape fabric, six wooden pallets, plastic drain pipe, used dimensional lumber (with painted surfaces, nails, and screw fasteners), OSB, and landscape waste. The lumber was aged; however the carpet, drain pipe, and landscape fabric appeared fairly new. This debris pile was not here during the previous inspections.

Date: February 16, 2012
Time: 12:03 PM
Direction: NE
Photo by: Eisenbrandt
Exposure #: 007
Comments: Debris pile containing carpet scrap, landscape fabric, 6 wooden pallets, plastic drain pipe, used dimensional lumber (painted surfaces and screws observed), OSB, and landscape waste.

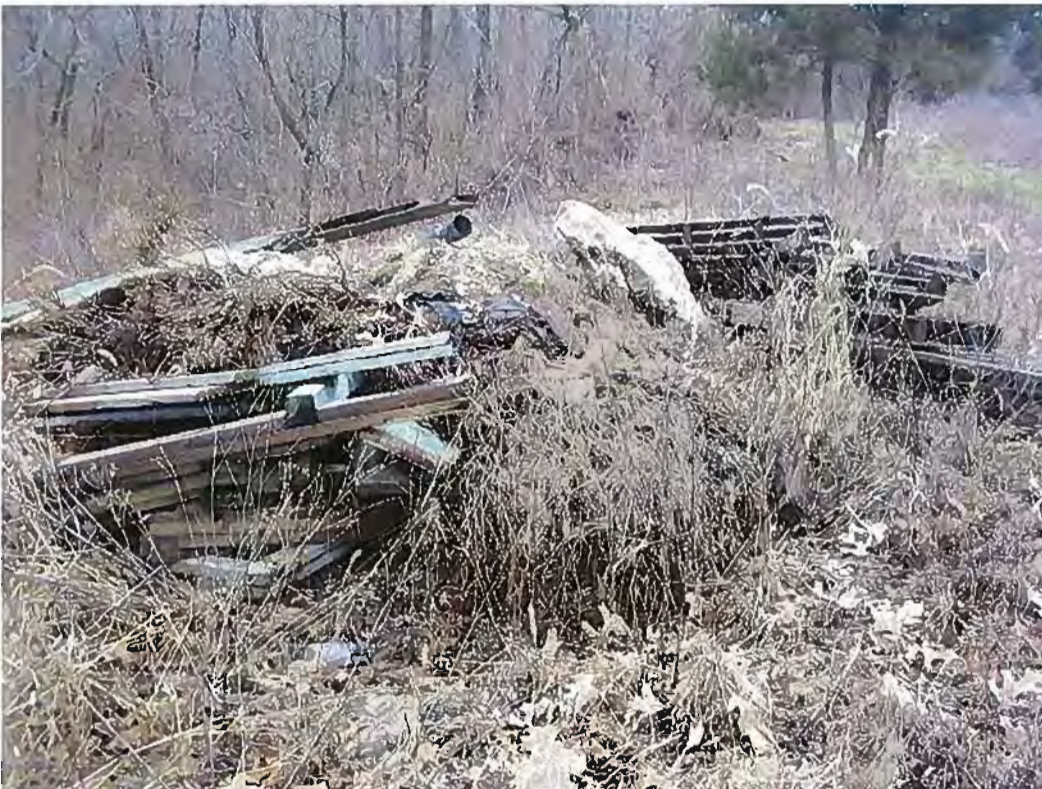
Date: February 16, 2012
Time: 12:05 PM
Direction: NW
Photo by: Eisenbrandt
Exposure #: 008
Comments: Alternate view of debris pile seen in Photograph 007.

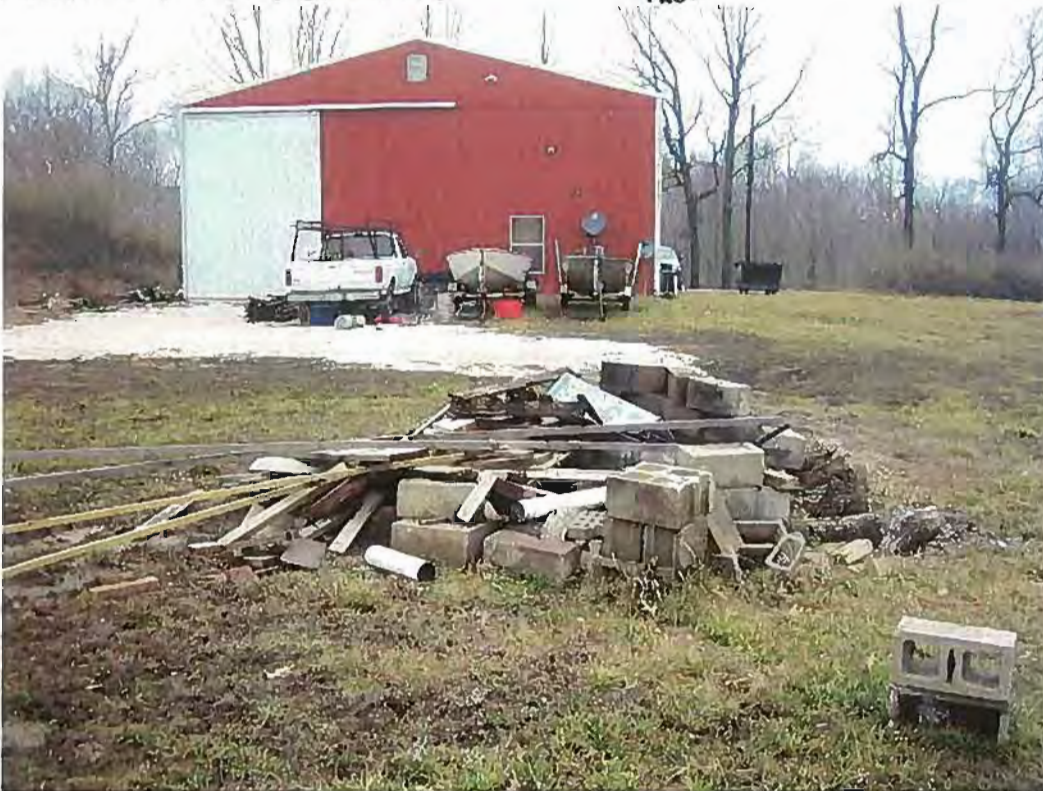
On my way back toward the building, I found another debris pile. This pile was partially ringed with dry stacked cinder block (see Photograph 009). The debris pile contained dimensional lumber, treated wood, cardboard boxes, white drain pipe, wire mesh, a metal bar, and pieces of synthetic expansion joint for concrete. Some of the lumber appeared to have been used as concrete forms as they were partially coated with cement cream.

Date: February 16, 2012
Time: 12:06 PM
Direction: N
Photo by: Eisenbrandt
Exposure #: 009
Comments: A loose stack of cinder blocks surrounding a debris pile. The debris pile contained dimensional lumber, treated wood, cardboard boxes, white drain pipe, a metal bar, and pieces of synthetic expansion joint for concrete. Some of the lumber appeared to be used concrete forms as they were partially covered with cement cream.

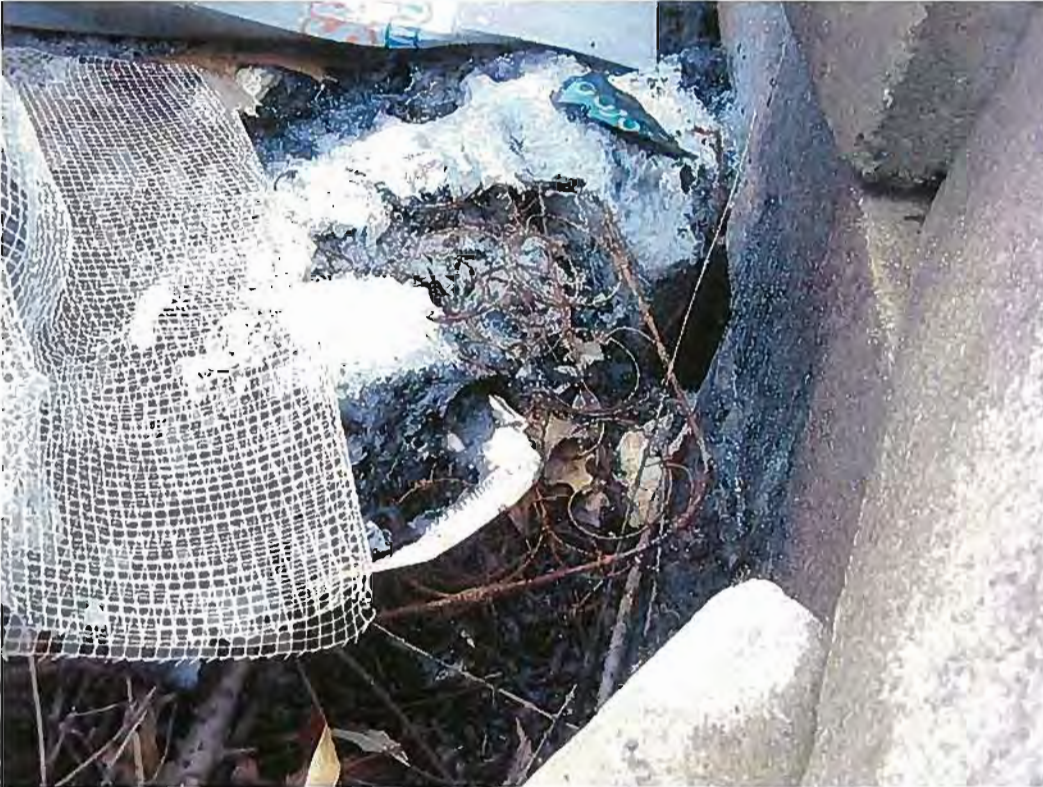
Photograph 010 shows ash and charred waste beneath the debris pile. A rusty mattress spring, charred paper, wire mesh and landscape waste can be seen on the Photograph 010.

Date: February 16, 2012
Time: 12:06 PM
Direction: NW
Photo by: Eisenbrandt
Exposure #: 010
Comments: Beneath the debris pile ash and charred waste was observed. This photograph shows a part of rusty spring from a mattress, charred paper, wire mesh, and landscape waste.

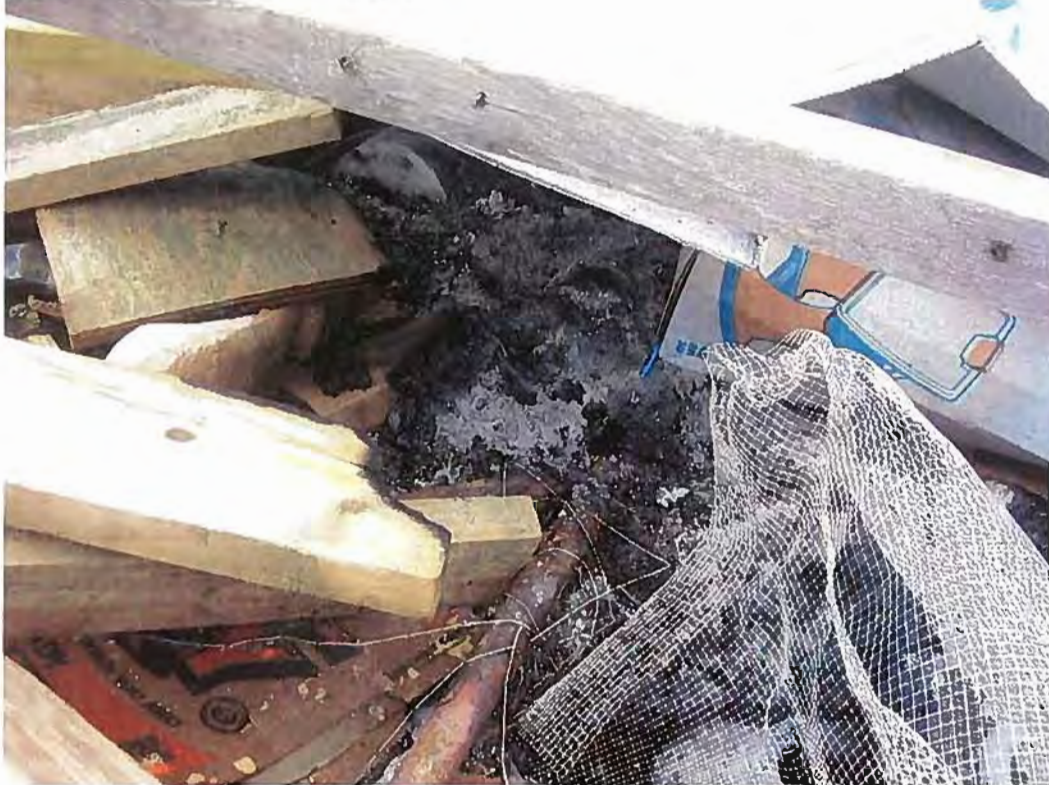
Photograph 011 shows partially burnt lumber, processed wood, cardboard, a pizza box, and a metal bar. Yellow rubber boots, black & red rubber boots, hardboard, aluminum cans, and Remington ammunition boxes, were among the waste in the debris pile.

Date: February 16, 2012
Time: 12:07 PM
Direction: W
Photo by: Eisenbrandt
Exposure #: 011
Comments: Partially burnt lumber, processed wood, cardboard, a pizza box, and a metal bar. Yellow rubber boots, black & red rubber boots, hardboard, aluminum cans, Remington ammunition boxes, were among the waste in the debris pile.

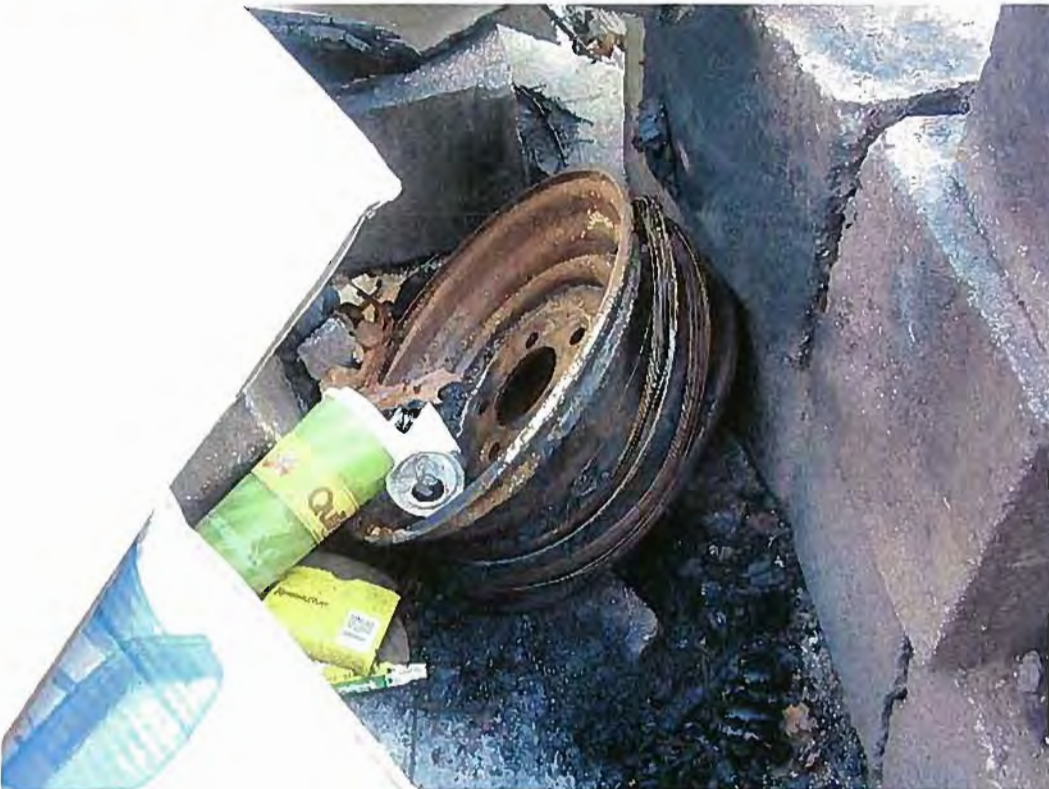
Photograph 012 shows a charred wheel rim with tire beads that indicates a used tires has been burned.

Date: February 16, 2012
Time: 12:08 PM
Direction: W
Photo by: Eisenbrandt
Exposure #: 012
Comments: A charred wheel rim with tire beads.

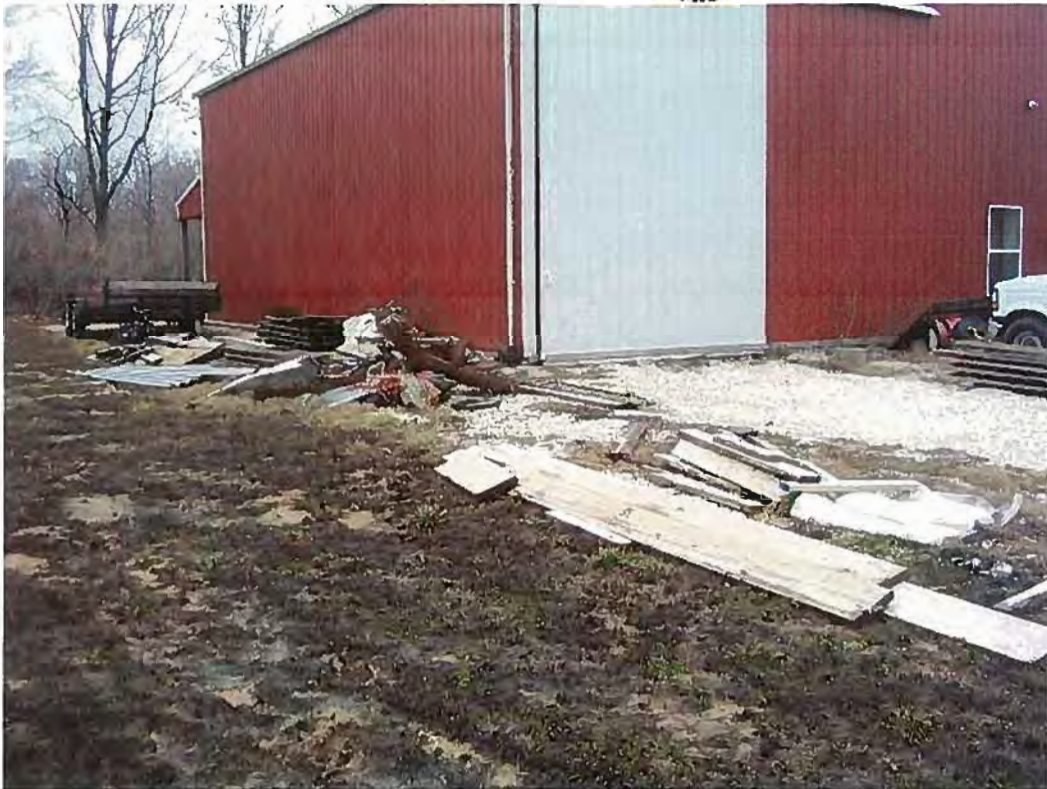
Off the west and southwest side of the pole building, wood and metal forms, wire reinforcement, and materials related to the concrete occupation can be seen in the Photograph 013.

Date: February 16, 2012
Time: 12:12 PM
Direction: NE
Photo by: Eisenbrandt
Exposure #: 013
Comments: Wood and metal forms, wire reinforcement, and materials related to the concrete occupation.

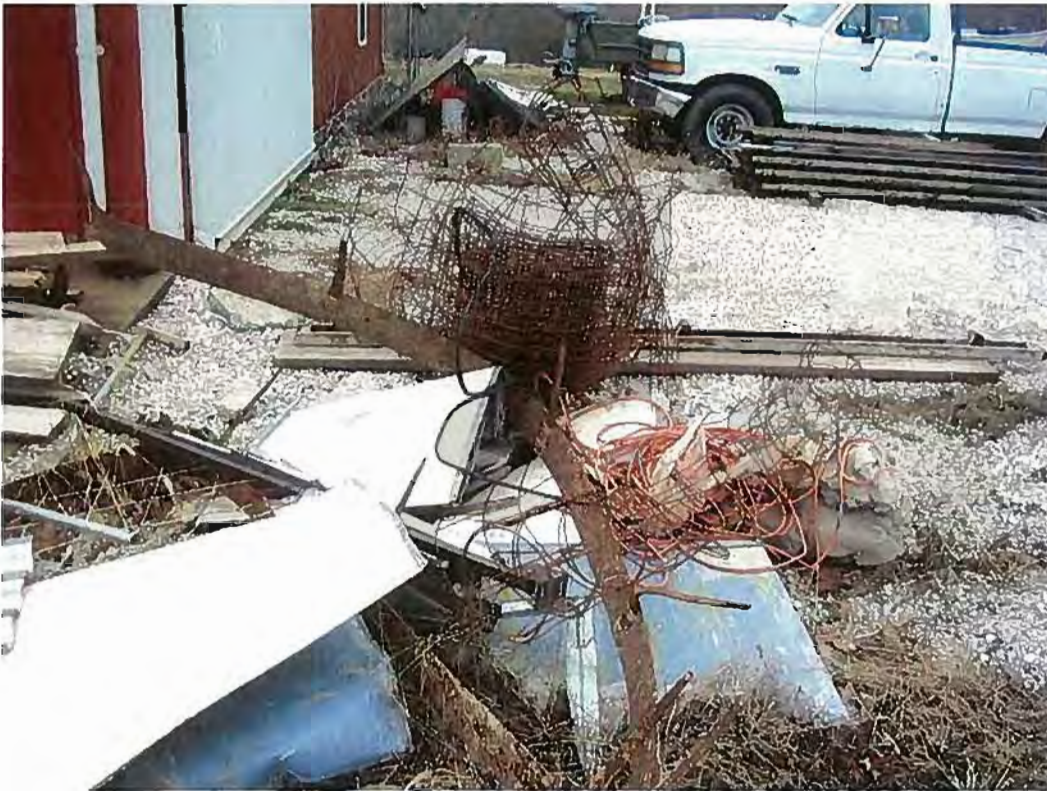
Photograph 014 shows a debris pile containing mangled wire mesh, plastic, scrap metal, and orange electrical cord, a metal bed frame, a destroyed barricade, rusty metal edging, and wire.

Date: February 16, 2012
Time: 12:13 PM
Direction: E
Photo by: Eisenbrandt
Exposure #: 014
Comments: Debris pile containing wire mesh, plastic, scrap metal, an orange electrical cord, a metal bed frame, a destroyed barricade, metal edging, and wire.

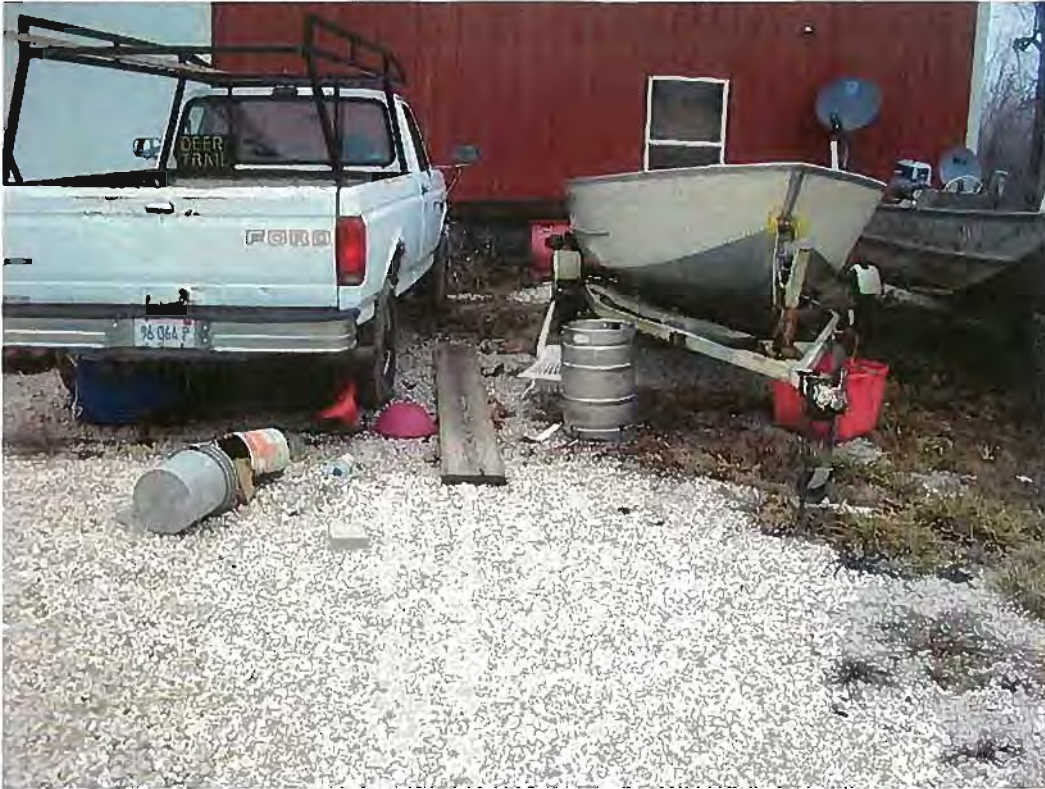
Photograph 015 shows a white Ford pickup truck (IL B truck plate 96 064 P) with a license sticker that expired in August 2010 (see Photograph 015). Also seen in the photograph is an Anheuser Busch keg, a red plastic bowl, a red tote full of household waste, a broken lawn chair, two plastic buckets containing 2x6 cutoffs, and a piece of red plastic astray behind the building.

Date: February 16, 2012
Time: 12:14 PM
Direction: N
Photo by: Eisenbrandt
Exposure #: 015
Comments: A white Ford F250 pickup truck with a license sticker that expired August 2010. An Anheuser Busch keg, a red plastic bowl, a red tote full of household waste, a broken lawn chair, two plastic buckets containing 2x6 cutoffs, and a piece of red plastic astray behind the building.

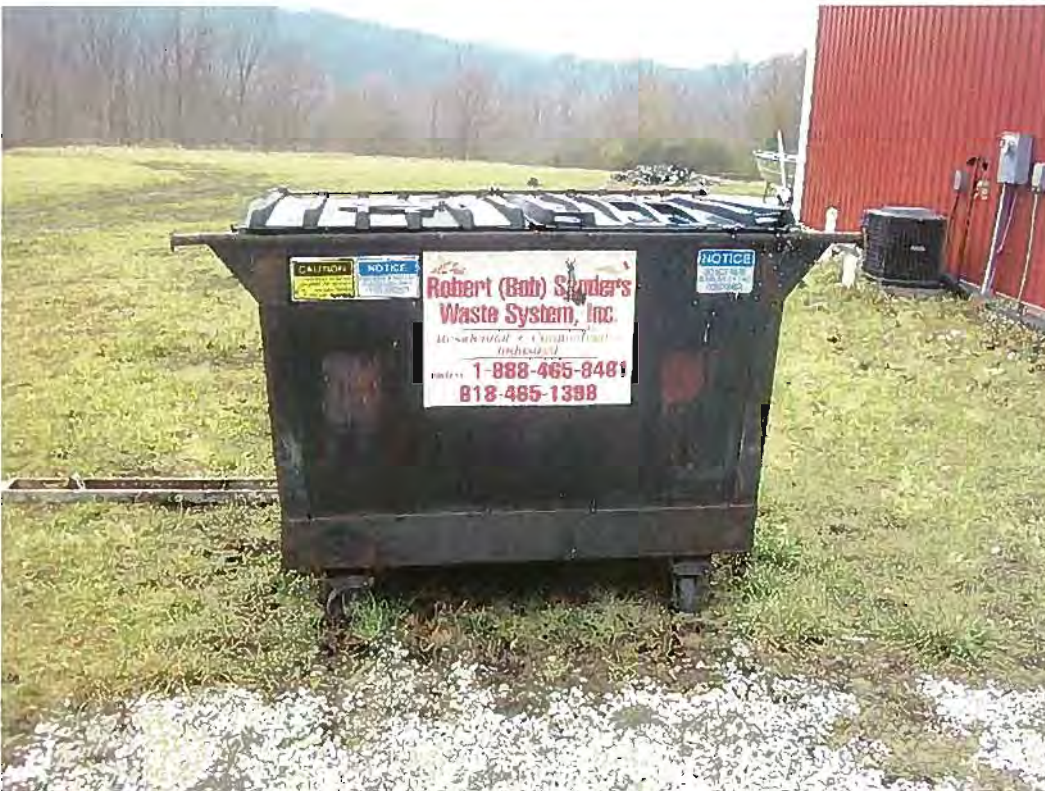
At the head of the driveway and just east of the covered porch, a Robert (Bob) Sanders Waste Systems, Inc. 2-yard dumpster was situated. The dumpster was empty during the inspection. The Hagen's may use the dumpster to dispose of the waste observed at their property.

Date: February 16, 2012
Time: 12:18 PM
Direction: S
Photo by: Eisenbrandt
Exposure #: 016
Comments: A Robert (Bob) Sanders Waste System, Inc. 2-yard dumpster near the driveway. The dumpster was empty during the inspection.
