**FINAL REPORT
ROUND 10 DAM ASSESSMENT
DYNEGY MIDWEST GENERATION, LLC – BALDWIN ENERGY COMPLEX
PRIMARY FLY ASH POND, SECONDARY FLY ASH POND, SECONDARY POND,
INTERMEDIATE POND, FINAL POND
BALDWIN, ILLINOIS**

December 21, 2012
GZA File No. 170142.30

RE: FINAL Assessment of Dam Safety of Coal Combustion Surface Impoundments at the Baldwin Energy Complex

**FINAL REPORT
ROUND 10 DAM ASSESSMENT
DYNEGY MIDWEST GENERATION, LLC – HENNEPIN POWER STATION
ACTIVE EAST ASH POND SYSTEM, EAST ASH POND SYSTEM, WEST ASH POND
SYSTEM
HENNEPIN, ILLINOIS**

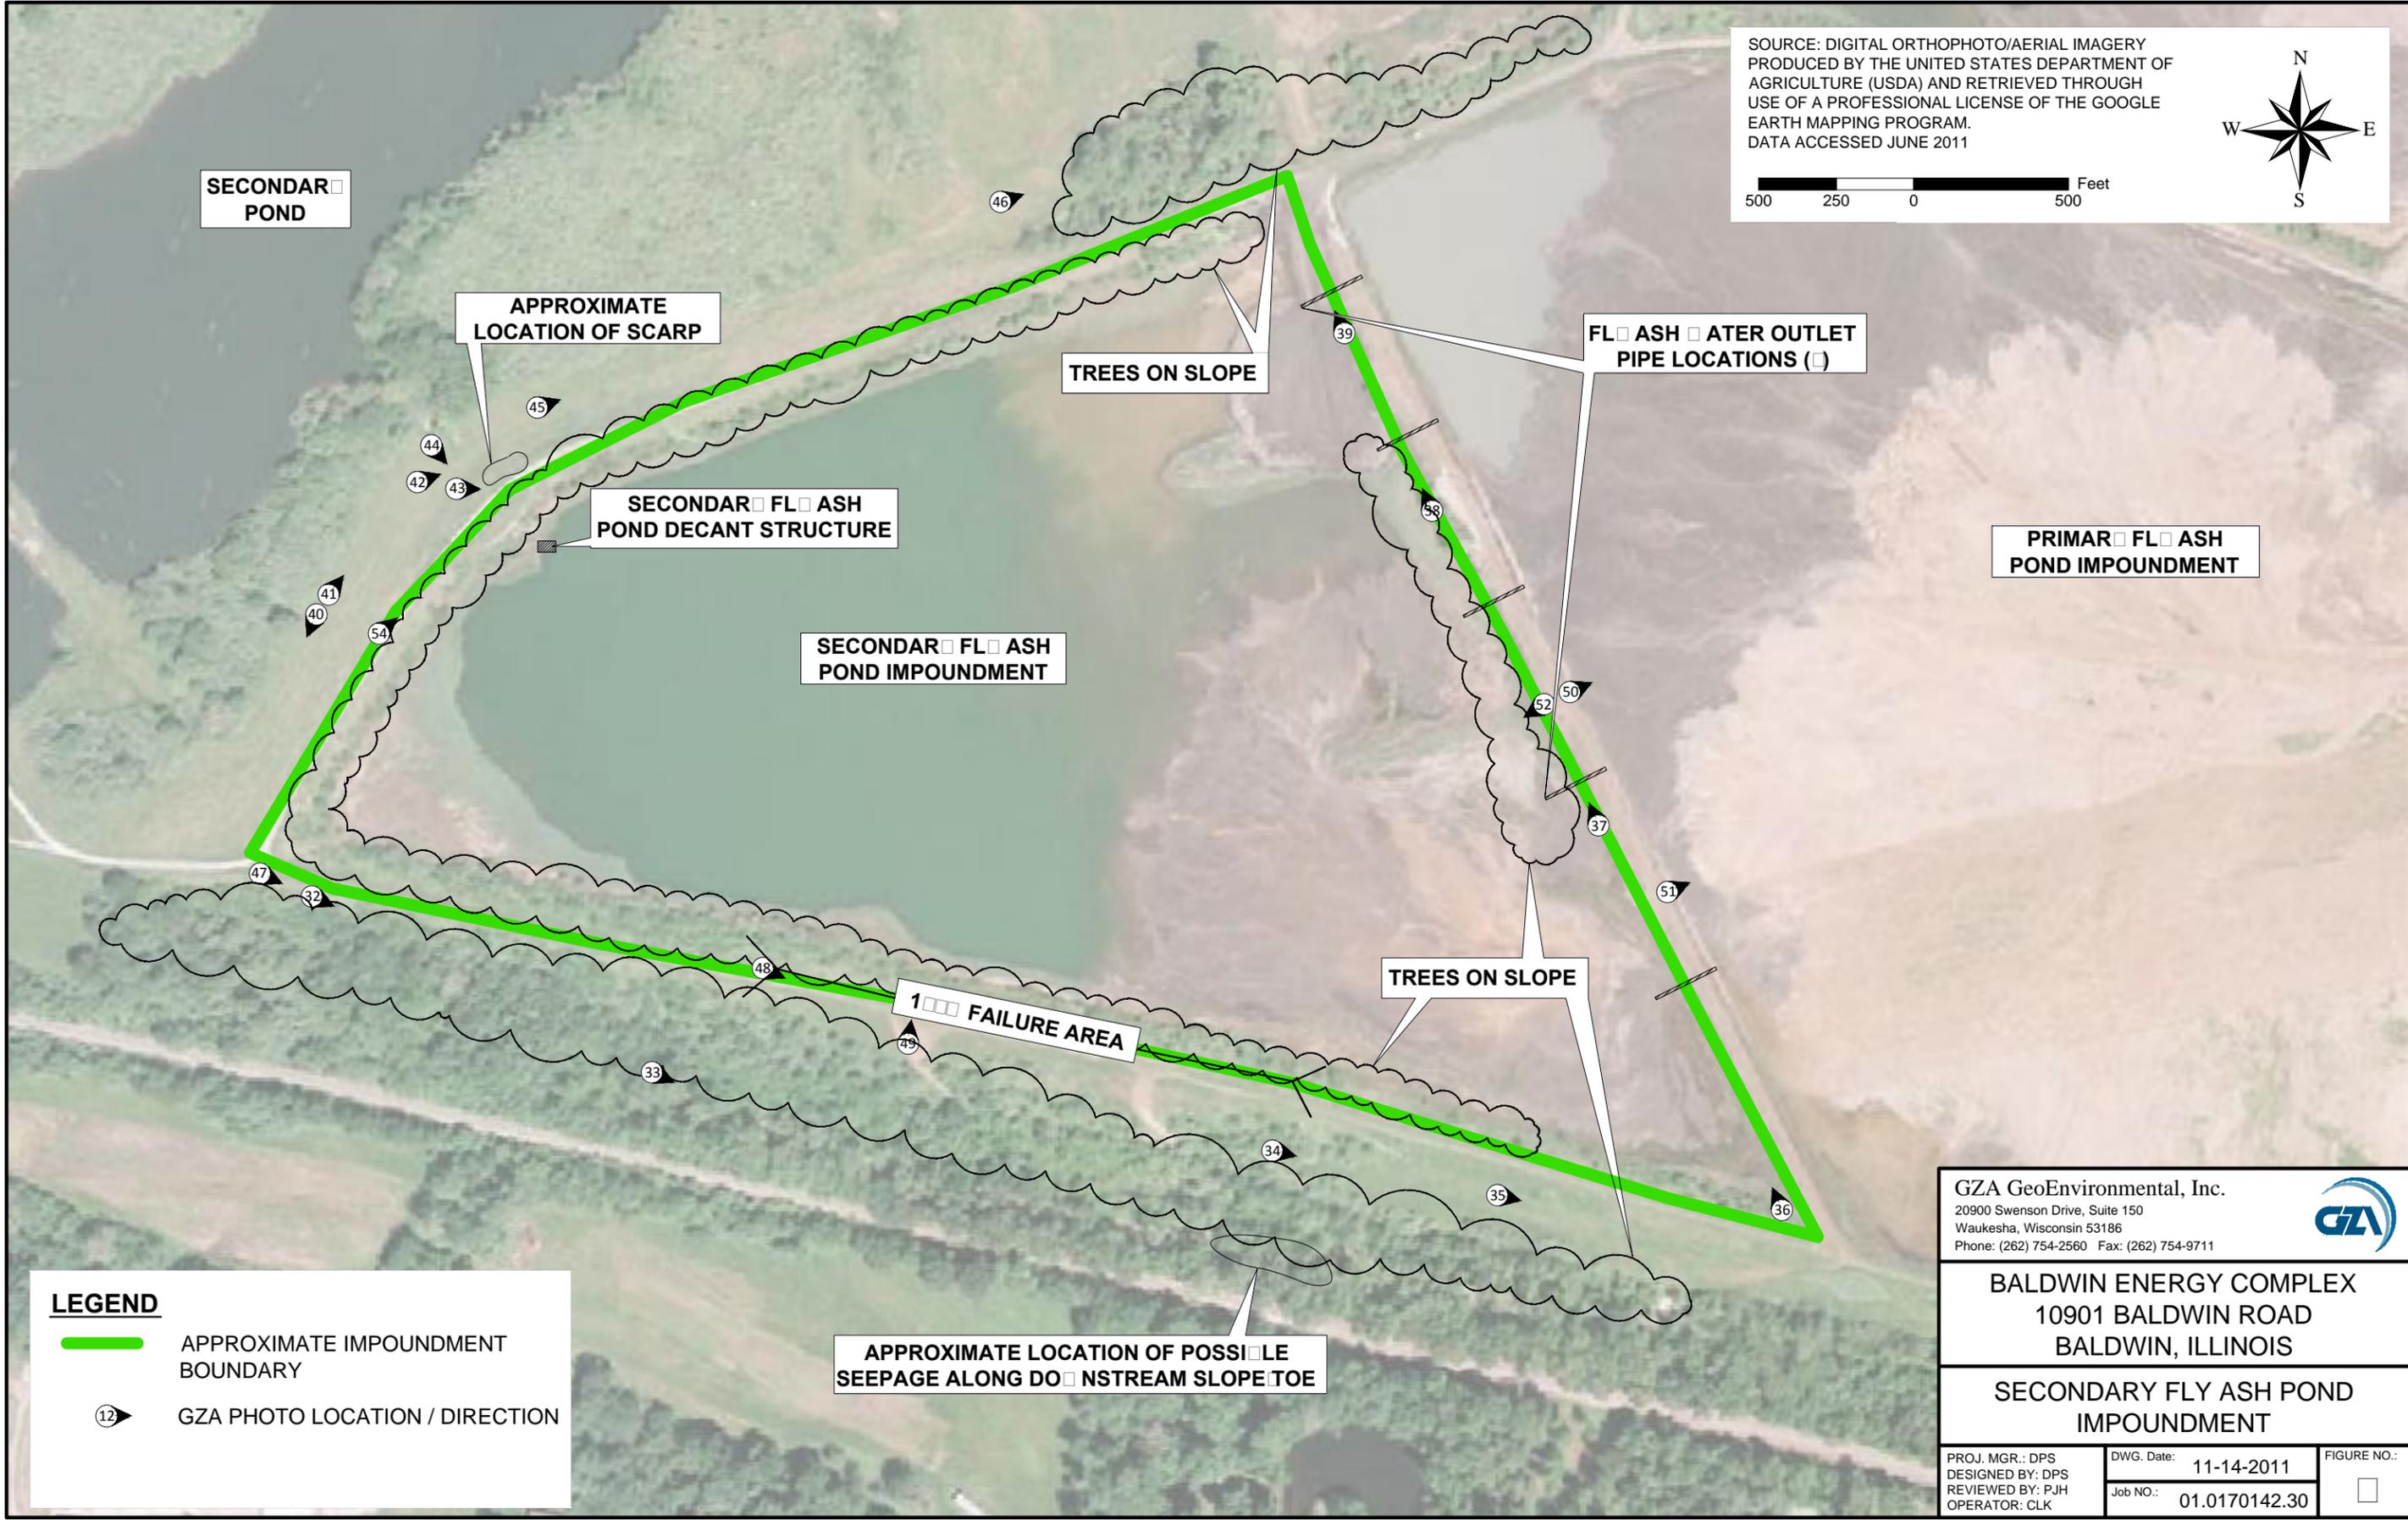
A scarp was observed near the crest of the downstream slope of the northwestern embankment at the approximate location shown on **Figure 8**. The scarp was approximately 100 feet wide along the slope and extended approximately 30 feet to 40 feet down the slope. The vertical face at the head of the scarp was approximately 2 feet high. The scarp had reportedly developed 2 weeks prior to our assessment and repair of the scarp has been completed since our visit according to BEC personnel. Moist surface conditions that may have been an indicator of seepage were observed along the toe of the southern embankment. However, we were not able to confirm the nature or extent of moist conditions due to the thick vegetation.

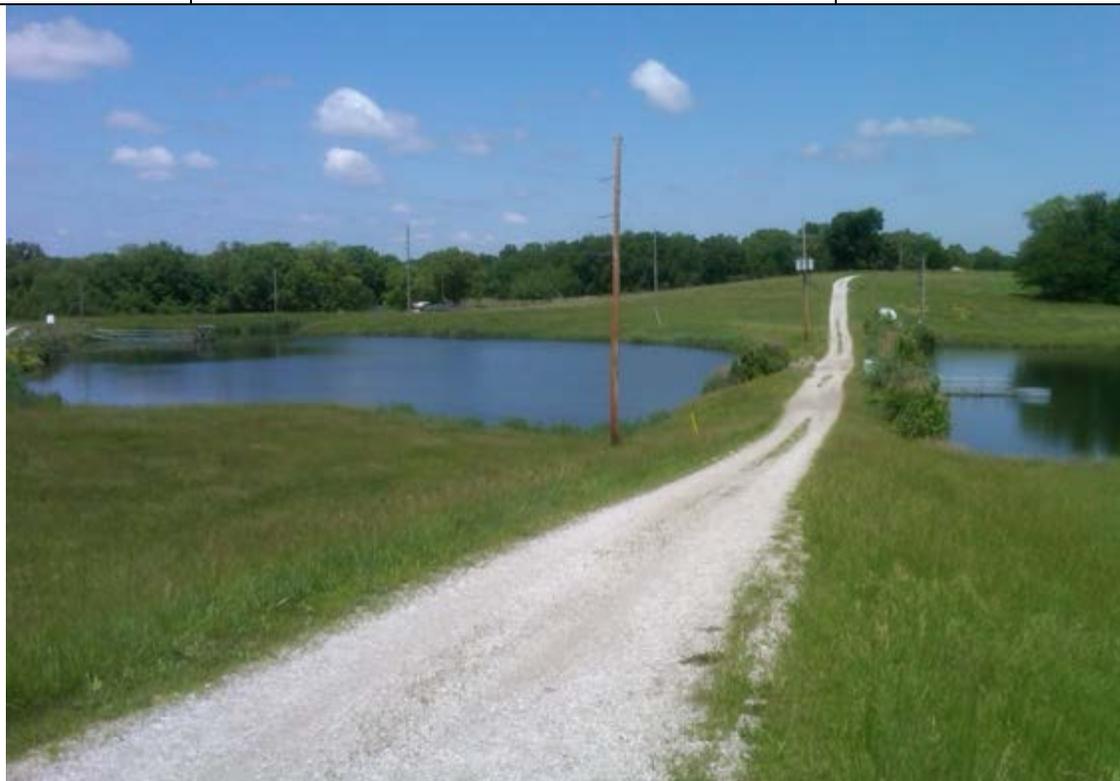
Photo No. 1	Date: 5/24/11
Direction Photo Taken: Northwest

Description:
Downstream slope and crest of the Ash Pond Dike which retains the water that forms the Intermediate Pond.

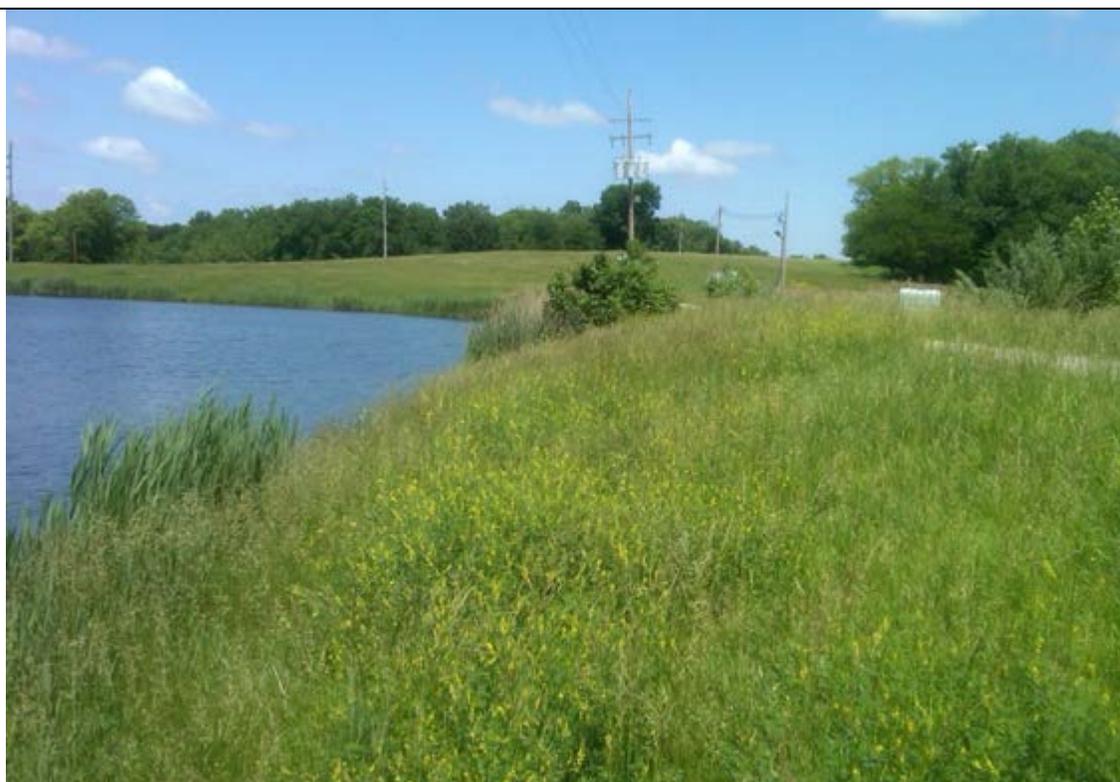
Photo No. 2	Date: 5/24/11
Direction Photo Taken: Northwest

Description:
Downstream slope of the Ash Pond Dike.

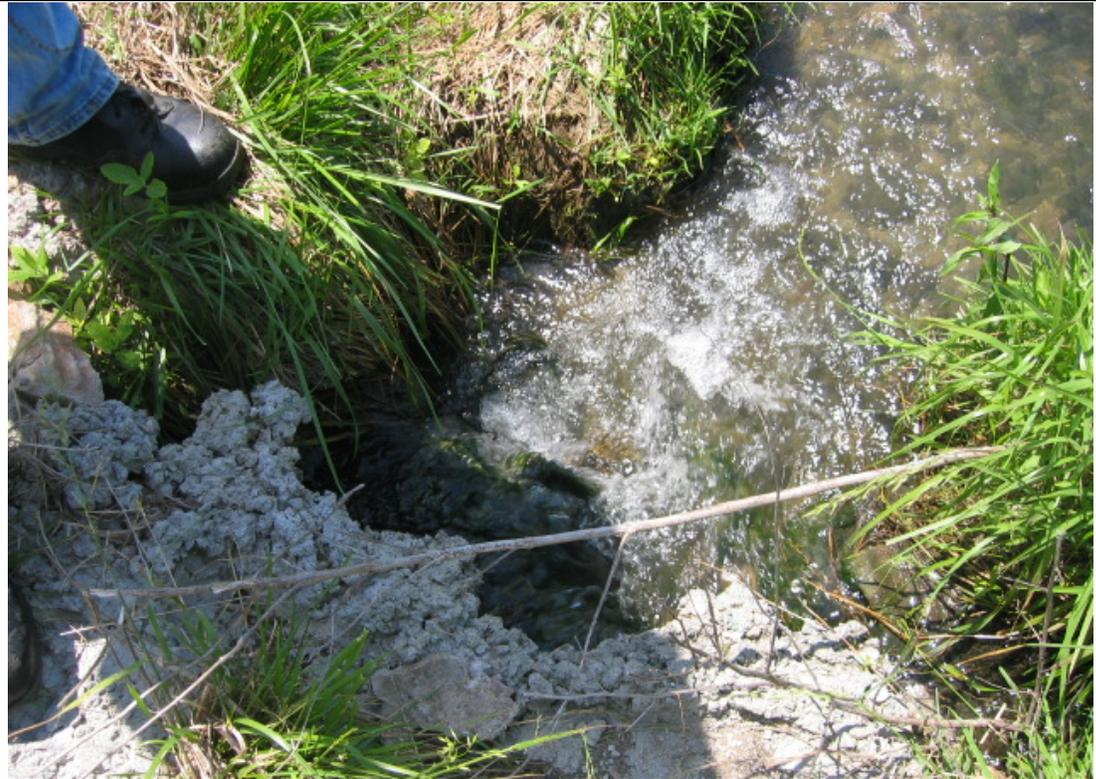
Photo No. 3	Date: 5/24/11
Direction Photo Taken: South

Description:
Seepage from the downstream slope of the Ash Pond Dike.

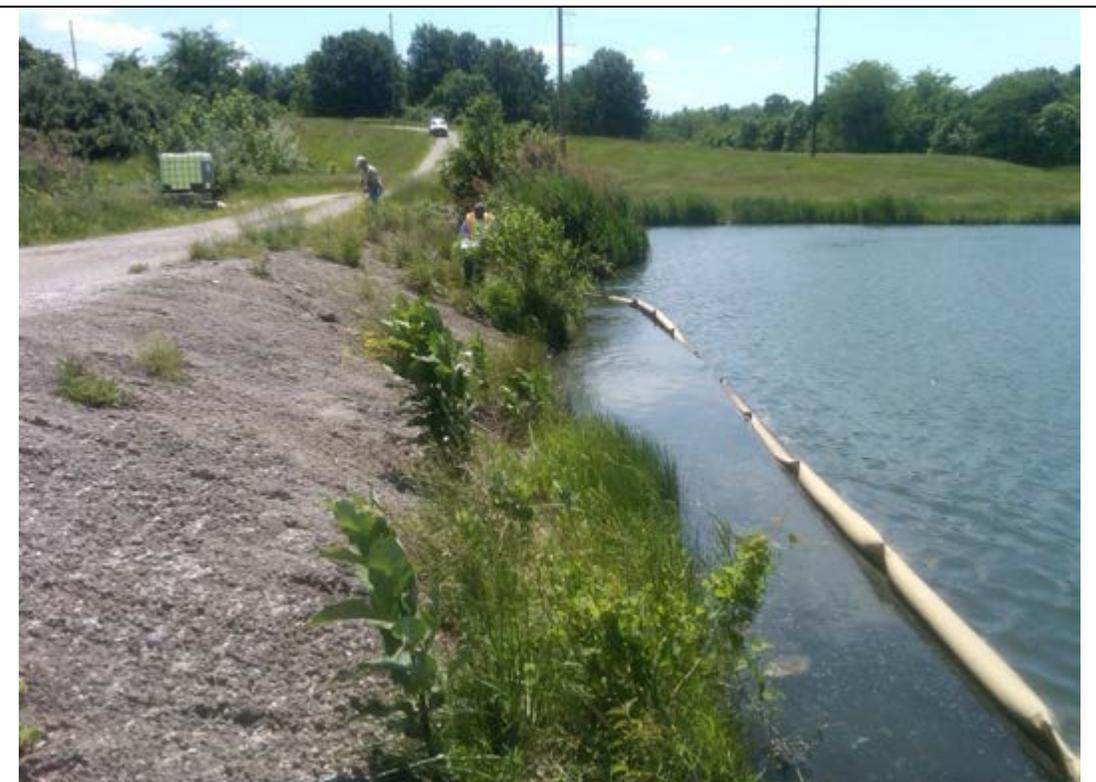
Photo No. 4	Date: 5/24/11
Direction Photo Taken: Southeast

Description:
Surface grouting/concrete along the downstream slope of Ash Pond Dike. Seepage present beneath the surface grouting in several locations.

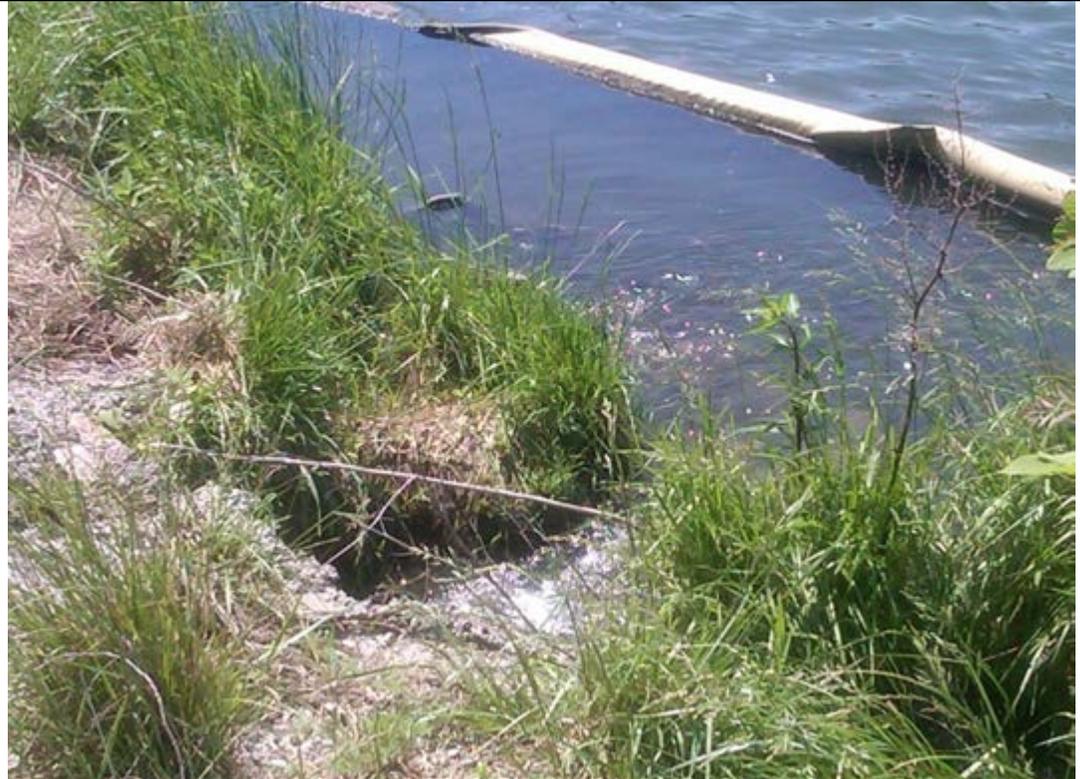
Photo No. 5	Date: 5/24/11
Direction Photo Taken: South

Description:
Seepage beneath the surface grouting on Ash Pond Dike.

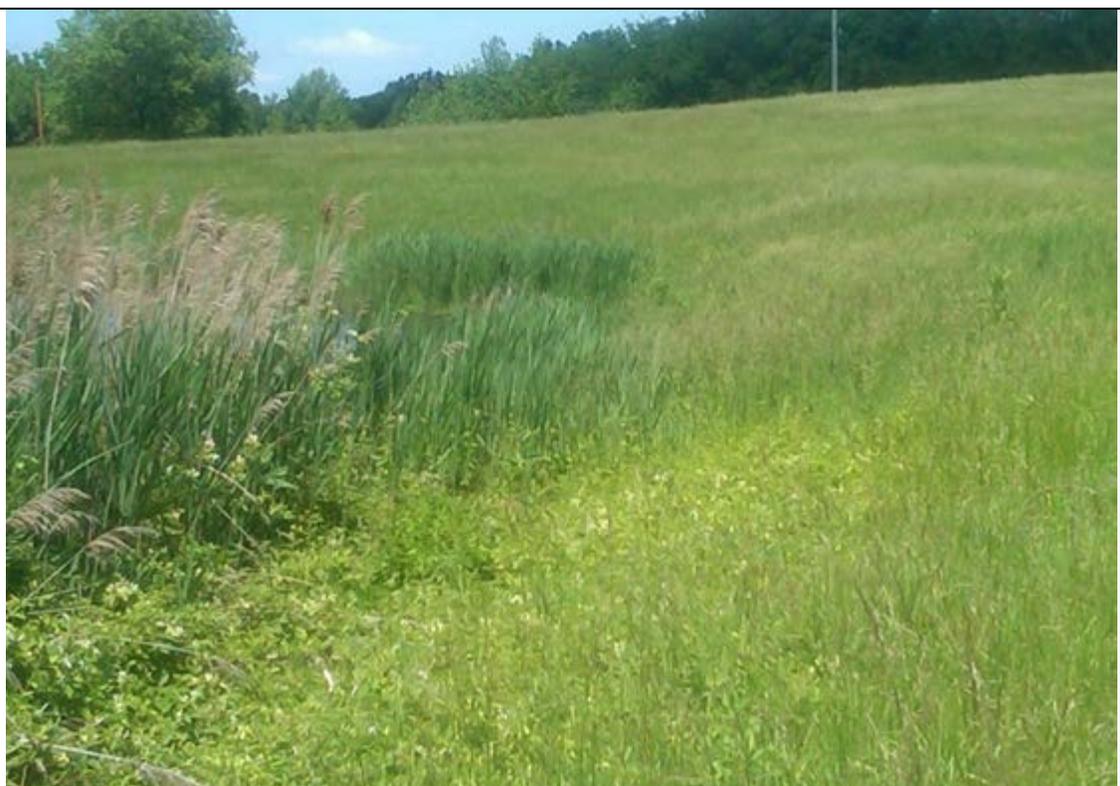
Photo No. 6	Date: 5/24/11
Direction Photo Taken: West

Description:
Valley slope along the Final Pond.

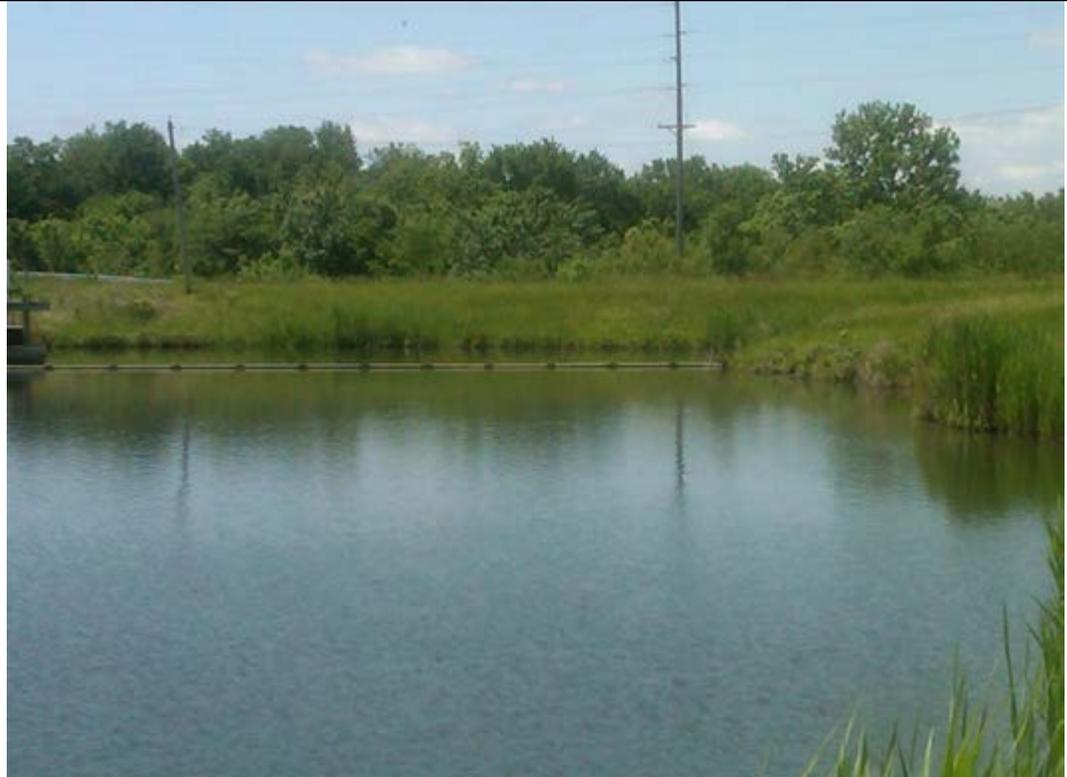
Photo No. 7	Date: 5/24/11

Direction Photo Taken: Southwest		
Description: Upstream slope of the Final Pond.

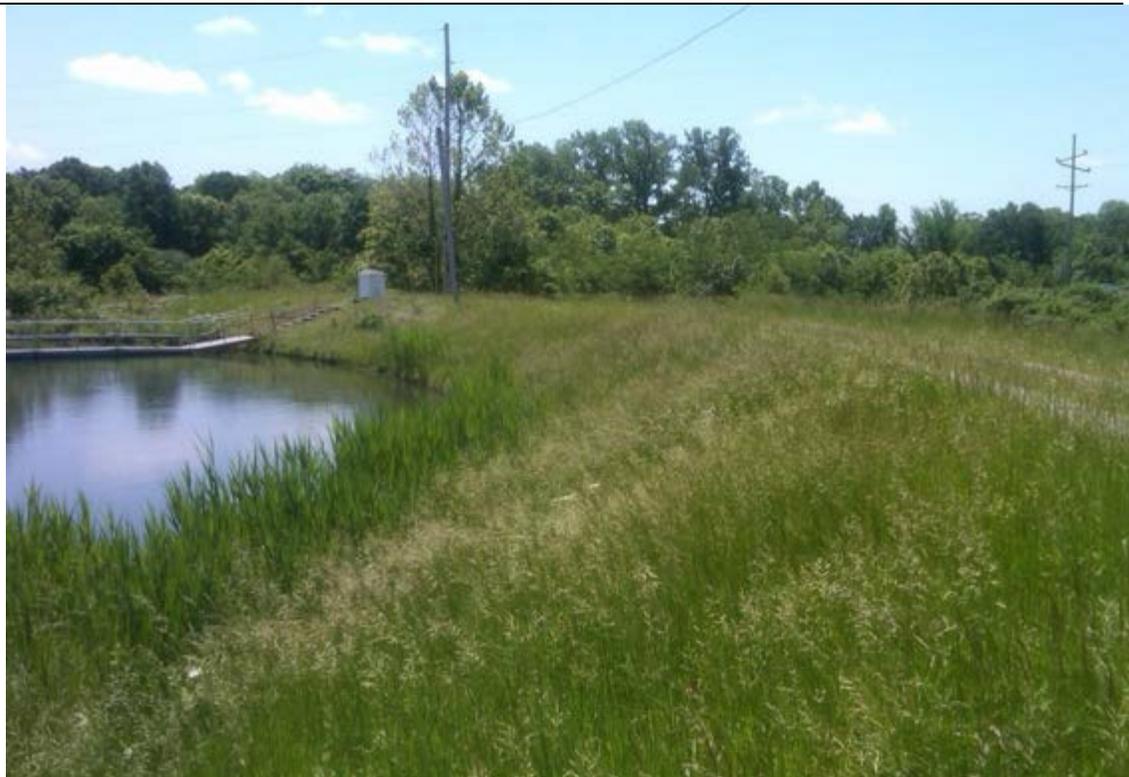
Photo No. 8	Date: 5/24/11

Direction Photo Taken: South		
Description: Upstream slope of the Final Pond.

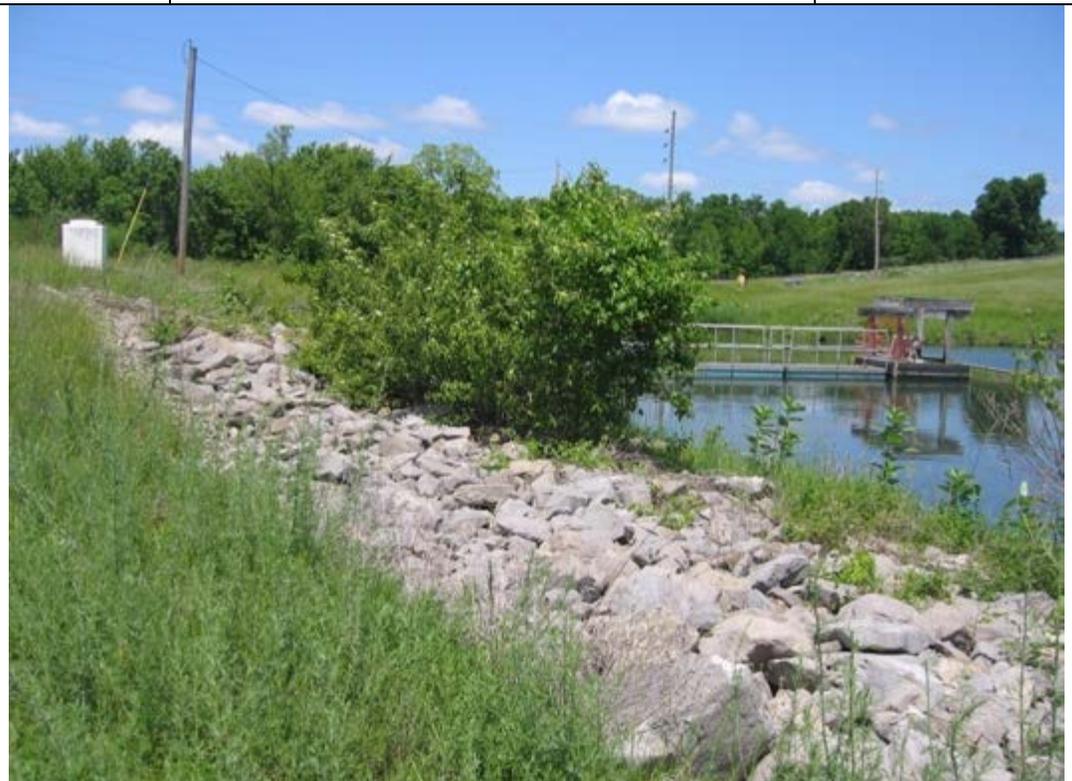
Photo No. 9	Date: 5/24/11
Direction Photo Taken: West

Description:
Upstream slope and decant structure of the Final Pond.

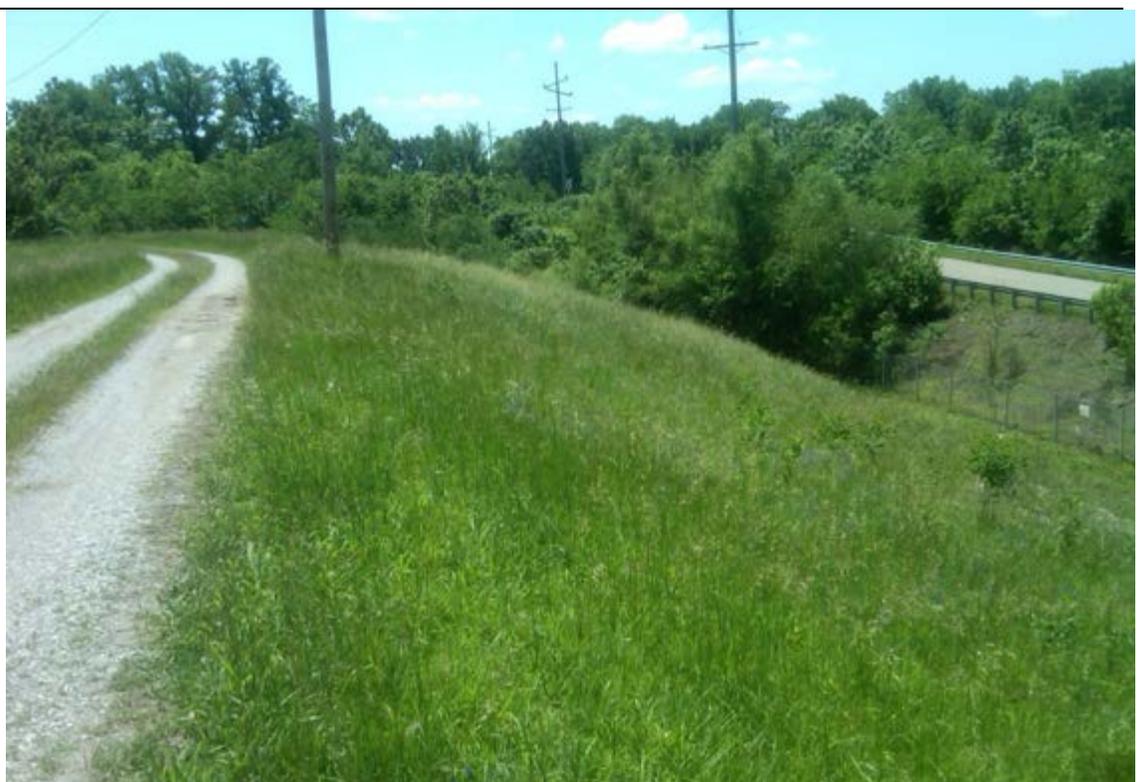
Photo No. 10	Date: 5/24/11
Direction Photo Taken: South

Description:
Crest and downstream slope of the Final Pond.

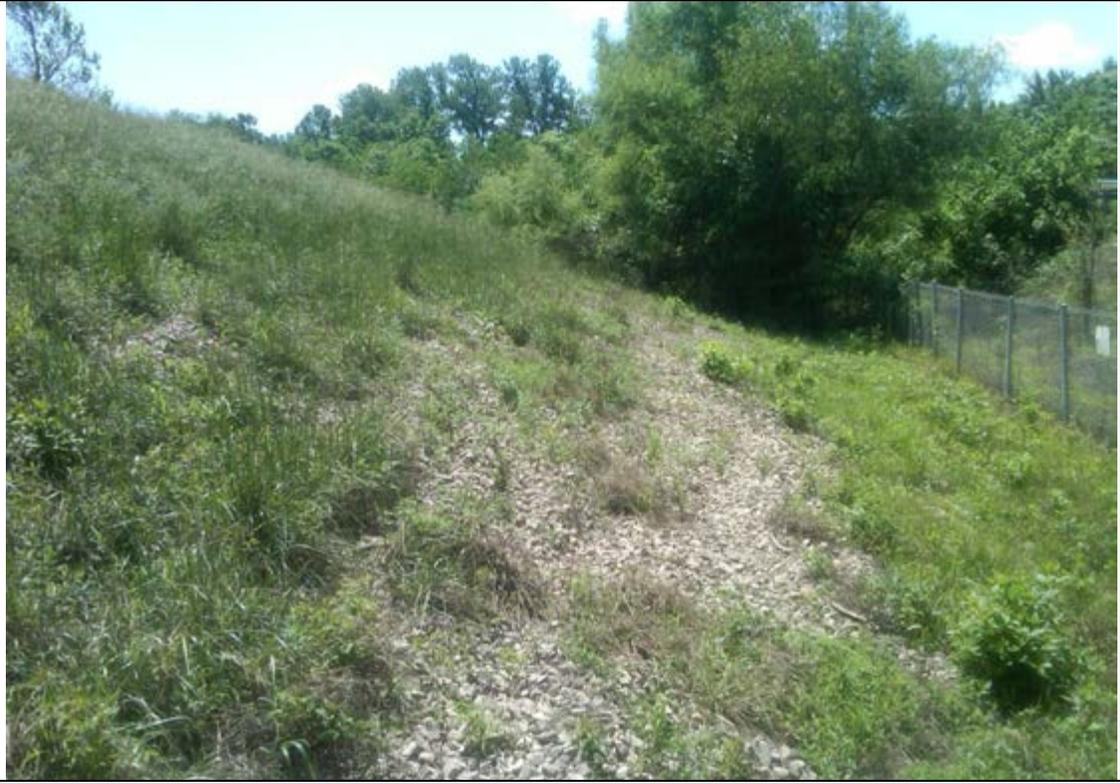
Photo No. 11	Date: 5/24/11
Direction Photo Taken: South

Description:
Downstream slope of the Final Pond.

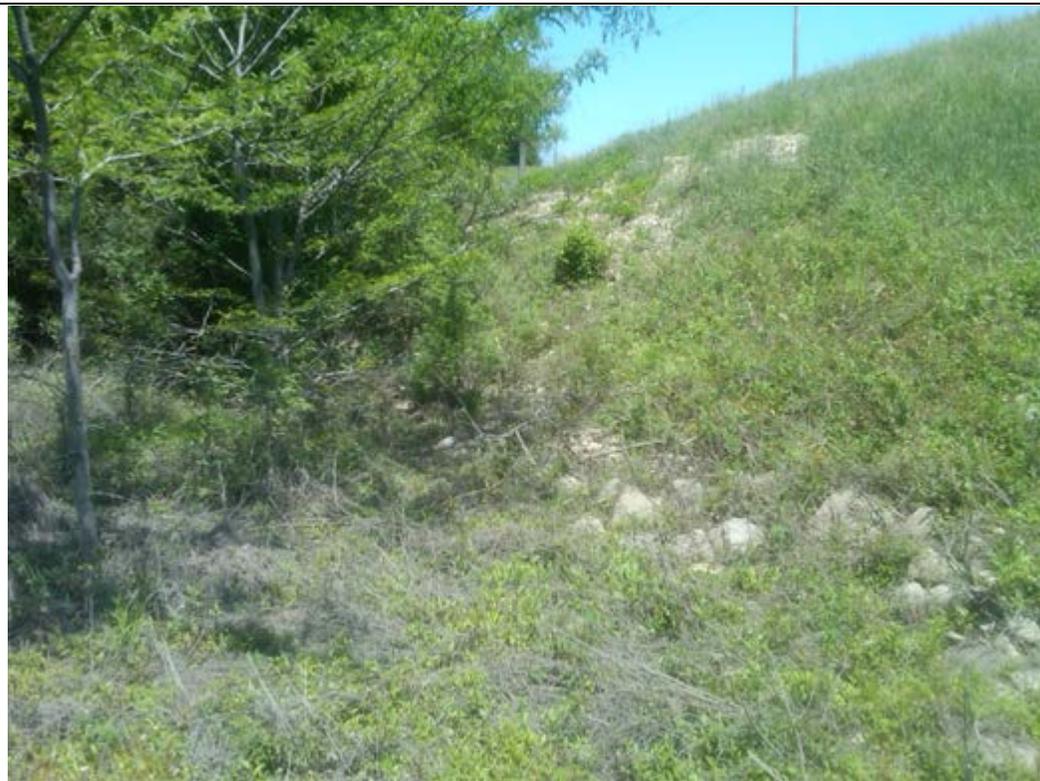
Photo No. 12	Date: 5/24/11
Direction Photo Taken: North

Description:
Downstream slope of the Final Pond.

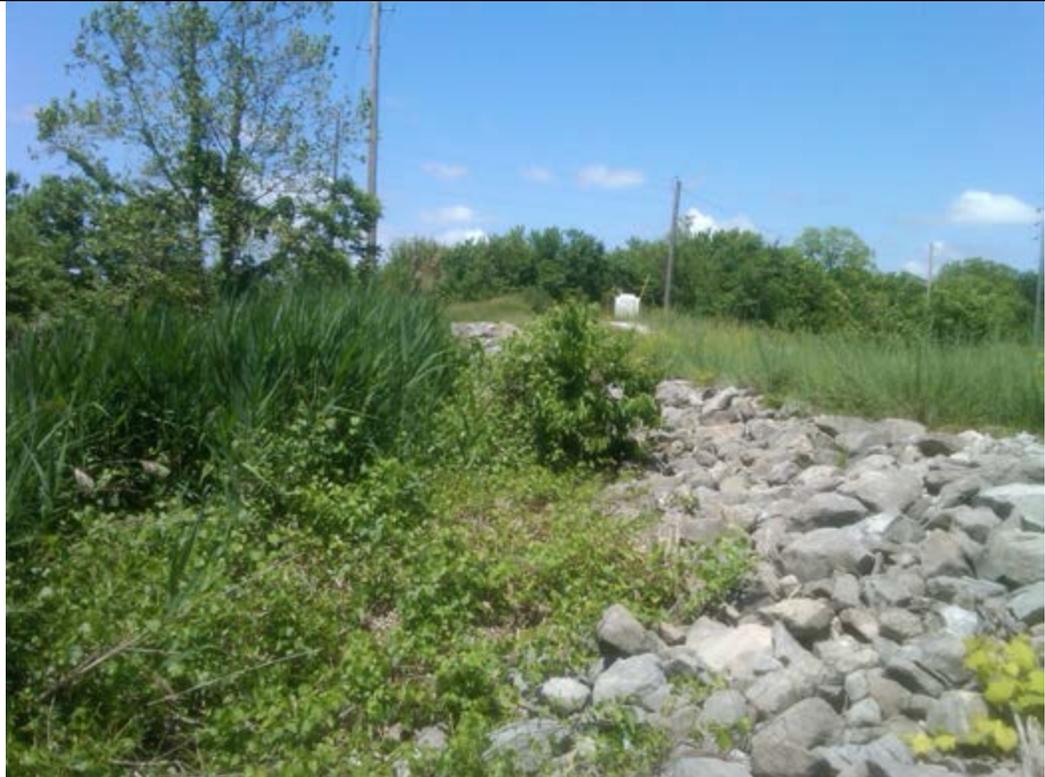
Photo No. 13	Date: 5/24/11
Direction Photo Taken: Northwest

Description:
Riprap on downstream slope of the Final Pond.

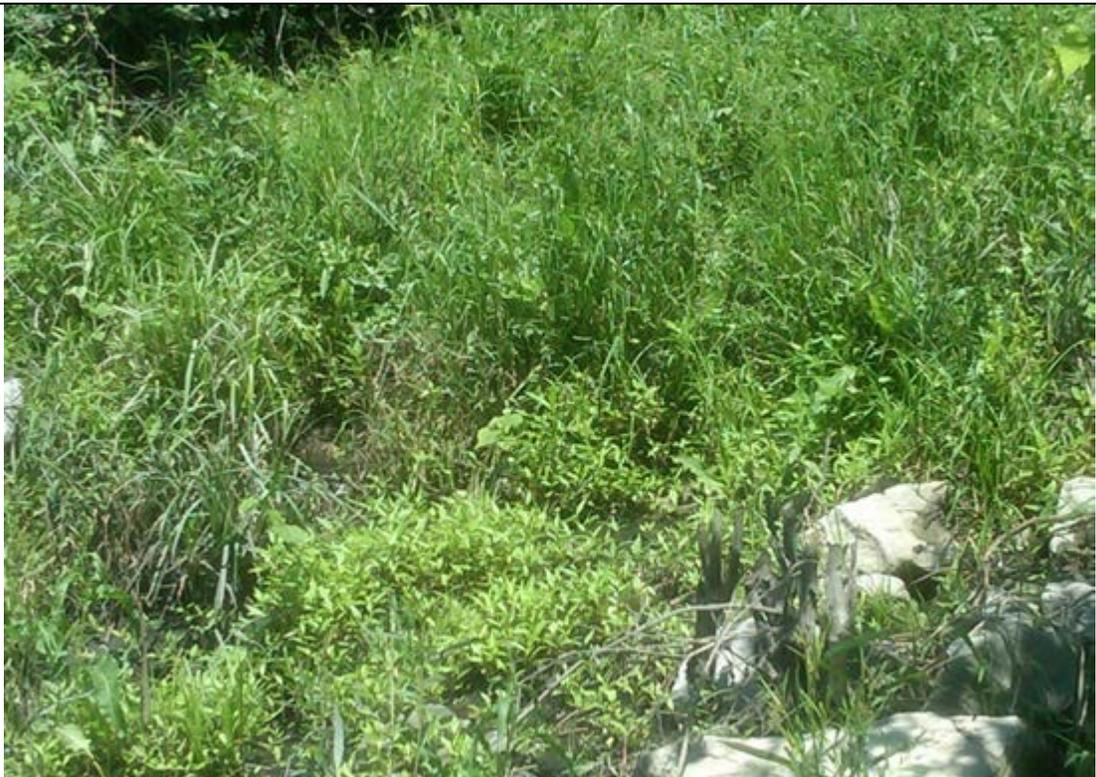
Photo No. 14	Date: 5/24/11
Direction Photo Taken: Southwest

Description:
Seepage on downstream slope of the Final Pond.

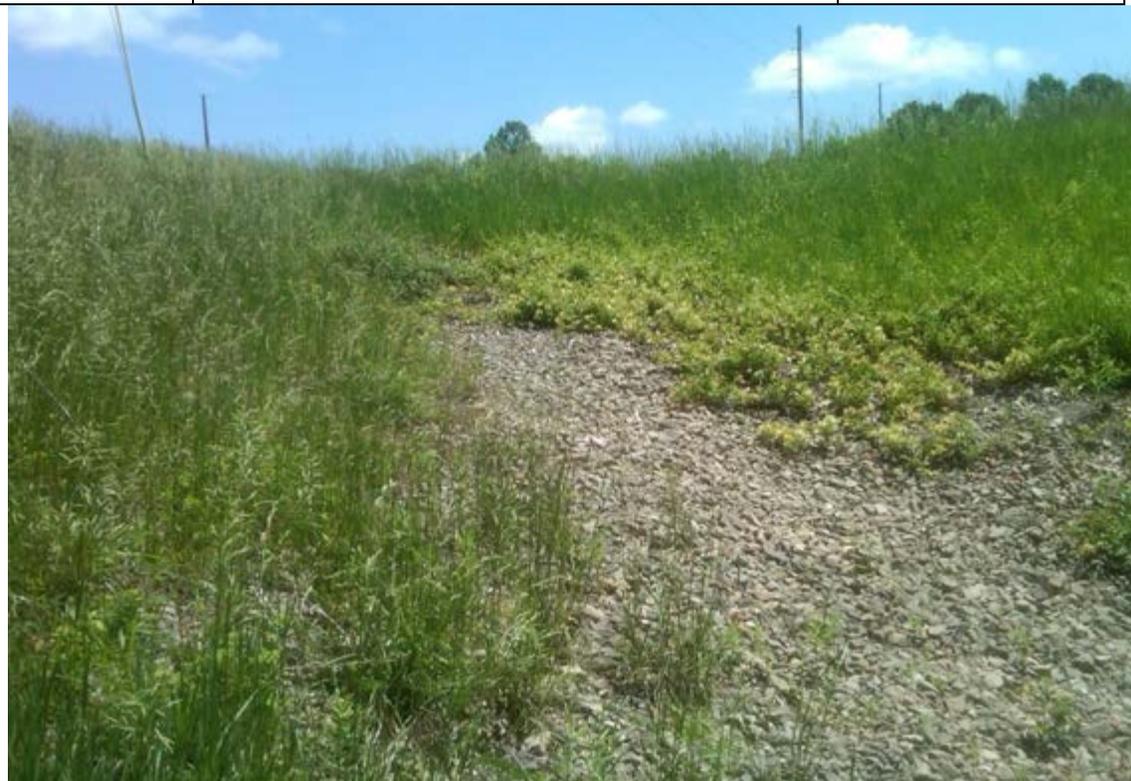
Photo No. 15	Date: 5/24/11
Direction Photo Taken: Northeast

Description:
Gravel lined drainage ditch on downstream slope of the Final Pond.

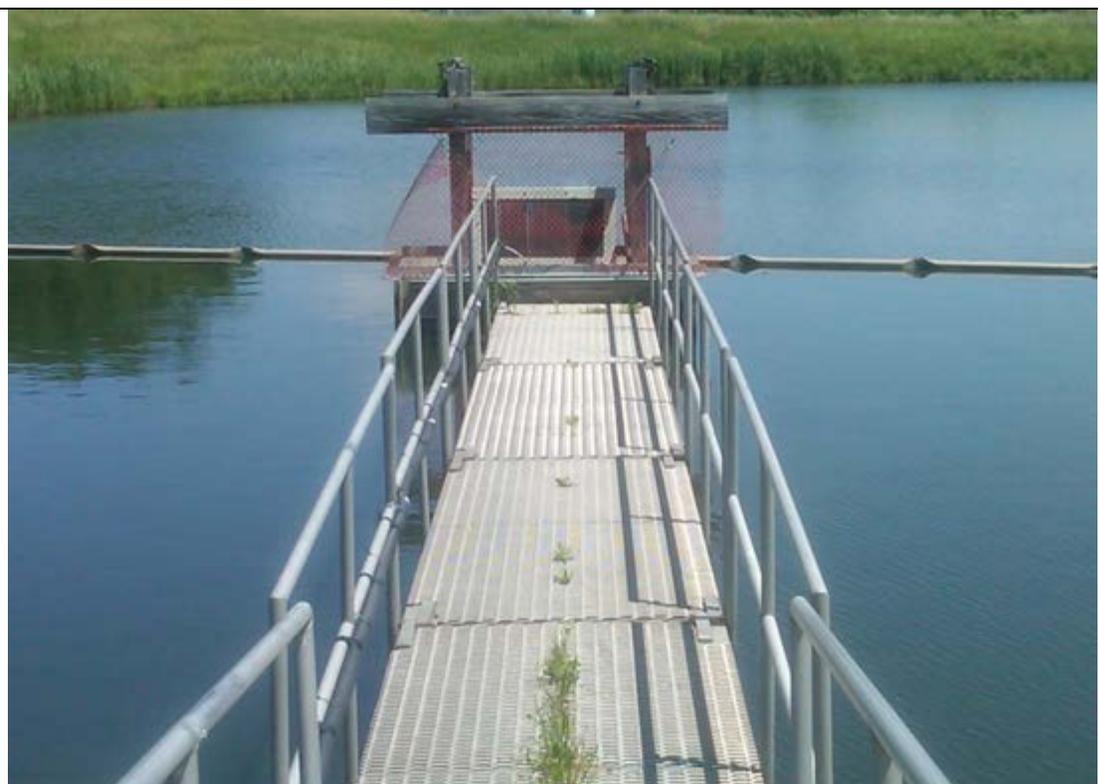
Photo No. 16	Date: 5/24/11
Direction Photo Taken: Northeast

Description:
Platform and decant structure for the Final Pond

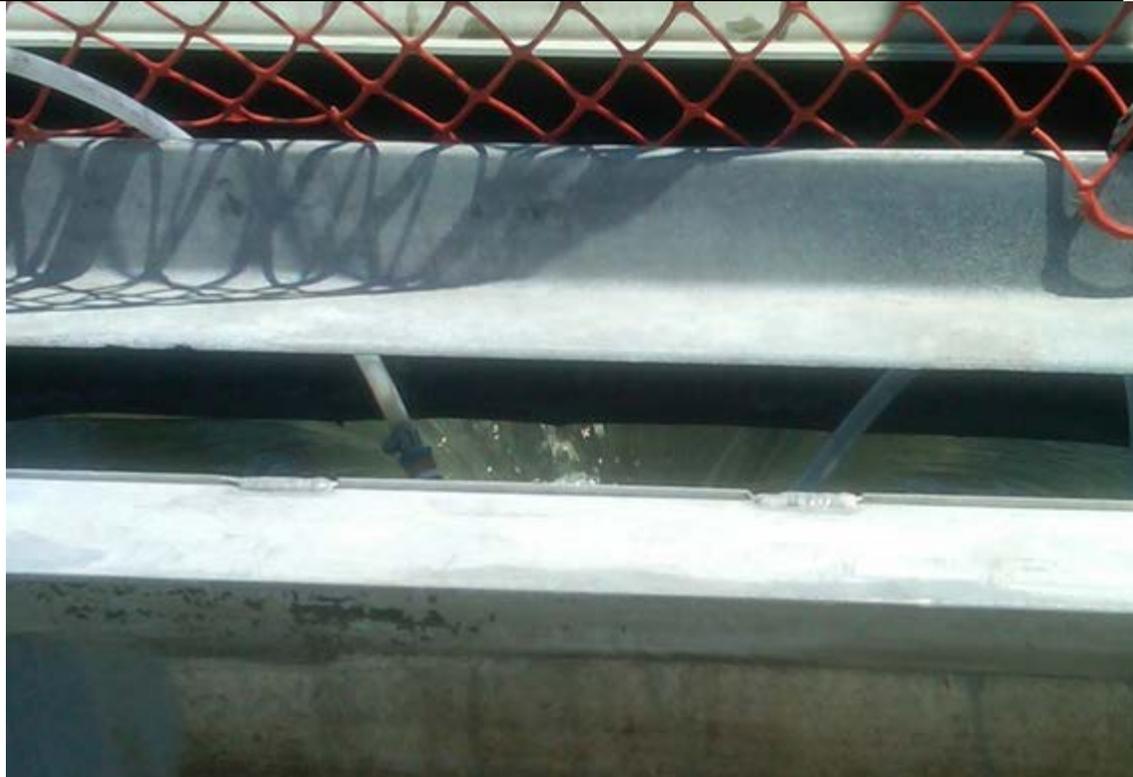
Photo No. 17	Date: 5/24/11
Direction Photo Taken: Northeast

Description:
Decant structure of the Final Pond showing the decant pipe appears to be nearly at capacity.

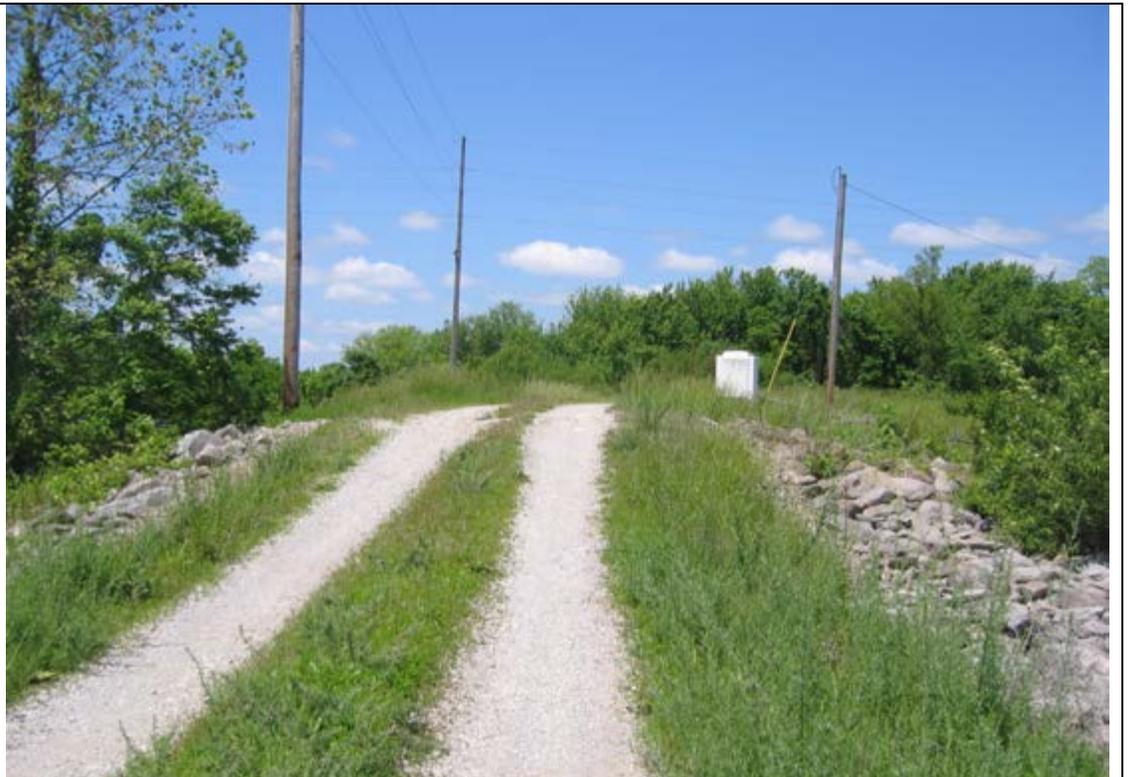
Photo No. 18	Date: 5/24/11
Direction Photo Taken: West

Description:
Crest of the Settling Pond Dike.

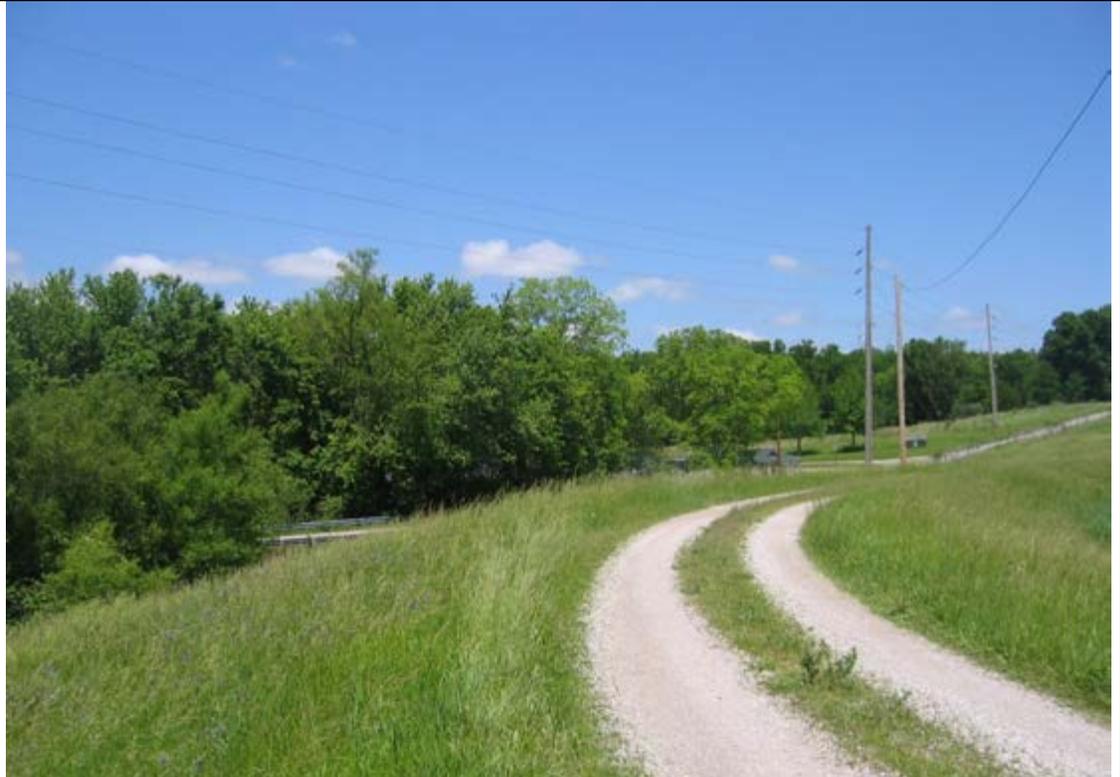
Photo No. 19	Date: 5/24/11
Direction Photo Taken: Northwest

Description:
Crest of the Settling Pond Dike.

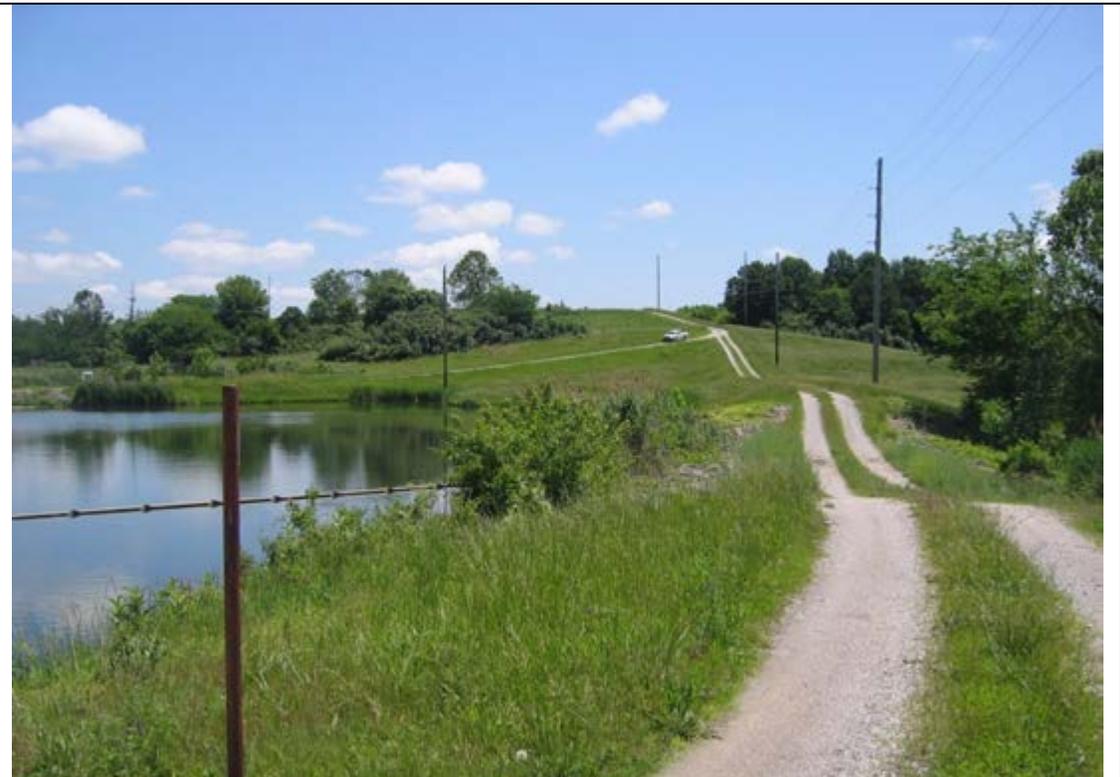
Photo No. 20	Date: 5/24/11
Direction Photo Taken: East

Description:
Crest of the Settling Pond Dike near the overflow section.

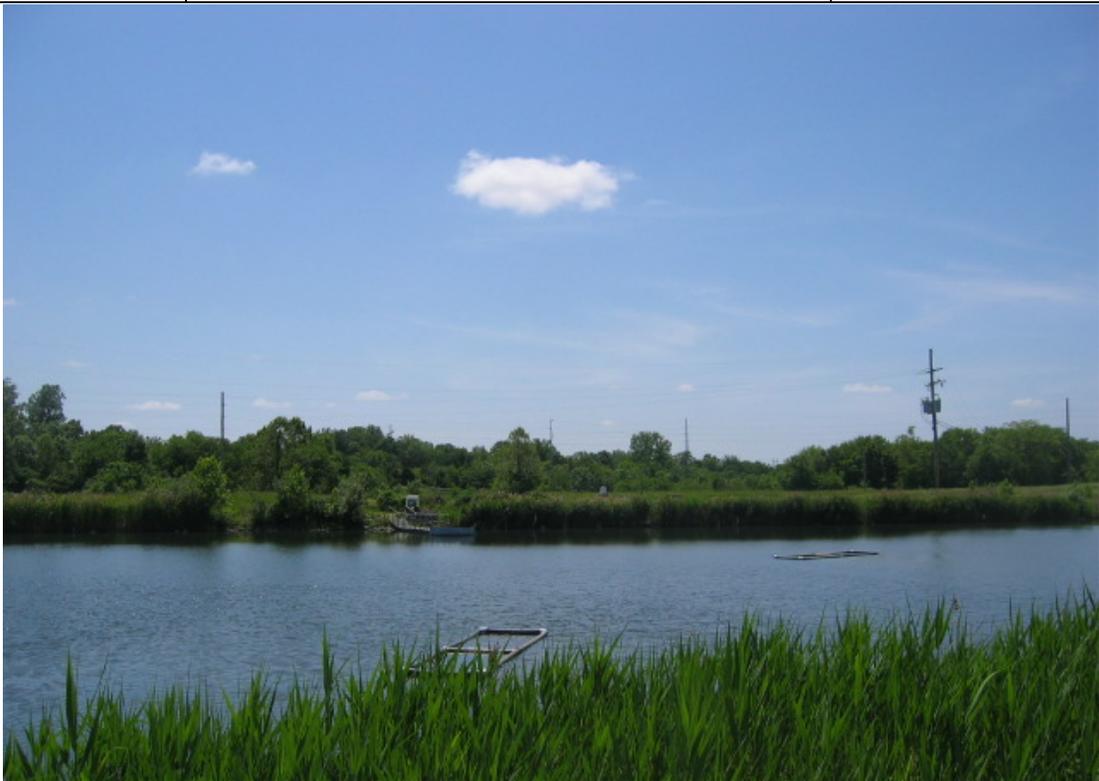
Photo No. 23	Date: 5/24/11

Direction Photo Taken: Southwest		
Description: Upstream slope of the Ash Pond Dike as seen from Secondary Dike
