**FINAL REPORT
ROUND 10 DAM ASSESSMENT
DYNEGY MIDWEST GENERATION, LLC – BALDWIN ENERGY COMPLEX
PRIMARY FLY ASH POND, SECONDARY FLY ASH POND, SECONDARY POND,
INTERMEDIATE POND, FINAL POND
BALDWIN, ILLINOIS**

December 21, 2012
GZA File No. 170142.30

RE: FINAL Assessment of Dam Safety of Coal Combustion Surface Impoundments at the Baldwin Energy Complex

**FINAL REPORT
ROUND 10 DAM ASSESSMENT
DYNEGY MIDWEST GENERATION, LLC – HENNEPIN POWER STATION
ACTIVE EAST ASH POND SYSTEM, EAST ASH POND SYSTEM, WEST ASH POND
SYSTEM
HENNEPIN, ILLINOIS**

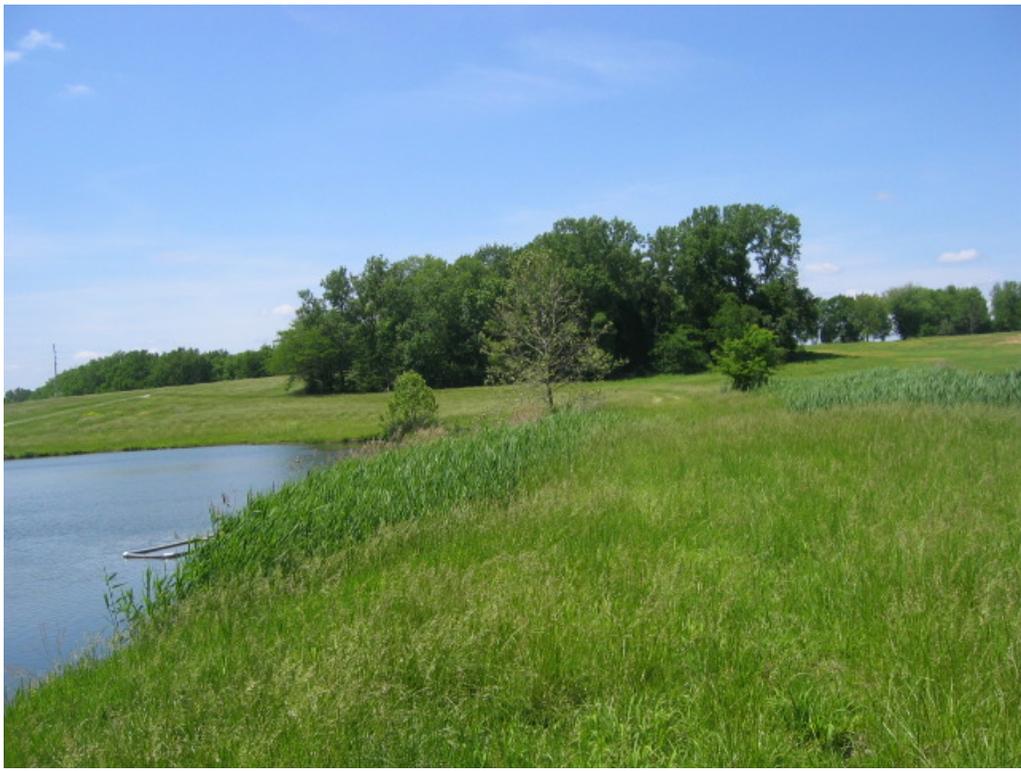
Photo No. 24	Date: 5/24/11

Direction Photo Taken: Northwest		
Description: Crest, upstream and downstream slope of the Secondary Dike

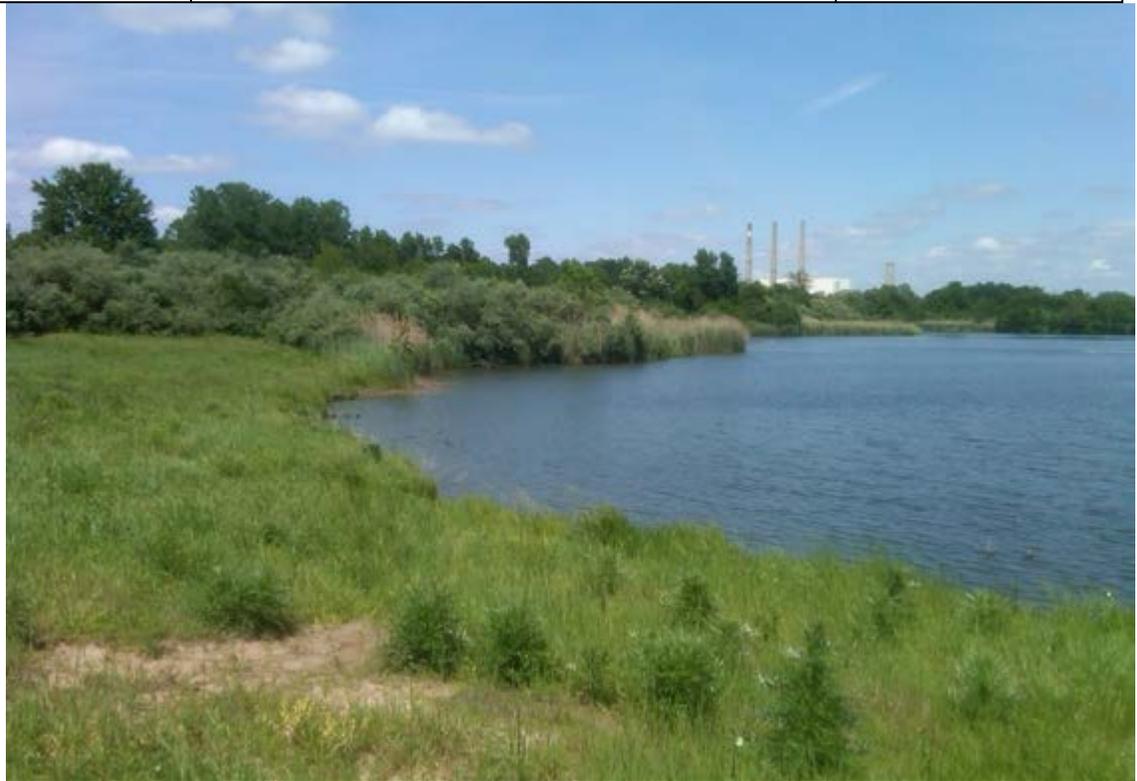
Photo No. 25	Date: 5/24/11
Direction Photo Taken: North	
Description: Upstream slope of the Secondary Pond

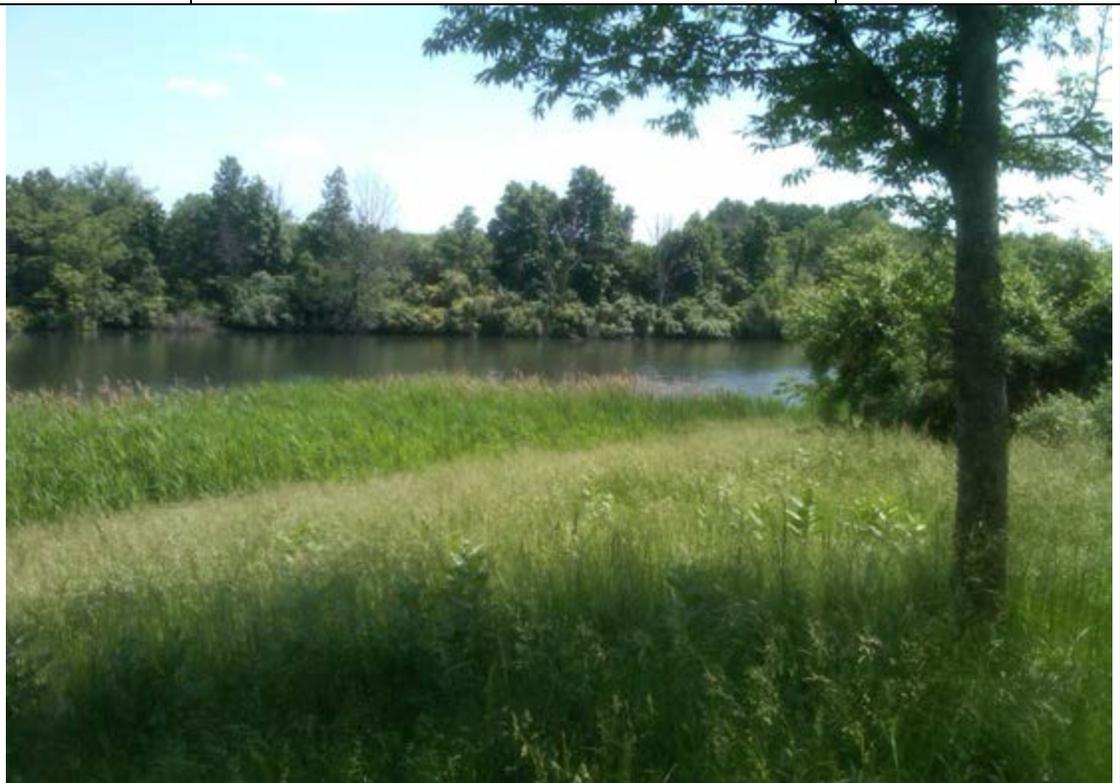
The water surface elevation in the Secondary Pond at the time of assessment was at elevation 396.1 feet MSL. Therefore, the lower portion of the upstream slope was below the water level and not visible. The upstream valley slopes that were above the water were generally thickly vegetated with shrubs and trees up to 24 inches in diameter. The typical conditions of the valley slopes are shown on Photos 26, 27, 28, and 31.

Description:
Upstream slope of
Secondary Pond

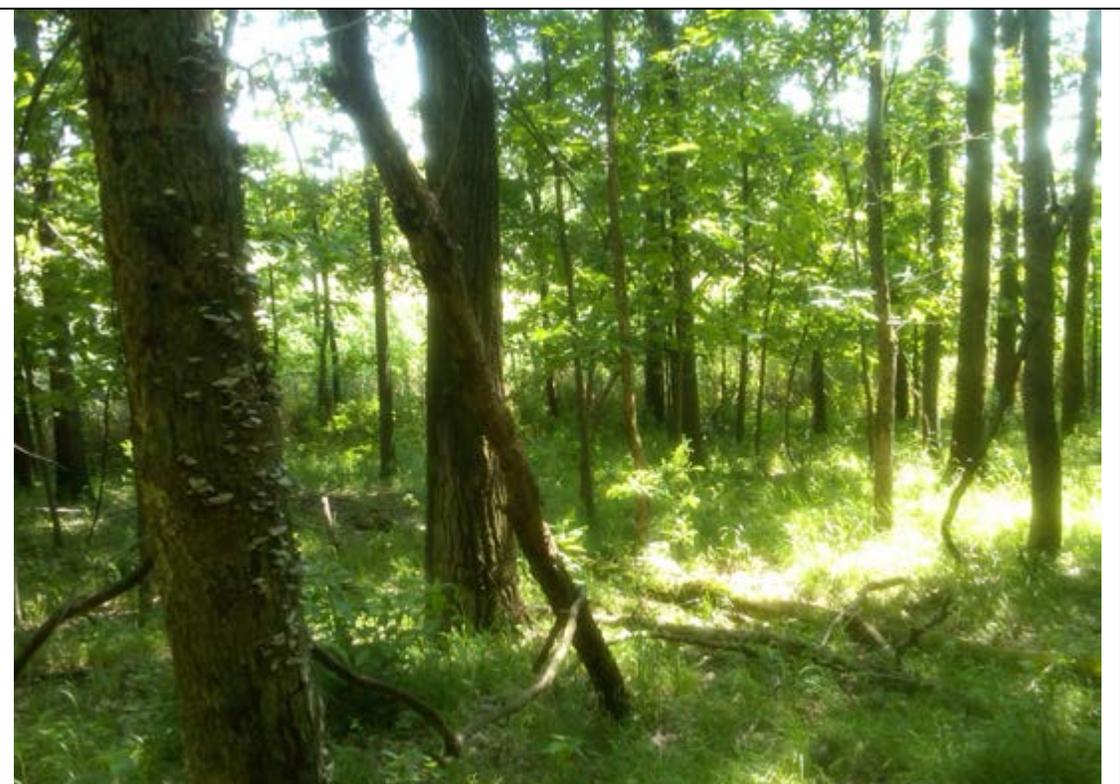
Photo No. 28	Date: 5/24/11
-------------------------------	-------------------------

Description:
Upstream slope of the
Secondary Pond

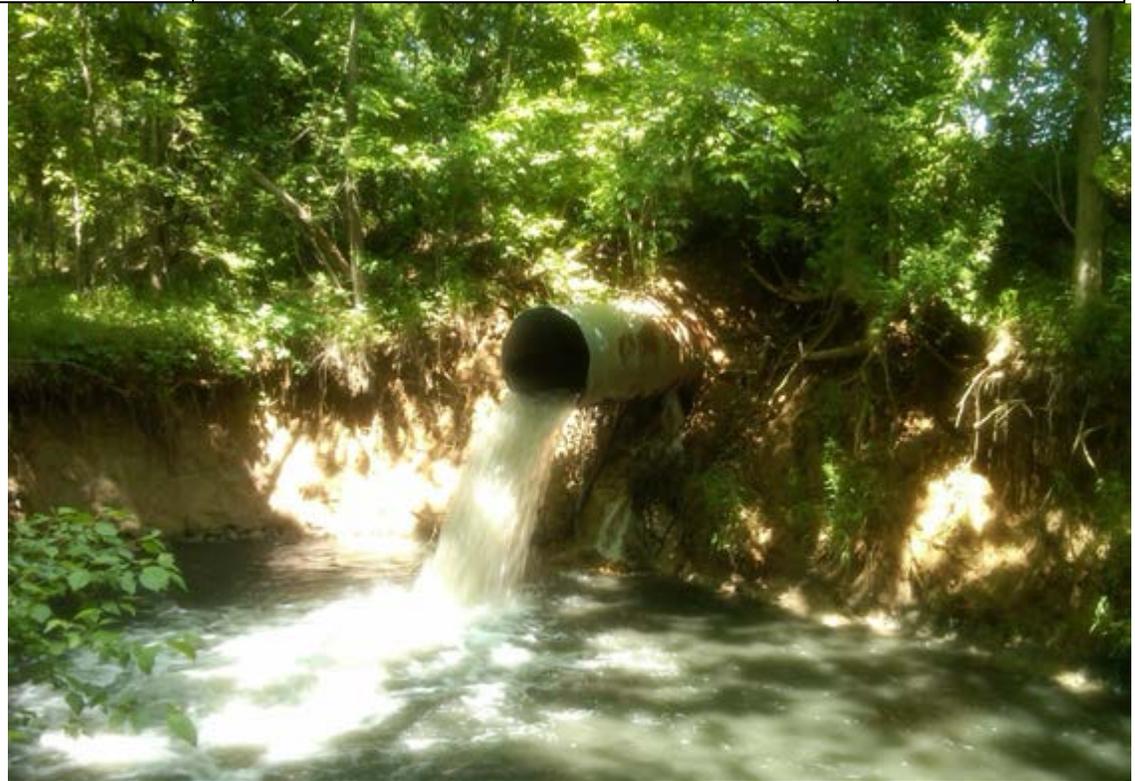
Photo No. 29	Date: 5/24/11
Direction Photo Taken: East

Water and CCW enters the northern portion of the PFAP through a series of 10 inch diameter steel pipes. The discharge pipes appeared to be in good condition based on our visual observations. Water is removed from the northern portion of the PFAP through the decant structure for the northern portion of the PFAP that appeared to be approximately 24 inches in diameter. However, the decant structure was difficult to access due to dense vegetation. Water that enters the northern decant structure discharges upstream of the Secondary Pond via an approximately 24-inch diameter CMP pipe. The CMP discharge pipe showed signs of damage and significant leaking. The leaking water had eroded the soil around a portion of the discharge pipe as shown in Photos 29 and 30. There was no riprap or other erosion control protection observed near the CMP discharge pipe.

Description:
Discharge pipe for Bottom Ash Process water from the northern part of the Primary Fly Ash Pond to the Secondary Pond.

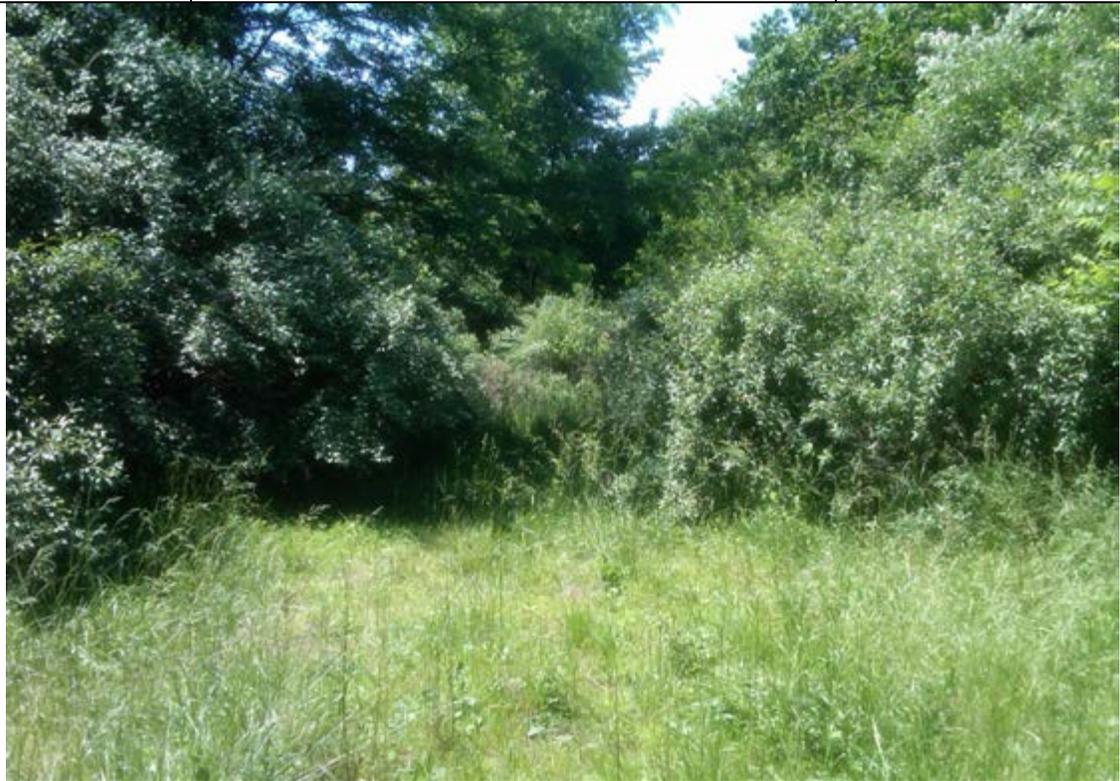
Photo No. 31	Date: 5/24/11

Direction Photo Taken: East		
Description: Upstream slope of the Secondary Pond

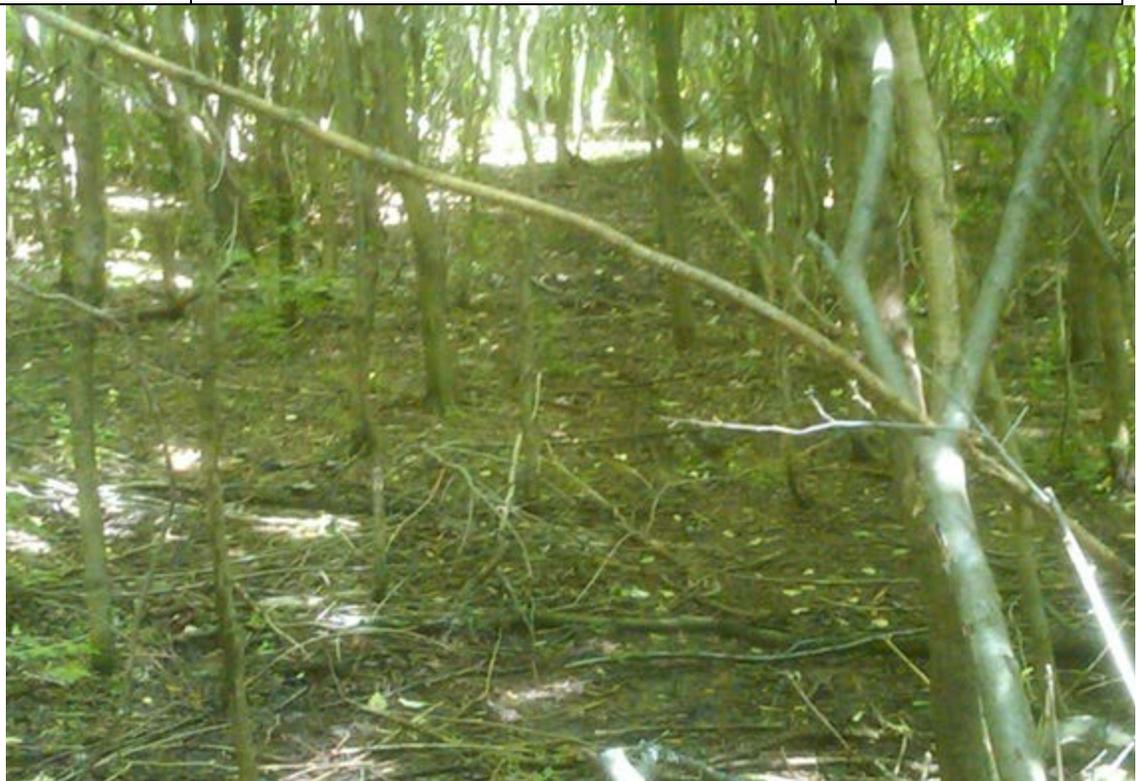
Photo No. 33	Date: 5/24/11
Direction Photo Taken: East

Description:
Conditions at the downstream toe of the southern embankment of the Secondary Fly Ash Pond.

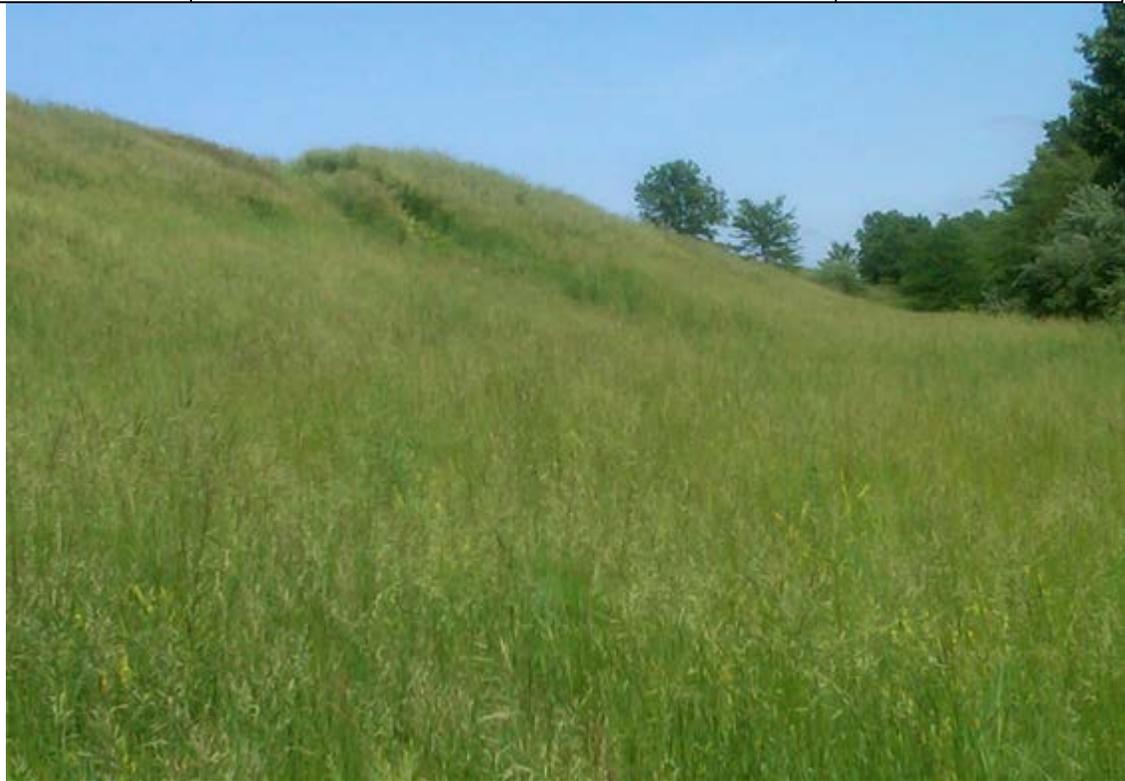
Photo No. 35	Date: 5/24/11
Direction Photo Taken: East

Description:
Downstream slope and toe of the southern embankment of the Secondary Fly Ash Pond.

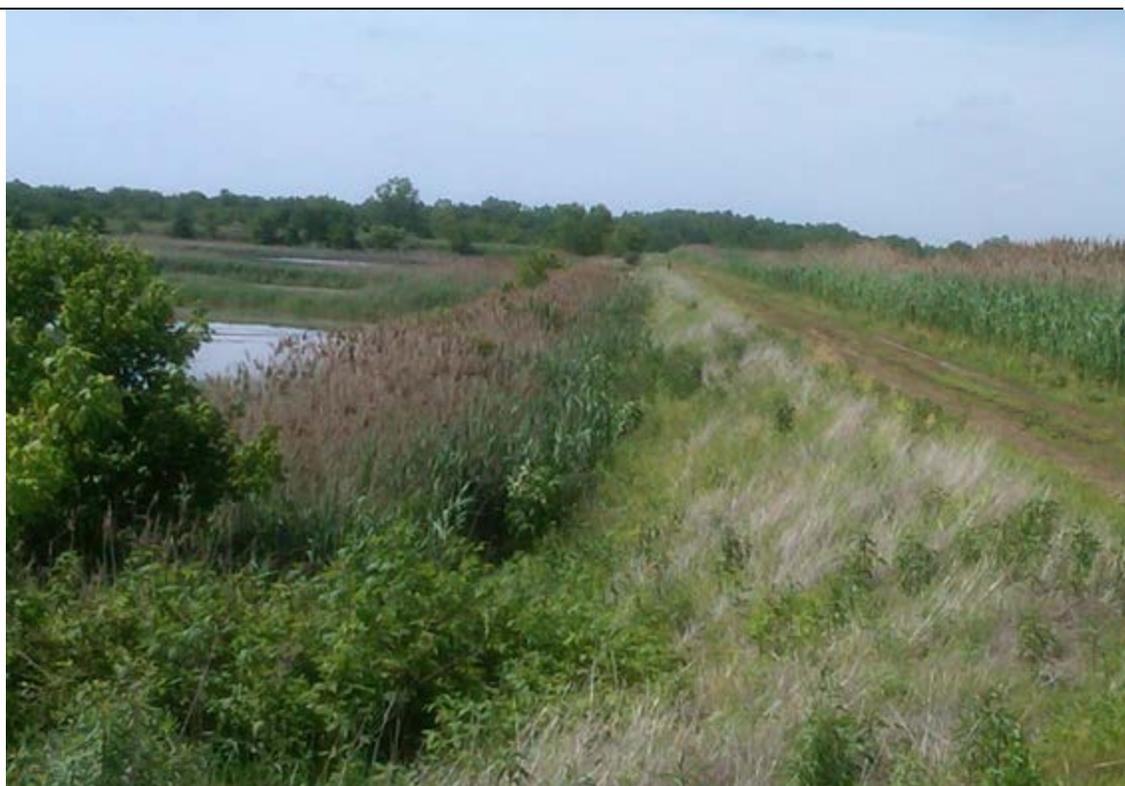
Photo No. 36	Date: 5/24/11
Direction Photo Taken: Northwest

Description:
Downstream slope and crest of Intermediate Embankment.

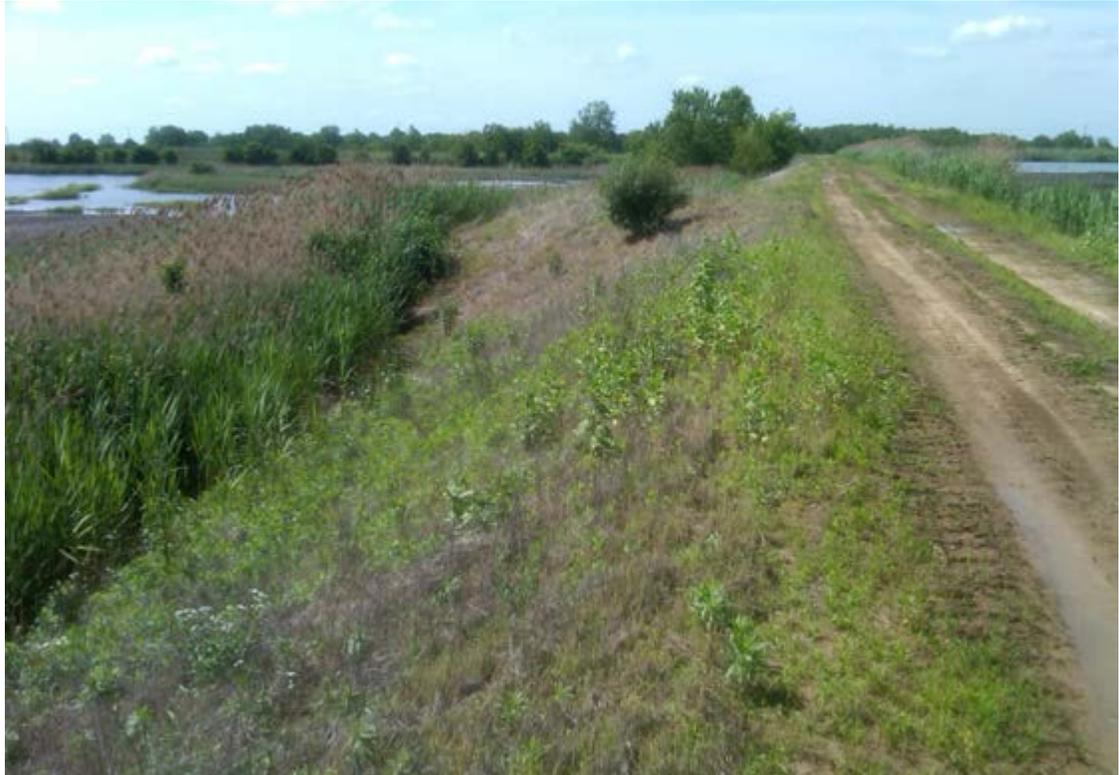
Photo No. 37	Date: 5/24/11

Direction Photo Taken: Northwest		
Description: Downstream slope and crest of the Intermediate Embankment.

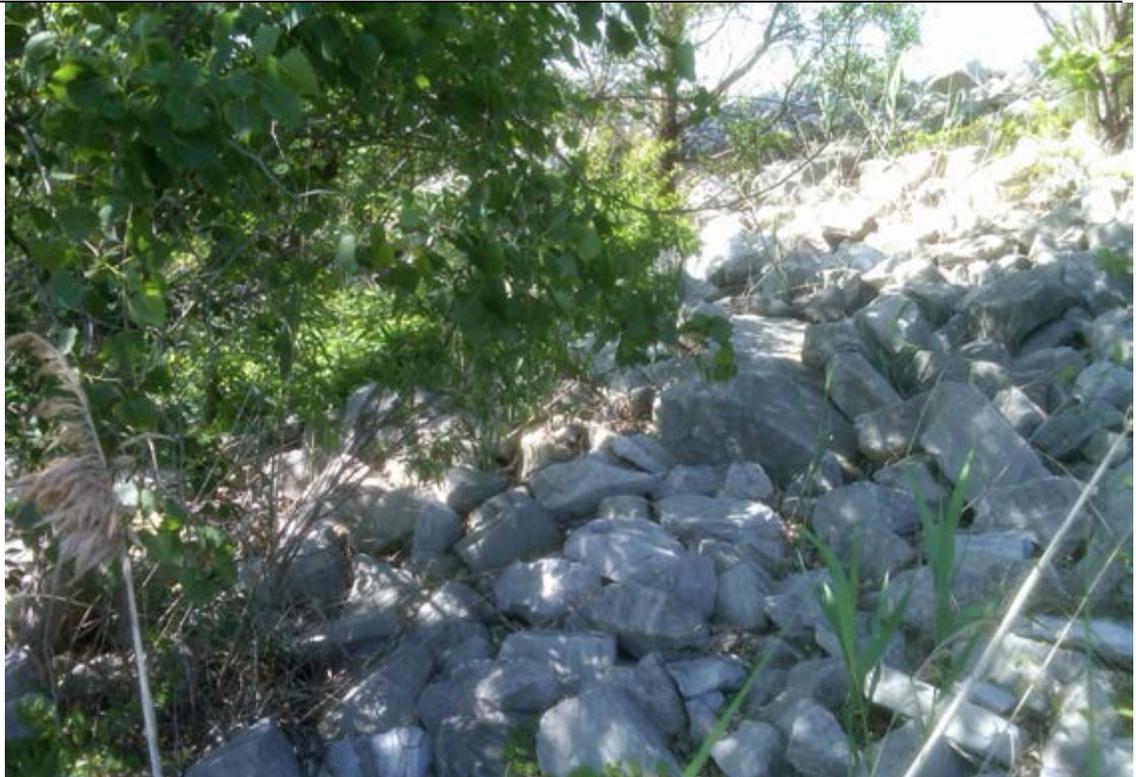
Photo No. 38	Date: 5/24/11

Direction Photo Taken: Northwest		
Description: Downstream slope of the Intermediate Embankment showing an area that had been armored with riprap.

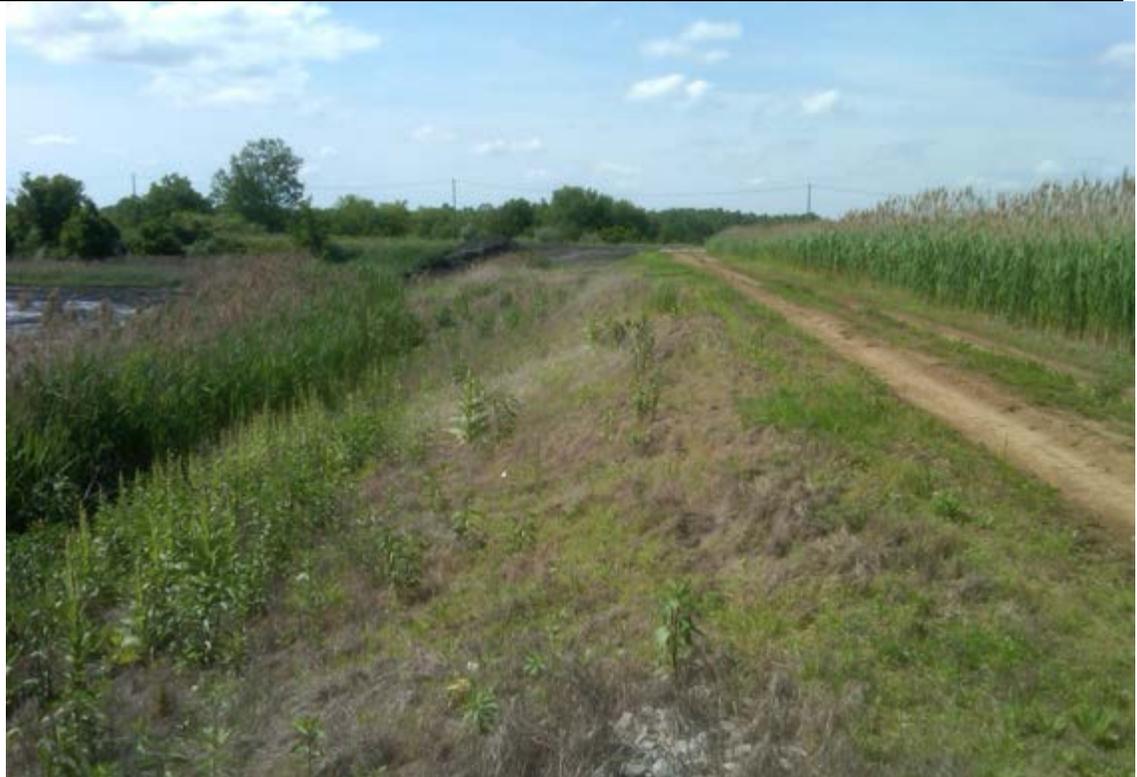
Photo No. 39	Date: 5/24/11
Direction Photo Taken: Northwest	
Description: Downstream slope and crest of the Intermediate Embankment.

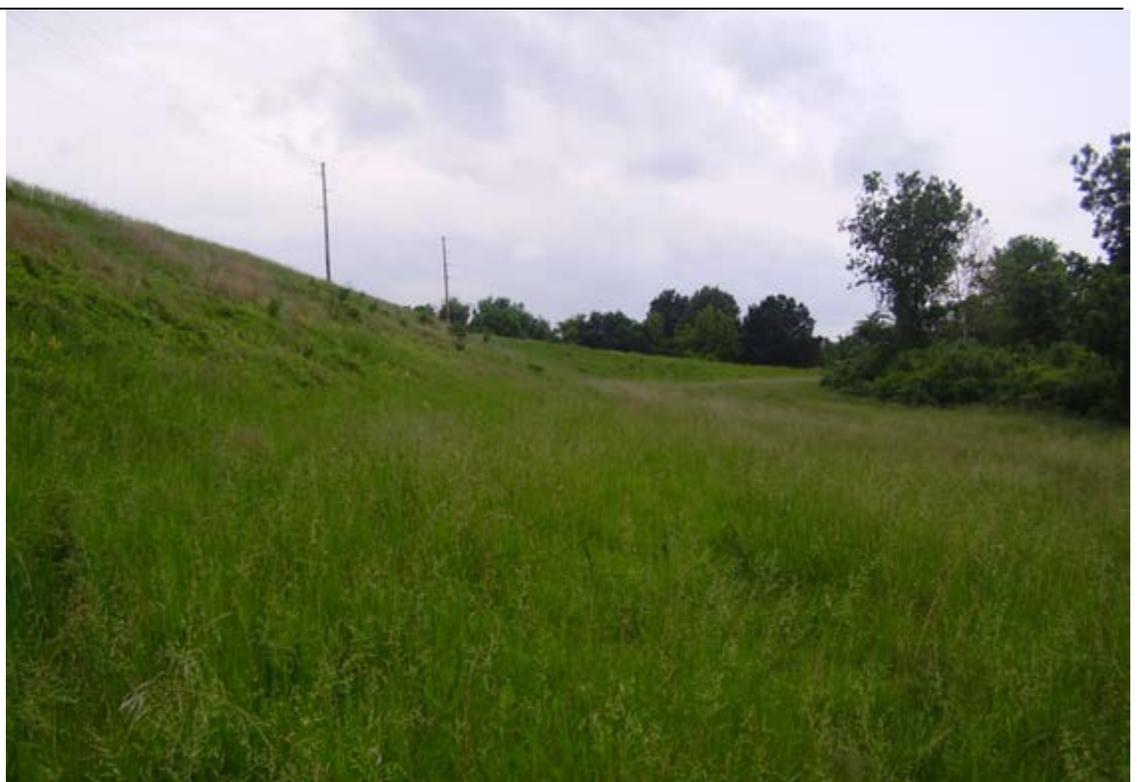
Photo No. 40	Date: 5/24/11
Direction Photo Taken: Southwest	
Description: Downstream slope and toe of the northern embankment of the Secondary Fly Ash Pond

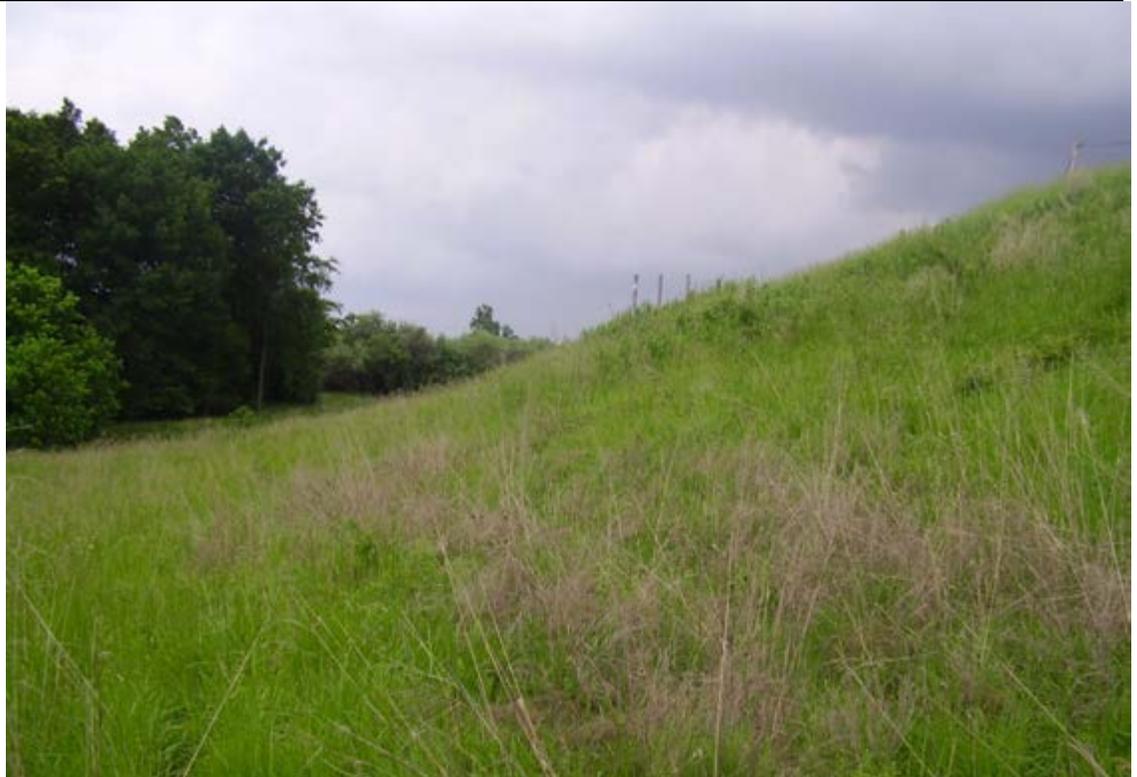
Photo No. 41	Date: 5/24/11
Direction Photo Taken: Northeast	
Description: Downstream slope and toe of the northern embankment of the Secondary Fly Ash Pond.

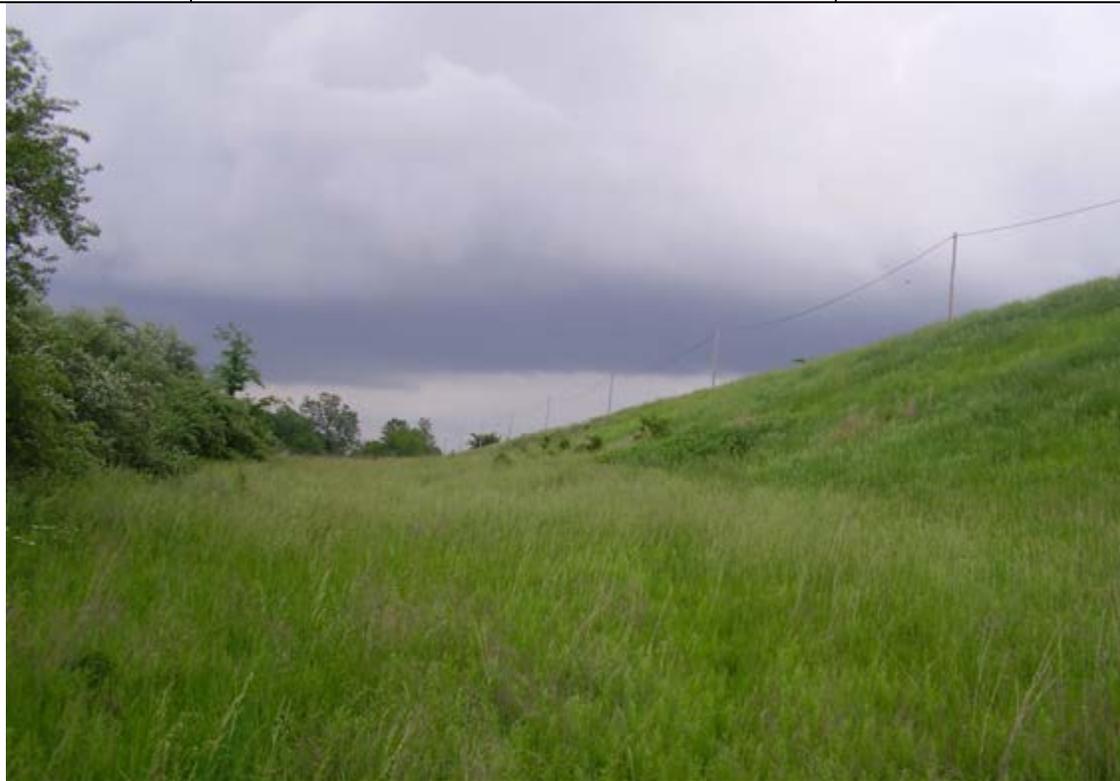
Photo No. 45	Date: 5/24/11
Direction Photo Taken: Northeast

Description:
Downstream slope and toe of the northern embankment of the Secondary Fly Ash Pond.

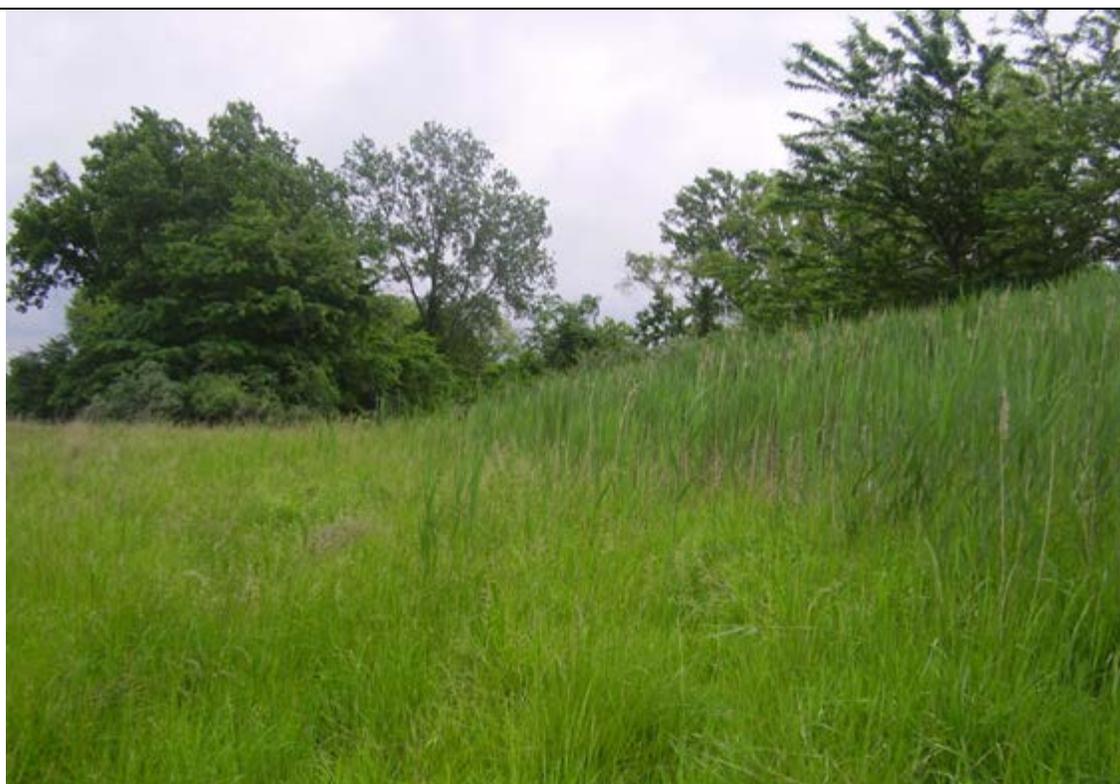
Photo No. 46	Date: 5/24/11
Direction Photo Taken: Northeast

Description:
Downstream slope and toe of the northern embankment of the Secondary Fly Ash Pond.

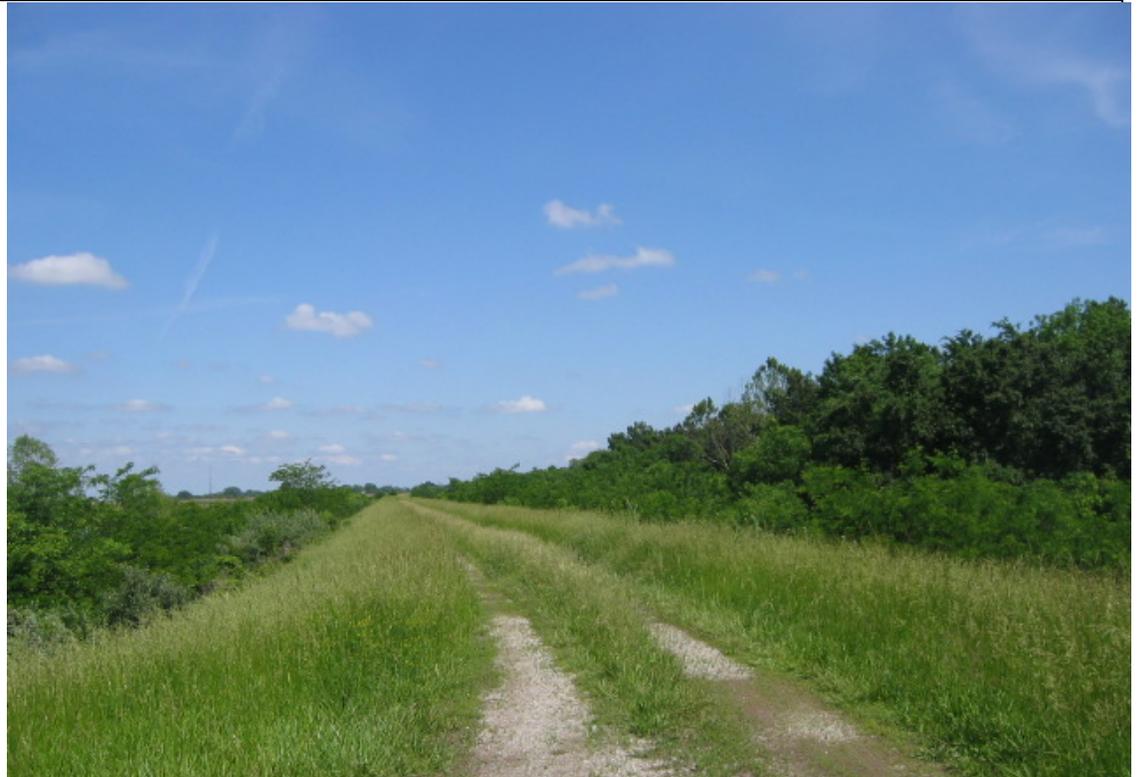
Photo No. 47	Date: 5/24/11
Direction Photo Taken: East

The crest was lowered 21 feet to an elevation of 434 feet MSL along a portion of the southern embankment in response to the 1995 Failure as shown in Photo 47. No significant settlement or evidence of continued movement was observed at the time of our assessment. There was approximately 4 feet of free board at the time of our assessment.

Description:
Crest and upstream Slope of the southern embankment of the Secondary Fly Ash Pond.

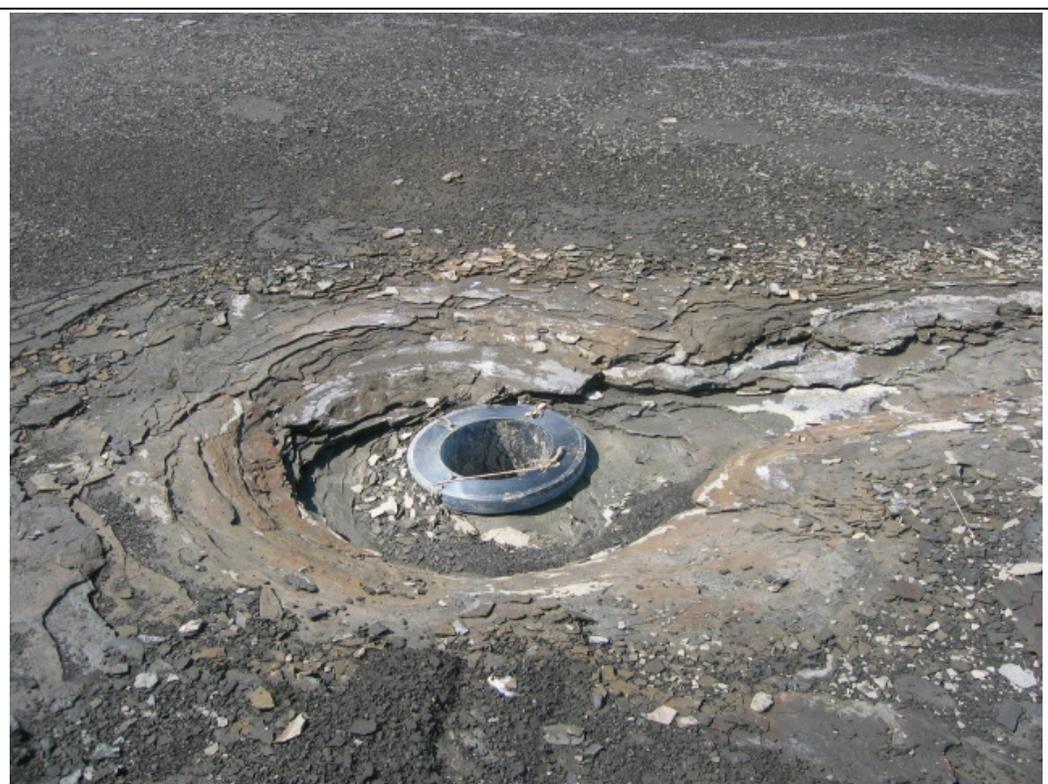
Photo No. 50	Date: 5/24/11
Direction Photo Taken: Northeast

Description:
One of several decant pipes used to transport water from the southern portion of the Primary Fly Ash Pond to the Secondary Fly Ash Pond.

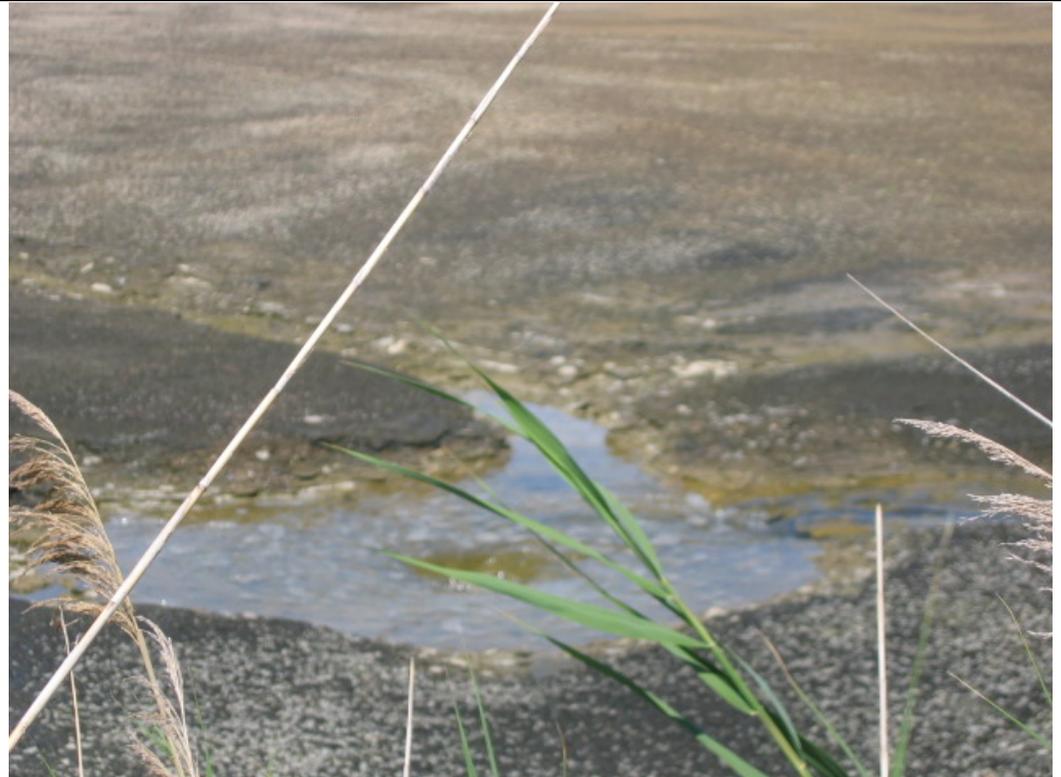
Photo No. 51	Date: 5/24/11
Direction Photo Taken: Northeast

Description:
Decant pipe transmitting water from the Primary Fly Ash Pond to the Secondary Fly Ash Pond.

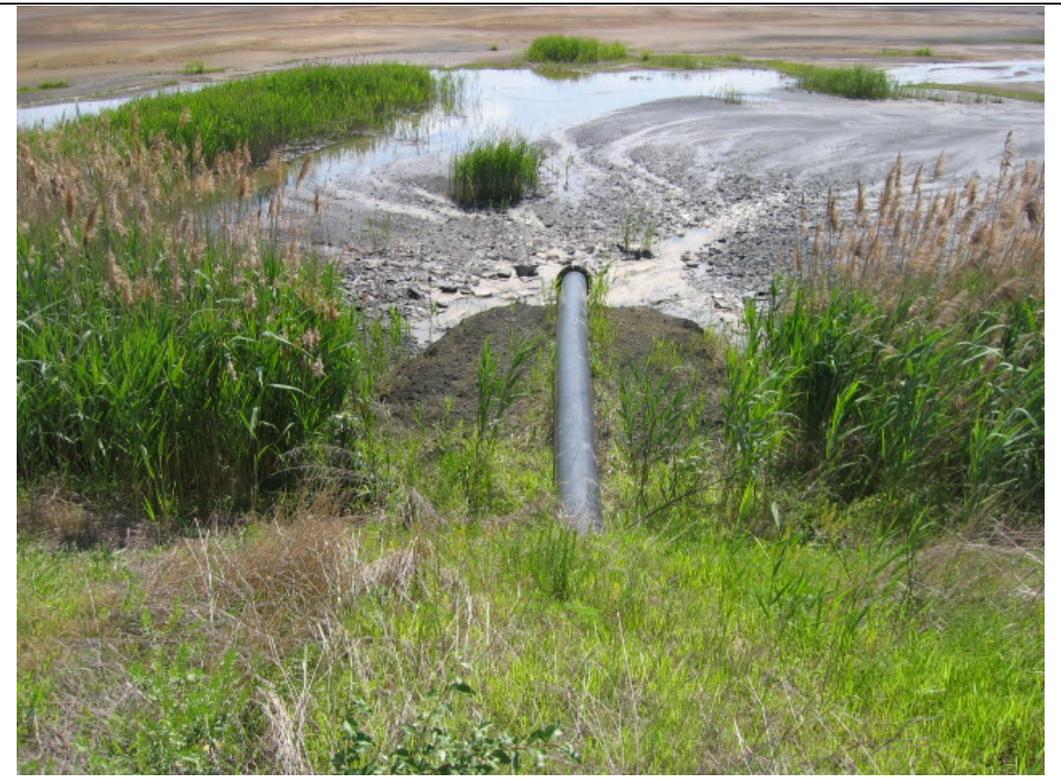
Photo No. 52	Date: 5/24/11
Direction Photo Taken: Southwest

Description:
One of several discharge pipes from the Primary Fly Ash Pond into the Secondary Fly Ash Pond.

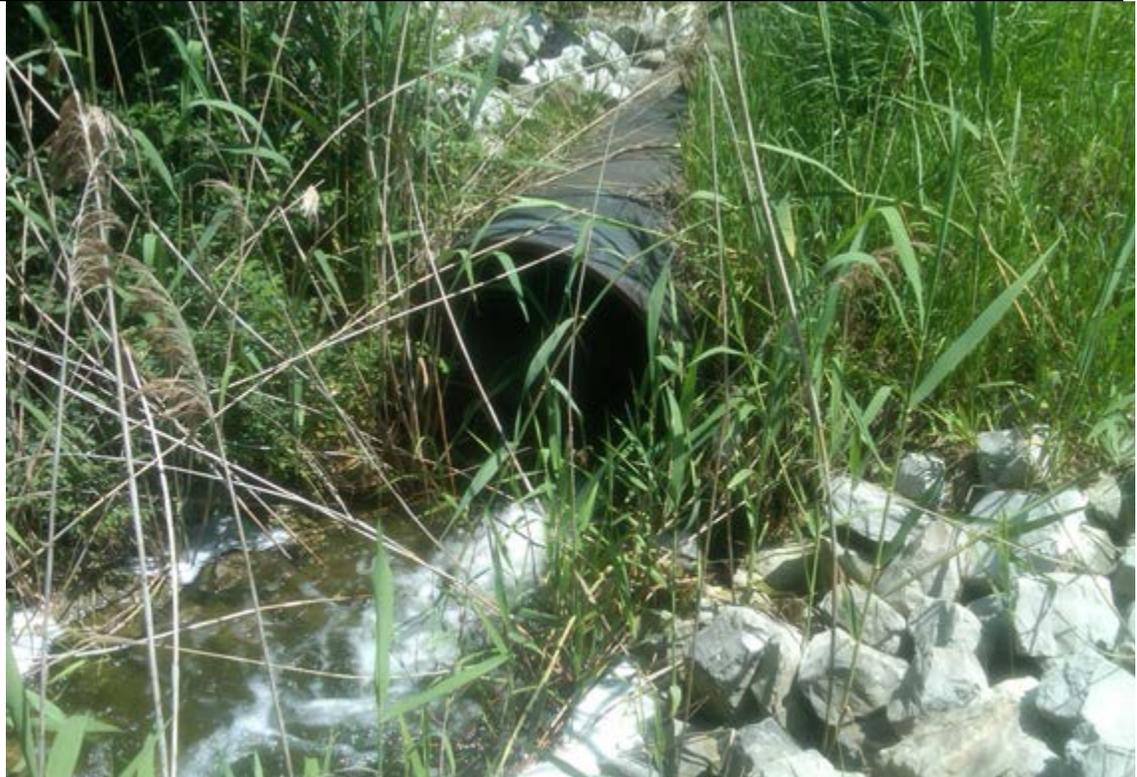
Photo No. 53	Date: 5/24/11
Direction Photo Taken: Southeast

Description:
Discharge pipe from the Secondary Fly Ash Pond into the Secondary Pond.

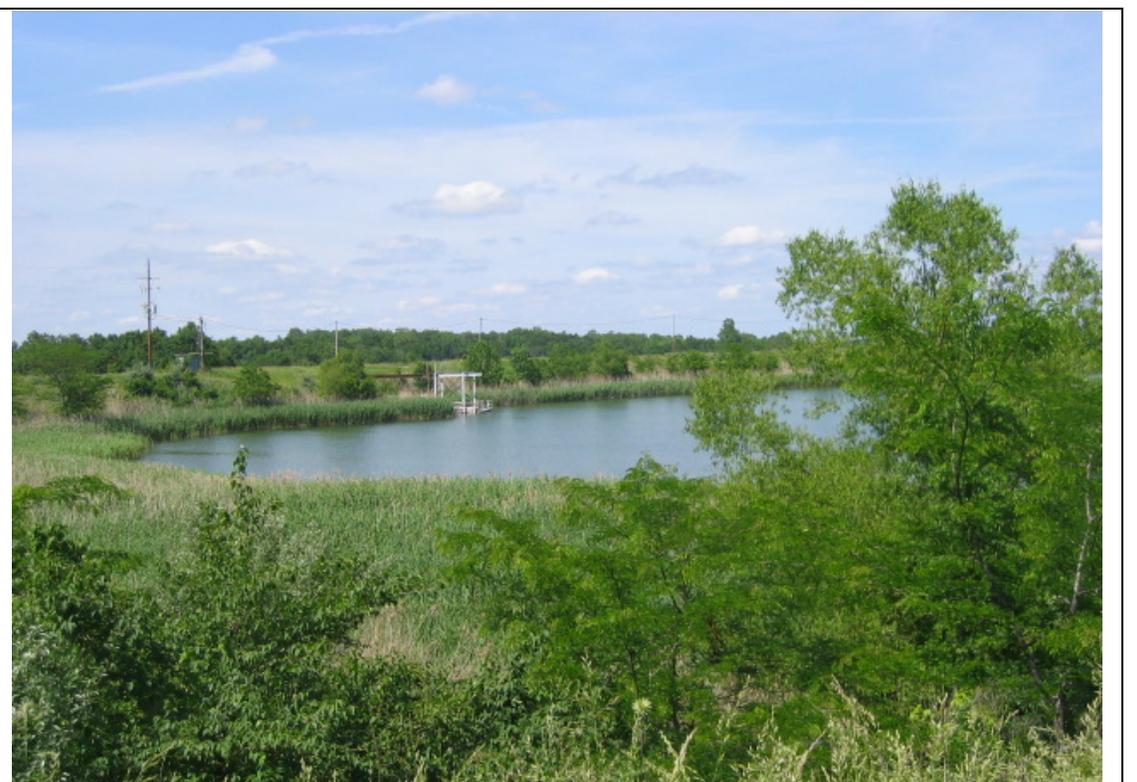
Photo No. 54	Date: 5/24/11
Direction Photo Taken: Northeast

Description:
Upstream slope and decant structure in the Secondary Fly Ash Pond

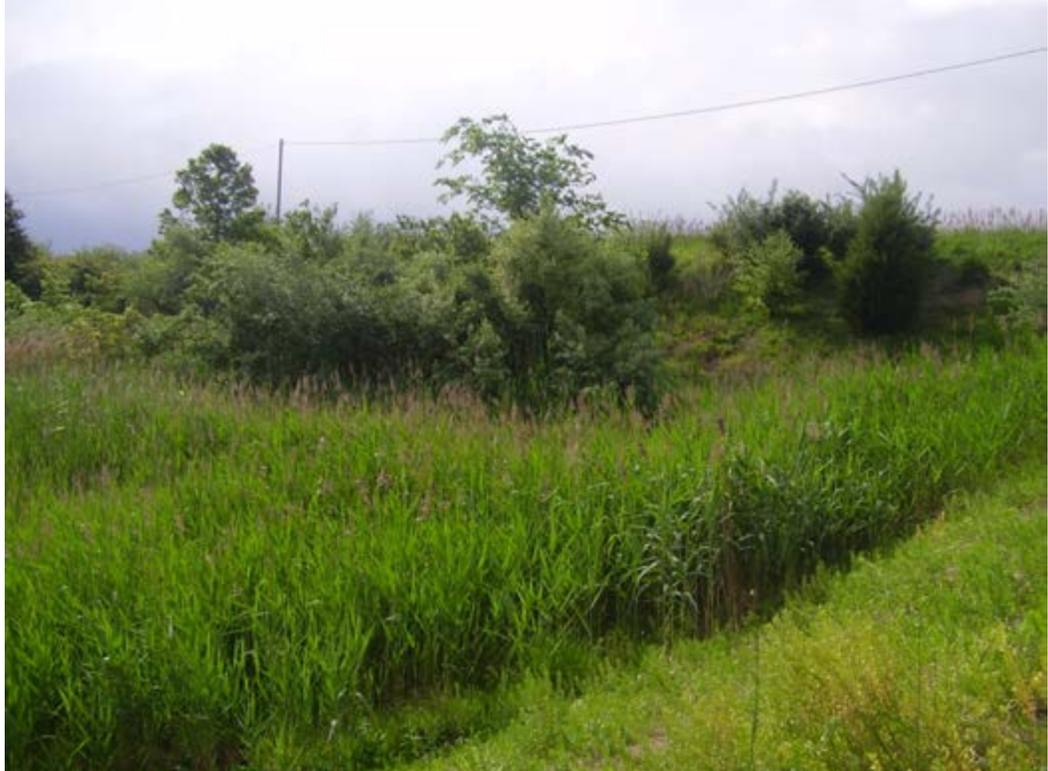
Photo No. 55	Date: 5/25/11

Direction Photo Taken: Southwest		
Description: Downstream slope of the eastern embankment of the Primary Fly Ash Pond.

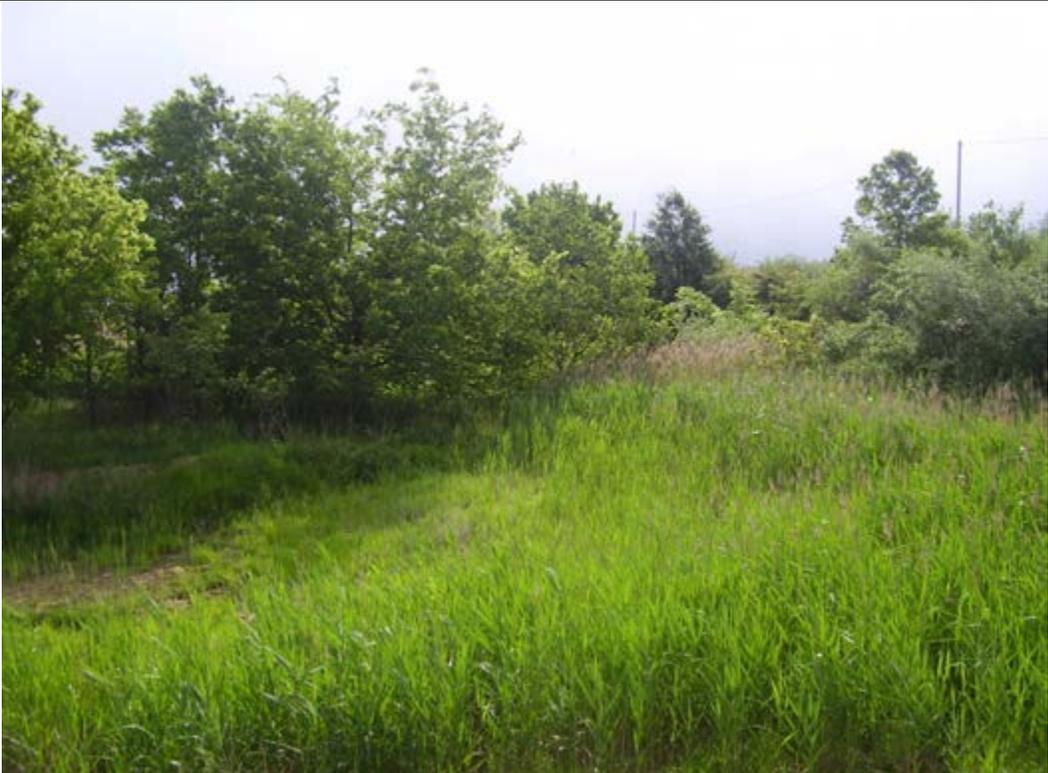
Photo No. 56	Date: 5/25/11

Direction Photo Taken: Southwest		
Description: Downstream slope of the eastern embankment of the Primary Fly Ash Pond.

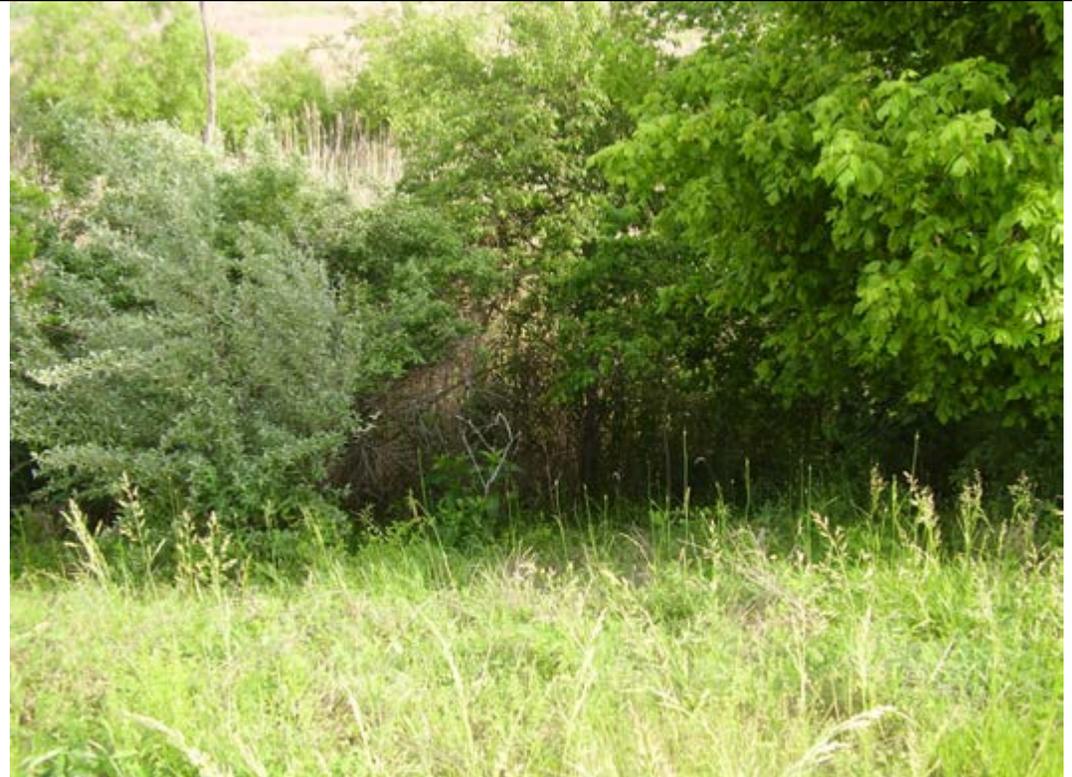
Photo No. 57	Date: 5/25/11
Direction Photo Taken: South

Description:
Downstream slope of the eastern embankment of the Primary Fly Ash Pond.
