**FINAL REPORT
ROUND 10 DAM ASSESSMENT
DYNEGY MIDWEST GENERATION, LLC – BALDWIN ENERGY COMPLEX
PRIMARY FLY ASH POND, SECONDARY FLY ASH POND, SECONDARY POND,
INTERMEDIATE POND, FINAL POND
BALDWIN, ILLINOIS**

December 21, 2012
GZA File No. 170142.30

RE: FINAL Assessment of Dam Safety of Coal Combustion Surface Impoundments at the Baldwin Energy Complex

**FINAL REPORT
ROUND 10 DAM ASSESSMENT
DYNEGY MIDWEST GENERATION, LLC – HENNEPIN POWER STATION
ACTIVE EAST ASH POND SYSTEM, EAST ASH POND SYSTEM, WEST ASH POND
SYSTEM
HENNEPIN, ILLINOIS**

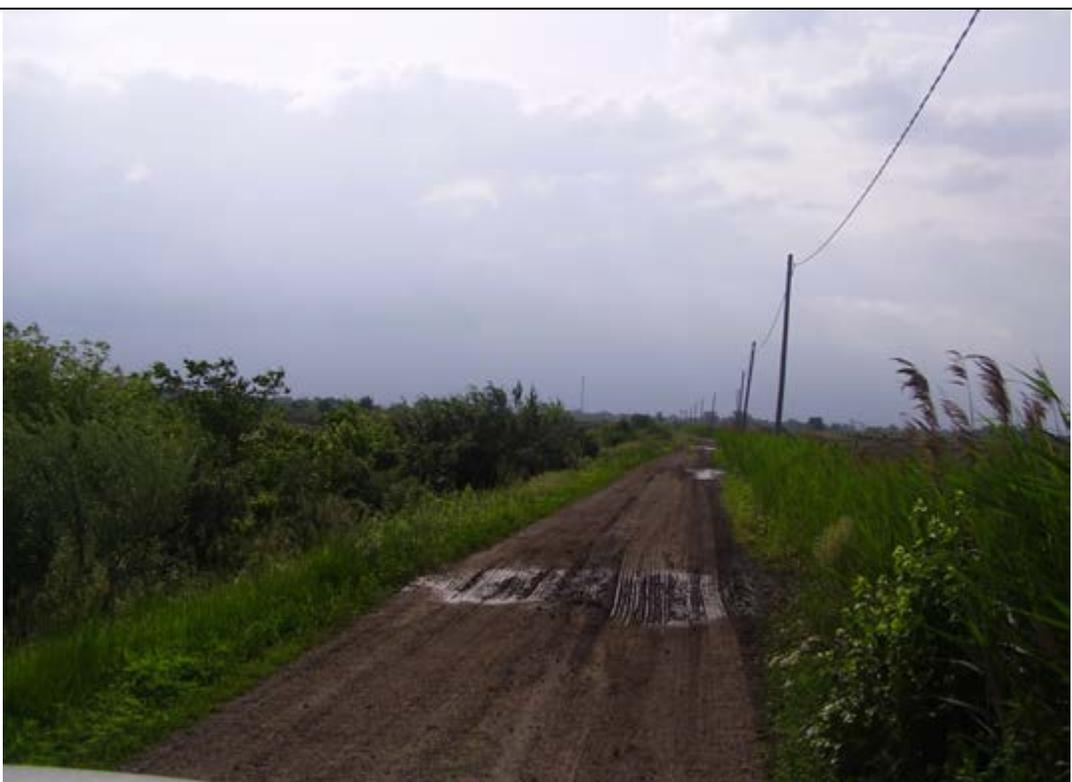
Photo No. 58	Date: 5/25/11
Direction Photo Taken: West

Description:
Crest and upstream slope of the southern embankment of the Primary Fly Ash Pond.

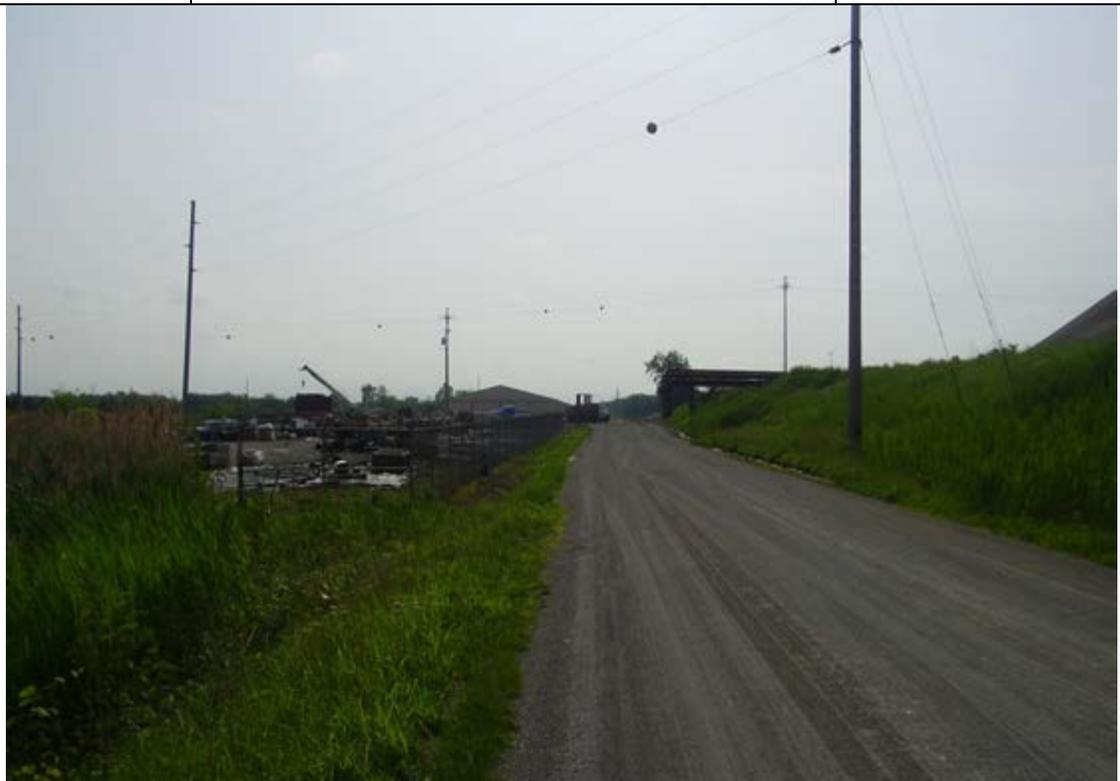
Photo No. 59	Date: 5/25/11
Direction Photo Taken: East	
Description: Toe and downstream slope of the northern embankment of the Primary Fly Ash Pond.

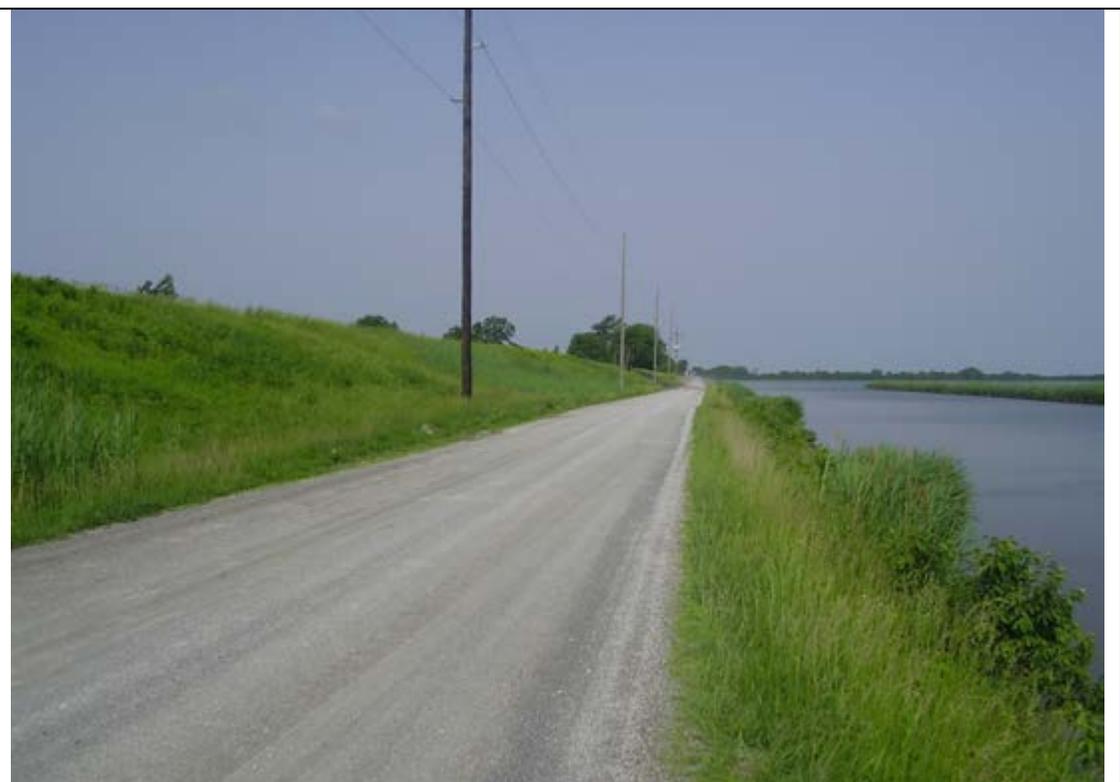
Photo No. 60	Date: 5/25/11
Direction Photo Taken: West	
Description: Toe and downstream slope of the northern embankment of the Primary Fly Ash Pond.

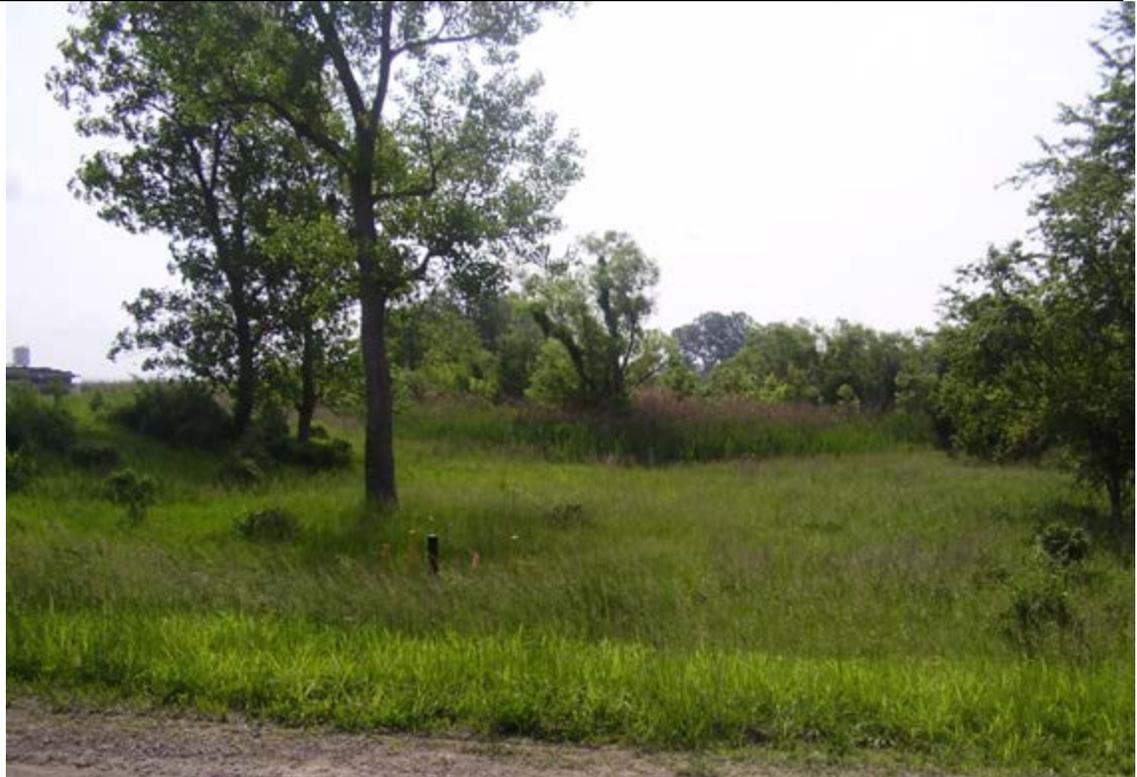
Photo No. 63	Date: 5/25/11
Direction Photo Taken: Southeast

Description:
Crest of the northern embankment of the Primary Fly Ash Pond.

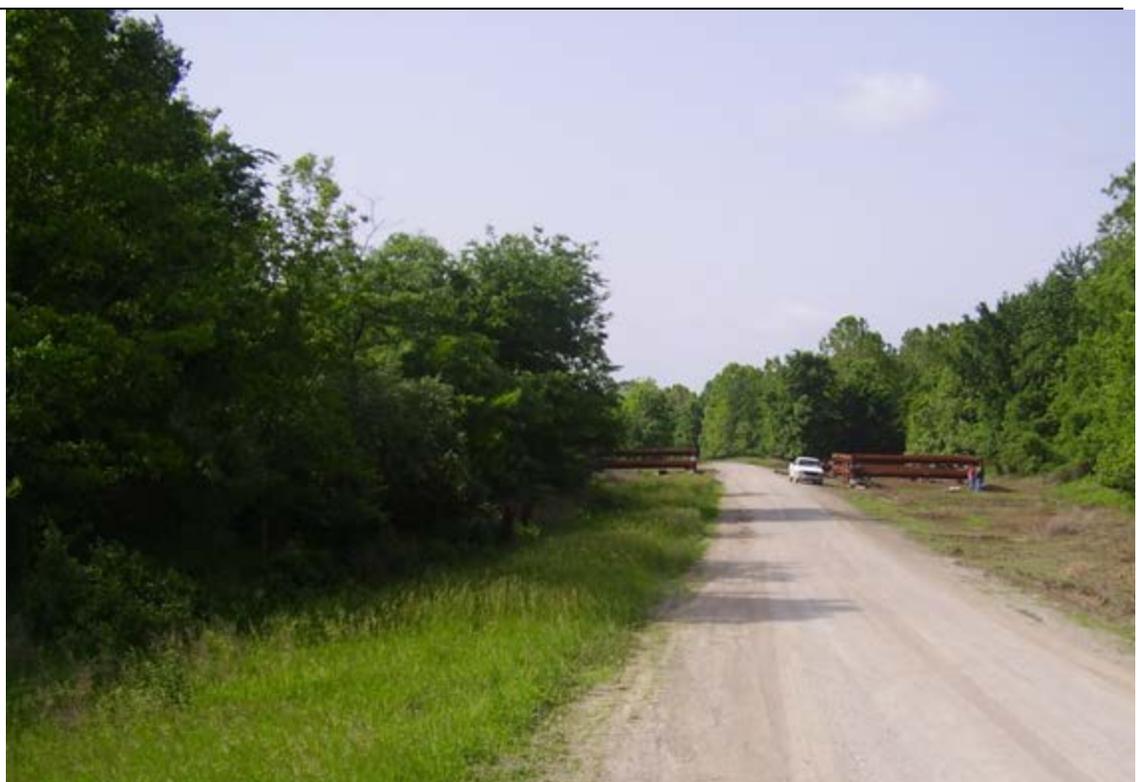
Photo No. 64	Date: 5/24/11
Direction Photo Taken: South

Description:
Crest and upstream slope of the northern embankment of the Primary Fly Ash Pond.

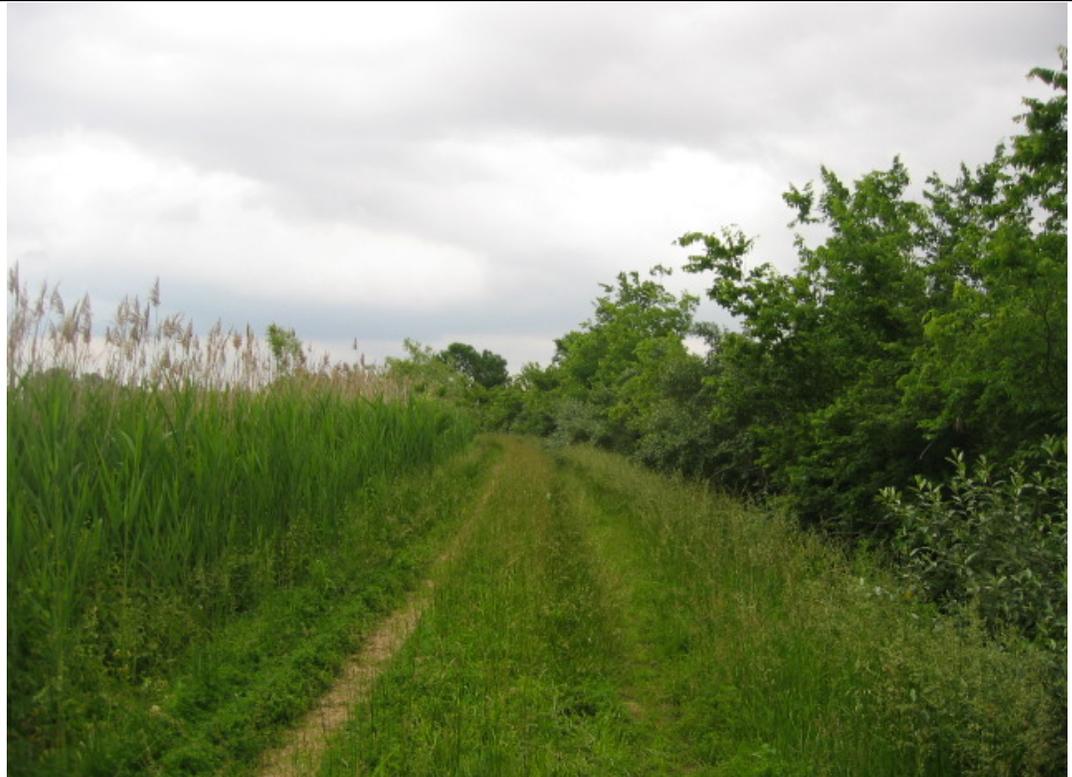
Photo No. 65	Date: 5/25/11
Direction Photo Taken: Northeast

Description:
Crest and upstream slope of the southern embankment of the Primary Fly Ash Pond.

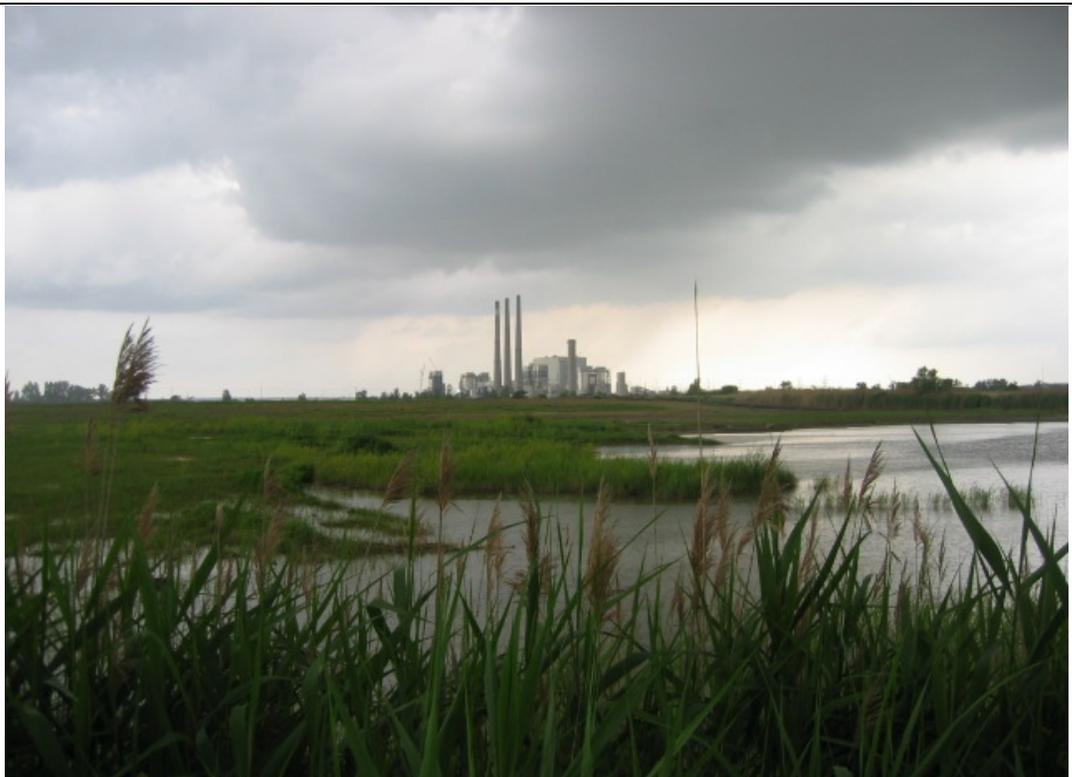
Photo No. 66	Date: 5/25/11
Direction Photo Taken: North

Description:
Upstream slope of the Primary Fly Ash Pond.

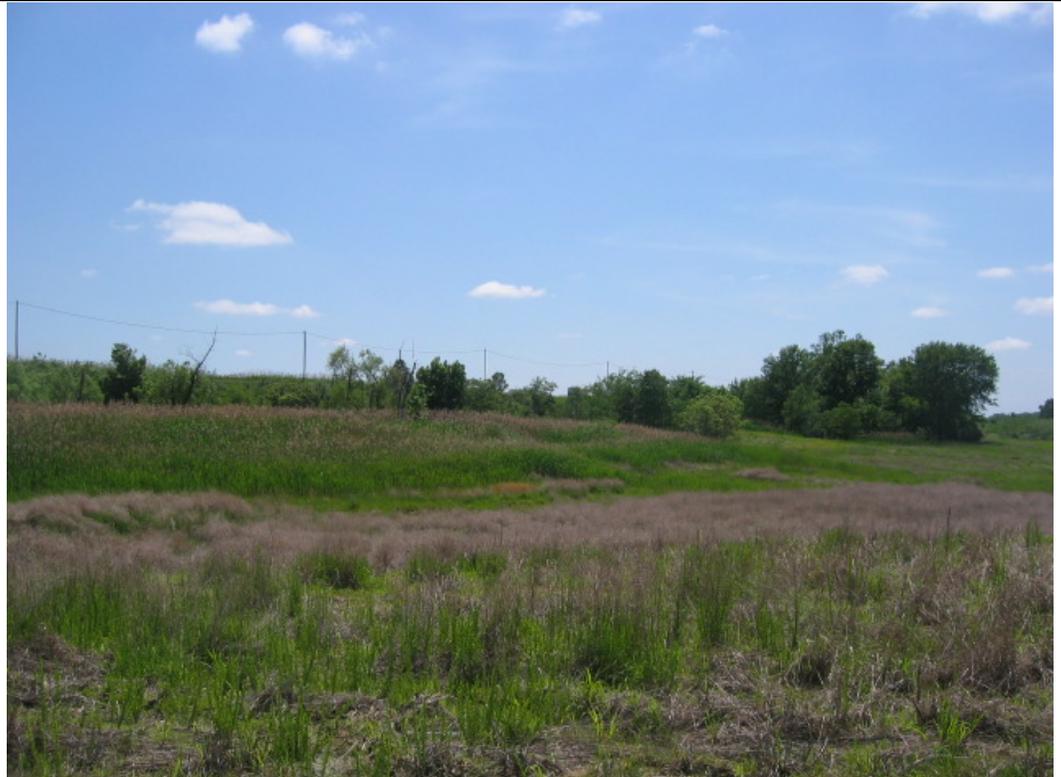
Photo No. 67	Date: 5/25/11
Direction Photo Taken: Southwest

Description:
Downstream slope of the western embankment of the Primary Fly Ash Pond.

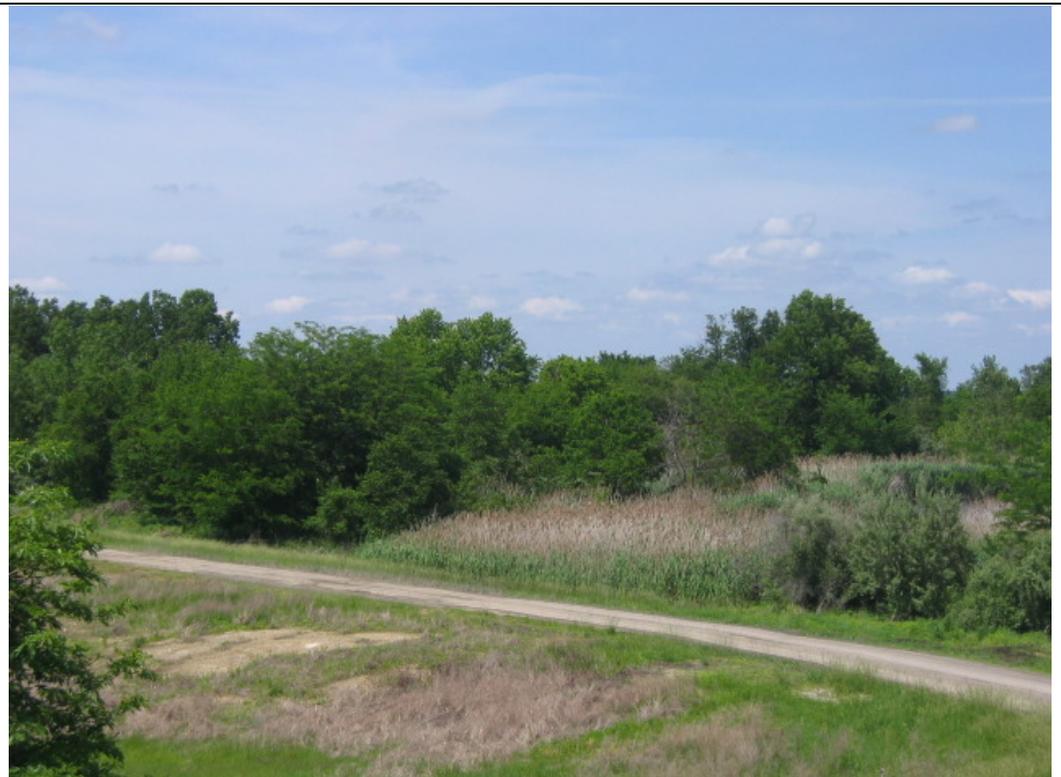
Photo No. 68	Date: 5/25/11
Direction Photo Taken: North

Description:
Crest and upstream area of the western embankment of the Primary Fly Ash Pond.

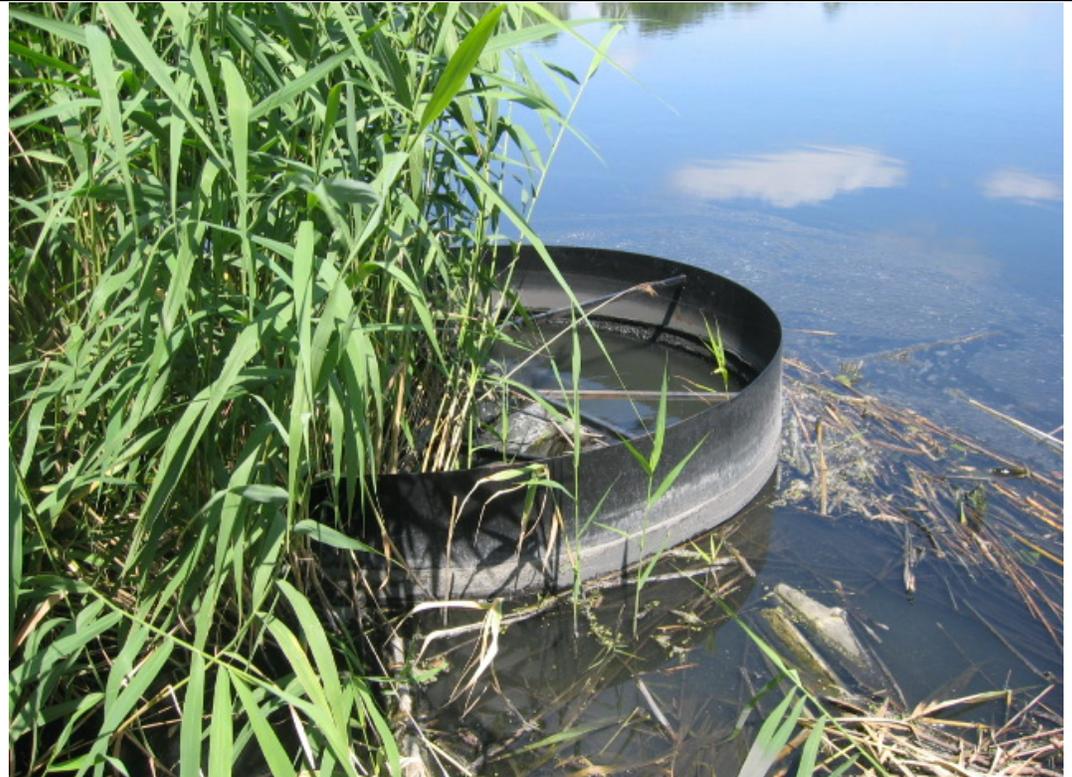
Photo No. 69	Date: 5/25/11
Direction Photo Taken: West

Description:
Decant from the northern portion of the Primary Fly Ash Pond.

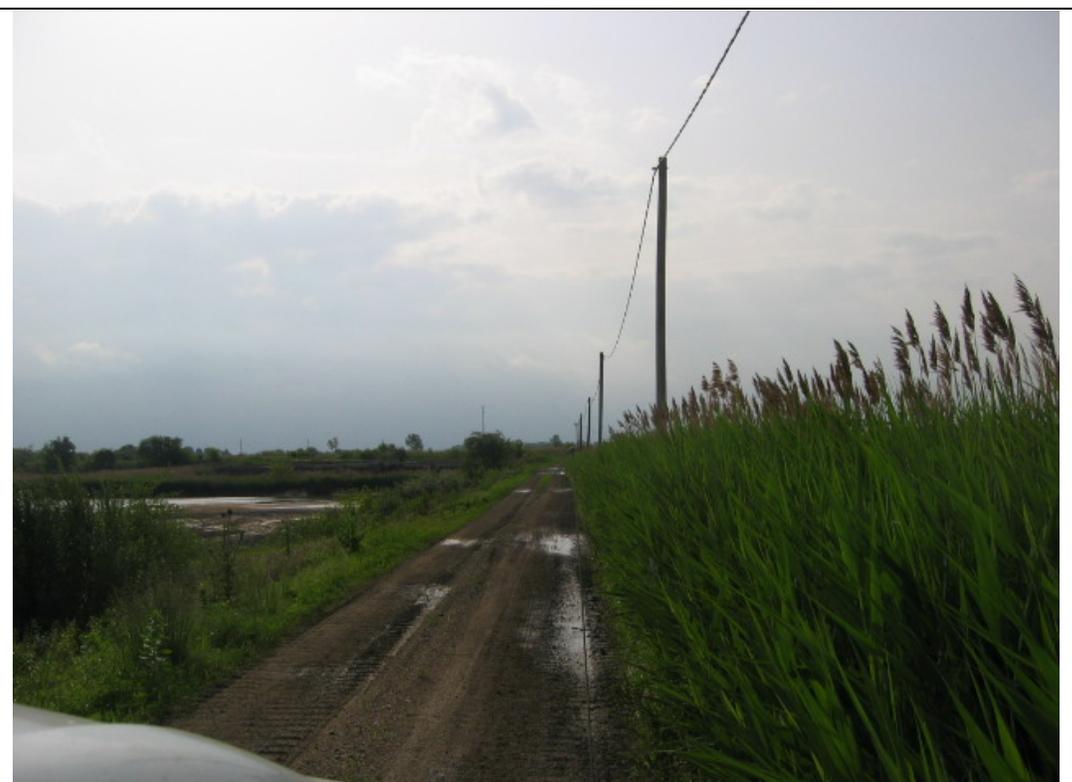
Photo No. 70	Date: 5/25/11
Direction Photo Taken: Southeast

Description:
Interior berm in Primary Fly Ash Pond separating the northern and southern portions.

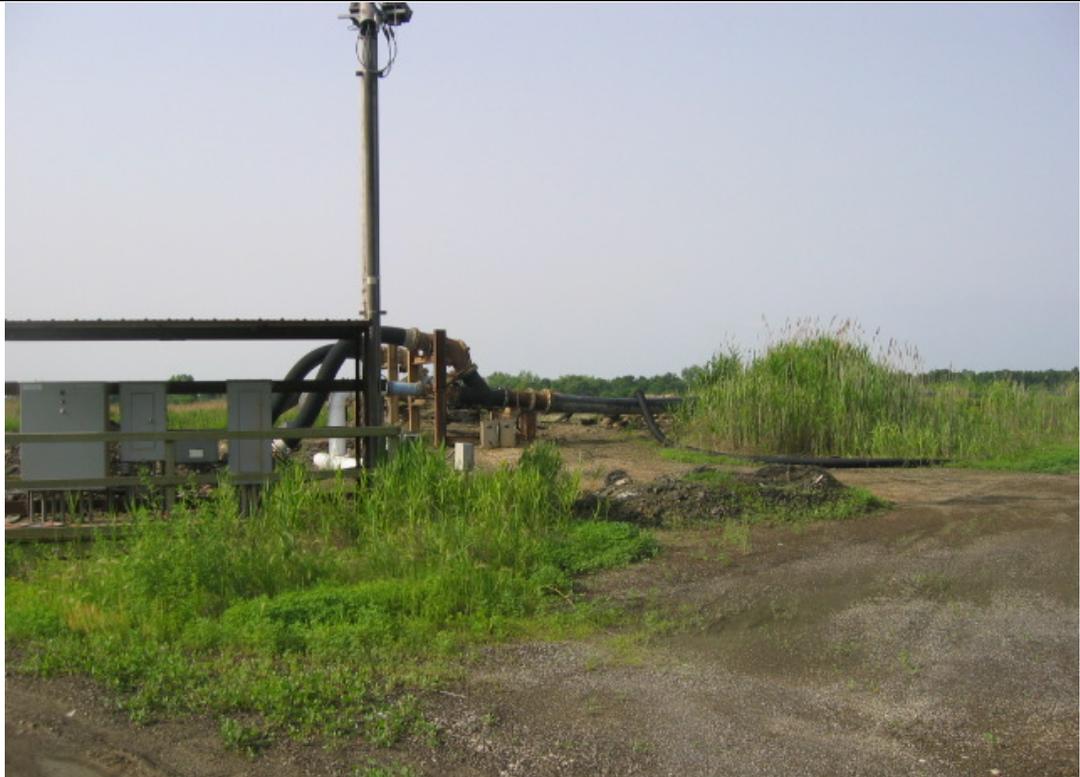
Photo No. 71	Date: 5/25/11
Direction Photo Taken: South

Description:
Intermediate pump station for the fly ash process water.

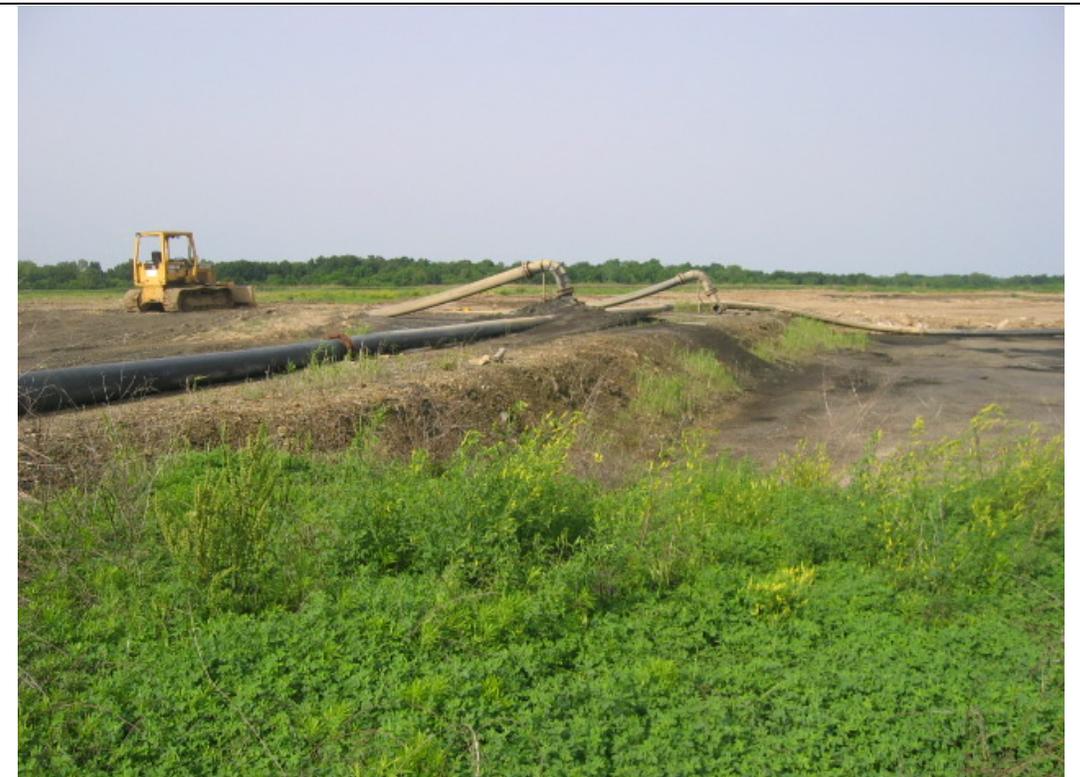
Photo No. 72	Date: 5/25/11
Direction Photo Taken: South

Description:
Transport pipes for fly ash process water.

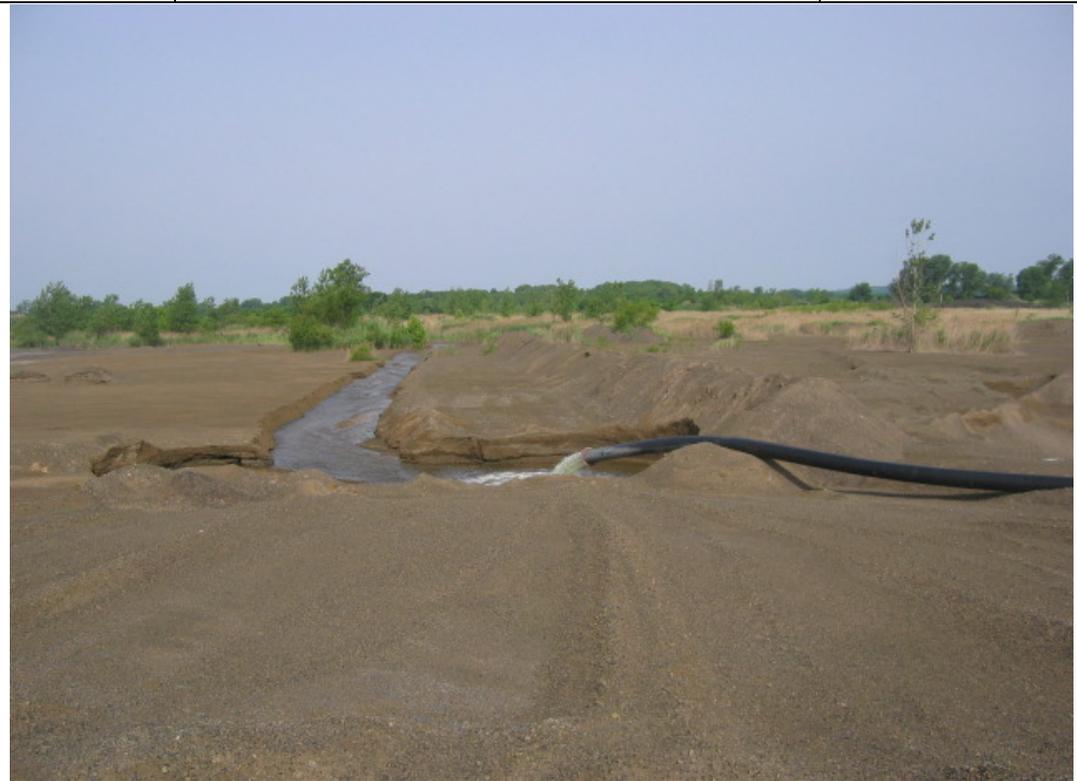
Photo No. 73	Date: 5/25/11
Direction Photo Taken: West

Description:
One of several discharge lines into the bottom ash (northern) area of the Primary Fly Ash Pond.

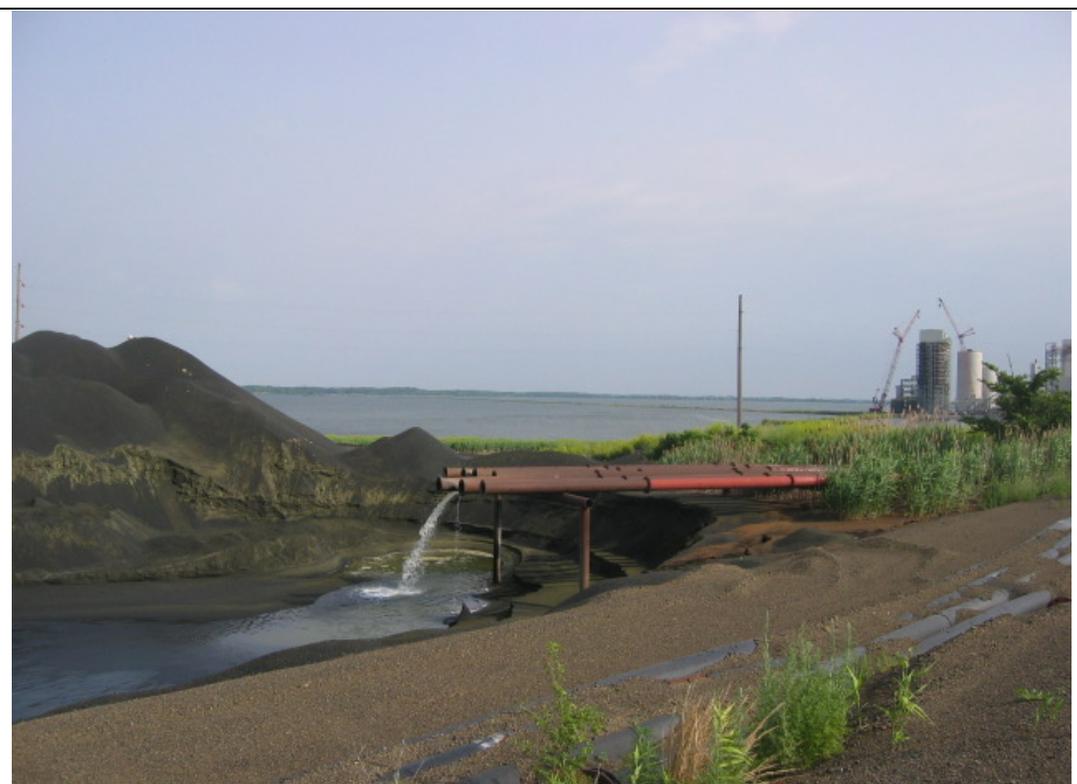
Photo No. 74	Date: 5/25/11
Direction Photo Taken: Northwest

Description:
Several discharge lines into the bottom ash processing area of the Primary Fly Ash Pond.

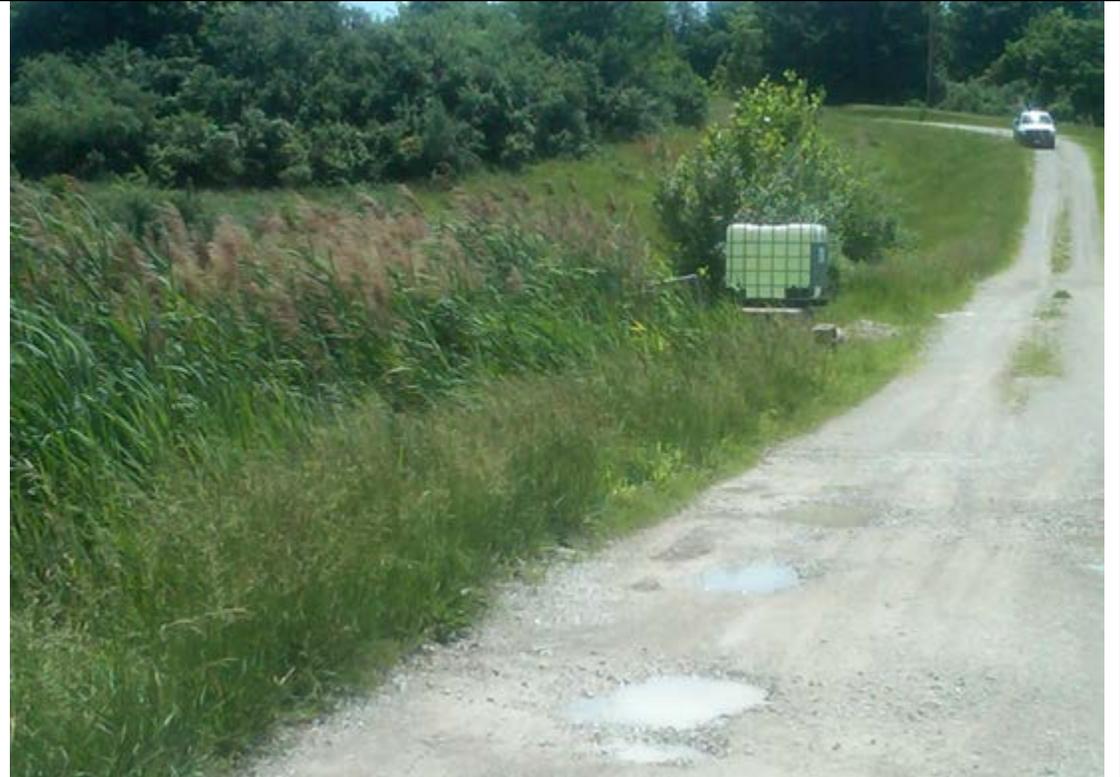
Photo No. 75	Date: 5/24/11
Direction Photo Taken: Southwest

Description:
Crest and upstream slope of the Ash Pond Dike.

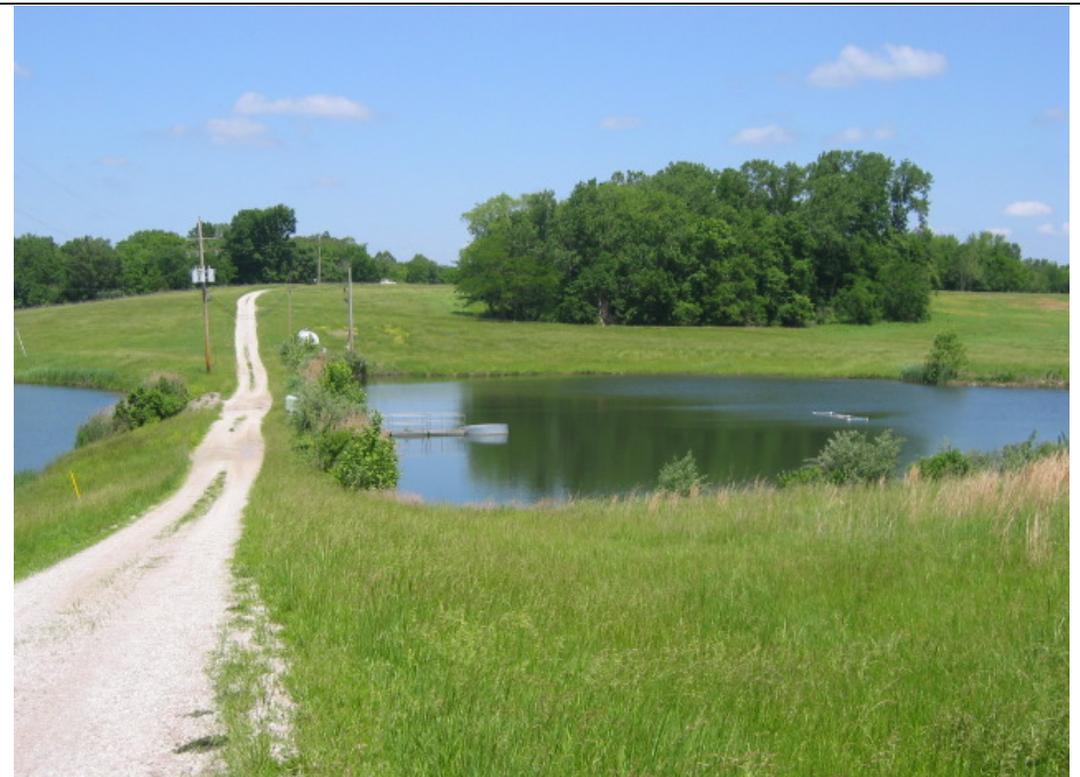
Photo No. 76	Date: 5/24/11
Direction Photo Taken: South

Description:
Crest and upstream slope of the Ash Pond Dike.

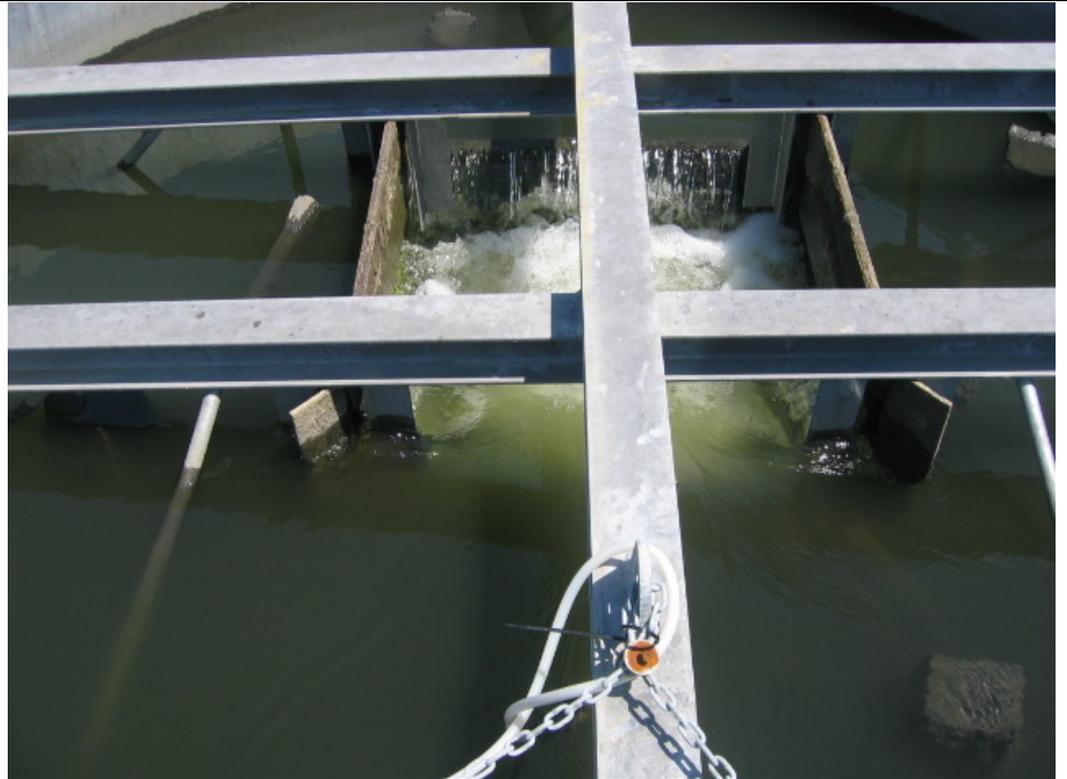
Description:
Decant structure of the Intermediate Pond.

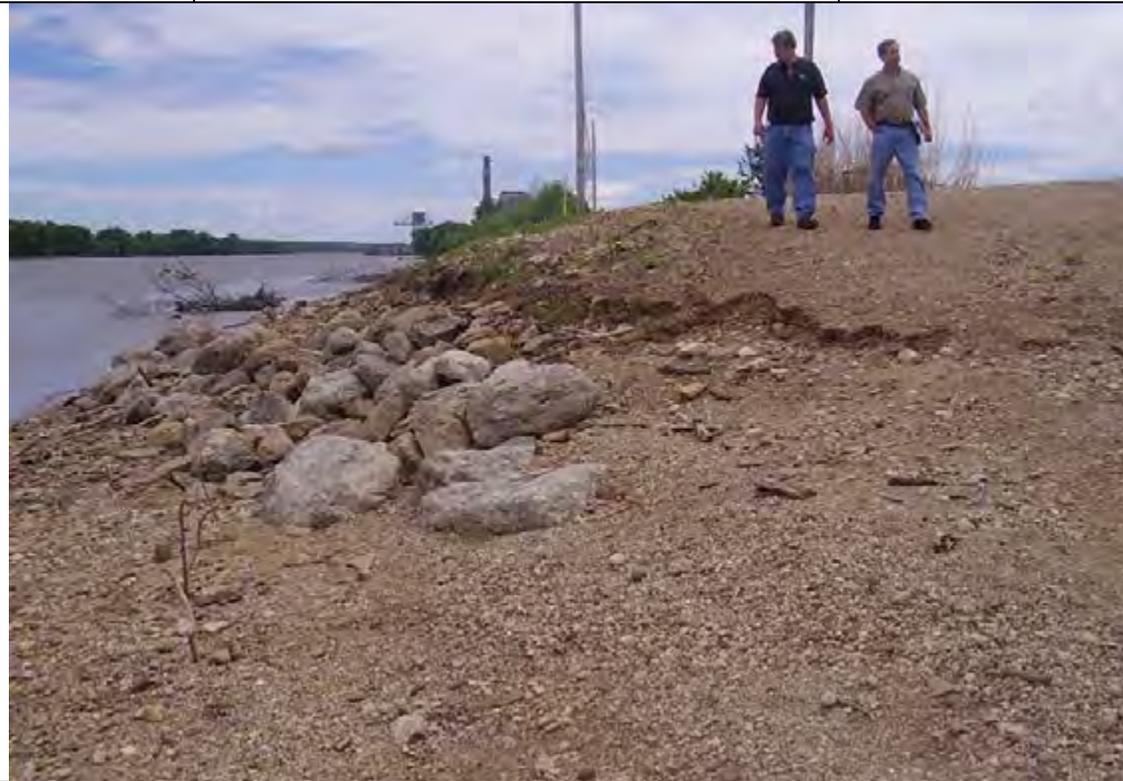
Photo No. 1	Date: 5/23/11
Direction Photo Taken: Northeast	
Description: Downstream slope of the West Ash Pond System (WAPS) Impoundment.

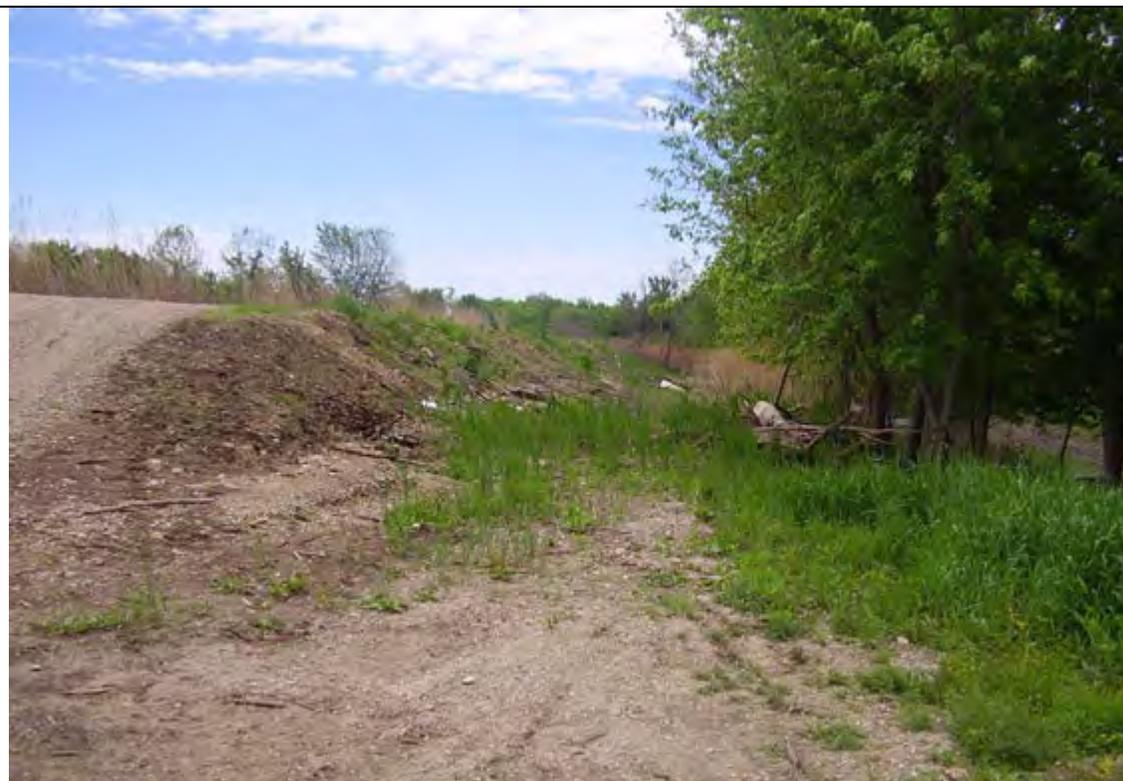
Photo No. 2	Date: 5/23/11
Direction Photo Taken: South	
Description: Downstream slope of the WAPS.

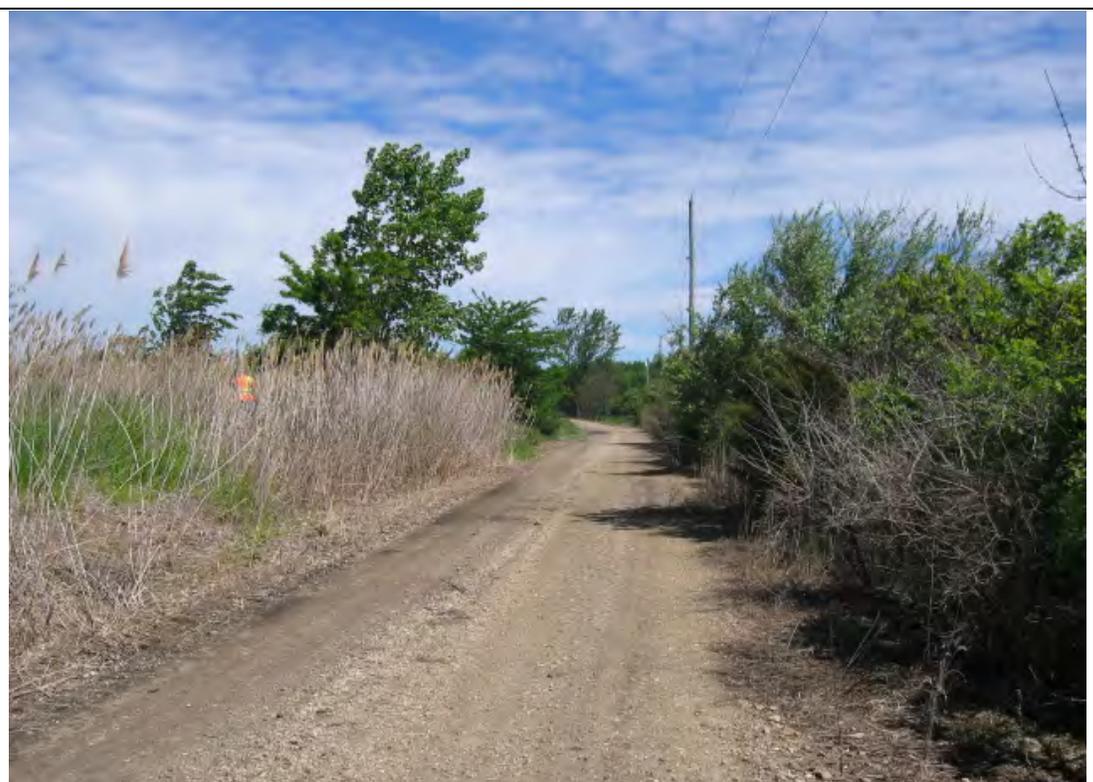
Photo No. 14	Date: 5/23/11
Direction Photo Taken: North

Description:
Toe access road along the eastern portion of the WAPS.

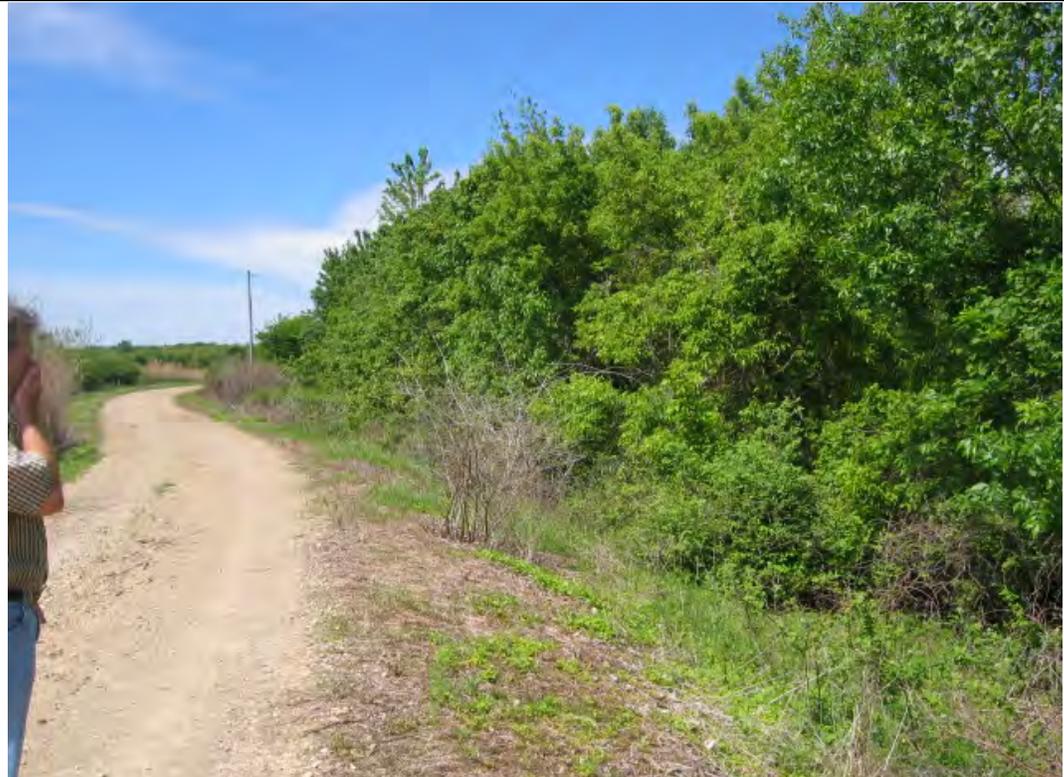
Photo No. 15	Date: 5/23/11

Direction Photo Taken: Southwest		
Description: Crest of the WAPS.

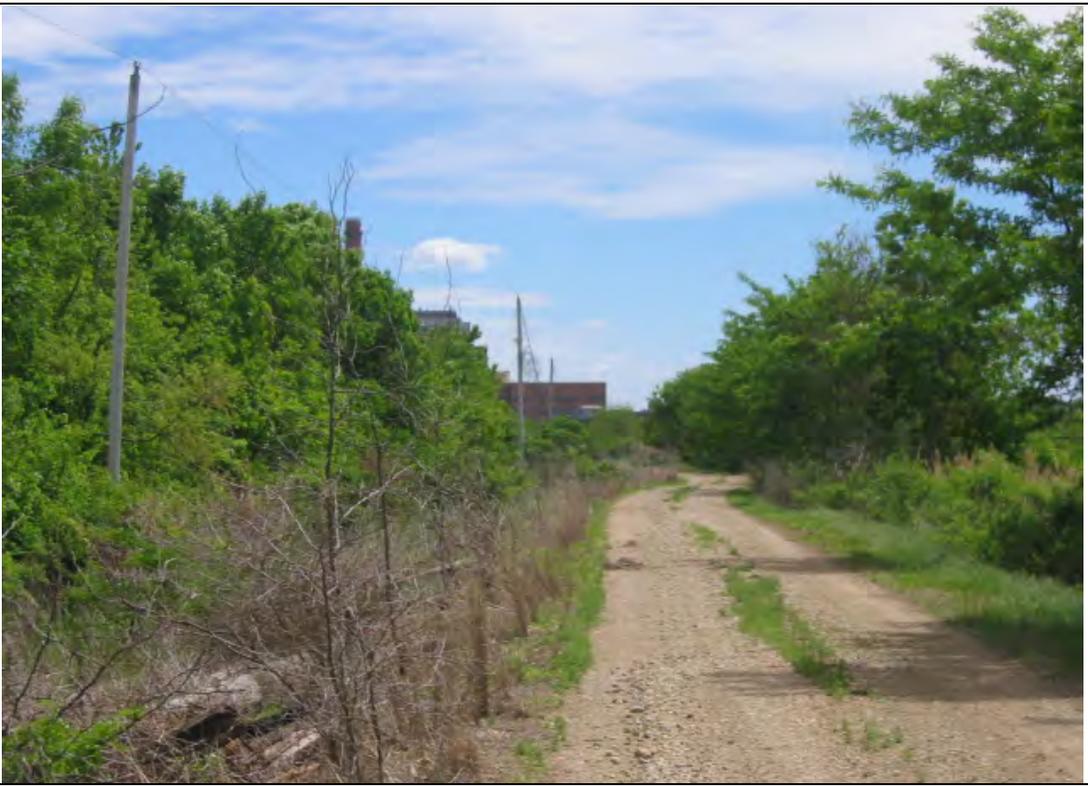
Photo No. 16	Date: 5/23/11

Direction Photo Taken: Northeast		
Description: Crest of the WAPS.

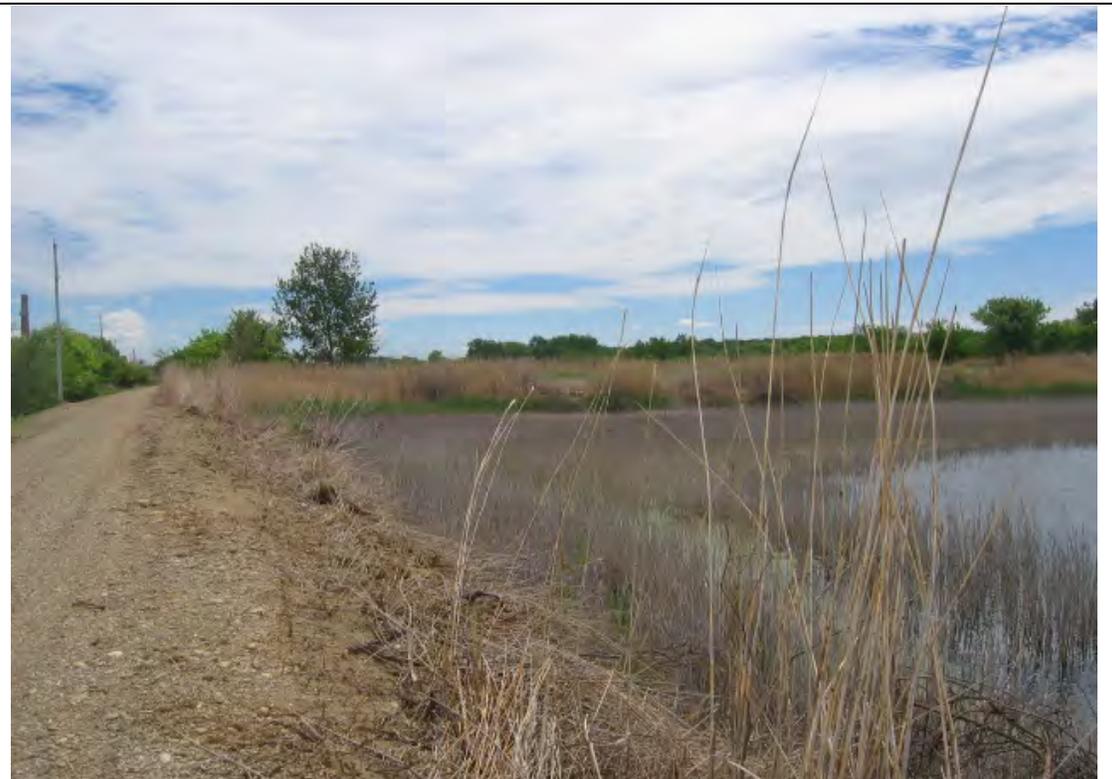
Photo No.
18

Description:
Crest and upstream slope of the WAPS.

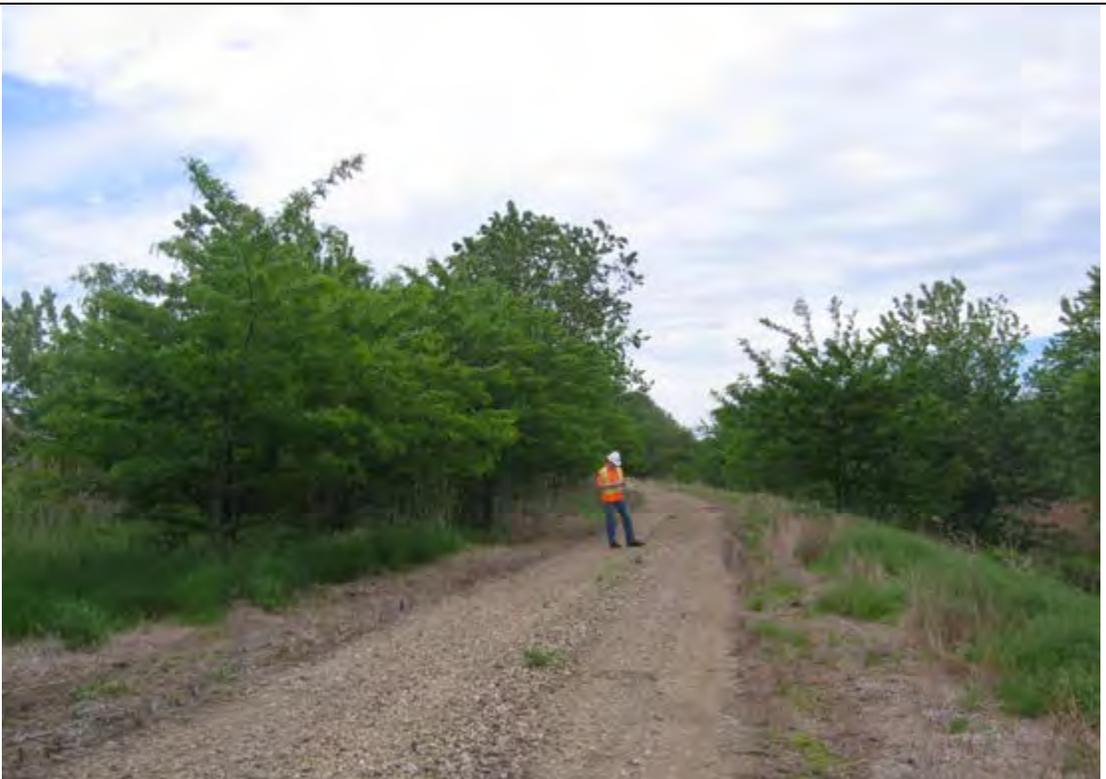
Photo No.
20

Description:
Crest and upstream slope of the WAPS.

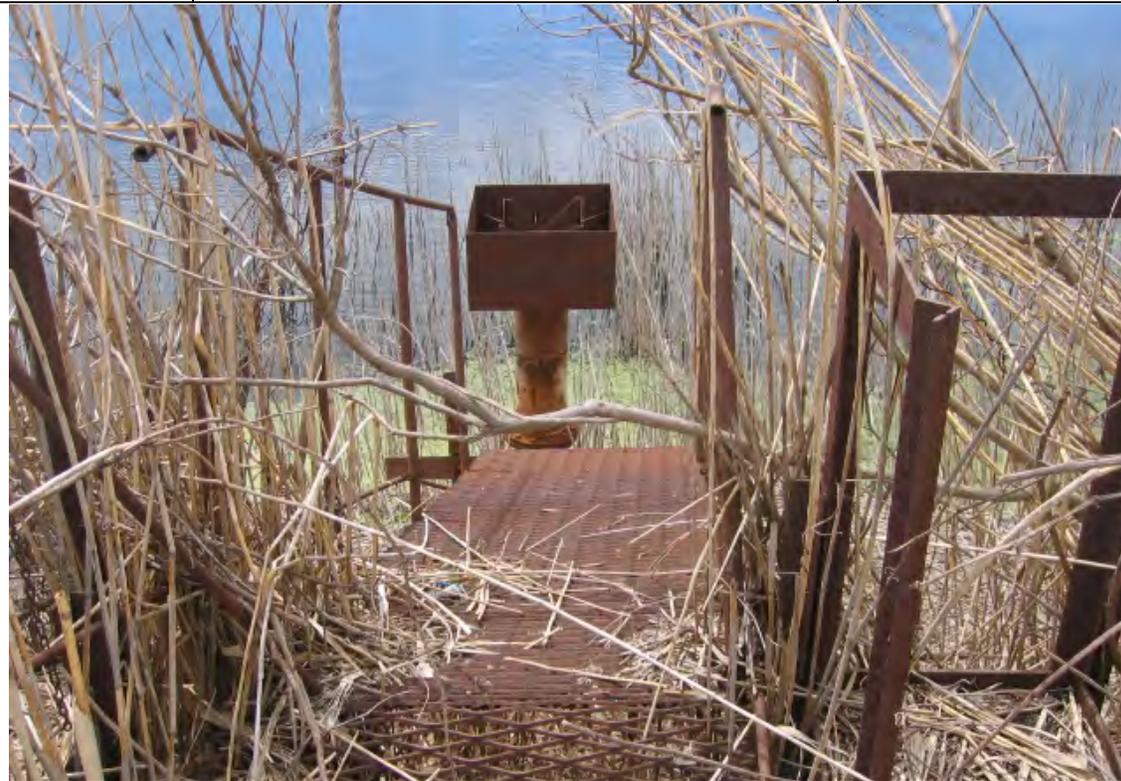
Photo No. 21	Date: 5/23/11
Direction Photo Taken: South

The decant structure for the WAPS Impoundment consists of a 12-inch diameter steel pipe with a trash rack as shown in Photo 21. The pipe discharges into the Illinois River and the discharge pipe is shown in Photo 22. The decant and discharge portions of the pipe appeared to be in good condition at the time of our assessment.

Description:
Decant structure in the WAPS.
