**FINAL REPORT
ROUND 10 DAM ASSESSMENT
DYNEGY MIDWEST GENERATION, LLC – BALDWIN ENERGY COMPLEX
PRIMARY FLY ASH POND, SECONDARY FLY ASH POND, SECONDARY POND,
INTERMEDIATE POND, FINAL POND
BALDWIN, ILLINOIS**

December 21, 2012
GZA File No. 170142.30

RE: FINAL Assessment of Dam Safety of Coal Combustion Surface Impoundments at the Baldwin Energy Complex

**FINAL REPORT
ROUND 10 DAM ASSESSMENT
DYNEGY MIDWEST GENERATION, LLC – HENNEPIN POWER STATION
ACTIVE EAST ASH POND SYSTEM, EAST ASH POND SYSTEM, WEST ASH POND
SYSTEM
HENNEPIN, ILLINOIS**

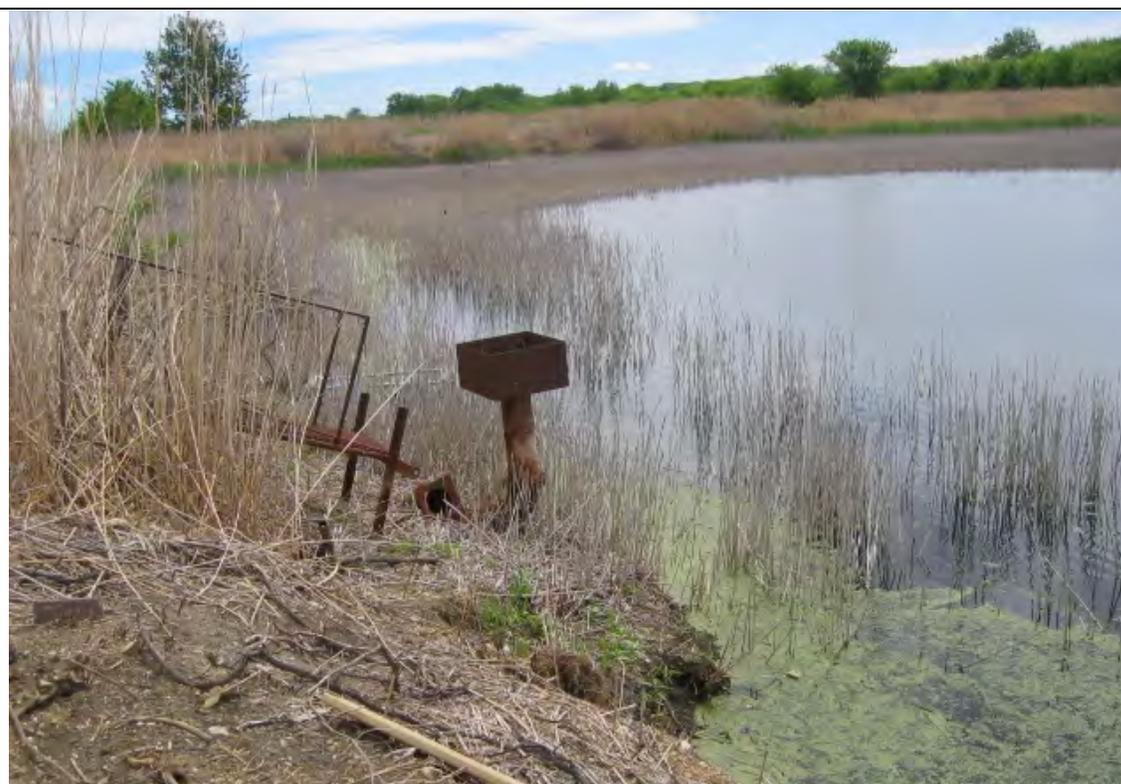
Photo No. 22	Date: 5/23/11
Direction Photo Taken: Southeast

The decant structure for the WAPS Impoundment consists of a 12-inch diameter steel pipe with a trash rack as shown in Photo 21. The pipe discharges into the Illinois River and the discharge pipe is shown in Photo 22. The decant and discharge portions of the pipe appeared to be in good condition at the time of our assessment.

Description:
Decant structure in the WAPS.

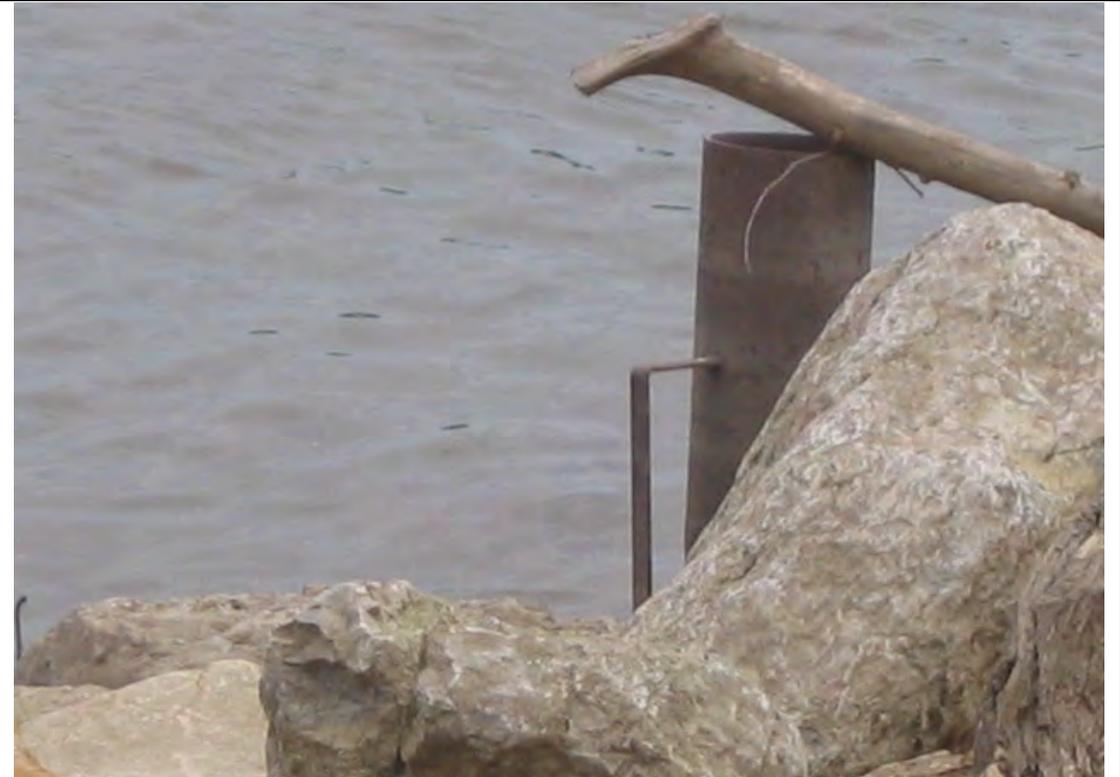
Photo No. 23	Date: 5/23/11
Direction Photo Taken: Northeast	
Description: Discharge pipe from the WAPS into the Illinois River.

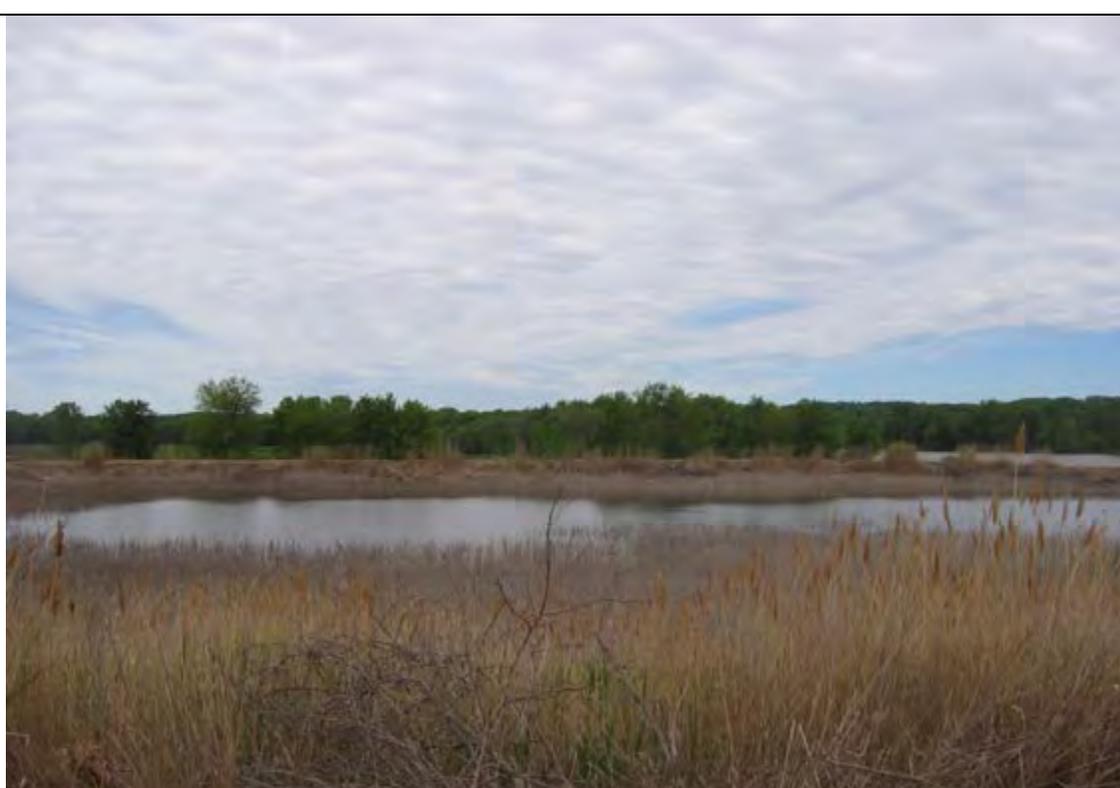
Photo No. 24	Date: 5/23/11
Direction Photo Taken: West	
Description: Upstream slope and ponded water in the WAPS.

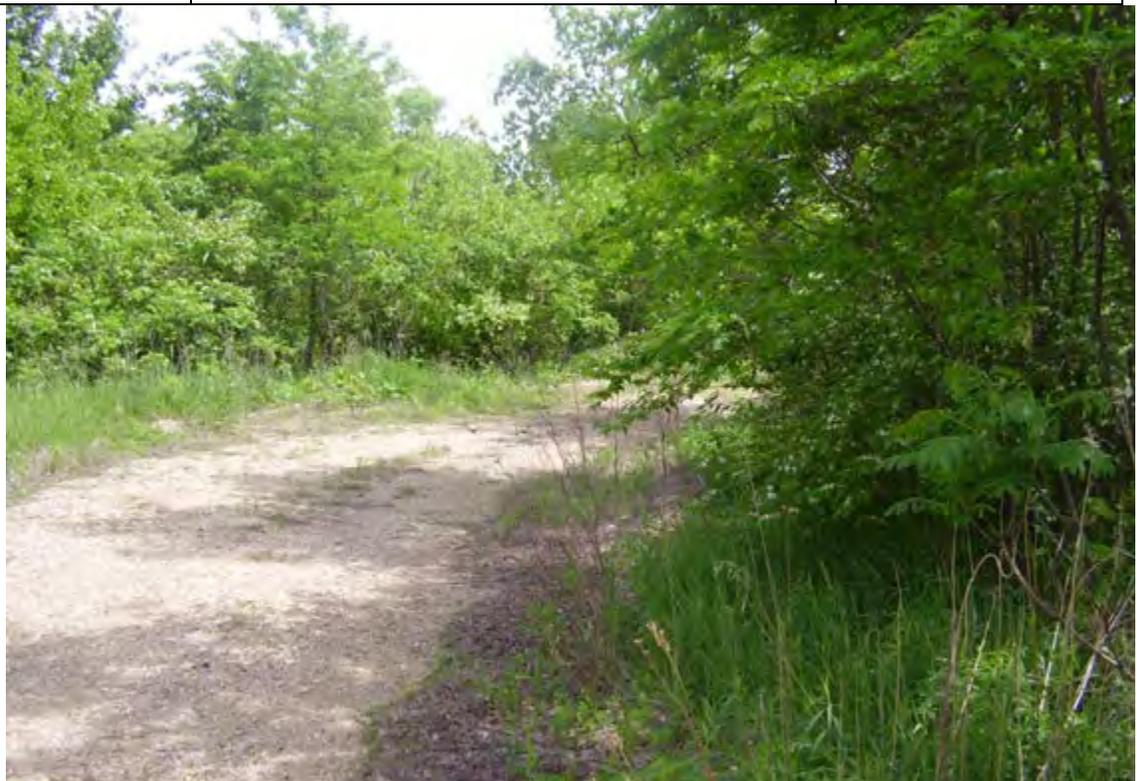
Photo No. 29	Date: 5/23/11
Direction Photo Taken: East

Description:
Crest of the 1978 embankment and downstream slope of the 1995 embankment near Pond 2E.

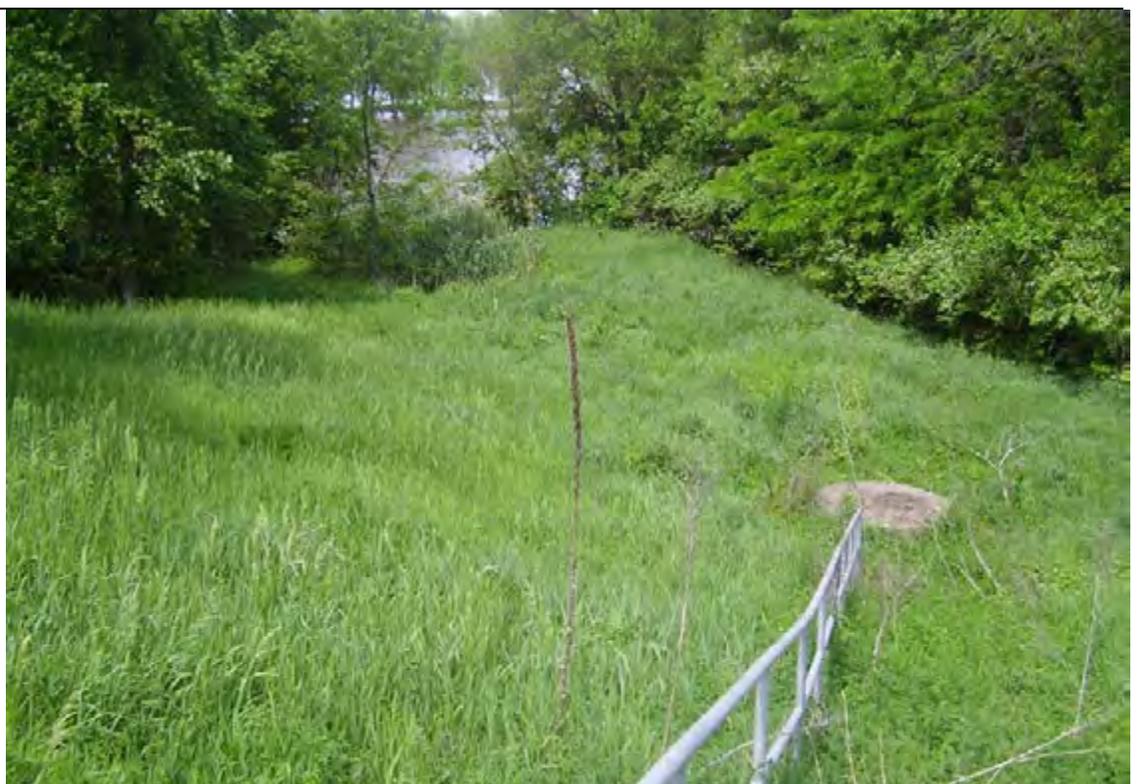
Photo No. 30	Date: 5/23/11
Direction Photo Taken: North

Description:
Downstream slope of Pond 2E.

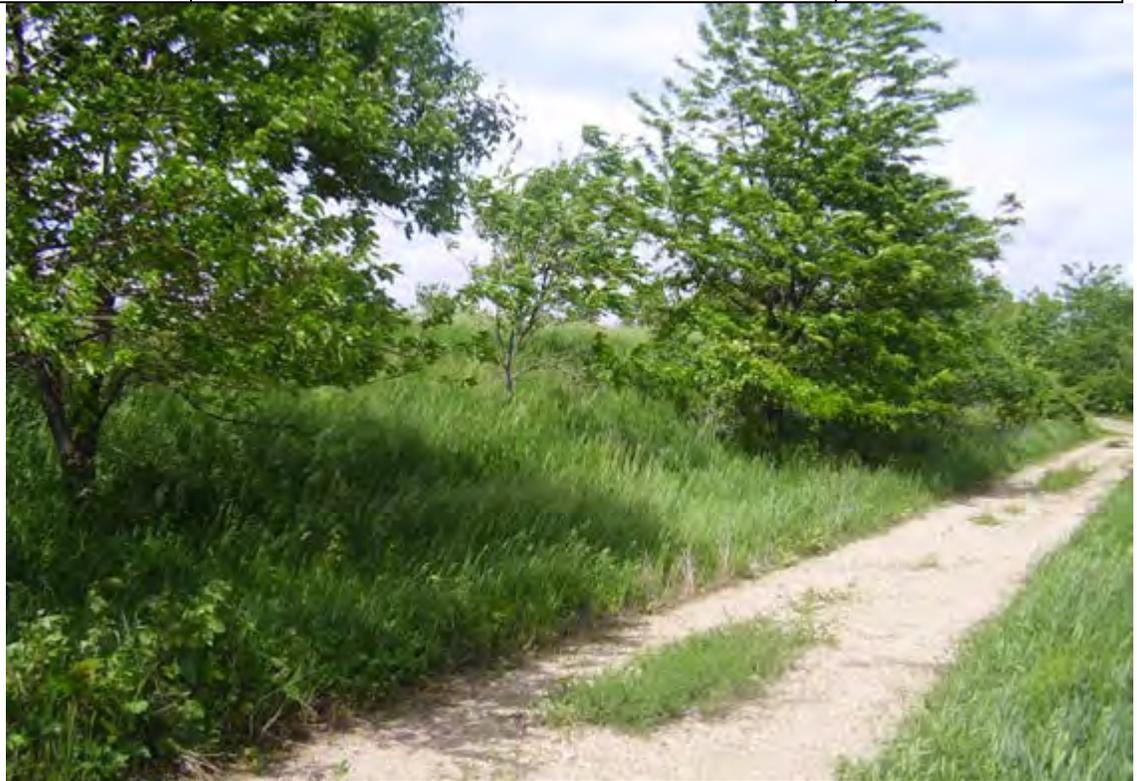
Photo No. 31	Date: 5/23/11
Direction Photo Taken: Northwest

Description:
Downstream slope of Pond 2E along crest of the 1978 embankment.

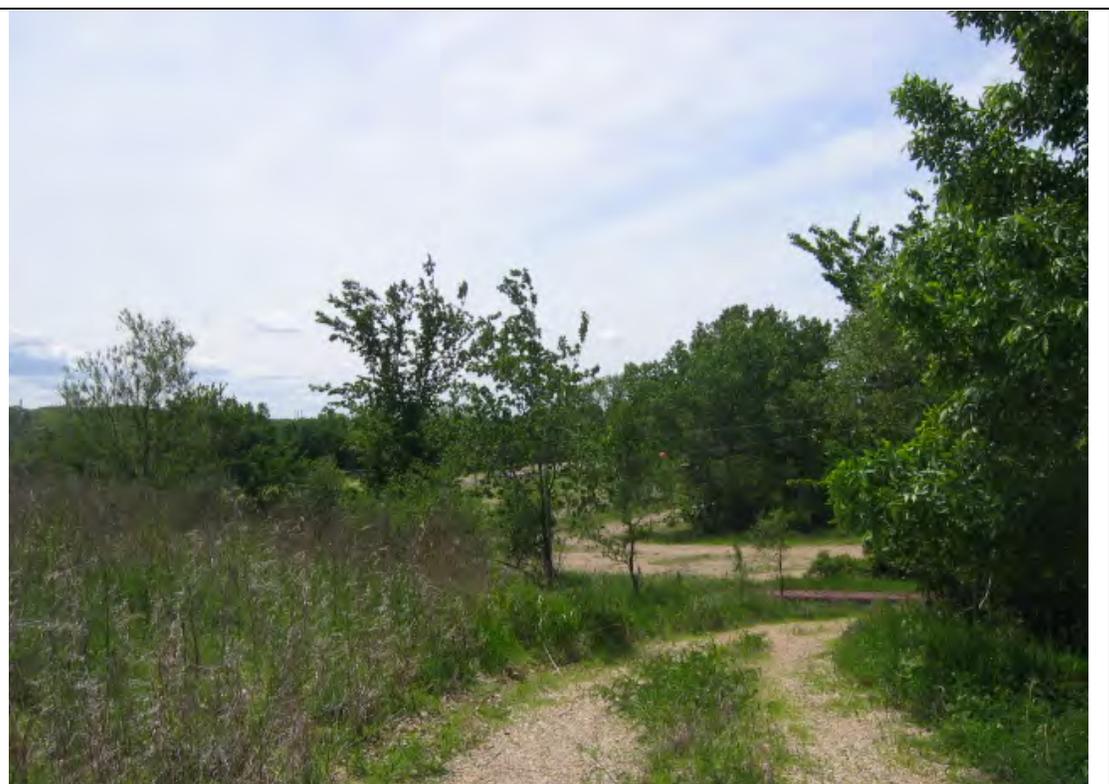
Photo No. 32	Date: 5/23/11
Direction Photo Taken: Southwest

Description:
Crest of the EAPS.

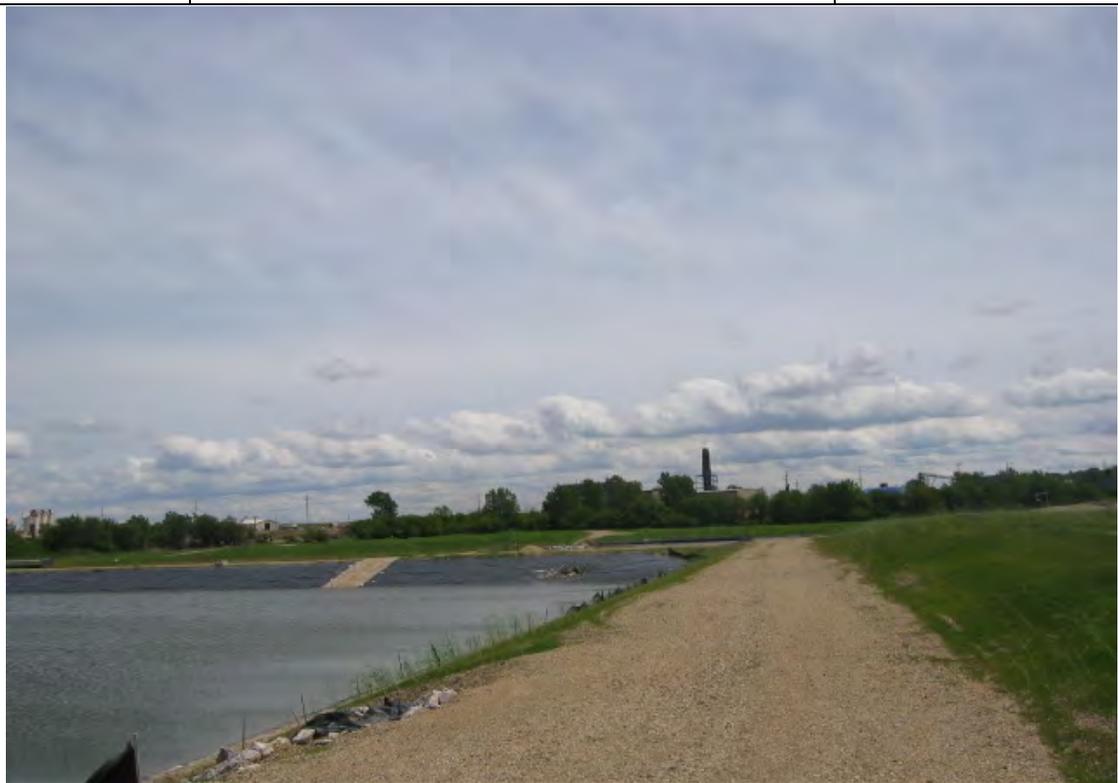
Photo No. 35	Date: 5/23/11
Direction Photo Taken: South

Description:
Crest of embankment between the EAPS and Pond 2E.

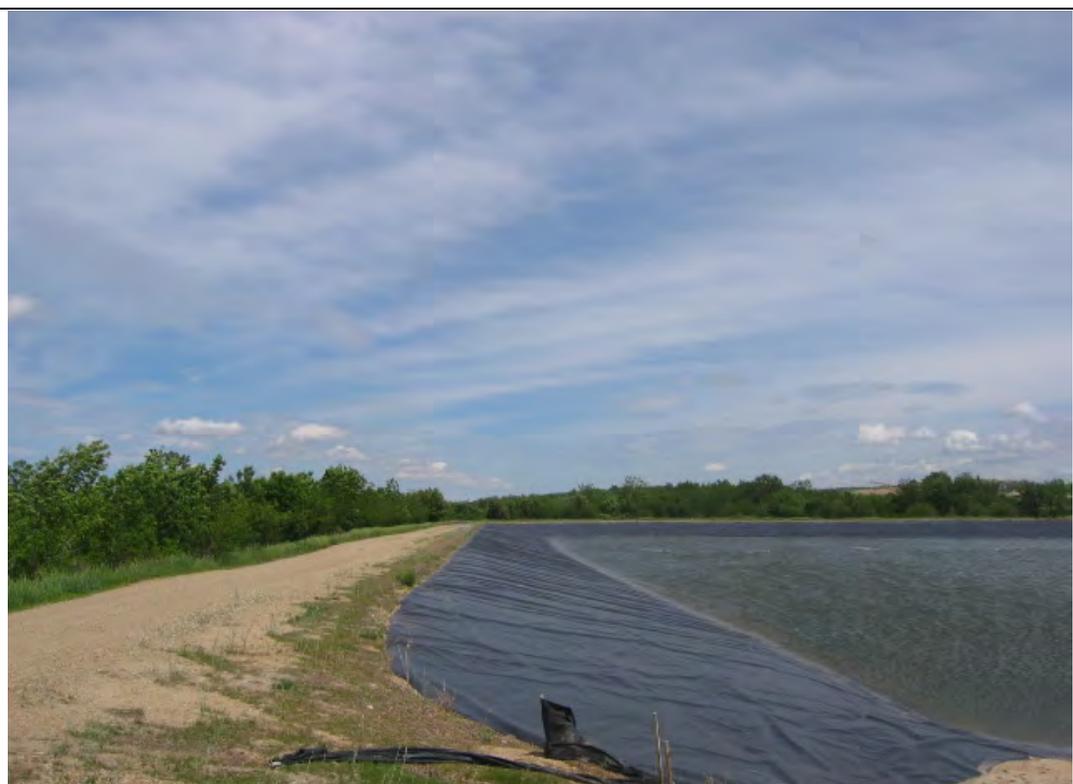
Photo No. 36	Date: 5/23/11
Direction Photo Taken: East

Description:
Crest and upstream slope of Pond 2E.

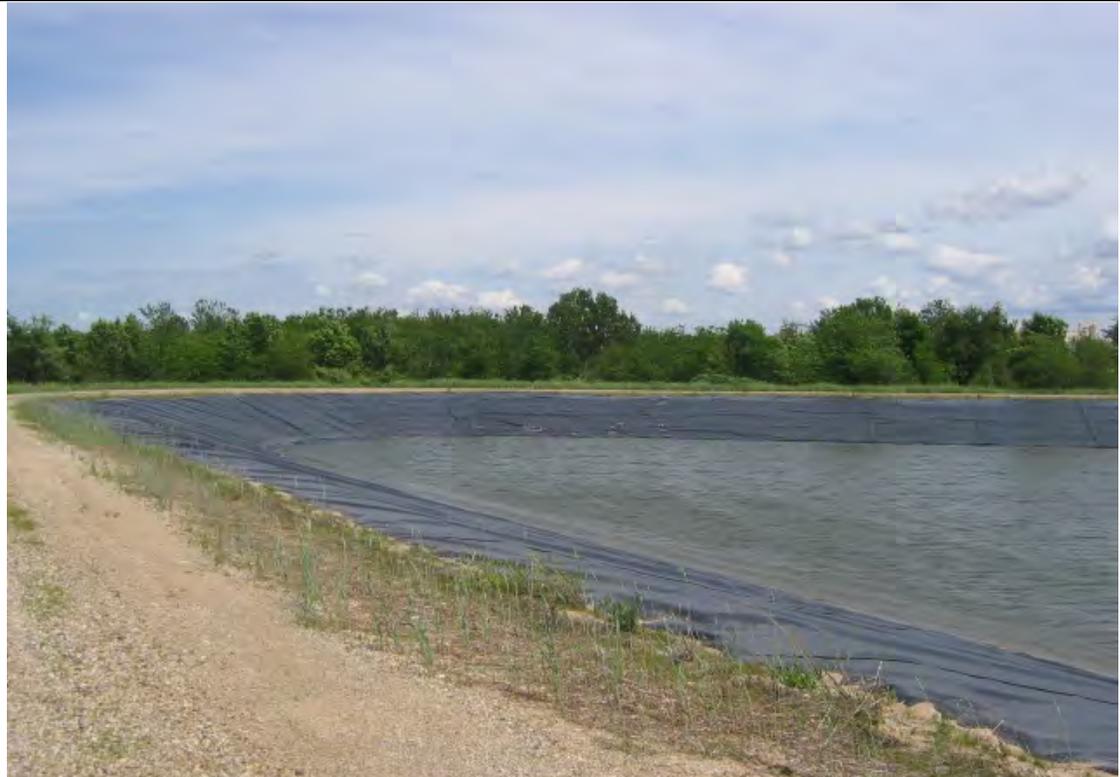
Photo No. 37	Date: 5/23/11
Direction Photo Taken: Southeast

Description:
Crest and upstream slope of Pond 2E.

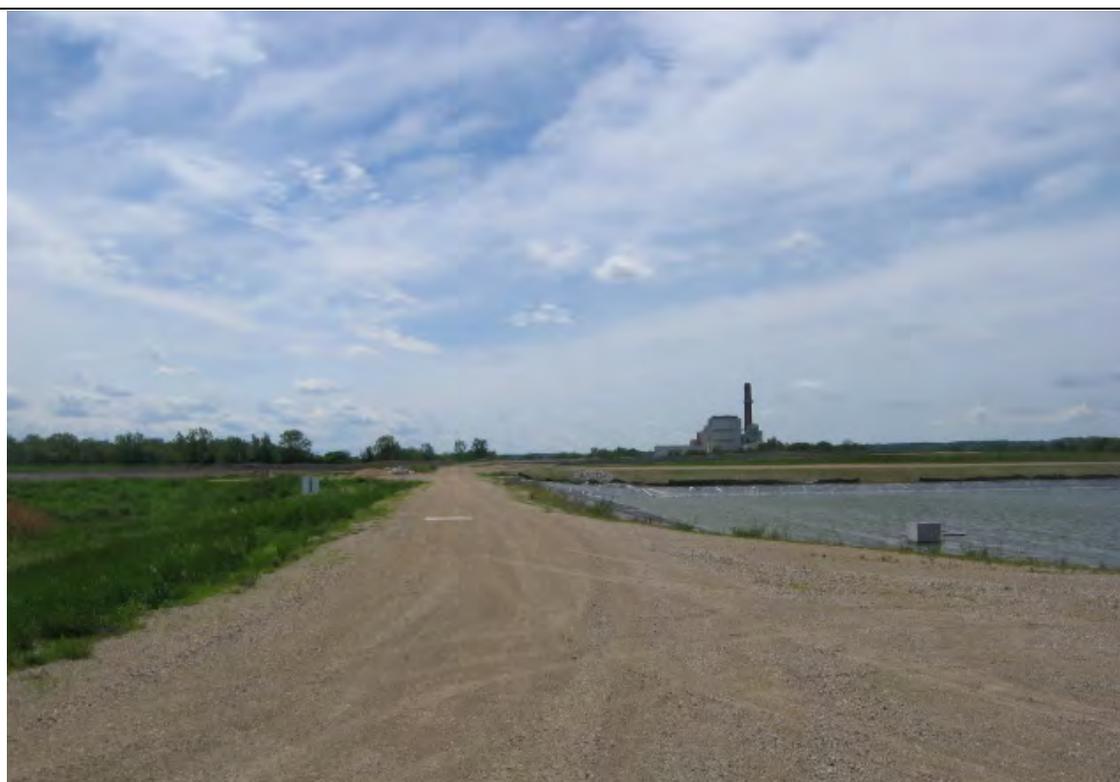
Photo No. 38	Date: 5/23/11
Direction Photo Taken: West

Description:
Crest of the embankment between Pond 2E and Secondary Cell.

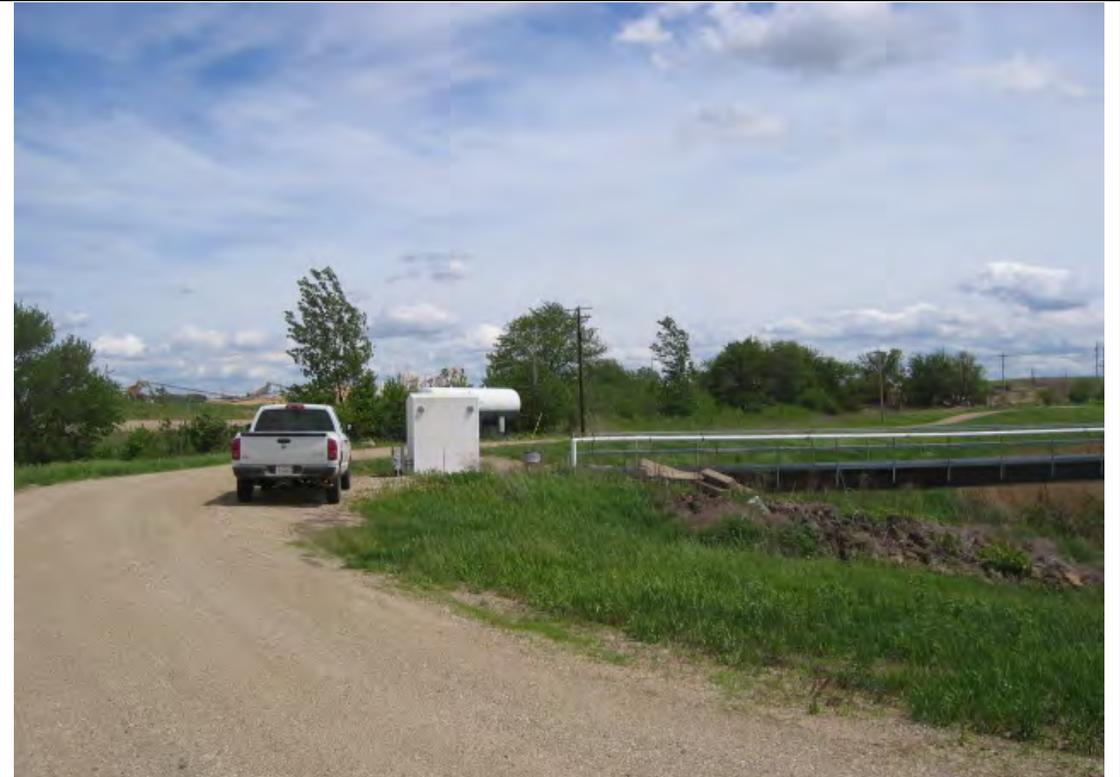
Photo No. 39	Date: 5/23/11
Direction Photo Taken: Southeast

Description:
Crest and upstream slope of the Secondary Cell.

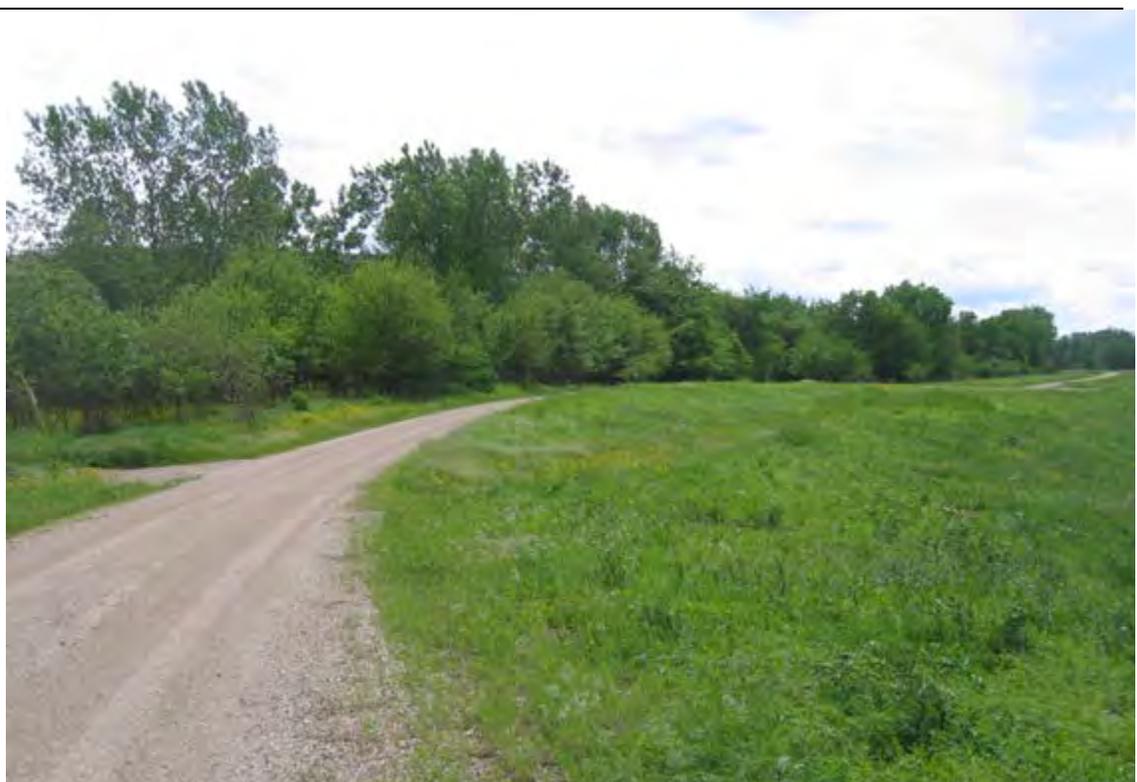
Photo No. 40	Date: 5/23/11
Direction Photo Taken: Southwest

Description:
Crest and upstream slope of the Secondary Cell.

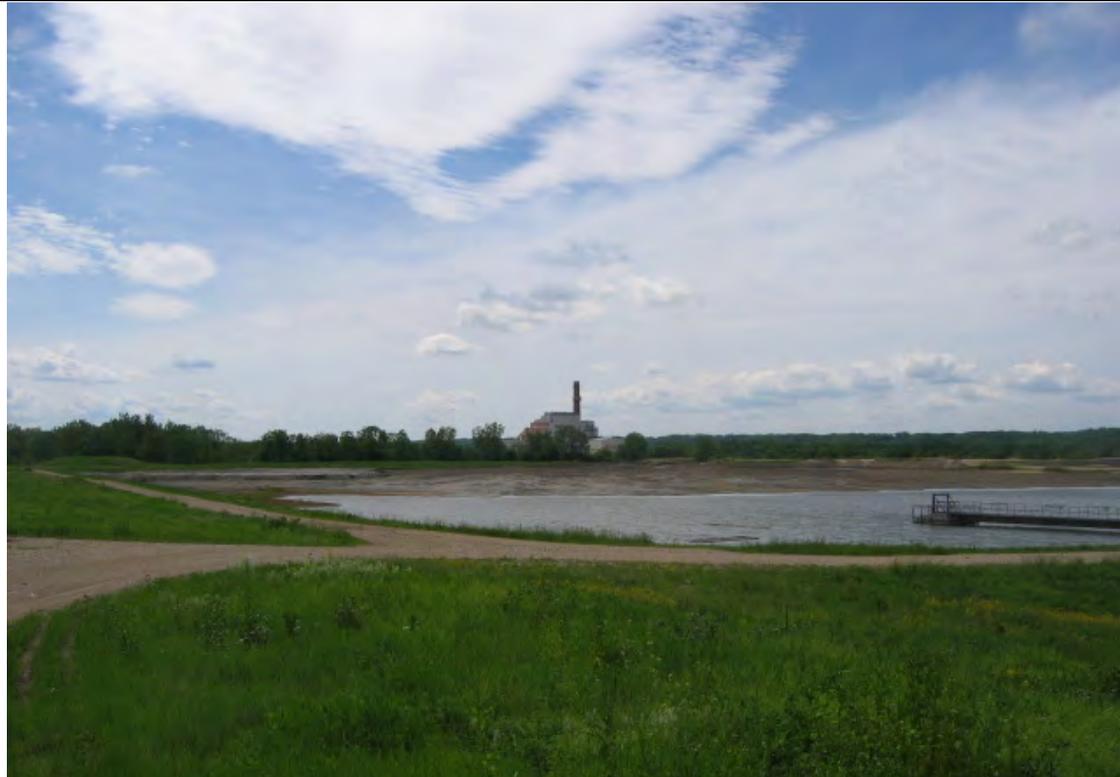
Photo No. 41	Date: 5/23/11
Direction Photo Taken: Northwest	
Description: Crest and upstream slope of the Secondary Cell.

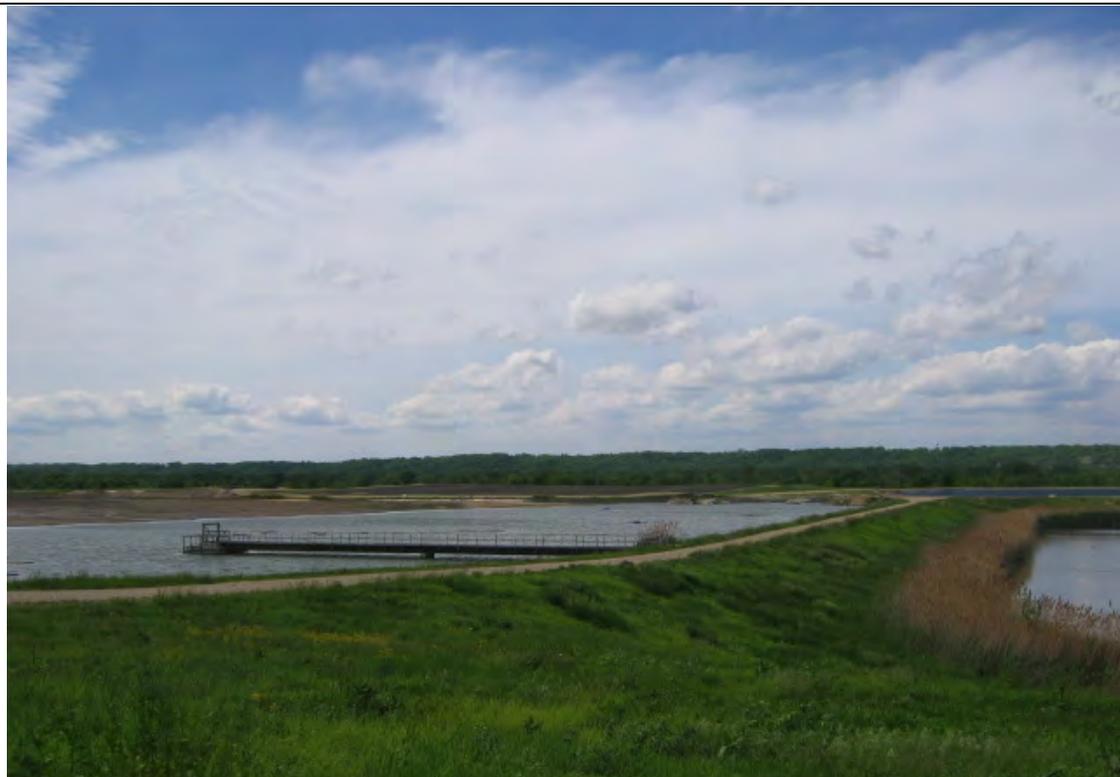
Photo No. 42	Date: 5/23/11
Direction Photo Taken: Northwest	
Description: Crest and upstream slope of the Secondary Cell.

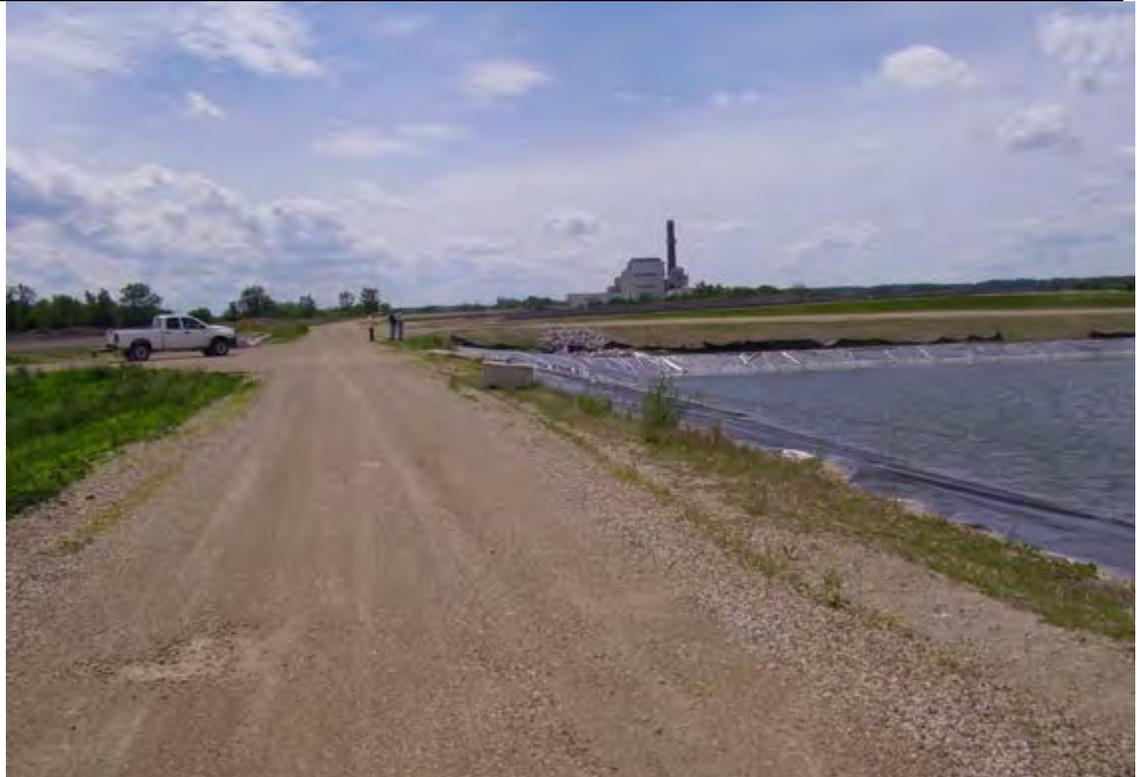
Photo No. 43	Date: 5/23/11
Direction Photo Taken: Southwest

Description:
Crest of the embankment between Pond 2E and the Secondary Cell.

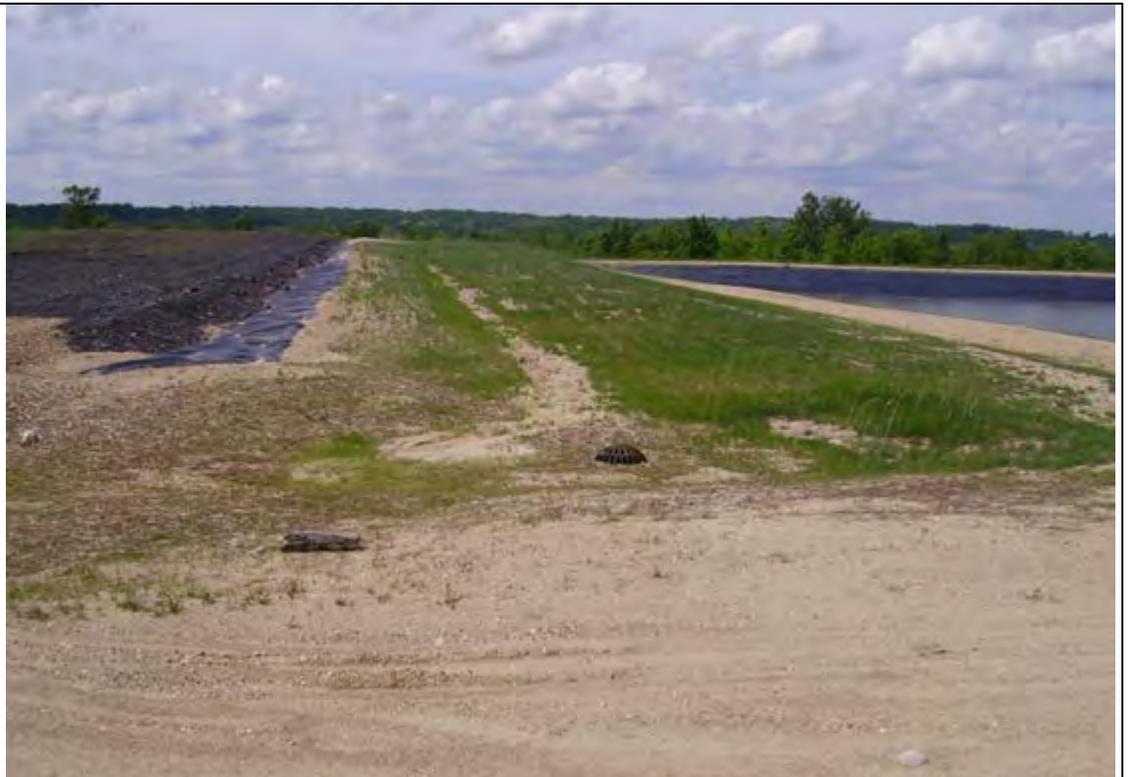
Photo No. 44	Date: 5/23/11
Direction Photo Taken: Northwest

The EAPS no longer functions as an active ash impoundment and no CCW sluice piping is present. Storm water drains have been installed along portions of the perimeter of the permitted landfill as shown in Photo 44. The drains appeared to be in good condition at the time of our assessment.

Description:
Upstream slope of the EAPS.

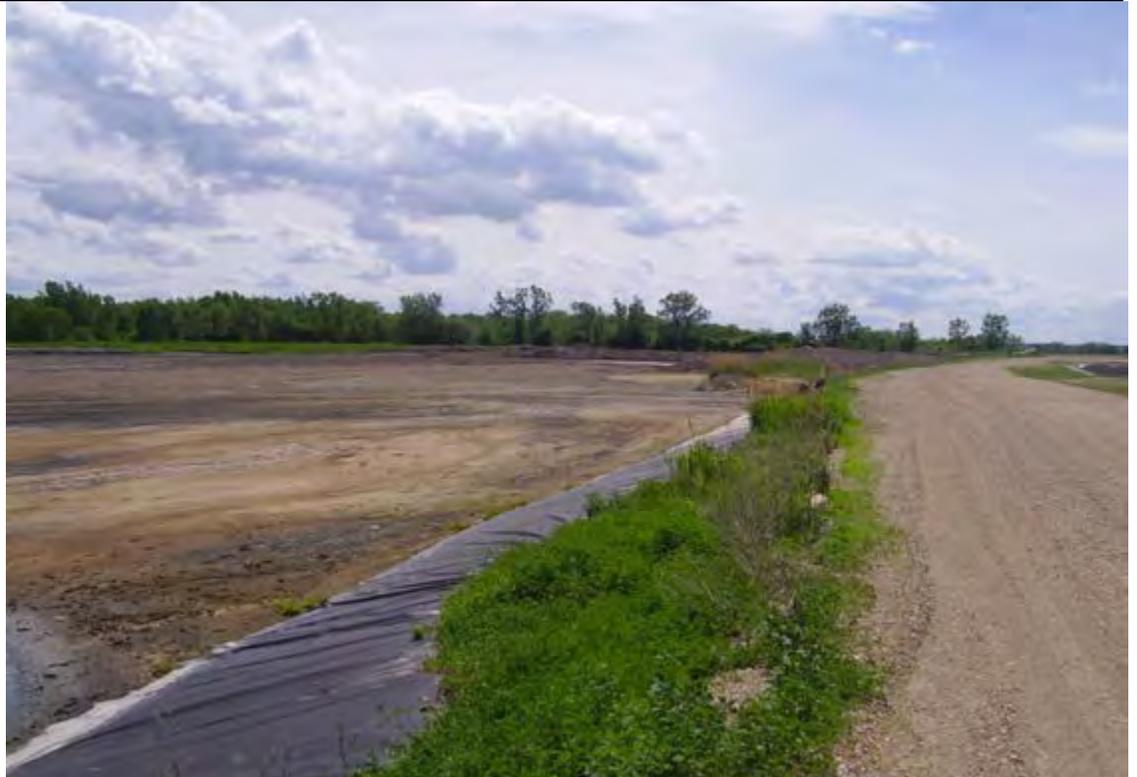
Photo No. 45	Date: 5/23/11
Direction Photo Taken: Southwest

Description:
Crest and upstream slope of the Primary Cell.

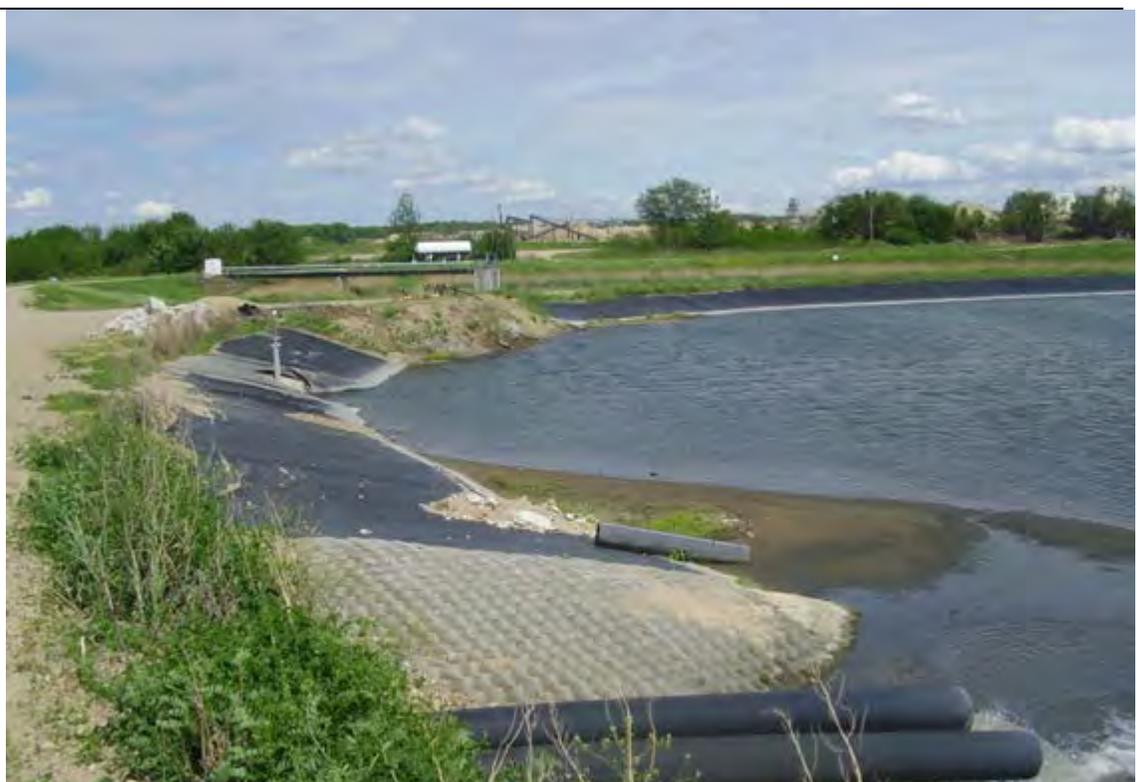
Photo No. 46	Date: 5/23/11
Direction Photo Taken: East

Description:
Upstream slope of the Primary Cell.

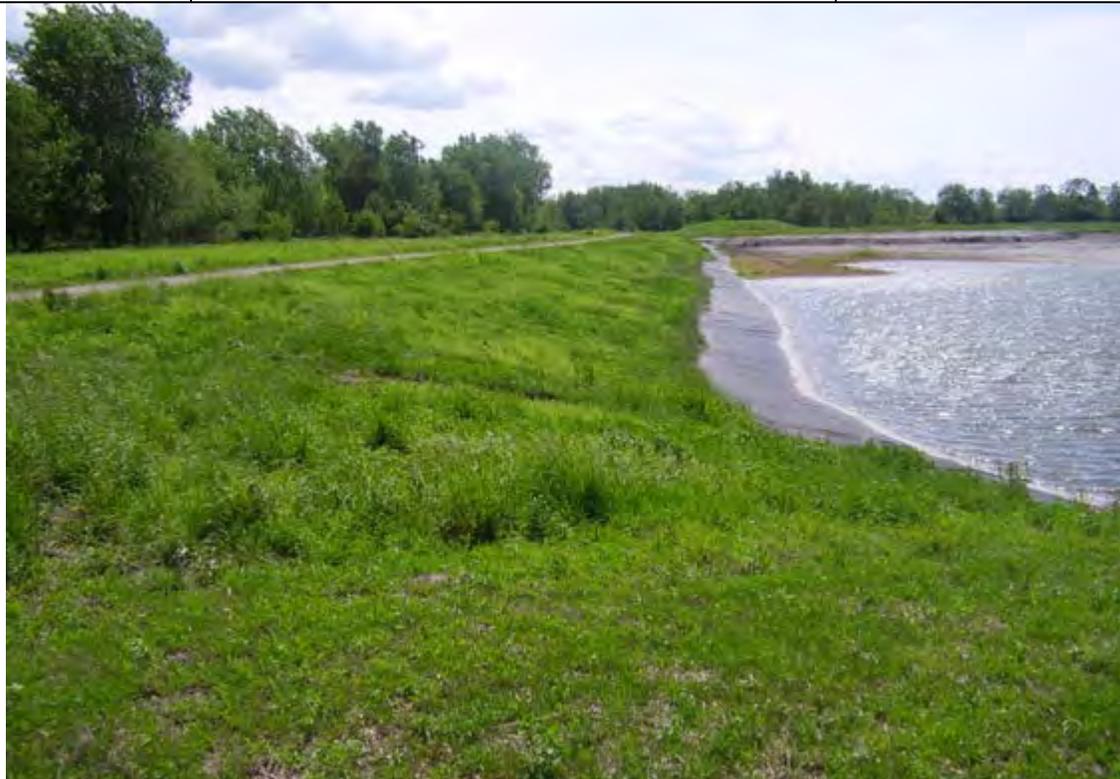
Photo No. 47	Date: 5/23/11
Direction Photo Taken: Southwest	
Description: Upstream slope of the Primary Cell.

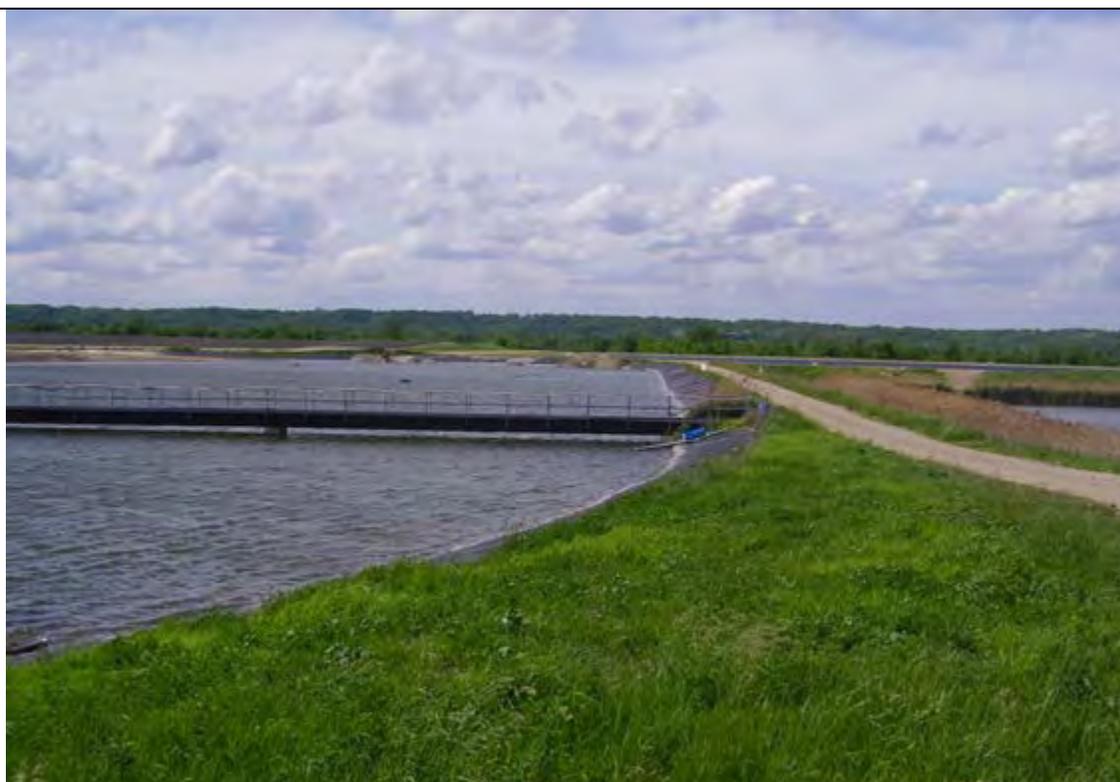
Photo No. 48	Date: 5/23/11
Direction Photo Taken: Northwest	
Description: Upstream slope of the Primary Cell near the decant structure.

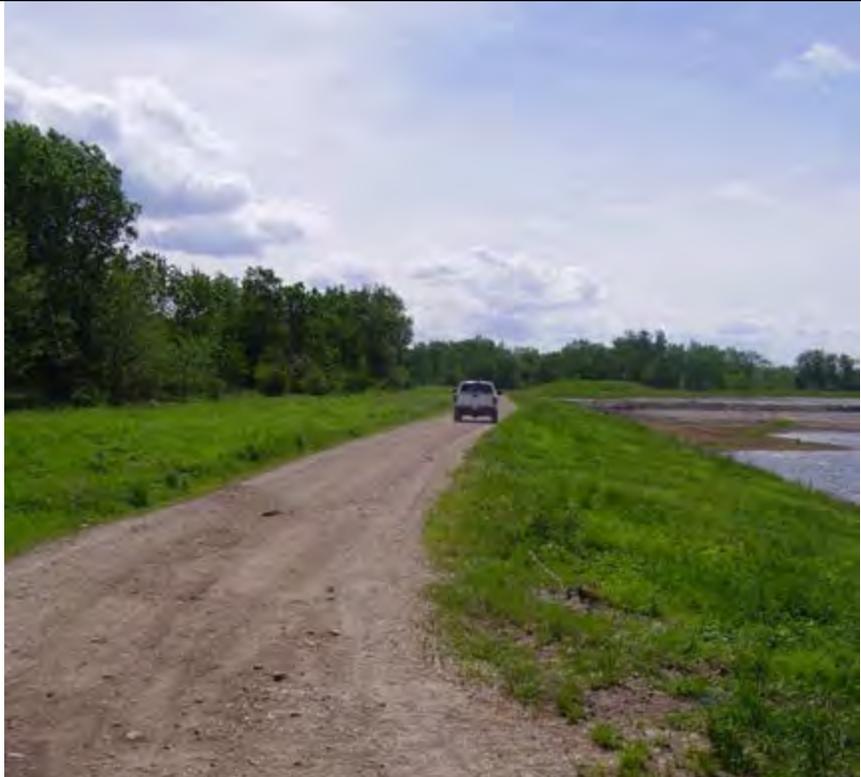
Photo No. 49	Date: 5/23/11

Direction Photo Taken: Southwest		
Description: Crest and upstream slope of the Primary Cell.

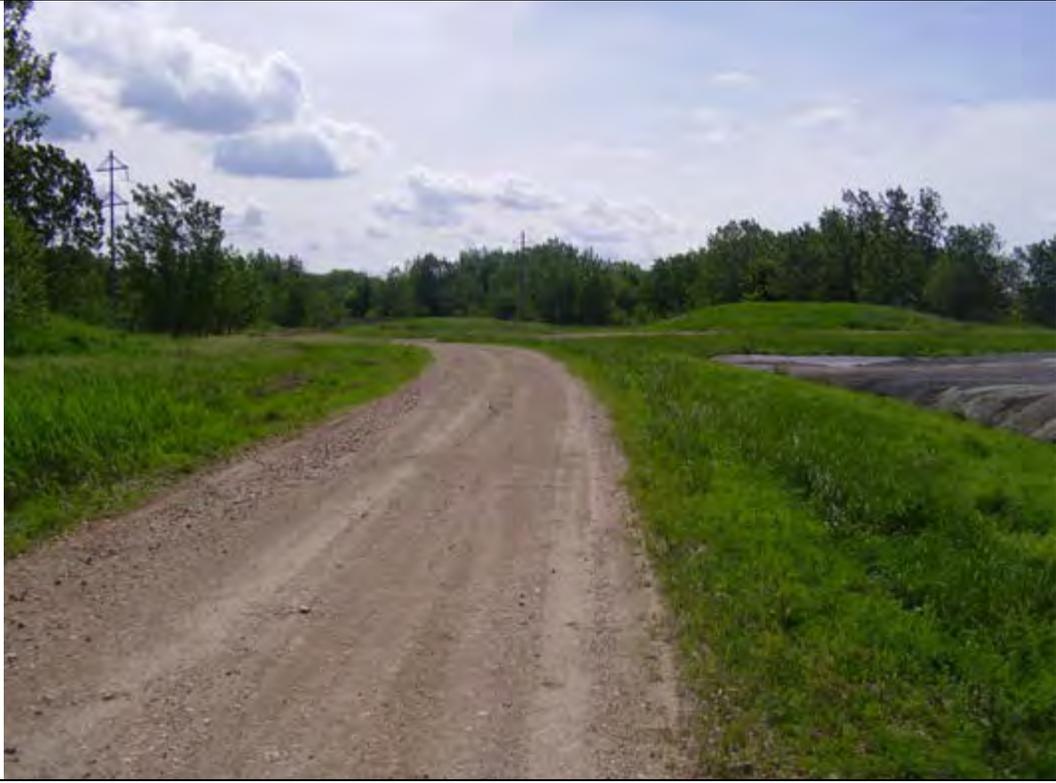
Photo No. 50	Date: 5/23/11

Direction Photo Taken: Southwest		
Description: Crest and upstream slope of the Primary Cell.

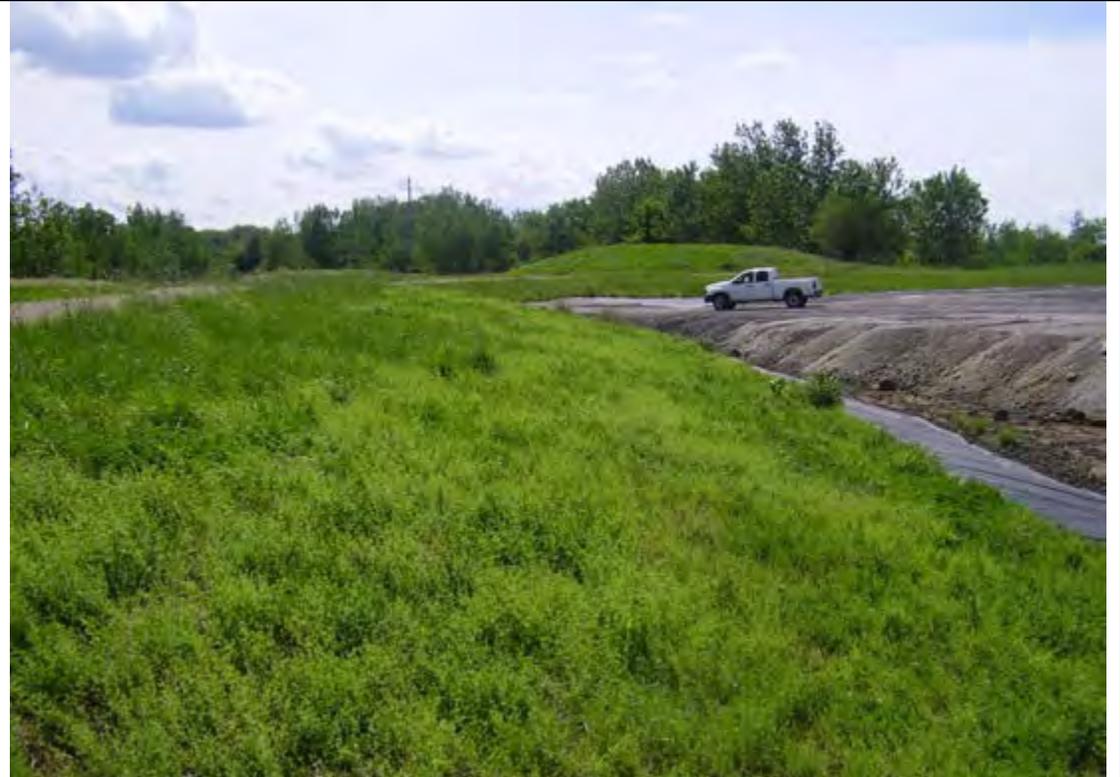
Photo No. 51	Date: 5/23/11
Direction Photo Taken: Southwest

Description:
Upstream slope of the Primary Cell.

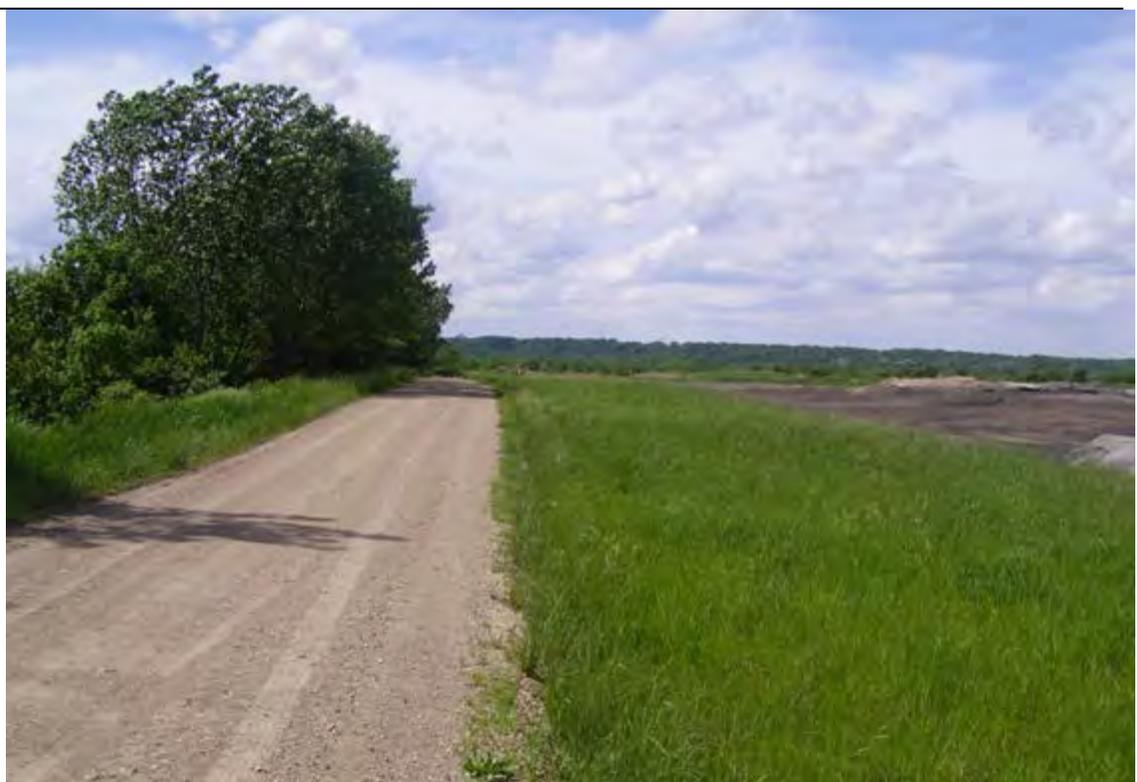
Photo No. 52	Date: 5/23/11
Direction Photo Taken: Northwest

Description:
Crest and upstream slope of the Primary Cell.
