**FINAL REPORT
ROUND 10 DAM ASSESSMENT
DYNEGY MIDWEST GENERATION, LLC – BALDWIN ENERGY COMPLEX
PRIMARY FLY ASH POND, SECONDARY FLY ASH POND, SECONDARY POND,
INTERMEDIATE POND, FINAL POND
BALDWIN, ILLINOIS**

December 21, 2012
GZA File No. 170142.30

RE: FINAL Assessment of Dam Safety of Coal Combustion Surface Impoundments at the Baldwin Energy Complex

**FINAL REPORT
ROUND 10 DAM ASSESSMENT
DYNEGY MIDWEST GENERATION, LLC – HENNEPIN POWER STATION
ACTIVE EAST ASH POND SYSTEM, EAST ASH POND SYSTEM, WEST ASH POND
SYSTEM
HENNEPIN, ILLINOIS**

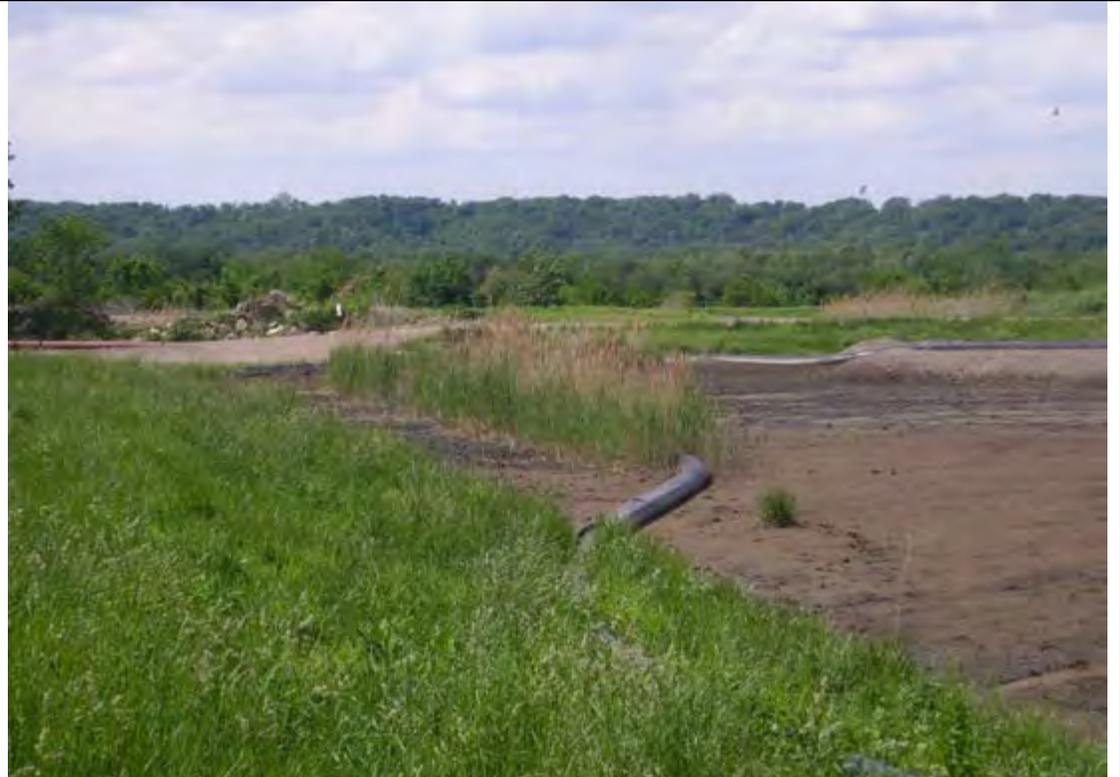
Photo No. 53	Date: 5/23/11
Direction Photo Taken: Northwest

Description:
Crest and upstream slope of the Primary Cell.

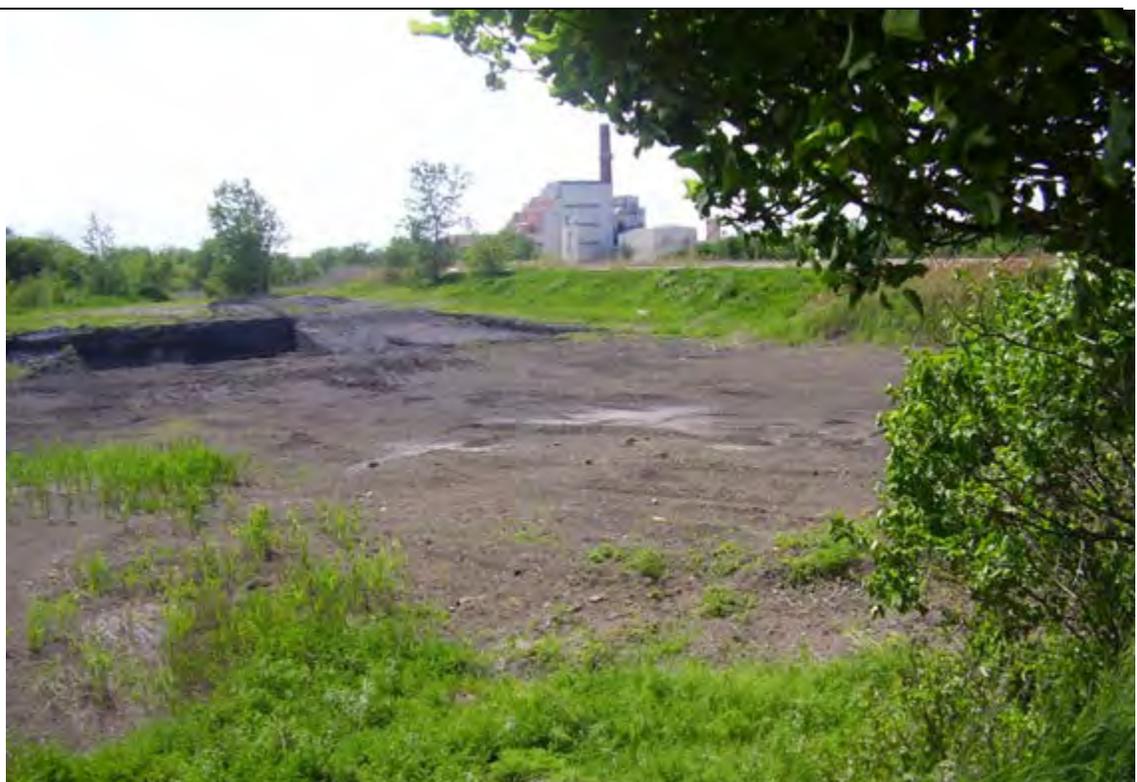
Photo No. 54	Date: 5/23/11
Direction Photo Taken: West

Description:
Downstream slope of the EAPS.

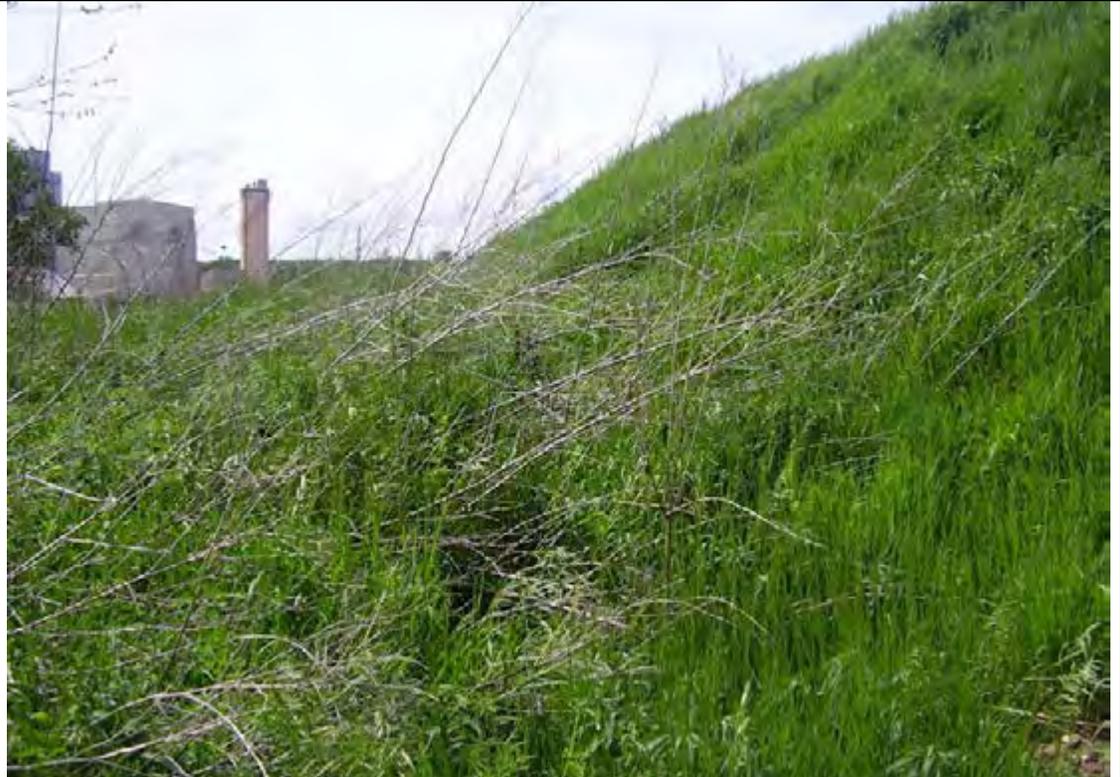
Direction Photo Taken:
Northwest

Description:
Downstream slope of the EAPS.

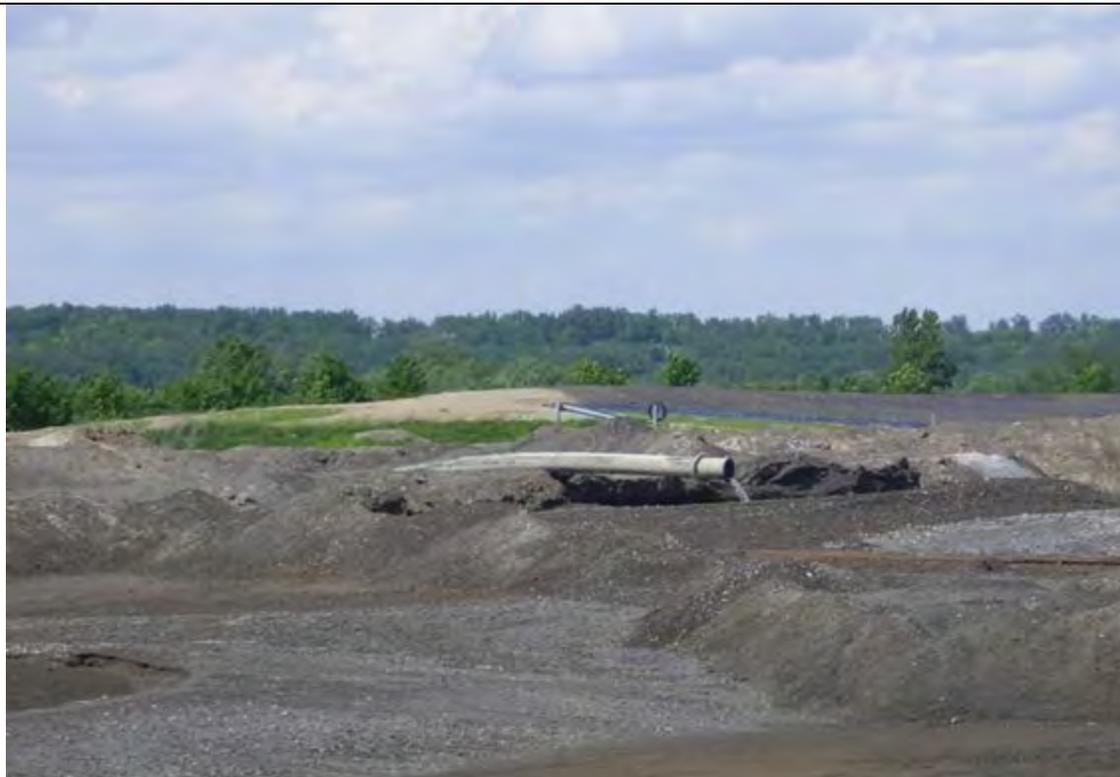
Photo No. 58	Date: 5/23/11
-------------------------------	-------------------------

Description:
Discharge pipe into the northwest portion of the Primary Cell.

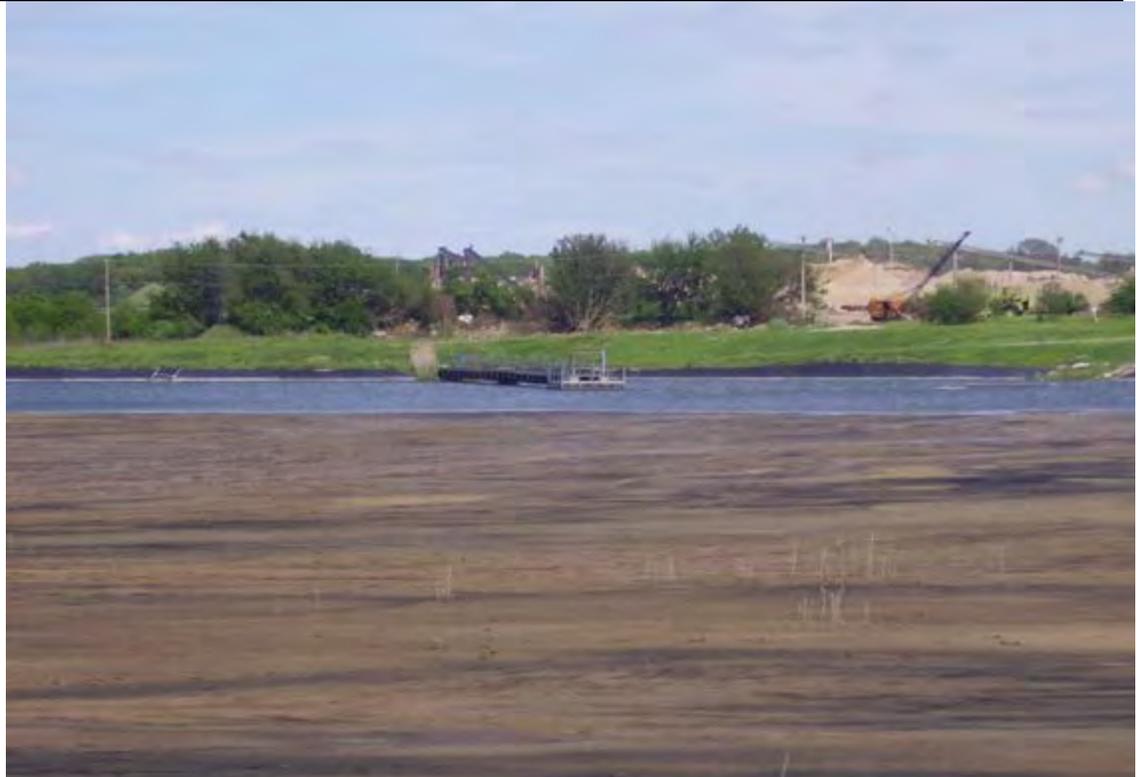
Photo No. 59	Date: 5/23/11
Direction Photo Taken: East

Description:
Old decant structure in the Primary Cell.

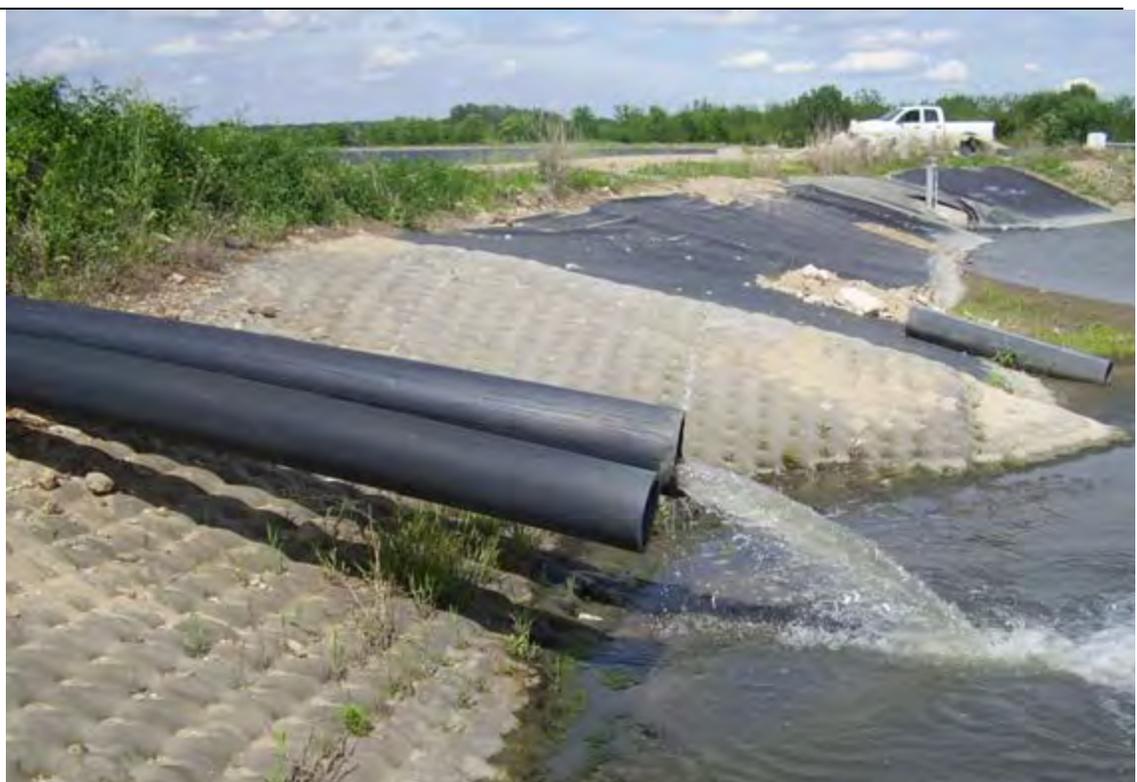
Photo No. 60	Date: 5/23/11
Direction Photo Taken: East

Description:
Discharge pipe into the Primary Cell near the northeast corner.

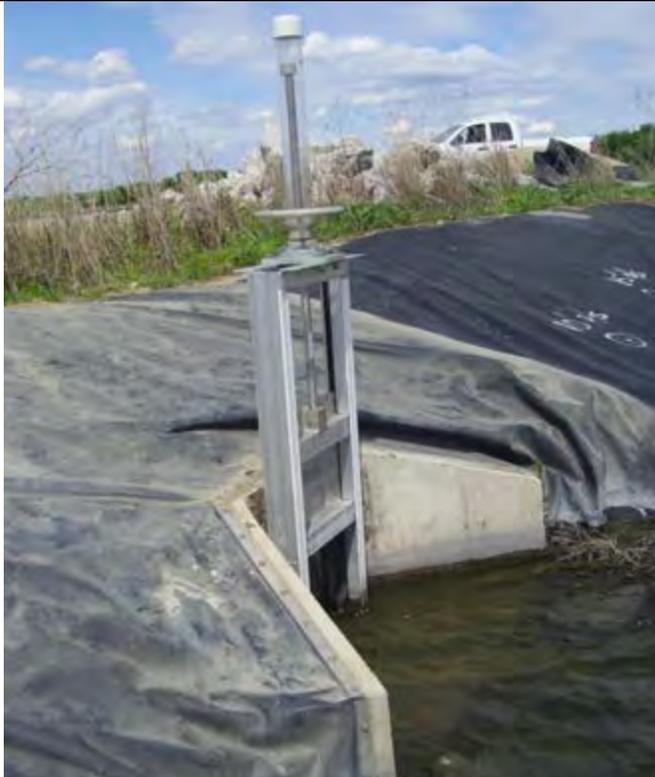
Photo No. 61	Date: 5/23/11
Direction Photo Taken: East

Description:
Decant structure in the Primary Cell.

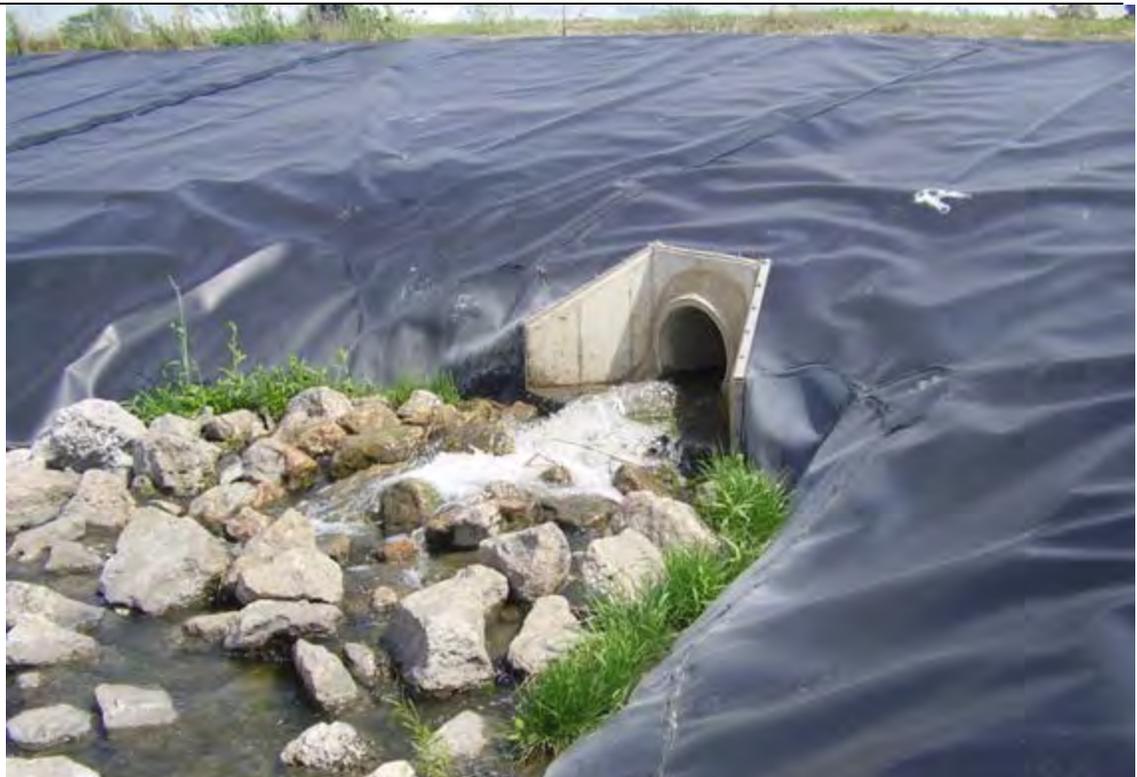
Photo No. 62	Date: 5/23/11
Direction Photo Taken: Southeast

Description:
Discharge pipe from the Primary Cell to Pond 2E.

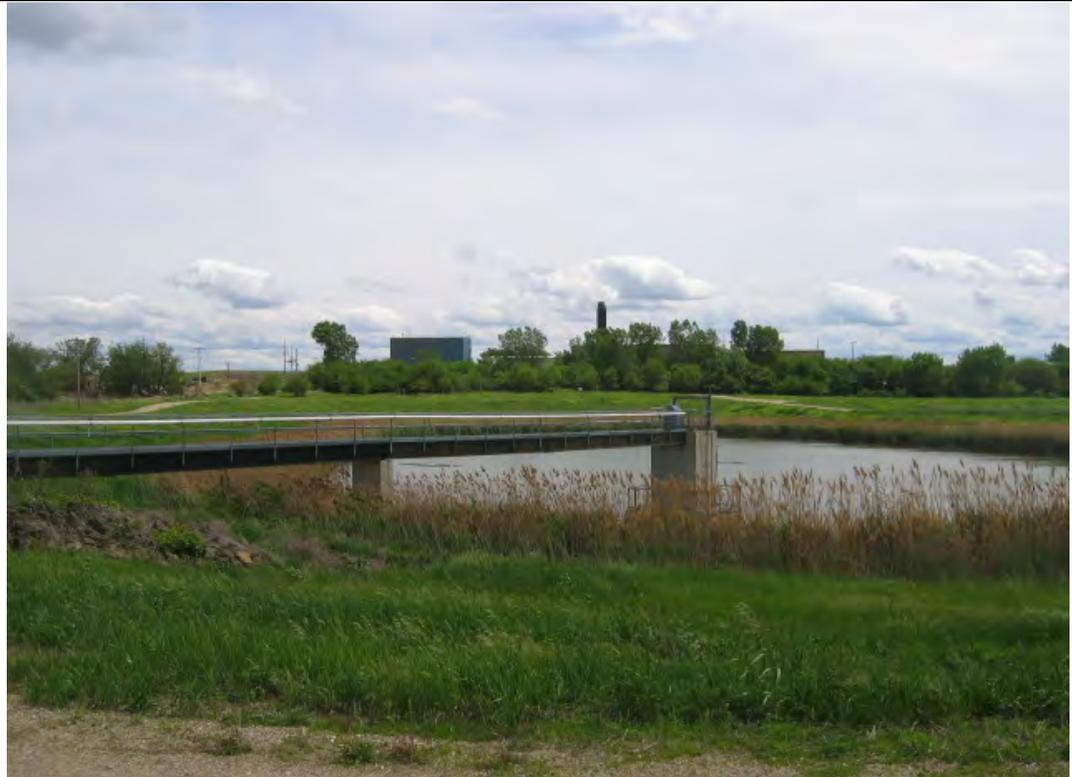
Photo No. 63	Date: 5/23/11
Direction Photo Taken: South

Description:
Decant structure in the Secondary Cell.

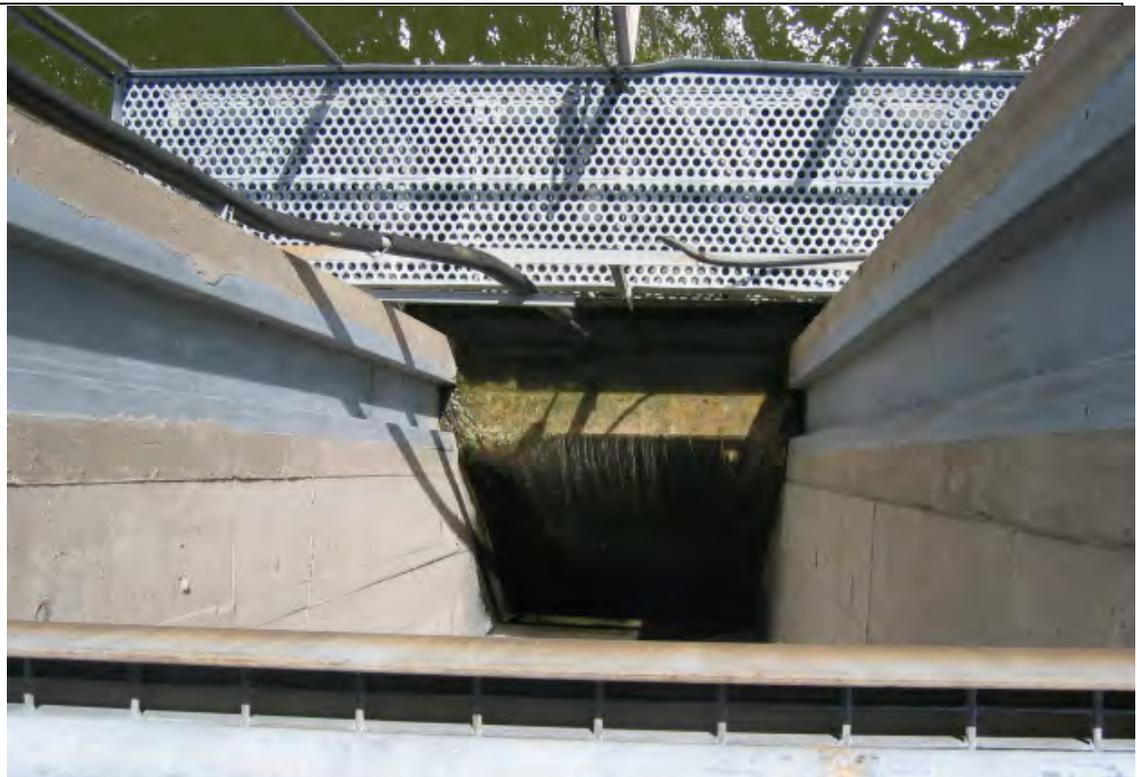
Photo No. 64	Date: 5/23/11
Direction Photo Taken: Down

Description:
Decant structure in the Secondary Cell.

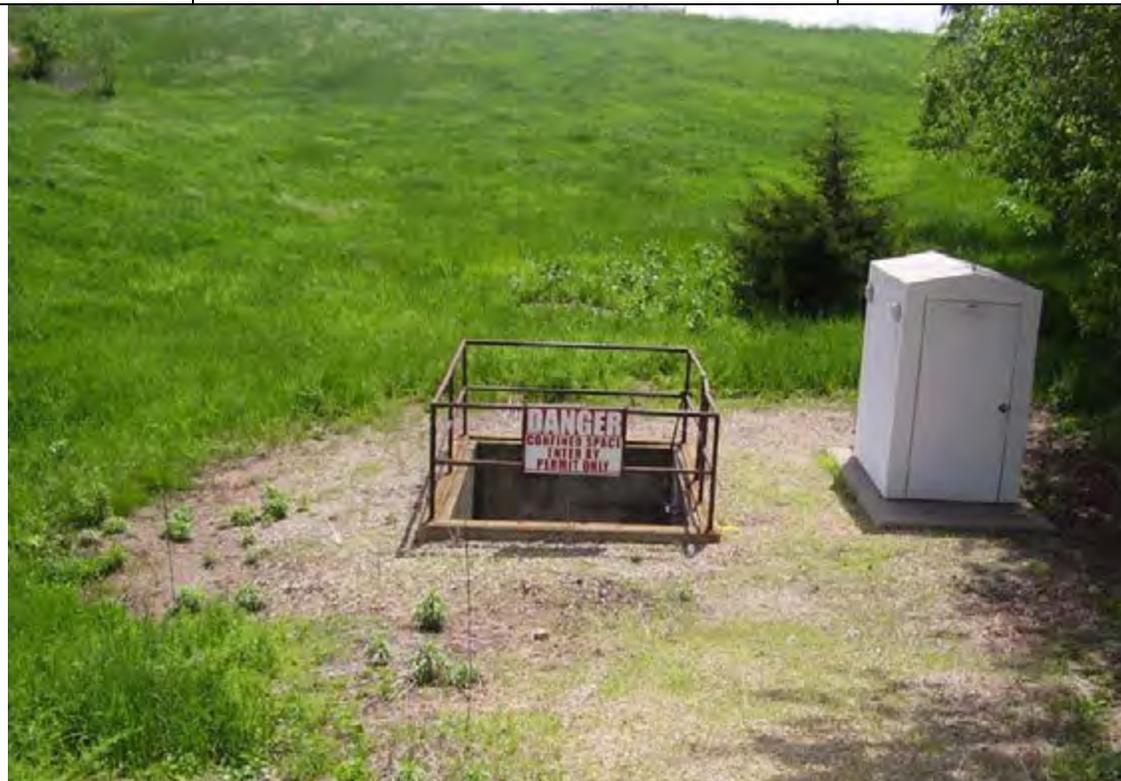
Photo No. 65	Date: 5/23/11
Direction Photo Taken: Southwest

Description:
Surface features of the flume structure in the discharge line from the Secondary Cell to the Illinois River.

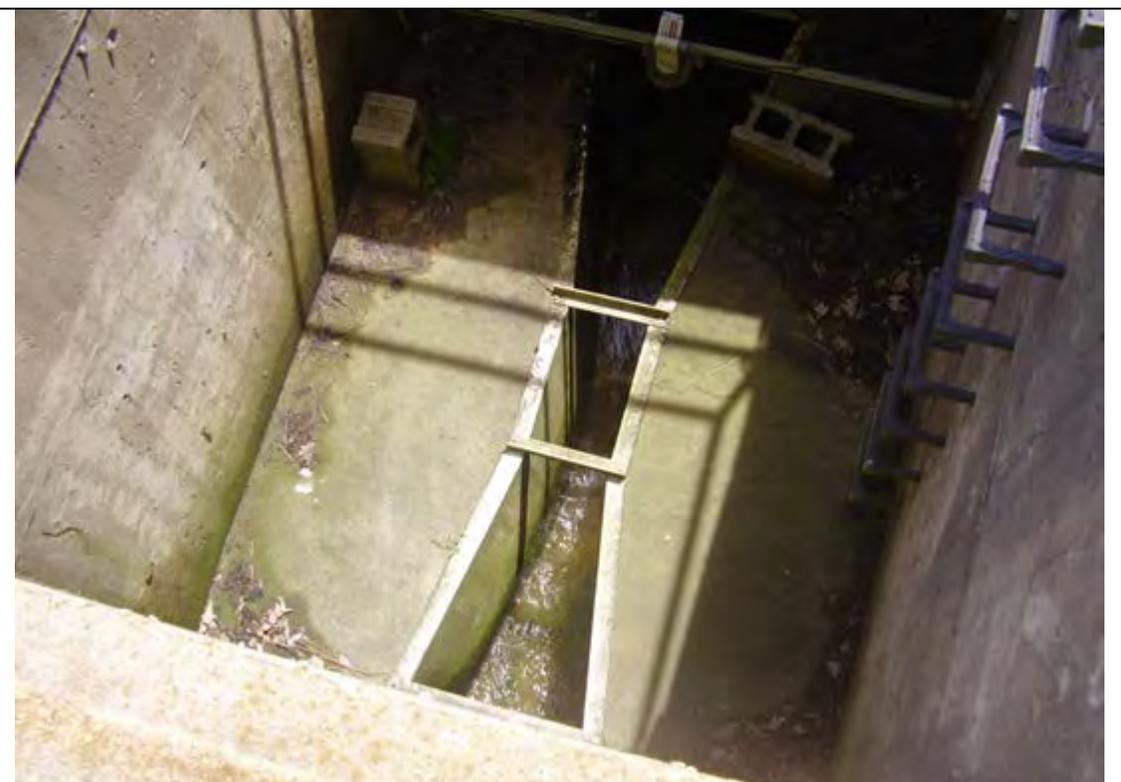
Photo No. 66	Date: 5/23/11
Direction Photo Taken: Down

Description:
Flume structure in the discharge line from the Secondary Cell to the Illinois River.

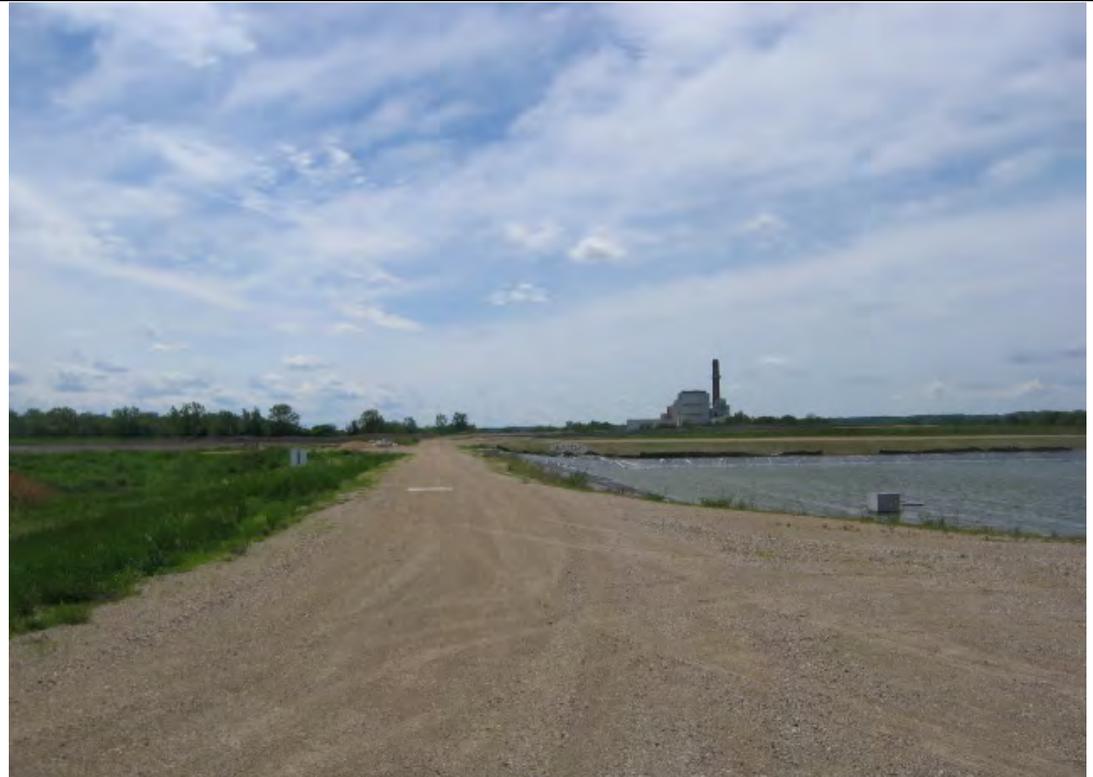
Photo No. 67	Date: 5/23/11
Direction Photo Taken: West

Description:
Crest of the interior embankment in the AEAPS with the Pond 2E decant structure shown.

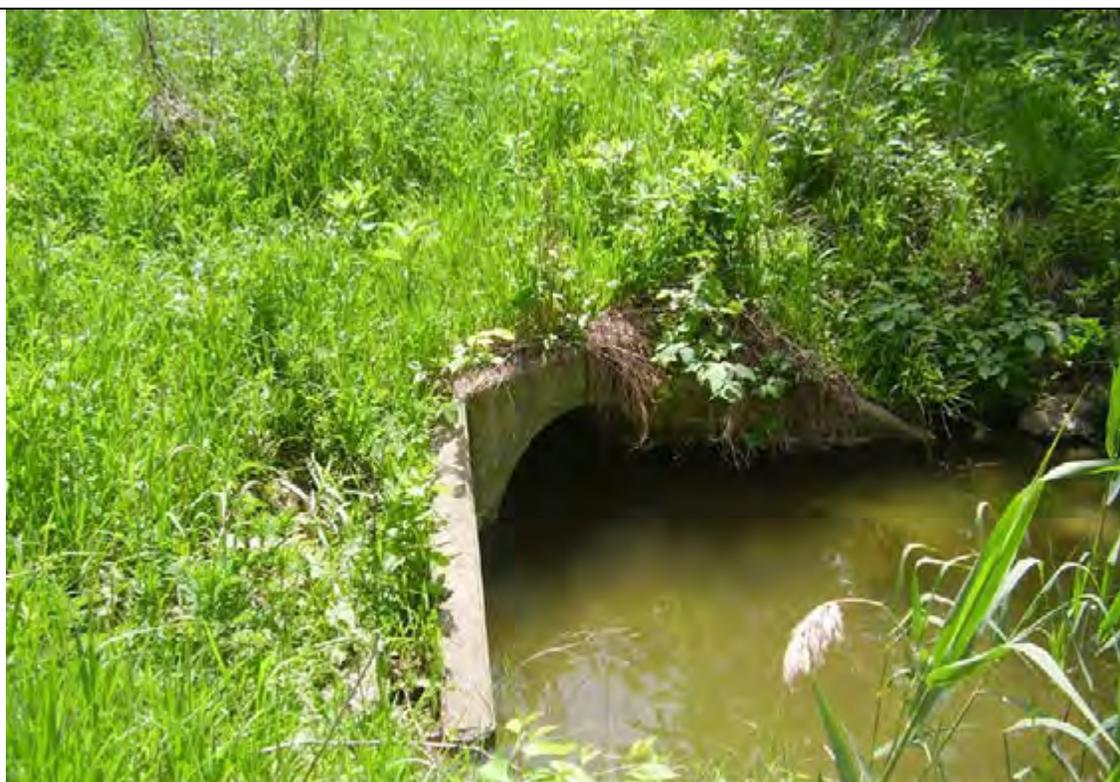
Photo No. 68	Date: 5/23/11
Direction Photo Taken: Southwest

Description:
Outfall at the Illinois River.

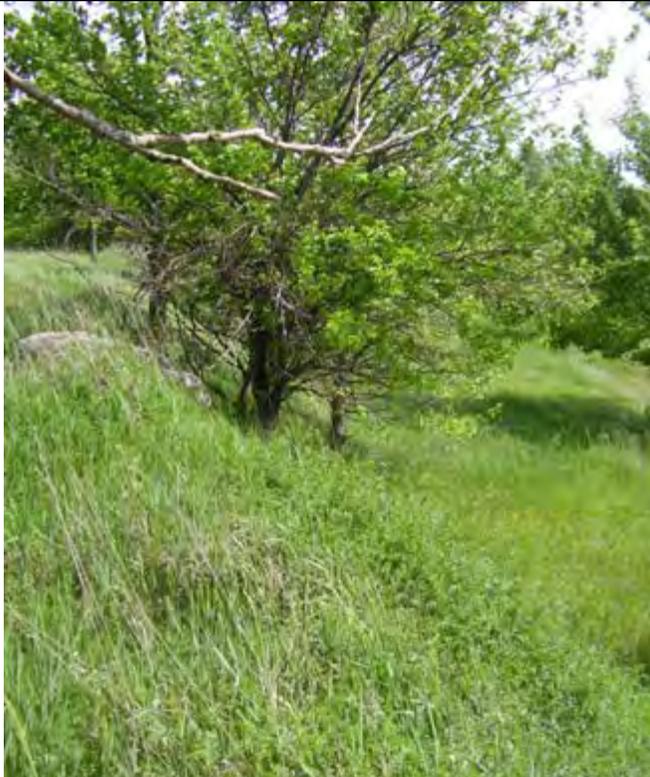
Photo No. 69	Date: 5/23/11

Direction Photo Taken: Southeast		
Description: Downstream slope of EAPS near Pond 4.

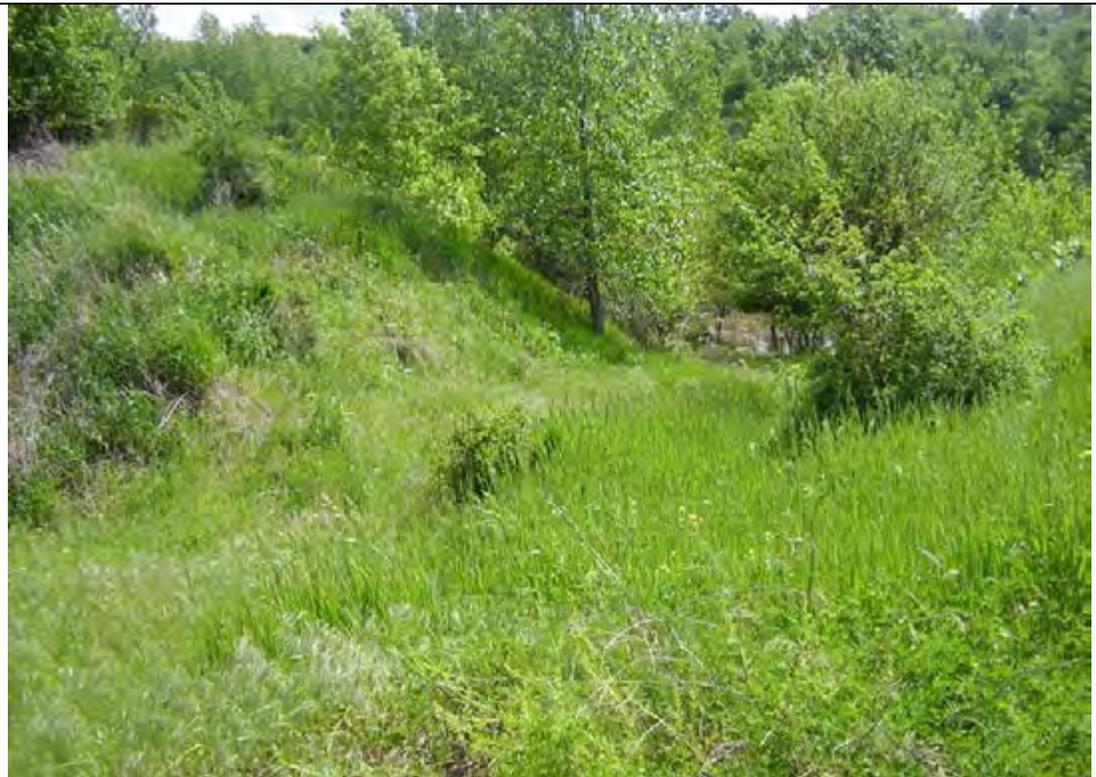
Photo No. 70	Date: 5/23/11

Direction Photo Taken: South		
Description: Downstream slope of the EAPS near Pond 4.

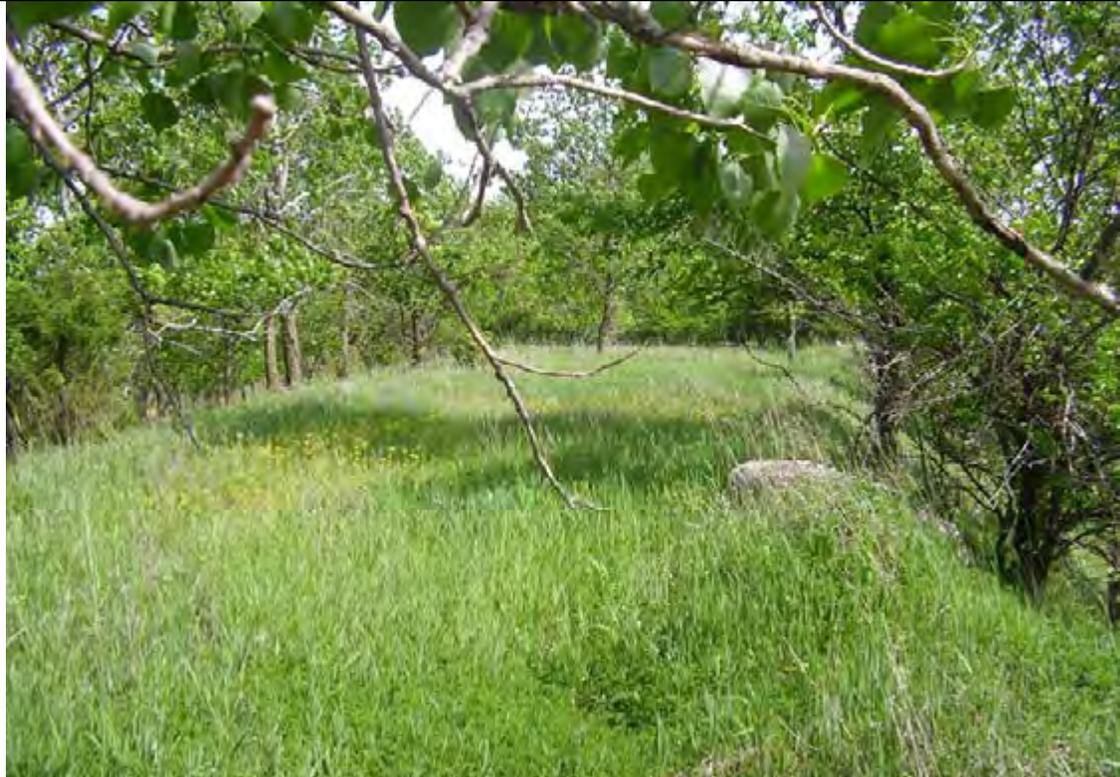
Photo No. 71	Date: 5/23/11
Direction Photo Taken: Southeast	
Description: Crest of the EAPS near Pond 4.

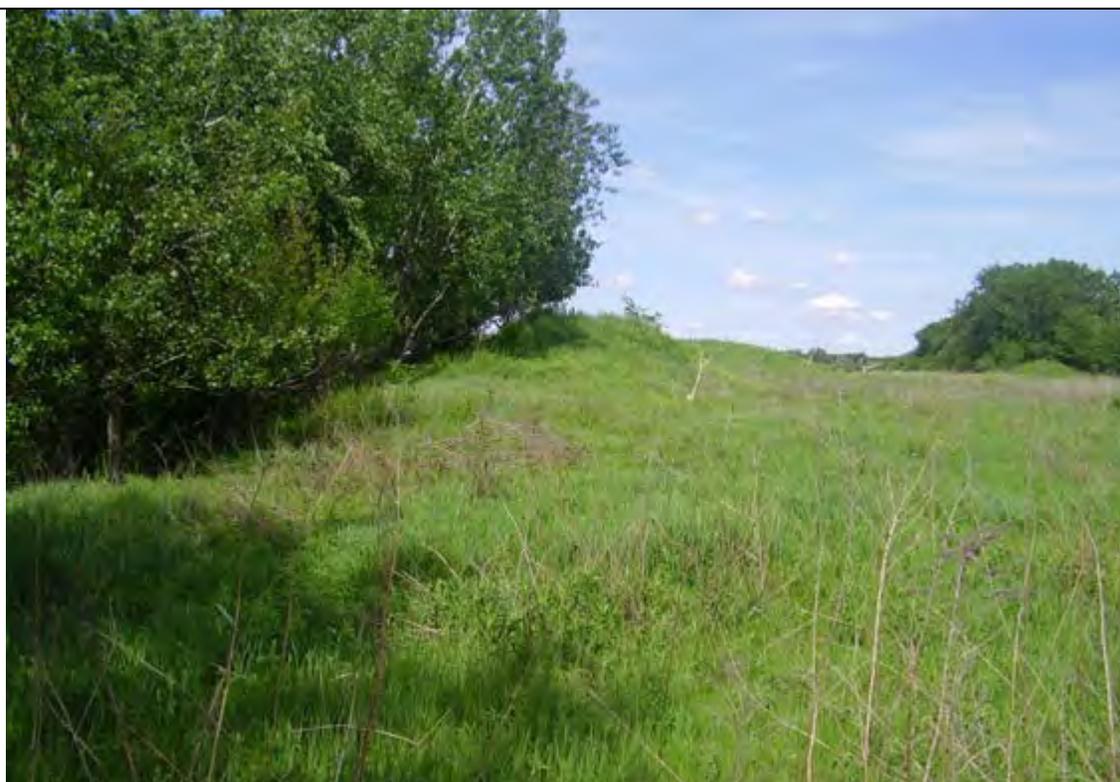
Photo No. 72	Date: 5/23/11
Direction Photo Taken: Northeast	
Description: Crest of the EAPS near Pond 4.

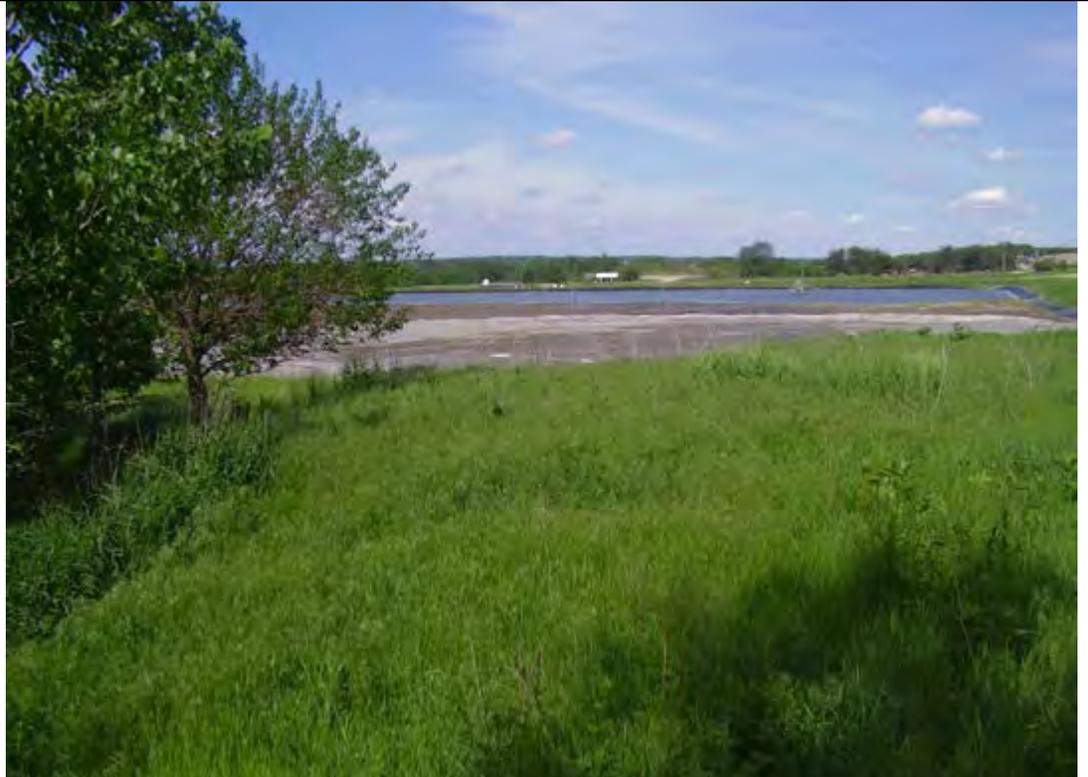
Photo No. 73	Date: 5/23/11
Direction Photo Taken: Northeast

Description:
Crest of the EAPS looking over the Primary Cell.

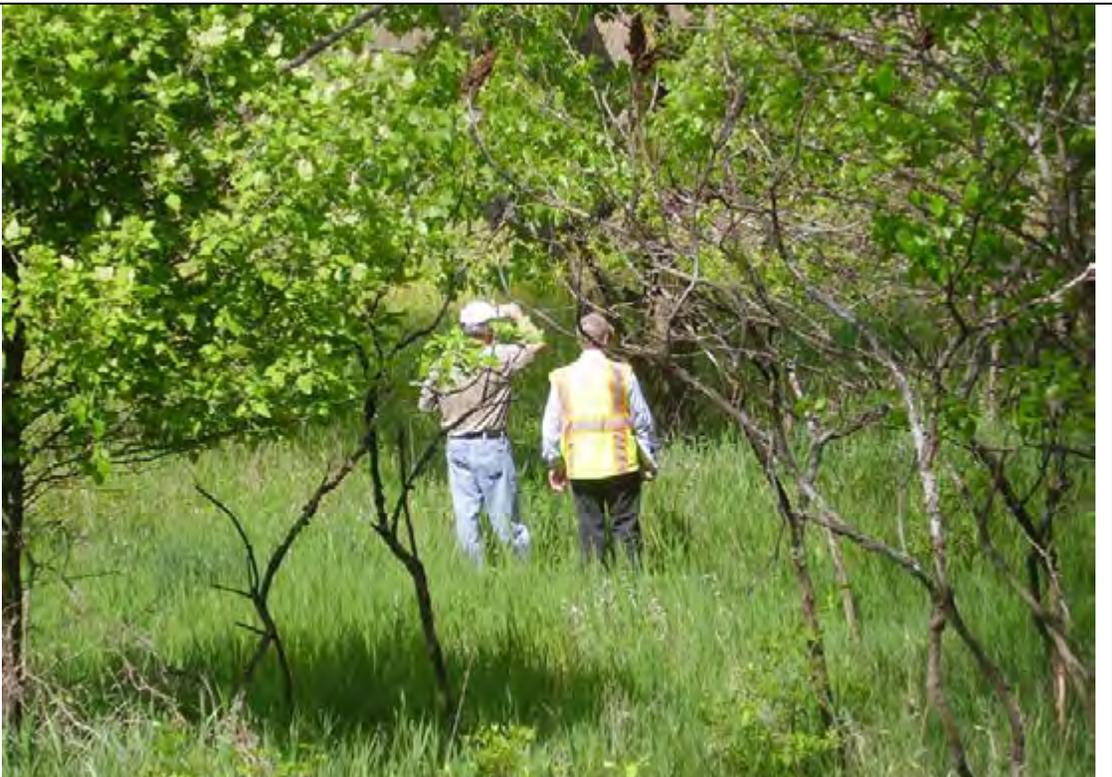
Photo No. 74	Date: 5/23/11
Direction Photo Taken: Northeast

Description:
Crest of the EAPS near Pond 4.
