)  
)  
)  
)  
)  
)  
) PCB 2013-015  
) (Enforcement – Water)  
)  
)  
)  
)  
)  
)

# Expert Report on Ground-water Contamination

**James R. Kunkel, Ph.D., P.E.**

**July 1, 2015**

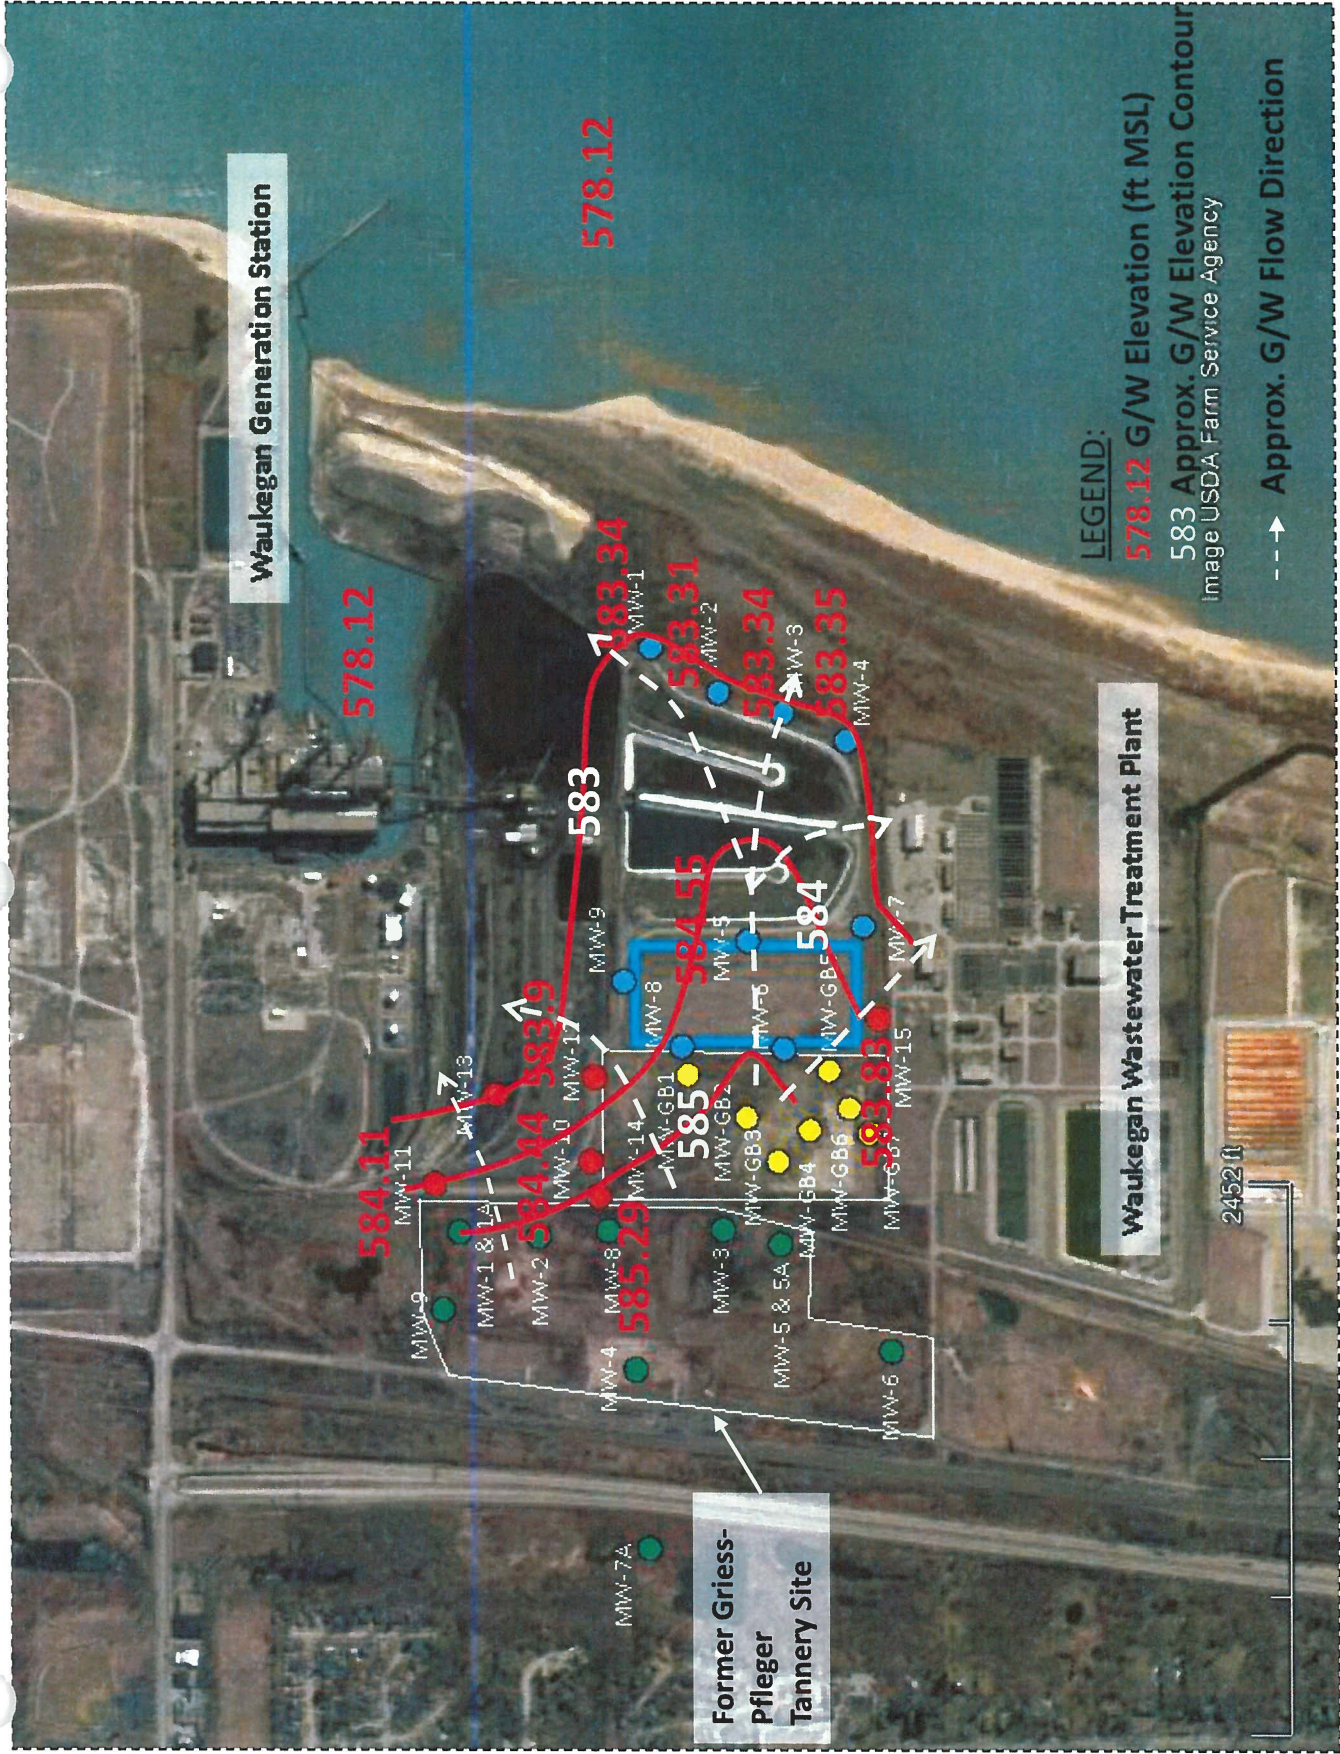
**Figure 18 Approximate Ground-water Contours  
June 2011 (PCB 2013-015)**

Additional interpretations of the ground-water elevation contours shown on Figures 18, 19, 20 and 21 indicate that:

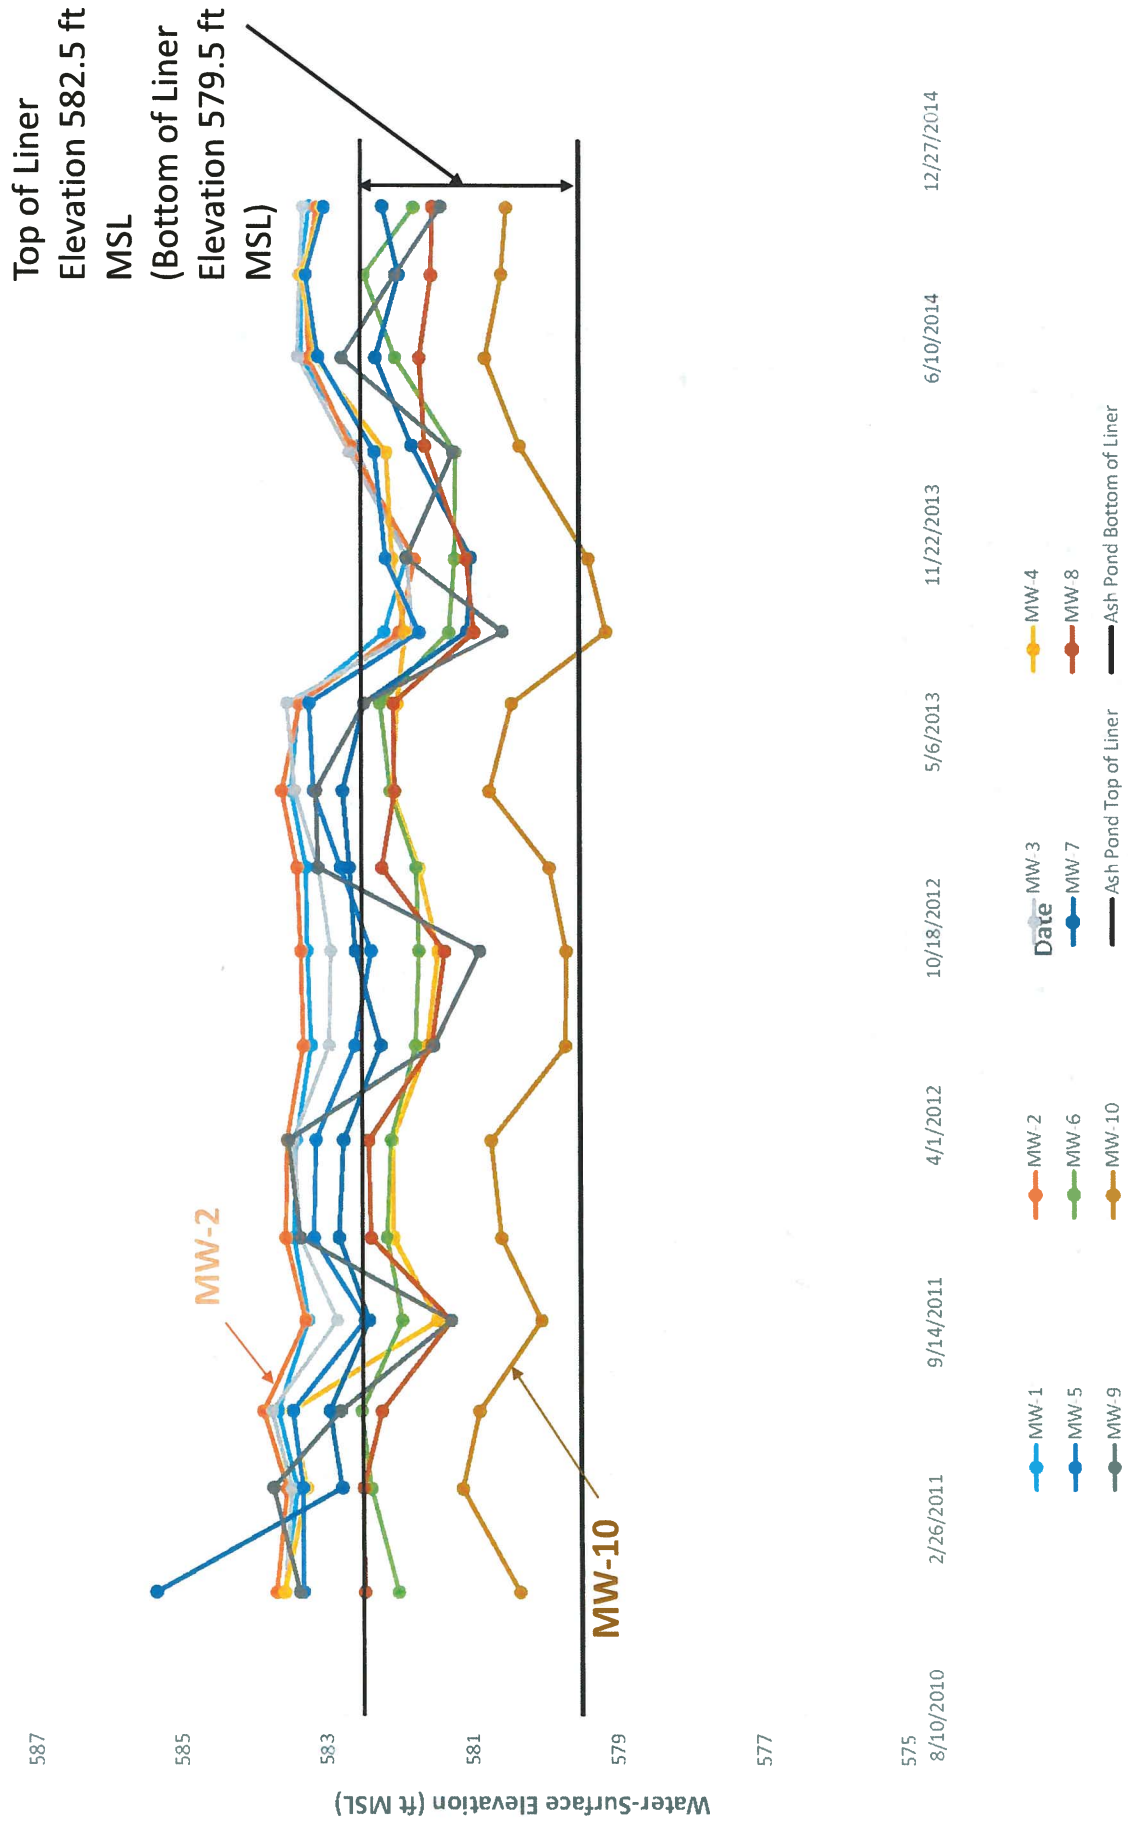
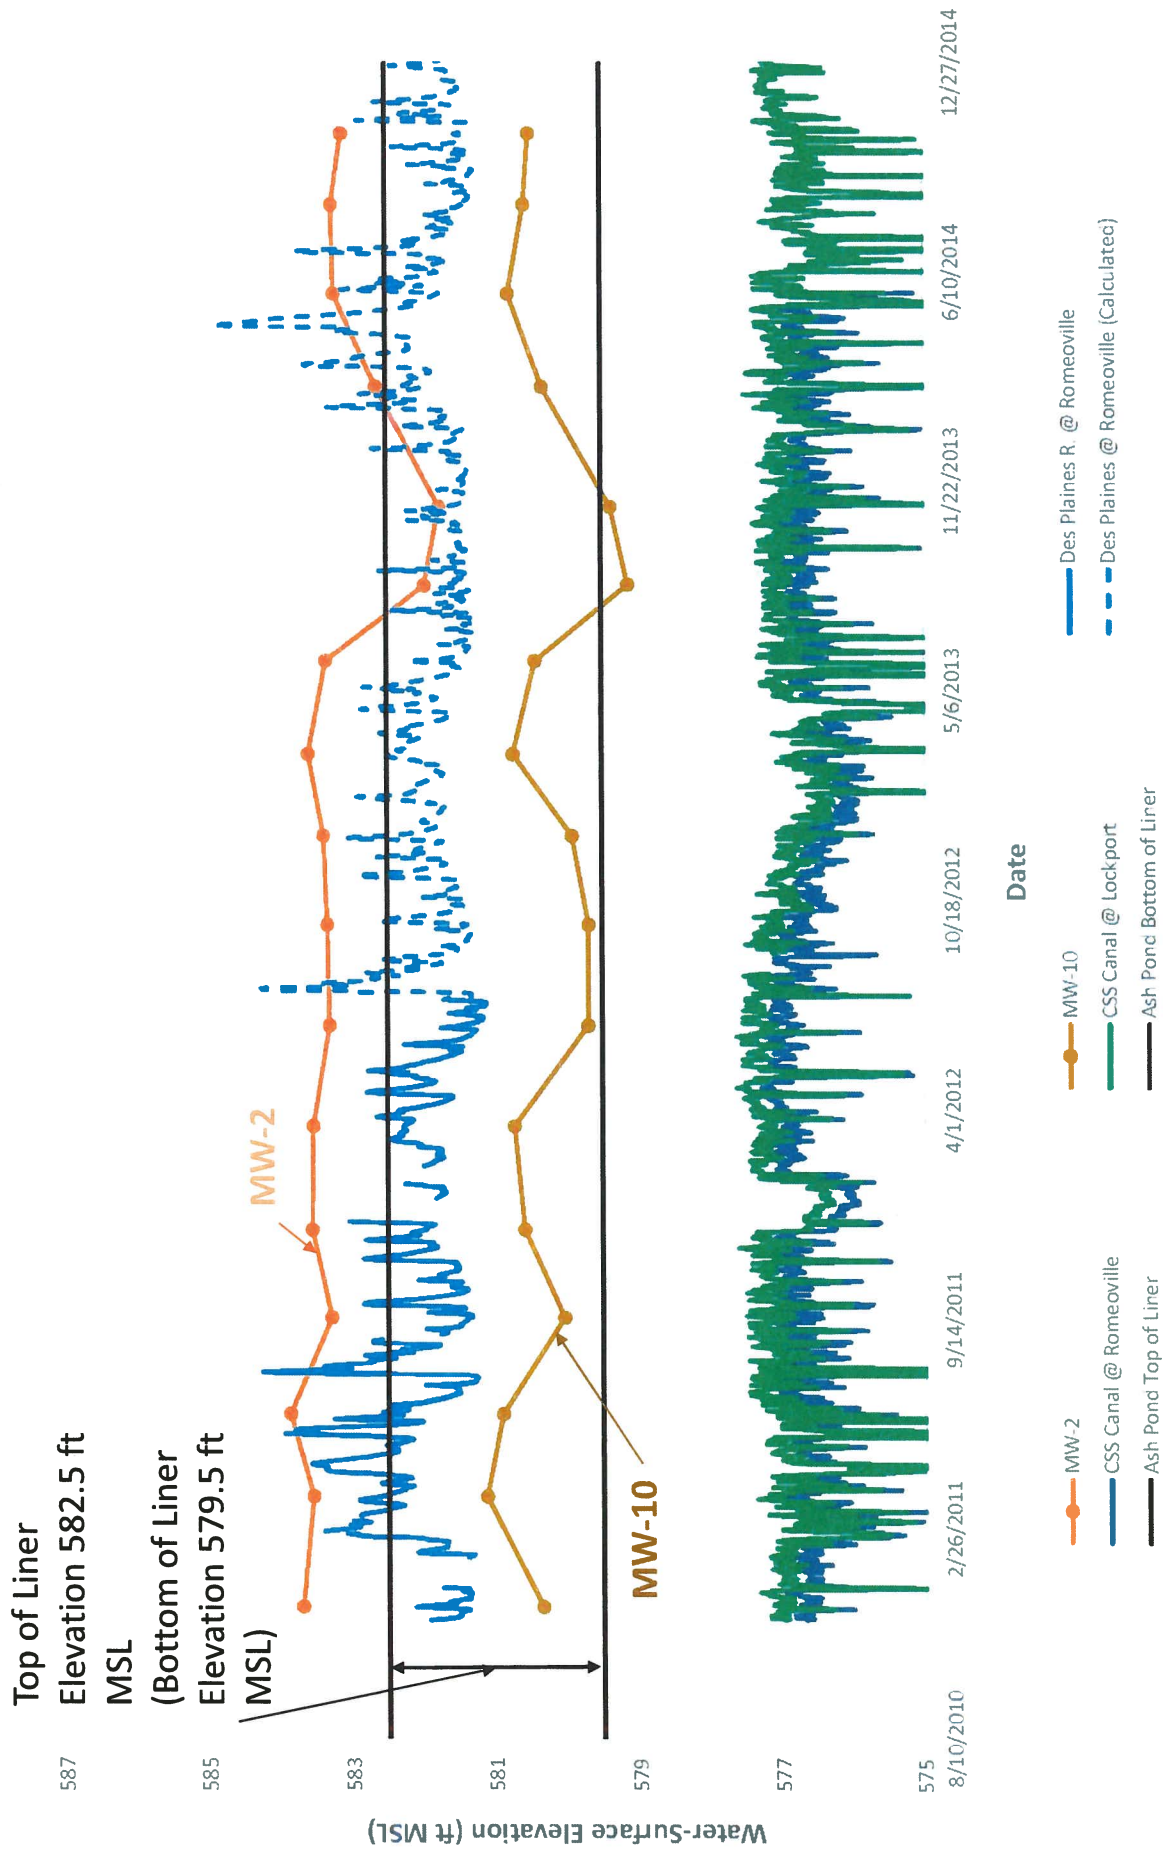
Figure 27 Will County Site Historical Ground-water Elevations (PCB 2013-015)

I also conclude from the above facts and the graphical presentation of ground-water and surface-water elevations shown on Figures 27 and 28 that the Will County ash ponds have historically leaked, are in intimate connection with the underlying ground water, have their liners episodically inundated by Des Plaines River and are causing contamination of the local ground-water from coal ash leachate and most likely contaminating the Des Plaines River and the CSS Canal. The ground-water quality data discussed below confirms that there is contamination due to leachate from the Will County ash ponds.

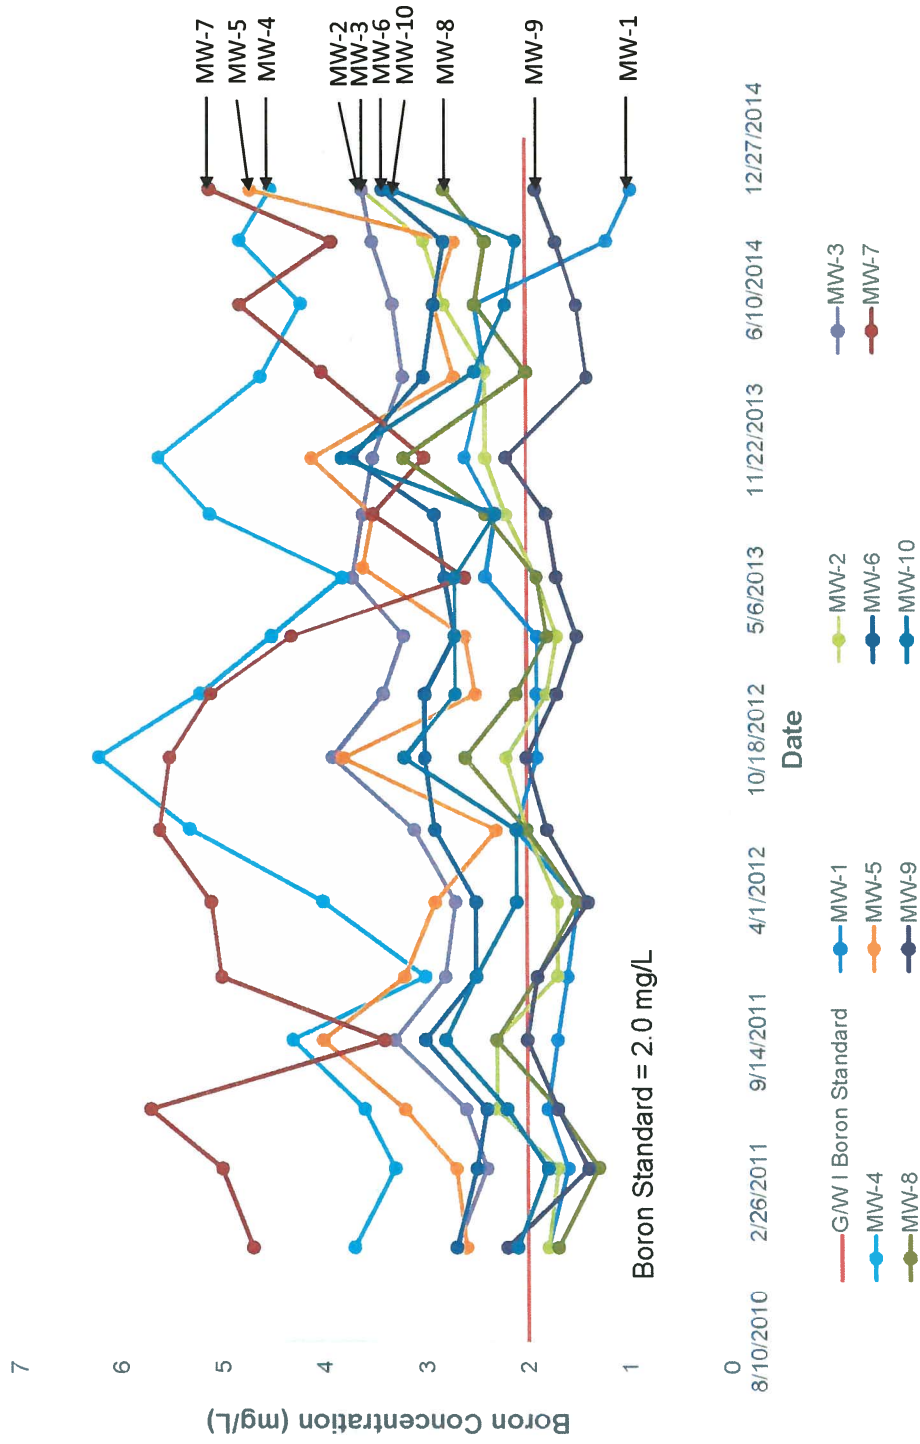
Figure 29 Boron Concentrations in Ground Water  
Will County Site (PCB 2013-015)

Figure 29 shows the time series of B concentrations in ground-water at the Will County site. Every monitoring well has had B concentrations higher than the IEPA Class I ground-water standard of 2.0 mg/L during the monitoring

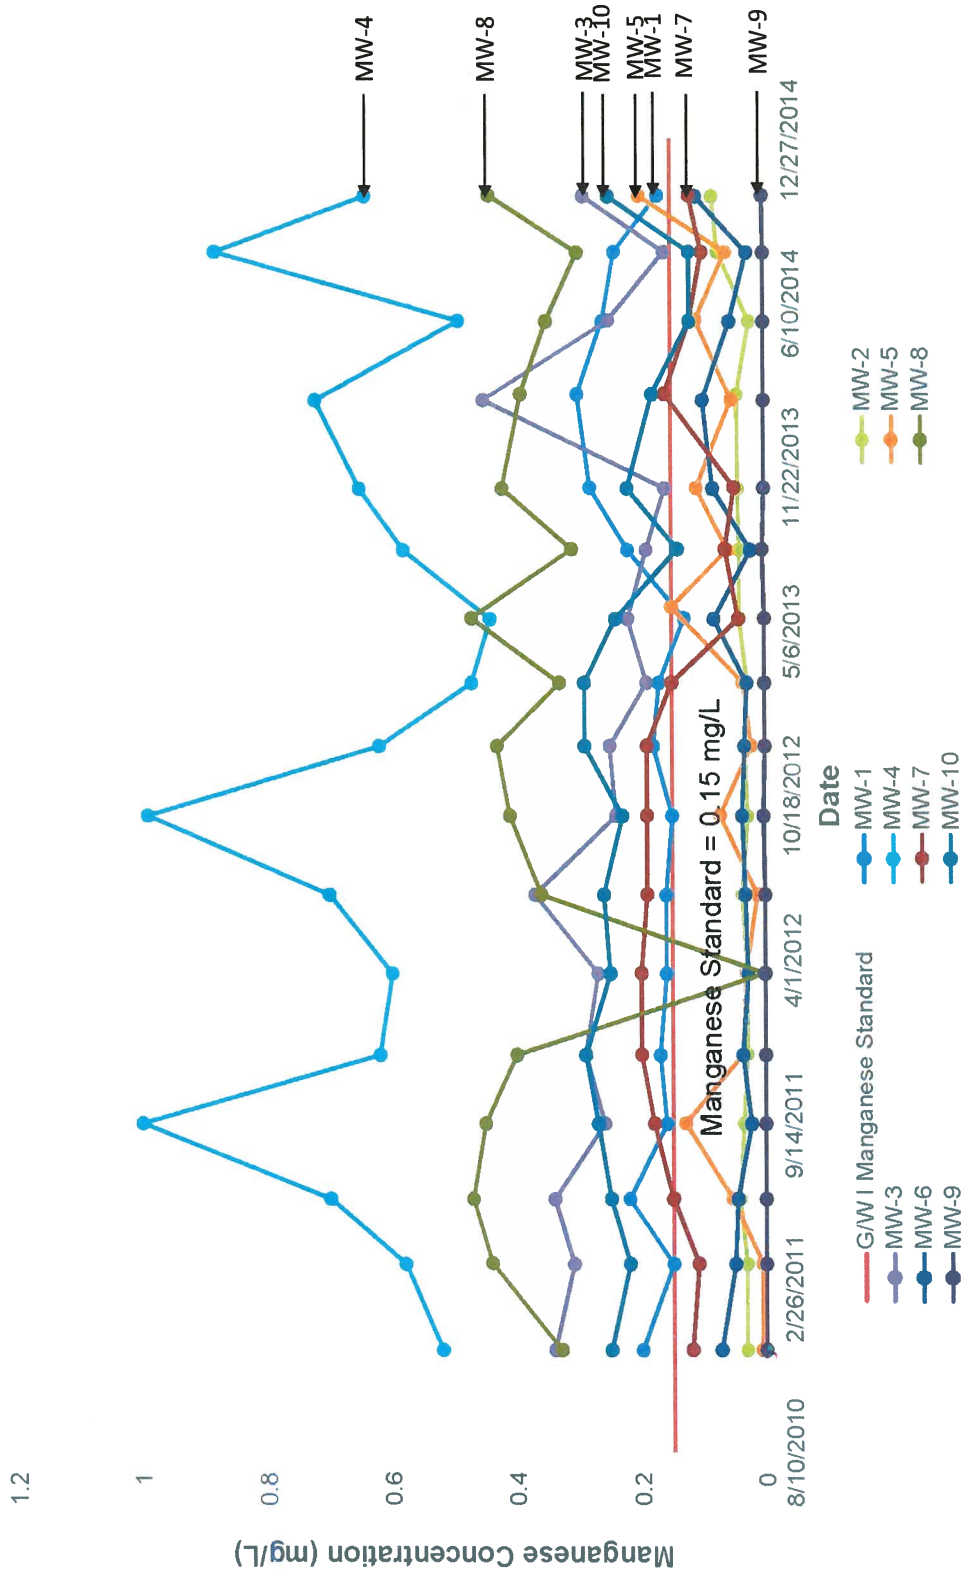
**Figure 30 Manganese Concentrations in Ground Water  
Will County Site (PCB 2013-015)**

Mn concentrations in ground water as shown in the time series on Figure 30, behave similarly to B concentrations at the Will County site, with all but 3 of the 10 monitoring wells having Mn concentrations higher than the IEPA Class I ground-water standard of 0.15 mg/L a majority of the time during the monitoring period. As with B, Mn is known to be a contaminant found in coal ash leachate (Table 2) and the high concentrations in ground water at the Will County site indicate ash pond liner leakage and/or leaching of coal ash deposits located outside the ash ponds. With the exception of MW-9, all of the monitoring well Mn concentrations at the Will County site are higher than the background Mn concentration of 0.0029 mg/L for shallow bedrock.

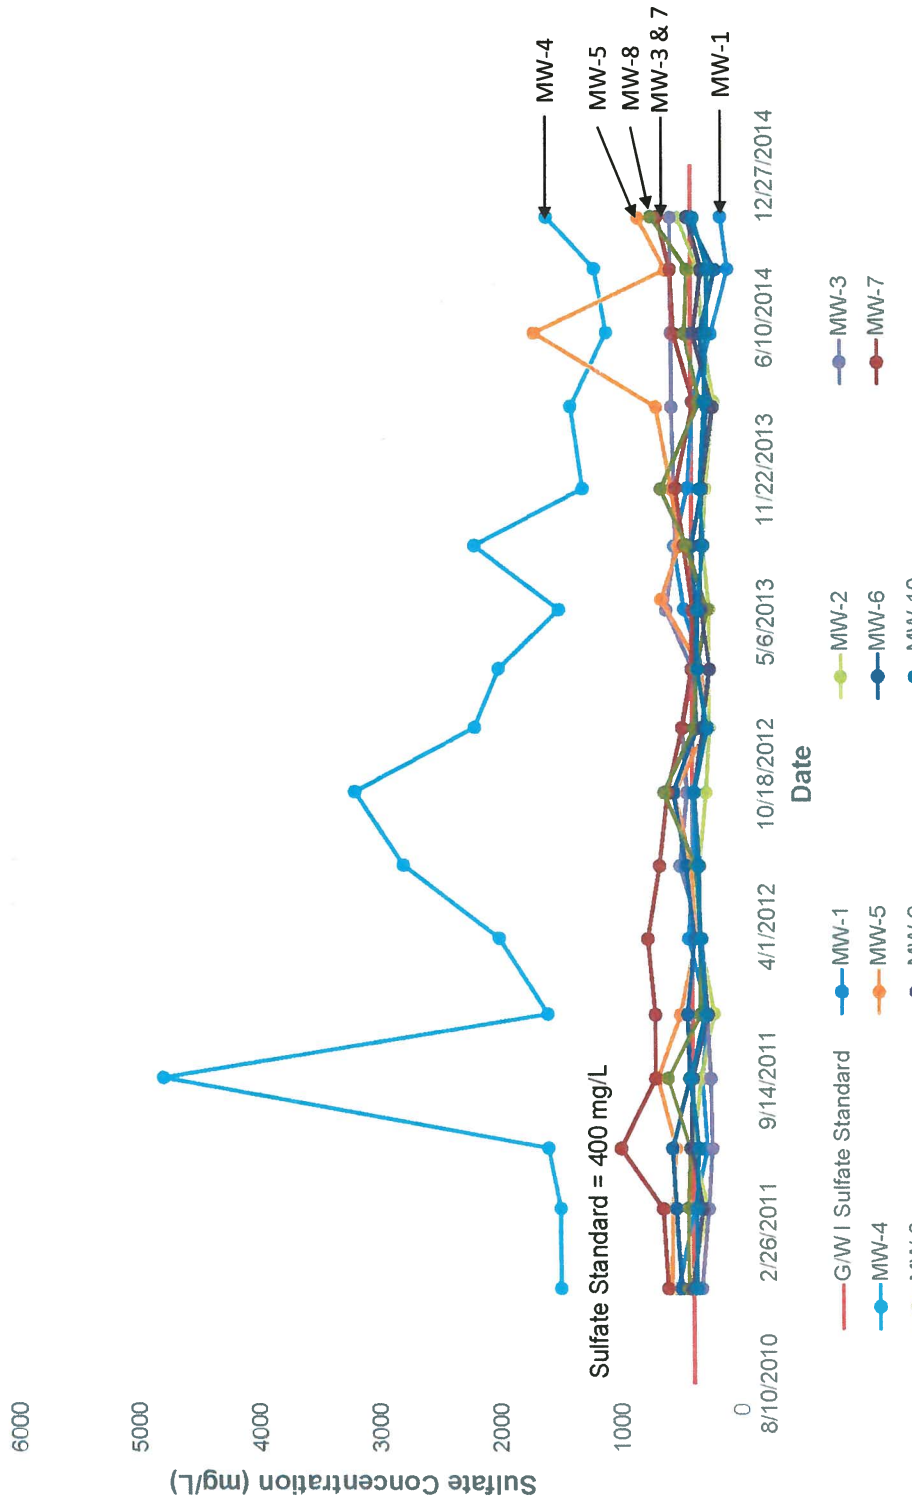
**Figure 31 Sulfate Concentrations in Ground Water  
Will County Site (PCB 2013-015)**

Figure 31 shows the time series of SO<sub>4</sub> concentrations in ground water at the Will County site with all but one of the monitoring wells having SO<sub>4</sub> concentrations higher than the IEPA Class I ground-water standard of 400 mg/L. Except at MW-4 and MW-5, the SO<sub>4</sub> concentrations in the monitoring wells have remained steady but persistently higher than the IEPA Class I ground-water standard. This indicates that the ash pond liners continue to leak and/or coal ash deposits located outside the ash ponds are leaching. Concentrations of SO<sub>4</sub> in all of the monitoring wells at the Will County site are higher than the background SO<sub>4</sub> concentration of 106 mg/L for shallow bedrock.
