ILLINOIS ENVIRONMENTAL PROTECTION AGENCY

Re: Illinois Environmental Protection Agency v. C. John Blickhan
IEPA File No.23-08-AC; 0010650002—Adams County

BEFORE THE ILLINOIS POLLUTION CONTROL BOARD
ADMINISTRATIVE CITATION

C. JOHN BLICKHAN,

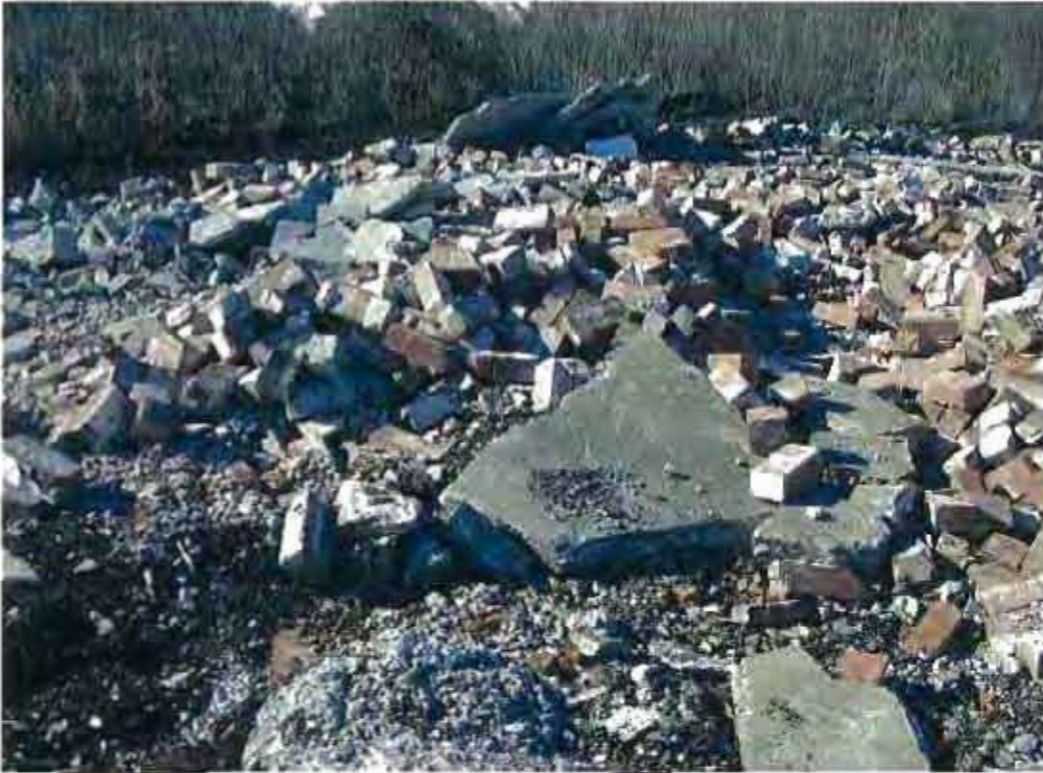
Date: January 15, 2008
Time: 11:02 AM
Direction: SW
Photo by: Eisenbrandt
Exposure #: 023
Comments: Concrete, brick, and cinder block fill material.

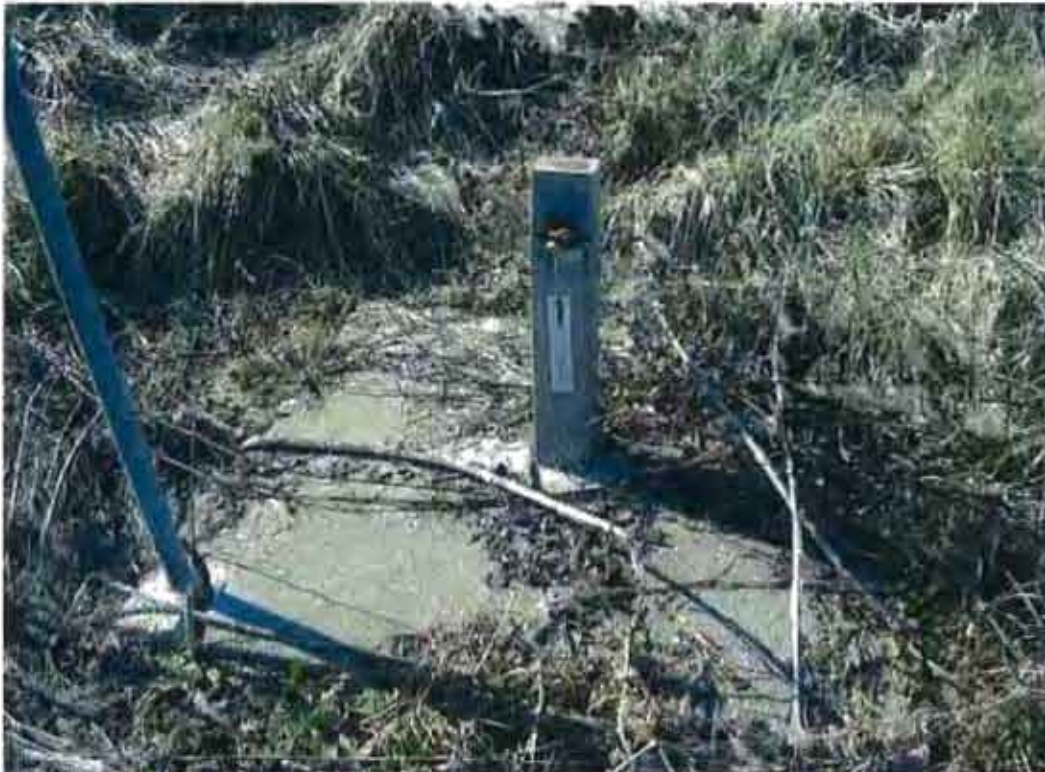
Date: January 15, 2008
Time: 11:33 AM
Direction: SW
Photo by: Eisenbrandt
Exposure #: 037
Comments:
Groundwater monitoring
Well G103.

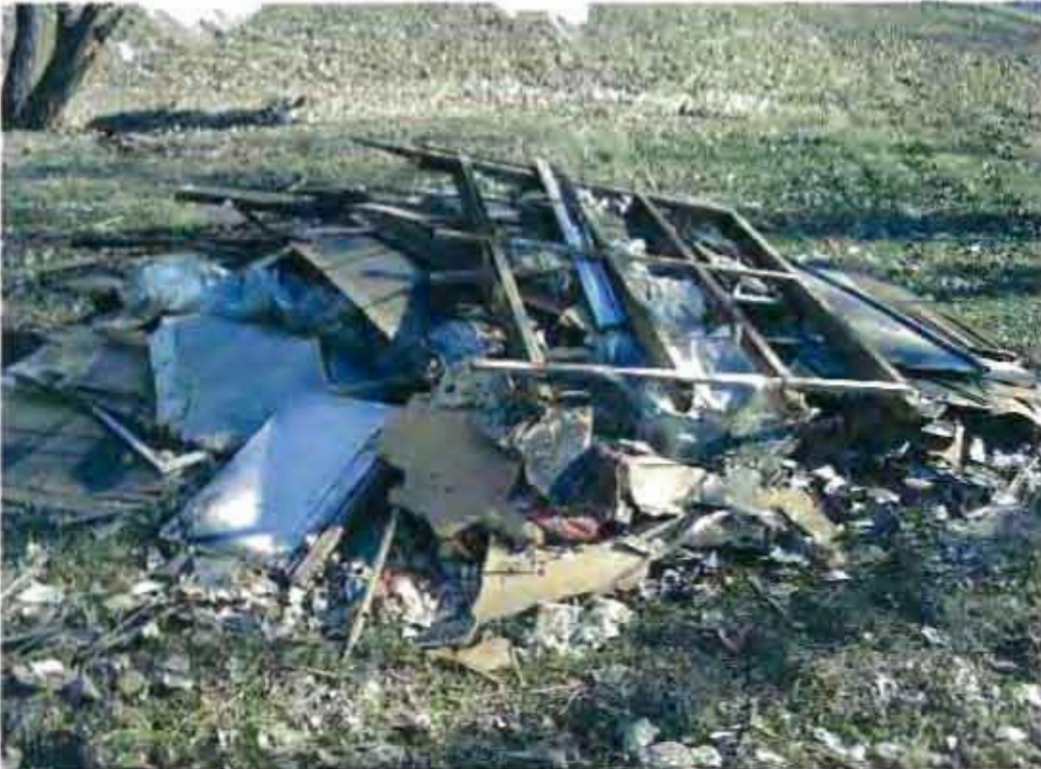
Date: January 15, 2008
Time: 11:41 AM
Direction: E
Photo by: Eisenbrandt
Exposure #: 045
Comments: Alternate view of demolition debris open dumped south of House No. 2.

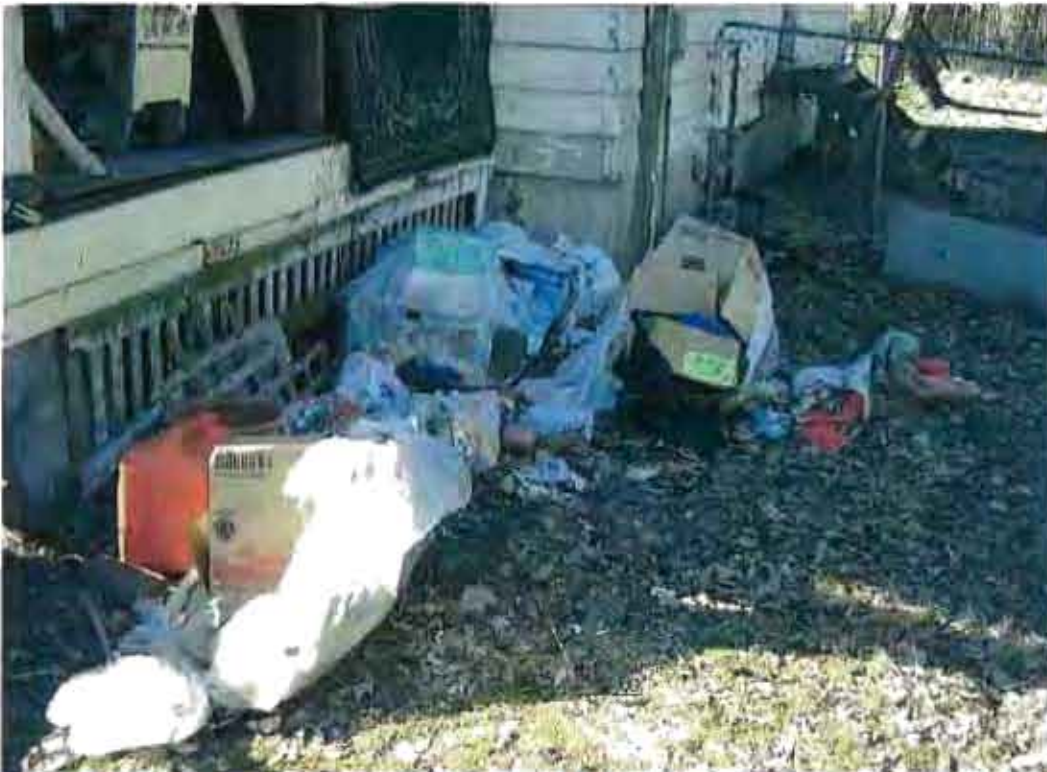
Date: January 15, 2008
Time: 11:43 AM
Direction: SW
Photo by: Eisenbrandt
Exposure #: 051
Comments: Garbage and trash piled on the north side of porch at House No. 6.

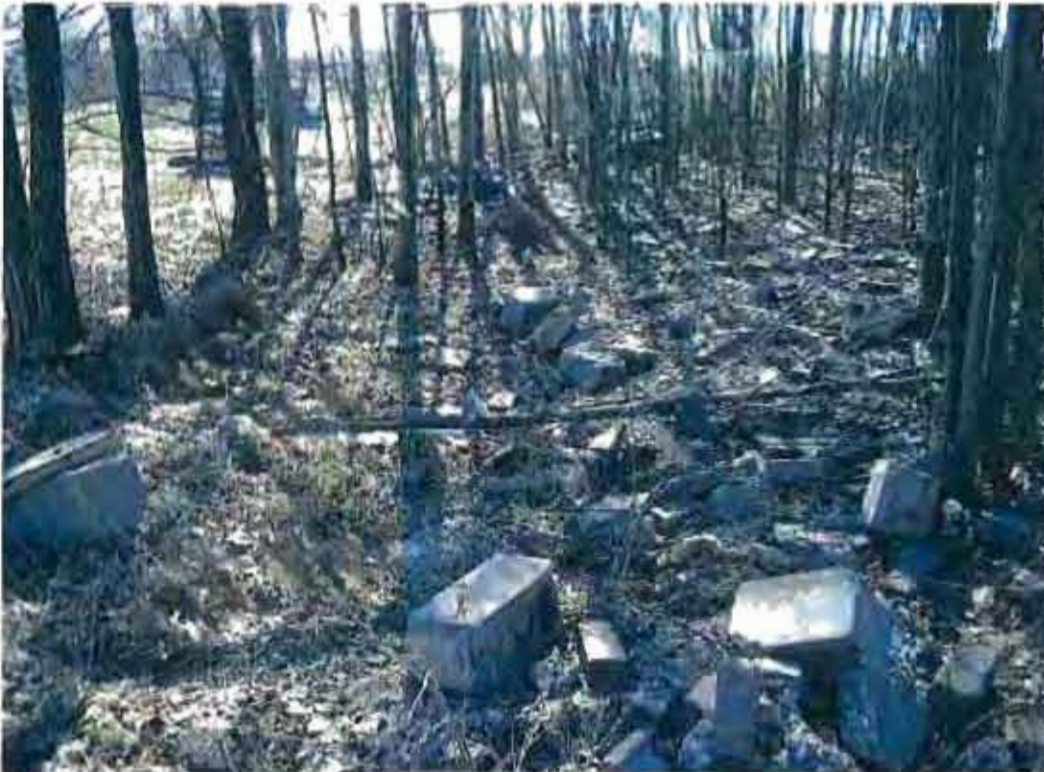
Date: January 15, 2008
Time: 11:50 AM
Direction: S
Photo by: Eisenbrandt
Exposure #: 065
Comments: Alternate view of brick and cinder block demolition waste behind house No. 5.

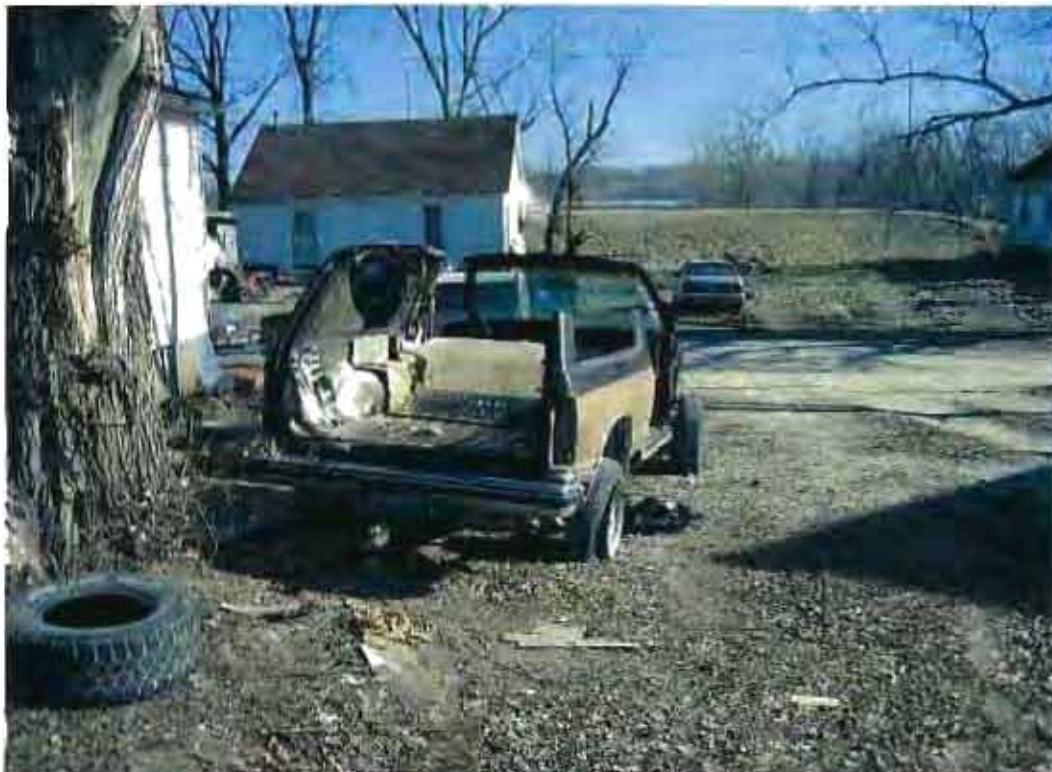
Date: January 15, 2008
Time: 11:55 AM
Direction: E
Photo by: Eisenbrandt
Exposure #: 073
Comments: Inoperable brown Chevy Blazer south of House No. 5. The occupant claimed the vehicle had only been onsite one week and was actively being cut up and recycled.

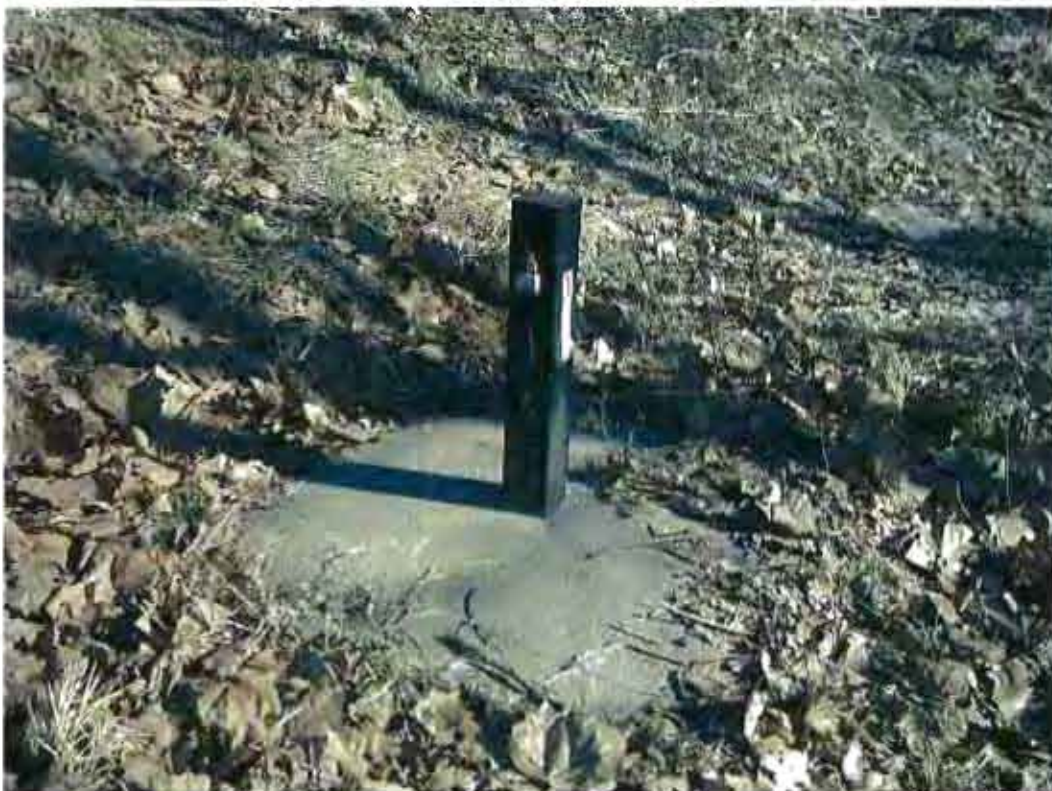
Date: January 15, 2008
Time: 11:58 AM
Direction: E
Photo by: Eisenbrandt
Exposure #: 074
Comments: Groundwater Monitoring Well G106.
