**BEFORE THE ILLINOIS POLLUTION CONTROL BOARD**

**CHAMPION ENVIRONMENTAL SERVICES, INC.,  
A Wisconsin corporation,**

**No. PCB 2005-199**

**REQUEST FOR ADMISSION OF FACT AND GENUINENESS OF DOCUMENTS**

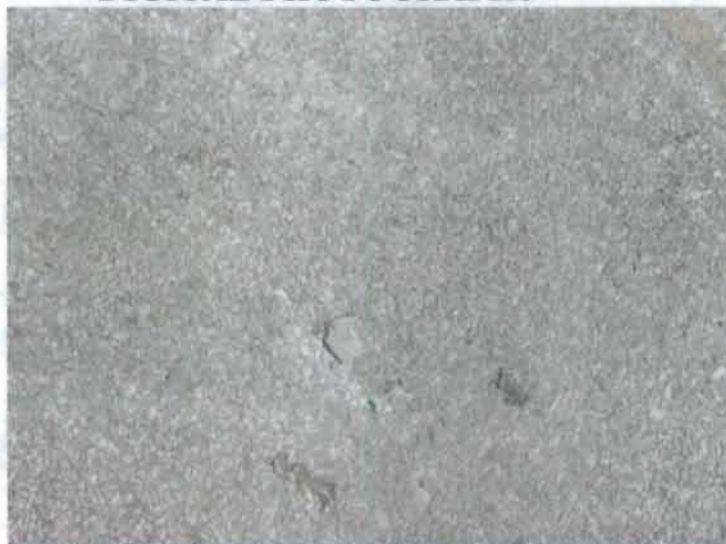
**Date: May 5, 2005  
Time: ~ 10:30 am  
Direction: West  
Photo by: D. Hancock  
File No: DAH050505~05052005-001  
Comments: Suspect transite lying on the  
ground outside of dumpster area**

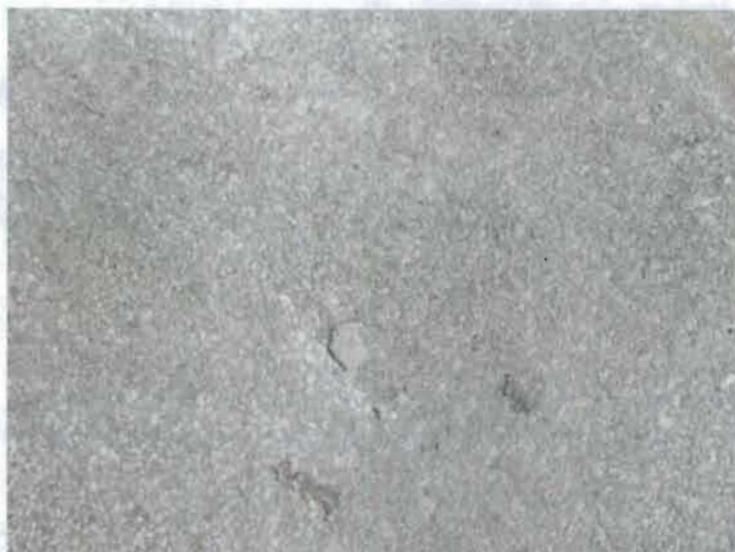
**File No: DAH050505~05052005-013**

**Comments: More transite lying on the ground**

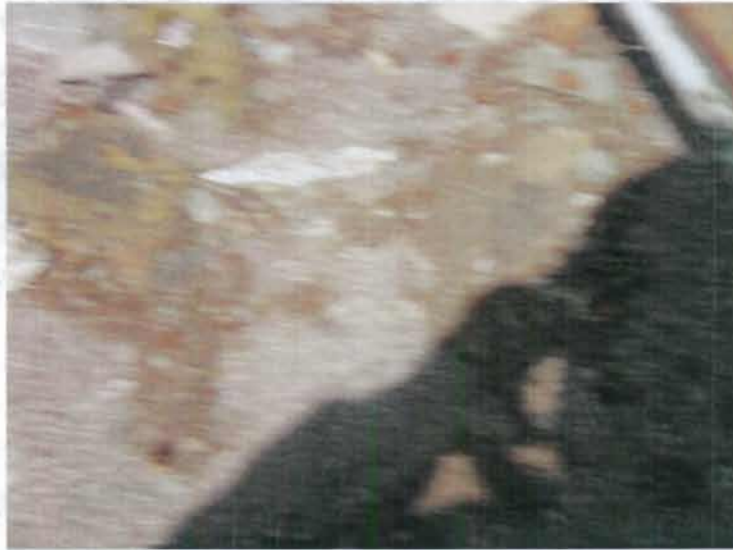
Date: May 5, 2005  
Time: ~ 10:50 am  
Direction: East  
Photo by: D. Hancock  
File No: DAH050505~05052005-017  
Comments: More transite debris lying on the ground under where roofing material had been removed

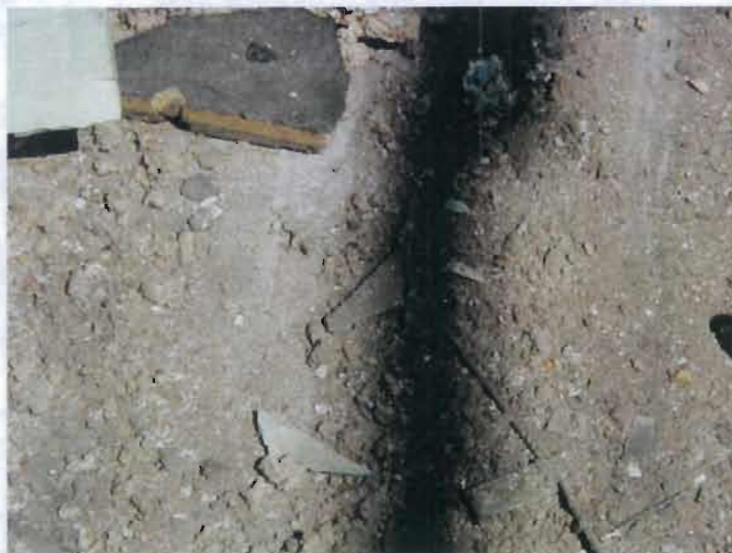
**File No: DAH050505~05052005-039**

**Comments: Photo of insulation and small piece of transite material lying on the floor on the east side of building**

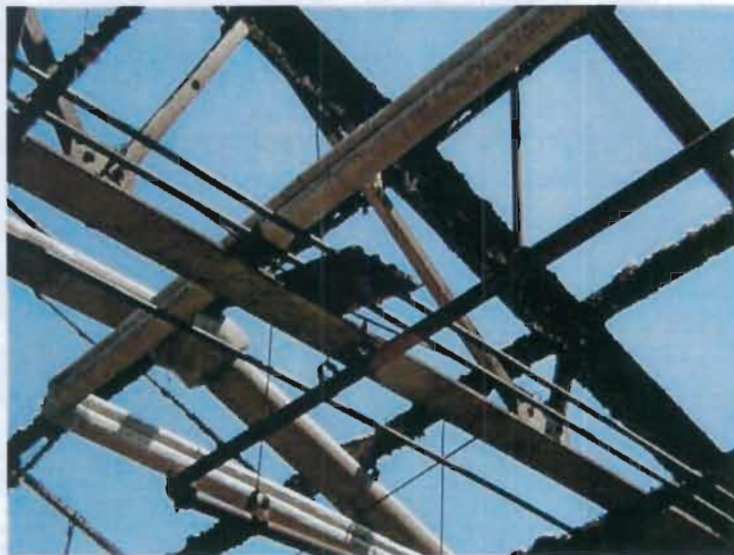
**File No: DAH050505~05052005-059**

**Comments: Photo showing another small piece of transite hung on the beams from the roof**

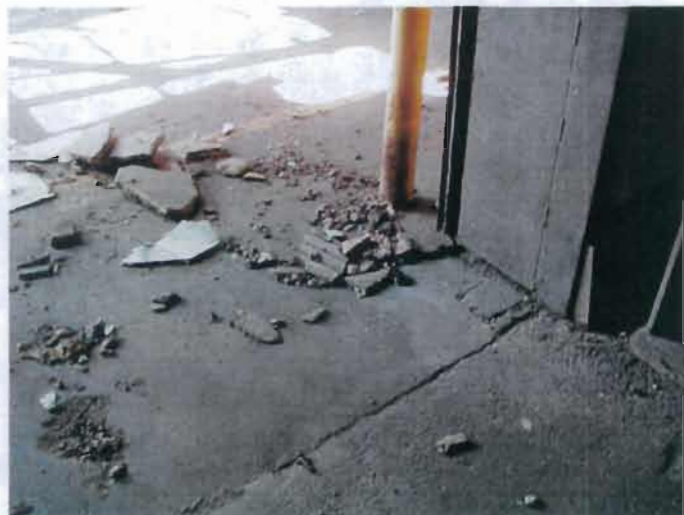
File No: DAH050505~05052005-063

Comments: Photo showing several broken pieces of transite lying in the doorway at the far South section of the building

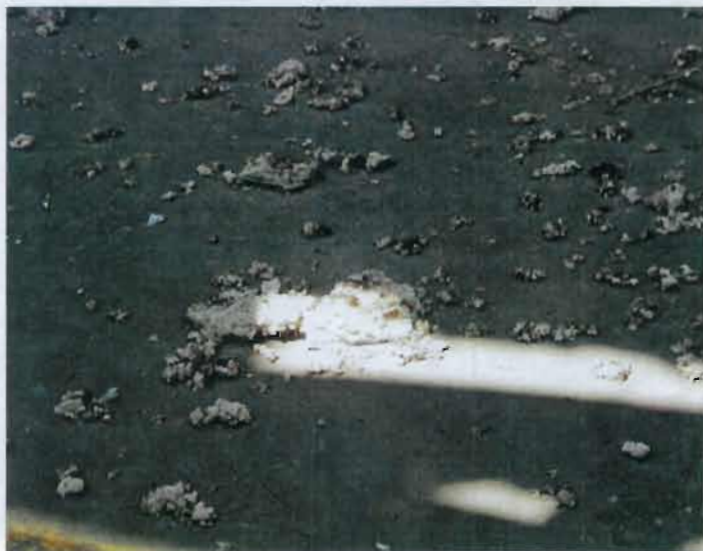
**Date: May 5, 2005**  
**Time: ~11:45 am**  
**Direction: South**  
**Photo by: D. Hancock**  
**File No: DAH050505~05052005-068**  
**Comments: Photo showing more transite and insulation lying in the center area of the building floor where the transite roof was removed**

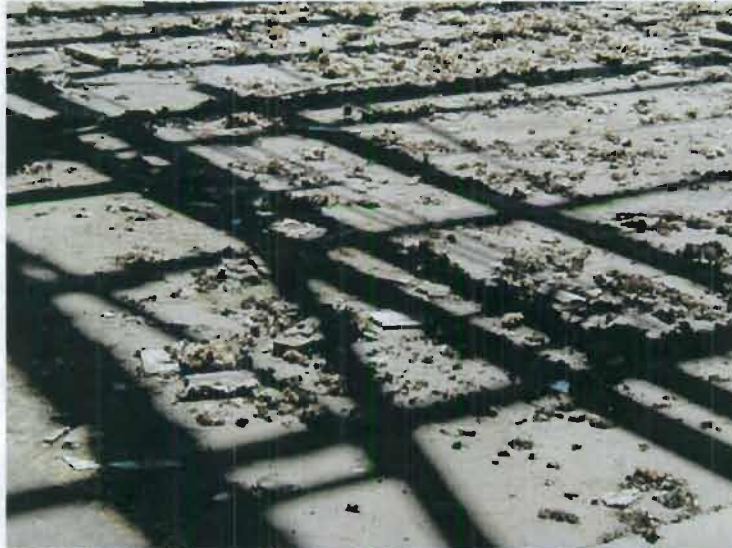
**File No: DAH050505~05052005-073**

**Comments: More transite and misc. debris scattered throughout the center of the east building**

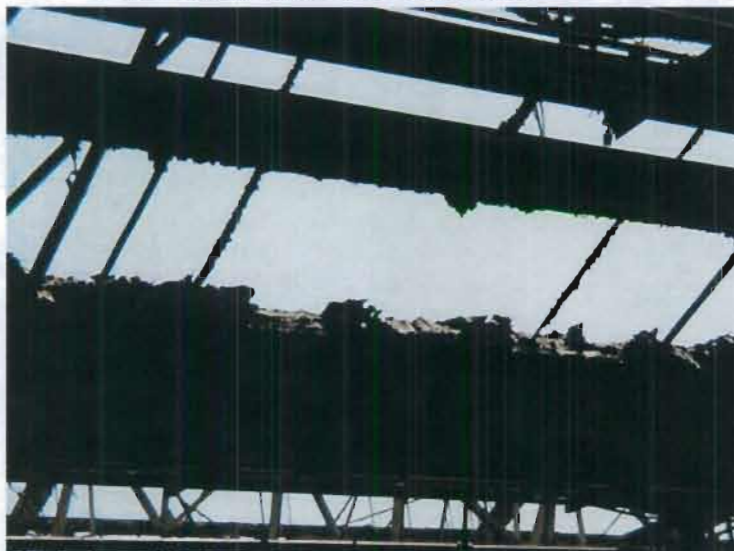
File No: DAH050505~05052005-081

Comments: Photo showing broken transite still not removed from the roof at this time it seems as though this material may be caught between the beam sections.

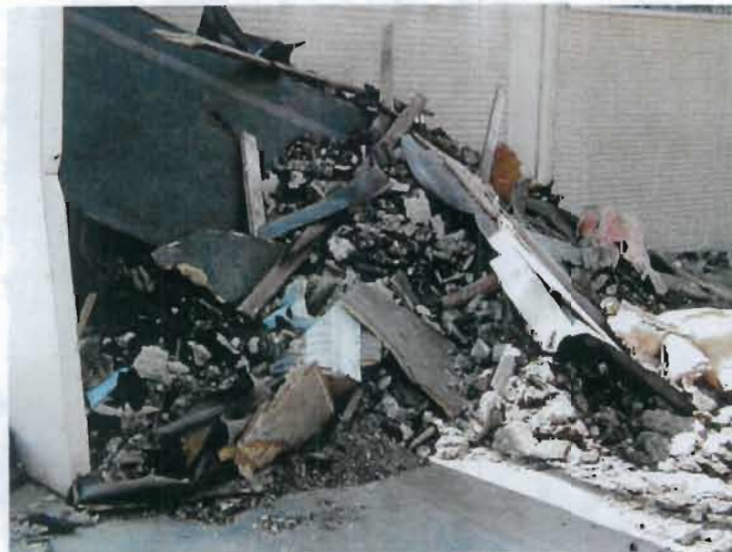
File No: DAH050505~05052005-087

Comments: Closer photo of the above shot of debris and small transite pieces in the pile

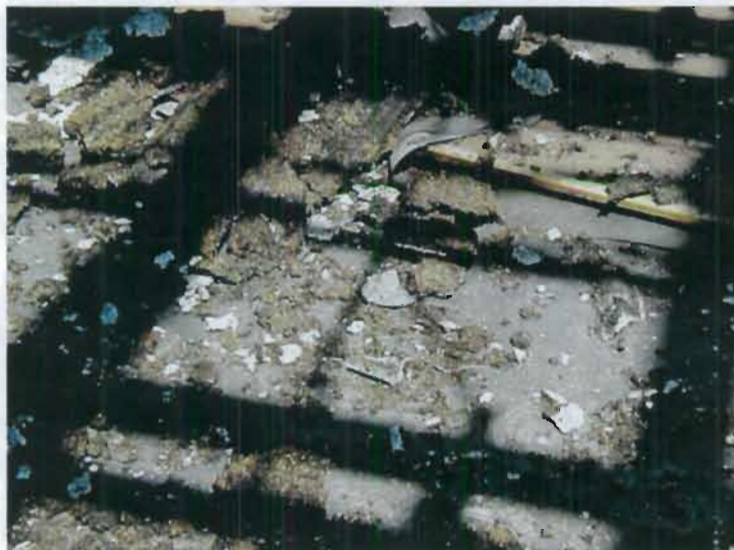
File No: DAH050505~05052005-089

Comments: More photos of dry broken transite lying on the floor going west in the South section of the building

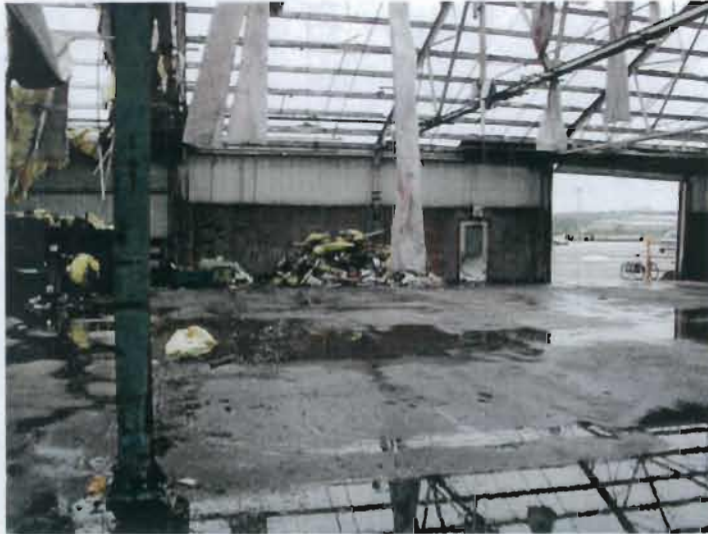
**File No: DAH051105~05112005-009**

**Comments: Photo still showing trash material still lying around the work site area inside of the building. Supervisor was told to clean this up and try to do a good cleanup everyday prior to leaving site so debris does not blow around the property or go over to some other properties and he agreed to do this**

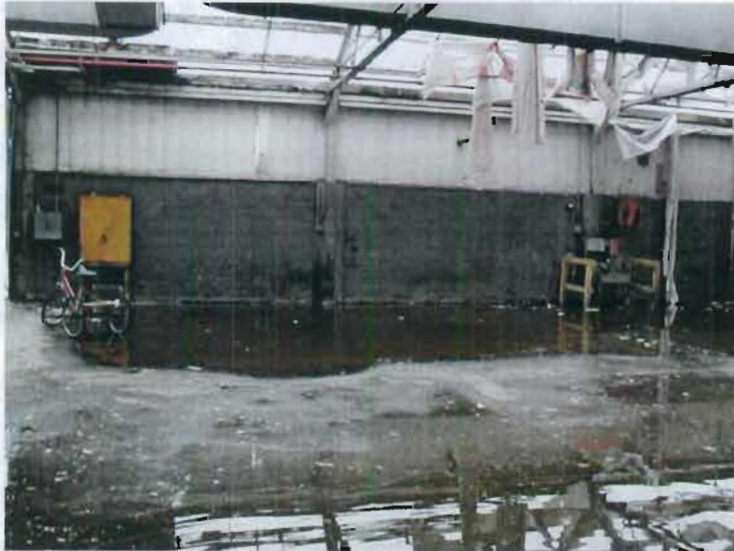
Date: May 11, 2005  
Time: ~10:25 am  
Direction: East  
Photo by: D. Hancock  
File No: DAH051105~05112005-011  
Comments: Photo showing where a lot of debris was located during the initial inspection and appears to be cleaned up at this time.

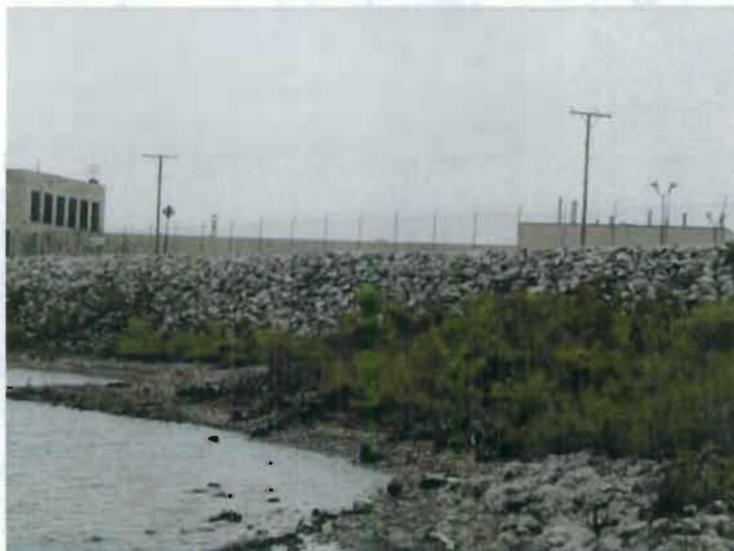
**File No:** DAH051105~05112005-015

**Comments:** Photo of bank area where misc. debris was seen but camera was not able to pick up until I moved closer

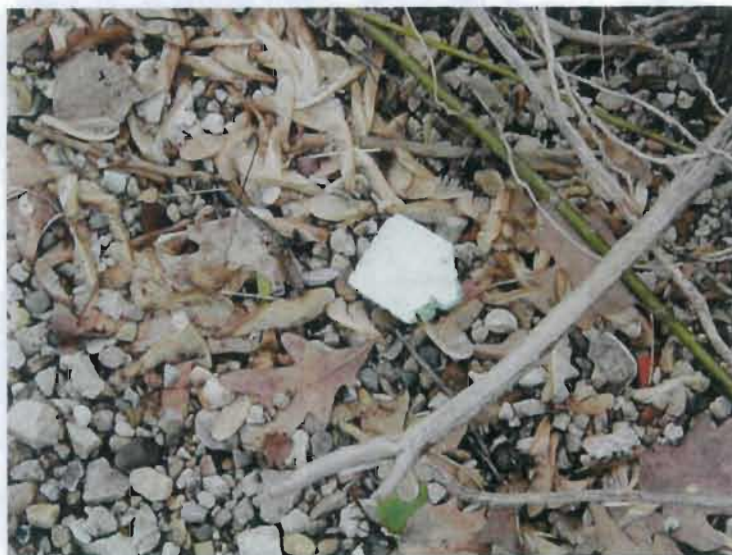
**File No: DAH051105~05112005-017**

**Comments: Photo showing close up of green insulation board lying on the rocks next to the banks of the Mississippi River.**

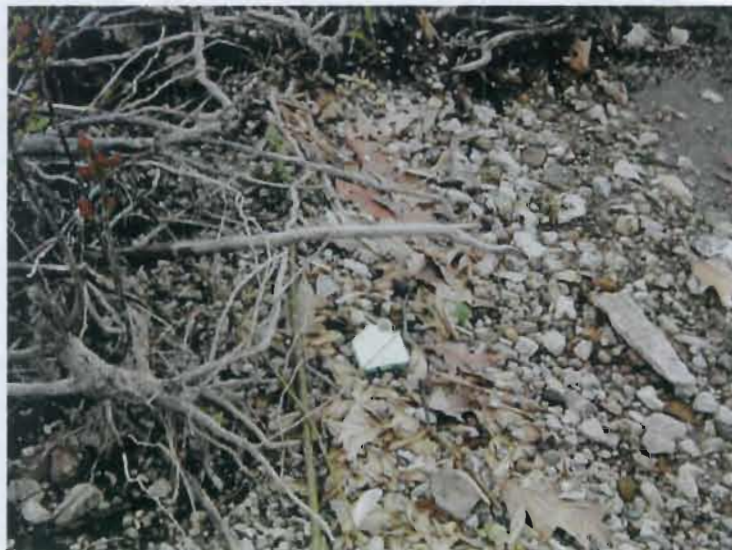
**File No: DAH051105~05112005-021**

**Comments: More green insulation board lying on the beach area of the Mississippi River**

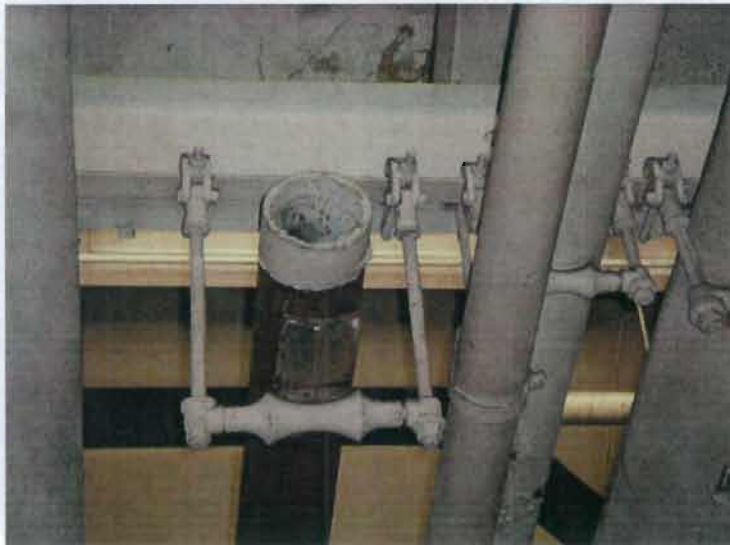
**File No: DAH051105~05112005-025**

**Comments: More of the piping to be removed by Champion after prepping is completed**

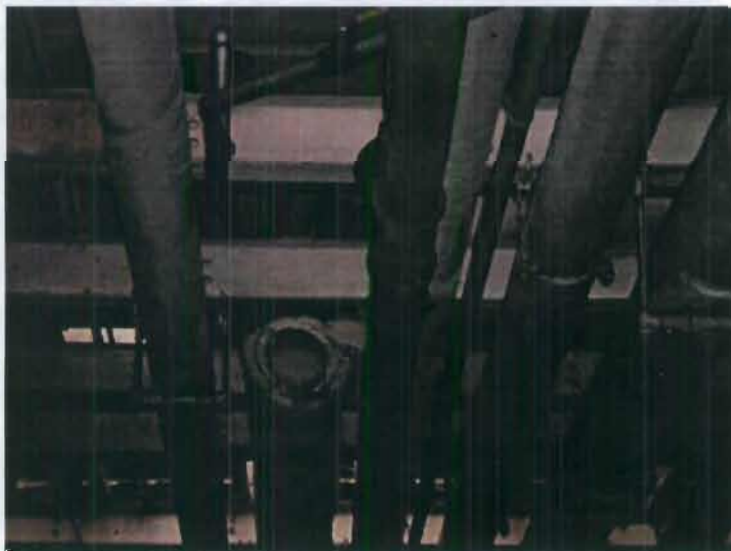
File No: DAH051105~05112005-027

Comments: Another view of the piping to be removed by gross removal with enclosure that are being set up at this time

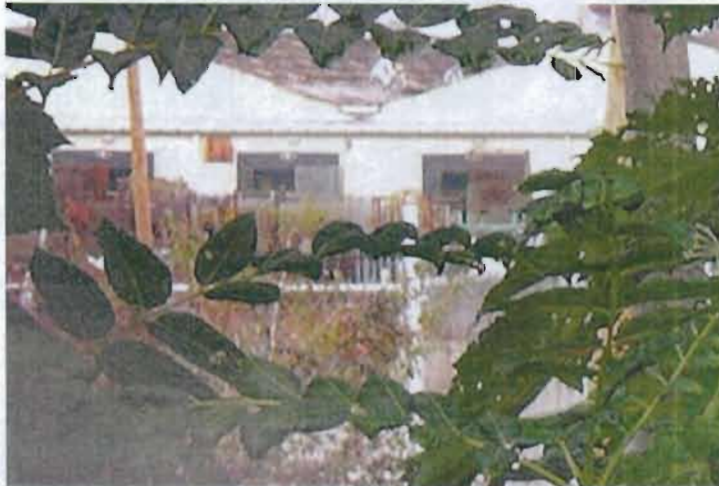
Date: September 28, 2005  
Time: ~ 11:10 am  
Direction: North  
Photo by: D. Hancock  
File No: DAH092805~09282005-003  
Comments: Workers sliding down a sheet of transite on the roof

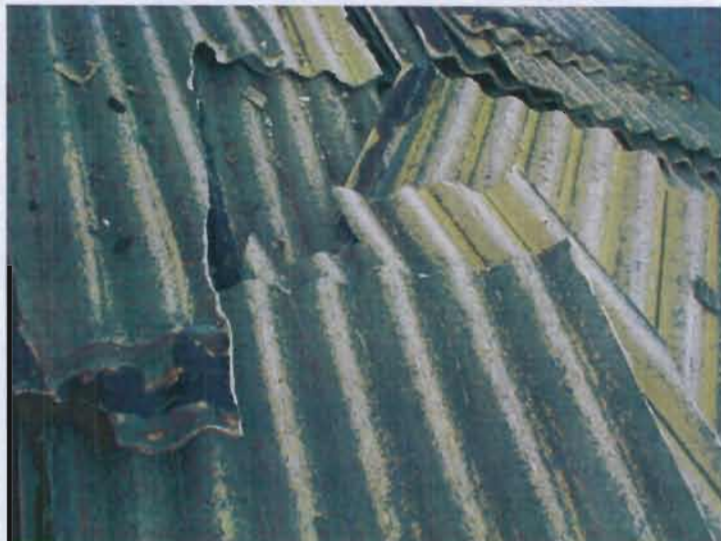
**Date: March 1, 2006  
Time: ~11:00 am  
Direction: Inside of dumpster  
Photo by: D. Hancock  
File No: DAH030106~03012006-007  
Comments: More photos of material in dumpsters**

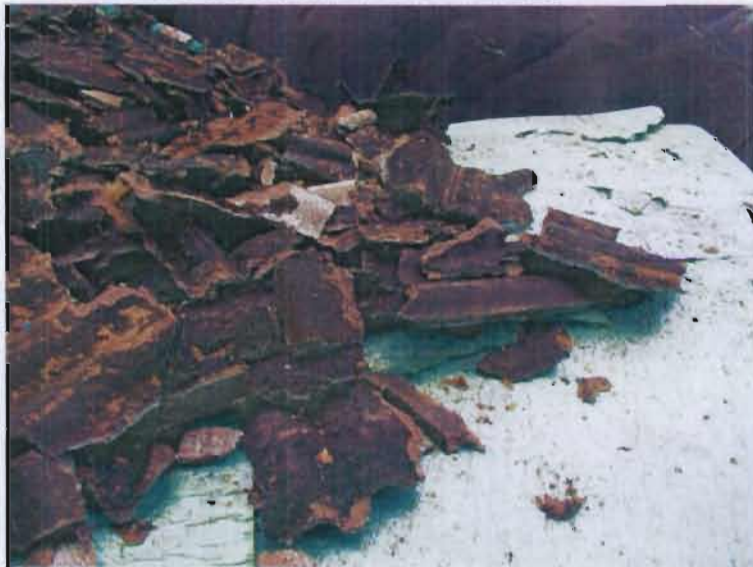
**Comments: Photo of several small pieces of broken transite material inside of dumpste**
