STATE OF ILLINOIS                     )  
  )  
COUNTY OF LA SALLE                )                     PCB 2005-199

**AFFIDAVIT**

4.       On May 5, 2005, I inspected the facility known as the Case Manufacturing Facility, located at 1100 Third Street in East Moline, Rock Island County, Illinois (facility). The facility was approximately two million five hundred thousand (2,500,000) square feet.

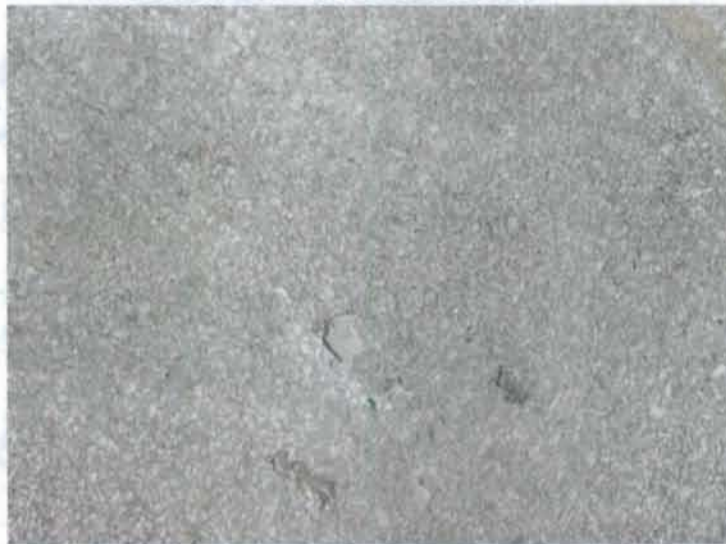
**Date: May 5, 2005  
Time: ~ 10:30 am  
Direction: West  
Photo by: D. Hancock  
File No: DAH050505~05052005-001  
Comments: Suspect transite lying on the  
ground outside of dumpster area**

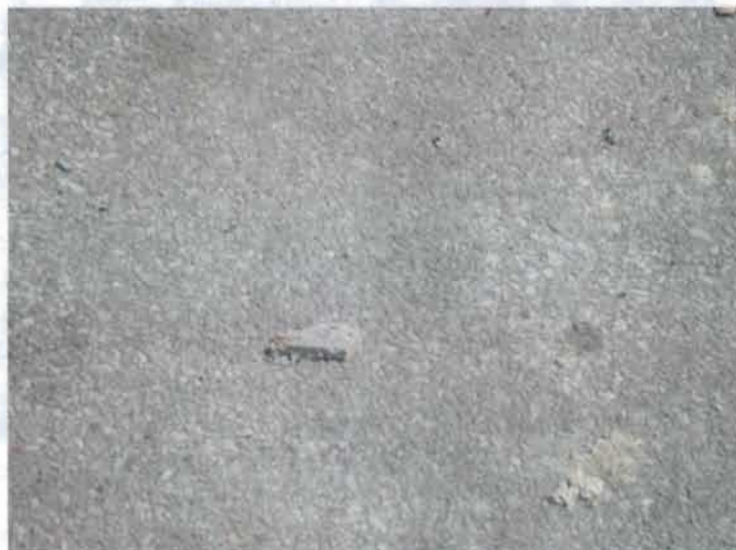
**Date: May 5, 2005  
Time: ~10:30 am  
Direction: West  
Photo by: D. Hancock  
File No: DAH050505~05052005-002  
Comments: Another piece of suspect transite  
lying on the ground outside of the building**

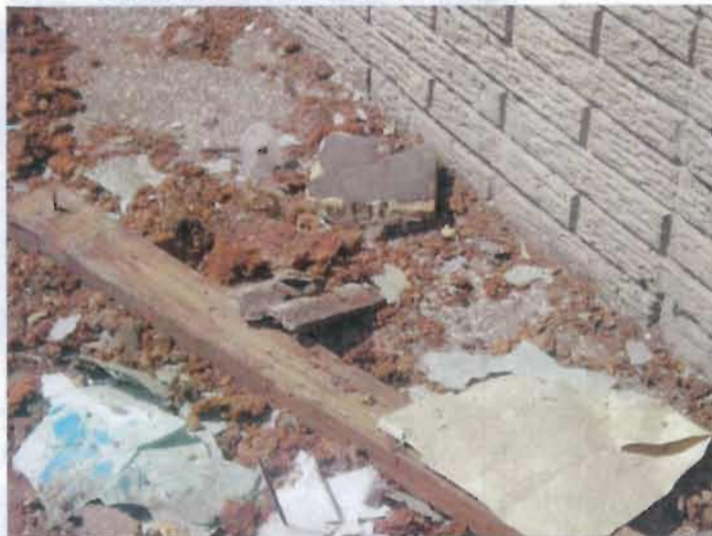
**File No: DAH050505~05052005-003**

**Comments: Suspect transite debris lying in regular debris alongside of the building on the East side.**

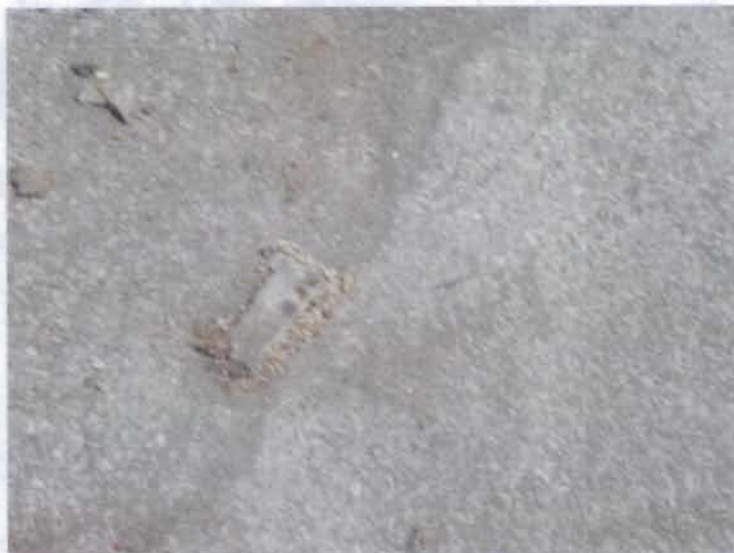
**File No: DAH050505~05052005-007**

**Comments: Transite material lying outside in  
dusty debris on the east side of the building**

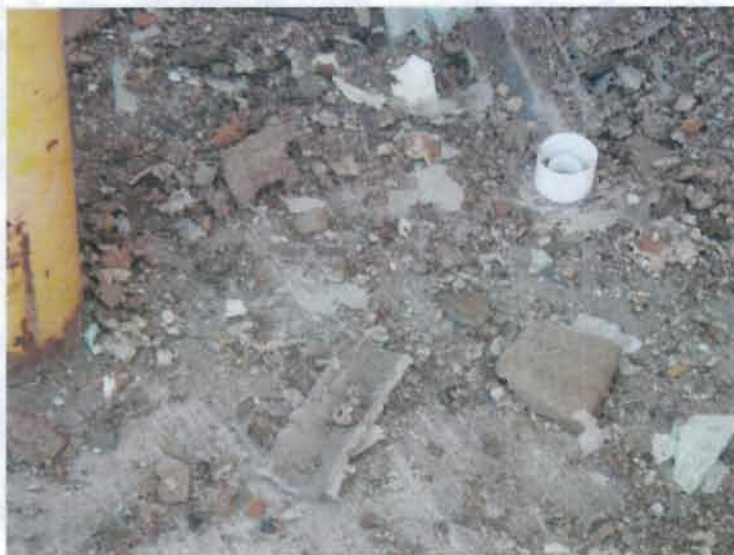
**File No: DAH050505~05052005-011**

**Comments: Transite lying on the floor inside c  
the building where the transite roof had been  
removed above this material**

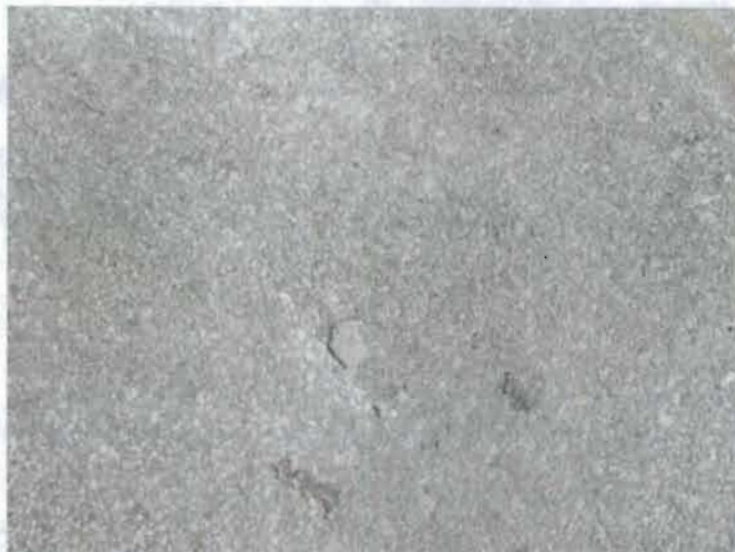
**File No: DAH050505~05052005-013**

**Comments: More transite lying on the ground**

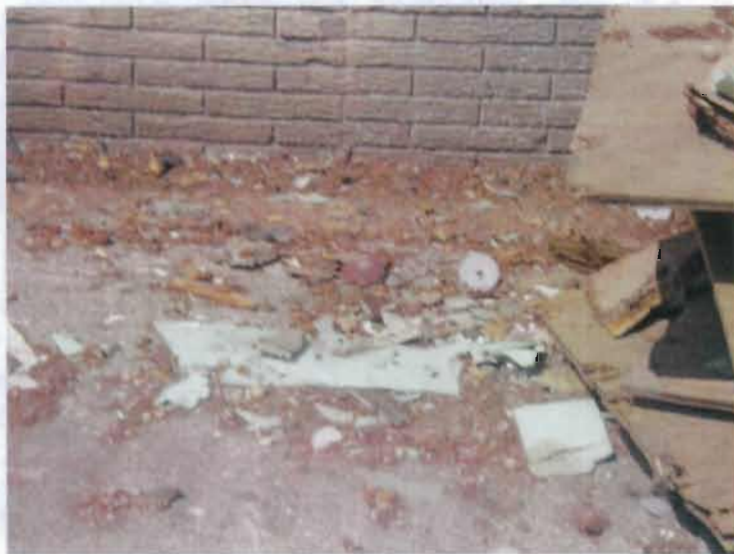
File No: DAH050505~05052005-015

Comments: Transite material lying on the green insulation lying on the concrete along with other debris

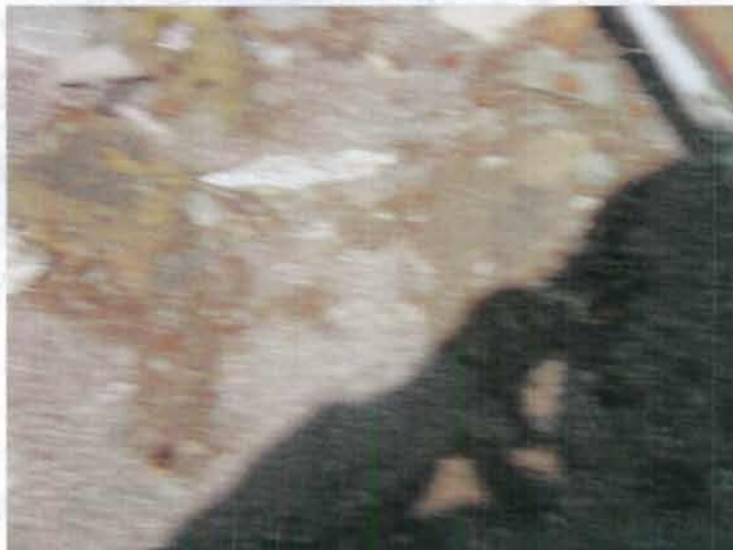
Date: May 5, 2005  
Time: ~ 10:50 am  
Direction: East  
Photo by: D. Hancock  
File No: DAH050505~05052005-017  
Comments: More transite debris lying on the ground under where roofing material had been removed

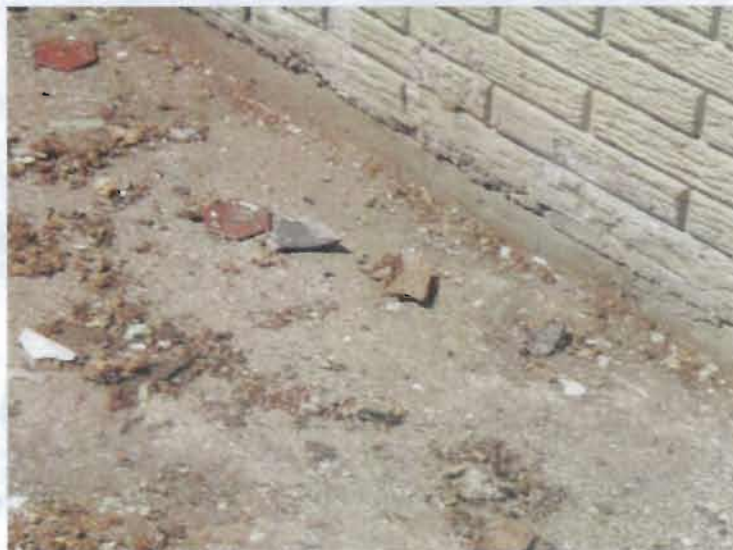
Date: May 5, 2005  
Time: ~10:50 am  
Direction: East  
Photo by: D. Hancock  
File No: DAH050505~05052005-018  
Comments: Transite pieces lying on the ground against the wall area below where roofing material had been removed

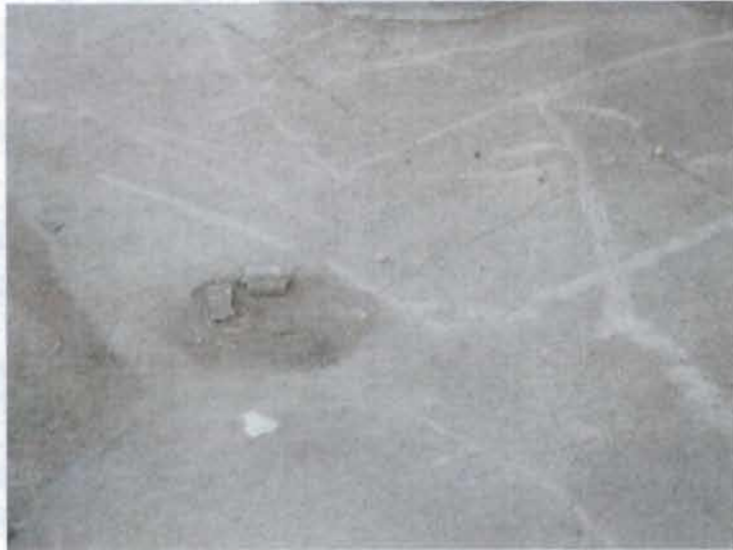
**File No: DAH050505~05052005-019**

**Comments: Transite material that has been reduced to powder after being run over by forklift that was being used inside of the building**

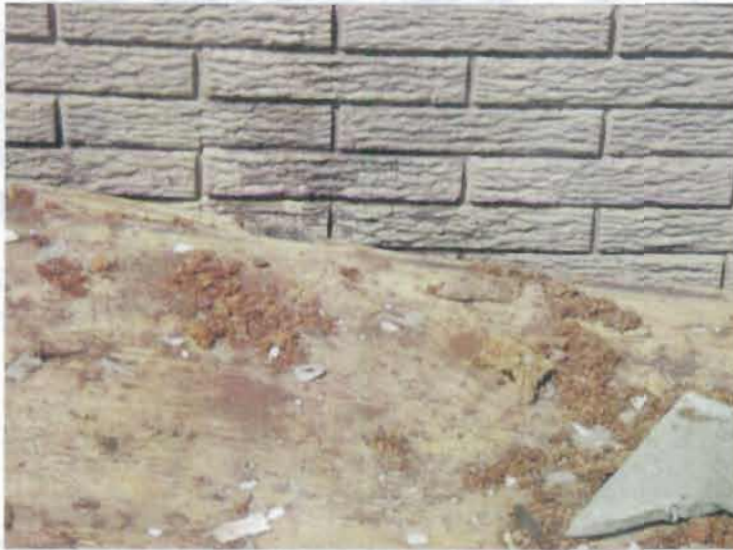
File No: DAH050505~05052005-021

Comments: Small pieces of transite material lying on the ground area

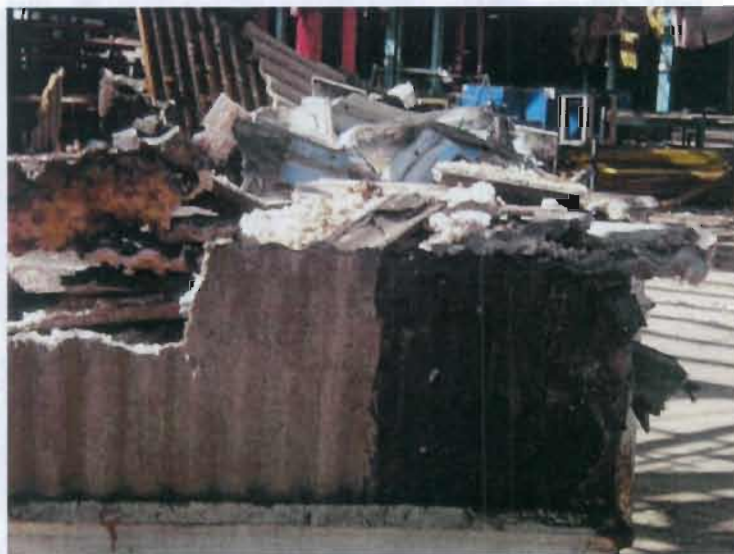
Comments: Broken transite material lying inside of one of the 8 gondolas inside of the building

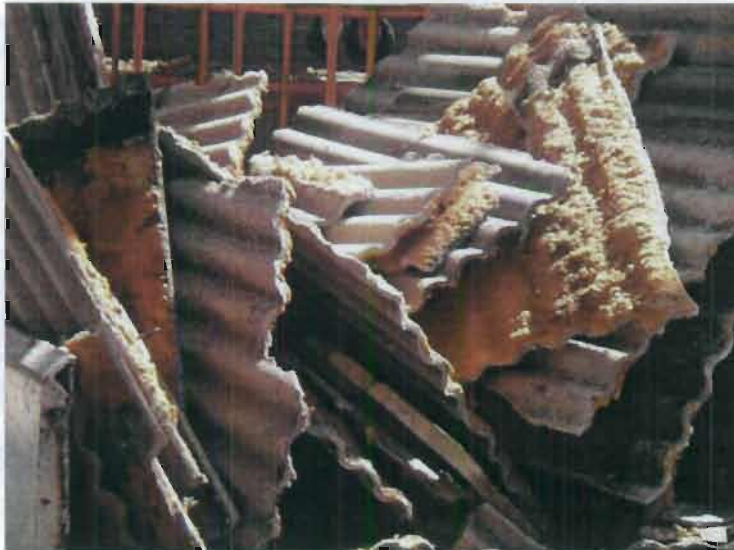
**File No: DAH050505~05052005-025**

**Comments: Closer view of broken transite material lying in the gondola inside of the building**

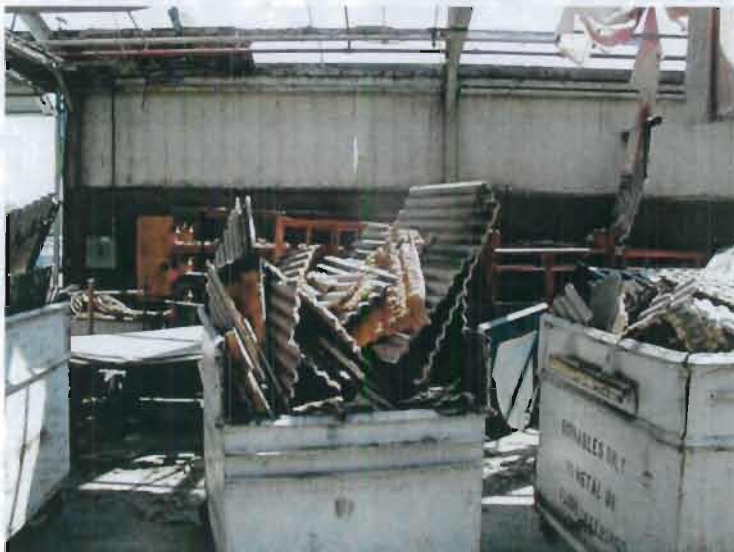
**Comments: Another view of the gondolas filled with broken transite that was among the 8 gondolas that were filled with dry material**

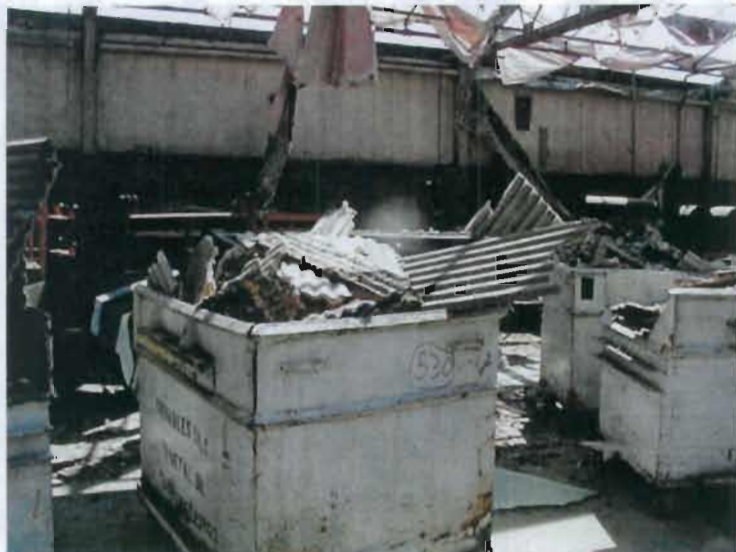
File No: DAH050505~05052005-027

Comments: Another view of the other gondola that were filled with dry broken transite material that had been sitting there for approximately 3 days

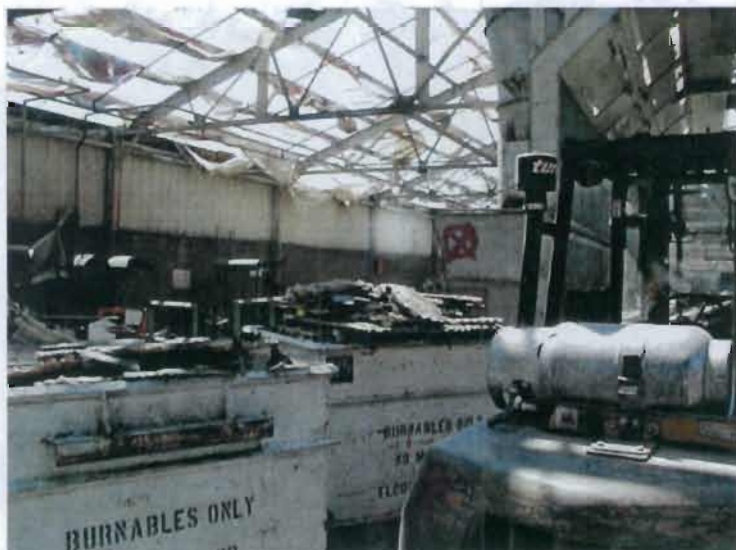
Comments: Another photo of the gondola boxes containing dry broken transite material

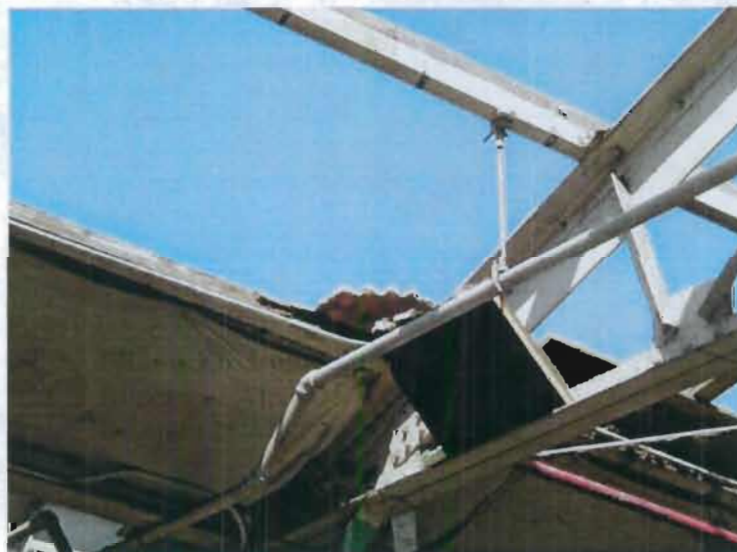
Comments: another photo showing another piece of broken transite at the corner of the beam showing it was a broken piece and not removed in a full section.

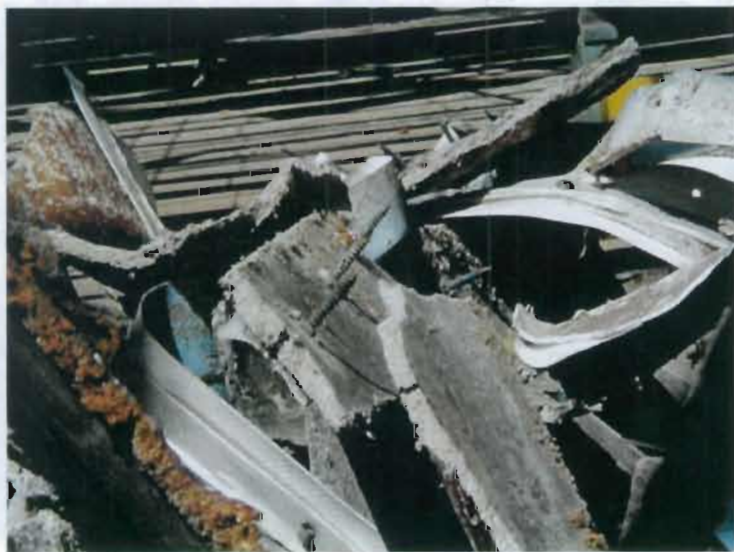
Comments: Photo showing broken transite still up on the roof at the left side of photo

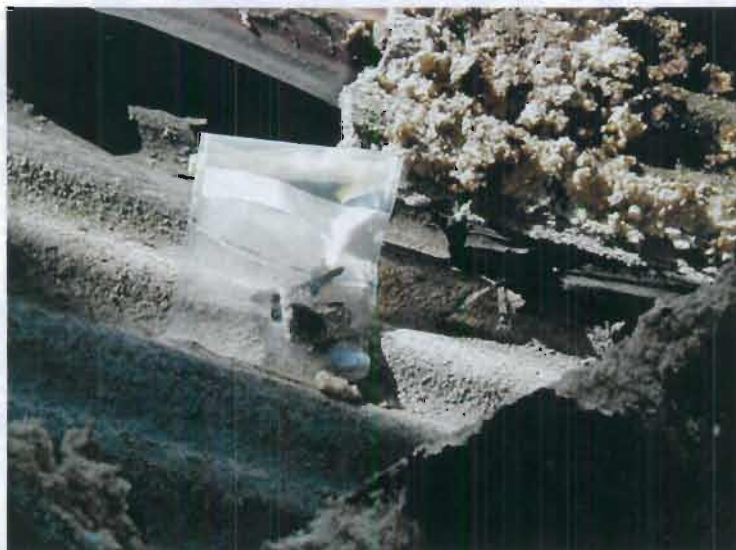
File No: DAH050505~05052005-037

Comments: Photo of sample of transite material taken from debris pile on the east side of the building

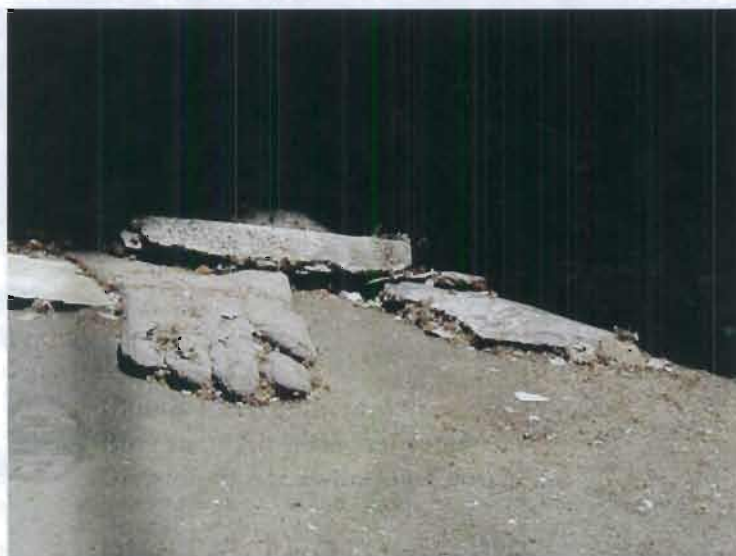
Comments: Broken dry transite lying on the floor next to a pair of gloves

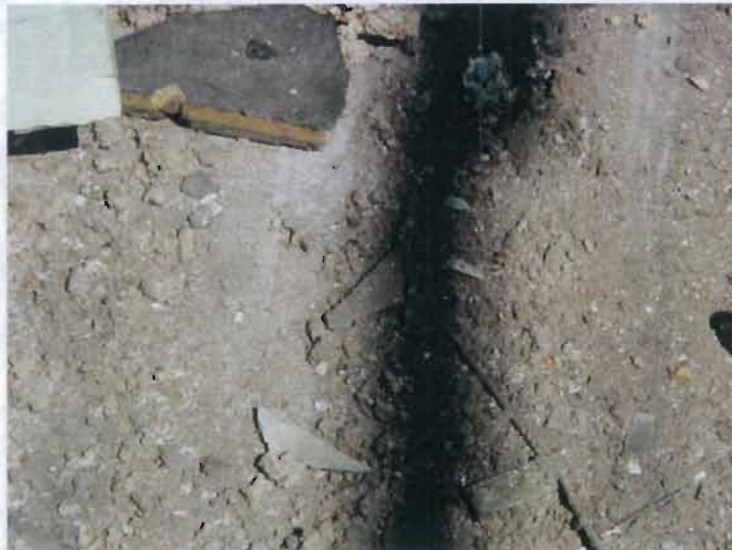
**File No: DAH050505~05052005-039**

**Comments: Photo of insulation and small piece of transite material lying on the floor on the east side of building**

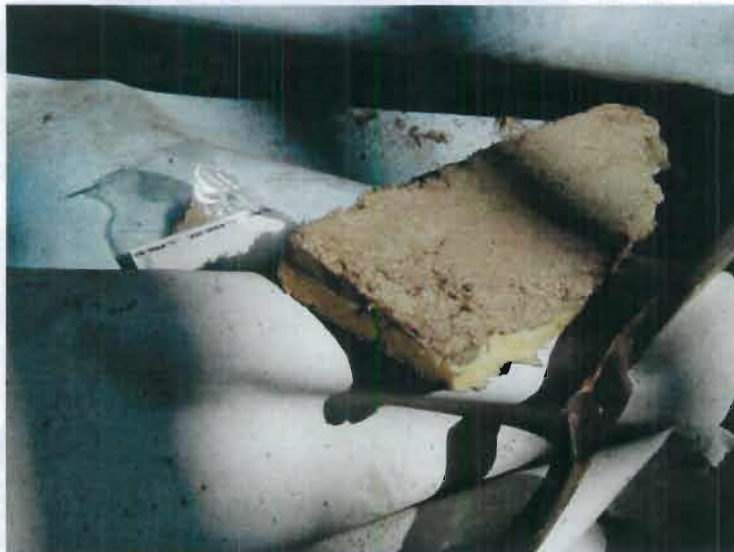
File No: DAH050505~05052005-041

Comments: Photo showing sample of insulation material taken from pile of debris on the east side of the building

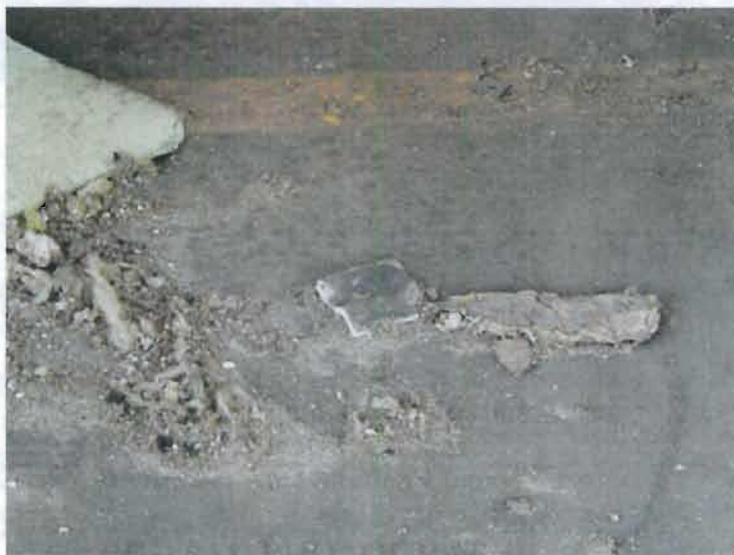
Comments: More photos of broken dry transite lying on the floor inside of the open building some of it is crushed by either the bobcat or forklift

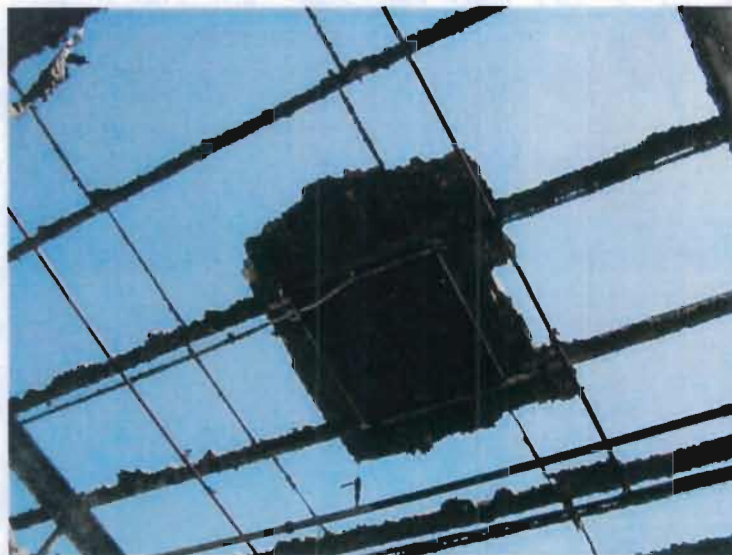
File No: DAH050505~05052005-043

Comments: Photo showing a section of broken transite material lying on the beams of the roof this pieces again shows that the transite sheet was not removed in as full a sheet as possible

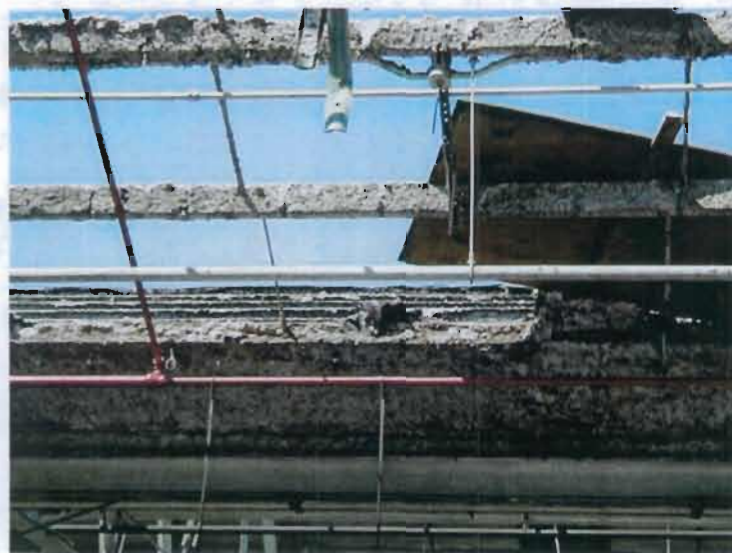
Comments: Photo showing broken pieces of transite that was between two beams and not removed at this time

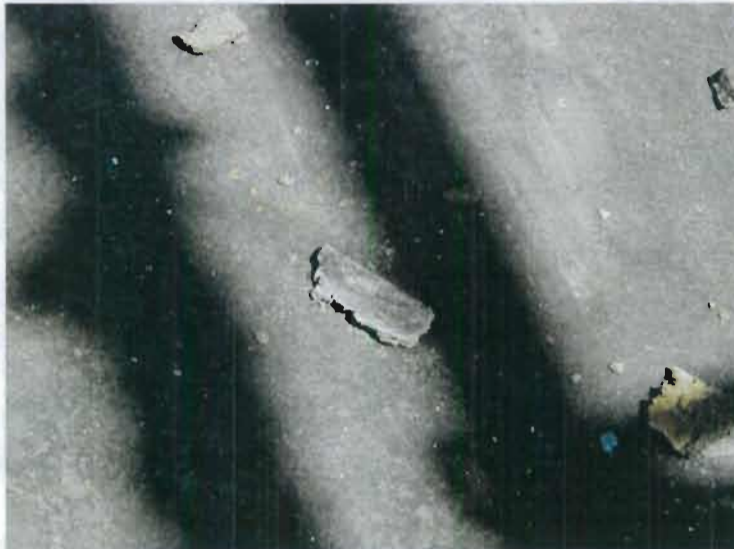
File No: DAH050505~05052005-045

Comments: Photo showing more pieces of small transite material dry lying on the floor inside of the building

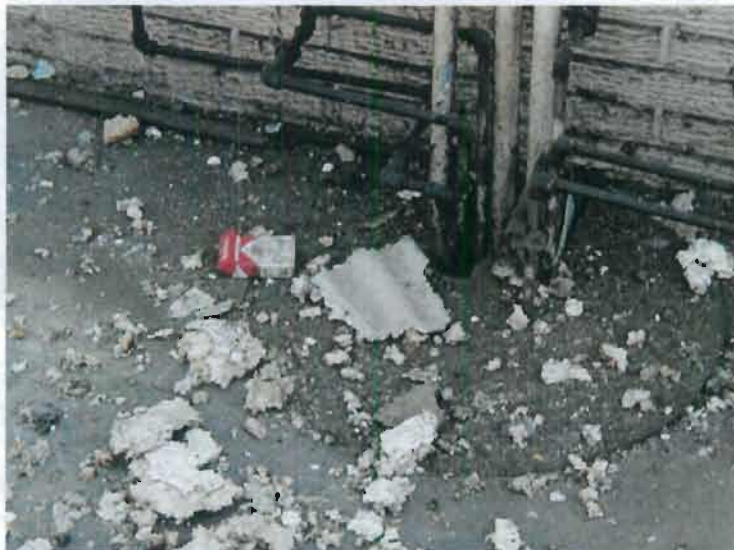
Comments: Photo showing small broken and crushed transite pieces lying on the floor against the east edge of the building

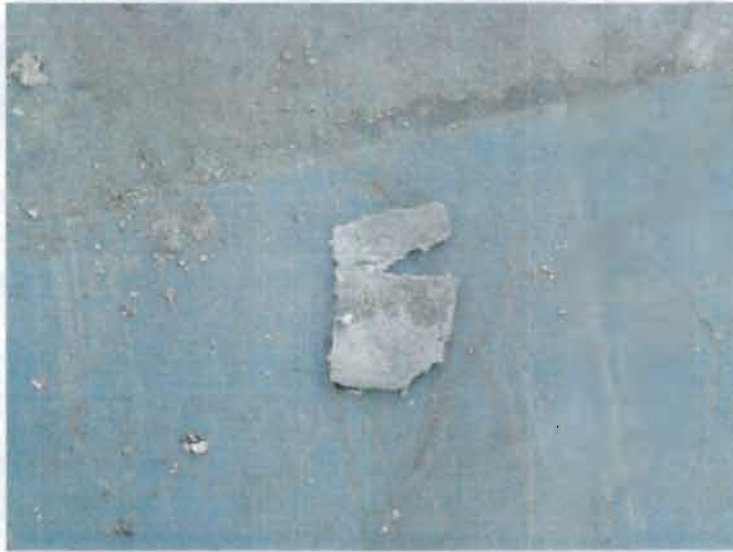
**File No: DAH050505~05052005-053**

**Comments: Photo showing a piece of dry transite that appears to have been run over by the equipment being used on the site**

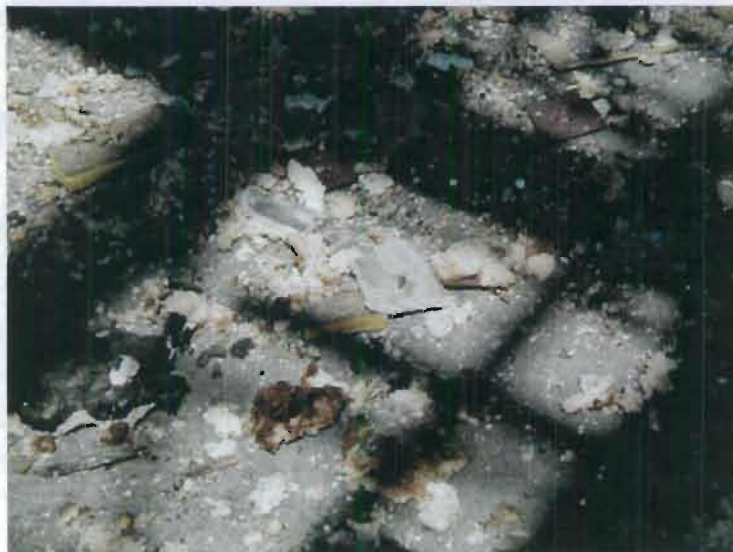
**Comments: Photo showing broken dry transite pieces of material lying on the floor among other misc. debris**

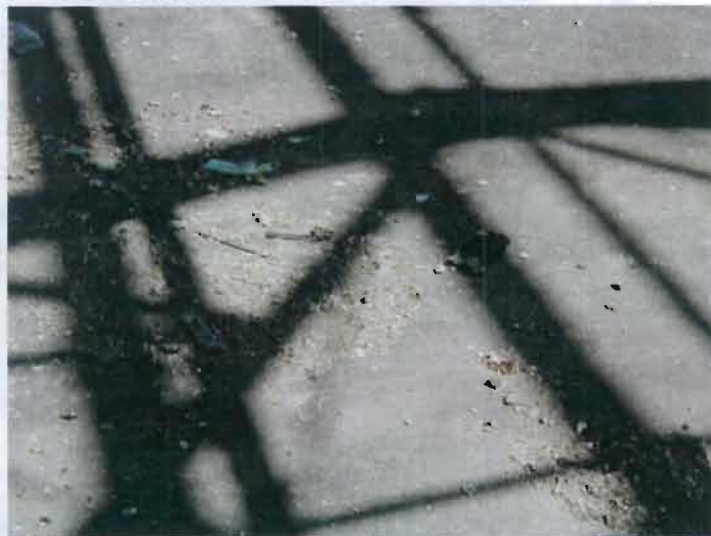
**File No: DAH050505~05052005-055**

**Comments: Photo showing small pieces of transite lying on the floor among other misc. debris**

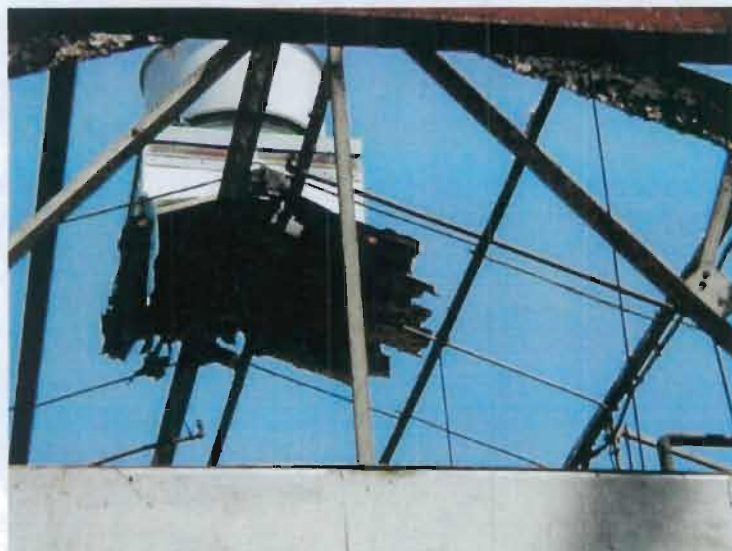
**Comments: Photo showing broken pieces of transite lying on the roof with the broken edge showing**

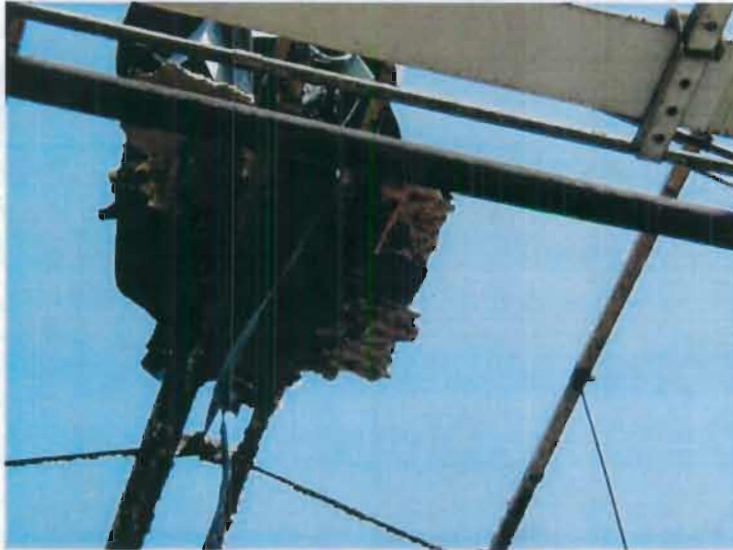
Comments: Another photo showing the broken transite still on the roof appears to be under a vent stack of some type

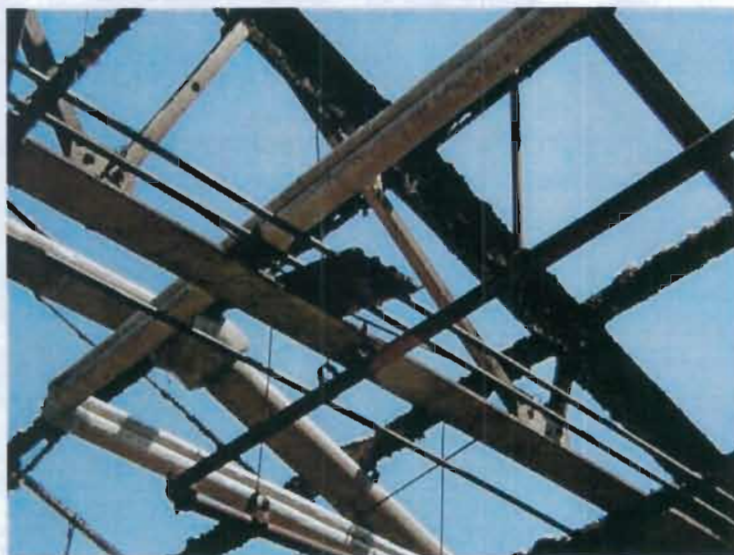
**File No: DAH050505~05052005-059**

**Comments: Photo showing another small piece of transite hung on the beams from the roof**

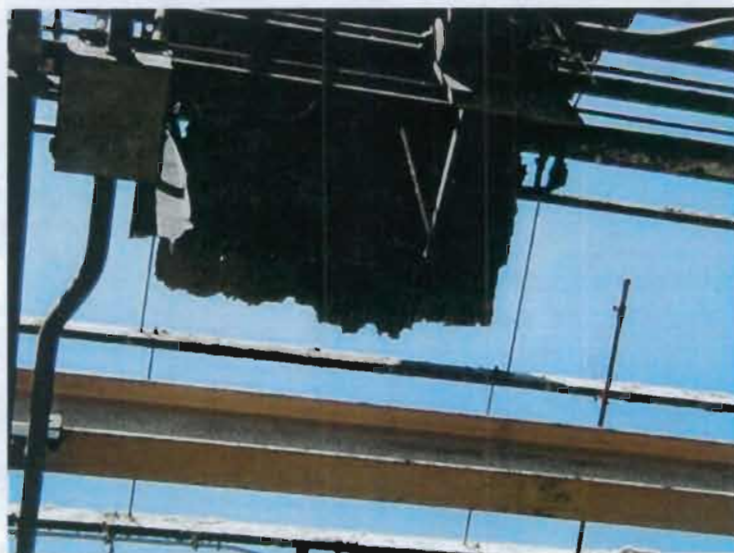
**Comments: Photo showing another section of broken transite stuck on top of the beams of the roof**

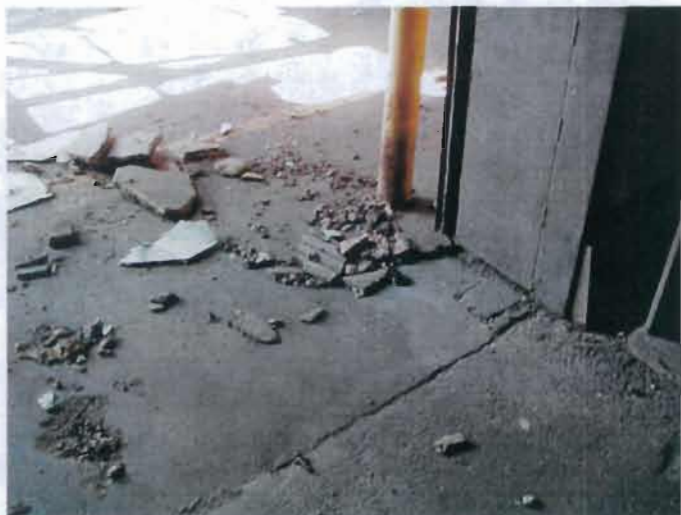
File No: DAH050505~05052005-063

Comments: Photo showing several broken pieces of transite lying in the doorway at the far South section of the building

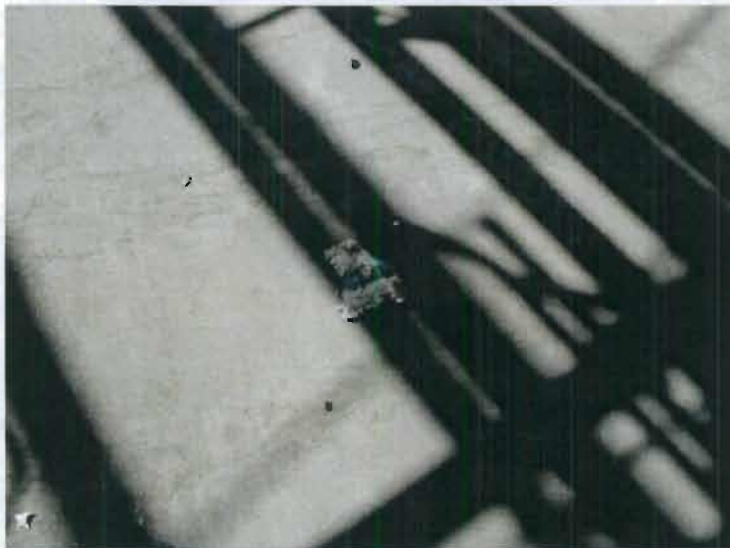
**File No: DAH050505~05052005-065**

**Comments: Photo showing a pile of transite made friable by being crushed by equipment running through the building**

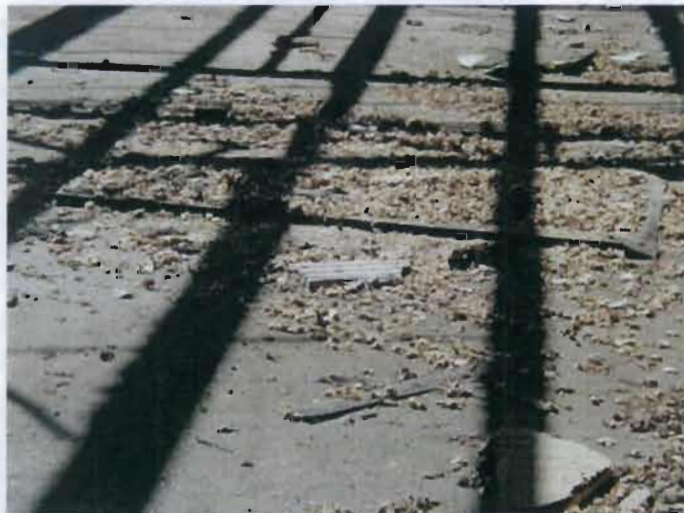
**Date: May 5, 2005**  
**Time: ~11:45 am**  
**Direction: South**  
**Photo by: D. Hancock**  
**File No: DAH050505~05052005-067**  
**Comments: Photo of transite and misc. debris lying on the floor through the center of the building that had transite roofing removed**

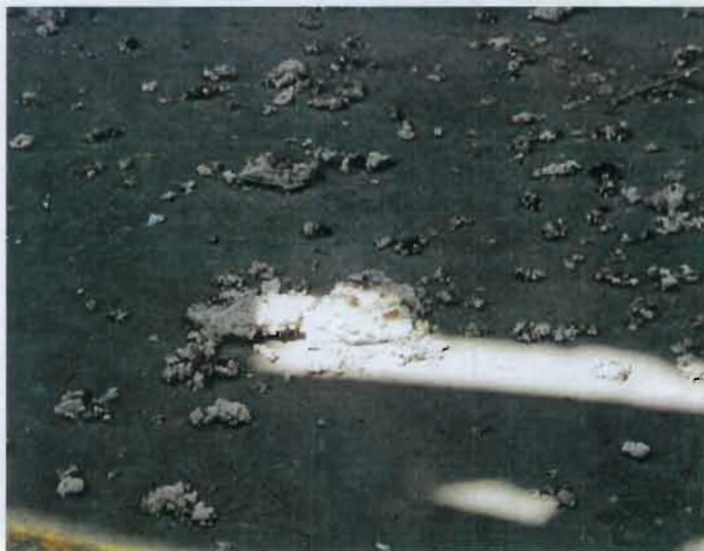
**Date: May 5, 2005**  
**Time: ~11:45 am**  
**Direction: South**  
**Photo by: D. Hancock**  
**File No: DAH050505~05052005-068**  
**Comments: Photo showing more transite and insulation lying in the center area of the building floor where the transite roof was removed**

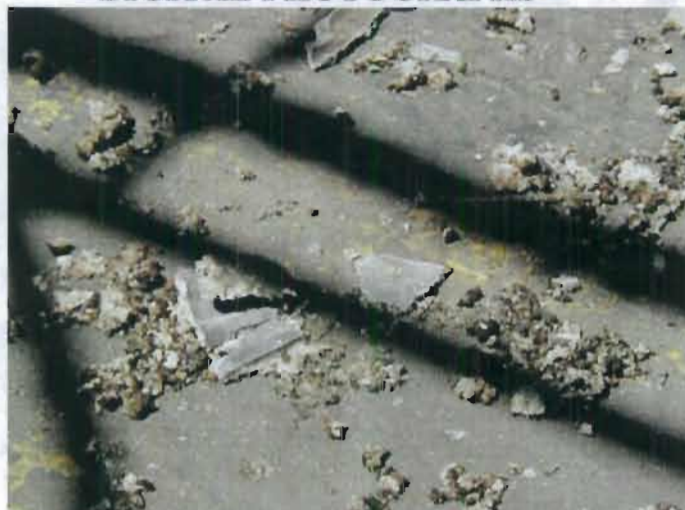
File No: DAH050505~05052005-069

Comments: Photo showing transite pieces mixed in with other misc. debris through the center of the building where the transite roof was removed

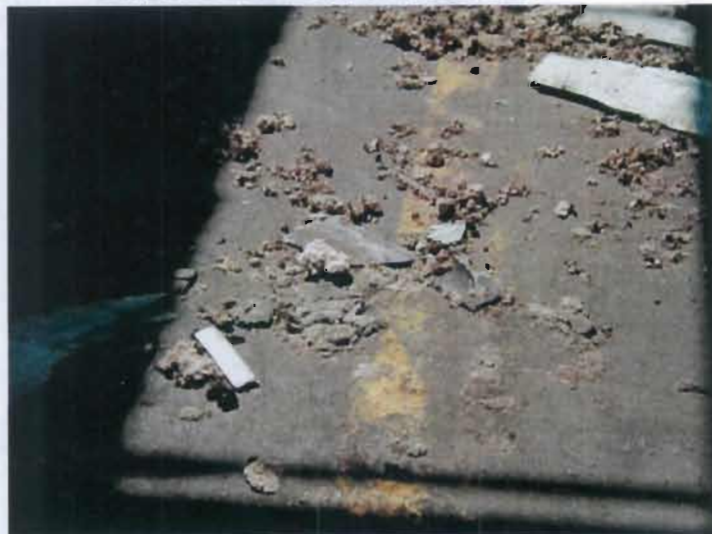
Date: May 5, 2005  
Time: ~11:45 am  
Direction: South  
Photo by: D. Hancock  
File No: DAH050505~05052005-071  
Comments: Another photo of transite pieces lying on the floor through the center of the building where the transite roof was removed

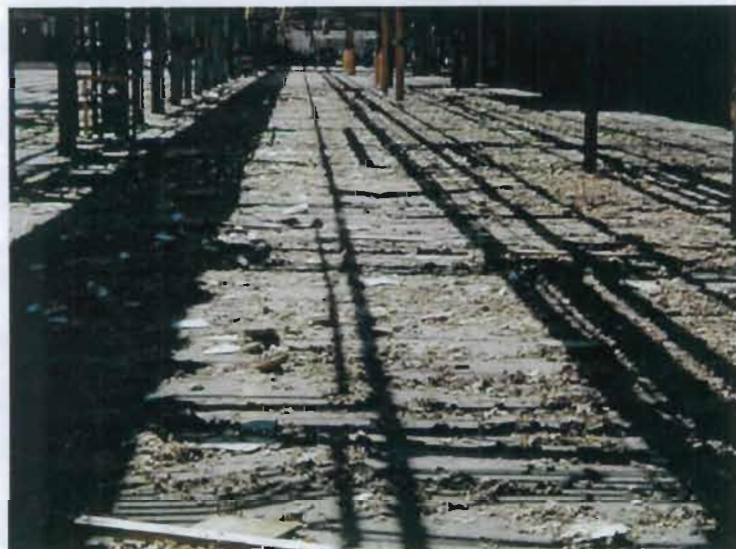
Date: May 5, 2005  
Time: ~11:45 am  
Direction: South  
Photo by: D. Hancock  
File No: DAH050505~05052005-072  
Comments: Photo showing the transite and misc. debris through the entire center section of the east building.

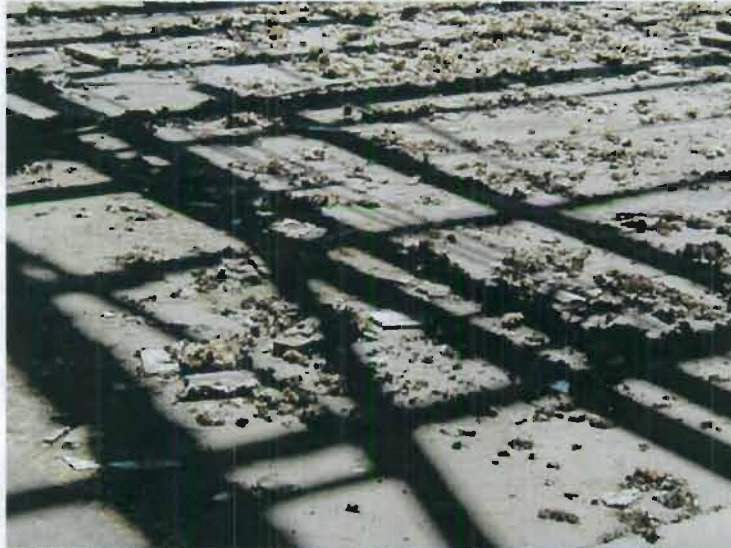
**File No: DAH050505~05052005-073**

**Comments: More transite and misc. debris scattered throughout the center of the east building**

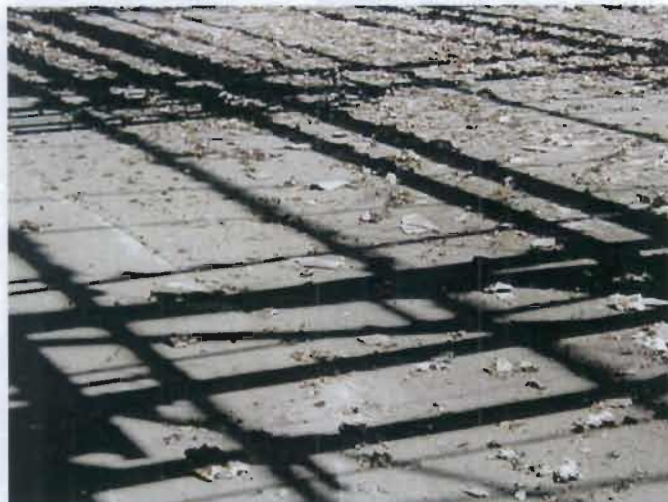
**File No: DAH050505~05052005-075**

**Comments: Transite and misc. debris scattered throughout the north section of the building where the transite roof was removed**

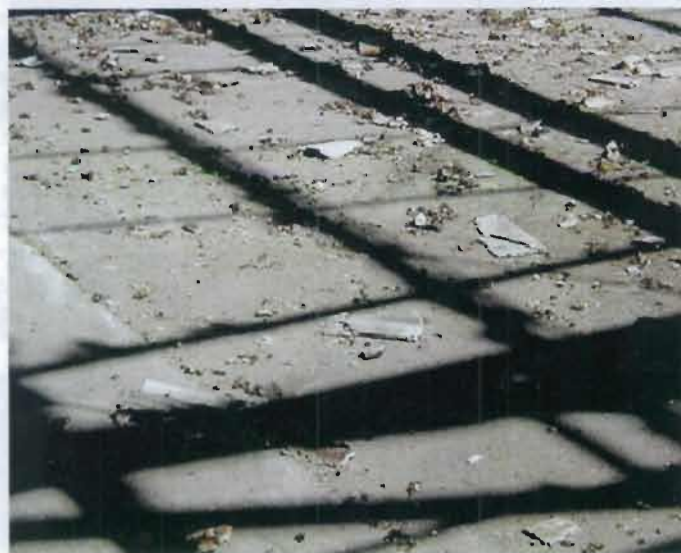
**Comments: Photo of more transite broken and dry lying on the floor some of this was crushed apparently by the equipment used in the building**

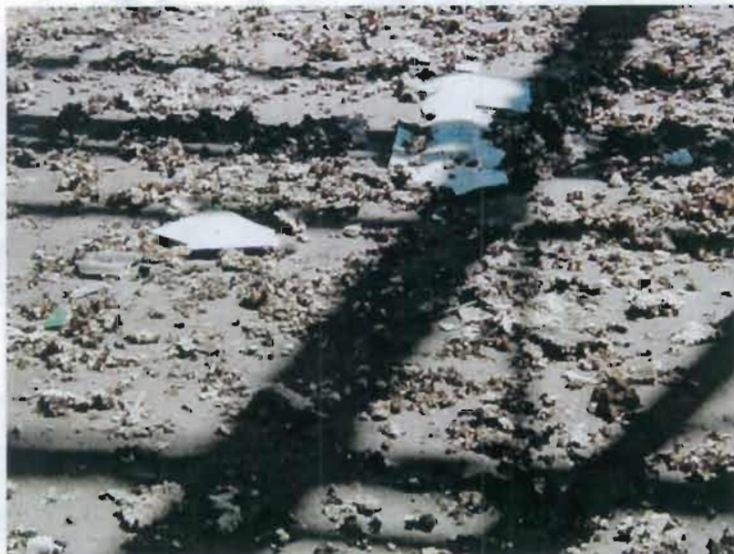
**File No: DAH050505~05052005-079**

**Comments: Transite and insulation material lying on the floor of the South end of the building below where transite roofing material was removed**

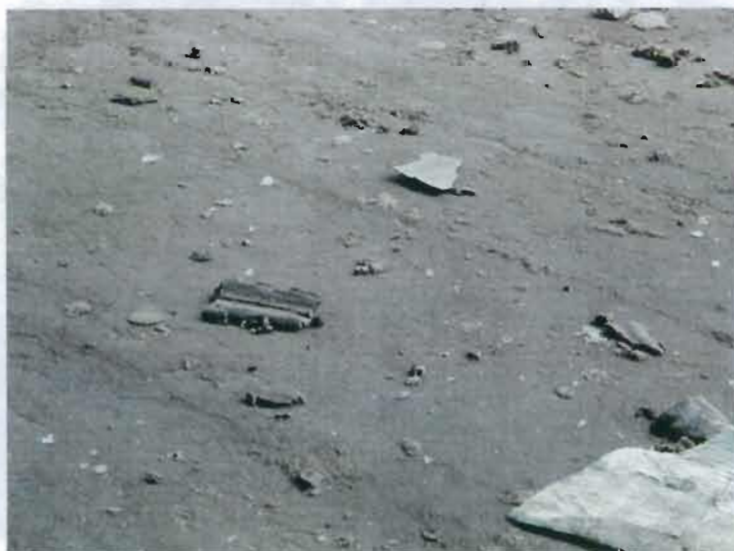
**Comments: Photo showing the broken and dry transite lying on the floor underneath where the transite roofing was removed**

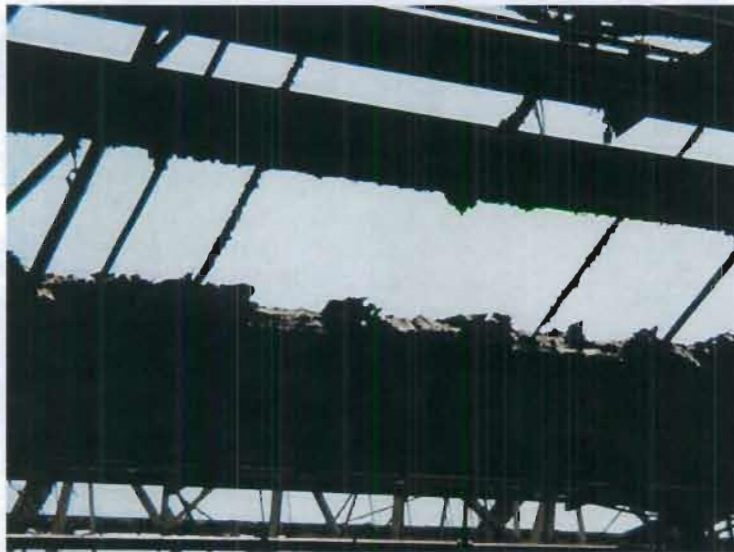
File No: DAH050505~05052005-081

Comments: Photo showing broken transite still not removed from the roof at this time it seems as though this material may be caught between the beam sections.

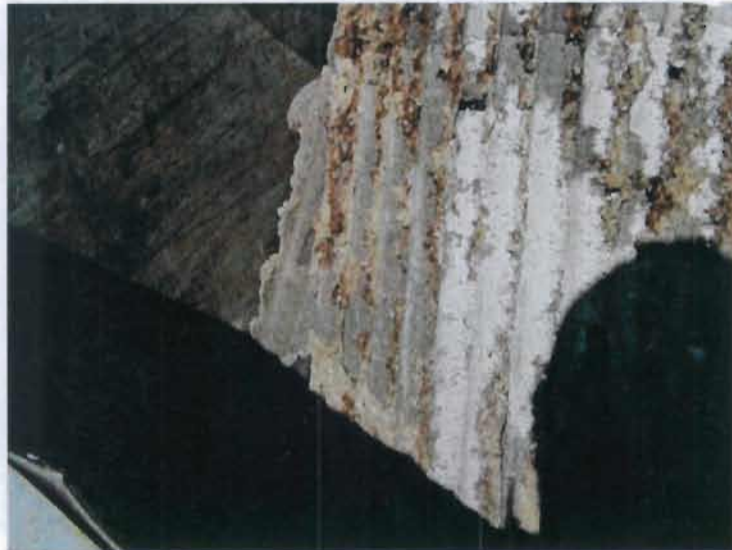
**File No: DAH050505~05052005-083**

**Comments: Photo showing the uncovered and dry transite panels that were broken and inside of uncovered dumpster**

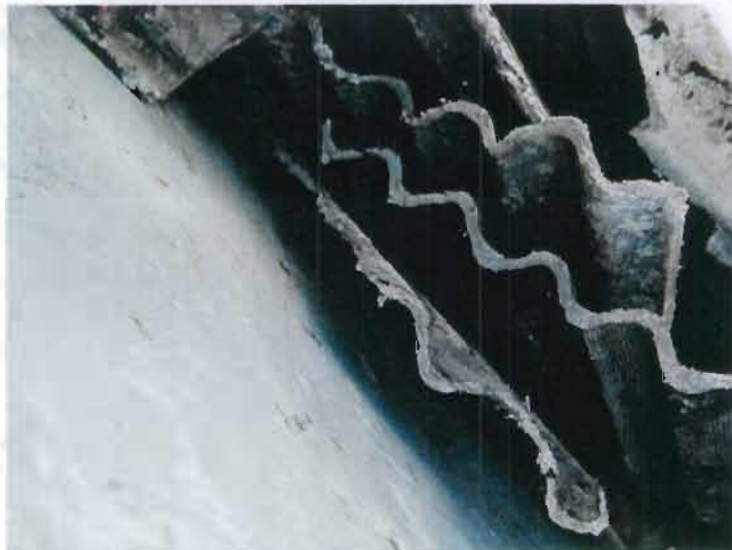
**Comments: Another photo of dry broken uncovered transite inside of the dumpster**

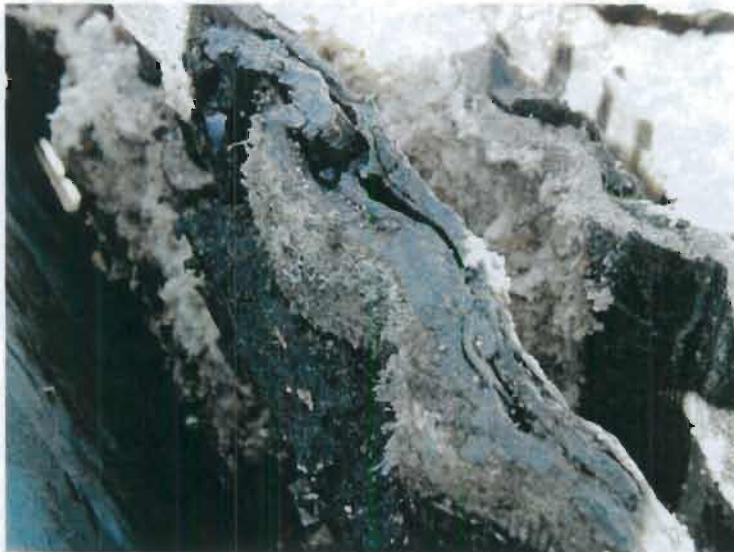
File No: DAH050505~05052005-085

Comments: Another photo of uncovered broken and dry transite inside of the dumpster

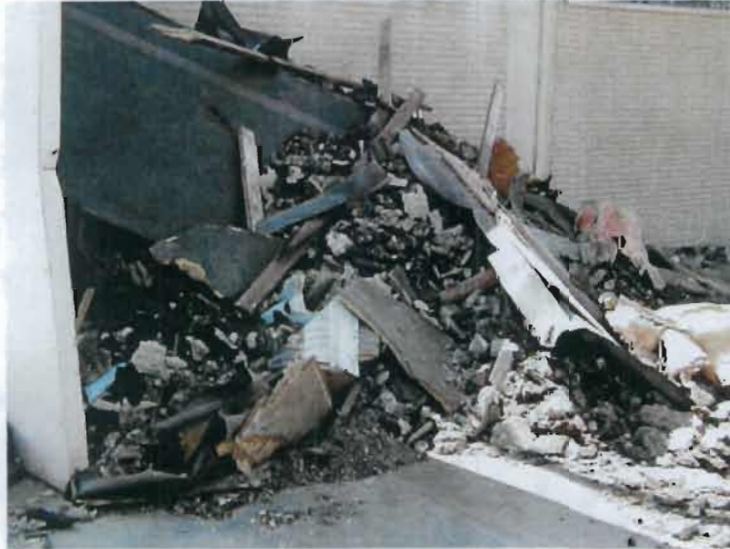
File No: DAH050505~05052005-087

Comments: Closer photo of the above shot of debris and small transite pieces in the pile

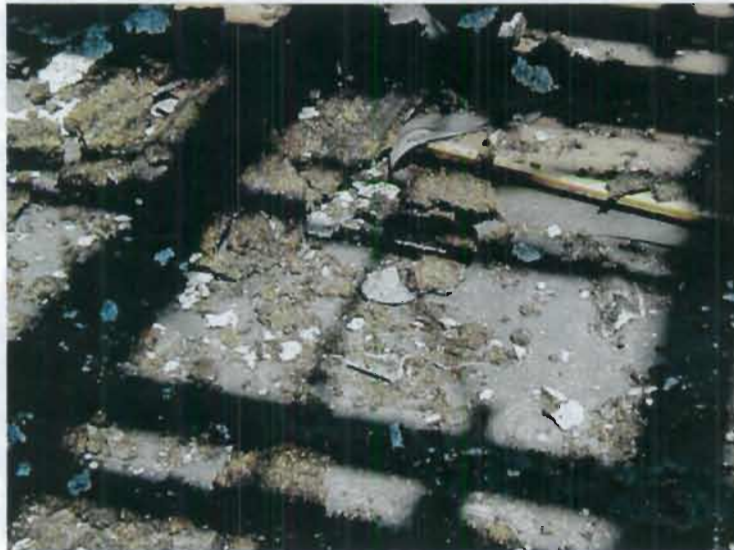
File No: DAH050505~05052005-089

Comments: More photos of dry broken transite lying on the floor going west in the South section of the building
