STATE OF ILLINOIS                     )  
  )  
COUNTY OF LA SALLE                )                     PCB 2005-199

**AFFIDAVIT**

4.       On May 5, 2005, I inspected the facility known as the Case Manufacturing Facility, located at 1100 Third Street in East Moline, Rock Island County, Illinois (facility). The facility was approximately two million five hundred thousand (2,500,000) square feet.

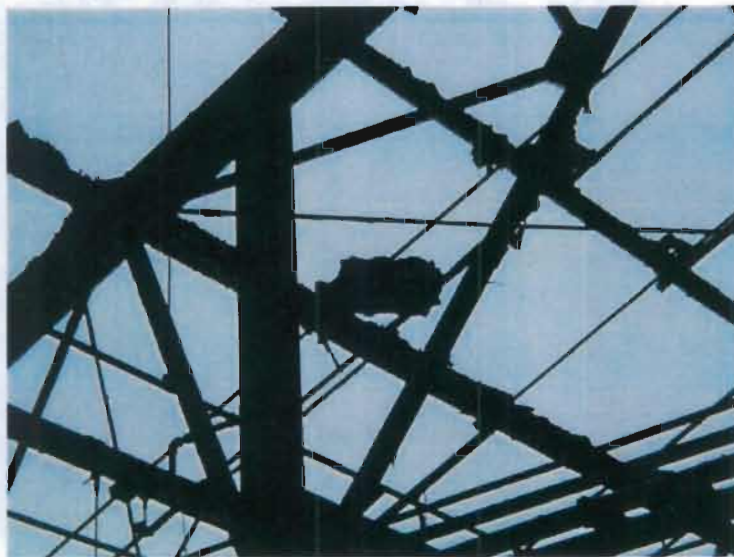
**File No: DAH0505055052005-091**

**Comments: Photo of piece of transite still up on the beams showing a lot of breakage**

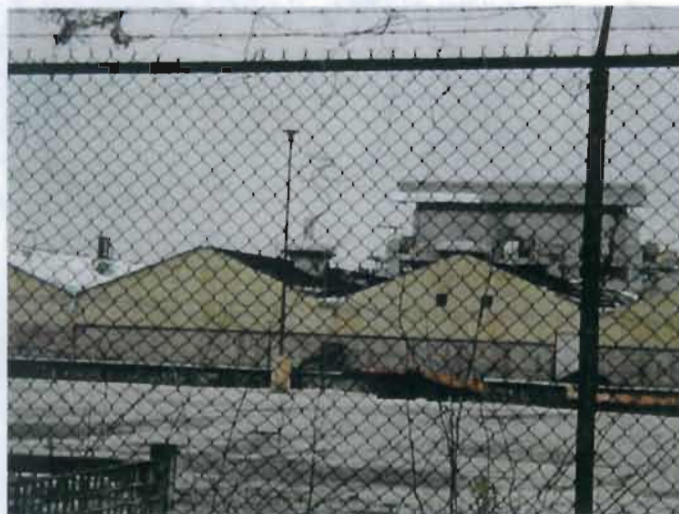
**File No: DAH051105~05112005-001**

**Comments: Photo looking across the fence from the property next door to see if I was able to get a better view of the roofing condition.**

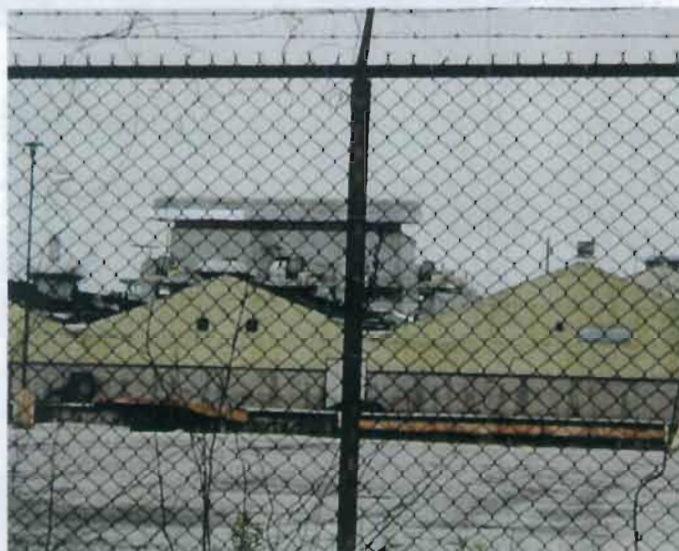
**Comments: Photo looking across the fence from the property next door to see if I was able to get a better look at the condition of the roof before removed**

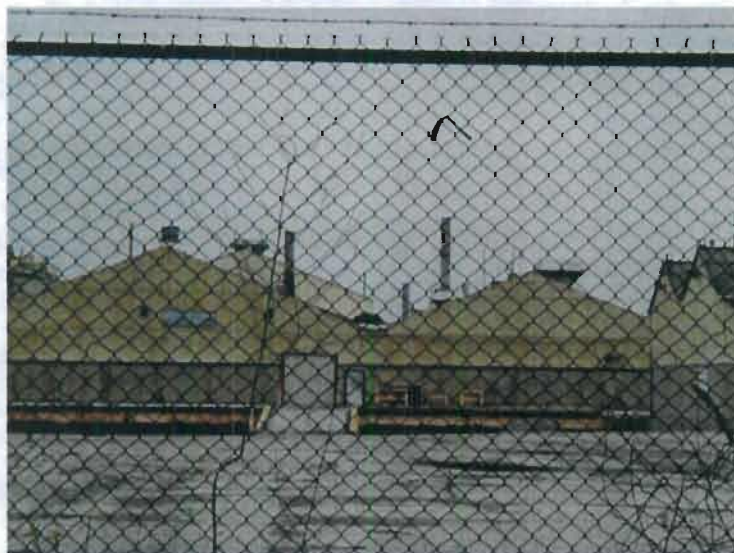
File No: DAH051105~05112005-003

Comments: A closer photo to see what condition the roofing was prior to removal

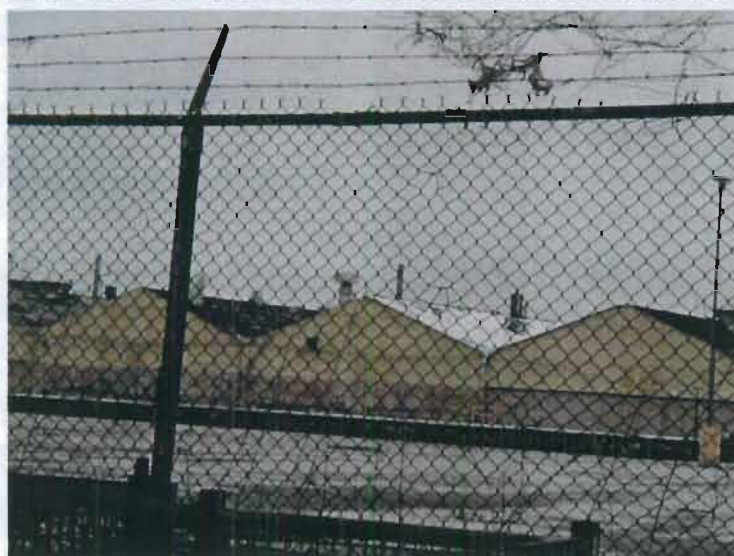
Comments: Closer photo to see the condition of the roofing material prior to removal

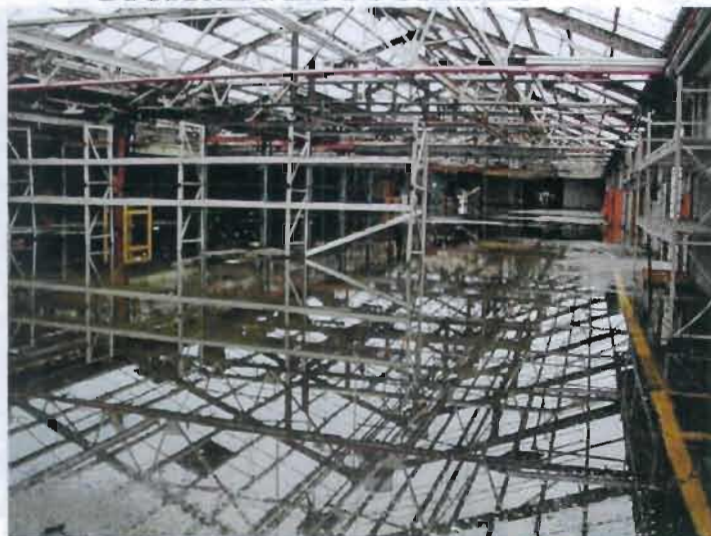
**Comments: Water on the floor of the inside of the building due to storm in the morning area appeared cleaned up but supervisor was informed to filter the water from this water since there was dust and broken transite lying on the floor in this area on first inspection**

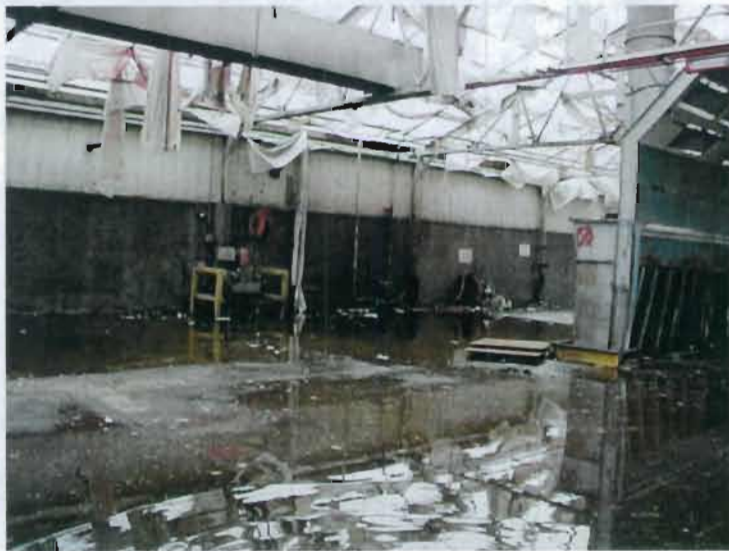
**File No: DAH051105~05112005-009**

**Comments: Photo still showing trash material still lying around the work site area inside of the building. Supervisor was told to clean this up and try to do a good cleanup everyday prior to leaving site so debris does not blow around the property or go over to some other properties and he agreed to do this**

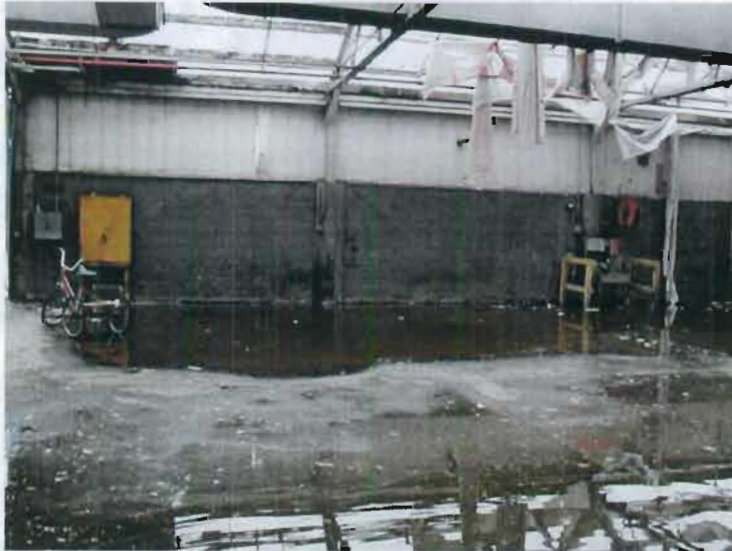
Date: May 11, 2005  
Time: ~10:25 am  
Direction: East  
Photo by: D. Hancock  
File No: DAH051105~05112005-011  
Comments: Photo showing where a lot of debris was located during the initial inspection and appears to be cleaned up at this time.

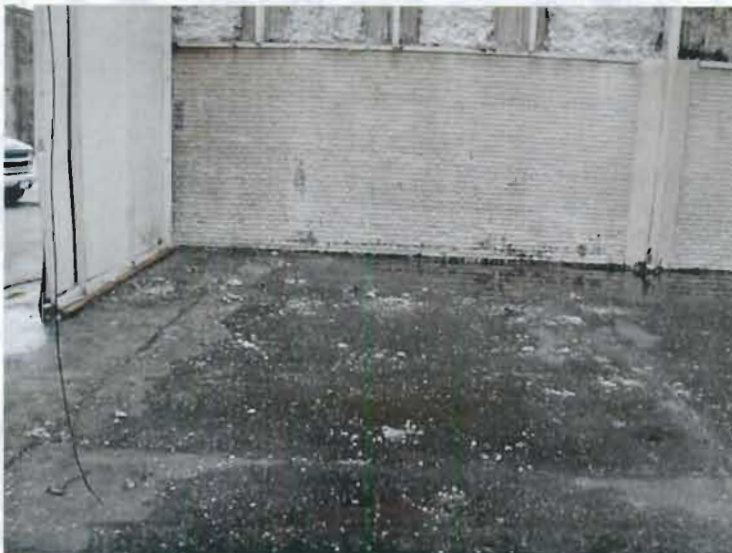
Date: May 11, 2005  
Time: ~10:30 am  
Direction: South  
Photo by: D. Hancock  
File No: DAH051105~05112005-012  
Comments: Area where transite and insulation had been piled up during initial inspection has been cleaned up

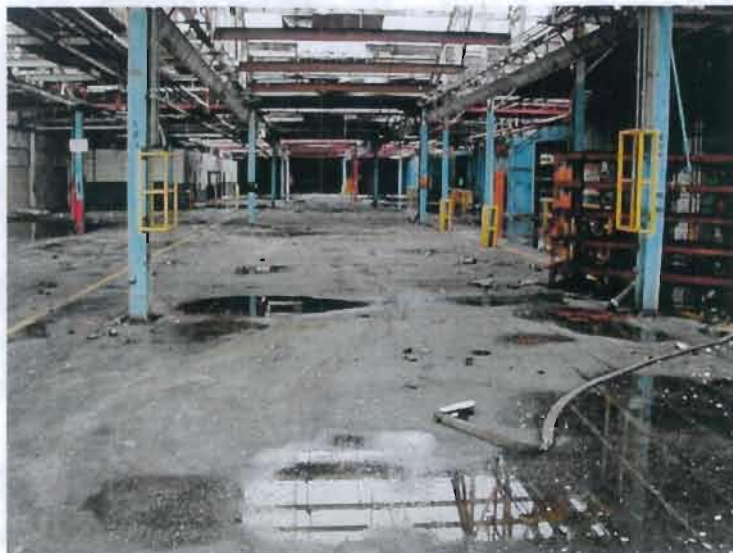
**File No: DAH051105~05112005-013**

**Comments: Photo showing where material had been during the initial inspection and now appears to be cleaned up**

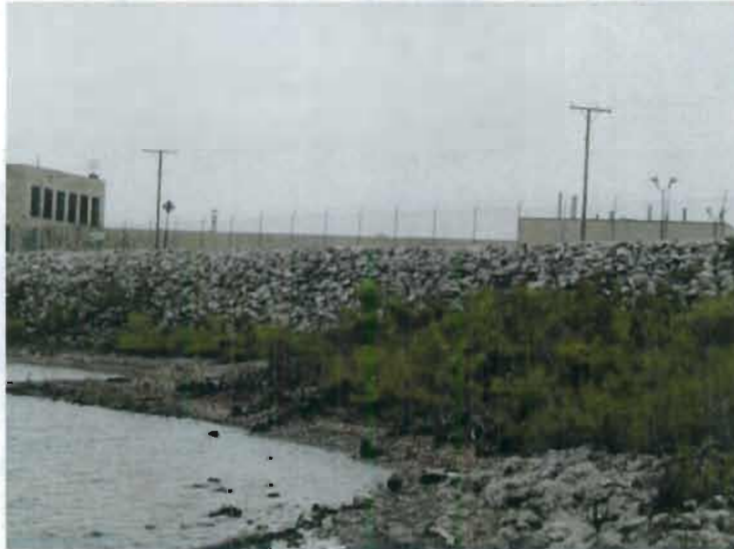
**File No:** DAH051105~05112005-015

**Comments:** Photo of bank area where misc. debris was seen but camera was not able to pick up until I moved closer

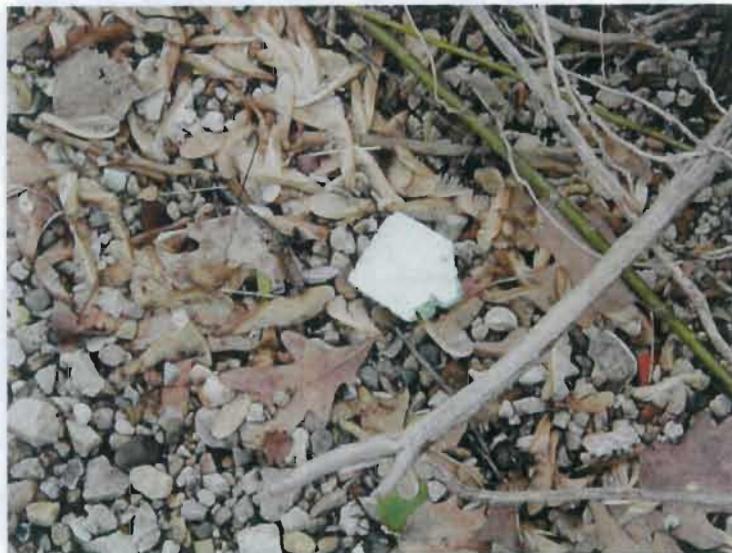
**File No: DAH051105~05112005-017**

**Comments: Photo showing close up of green insulation board lying on the rocks next to the banks of the Mississippi River.**

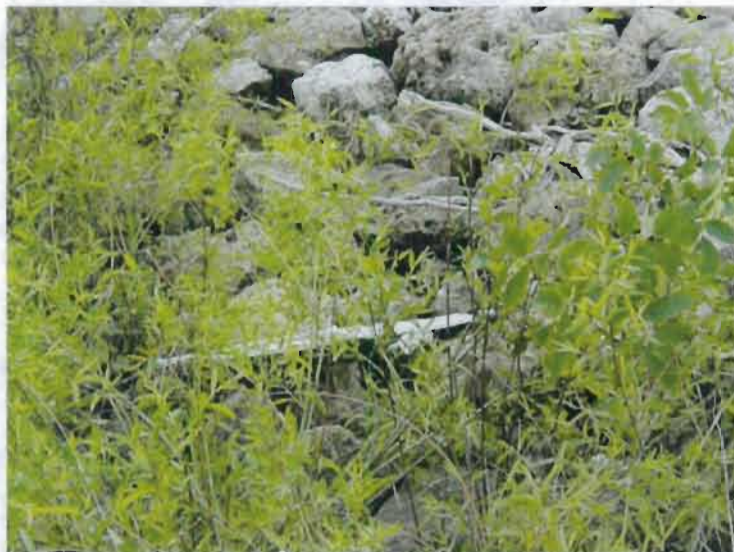
**Date: May 11, 2005  
Time: ~12:15 pm  
Direction: South  
Photo by: D. Hancock  
File No: DAH051105~05112005-019  
Comments: Another photo of more insulation green matching material from the demo site lying in the grassy area along the Mississippi River**

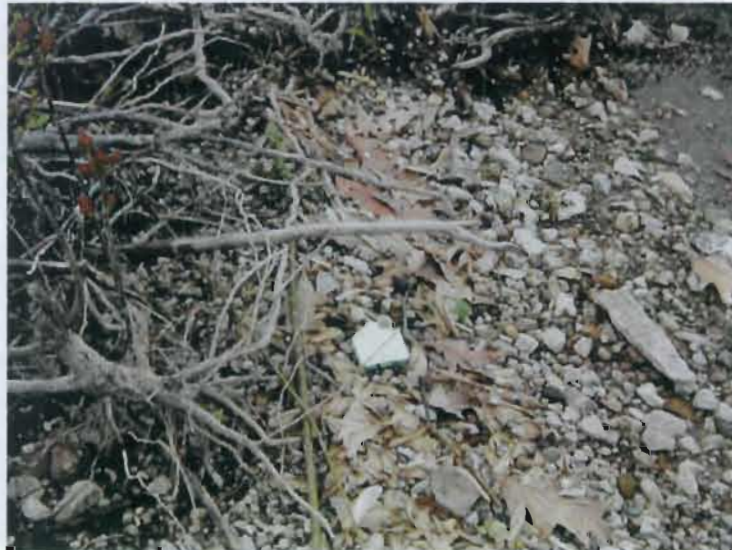
**File No: DAH051105~05112005-021**

**Comments: More green insulation board lying on the beach area of the Mississippi River**

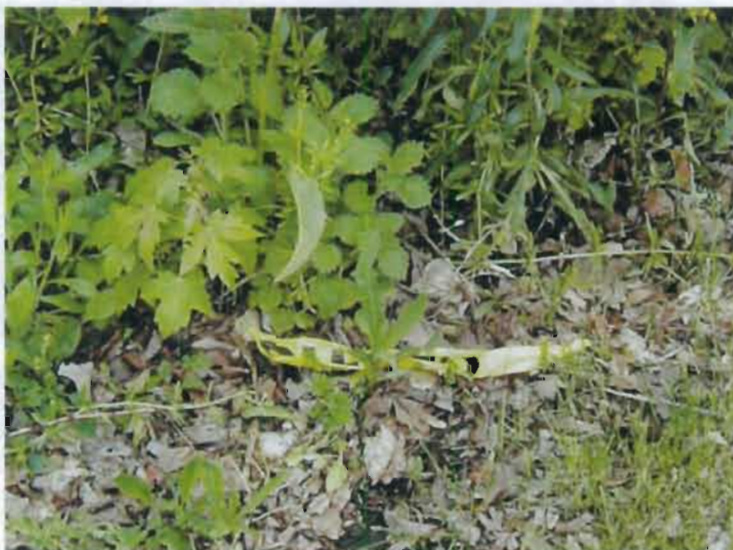
**File No: DAH051105~05112005-023**

**Comments: Caution tape lying in the park area  
from the demo site across the fence**

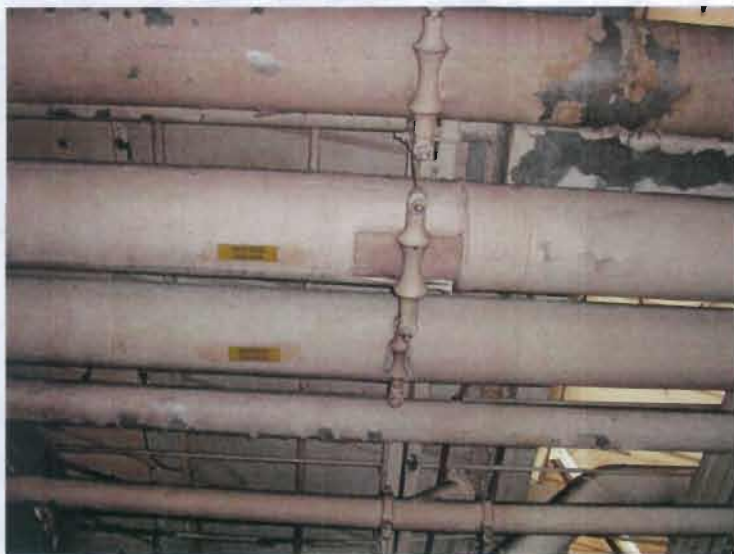
**File No: DAH051105~05112005-025**

**Comments: More of the piping to be removed by Champion after prepping is completed**

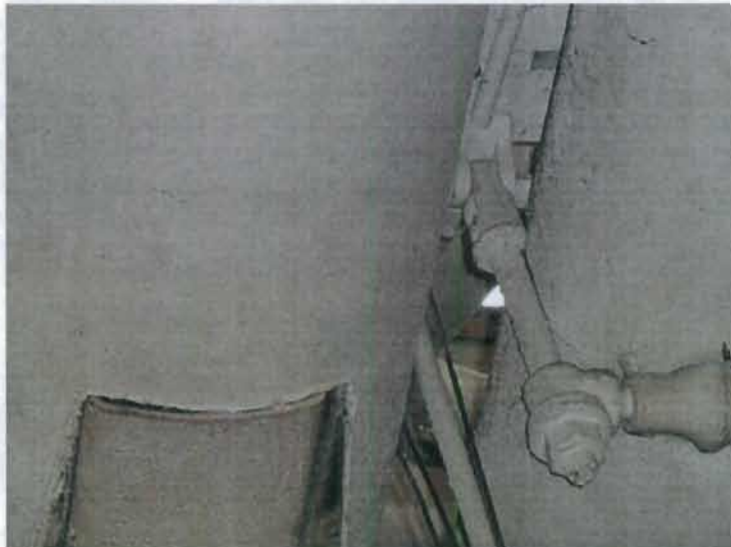
File No: DAH051105~05112005-027

Comments: Another view of the piping to be removed by gross removal with enclosure that are being set up at this time

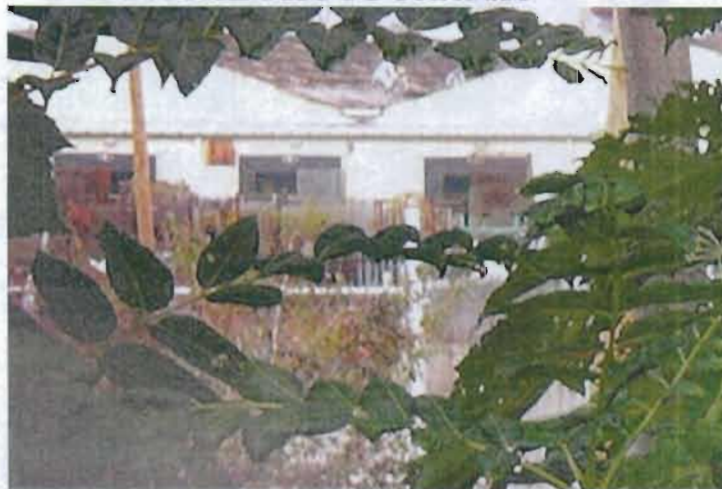
Date: September 28, 2005  
Time: ~ 11:10 am  
Direction: North  
Photo by: D. Hancock  
File No: DAH092805~09282005-003  
Comments: Workers sliding down a sheet of transite on the roof

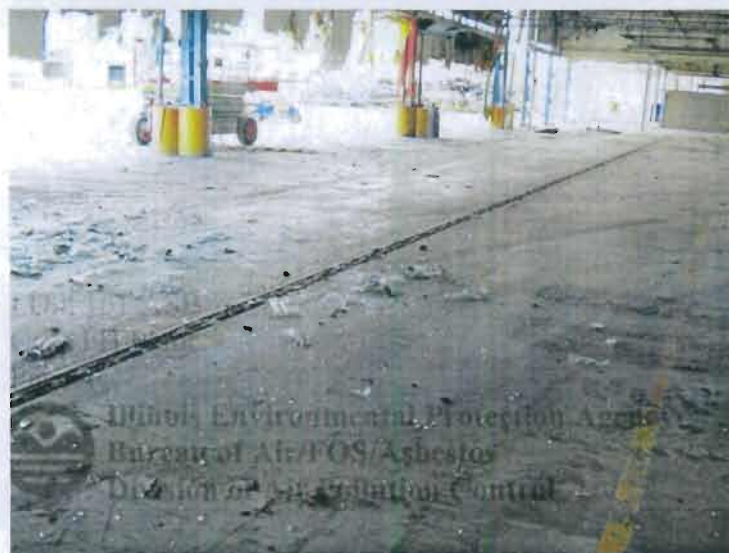
Date: November 3, 2005  
Time: ~1:54 pm  
Direction: South  
Photo by: D. Hancock  
File No: DAH110305~11032005-002  
Comments: Photo showing debris lying on the that had been dropped from the roof area

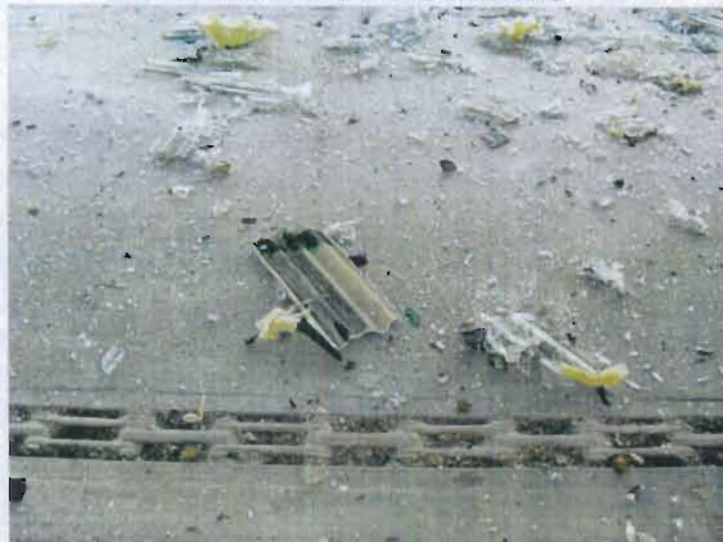
File No: DAH110305~11032005-003

Comments: Large pieces of broken transite that fallen off the roof during the removal of panel material is dry, floor is dry, insulation and glass dry.

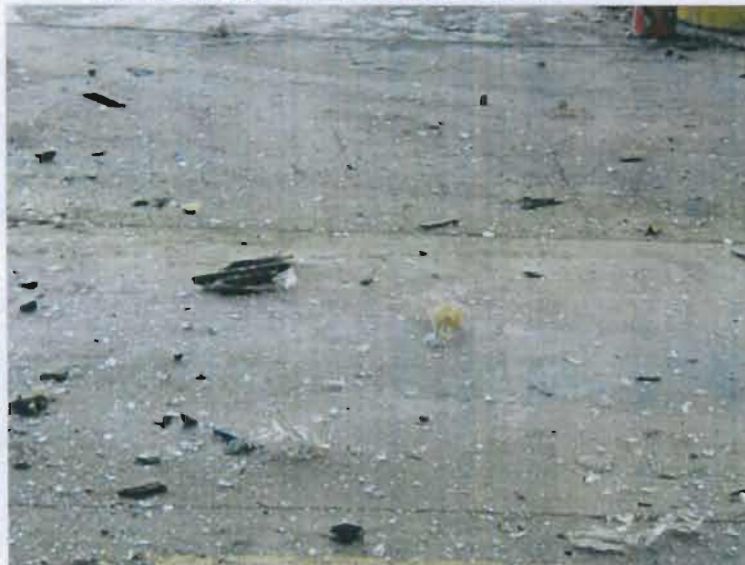
File No: DAH110305~11032005-005

Comments: More pieces of transite and glass a  
with insulation dropped from the roof to the  
concrete floor below where the workers were

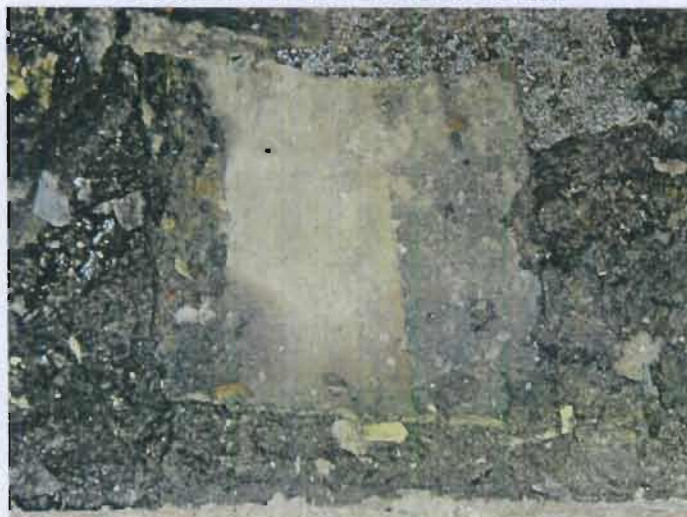
File No: DAH110305~11032005-007

Comments: Debris, insulation, and glass lying on the concrete floor under the workers

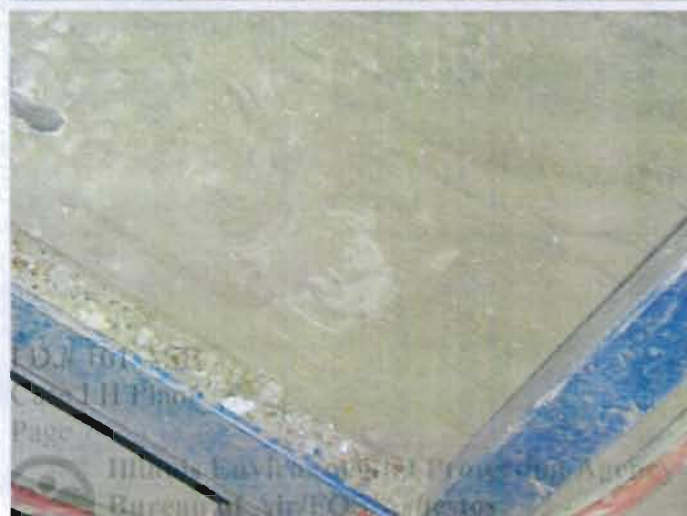
Comments: Transite pieces lying on the cutting tool cart observed by the supervisor and myself. Supervisor stated that was his cart but did not know how that material got there said someone must have picked it off of the floor and put it there.

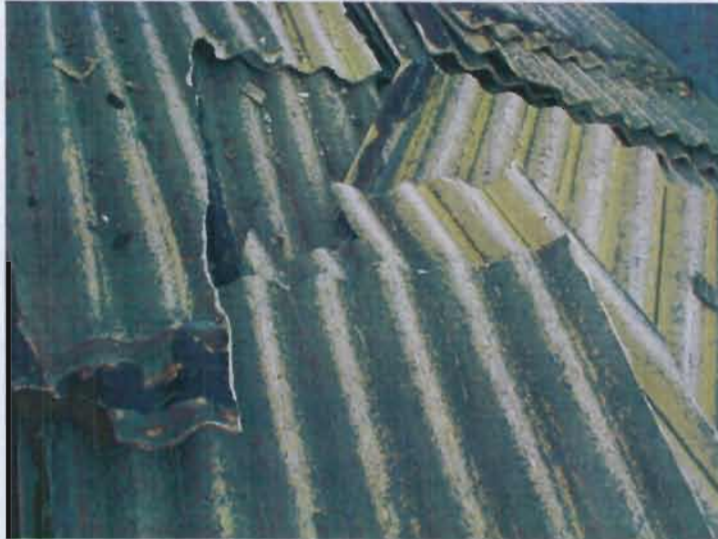
**Date: March 1, 2006  
Time: ~11:00 am  
Direction: Inside of dumpster  
Photo by: D. Hancock  
File No: DAH030106~03012006-007  
Comments: More photos of material in dumpsters**
