ILLINOIS ENVIRONMENTAL PROTECTION AGENCY

Re: Illinois Environmental Protection Agency v. Edward W. Fisher & Rhonda L. Fisher and  
DEM/EX Group, Inc.  
IEPA File No. 29-08-AC; 1250305011—Mason County

BEFORE THE ILLINOIS POLLUTION CONTROL BOARD  
ADMINISTRATIVE CITATION

February 7, 2008 Inspection

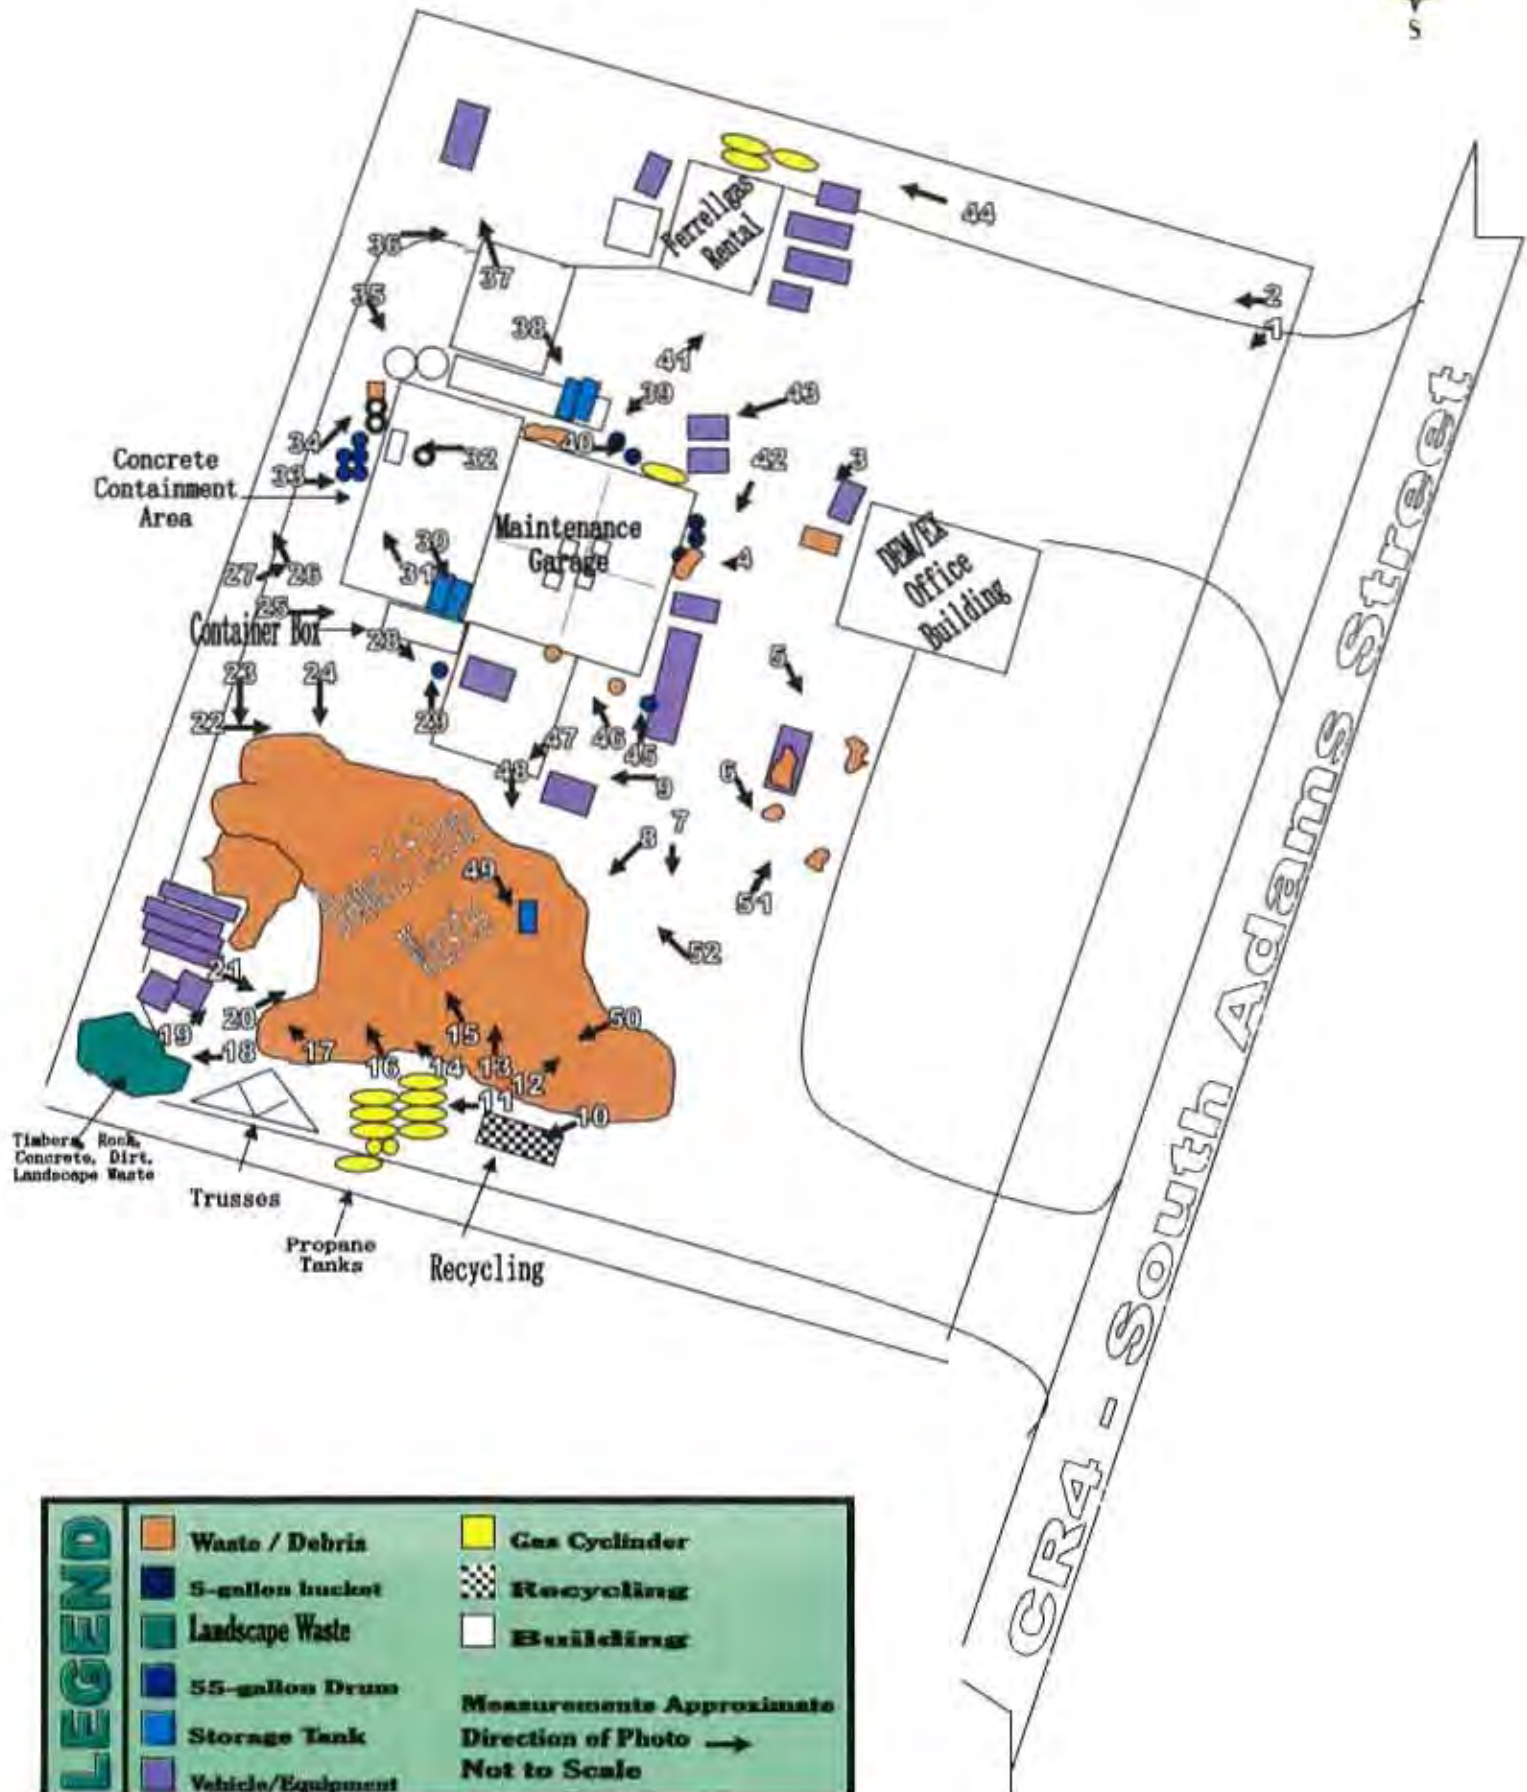
# SI SKETCH

Over 200 cubic yards of off-site generated waste were observed throughout the facility. All of the waste must be cleaned up. All materials stored outside should be organized in a manner that depicts a useable storage area rather than an open dump. Demolition debris must be hauled directly to an Illinois EPA approved disposal site. Crushing and salvaging operations must be completed at the demolition site. Waste can not be transported back to this facility for sorting and processing.
