ILLINOIS ENVIRONMENTAL PROTECTION AGENCY

Re: Illinois Environmental Protection Agency v. Hiram Vanderheiden, Jr.
IEPA File No. 51-08-AC; 1258075004—Mason County

BEFORE THE ILLINOIS POLLUTION CONTROL BOARD
ADMINISTRATIVE CITATION

LPC #1258075004 - Mason County
 Manito / Vanderheiden
 FOS File
 February 7, 2008 Inspection

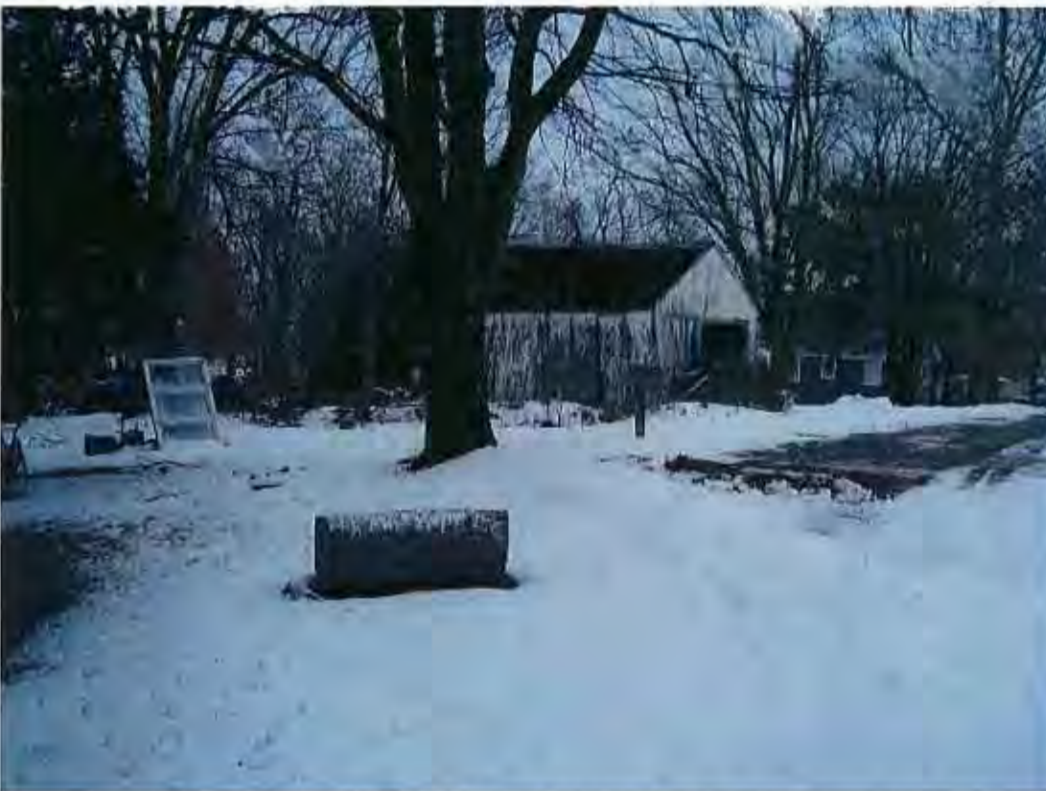
Date: February 7, 2008
Time: 11:14 AM
Direction: SE
Photo by: Eisenbrandt
Exposure #: 016
Comments: North end of North Park Avenue.
