*SIERRA CLUB, ET AL. V. MIDWEST GENERATION, LLC* PCB 13-15

**EXPERT REPORT ON GROUNDWATER  
CONTAMINATION BY JAMES R. KUNKEL  
JULY 1, 2015**

# Expert Report on Ground-water Contamination

**James R. Kunkel, Ph.D., P.E.**

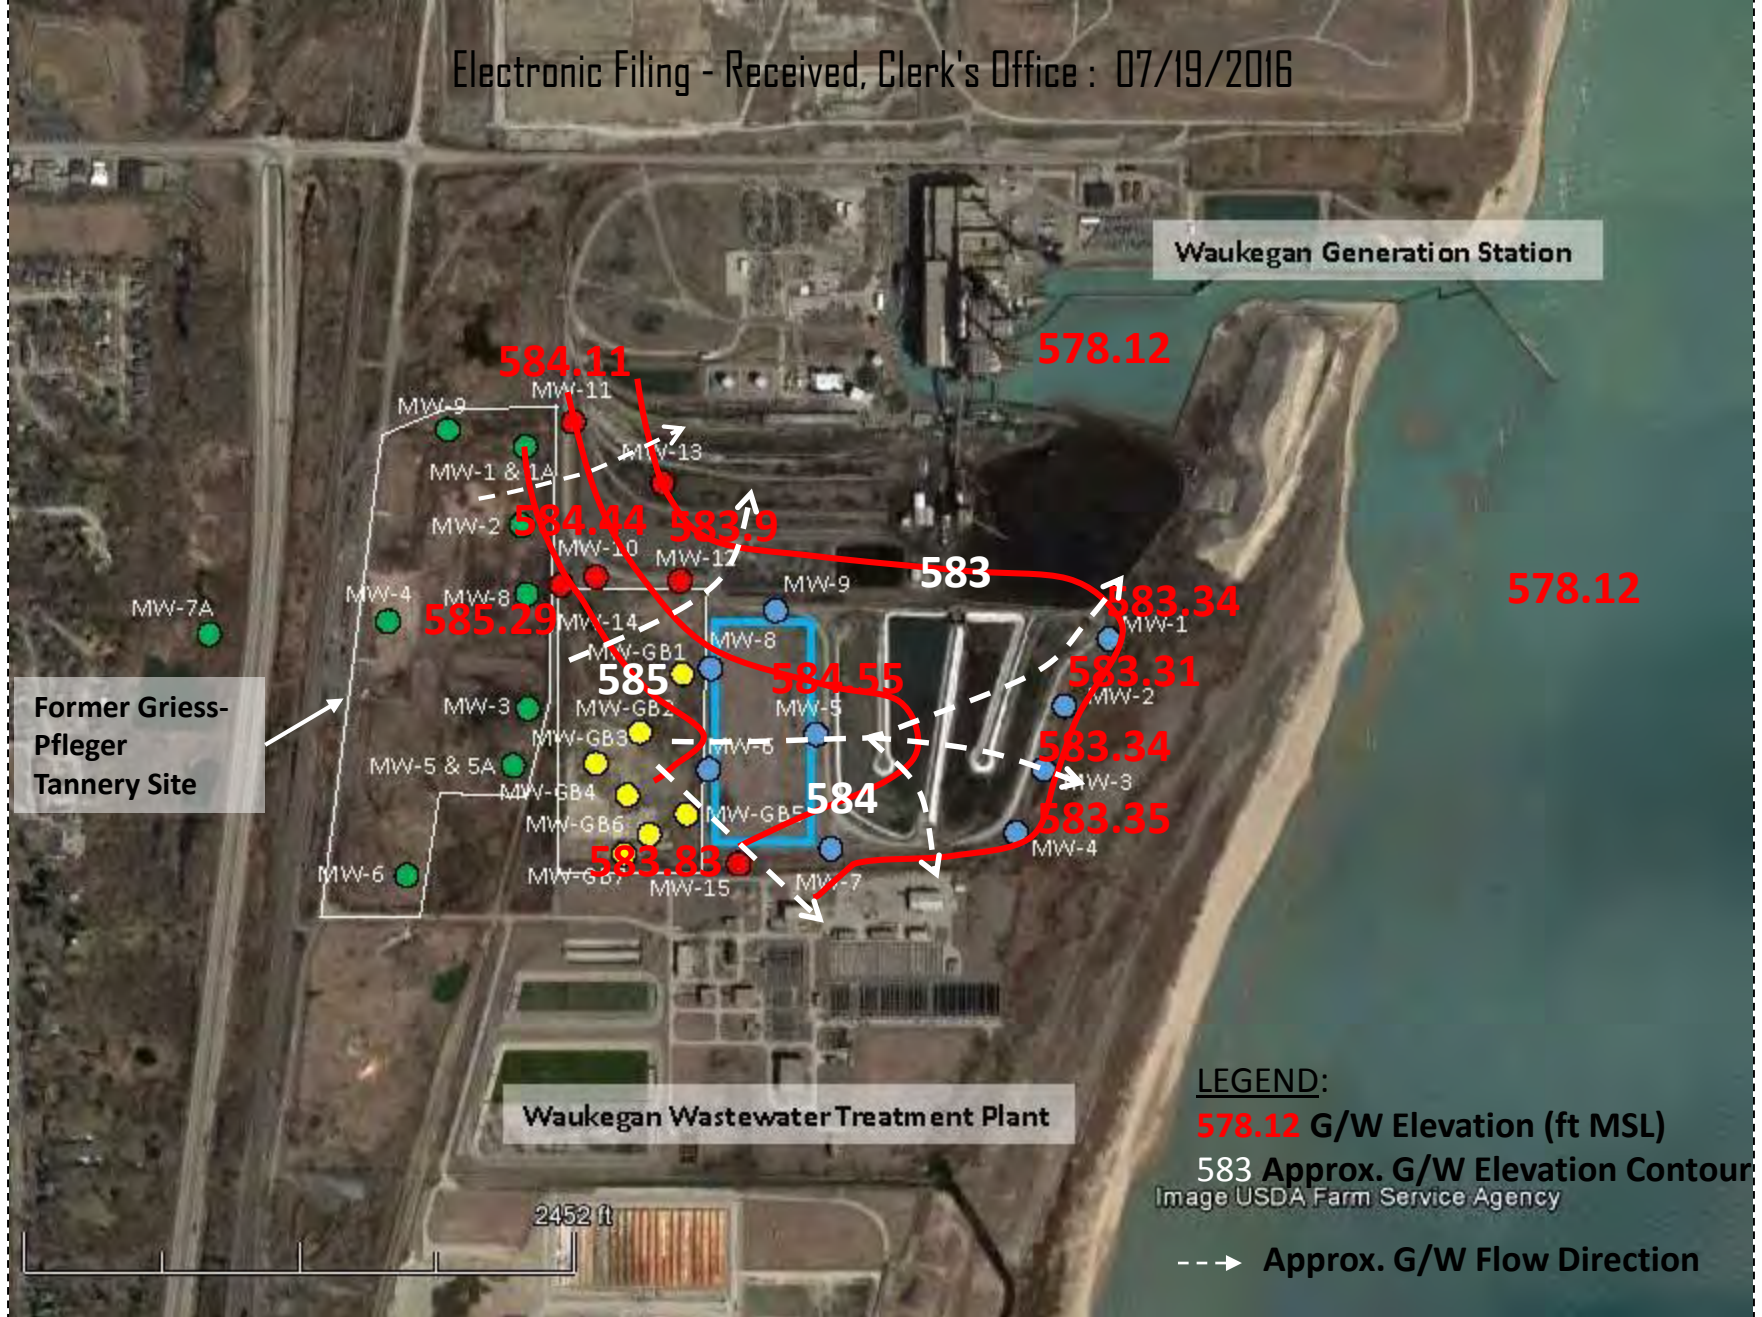
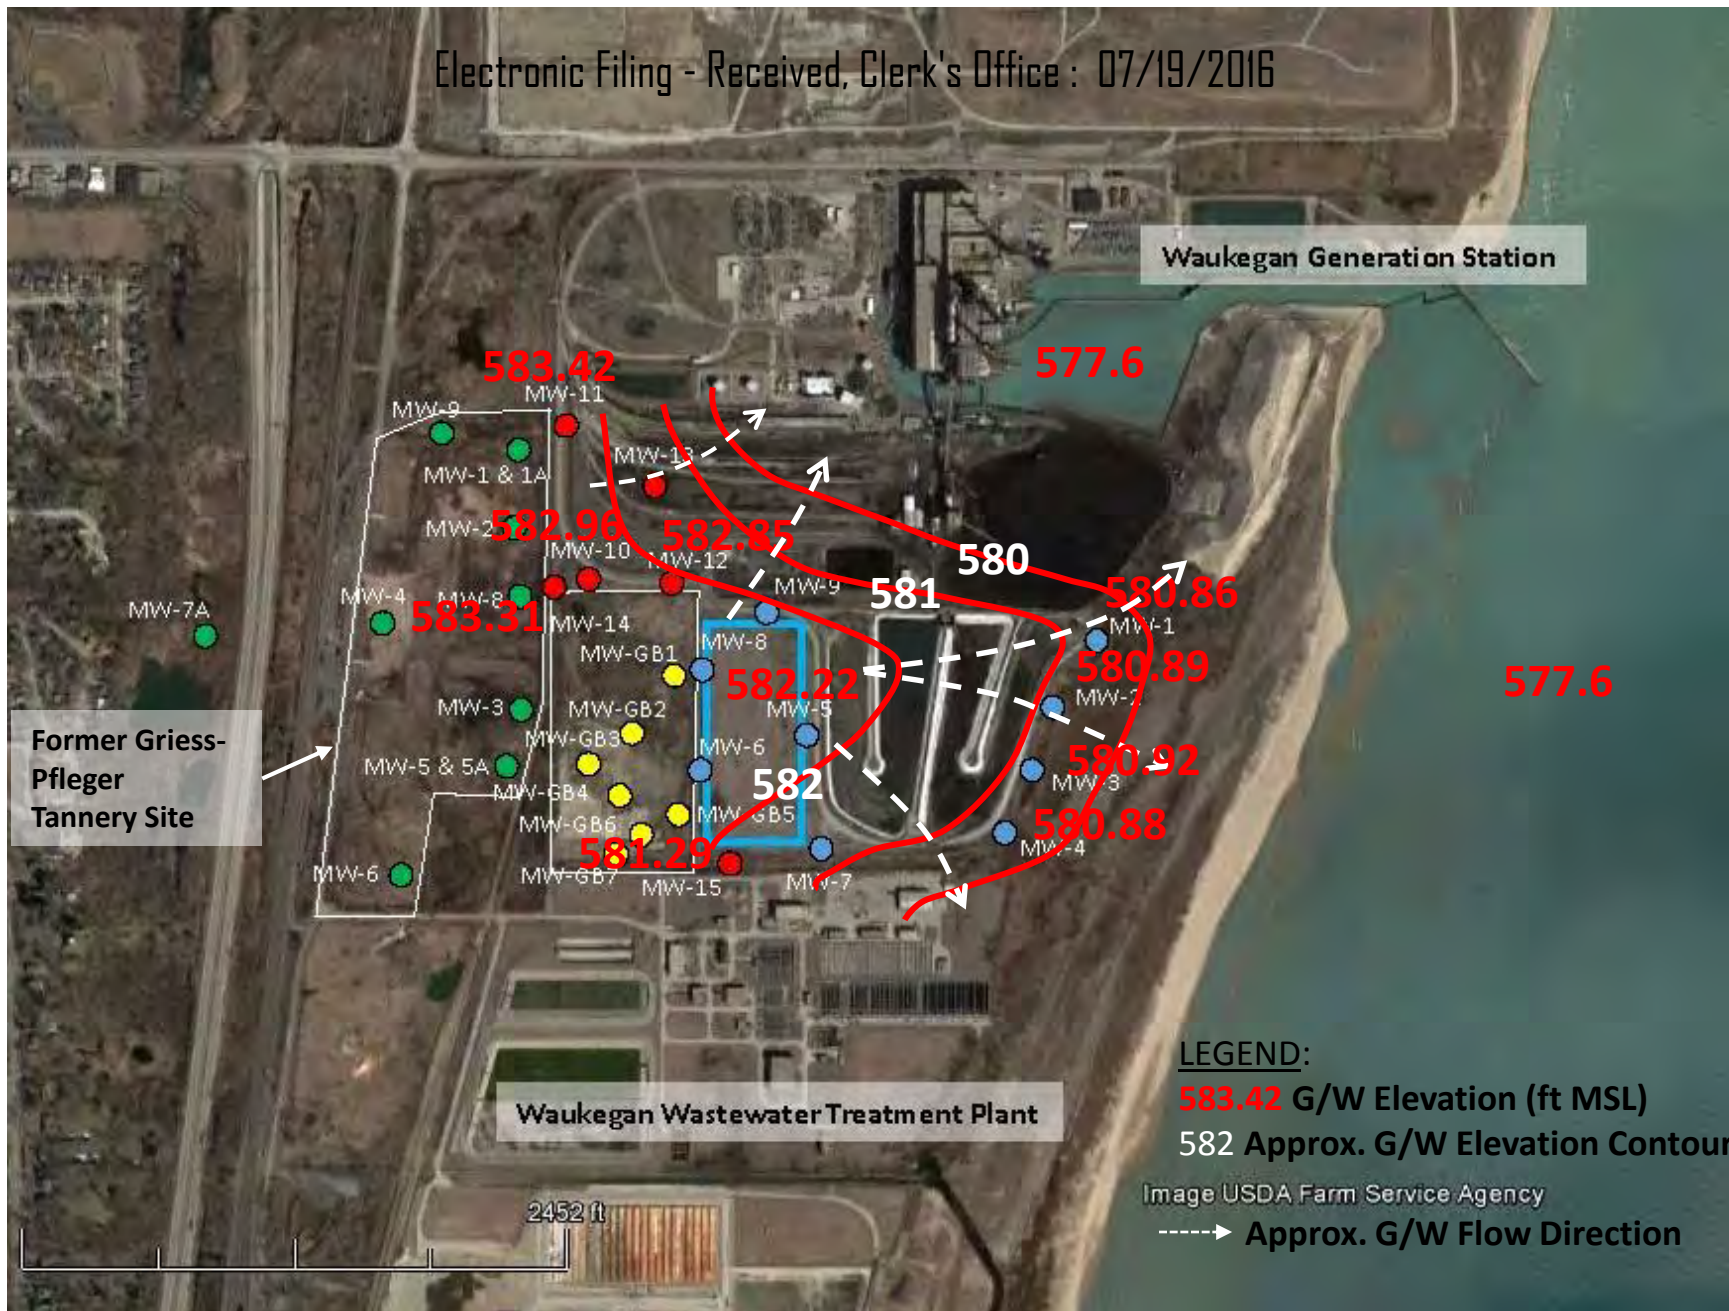
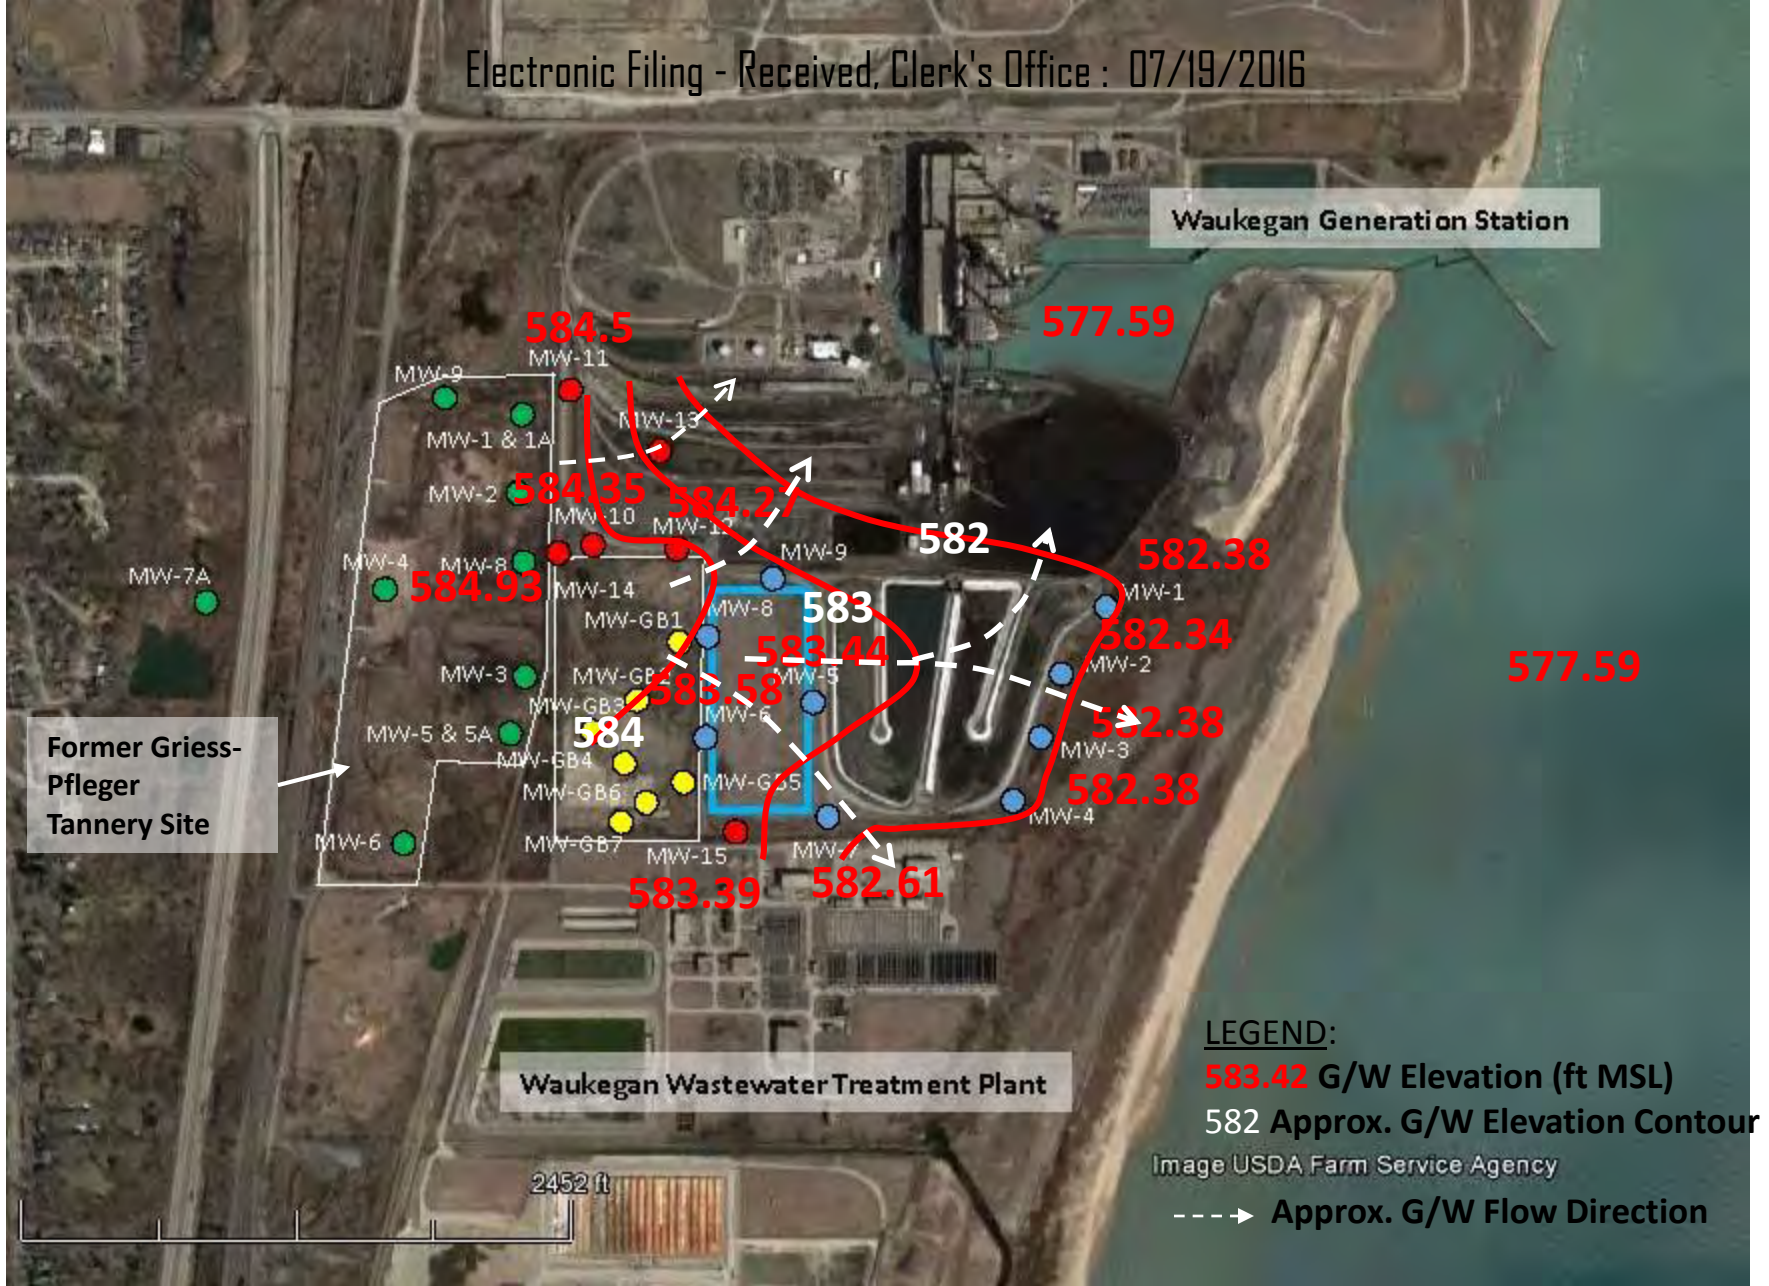
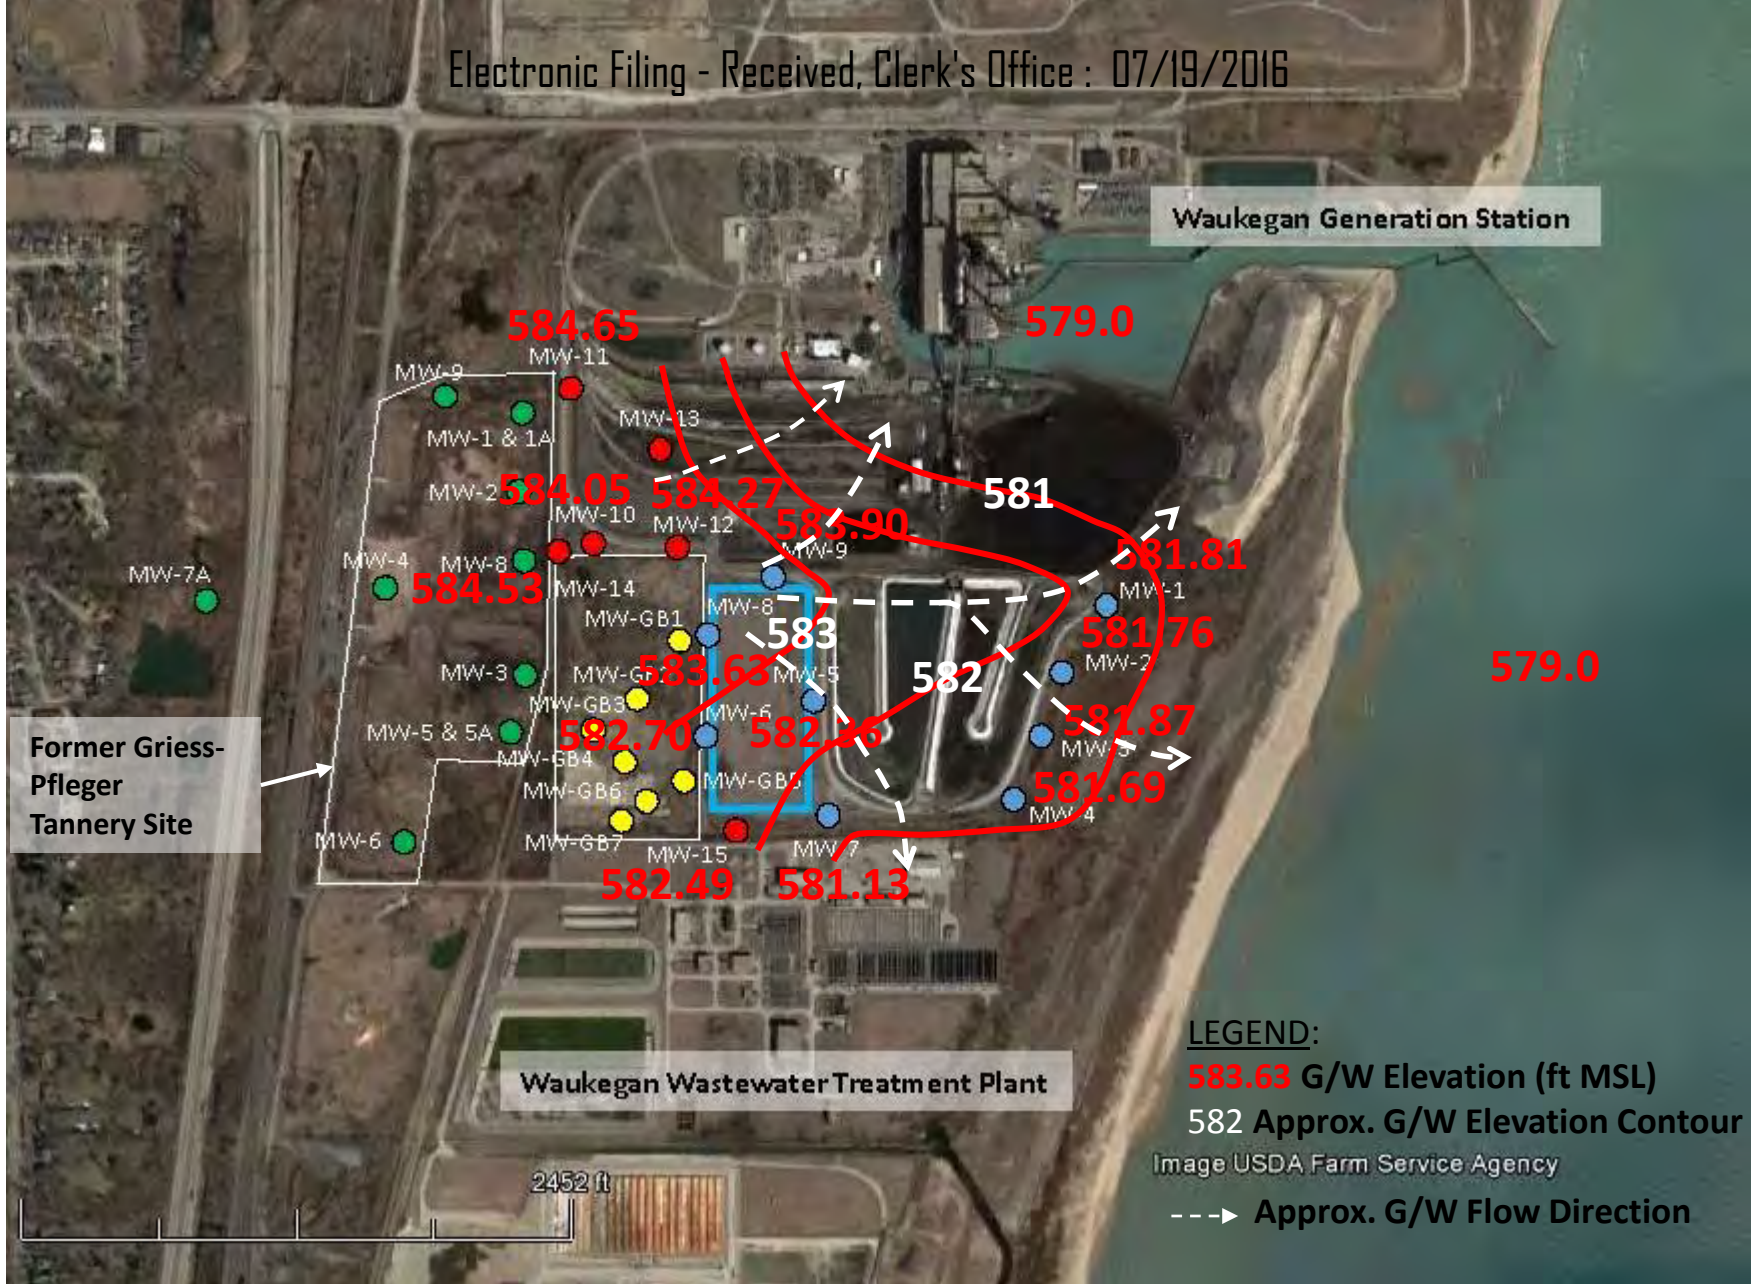
Additional interpretations of the ground-water elevation contours shown on Figures 18, 19, 20 and 21 indicate that:

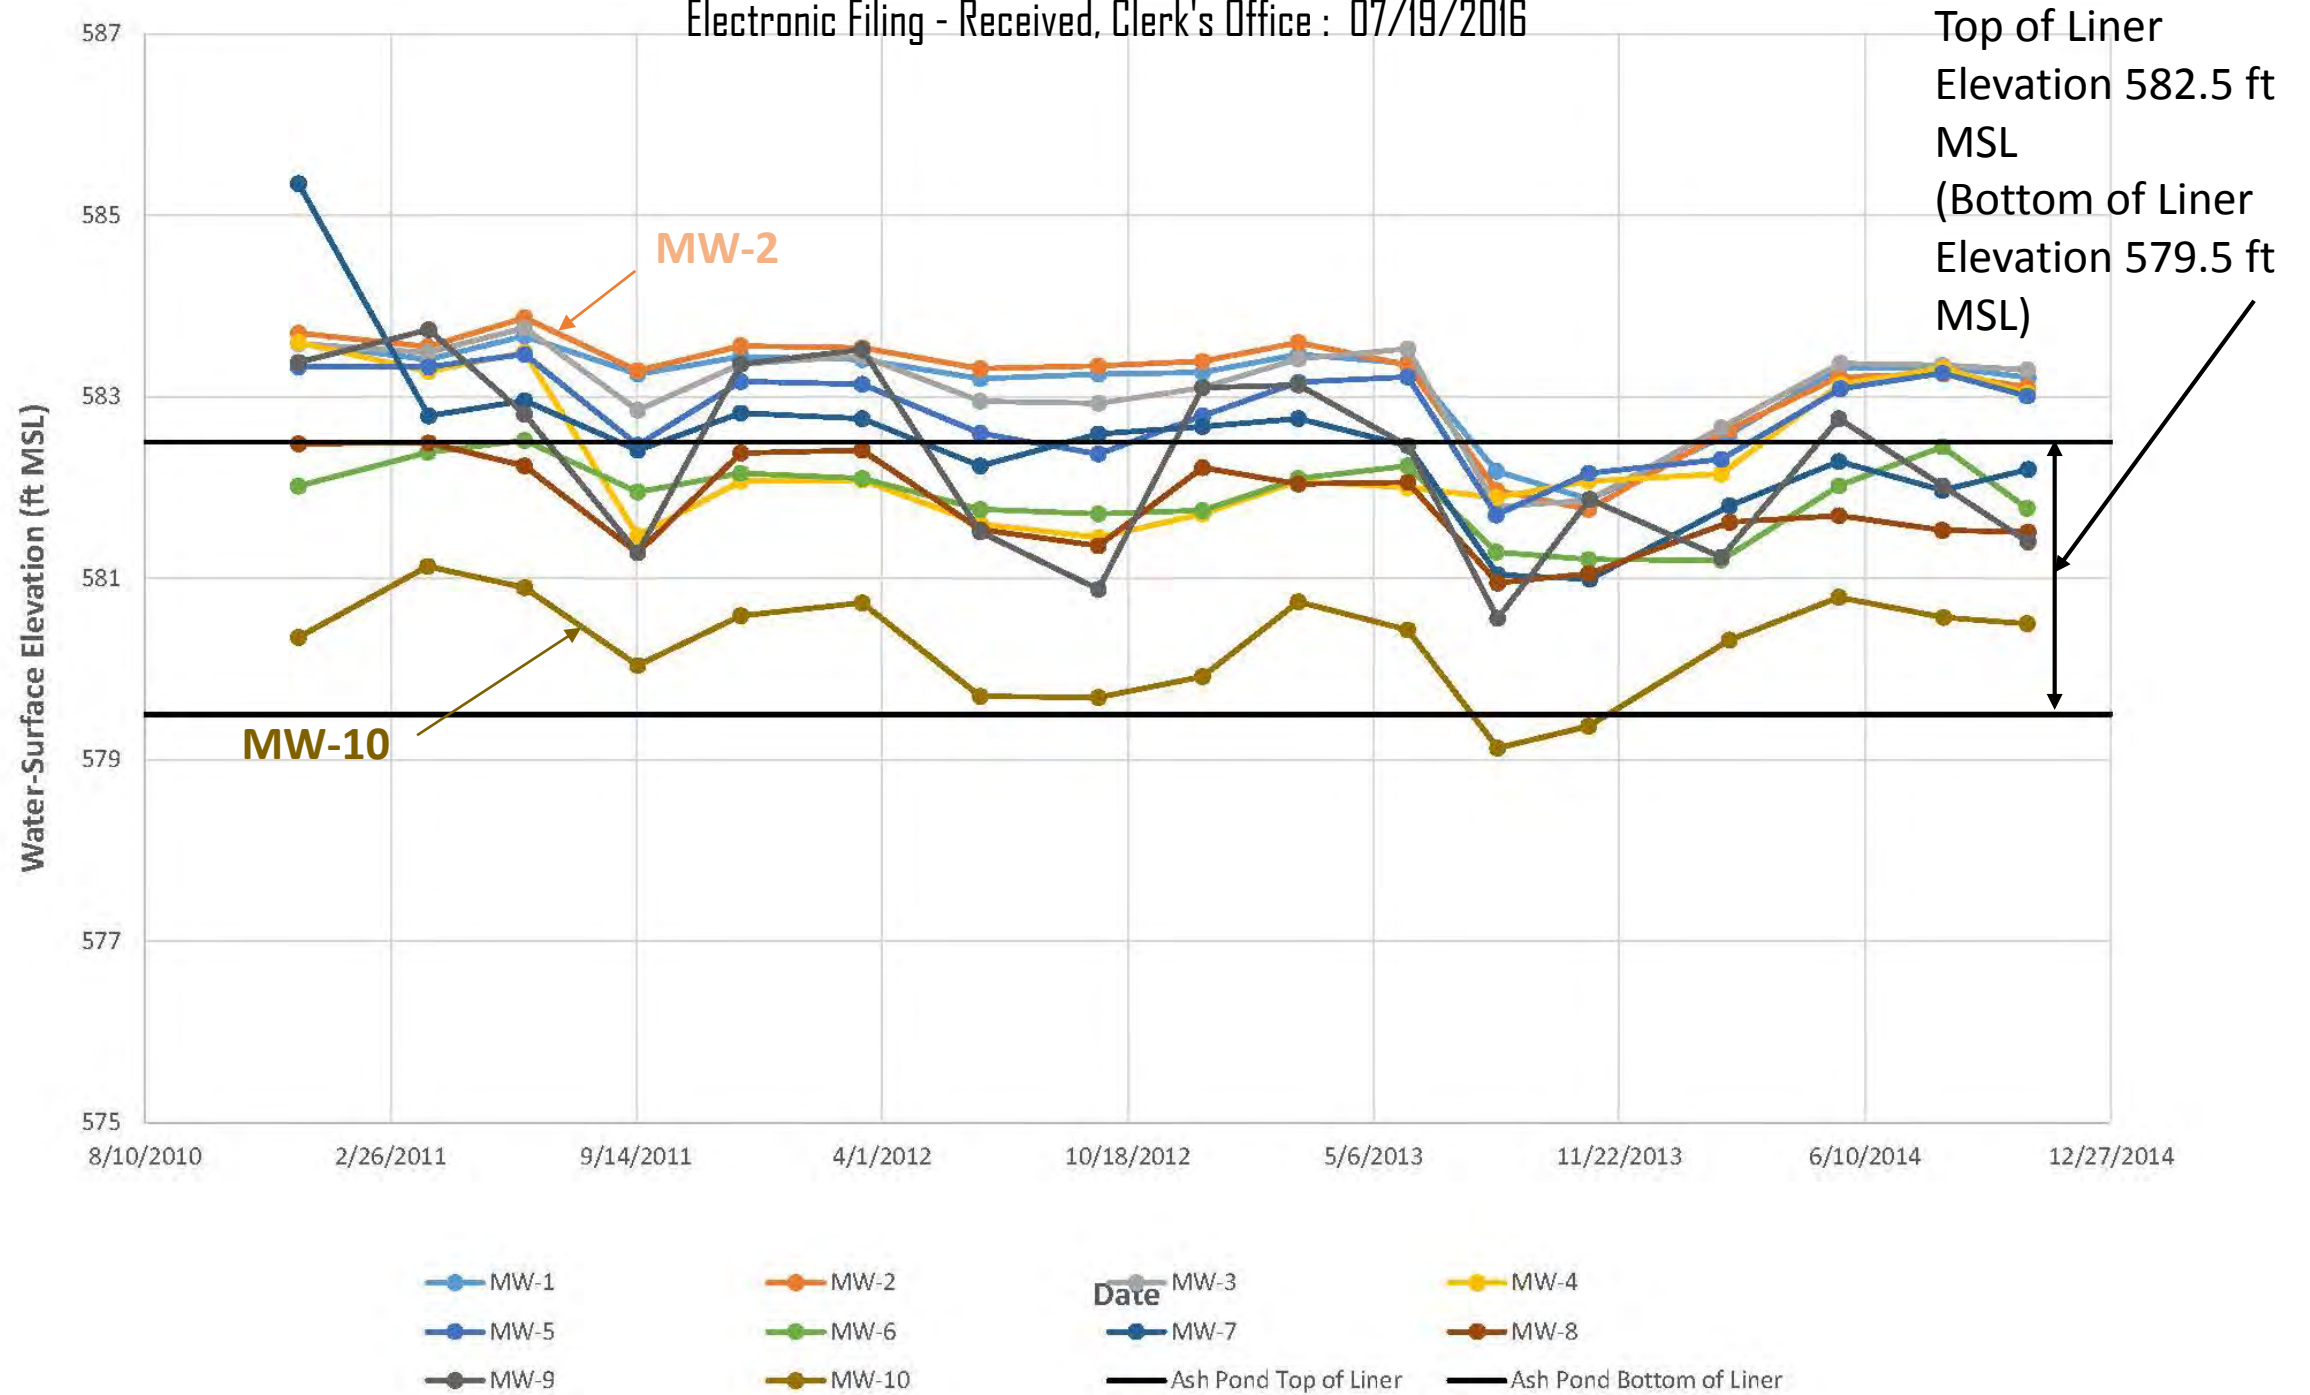
Figure 27 Will County Site Historical Ground-water Elevations (PCB 2013-015)

**Water Surface Elevations.** Ground-water at the Will County site is strongly influenced by changes in Des Plaines River and CSS Canal surface-water elevations as well as likely leaking ash ponds. Interpretation of historical surface-water elevations and ground-water elevations in the Dolomite limestone bedrock beneath the ash ponds, as shown on Figures 27 and 28 respectively, coupled with the stratigraphy at the site, indicate that:

I also conclude from the above facts and the graphical presentation of ground-water and surface-water elevations shown on Figures 27 and 28 that the Will County ash ponds have historically leaked, are in intimate connection with the underlying ground water, have their liners episodically inundated by Des Plaines River and are causing contamination of the local ground-water from coal ash leachate and most likely contaminating the Des Plaines River and the CSS Canal. The ground-water quality data discussed below confirms that there is contamination due to leachate from the Will County ash ponds.

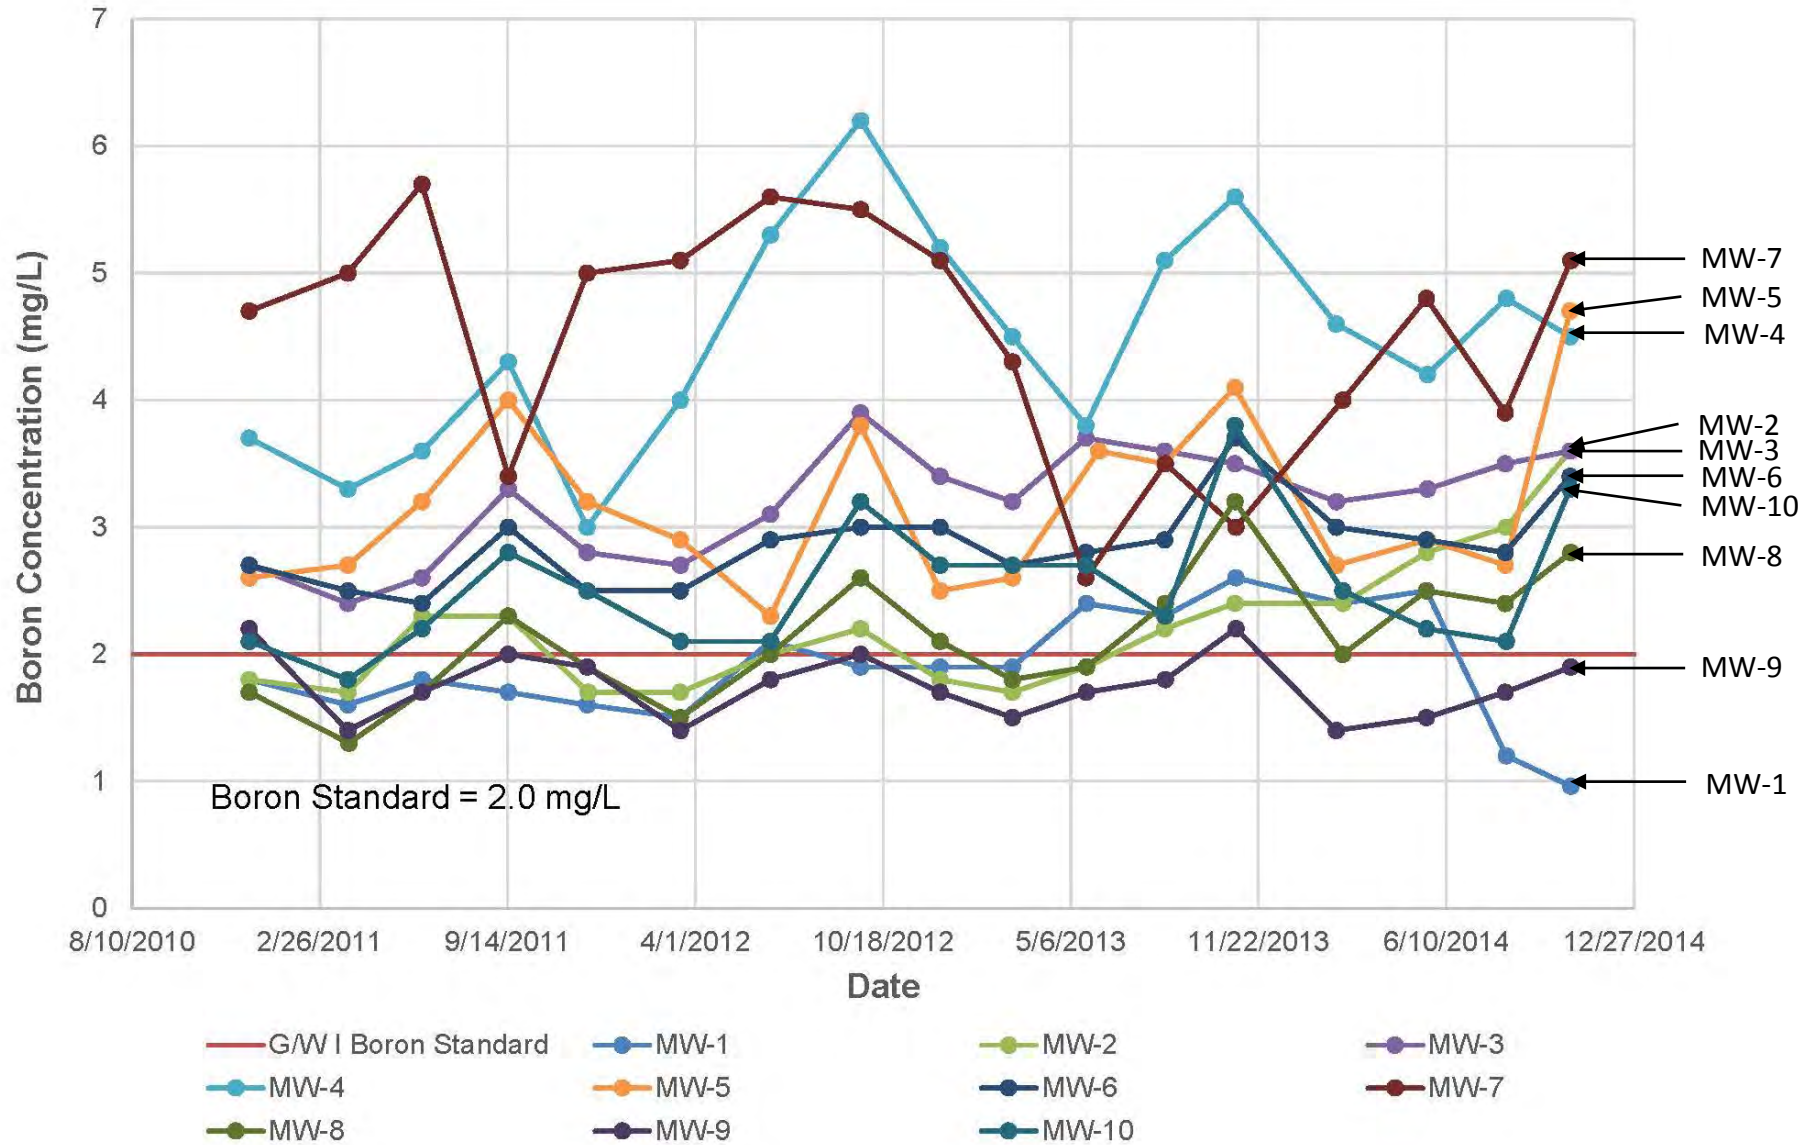
**Figure 29 Boron Concentrations in Ground Water  
Will County Site (PCB 2013-015)**

Figure 29 shows the time series of B concentrations in ground-water at the Will County site. Every monitoring well has had B concentrations higher than the IEPA Class I ground-water standard of 2.0 mg/L during the monitoring

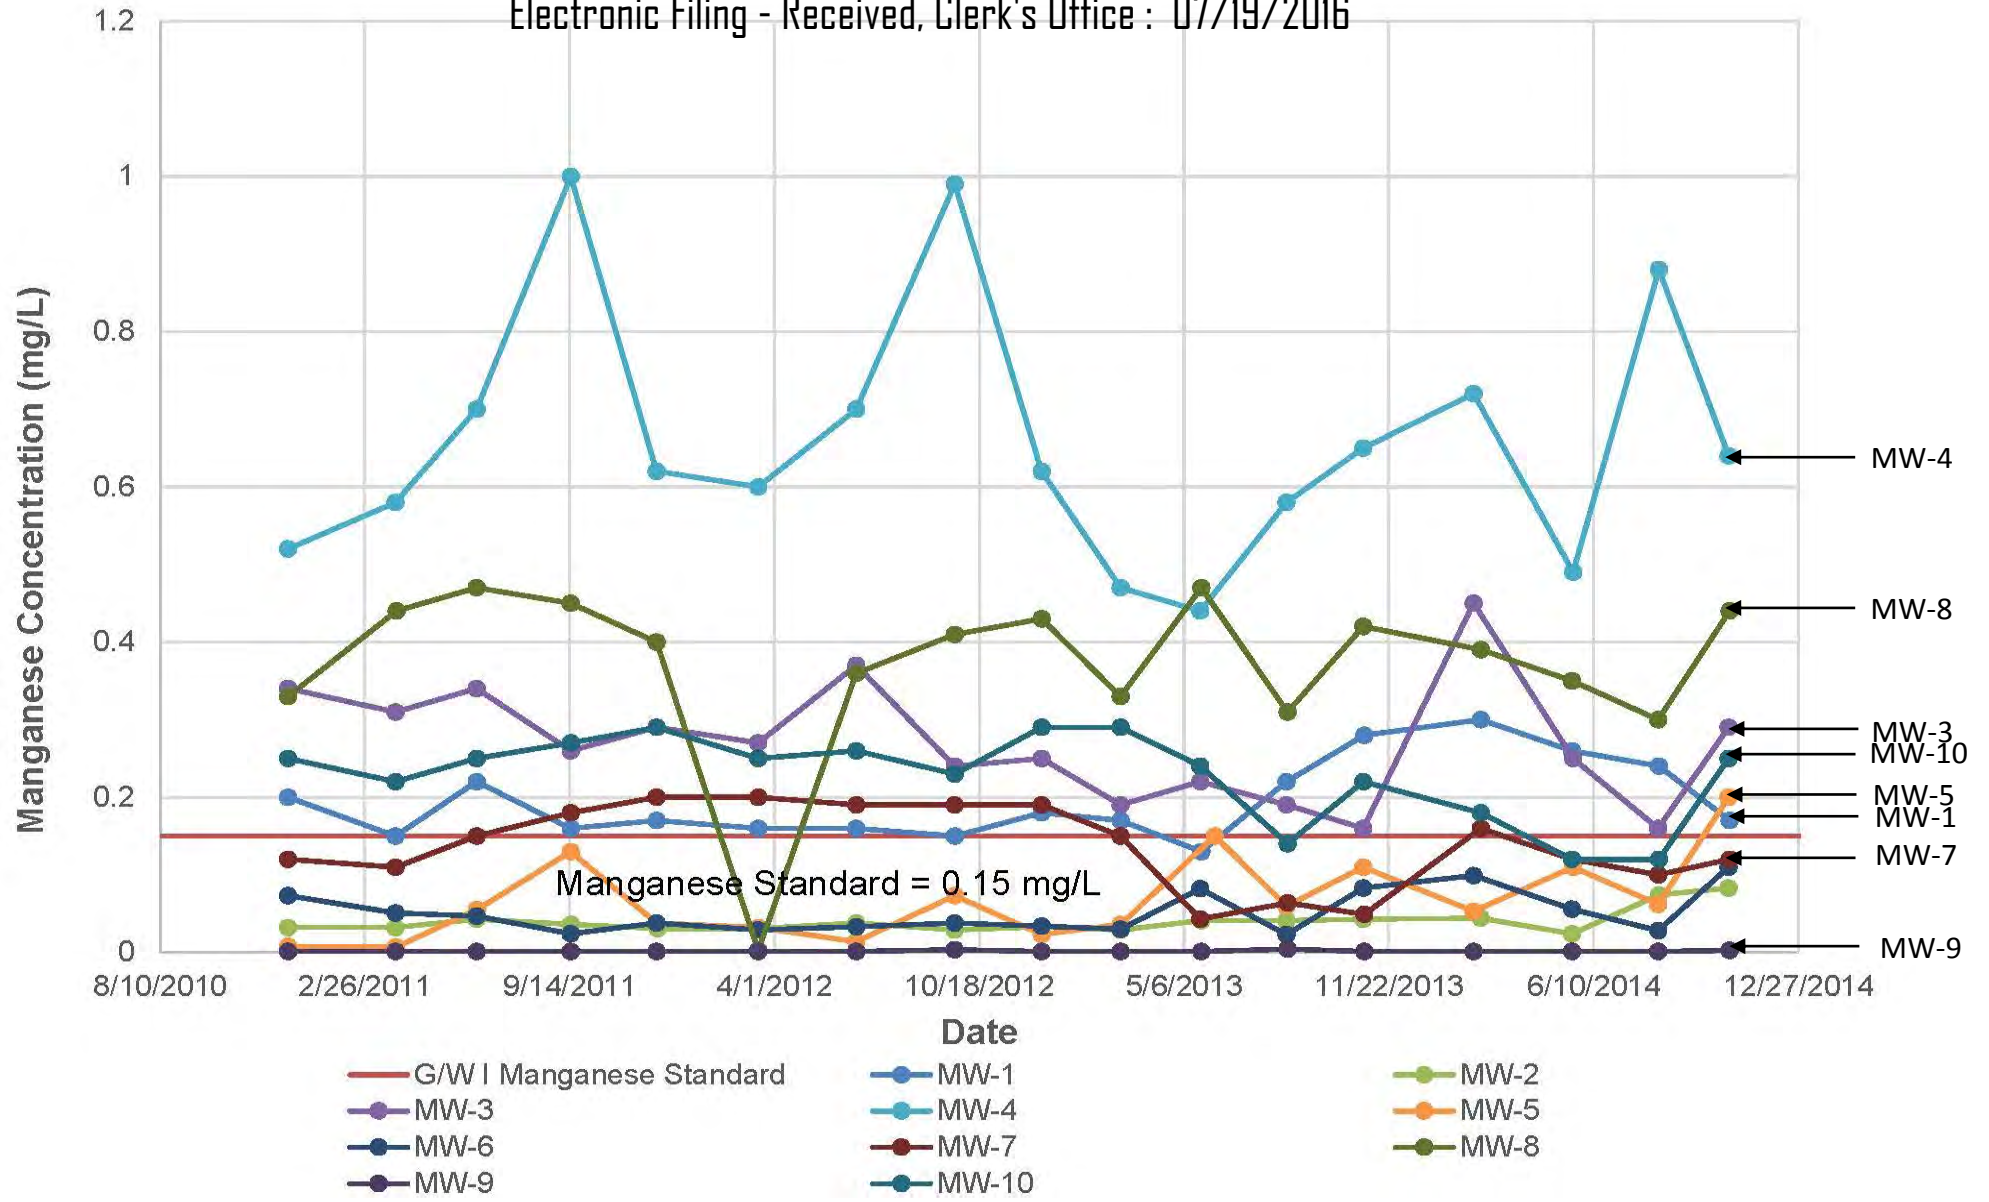
Figure 30 Manganese Concentrations in Ground Water  
Will County Site (PCB 2013-015)

Mn concentrations in ground water as shown in the time series on Figure 30, behave similarly to B concentrations at the Will County site, with all but 3 of the 10 monitoring wells having Mn concentrations higher than the IEPA Class I ground-water standard of 0.15 mg/L a majority of the time during the monitoring period. As with B, Mn is known to be a contaminant found in coal ash leachate (Table 2) and the high concentrations in ground water at the Will County site indicate ash pond liner leakage and/or leaching of coal ash deposits located outside the ash ponds. With the exception of MW-9, all of the monitoring well Mn concentrations at the Will County site are higher than the background Mn concentration of 0.0029 mg/L for shallow bedrock.

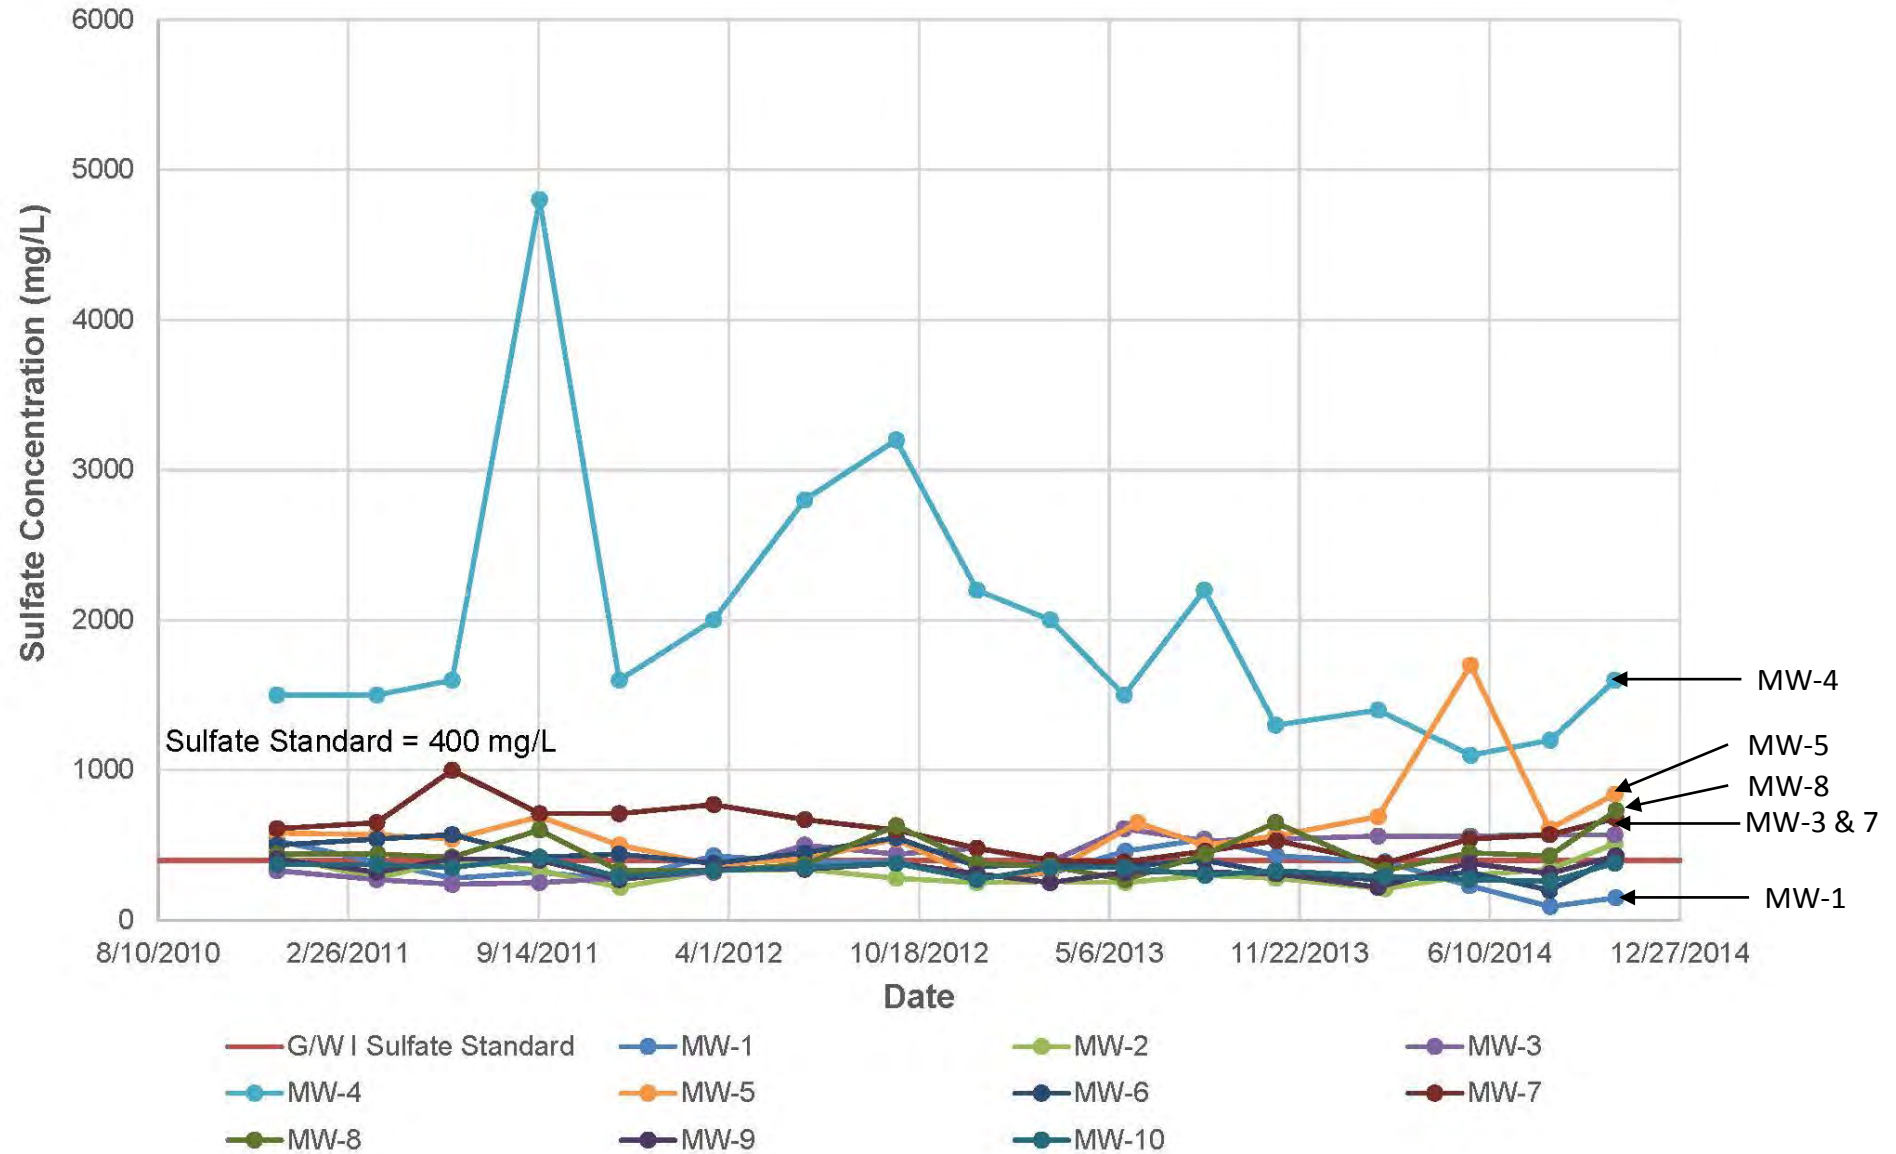
Figure 31 Sulfate Concentrations in Ground Water Will County Site (PCB 2013-015)

Figure 31 shows the time series of SO<sub>4</sub> concentrations in ground water at the Will County site with all but one of the monitoring wells having SO<sub>4</sub> concentrations higher than the IEPA Class I ground-water standard of 400 mg/L. Except at MW-4 and MW-5, the SO<sub>4</sub> concentrations in the monitoring wells have remained steady but persistently higher than the IEPA Class I ground-water standard. This indicates that the ash pond liners continue to leak and/or coal ash deposits located outside the ash ponds are leaching. Concentrations of SO<sub>4</sub> in all of the monitoring wells at the Will County site are higher than the background SO<sub>4</sub> concentration of 106 mg/L for shallow bedrock.
