May 29, 2015

Re: Ash Pond Berm  
Visual Assessment  
Valdes Project Number 2015-033 BG04

NRG - WAUKEGAN STATION  
ASH POND  
SLOPE REPAIRS  
PLAN AND SECTION

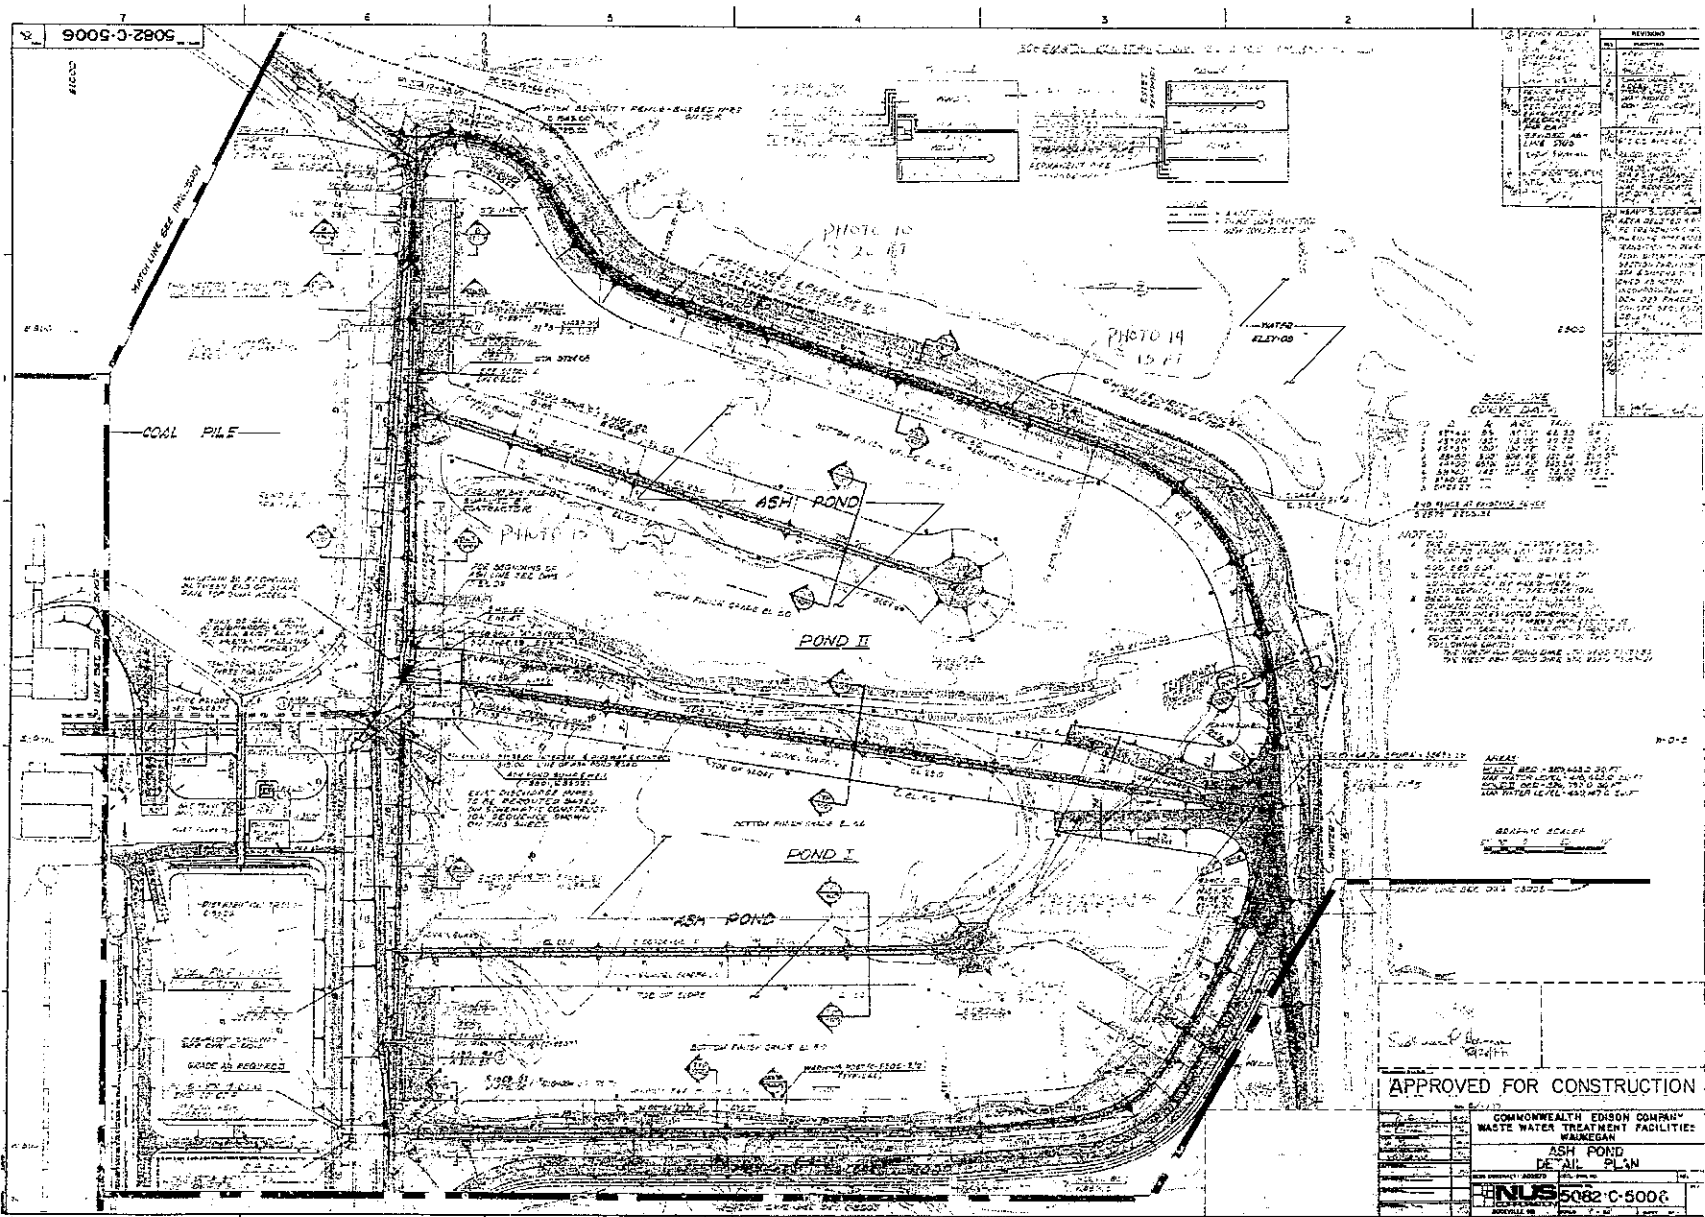
DRAWN BY MIKE SMITH	SCALE NONE	DATE 05/29/15
CHECKED BY SLP	DESIGNED BY MJS	DRAWING No. 2015-033-04-001
APPROVED BY SLP	CAD FILE NAME	REV. 0

The crushed stone placed to repair a washout in 2008 is in good condition (Photo 10). However most of the rest of the east berm has a one foot flat area between the fence and the top of the slope. The flat area is missing in this repair area (Photo 10). This is also the case near the end of the center dike in Pond II (Photo 14).

Rebuild the areas along the east berm where the top of the slope is at the fence line. Any erosion from the current condition will affect the road which is the design feature that prevents runoff into the wetlands. A sketch of the recommended repair detail is attached.
