**CHICAGO AREA WATERWAY SYSTEM HABITAT EVALUATION
AND IMPROVEMENT STUDY:**

HABITAT IMPROVEMENT REPORT

Prepared for:
The Metropolitan Water Reclamation District of Greater Chicago

Prepared by LimnoTech

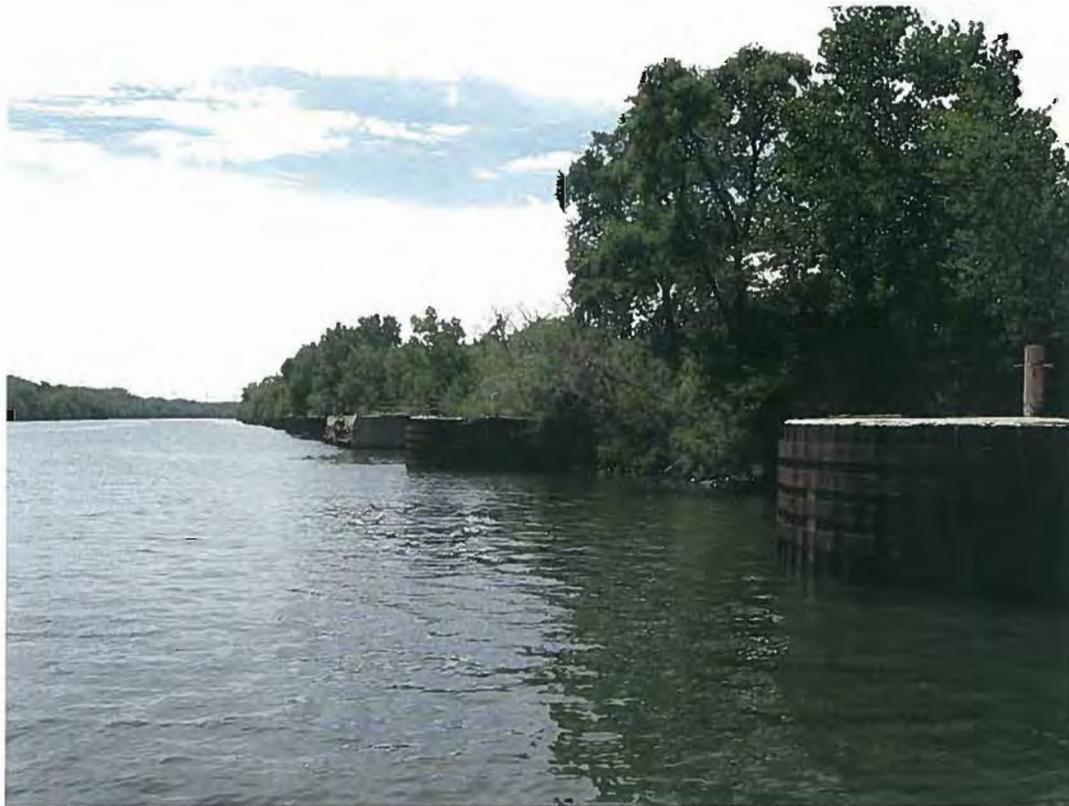
Figure 2-2: Examples of Dolphin Structures on the Chicago Sanitary and Ship Canal near AWQM 41.

- **Manmade structures** – The presence of manmade structures in the channel (bridge abutments, dolphins, piers) in the channel was found to be an important habitat variable, in a negative sense. An example of these structures is shown in Figure 2-2. It is not clear why these structures are negatively associated with fisheries in the CAWS, but it is likely that it is the

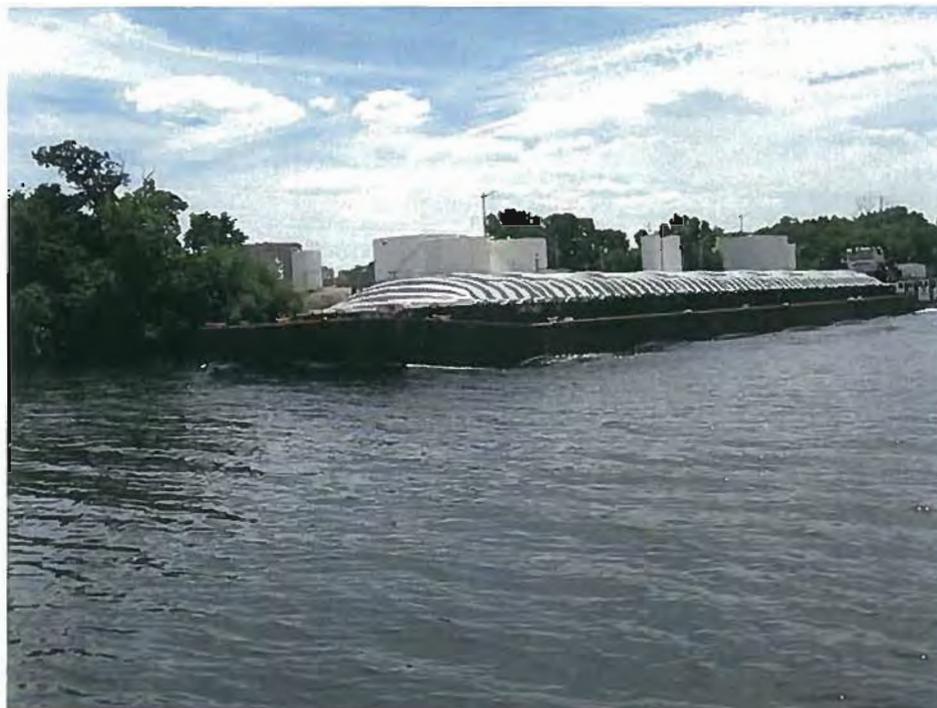
Figure 2-3: Barge and Tug on the Chicago Sanitary and Ship Canal. Many CAWS Reaches are Deep Draft Waters (photo taken near AWQM 41, 2008).

Deep water reaches in the CAWS can be greater than 20 feet deep to maintain adequate depth for commercial ship traffic (Figure 2-3) and to maintain storage volume for flood flows. These depths are maintained in many parts of the CAWS through dredging by the U.S. Army Corps of Engineers.

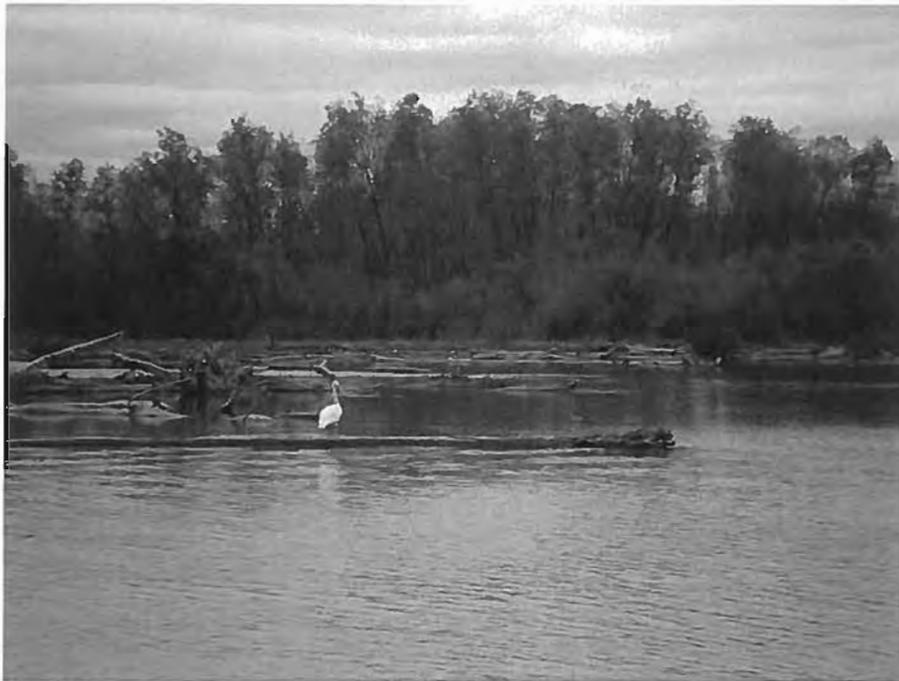
Figure 2-4: Example of Off Channel Refuge Found in Natural Rivers, absent from the CAWS (photo taken in Lake Pepin, on the Mississippi River, 2007).

Natural waterways provide areas off of, but connected to, the main channel, which provide a variety of value to fish. These areas include riparian wetlands, sloughs, and embayments that create diverse habitats for a wide range of fish species and age classes (Figure 2-4). They also provide spawning areas for many species, that are protected from the higher velocities and shear stresses found in the main channel. They are often the primary reproduction area in natural rivers (Allan, 1995). These areas provide refuge for prey and forage for predatory species. In the CAWS, where the channels are either manmade or significantly modified, these off-channel refuge areas are nearly non-existent. However, there are scattered areas of shelter along the waterways, within the main channels, that appear to provide the same function, albeit on a smaller scale.

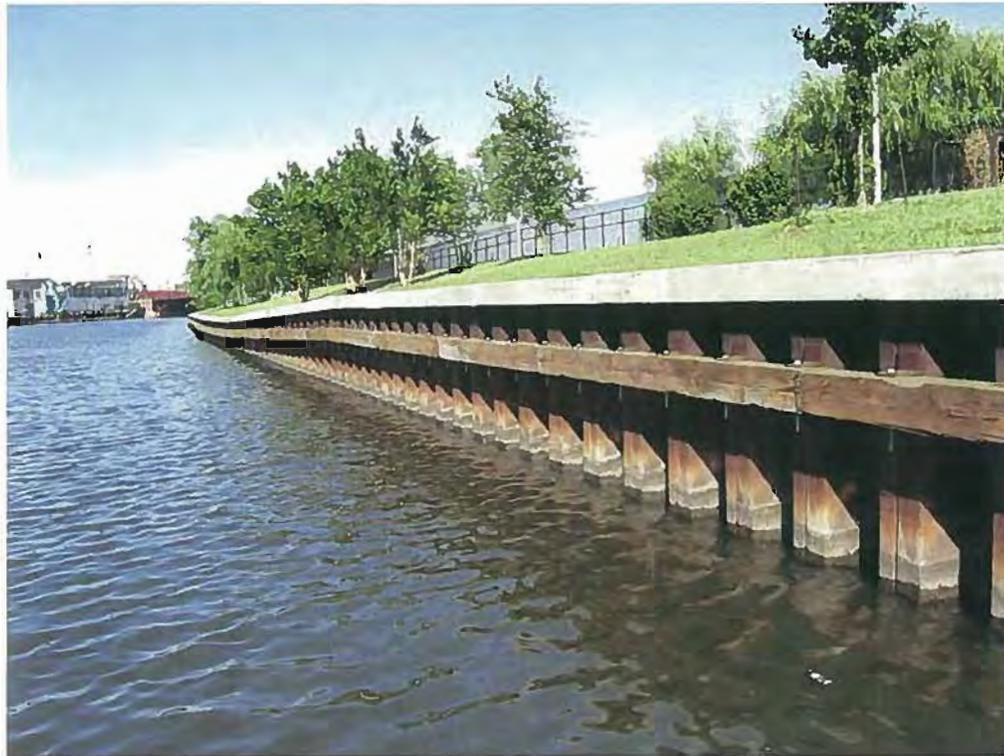
Figure 2-5: Vertical Wall Banks are found throughout the CAWS (photo taken in South Branch Chicago River, near AWQM 40, 2008).

The CAWS reaches evaluated in this Study have approximately 65 miles of vertical walled banks, which is about 42% of the banks in the Study area. These vertical walls consist of steel sheet piling (Figure 2-5), stone, and in some cases, wooden walls. The condition reflects the constructed nature of the CAWS and the primary functions of the system for support of effluent disposal, commercial navigation, and flood control. It goes without saying that these vertical wall banks do not resemble natural banks. They reflect the general absence of a littoral zone, disconnection from riparian areas, deep water, reduced in-stream aquatic vegetation and, in many cases, riparian development right to the water's edge.

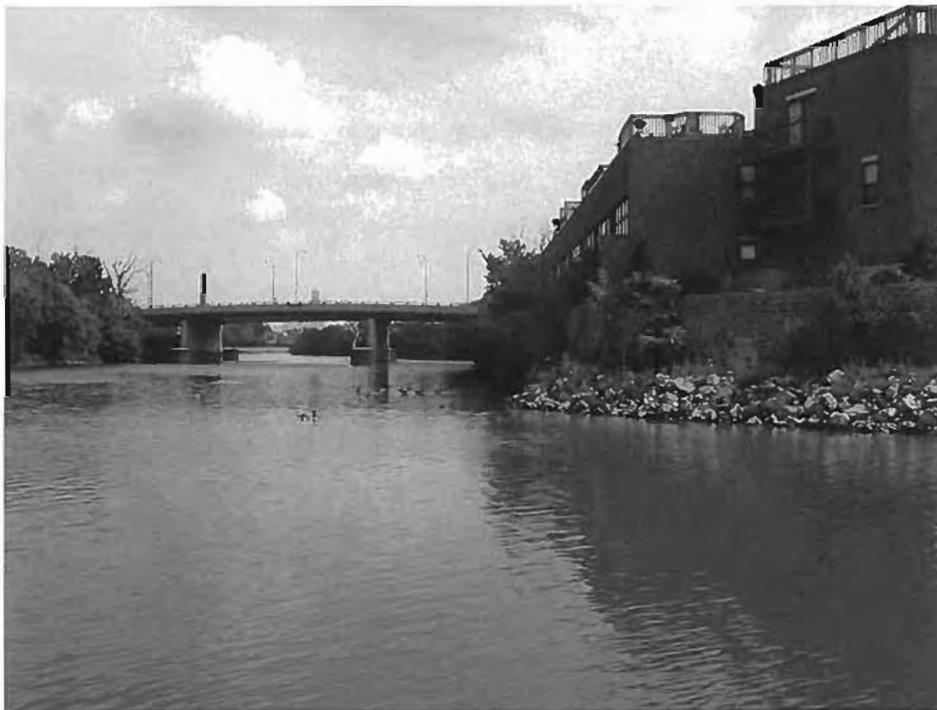
Figure 2-6: Riprap Banks in the North Branch Chicago River (photo taken near AWQM 73, 2008).

Riprap is graded stone of relatively large size, used to stabilize banks and prevent erosion. Almost 20% of the banks in the CAWS are covered with riprap, based on measurements collected during the Study. On a reach-by-reach basis in the CAWS, the presence of riprap banks (Figure 2-6) varies considerably. It is completely absent in the Chicago River (where the banks consist entirely of vertical walls) and the upper North Shore Channel. In the Cal-Sag Channel and the Upper North Branch Chicago River, more than half of the banks are riprap.

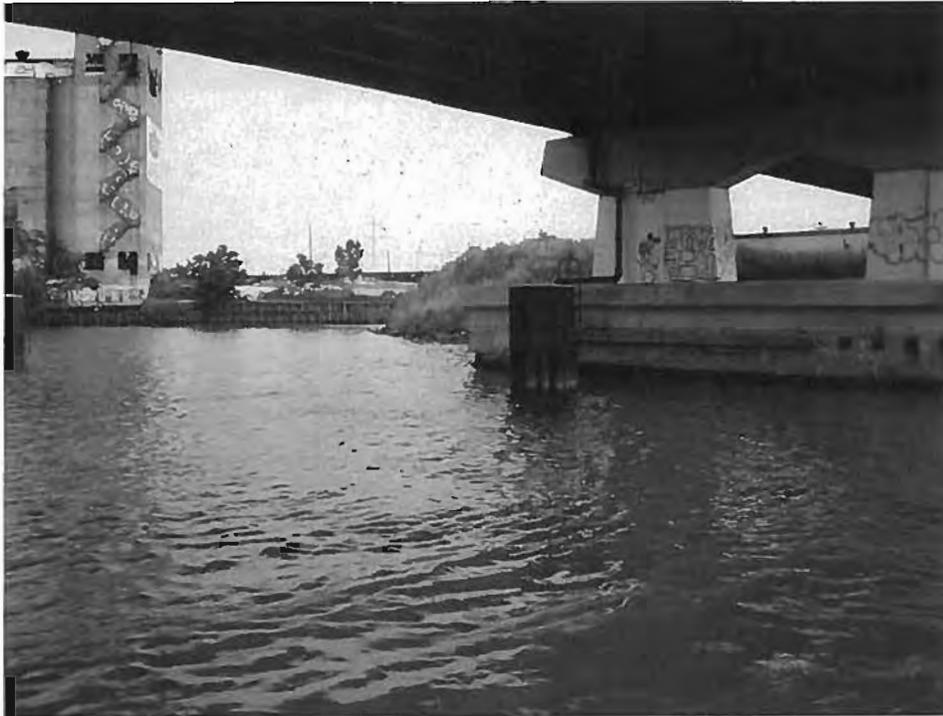
Figure 2-7: Manmade Structure Such as Shown Here Were Negatively Correlated with Fish in the CAWS (photo taken in South Branch Chicago River at AWQM 40, 2008).

Manmade in-channel structures were identified in this Study as being negatively correlated with fish in the CAWS. These structures include bridge abutments and piers, docks, dolphins, and other structure that extend into the channel (Figure 2-7). As with riprap, it is not clear from the available data why these structures are negatively correlated with fish or whether it is the structures themselves or some other aspect of the waterways at these locations that is affecting fish. One possible explanation is that these structures simply do not offer sufficiently high structural quality or diversity for fish.

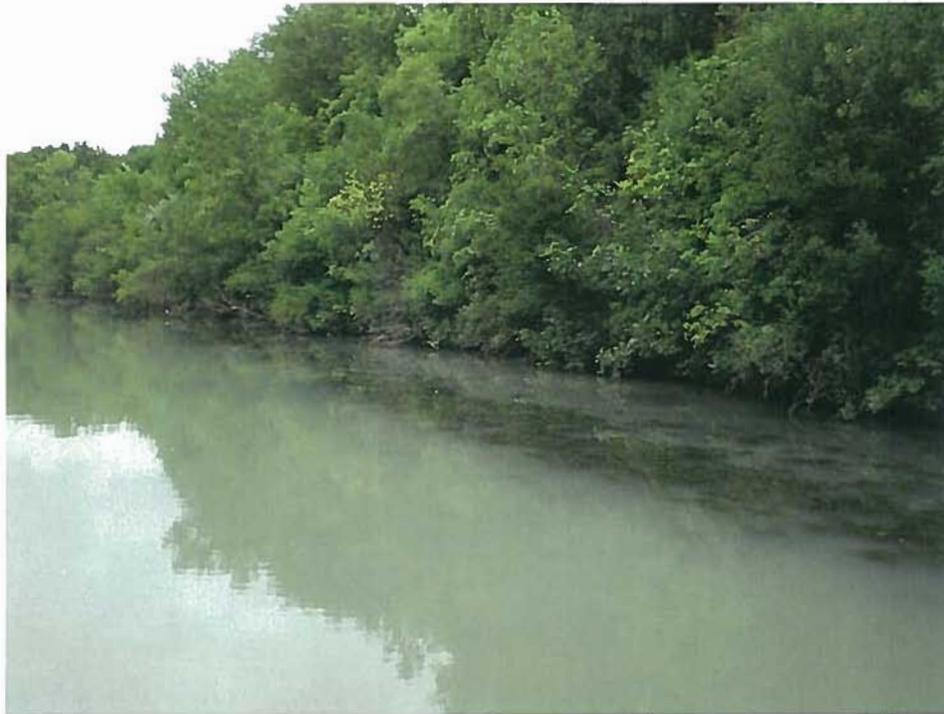
Figure 2-8: Near-Shore Macrophyte Cover in the North Shore Channel (photo taken near AWQM 35, 2008)

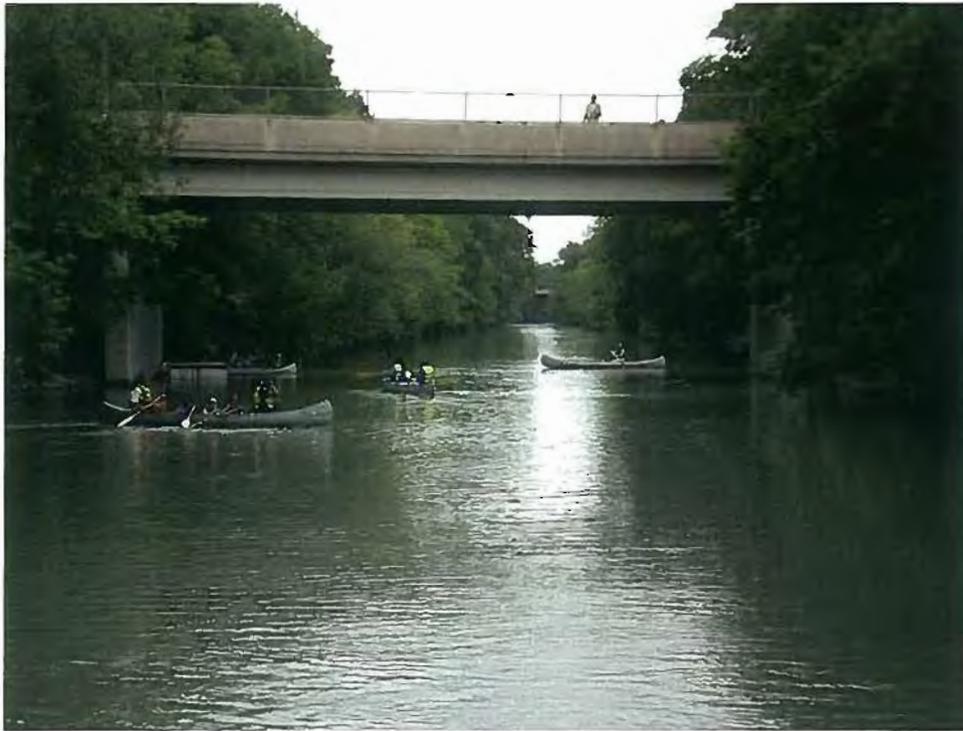
Figure 2-9: Relatively High Overhanging Vegetative Cover in the North Shore Channel (photo taken upstream of AWQM 102, 2008).

Overhanging vegetative cover was found to be one of the habitat variables most strongly correlated with fish in the CAWS, but it is very limited in most of the CAWS waterways. This variable was measured in the Study as the percent of the channel reach area covered by overhanging riparian vegetation, based on actual field measurements. Overhanging vegetation provides shade and is a direct source of organic matter and insects to the water. The North Shore Channel (Figure 2-9) has the highest percentage of overhanging vegetation in the CAWS, with more than 30% of the channel covered by overhanging vegetation in some areas.

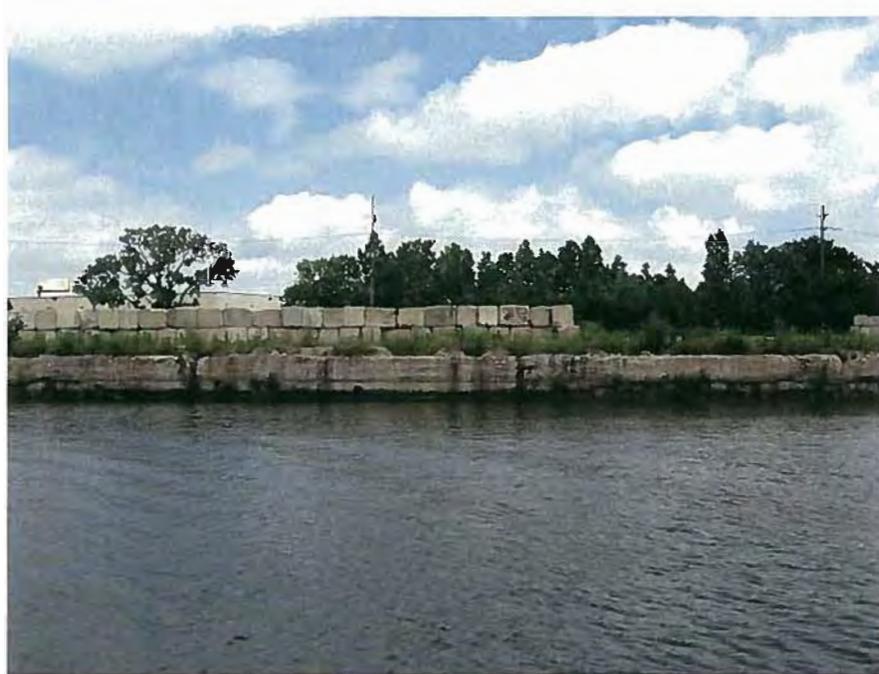
Figure 2-10: Low Overhanging Vegetative Cover in the Lower Cal-Sag Channel (photo taken near AWQM 48, 2008)

Parts of the upper North Branch Chicago River have similar overhanging vegetative cover, but in the rest of the CAWS the numbers are generally 10% or less, with some reaches having no overhanging vegetative cover.

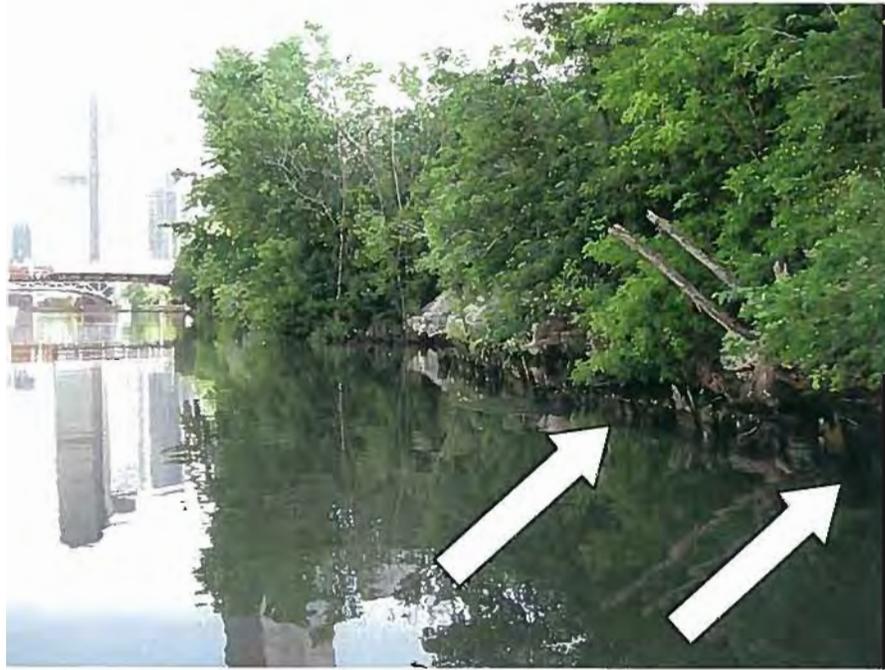
Figure 2-11: Bank Pocket Areas (indicated by white arrows) Created by a Decaying Wooden Seawall on the South Branch Chicago River (photo taken downstream of AWQM 39, 2008).

This habitat variable deals with the relative quantity of small pockets within bank materials that can provide refuge for fish, as measured by actual count in the field. In this Study, bank pocket areas were defined as small (but greater than 1 square meter), semi-protected areas that may serve as refuge from turbulence or as protective cover from predators. These small areas of protection may be available to the transient fishes within reaches of limited habitat structure. Examples are shown in Figures 2-11 and 2-12.

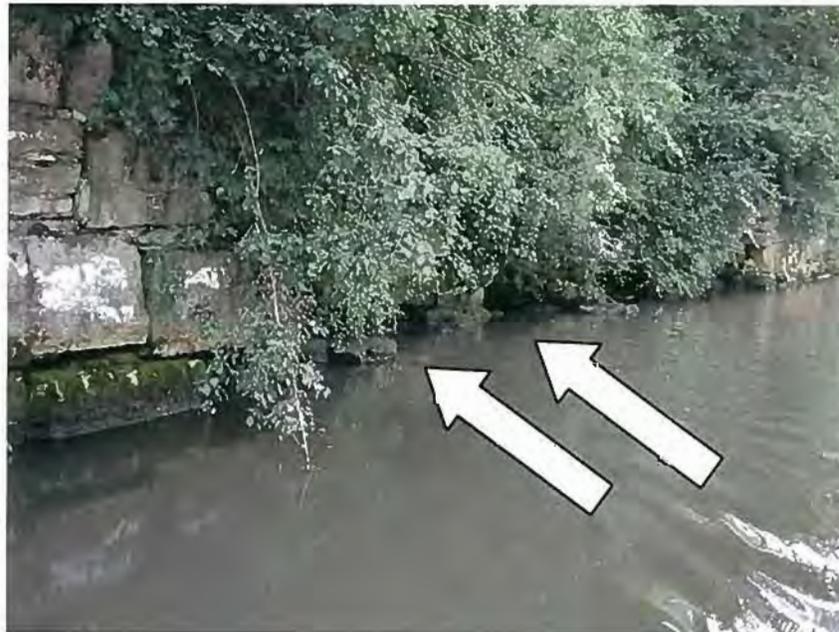
Figure 2-12: Bank Pocket Areas (indicated by white arrows) Created by a Gaps in Limestone Walls on the Chicago Sanitary and Ship Canal (photo taken downstream of AWQM 41, 2008).

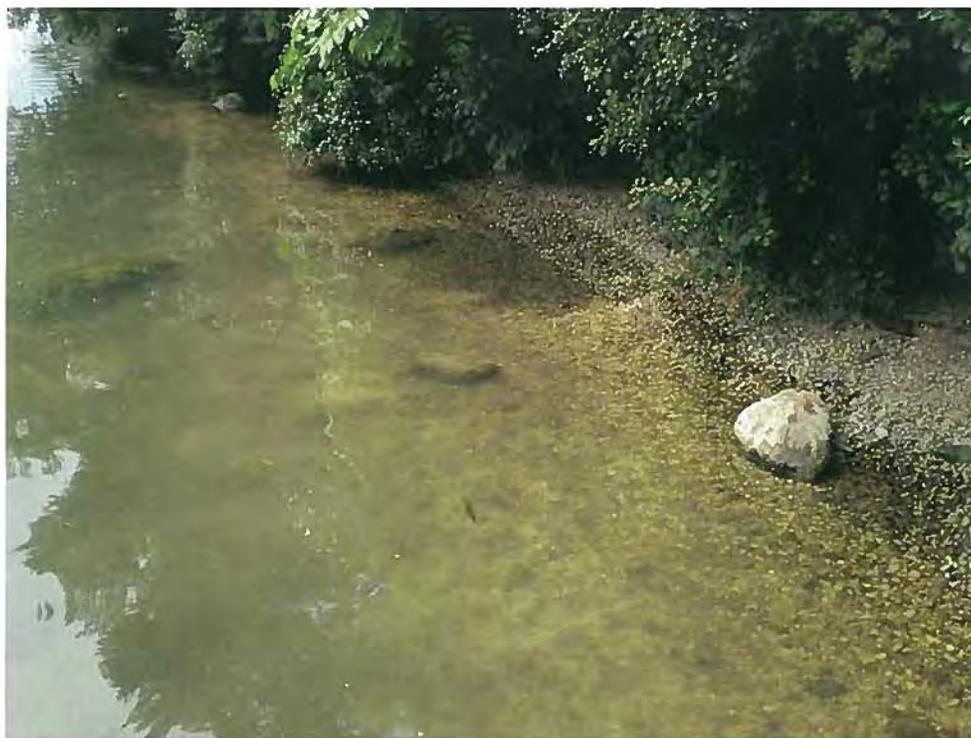
Figure 2-13: Large Substrate, Consisting of Gravel, Cobbles, and Boulders, is relatively Uncommon in the CAWS (photo taken in CSSC, downstream of AWQM 41, 2008).

In this Study, large substrate is characterized as bed material that consists of gravel or larger materials, including cobbles and boulders (Figure 2-13). Large substrate is important to fish because coarse-mixed substrate systems tend to contain highly diverse biota, with strong associations between macroinvertebrate and substrate diversity. Although macroinvertebrate diversity is more strongly associated with coarse substrate than fishes, fishes can greatly benefit from the prey base formed by diverse coarse substrate materials.

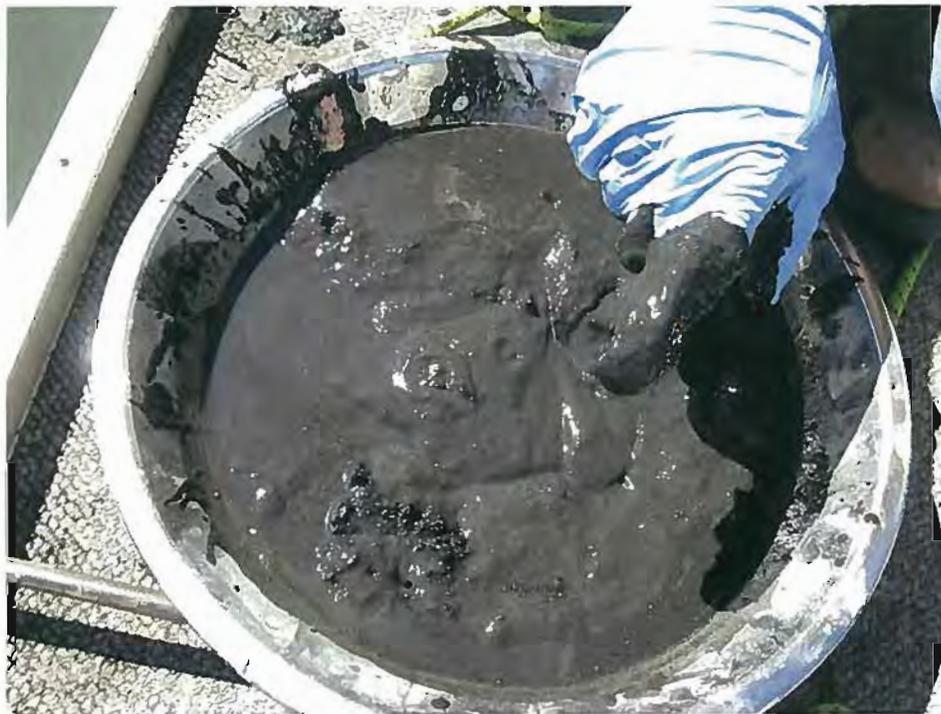
Figure 2-14: Organic Sludge is Present in a Number of CAWS Reaches, Such as in This Picture from Bubbly Creek (photo taken at AWQM 99, 2008).

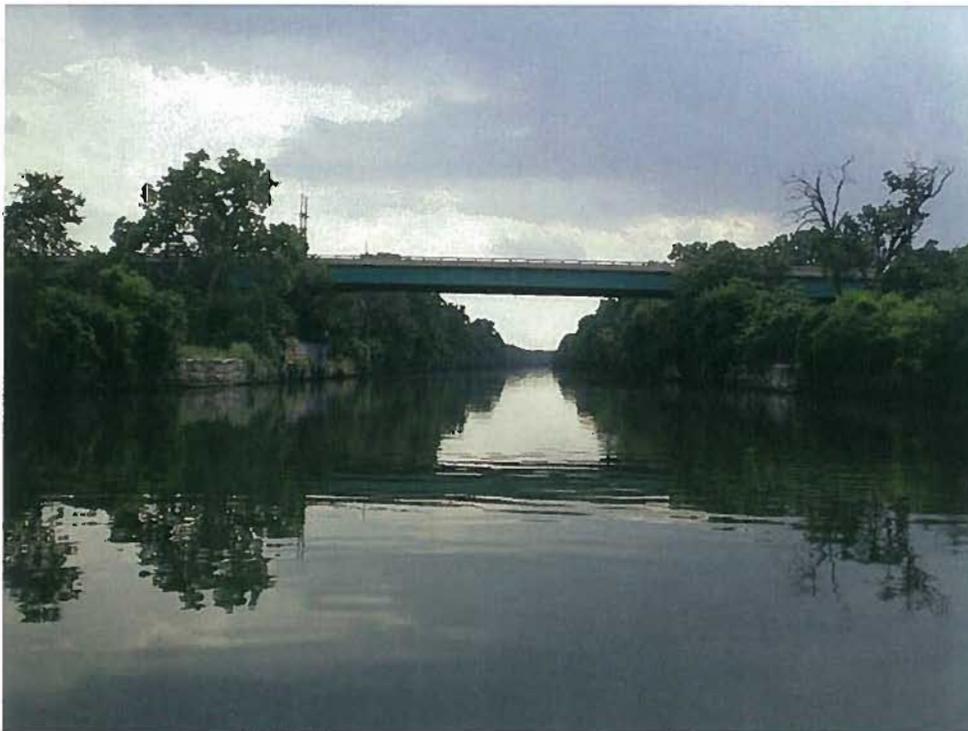
Figure 2-15: Most of the CAWS Waterways Were Constructed Without Floodplains, Like This Middle Portion of the Chicago Sanitary and Ship Canal (photo taken downstream of AWQM 41, 2008).

Floodplains never existed for the 75% of the CAWS that were excavated where channels did not previously exist (Figure 2-15), such as in the Cal-Sag Channel and the Chicago Sanitary and Ship Canal. In the CAWS reaches that were once natural waterways, or partially so, channelization has eliminated floodplain connectivity almost entirely. In addition to the absence of floodplains and floodplain connectivity, the entire system is actively managed to prevent flooding. For these reasons, there is no potential for improving this habitat impairment.

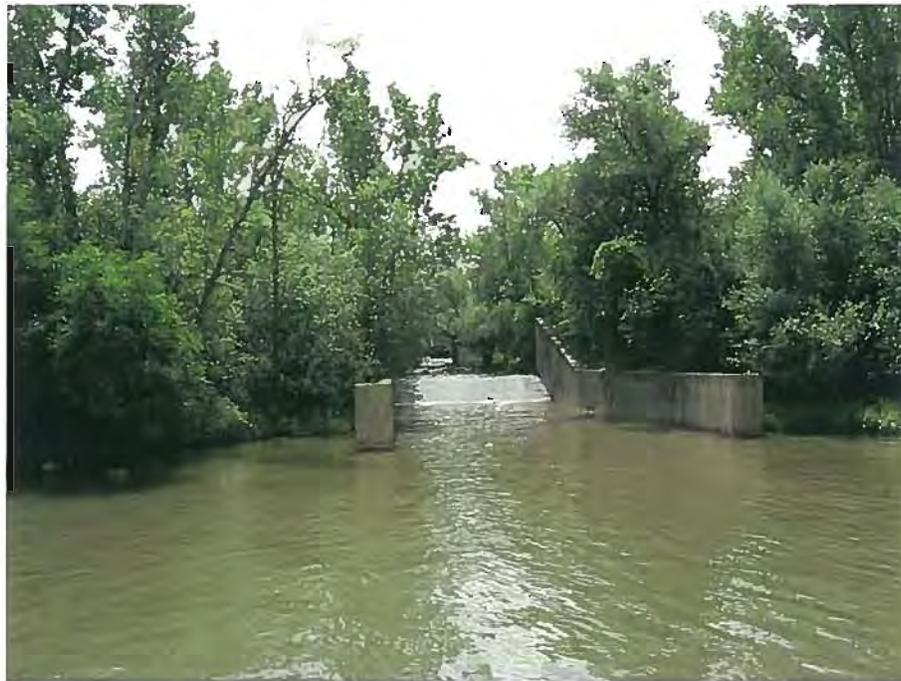
Figure 2-16: Tributary Access Blocked by a Concrete Structure at the Mouth of Tinley Creek on the Cal-Sag Channel (photo taken 2008).

A few tributaries are connected to the CAWS, but in many cases, structures have been built across tributary mouths (Figure 2-16). These structures can effectively block fish passage.

Where the structures constructed across tributary mouths serve an ongoing function such as flood control or sediment management, it is unlikely that they can be removed. In some cases, removal of the structures may be possible where they no longer serve a useful function. It may also be possible to retrofit some structures. For example, the District plans to retrofit the dam at the confluence of the Upper North Branch of the Chicago River and the North Shore Channel with a canoe chute and fish passage. In light of this, some potential for improvement of this habitat impairment is possible, but it not possible to determine quantitatively what the benefits to fisheries might be.

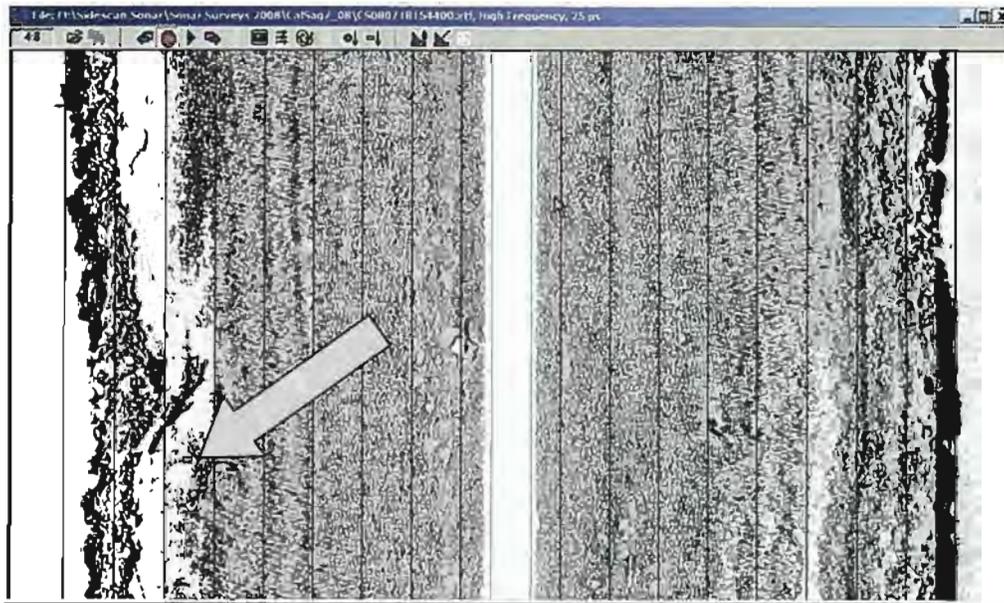
Figure 2-17: Limited In-Channel Structure Exists in the CAWS, Such as the Apparent Tree Trunk Visible on the Left Side of This Side Scan Sonar Image (white arrow) from the Cal-Sag Channel (near AWQM 59, 2008).

In the CAWS, the presence of submerged structure is counter to the primary uses of the system (effluent disposal, commercial navigation, and flood control). The operation and maintenance of the CAWS includes efforts to remove large objects like fallen trees from parts of the waterways in support of these uses. During the habitat evaluation part of this Study, pilot testing of side scan sonar was conducted to examine conditions below the water surface where visual inspection is not possible due to low water clarity (Figure 2-17). While not conclusive, this effort appeared to reveal the presence of some submerged structure such as automobiles, logs, and rubble. Full characterization of the system was not conducted, nor was ground-truthing to verify the interpretation of the sonar images, however it is apparent that some submerged structure exists. Without complete characterization, it was not possible to quantify the relative importance of this habitat attribute. It is probable, because of operation and maintenance activities in the CAWS such as dredging and removal of fallen trees, that in-channel structure is limited and thus is considered a habitat impairment.

Whether this habitat impairment can be improved is uncertain. The potential for improvement would likely depend on the location within the system. The potential for improvement would be higher in reaches that are not used for commercial navigation, such as the North Shore Channel. It may be, however, that sufficient structure already exists there. In other parts of the system, such as the Chicago Sanitary and Ship Canal and the Cal-Sag Channel, the potential to add structure may be limited due to the need to maintain clear passage for shipping.

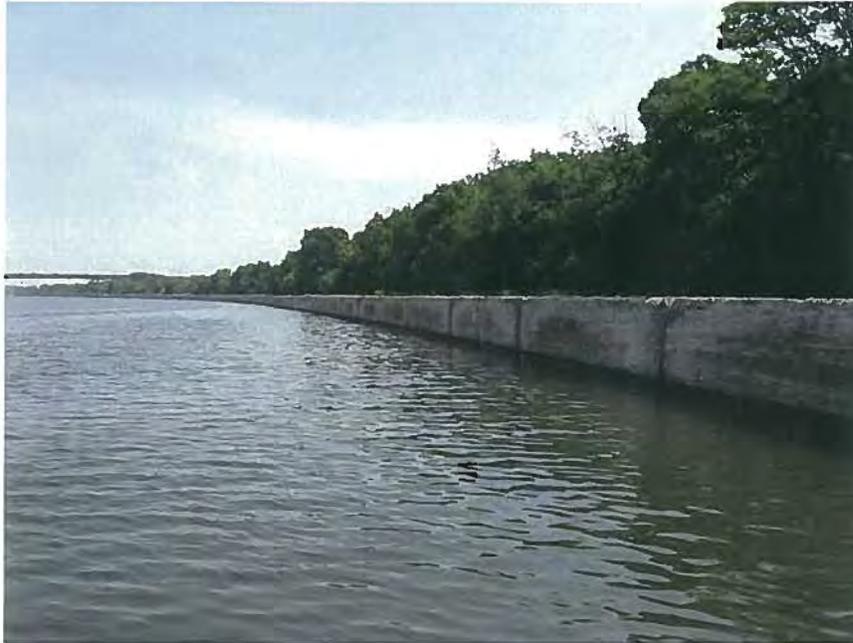
Figure 2-18: Many of the CAWS Reaches Completely Lack Littoral Zones by Design, Such as Seen Here in the Chicago Sanitary and Ship Canal (photo taken downstream of AWQM 48, 2008).

In the CAWS, large portions of the system were constructed without littoral zones, such as the Chicago Sanitary and Ship Canal, most of which was excavated into bedrock with vertical sides (Figure 2-18). Other reaches in the CAWS have had their littoral zones replaced with vertical sheet pile walls or other vertical revetments. This is the case in the entire Chicago River, as well as portions of the North and South Branches of the Chicago River, and Bubbly Creek. In total, approximately 65 miles of

Artificial construction of littoral zones in some parts of the CAWS may be feasible on a small scale, at a few locations, by adding rock and soil to the nearshore parts of the channels or by widening the channels and sloping the banks. However, it is unlikely that this could be done on a large scale in the system due to potential interference with primary waterway uses (effluent disposal, commercial navigation, and flood control), interference with current land uses, and the high cost of earthwork on such a large scale. In general, for these reasons, the potential to improve this habitat impairment is limited. However, the potential for replacement of vertical wall banks in the CAWS with sloping, vegetated banks is evaluated later in this report, which would improve this attribute.

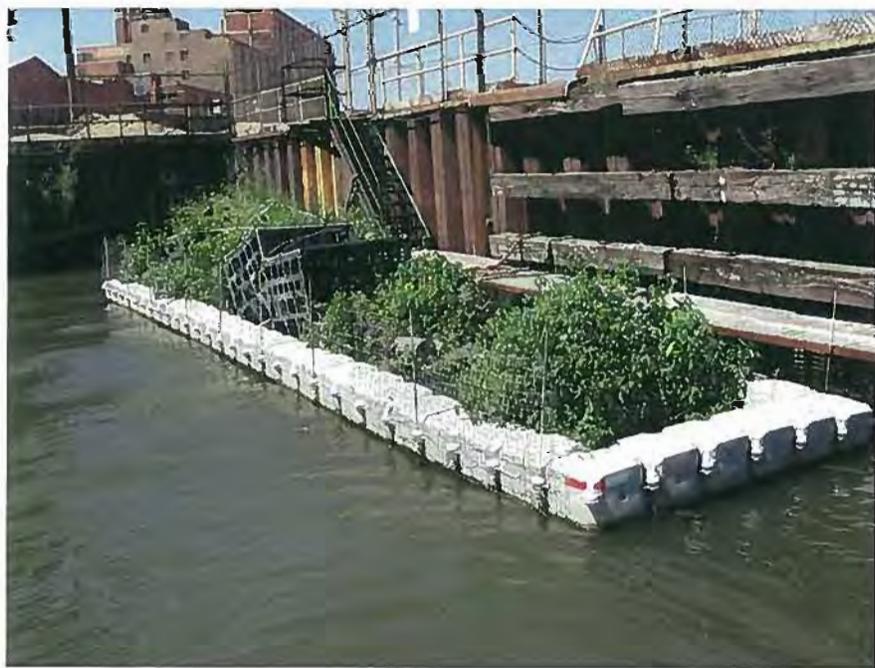
Figure 3-1: Fish Hotel, South Branch Chicago River, 2008

The friends of the Chicago River have implemented a habitat improvement project on the Chicago River that they refer to as the “fish hotel”, a floating island design that is intended to provide shelter, forage, and reproduction habitat for fish. A similar structure was observed on the South Branch Chicago River during field surveys in 2008 (Figure 3-1).

Based on a telephone inquiry to the Friends of the Chicago River, it is known that one fish hotel structure is currently deployed in the Chicago River and although periodic visual observations are made to identify fish, no biotic sampling has been conducted to quantify the benefit of the structure.

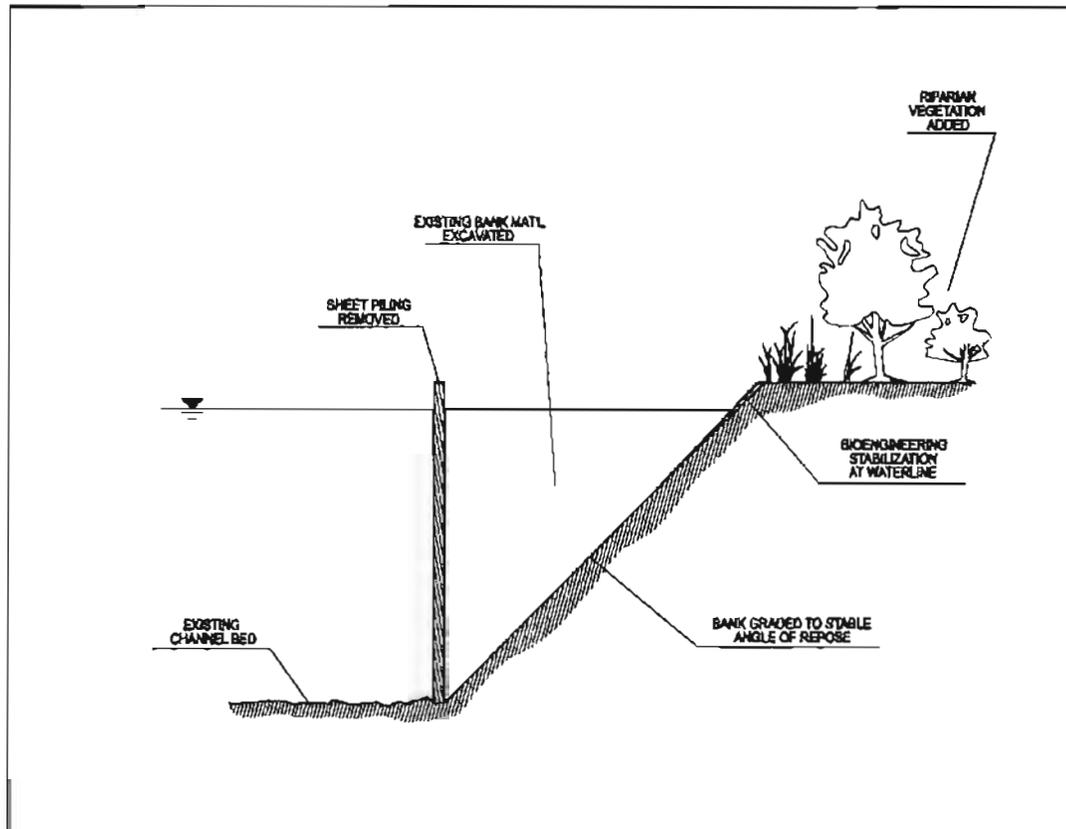
Figure 3-2: Conceptual Design (Profile) for Removal of Vertical Wall Banks

Removal of vertical walls has the potential to counter the greatest number of habitat impairments identified in the CAWS; therefore a conceptual design was developed specifically to examine this approach to habitat improvement. The design is illustrated in Figure 3-2 and would involve the following major elements:

- The project would involve the widening of the channel, which would require acquisition or riparian land along the waterways. Much of this land is currently owned by parties other than the District and may currently be in use by the owners or not available for acquisition.

- There are likely utilities and infrastructure present along parts of the CAWS that would interfere with this type of project. These would have to be relocated.

- Some of the riparian land that would be taken by this type of project may have structure built on it, which would require demolition.
- Much of the CAWS exists in areas that have been urbanized for over a century. It is possible that some of the land along the CAWS has been contaminated by release of petroleum and industrial chemicals in the past. This contamination might be exposed by a project of this type, which would complicate the project.

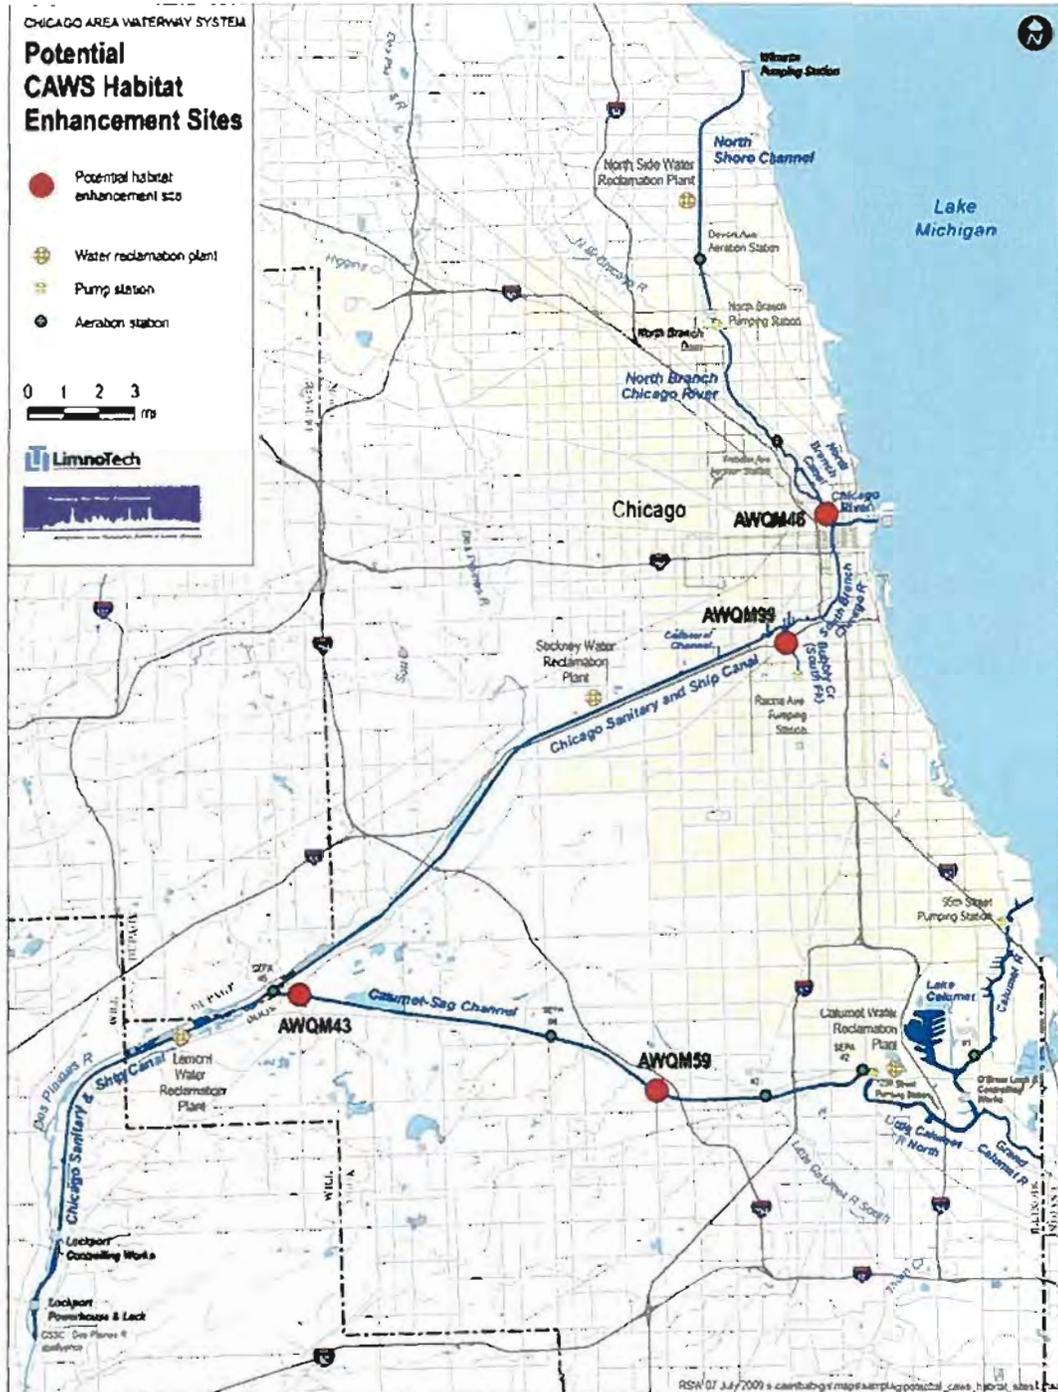
Figure 3-3: Locations of Habitat Restoration Conceptual Design Sites

A map of these sites is presented in Figure 3-3. Detailed descriptions of the conceptual design and concept plan view drawings are included in Appendix C. It should be noted that these designs are provided to illustrate how the potential habitat

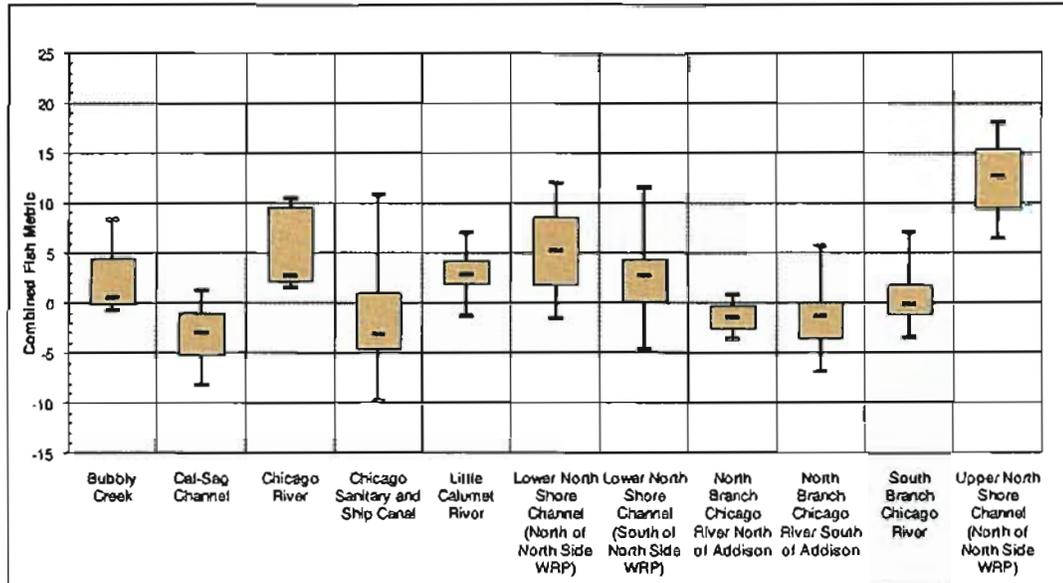
Figure 4-1: Variability in CAWS Fish Data by Reach as Indicated by the "Combined Fish Metric" (2001-2008)

Analysis of fish data from the CAWS, reported in the CAWS Habitat Evaluation Report, shows that fish data are extremely variable, with significantly different metrics being calculated from fish data collected at the same stations during different sampling events. If it is assumed that the potential change in biological community will be reflected in the fish data, then the potential change must be larger than the natural variability of the data in order for it to be measureable. If the potential change in fish metrics resulting from habitat improvement is less than the normal variability of the fish data, there is little potential for a measureable improvement in fisheries.

The "whiskers" in Figure 4-1 represent the minimum and maximum values of the combined fish metric calculated in each reach and illustrate the full range of values for each reach. The coefficient of variation was calculated from these data and is expressed as a percentage in Table 4-2, along with the potential percent change in habitat index scores.
