Re. City Water, Light, and Power - 35 IAC 620 Ash Pond Assessment

## **Ash Pond Assessment**

RE: Lakeside and Dallman Ash Ponds

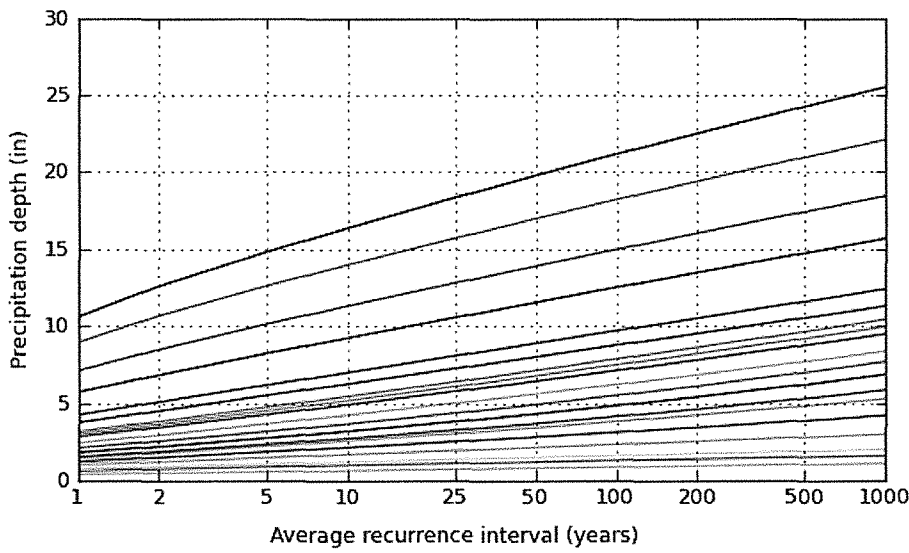
### PF graphical

PDS-based depth-duration-frequency (DDF) curves  
 Latitude: 39.7642°, Longitude: -89.5979°

Average recurrence interval (years)
1
2
5
10
25
50
100
200
500
1000

Duration	
5-min	2-day
10-min	3-day
15-min	4-day
30-min	7-day
60-min	10-day
2-hr	20-day
3-hr	30-day
6-hr	45-day
12-hr	60-day
24-hr
