BEFORE THE ILLINOIS POLLUTION CONTROL BOARD

IN THE MATTER OF:)	
)	AS 2021-008
PETITION OF AMEREN ENERGY MEDINA)	
VALLEY COGEN, LLC (OLD MEREDOSIA))	
FOR ADJUSTED STANDARDS)	(Adjusted Standard-Land)
FROM 35 ILL ADM. CODE Part 845)

RECOMMENDATION

ATTACHMENT A

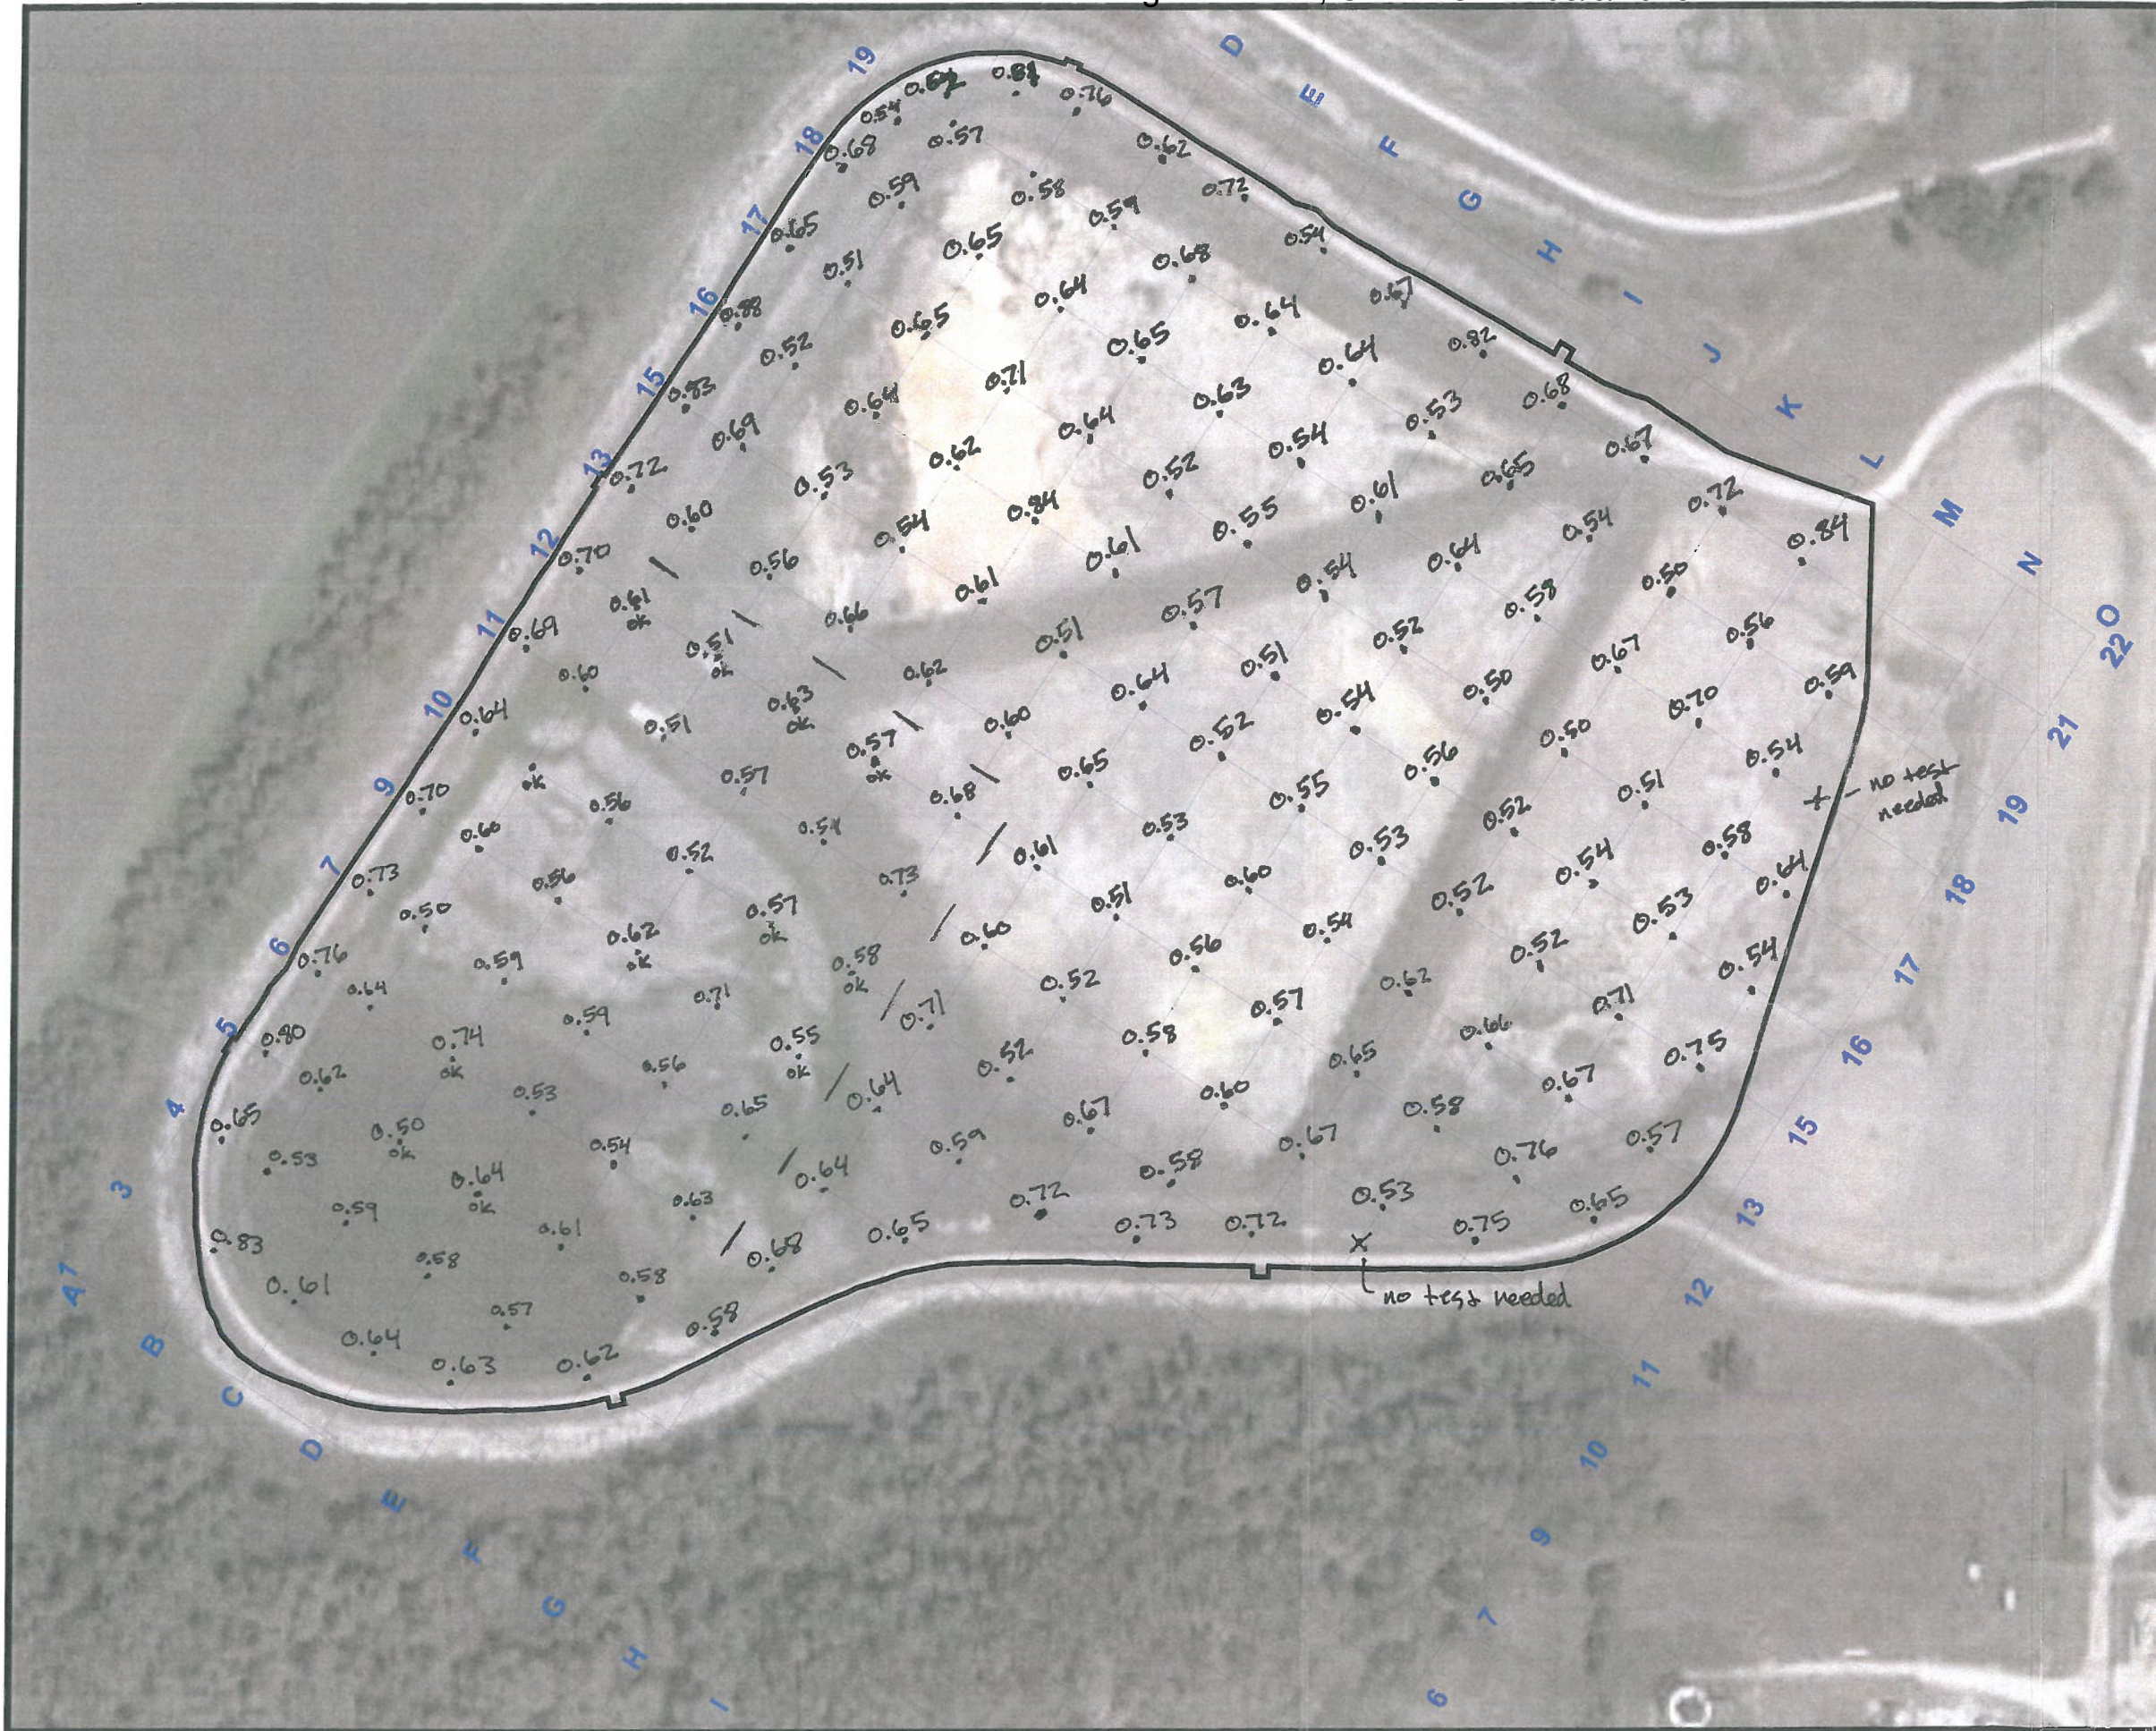
Fly Ash Pond -
Sand depths

Drawn By: WAH	Ck'd By:	App'vd By:
Date: 5-13-16	Date:	Date:
Meredosia Power Station Meredosia, Illinois		
SITE PLAN		
Project Number J024917.01	PLATE 2

Performed sand depth testing in the perimeter ditch of the Fly Ash Pond and untested (or unpassed) portions of the Fly Ash Pond surface. Noted three locations that require additional sand, which were located on the surface. These three locations were marked but not addressed on August 8, 2019; additional sand placement in remedial locations is planned for August 9, 2019.

Performed sand depth testing at the three locations that did not pass previously after additional sand placement. Upon retesting, the noted locations passed.

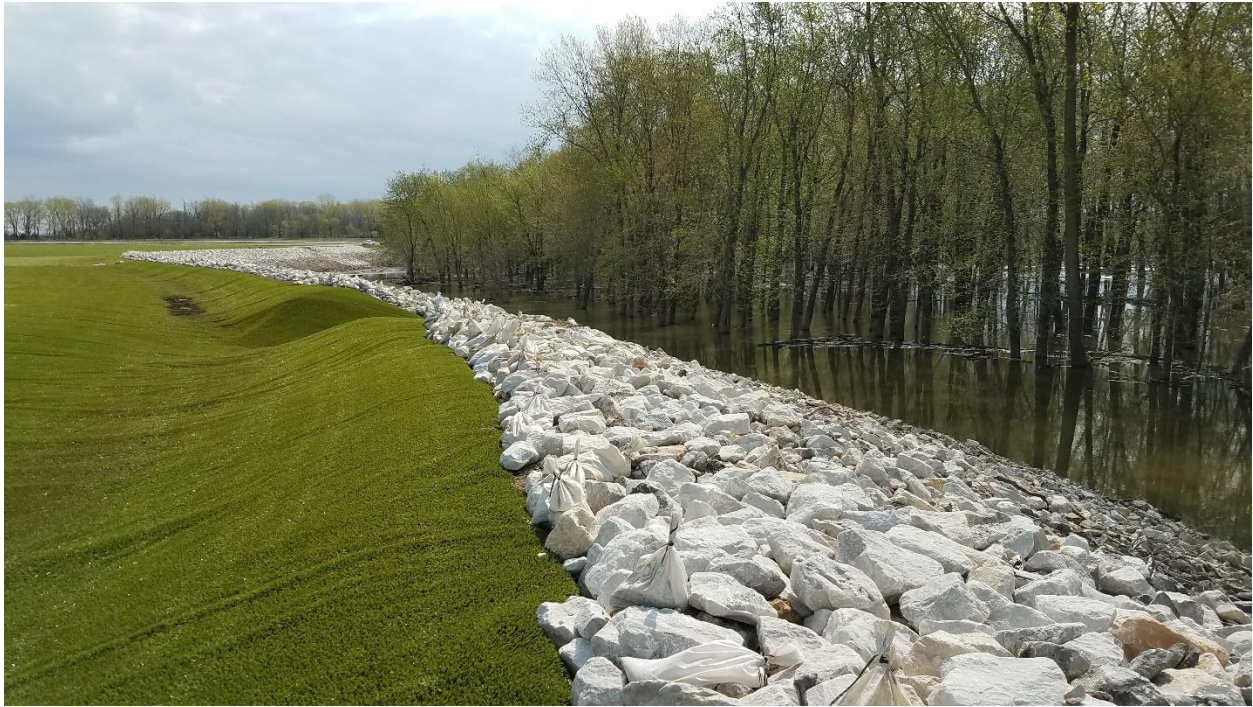
Photograph 1 ▲ - View of flooding near the Fly Ash Pond area, looking east.

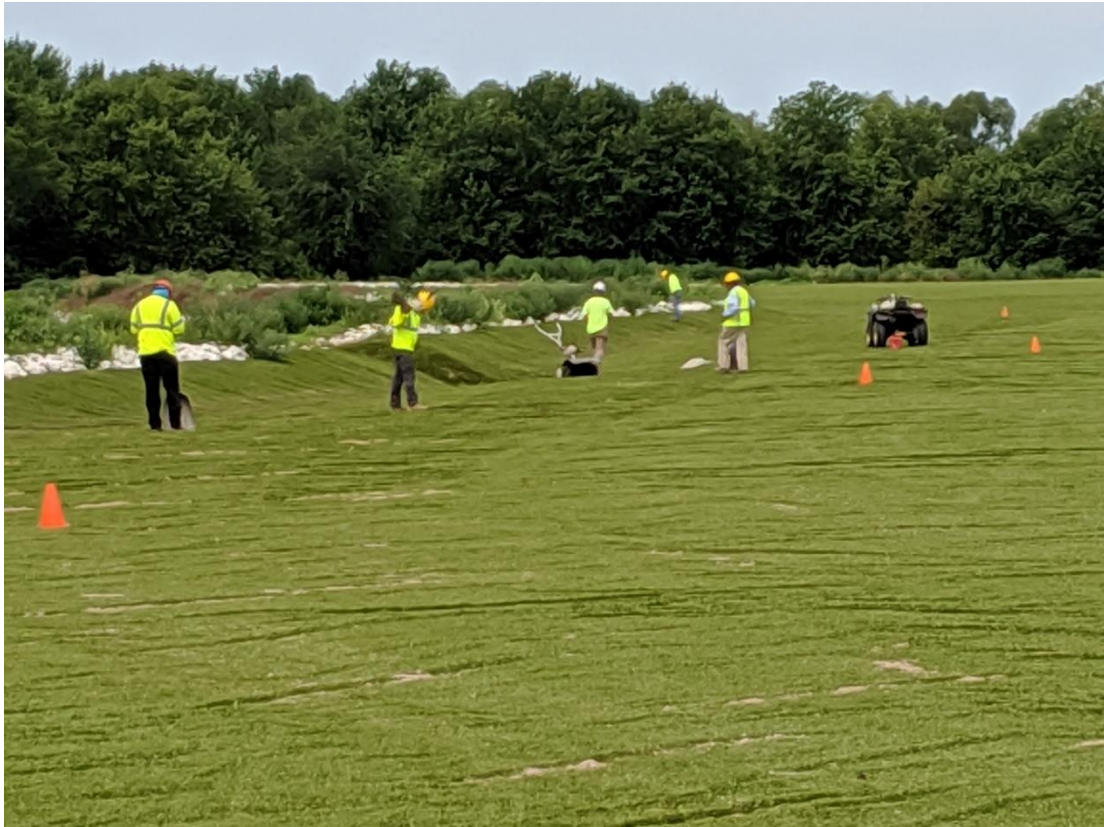
Photograph 2 ▲ - View of sand spreading activities in the perimeter ditch of the Fly Ash Pond, facing southwest.

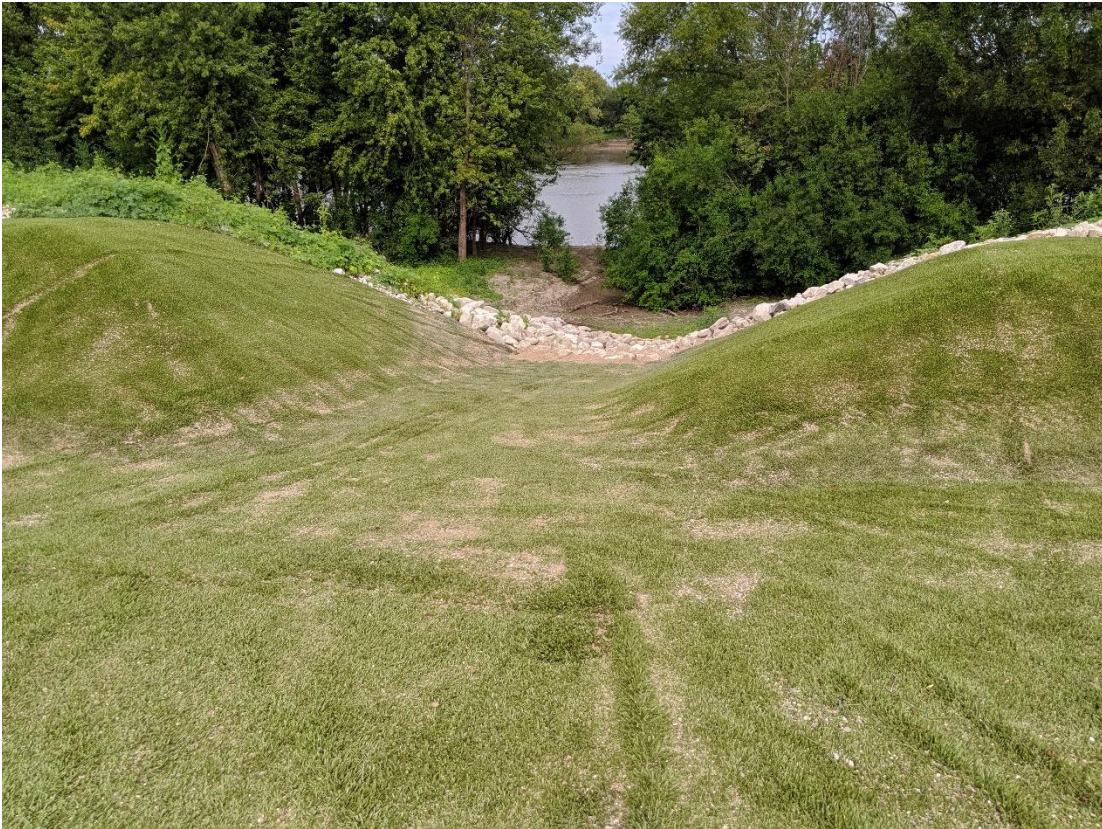
Photograph 3 ▲ - View of sand present in typical downlet structure, looking northwest.

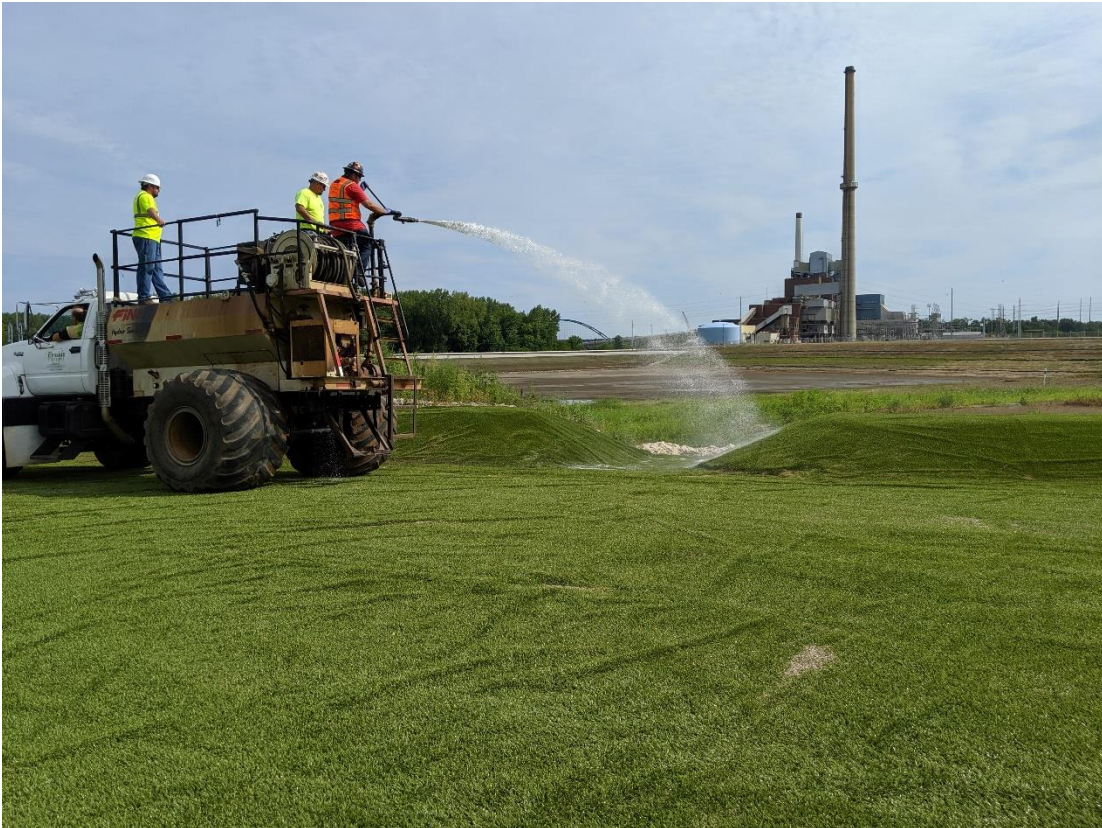
Photograph 4 ▲ - View of Armorfill placement activities, looking northeast.

Placement of Armorfill in the perimeter ditch and downlet structures of the Fly Ash Pond began on August 8, 2019 and concluded on August 9, 2019. The CQA officer or designated representative observed the placement of the Armorfill material for apparent saturation of the sand infill layer. A final inspection of the Armorfill was performed on August 28, 2019 by the CQA Officer to verify that the Armorfill material had properly set.

The ArmorFill material was mixed then sprayed in the FA Pond ditches while CQA personnel observed. On August 28, 2019, the CQA Officer observed the placed ArmorFill and verified that the material had set in accordance with the CQA Plan.

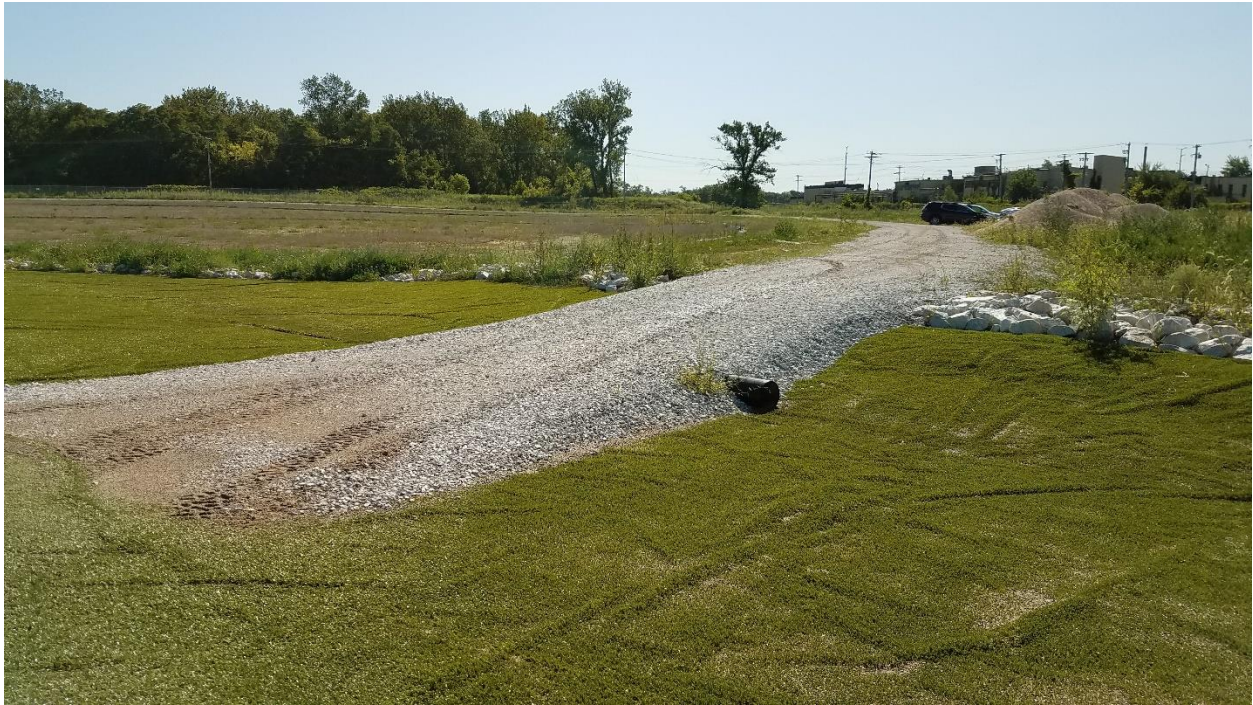
Photograph 5 ▲ - View of access road extending onto the Fly Ash Pond, looking east.

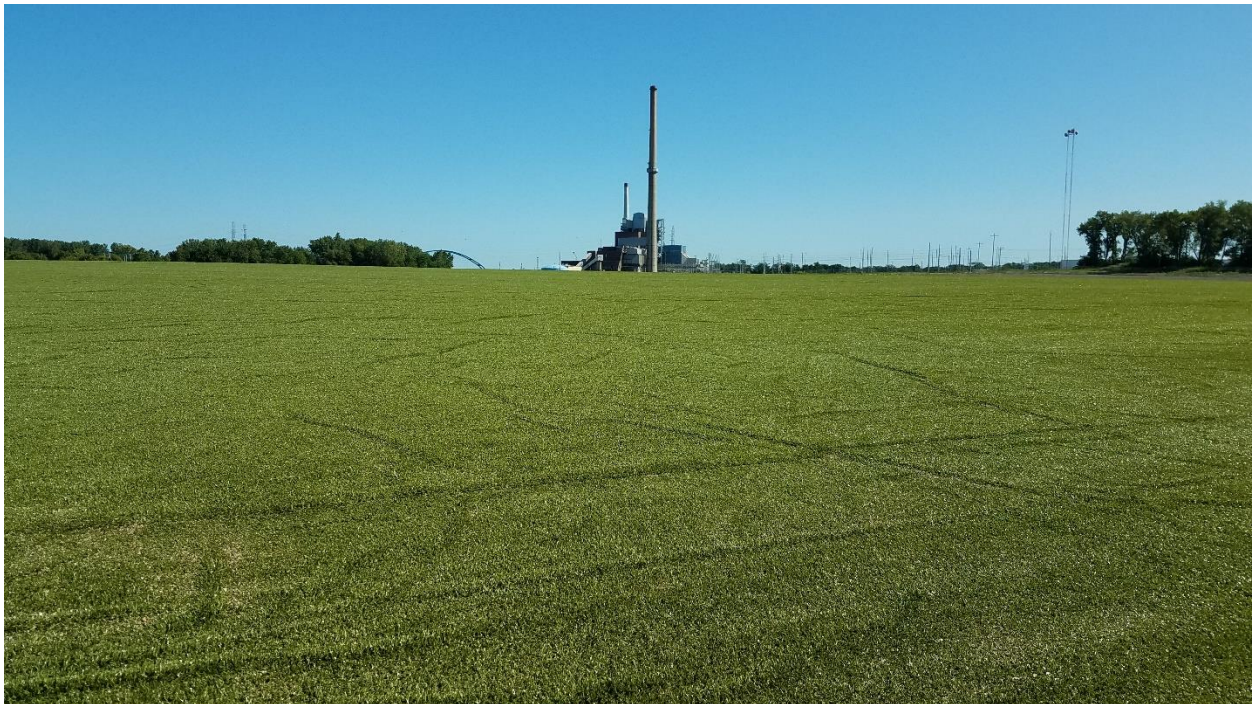
Photograph 6 ▲ - Typical view of final ClosureTurf cover, looking northeast.

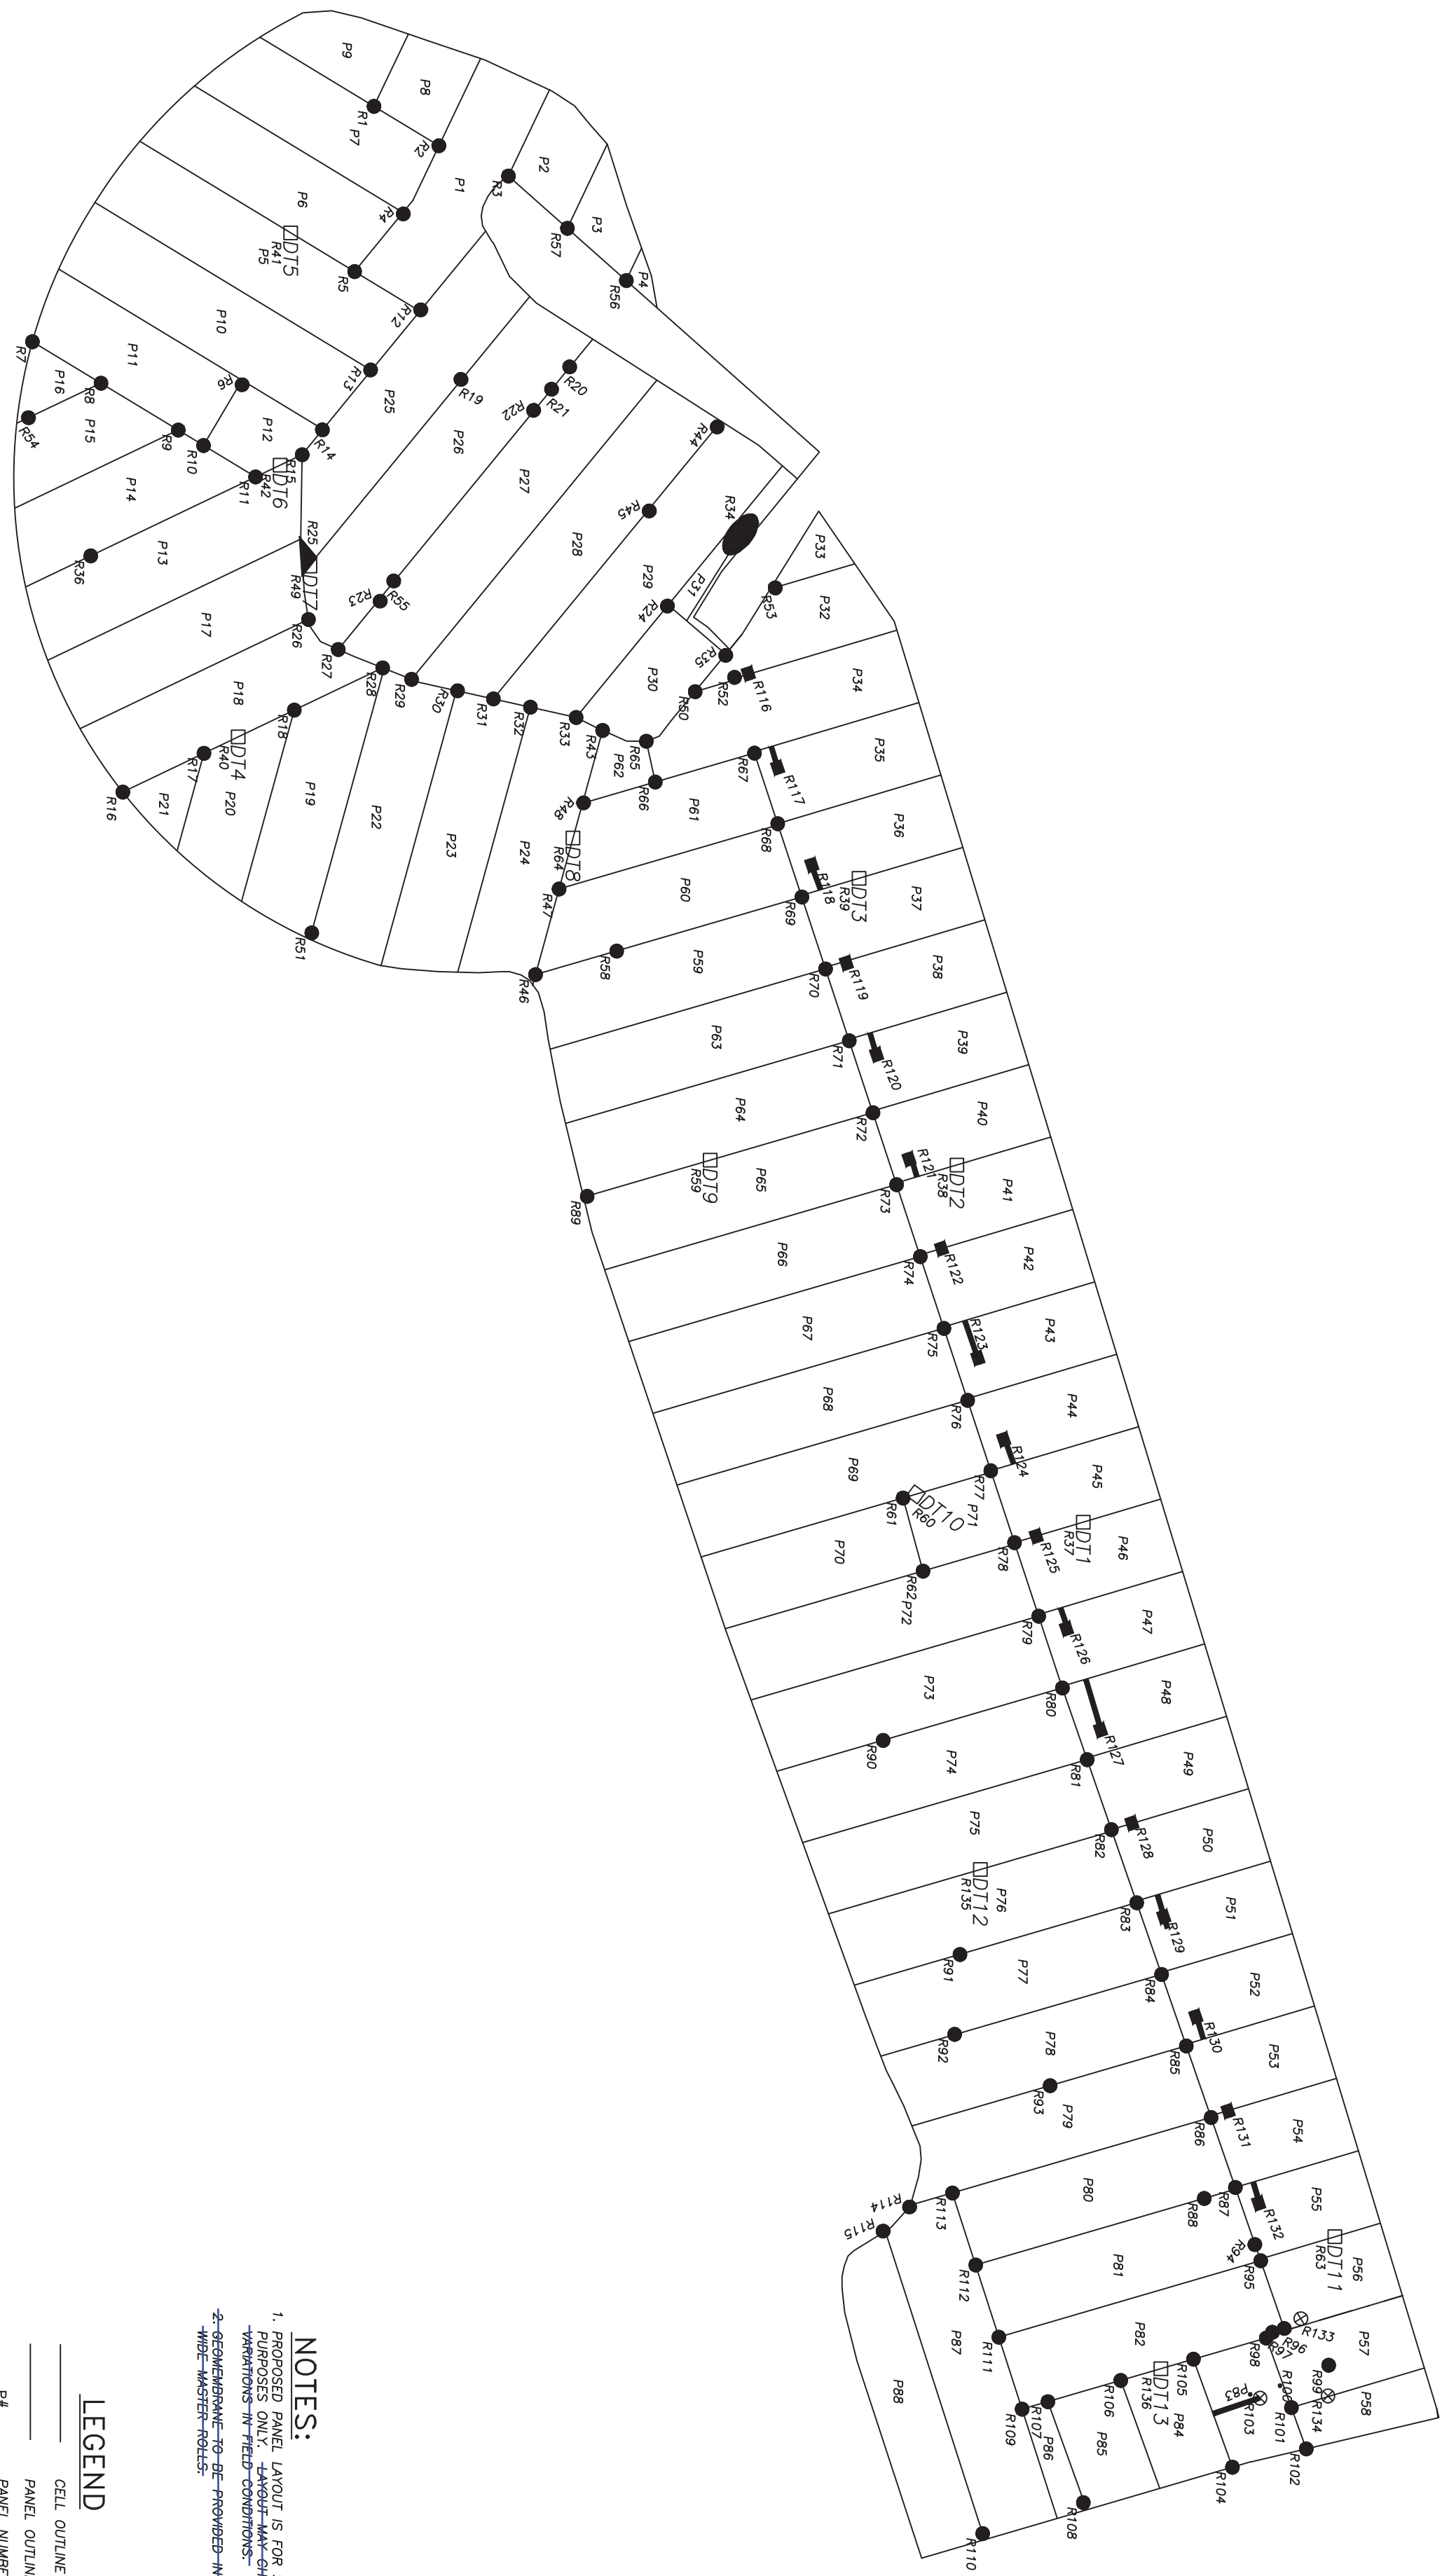
NOTES:
 1- PROPOSED PANEL LAYOUT IS FOR SCHEMATIC PURPOSES ONLY. LAYOUT MAY CHANGE DUE TO VARIATIONS IN FIELD CONDITIONS.
 2- GEOMETRIC FRAME TO BE PROVIDED IN 22' FOOT WIDE MASTER ROWS.

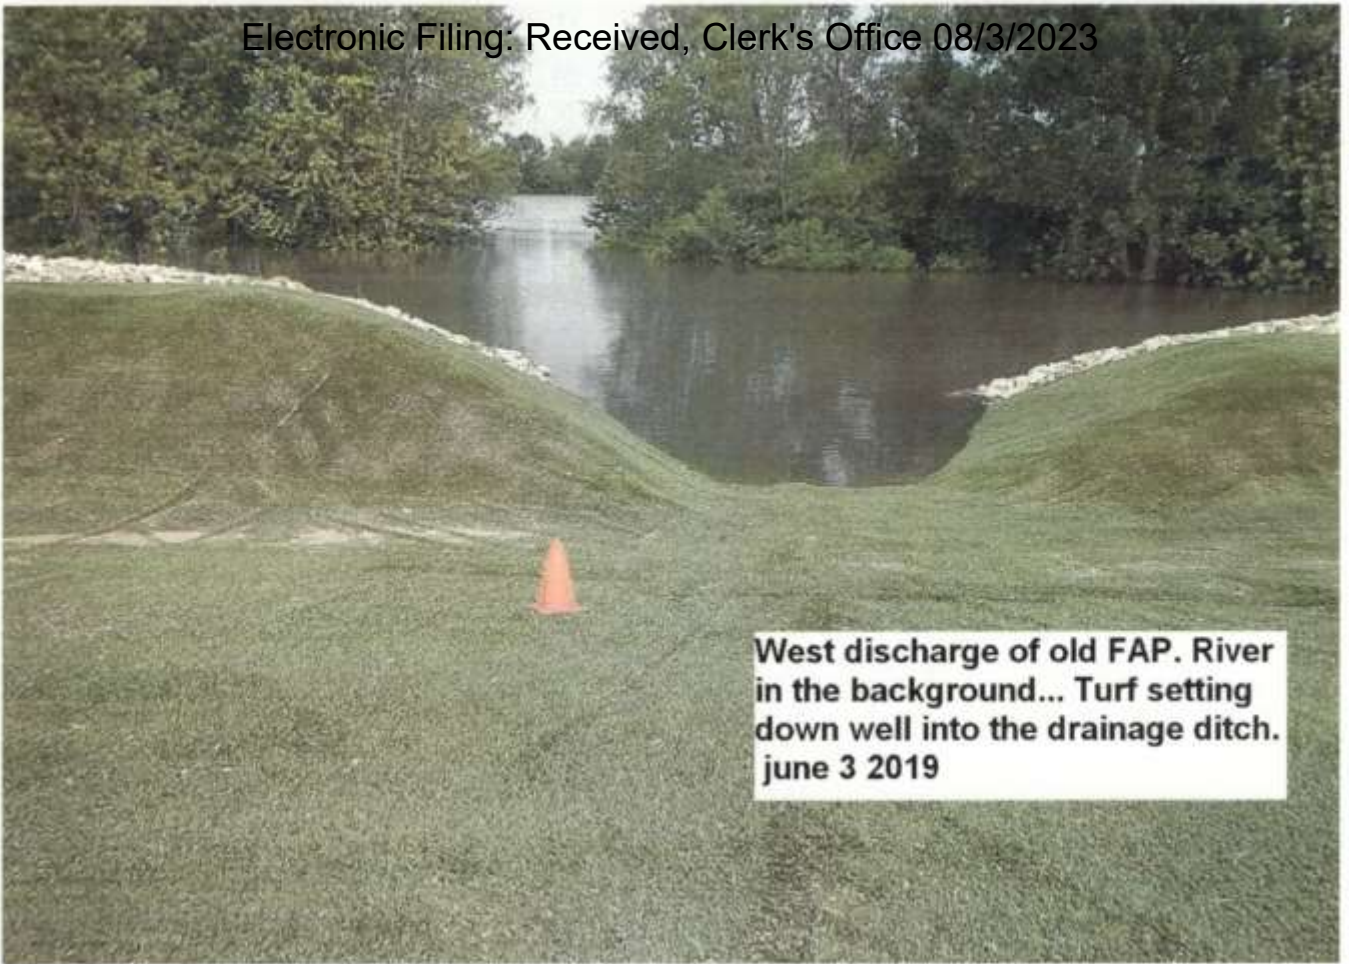
West discharge of old FAP. River in the background... Turf setting down well into the drainage ditch. june 3 2019

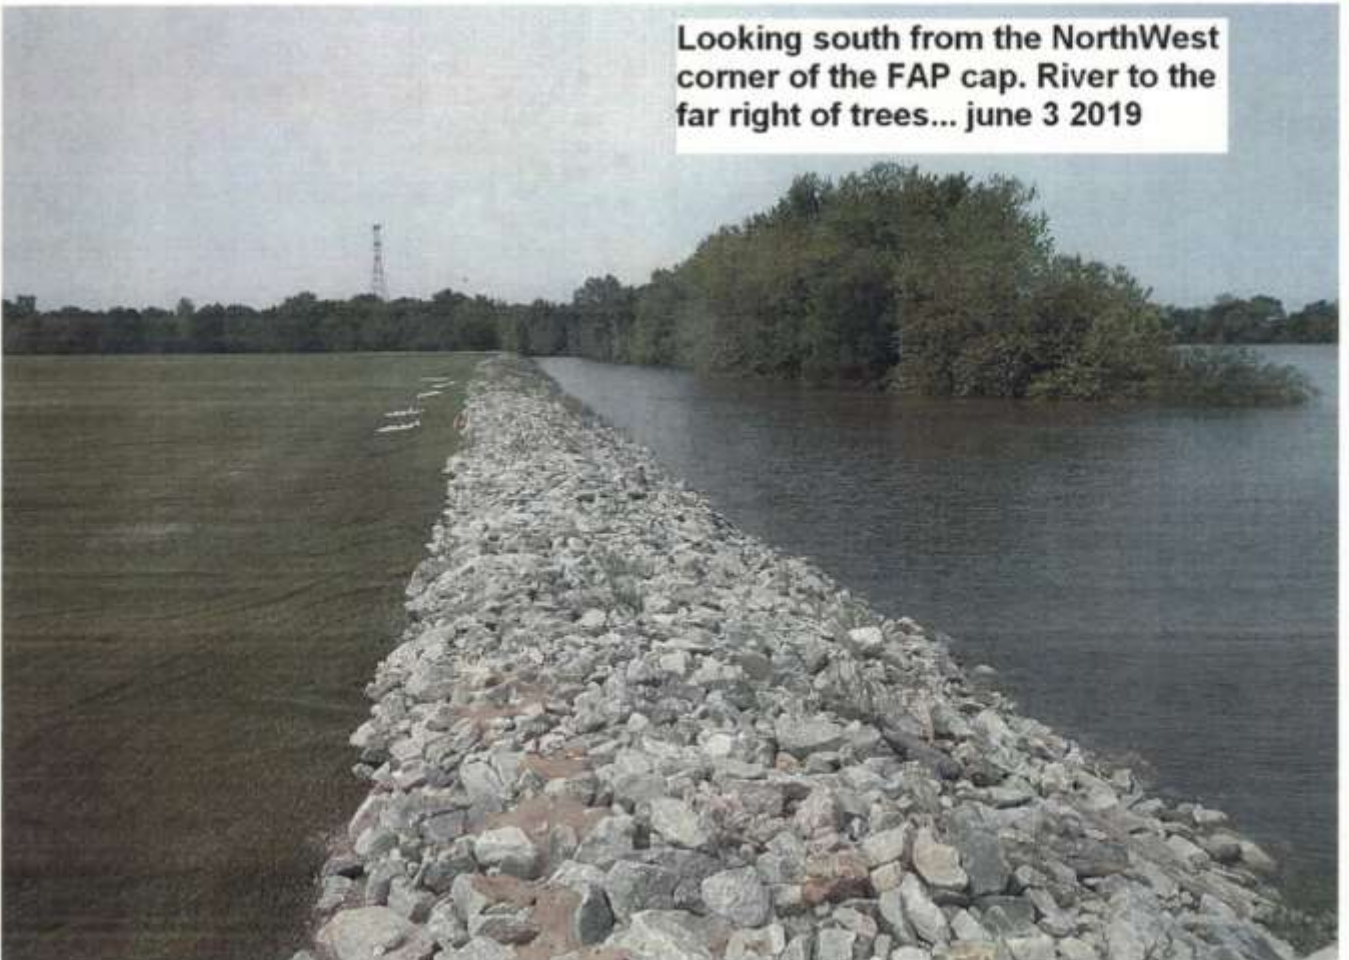
Looking south from the NorthWest corner of the FAP cap. River to the far right of trees... june 3 2019

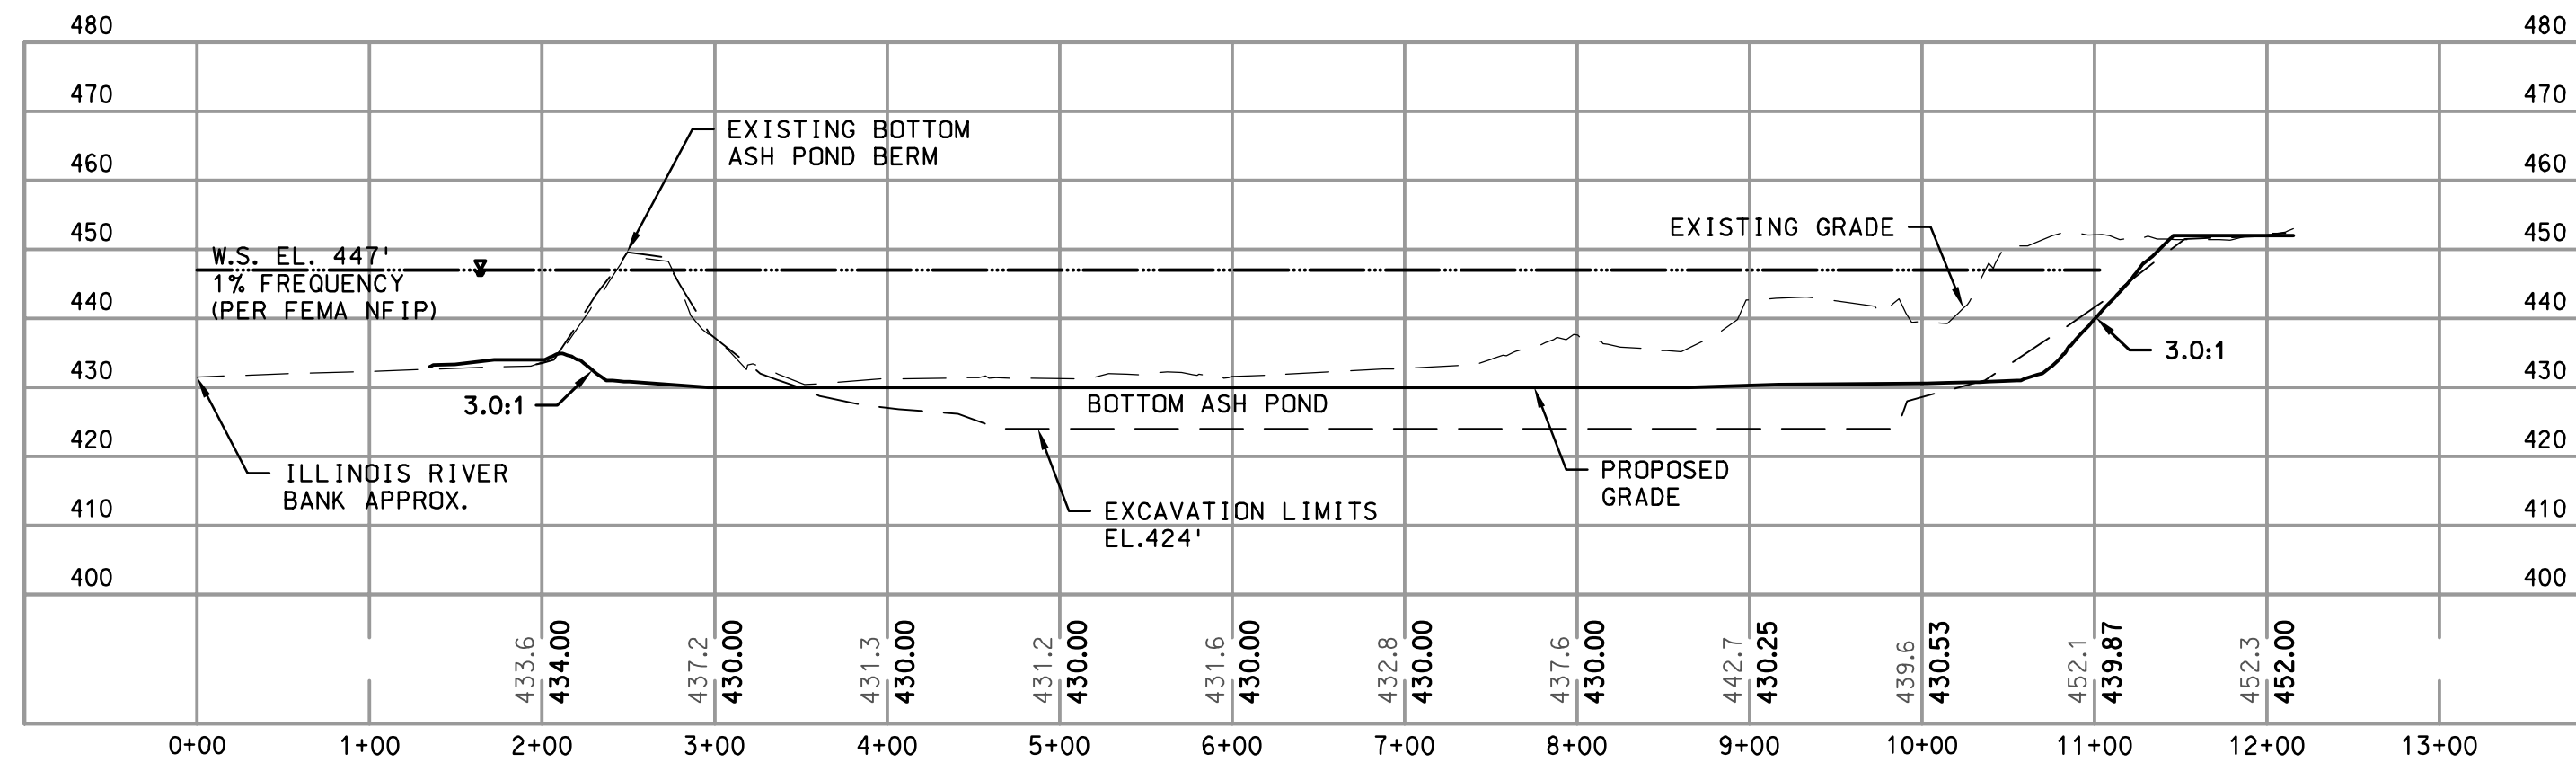
3 BOTTOM ASH POND (WEST - EAST) PROFILE
 SCALE: 1" = 100' HOR., 1" = 25' VER.
 NOTE: 1" = 100' ON 24x36
 1" = 200' ON 12x18

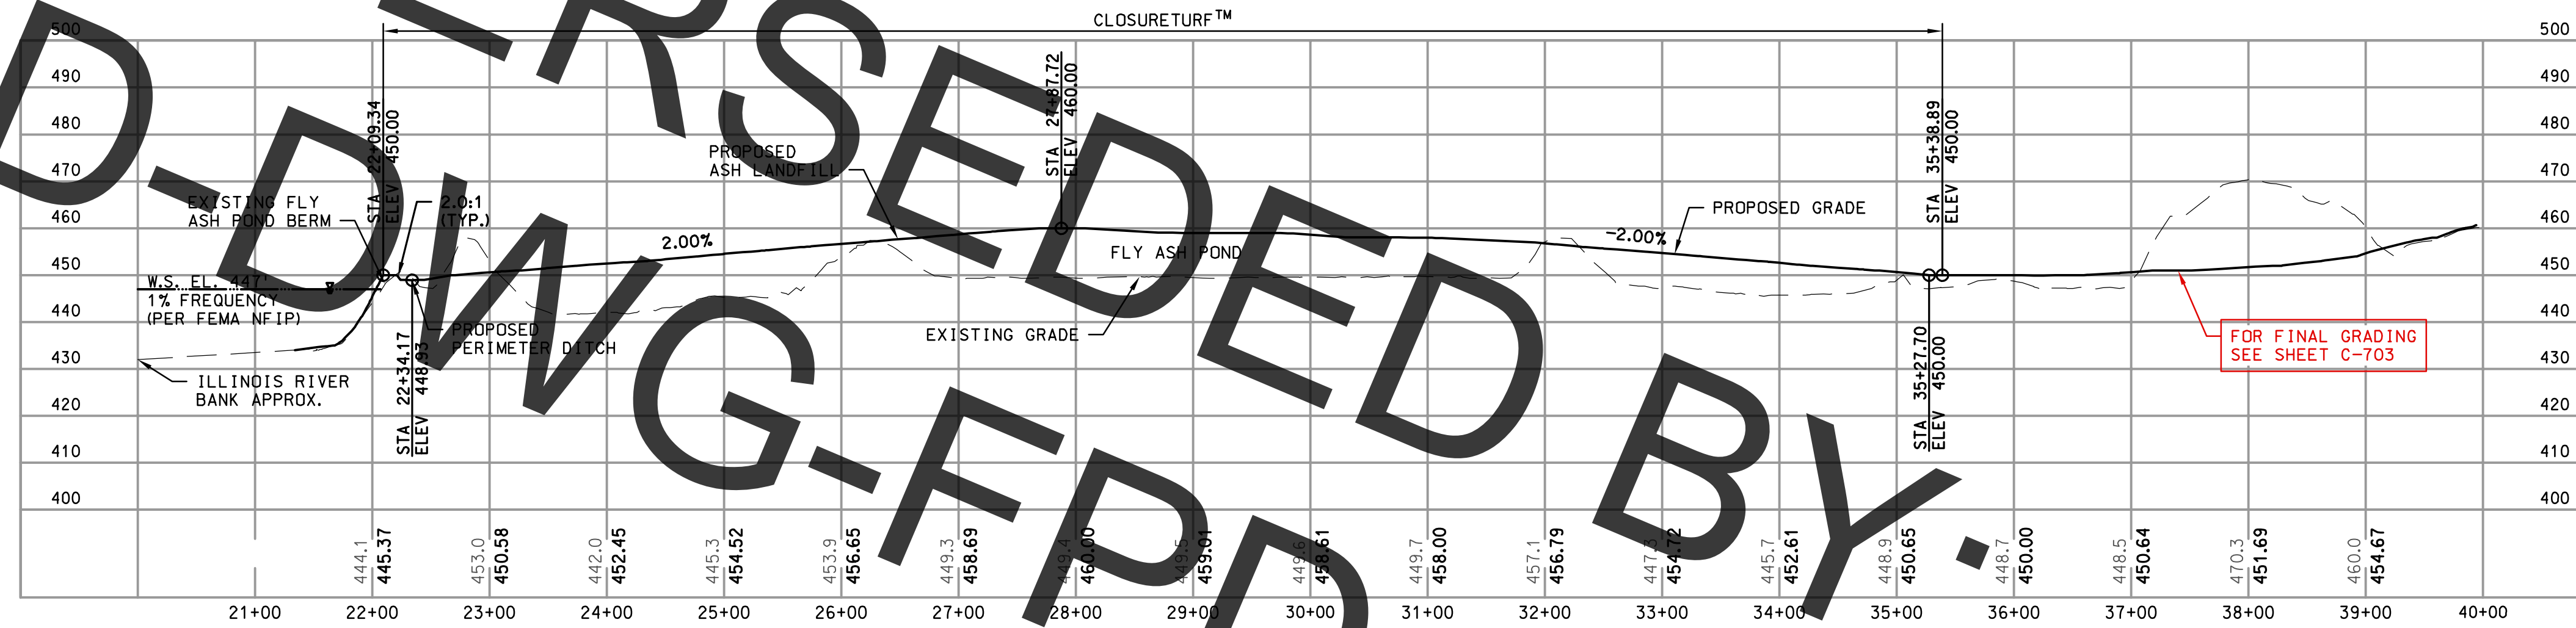
3 **2** FLY ASH POND (WEST - EAST) PROFILE
 SCALE: 1" = 100' HOR., 1" = 25' VER.
 NOTE: 1" = 100' ON 24x36
 1" = 200' ON 12x18

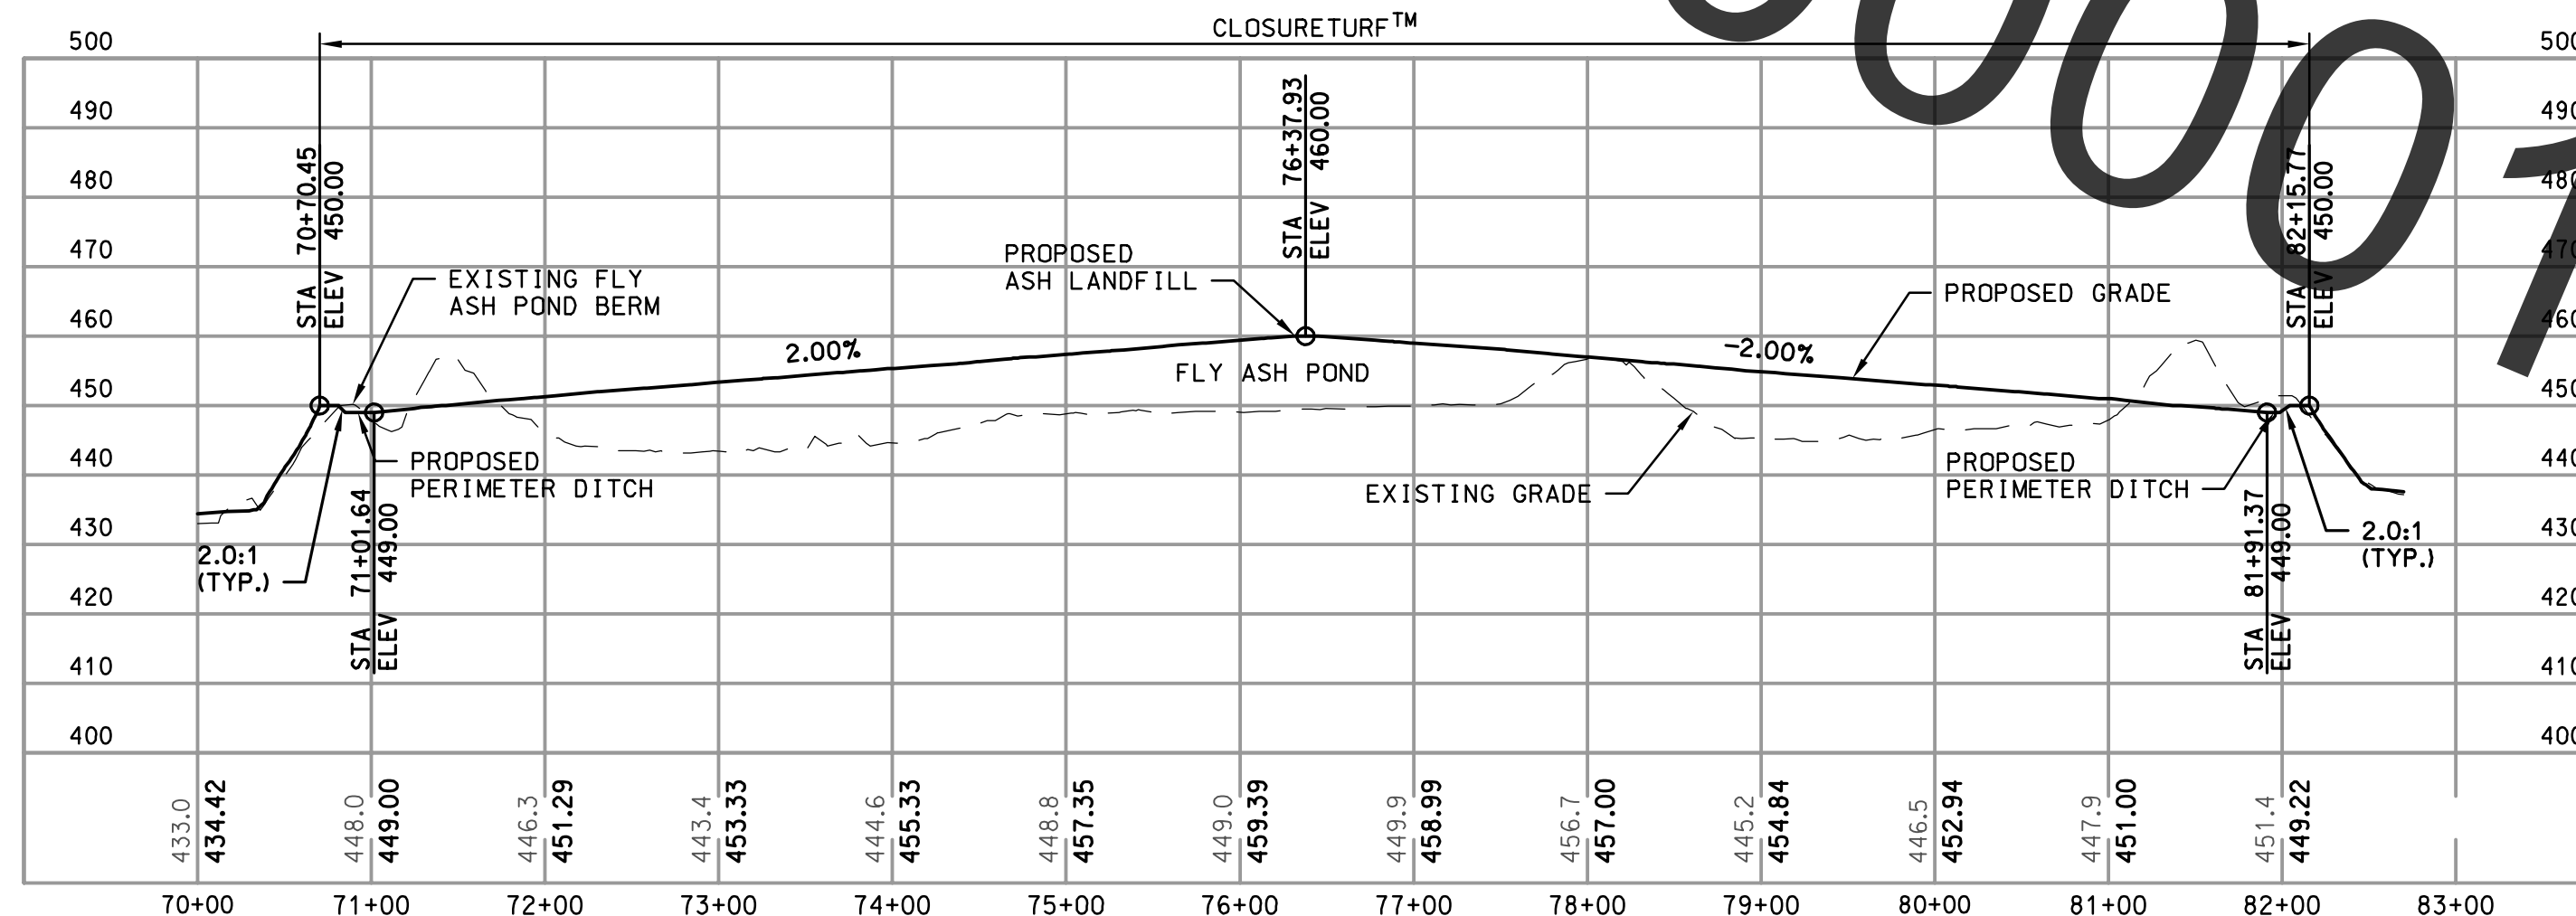
3 **2** FLY ASH POND (SOUTH - NORTH) PROFILE
 SCALE: 1" = 100' HOR., 1" = 25' VER.
 NOTE: 1" = 100' ON 24x36
 1" = 200' ON 12x18
