BEFORE THE ILLINOIS POLLUTION CONTROL BOARD

IN THE MATTER OF:)	
)	AS 2021-008
PETITION OF AMEREN ENERGY MEDINA)	
VALLEY COGEN, LLC (OLD MEREDOSIA))	
FOR ADJUSTED STANDARDS)	(Adjusted Standard-Land)
FROM 35 ILL ADM. CODE Part 845)

RECOMMENDATION

ATTACHMENT A

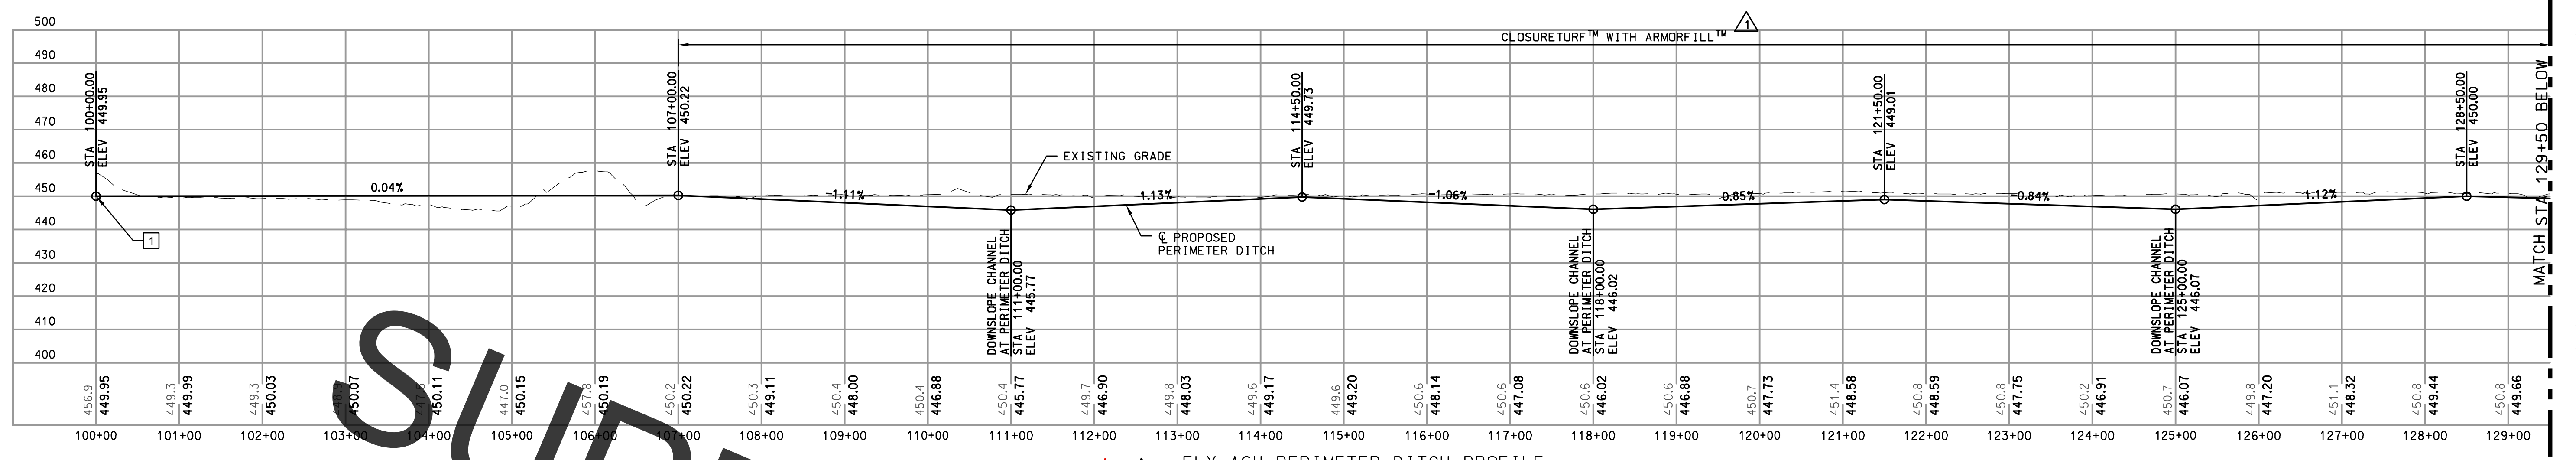
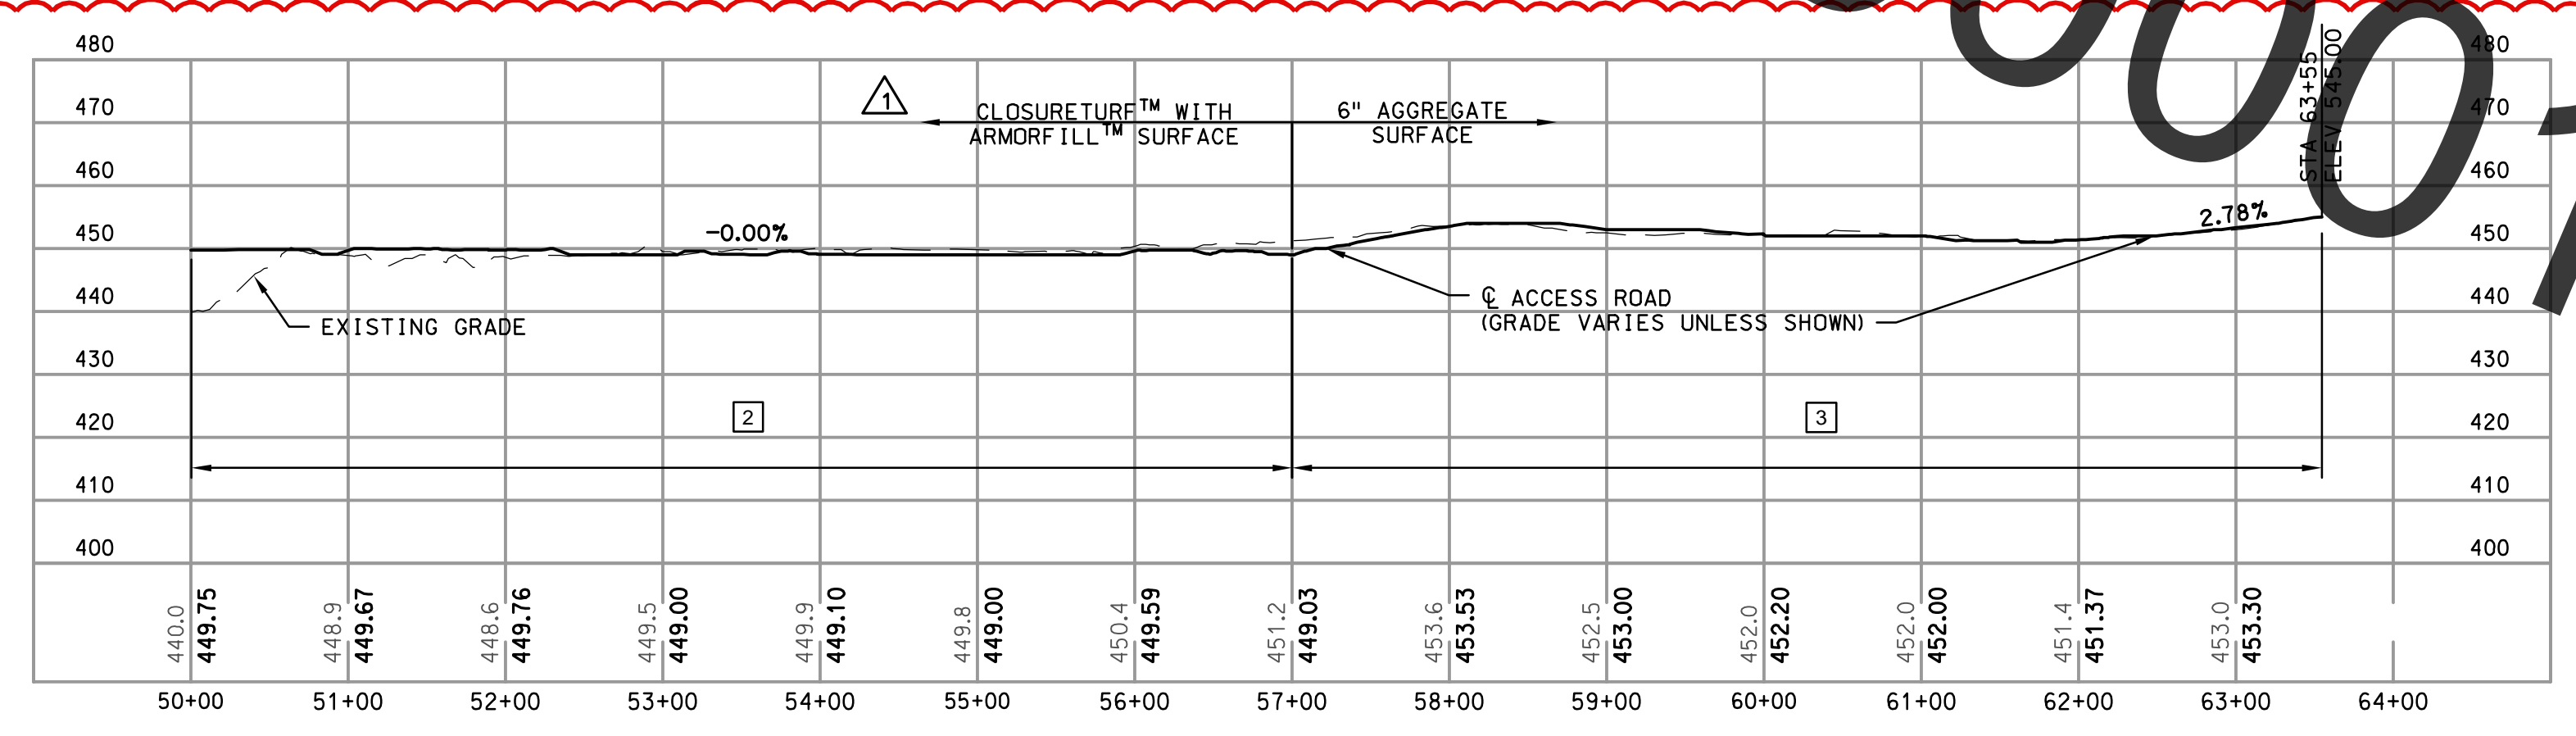
C-111

- 1 STA. 100+00 = STA. 148+91.21
- 2 CONTRACTOR TO EXCAVATE TOP 36" OF BOTTOM ASH BERM AND DISCARD WASTE MATERIAL TO FLY ASH POND. CONTRACTOR SHALL THEN PLACE CLOSURETURF OVER ASH BERM, THEN PLACE 12" SOIL UNDERNEATH 24" AGGREGATE FROM STA 50+00 TO 57+00. (SEE DETAIL 6/C-303)
- 3 CONTRACTOR TO EXCAVATE TOP 18" OF ACCESS ROAD BETWEEN STA 57+00 TO STA 63+55 AND DISCARD WASTE MATERIAL TO FLY ASH POND. CONTRACTOR SHALL THEN PLACE 6" AGGREGATE OVER 12" COMPACTED SUBGRADE. (SEE DETAIL 10/C-304)

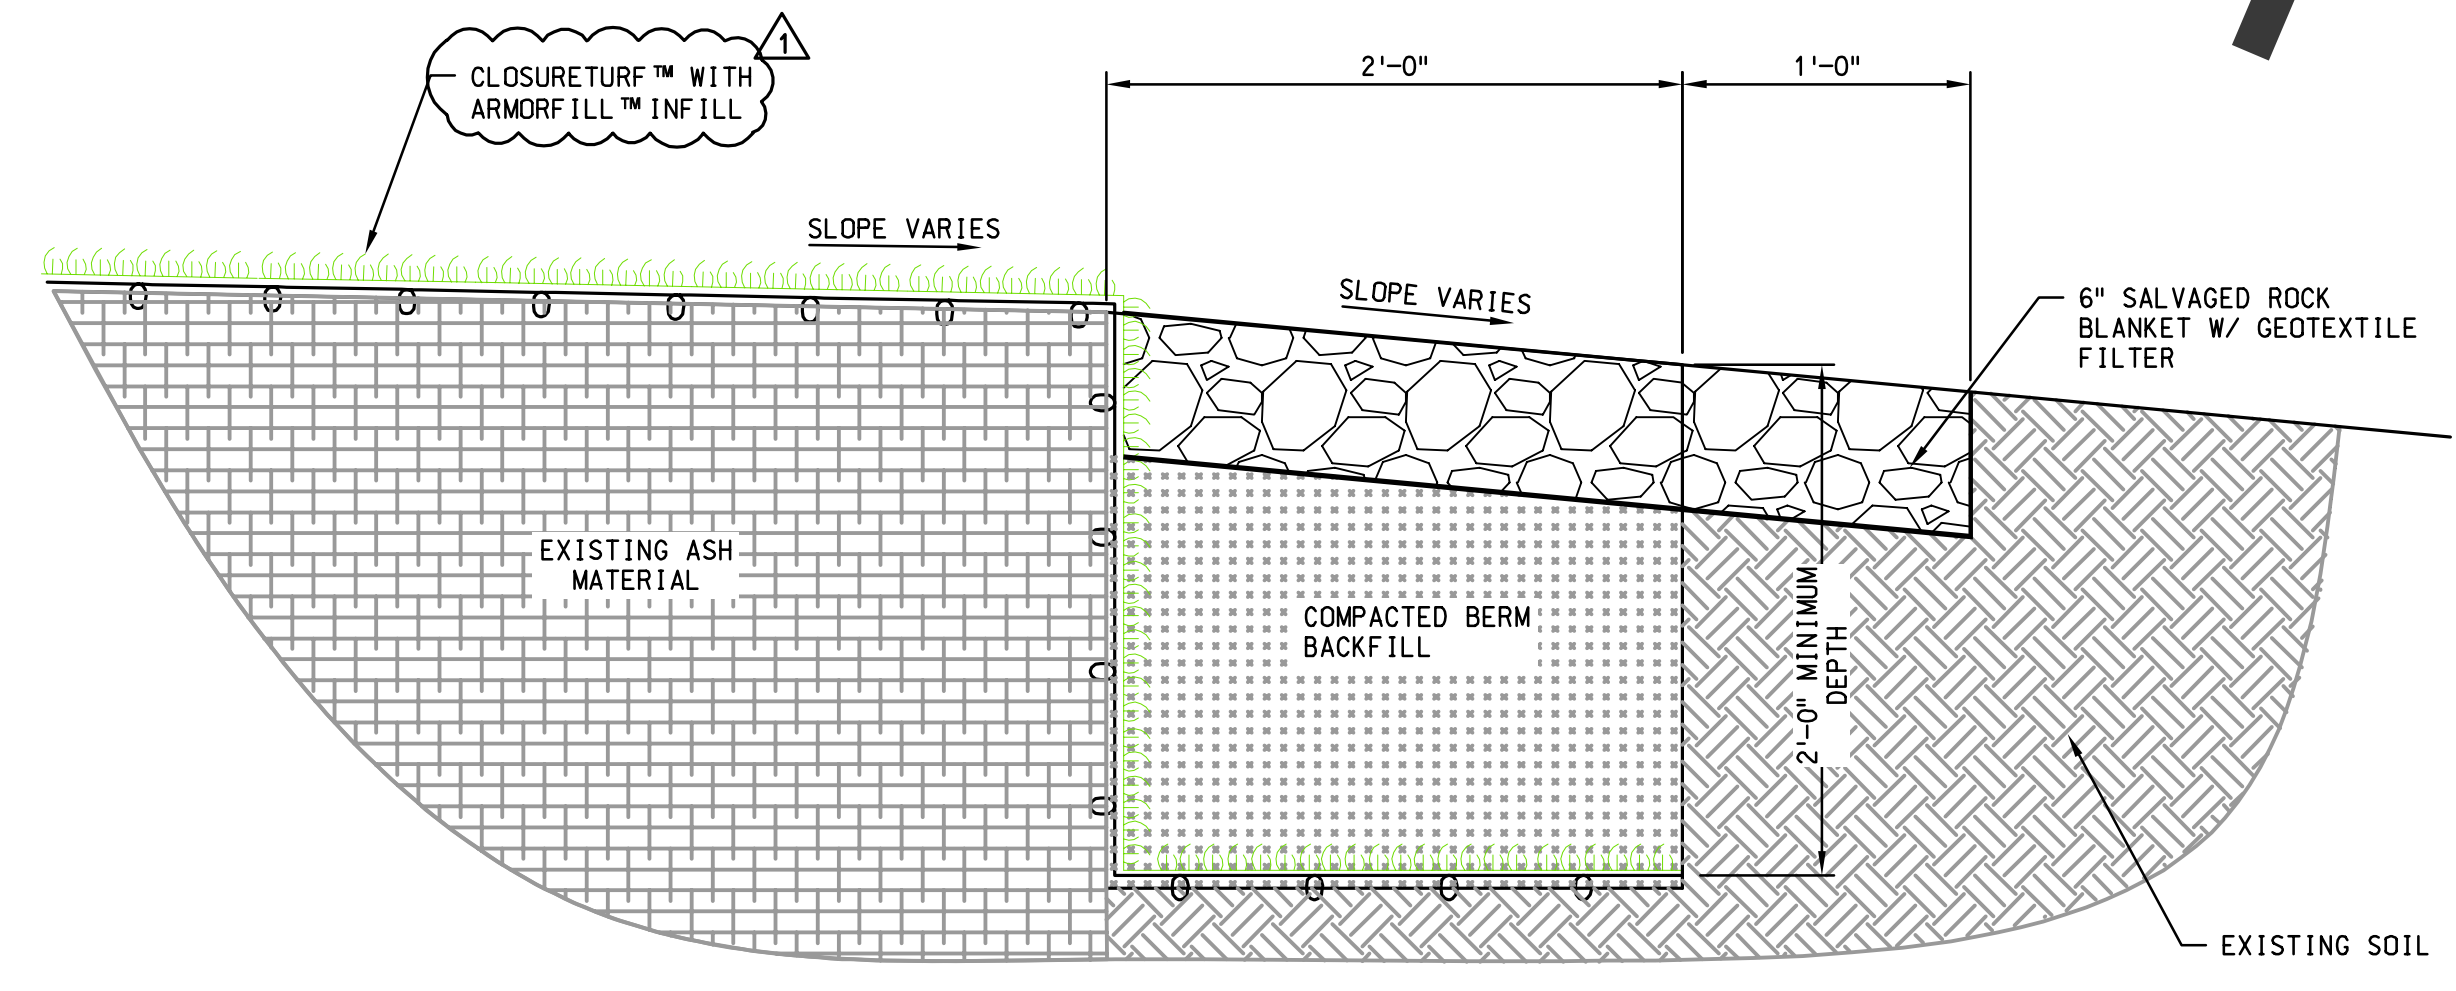
NOTE: SHALLOW SIDE ANCHOR TRENCH TO BE MINIMUM 2'-0\"/>

ANCHOR TRENCH (TYP.) NOT TO SCALE

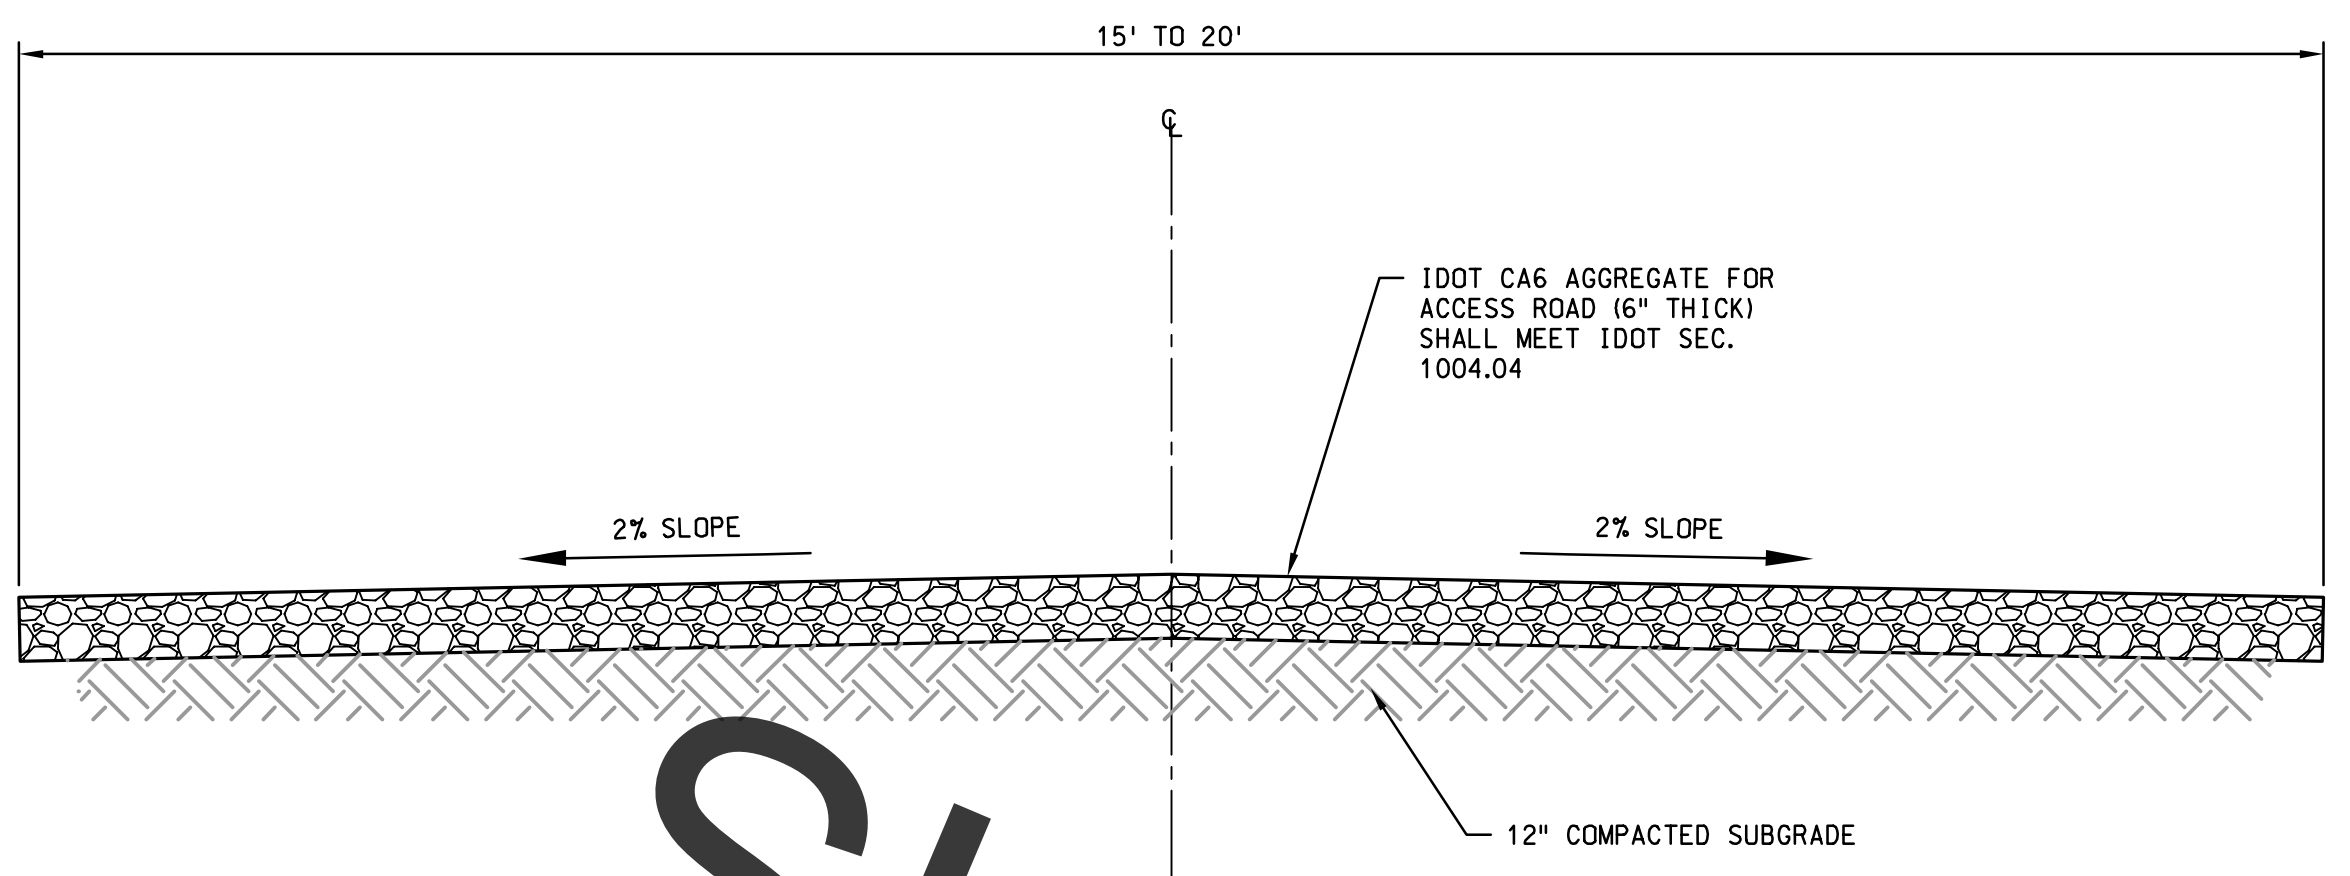
NOTE: 10% MAX. LONGITUDINAL SLOPE. SEE PAVEMENT DETAIL FOR AGGREGATE.

TYPICAL SECTION - GRAVEL ACCESS ROAD (10)
NOT TO SCALE
STA. 57+00 TO STA. 63+55
SEE SHEET C-111 FOR ACCESS ROAD PROFILE

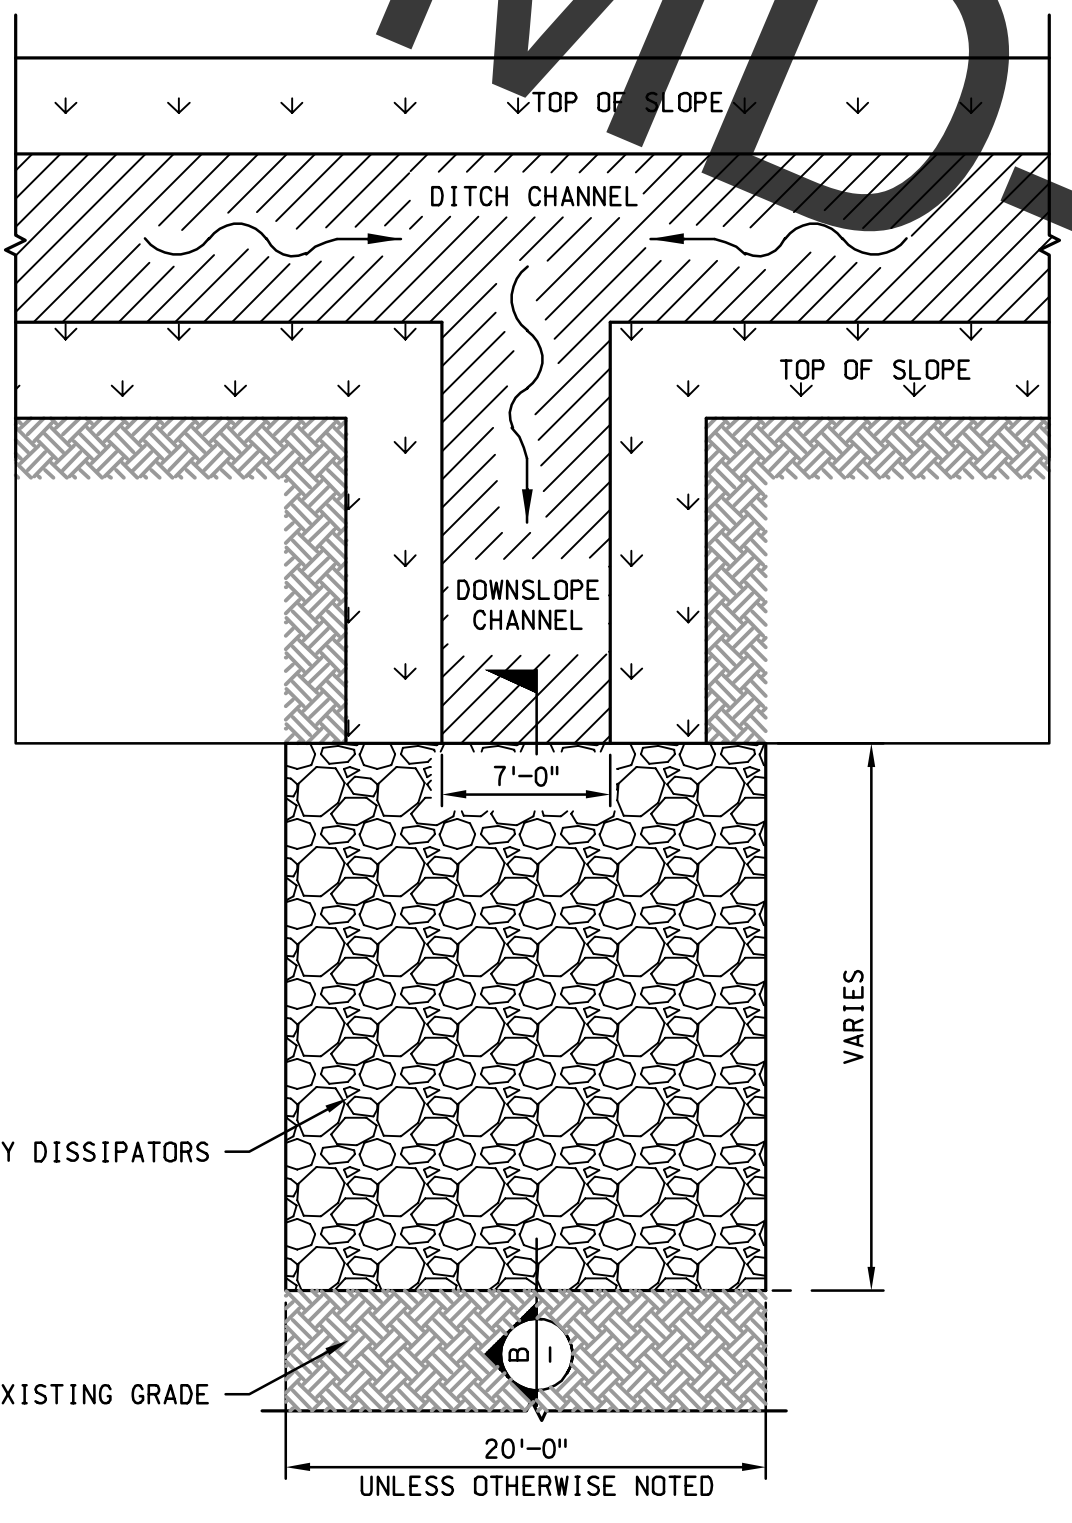
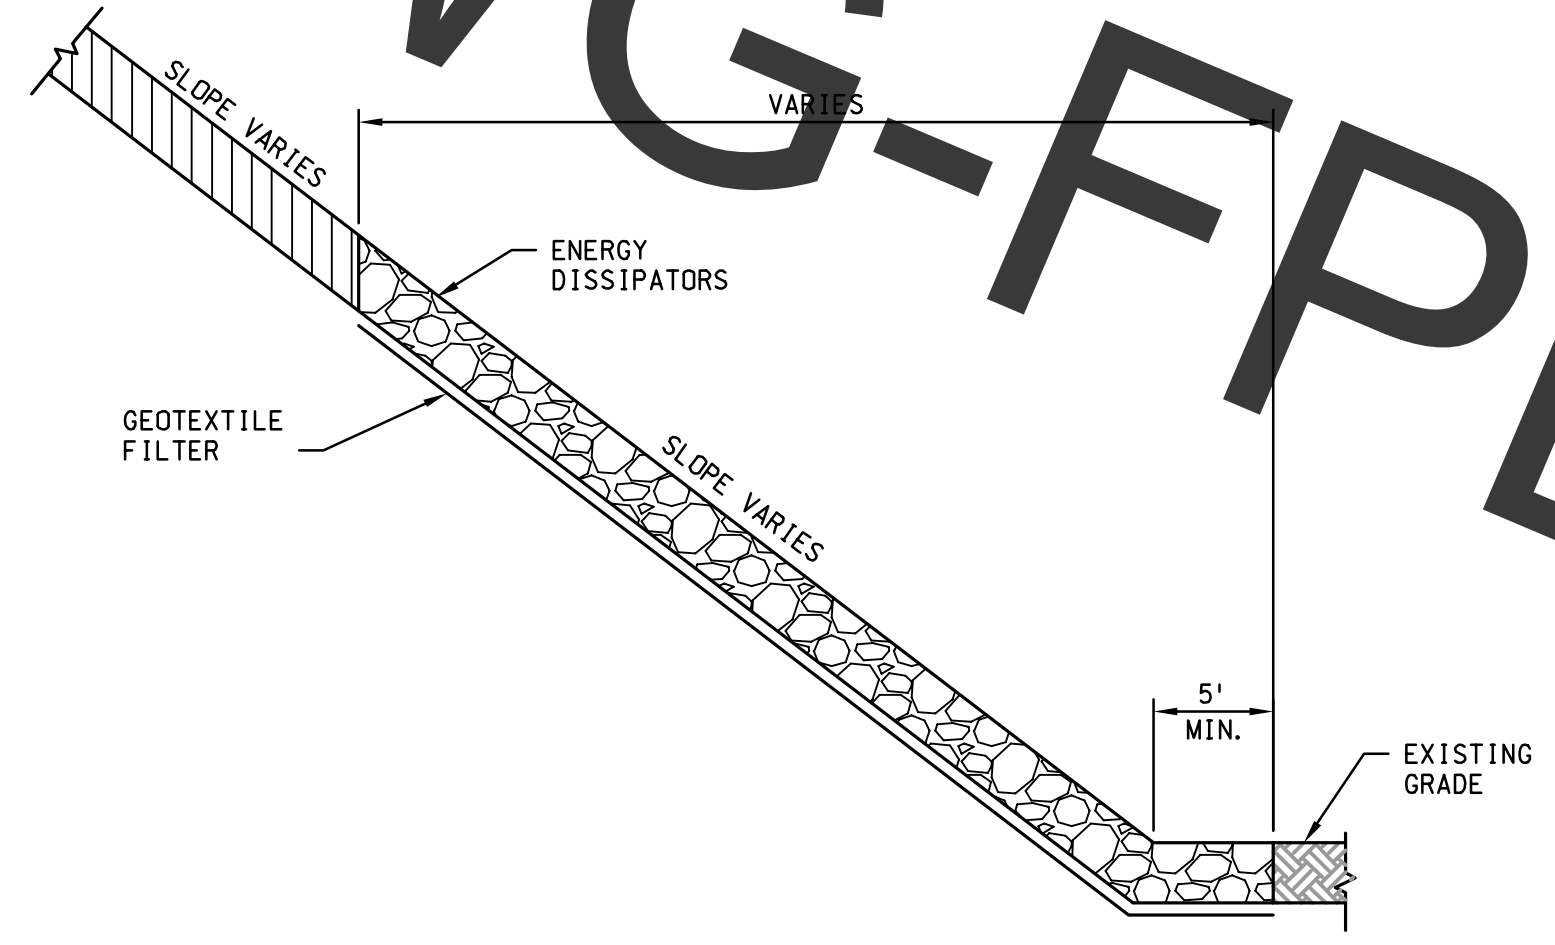
PLAN

PROFILE (12)

ENERGY DISSIPATOR @ DITCH DOWNSLOPE CHANNEL (TYP.) (12)
NOT TO SCALE

NOTE:
ENERGY DISSIPATORS AT SPECIFIED LOCATIONS SHALL HAVE THE FOLLOWING ROCK SIZES AND DEPTHS OF ROCK:
ENERGY DISSIPATOR
SPECIFICATION:
CRUSHED STONE
IDOT RR-4
DEPTH = 2'
D50 = 15"
6\"/>

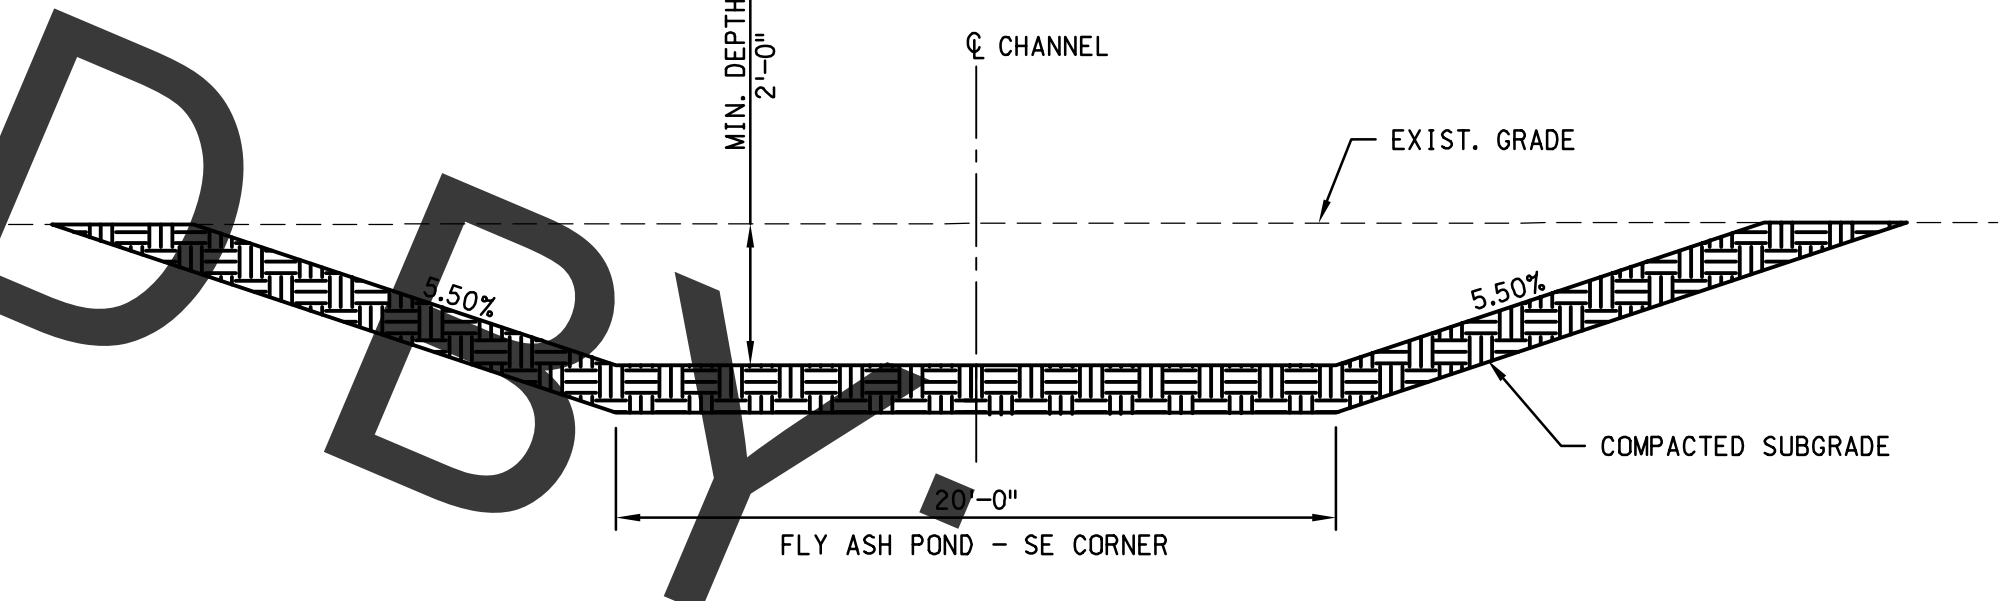
EARTHEN DRAINAGE CHANNEL DETAIL (13)
NOT TO SCALE

NOTE: MAINTAIN 1 FOOT OF FREEBOARD & 0.50% MIN. LONGITUDINAL SLOPE

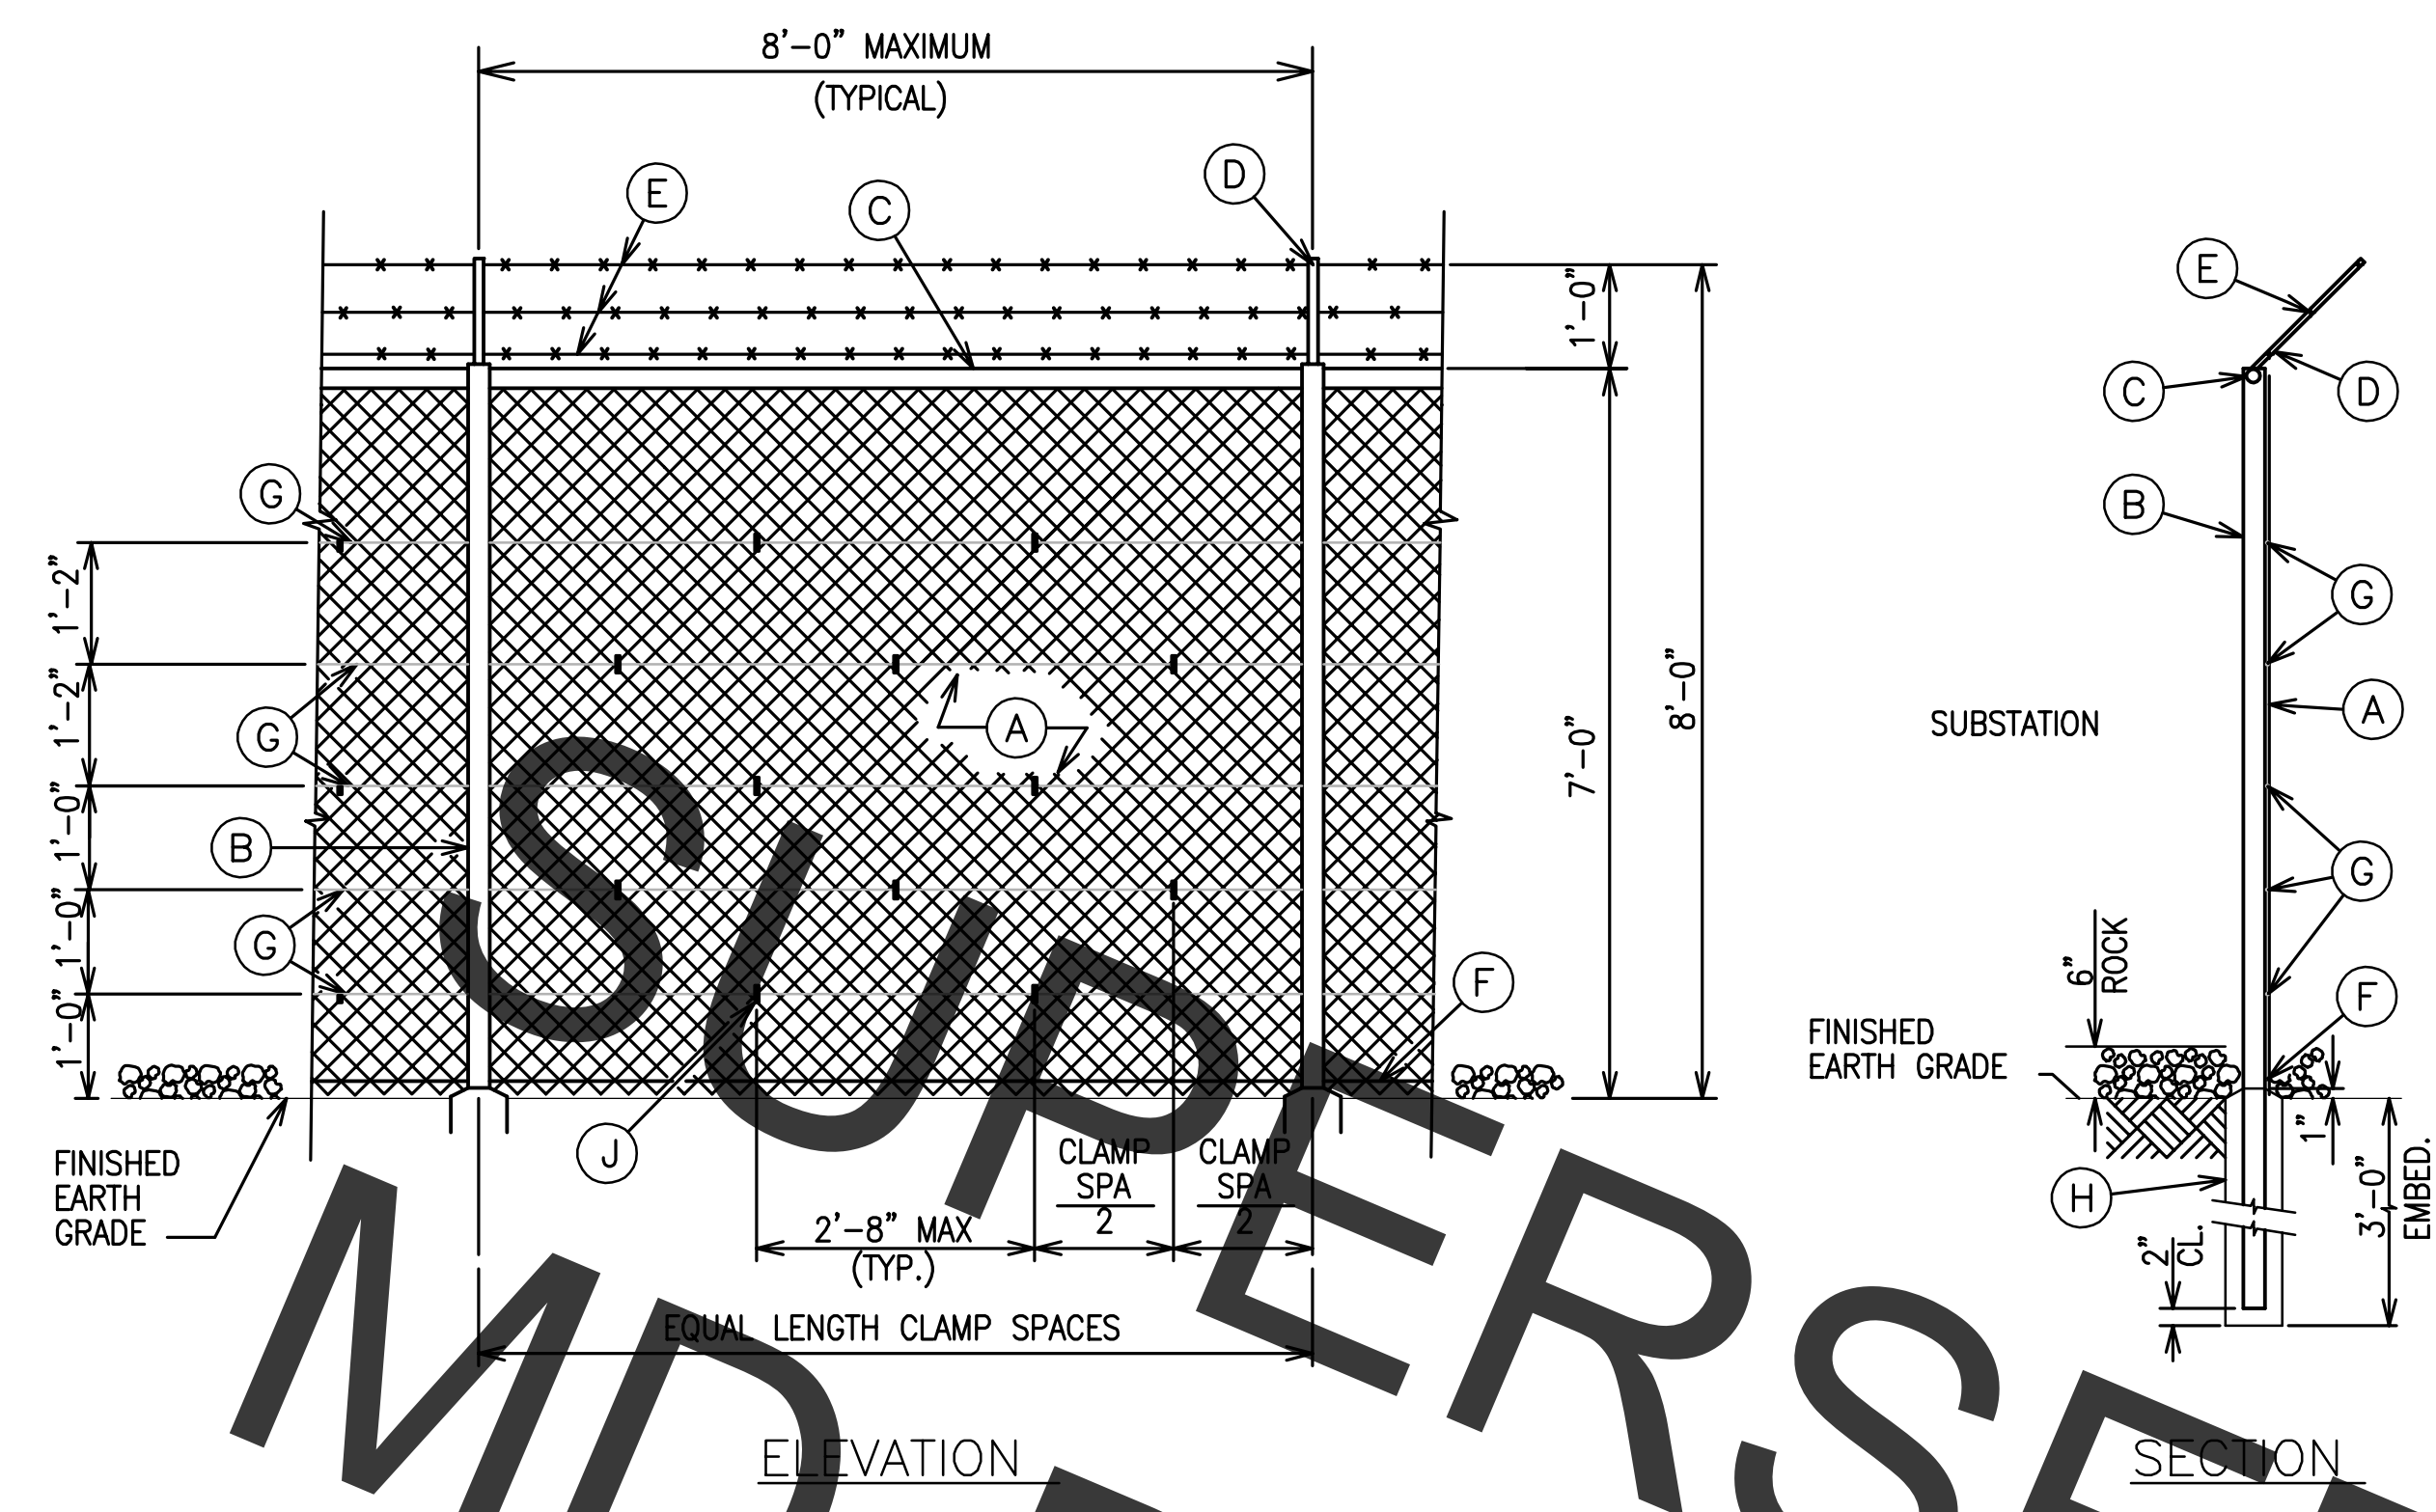
- MATERIAL LIST - NEW FENCE**
- (A) CHAINLINK FABRIC - #9 GAUGE STEEL WIRE, WOVEN 1" MESH SIZE FENCE, W/ A CLASS II ALUM. COATING.
 - (B) LINE POST - 23/8" O.D. ALLIED SS-40 OR WHEATLAND WT-40 GALV. STEEL PIPE
TERMINAL POST - 4" O.D ALLIED SS-40 OR WHEATLAND WT-40 GALV. STEEL PIPE
DRIVE GATE POST - 65/8" O.D. ASTM A53 GALV. STEEL PIPE

- (C) TOP RAIL - 15/8" O.D. ALLIED SS-40 OR WHEATLAND WT-40 GALV. STEEL PIPE
 - (D) EXTENSION ARM - ARRANGED TO CARRY 3 STRANDS OF BARBED WIRE, 45' TO OUTSIDE

- NOTE: FENCE SHALL BE PER SPEC. NO 02821, EXCEPT AS SHOWN.

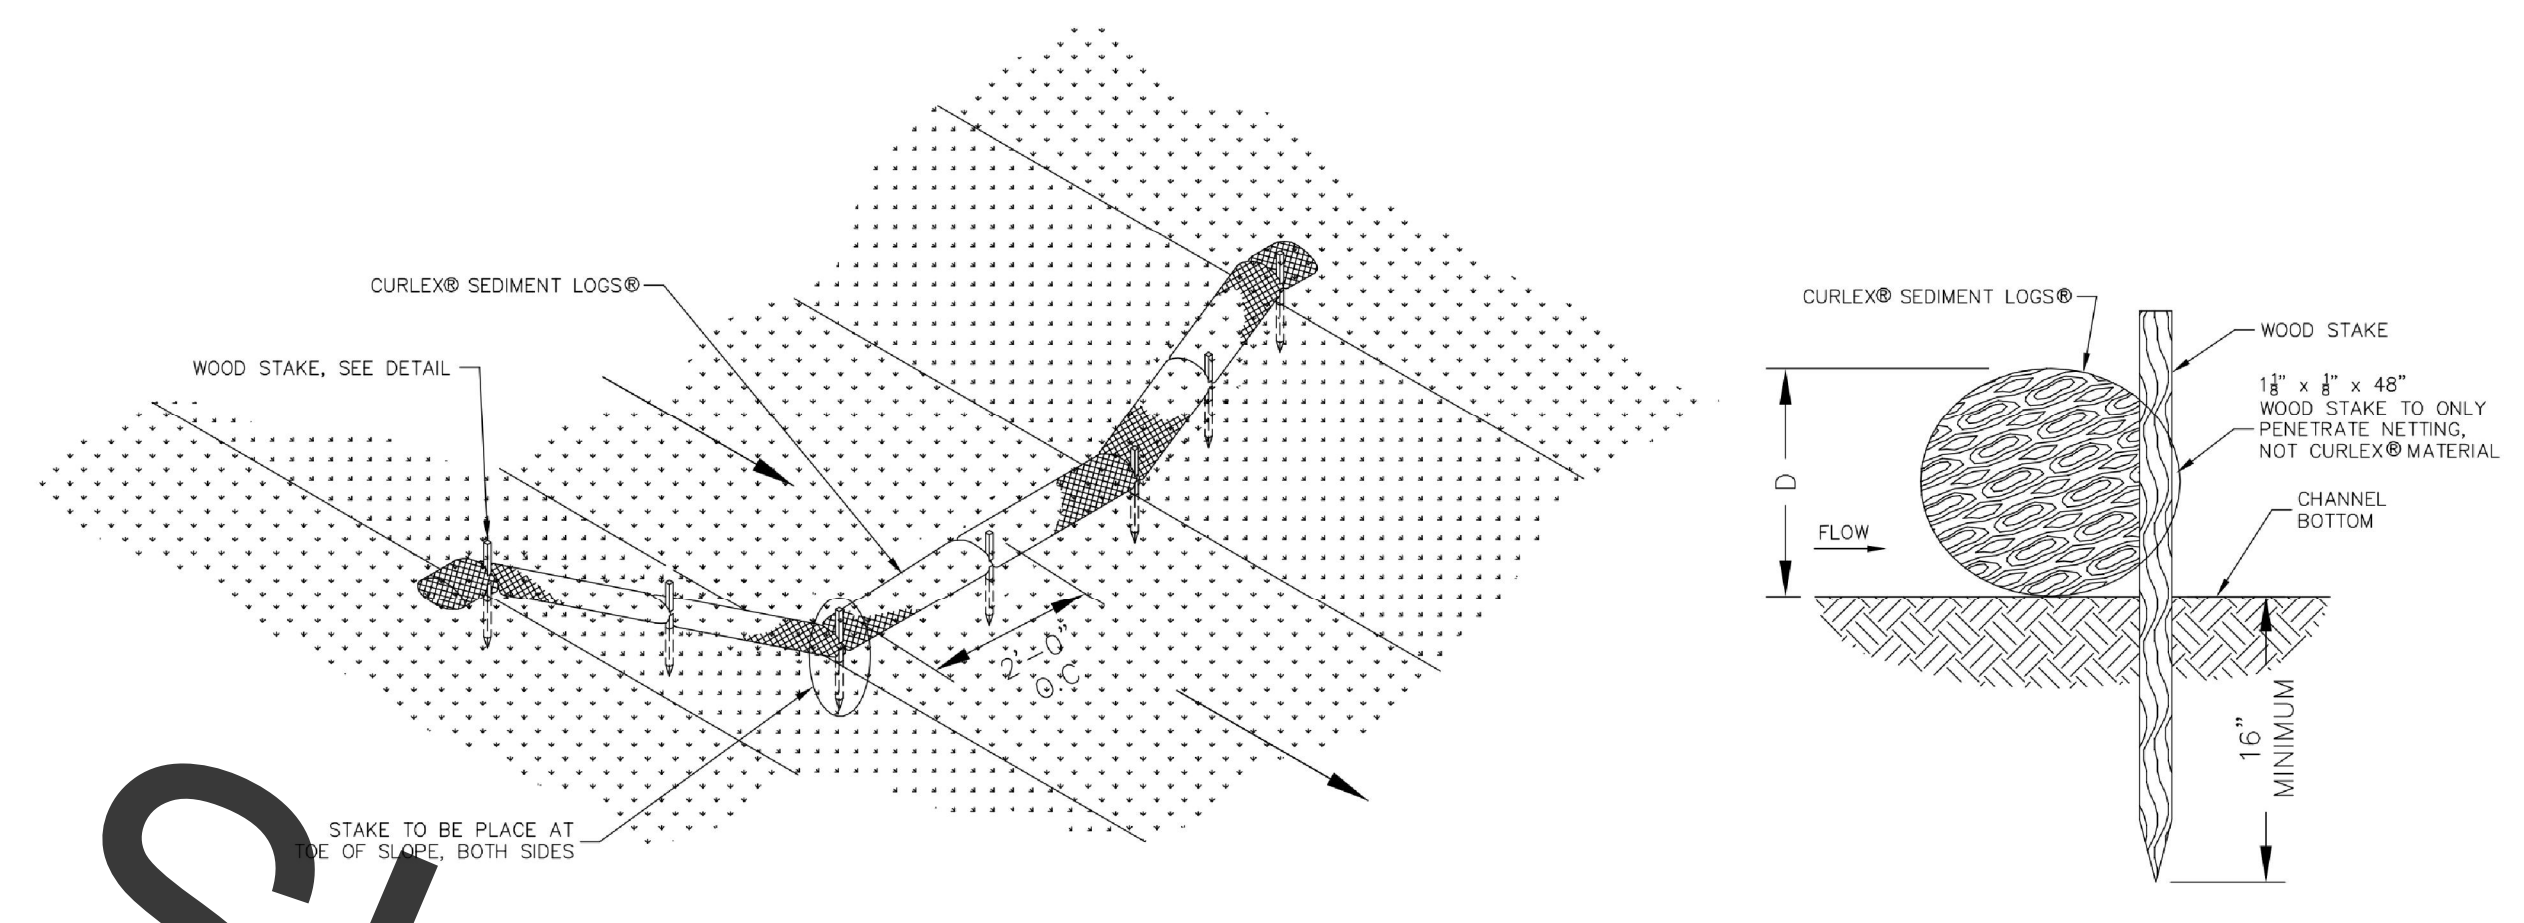
$$\left[\frac{\text{DISTANCE BETWEEN CHANNEL BOTTOM AND TOP OF INSTALLED CURLEX SEDIMENT LOGS (DEPTH)}}{\text{CHANNEL GRADIENT (\%)}} \right] \times 100 = \text{CURLEX SEDIMENT LOGS SPACING (ft)}$$
