BEFORE THE ILLINOIS POLLUTION CONTROL BOARD

In the Matter of:)	
)	
)	
STANDARD FOR THE DISPOSAL OF)	
COAL COMBUSTION RESIDUALS)	PCB 2020-019
IN SURFACE IMPOUNDMENTS:)	(Rulemaking - Water)
PROPOSED NEW 35 ILL. ADMIN.)	
CODE 845)	
)	
)	
)	
)

Analysis is performed herein for the Initial Safety Factor Assessment of the existing ash ponds at Springfield City Water, Light and Power, Lakeside and Dallman Ash Ponds, Springfield, Illinois, as required per 40 CFR 257.73(e). Based upon historical geotechnical data and the existing conditions of the ash ponds, all factors of safety exceed the regulatory minimums as demonstrated within this report.

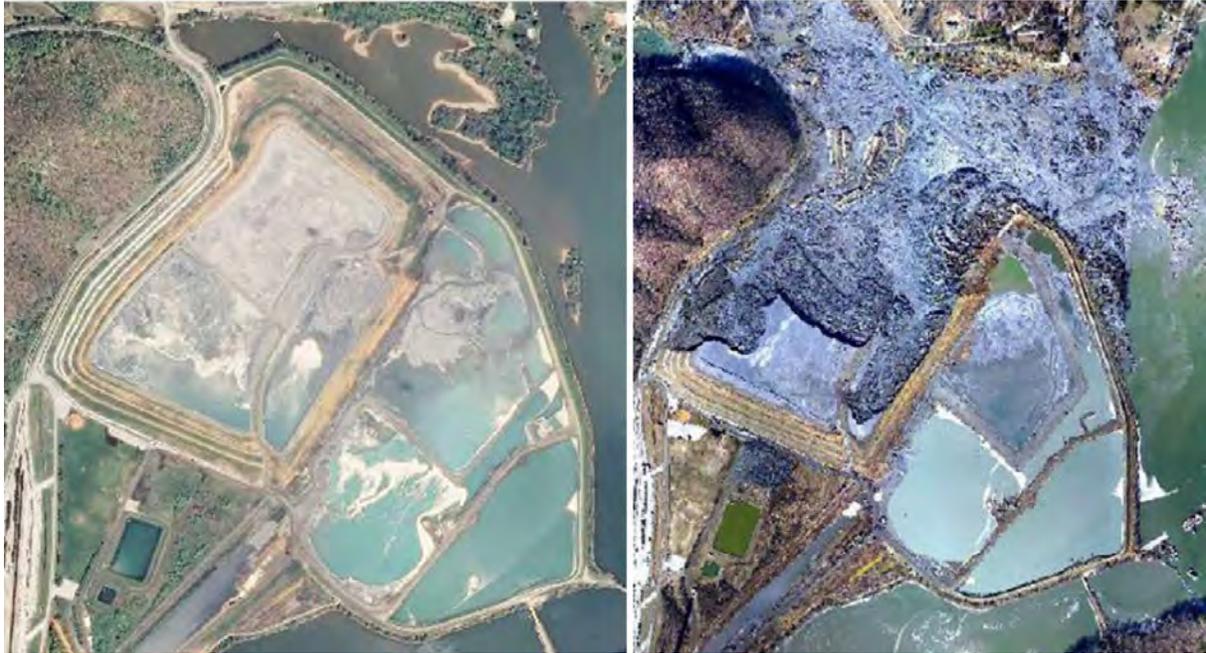
Figure 1: Aerial photographs comparing the Kingston Fossil Plant ash disposal area before and after the massive slope failure on December 22, 2008.

The AECOM Root Cause Analysis report attributed the failure as most likely due to creep in the aforementioned weak layer due to active loading in a dredge cell contained within the disposal area. This creep caused an initial failure of various disposal phase dikes founded on older disposed ash deposits, which, in turn, caused progressive failure of upstream ashes, leading to undrained loading and subsequent failure of the downstream ash material and disposal area perimeter dike. The upstream progressive failure stopped upon reaching a former divider dike within the disposal area. The estimated ash released in the failure was 5.4 million cubic yards. Figure 1 provides an aerial photograph of the disposal area before and after the slope failure.

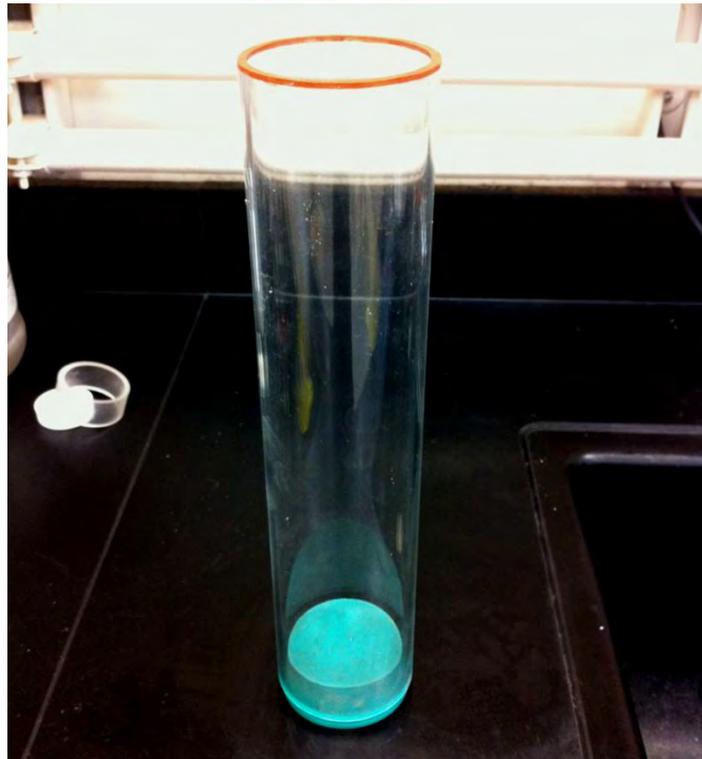
- Acrylic mixing tube, with an outer diameter slightly smaller than the target diameter of the sample being formed and a plug to seal off one end. The end opposite of the mixing tube will have rubber gasket seal glued around the rim. The other dimensions of this tube will be discussed later.

Figure 33: Acrylic mixing tube with a rubber stopper on one end and rubber gasket seal glued to the opposite end.

Figure 33: Acrylic mixing tube with a rubber stopper on one end and rubber gasket seal glued to the opposite end. 68

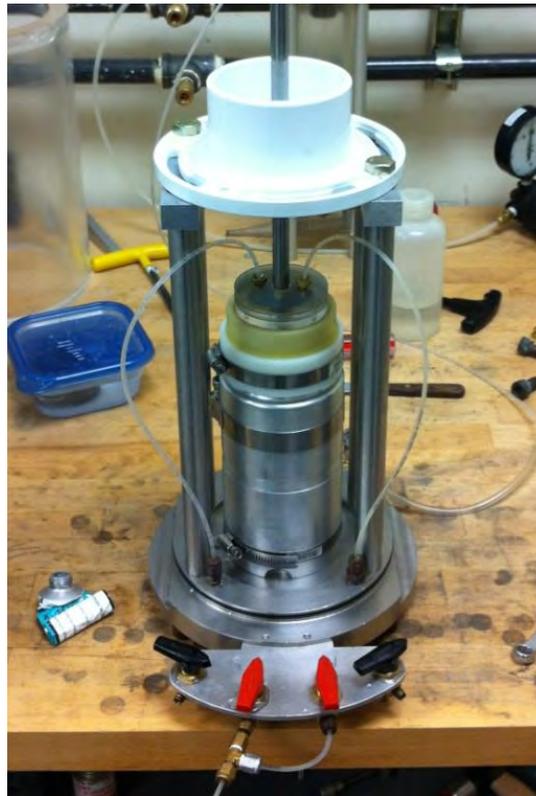
mixing tube water bath and oven-dried and later weighed to save time). Once the water level has dropped enough to allow removal of the extra membrane or flexible PVC connection, the slurry can be densified by attaching the top platen (which also has a filter-paper applied), applying a small pressure, and vibrating the sample if necessary, while allowing excess pore pressures to dissipate through top and bottom drainage lines, as shown in Figure 41. This should be done such that the piezometric pressure is the same across the sample, which was postulated to form specimens of sand at uniform densities with height by Vaid and Negussey (1988).

Figure 41: Setup used to densify SI CCR slurry-deposition samples. Notice that the short-circuit between the top and bottom drainage is being used to drain the sample as it is densified with the top platen applied. The top platen fits snugly enough into the extension collar to keep a water-proof seal. The white piece on the top of the triaxial base is simply a part to keep the piston plumb as the slight pressure is applied to the top of the sample during densification.

Figure 41: Setup used to densify SI CCR slurry-deposition samples. Notice that the short-circuit between the top and bottom drainage is being used to drain the sample as it is densified with the top platen applied. The top platen fits snugly enough into the extension collar to keep a water-proof seal. The white piece on the top of the triaxial base is simply a part to keep the

This vibrating can be accomplished with either a mechanical shaker or by tapping the side of the split mold gently with a mallet. However compaction of specimens to high relative densities can take quite a long time using a mallet, so a mechanical shaker would be preferable for SI CCR specimens. Once the target sample height is reached (and thereby the target sample volume reached), the extension collar is removed, the membrane is secured to the top platen with two o-

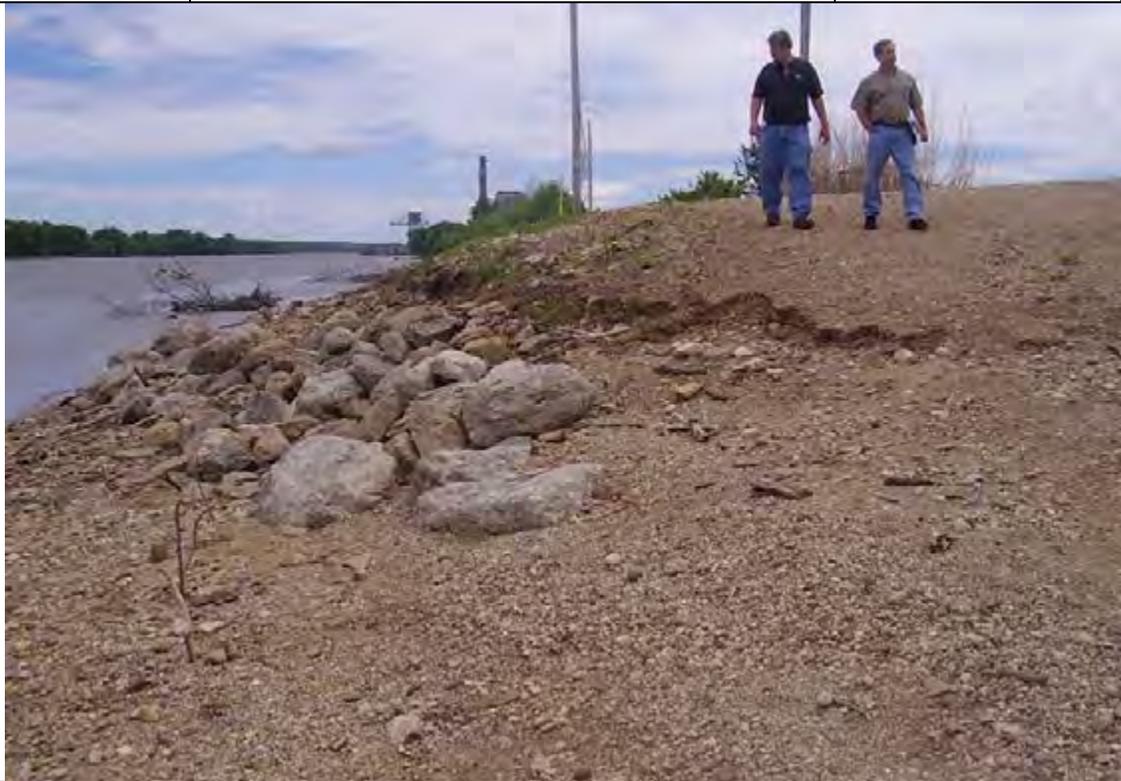
Description:
Downstream slope of the West Ash Pond System (WAPS) Impoundment.

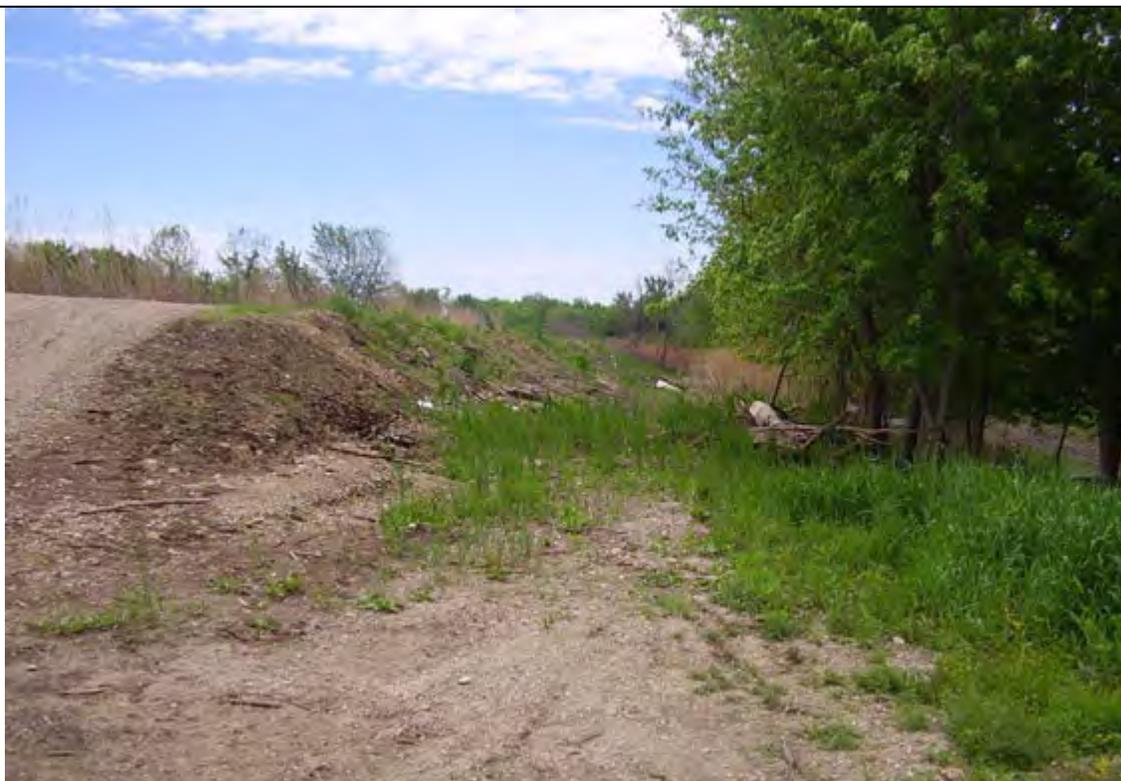
Description:
Downstream slope of the WAPS.

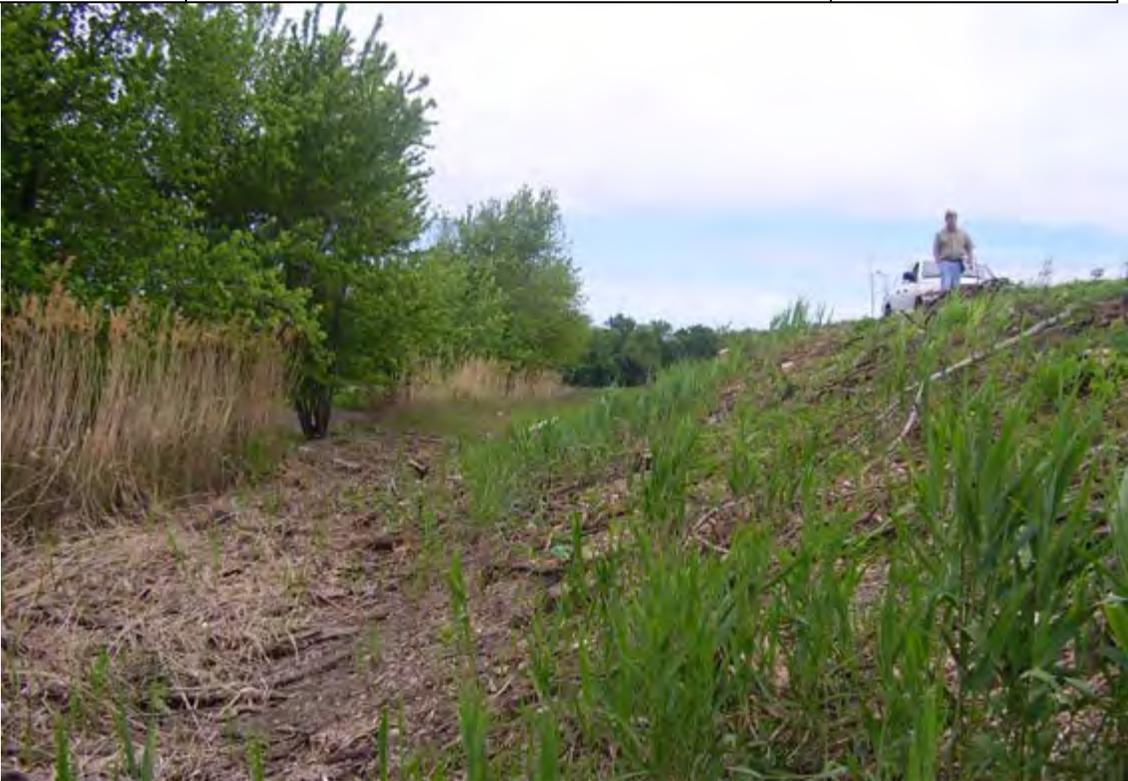
Description:
Downstream slope of the WAPS.

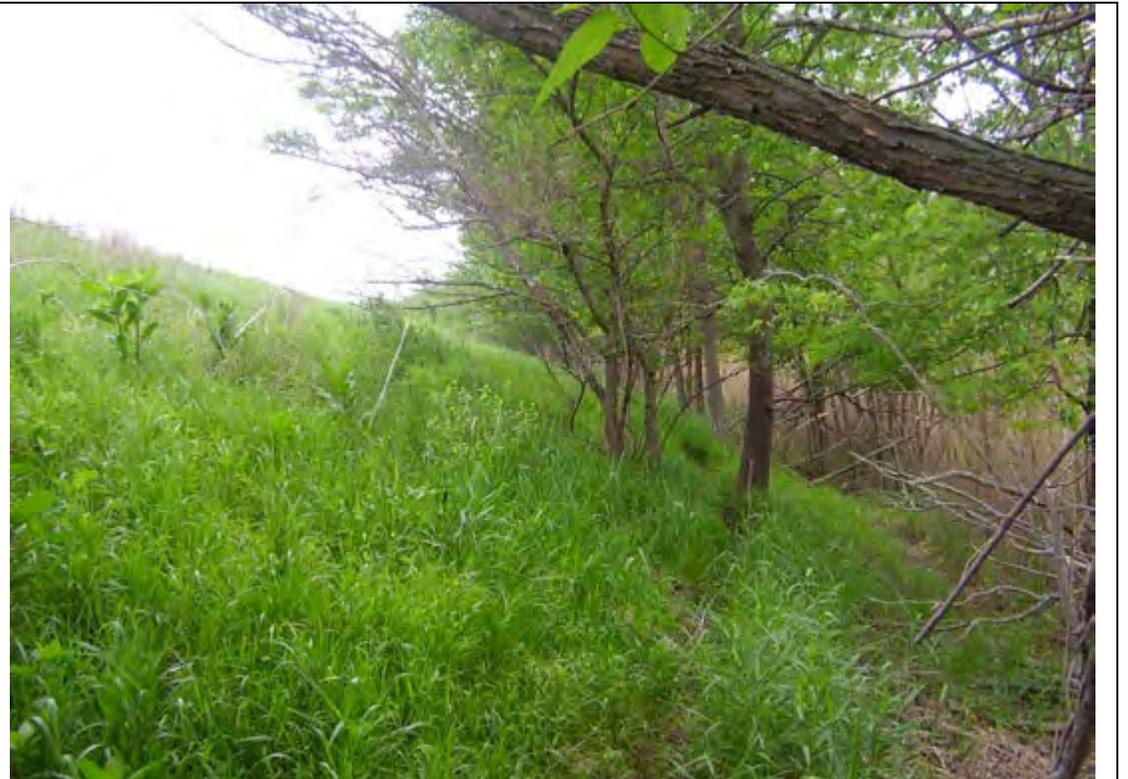
Photo No. 4	Date: 5/23/11
------------------------------	-------------------------

Description:
Downstream slope of the WAPS.

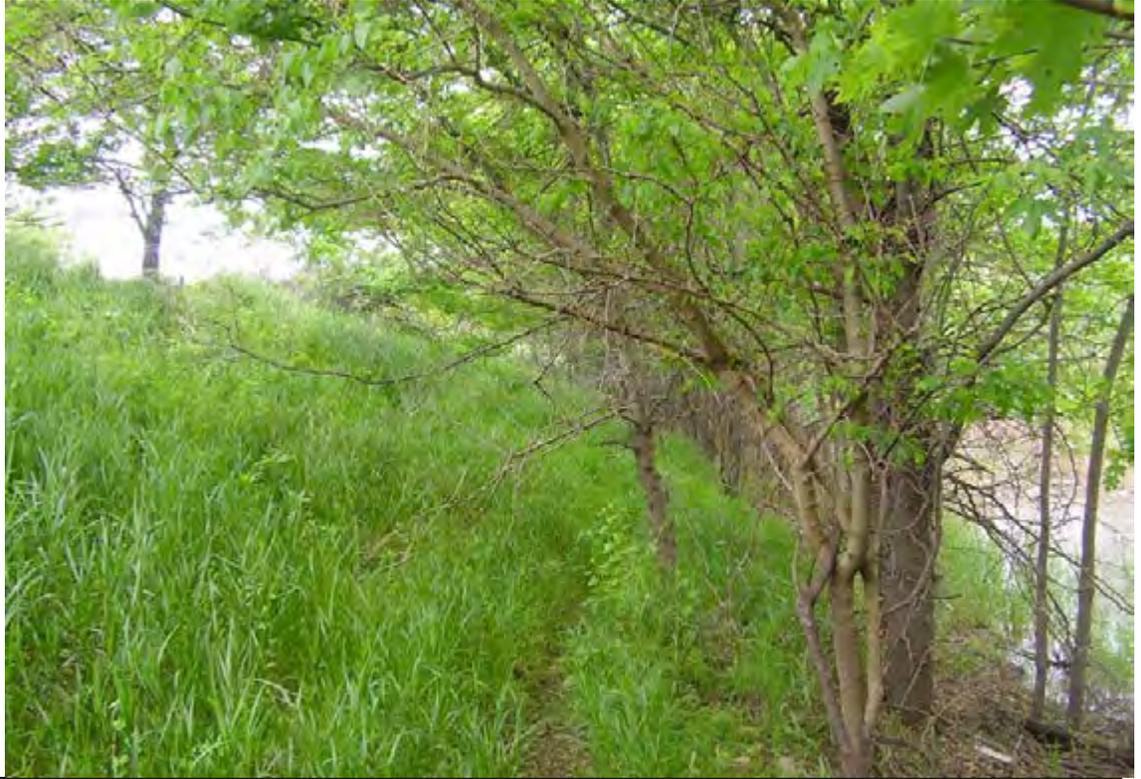
Description:
Downstream slope of the WAPS.

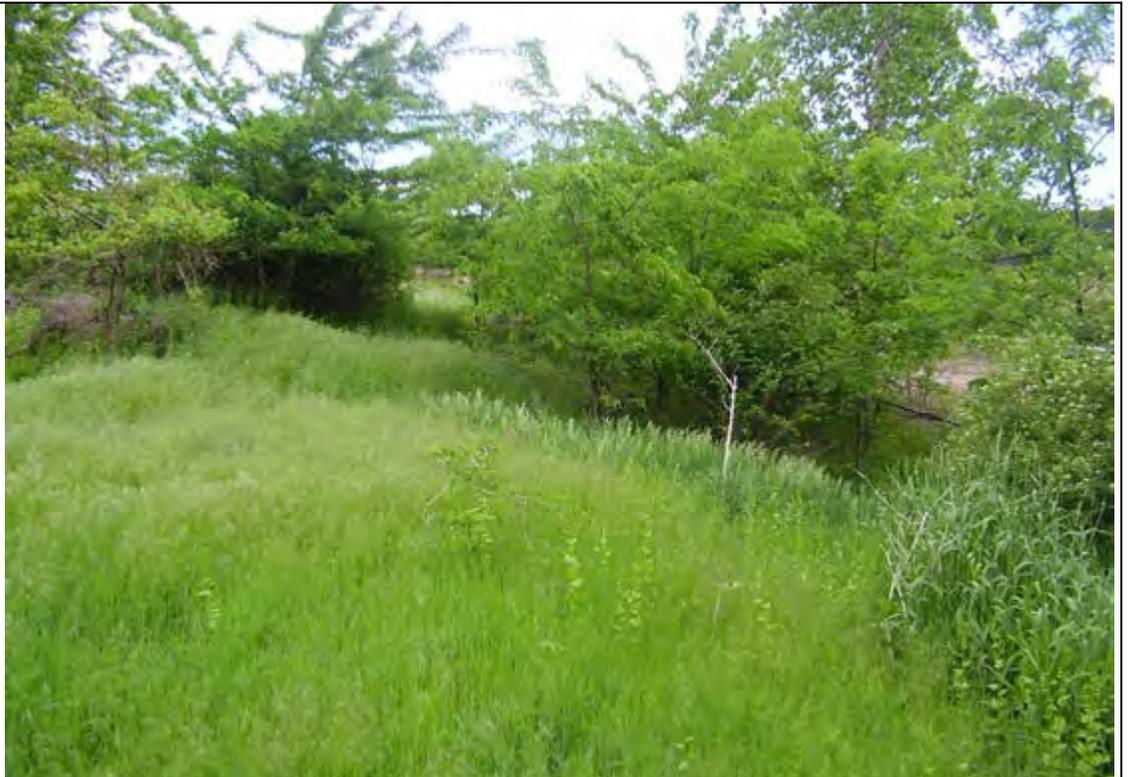
Photo No.
6

Description:
Crest and downstream slope of the WAPS.

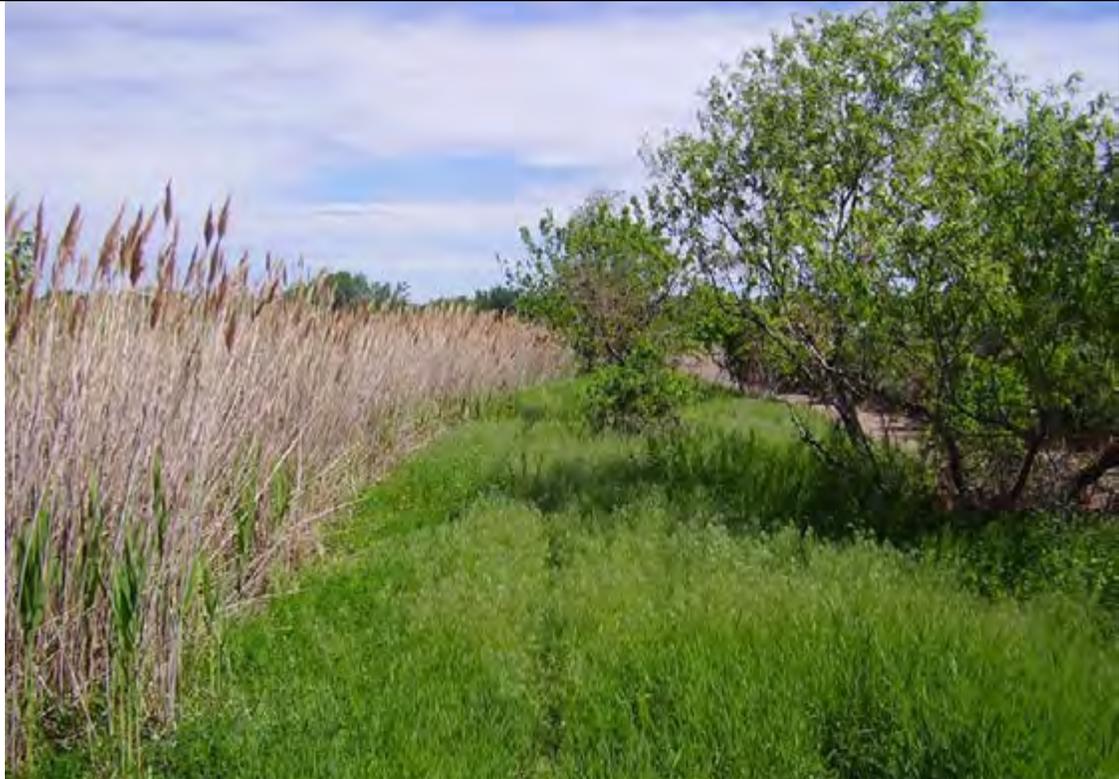
Photo No. 7	Date: 5/23/11
Direction Photo Taken: North

Description:
Crest and downstream slope of the WAPS.

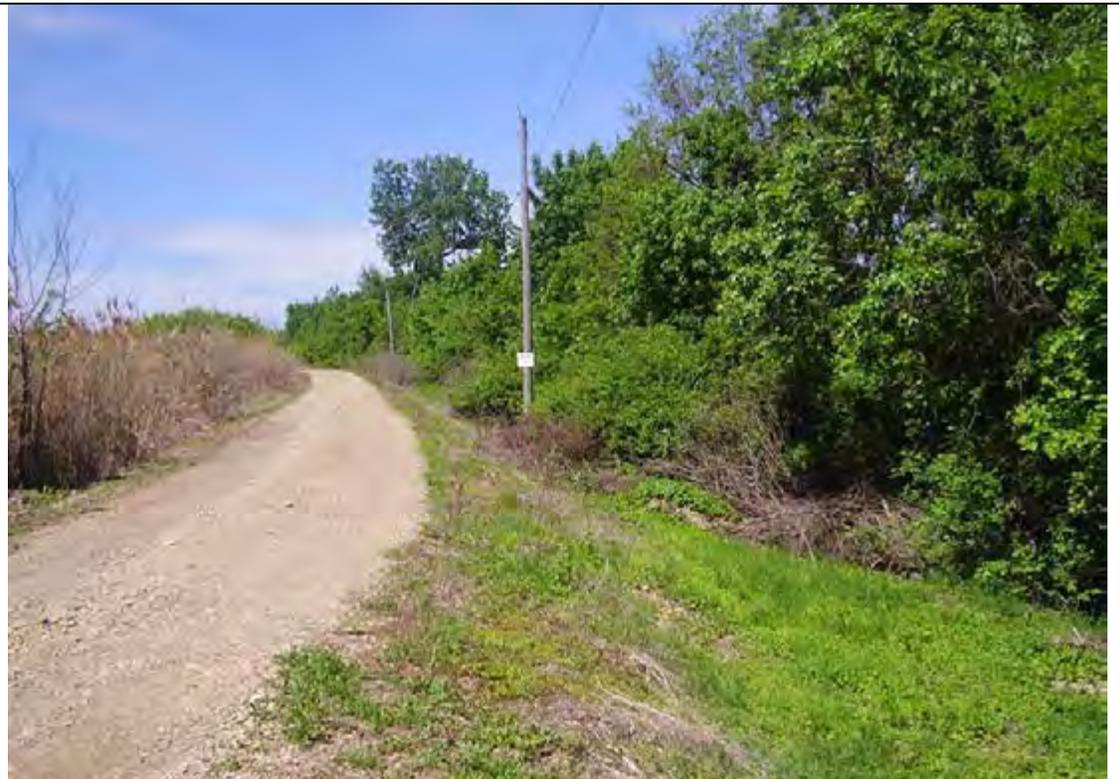
Photo No. 8	Date: 5/23/11
Direction Photo Taken: West

Description:
Crest and downstream slope of the WAPS.

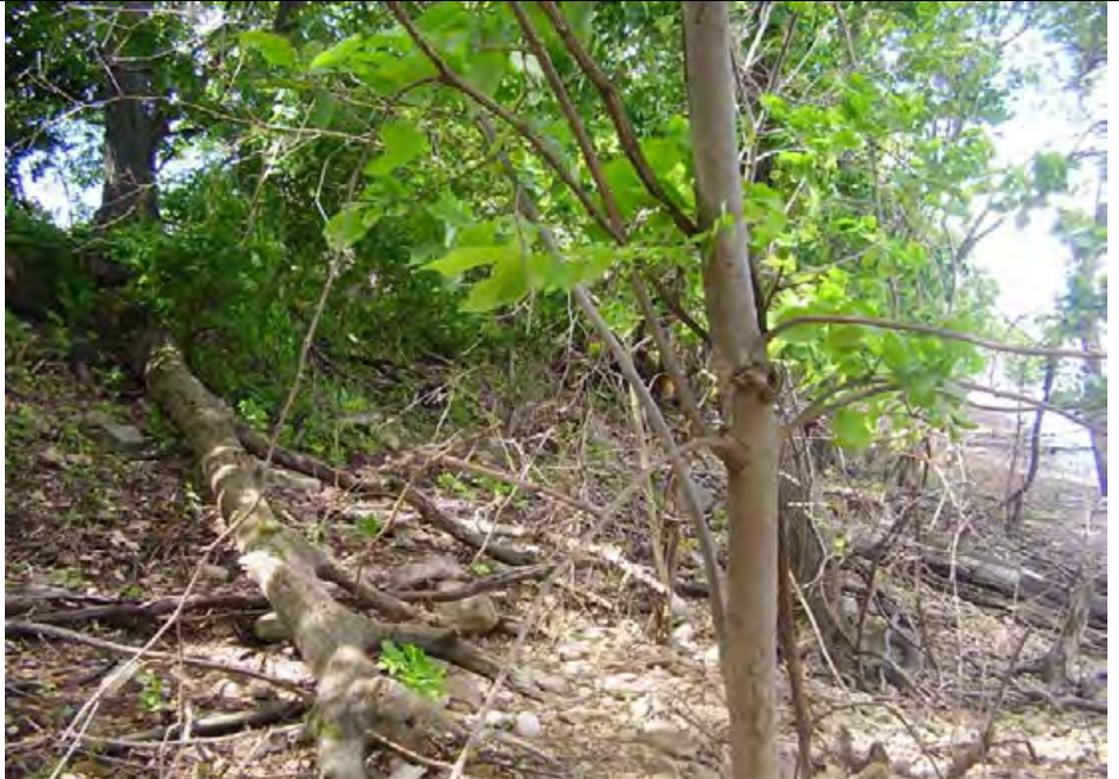
Photo No. 9	Date: 5/23/11
Direction Photo Taken: Southwest

Description:
Downstream slope of the WAPS.

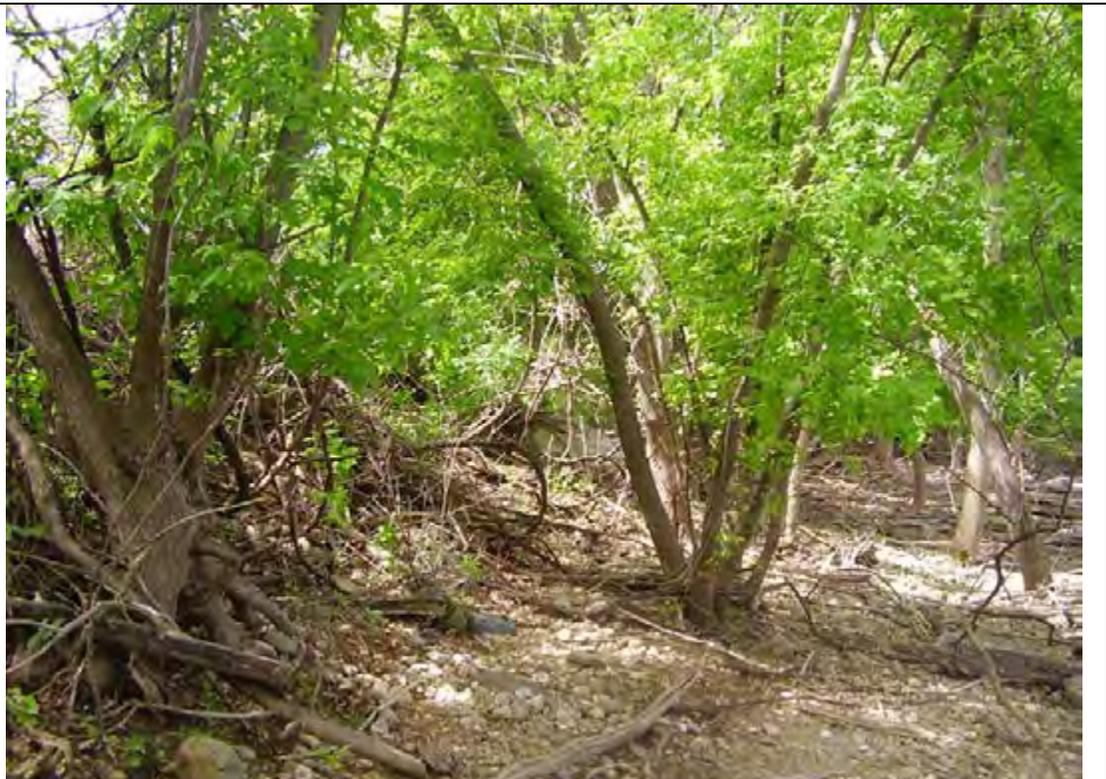
Photo No. 10	Date: 5/23/11
Direction Photo Taken: Southwest

Description:
Downstream slope of the WAPS.

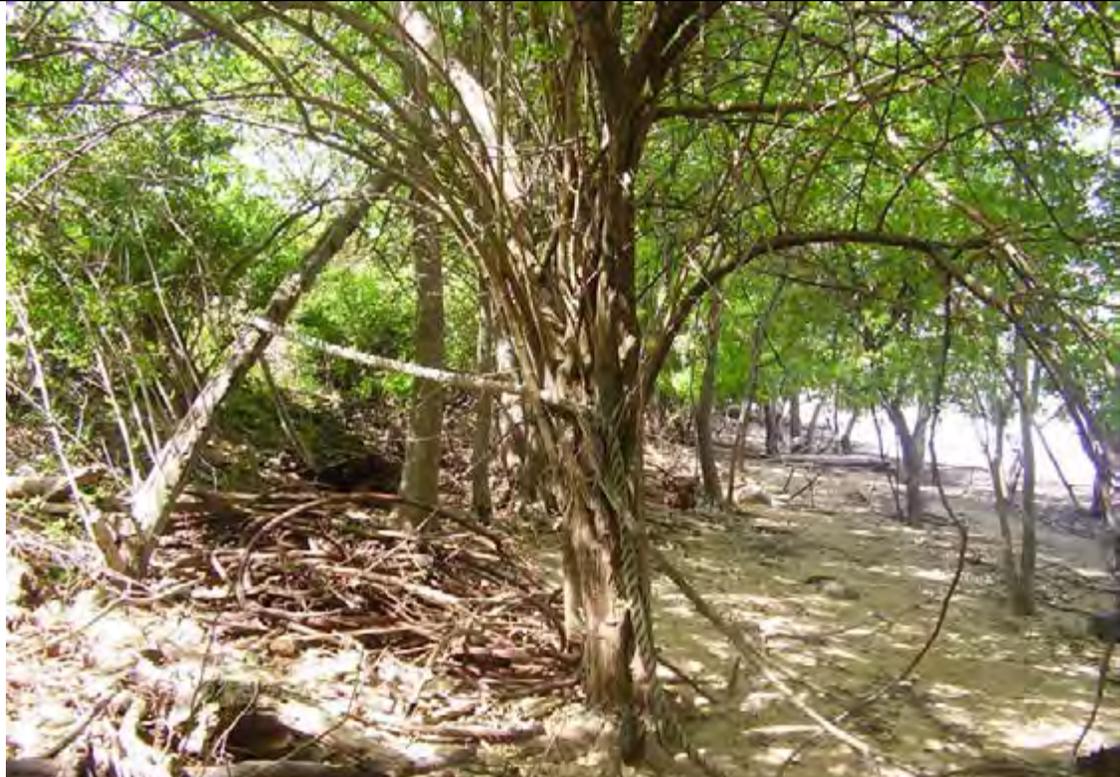
Description:
Downstream slope of the WAPS.

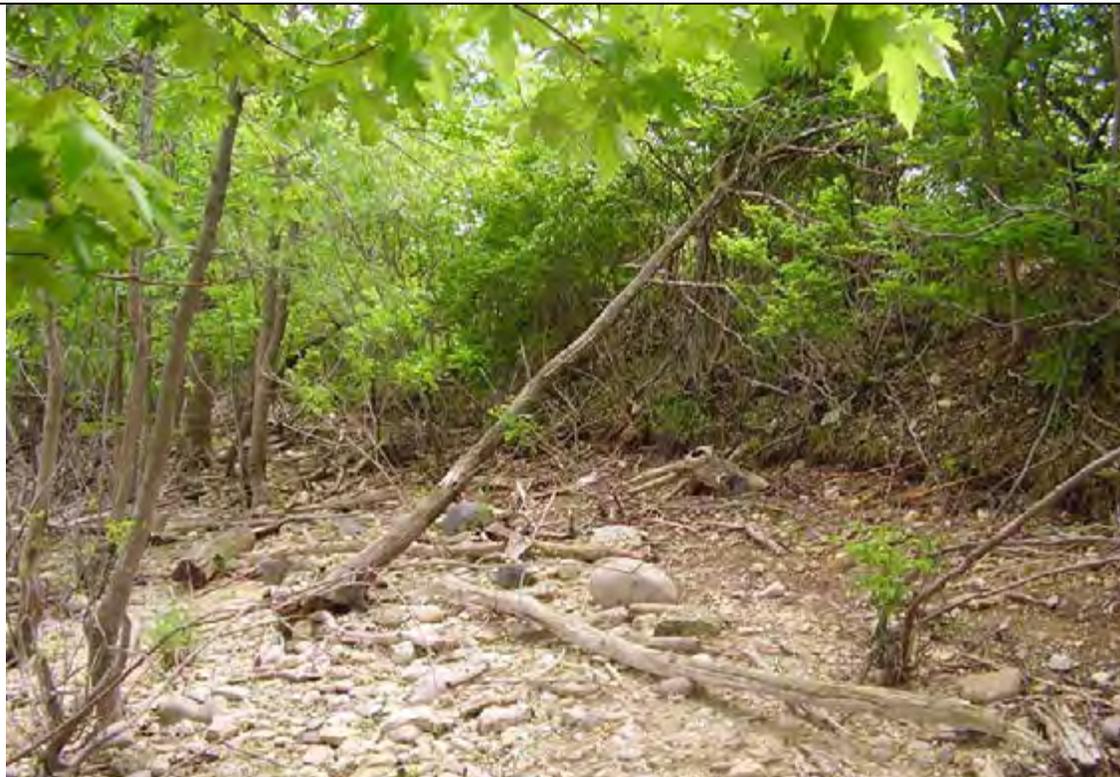
Photo No. 12	Date: 5/23/11
-------------------------------	-------------------------

Description:
Downstream slope of the WAPS.

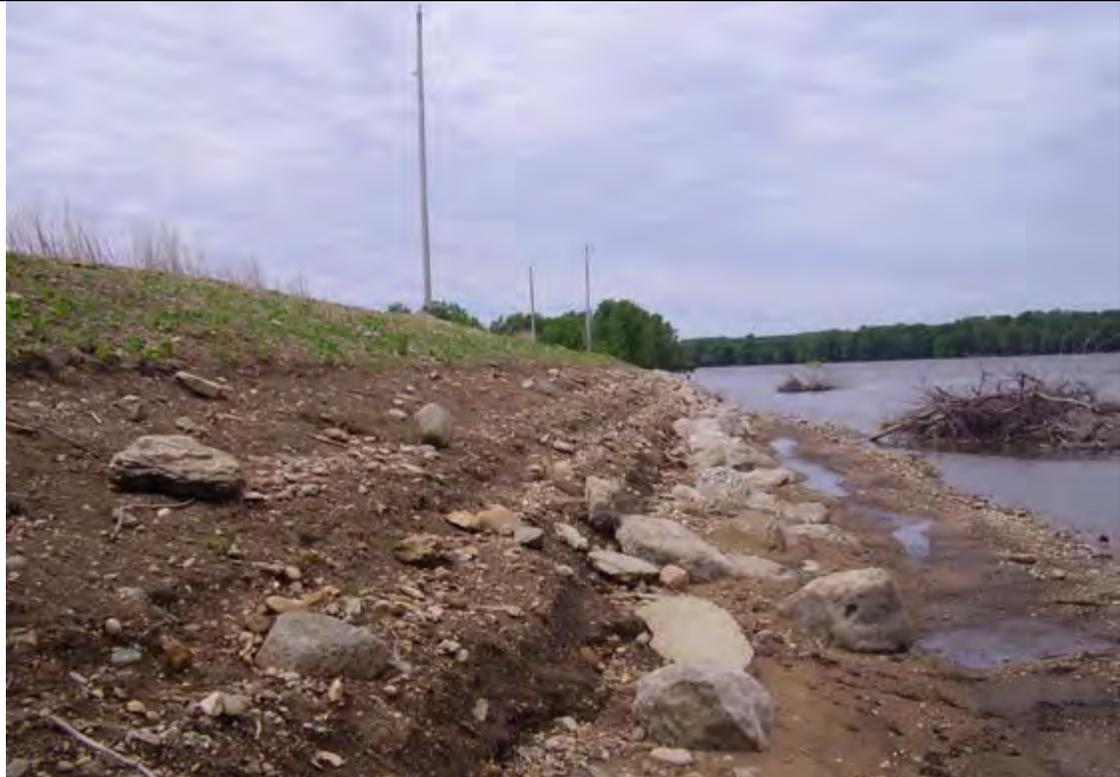
Description:
Downstream slope of the WAPS.

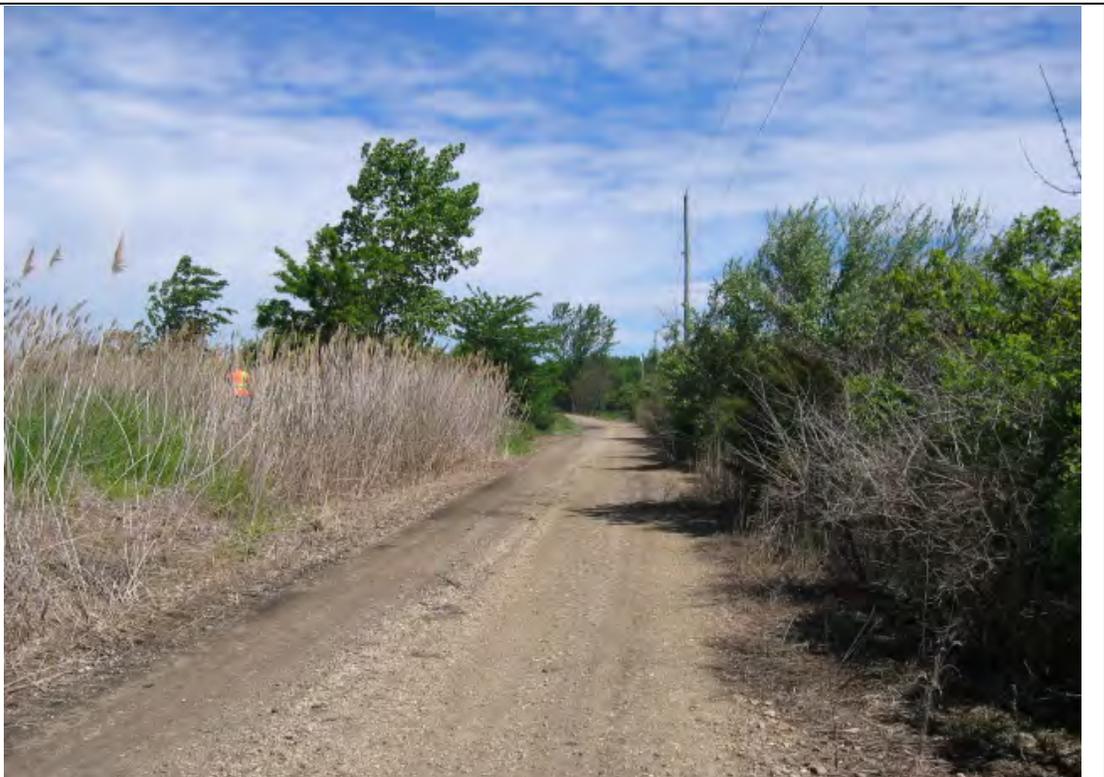
Photo No. 14	Date: 5/23/11
-------------------------------	-------------------------

Description:
Toe access road along the eastern portion of the WAPS.

2.1.13 WAPS Crest of Impoundment (Photos 14 through 20)

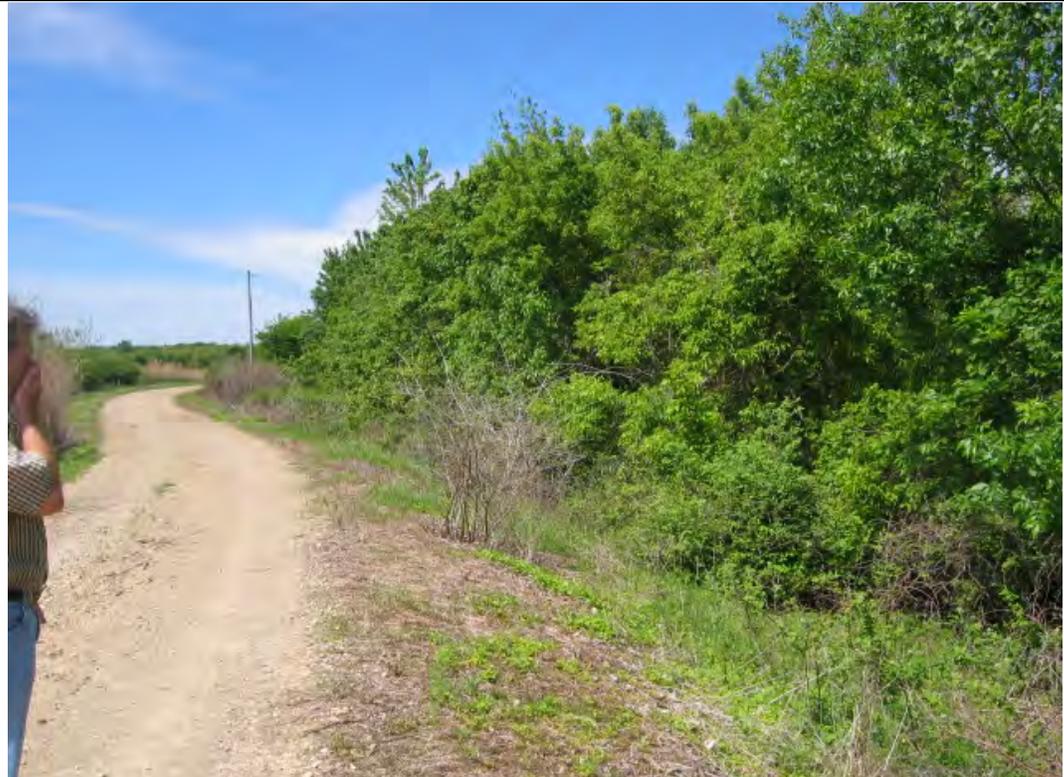
Description:
Crest of the WAPS.

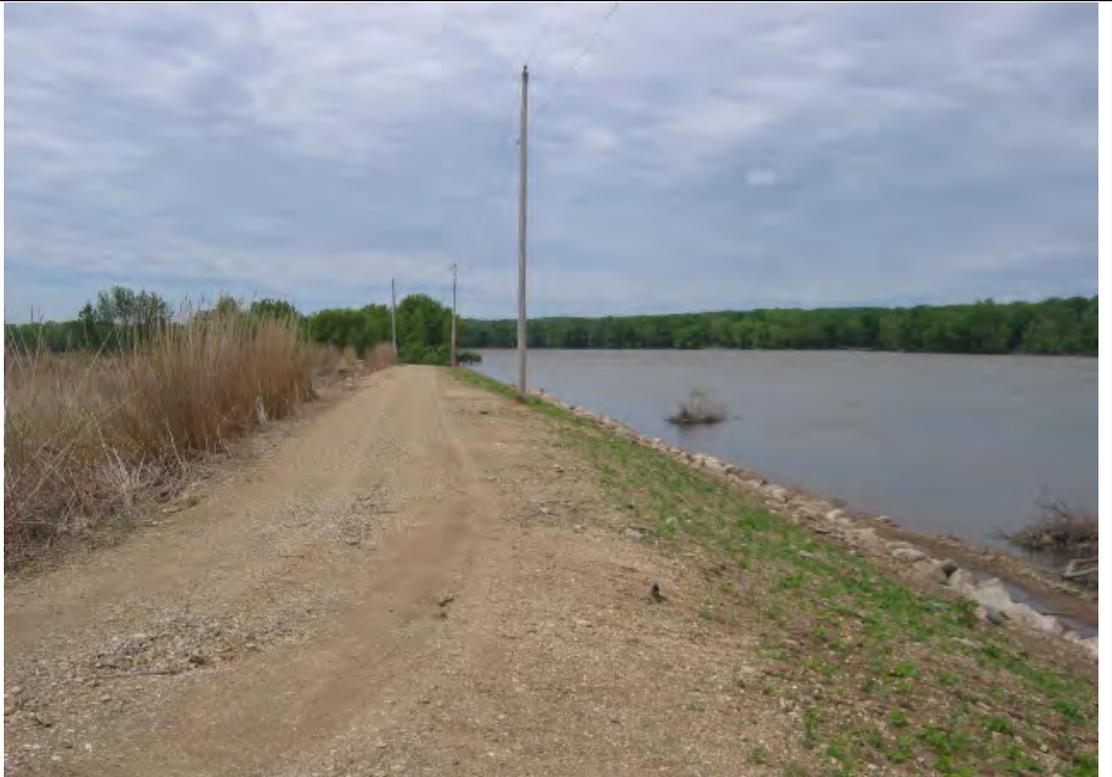
Photo No. 17	Date: 5/23/11
Direction Photo Taken: West

Description:
Crest of the WAPS.

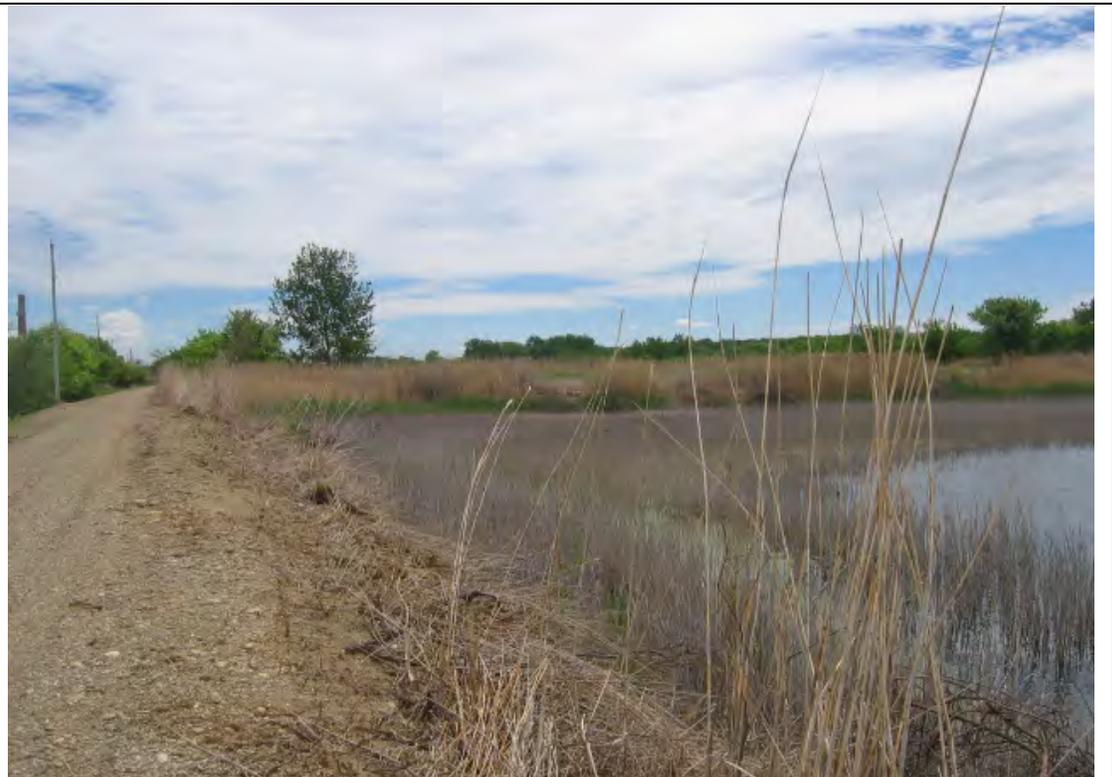
Photo No. 18	Date: 5/23/11
Direction Photo Taken: East

Description:
Crest and upstream slope of the WAPS.

2.1.12 WAPS Upstream Slope (Photos 18, 22, and 24)

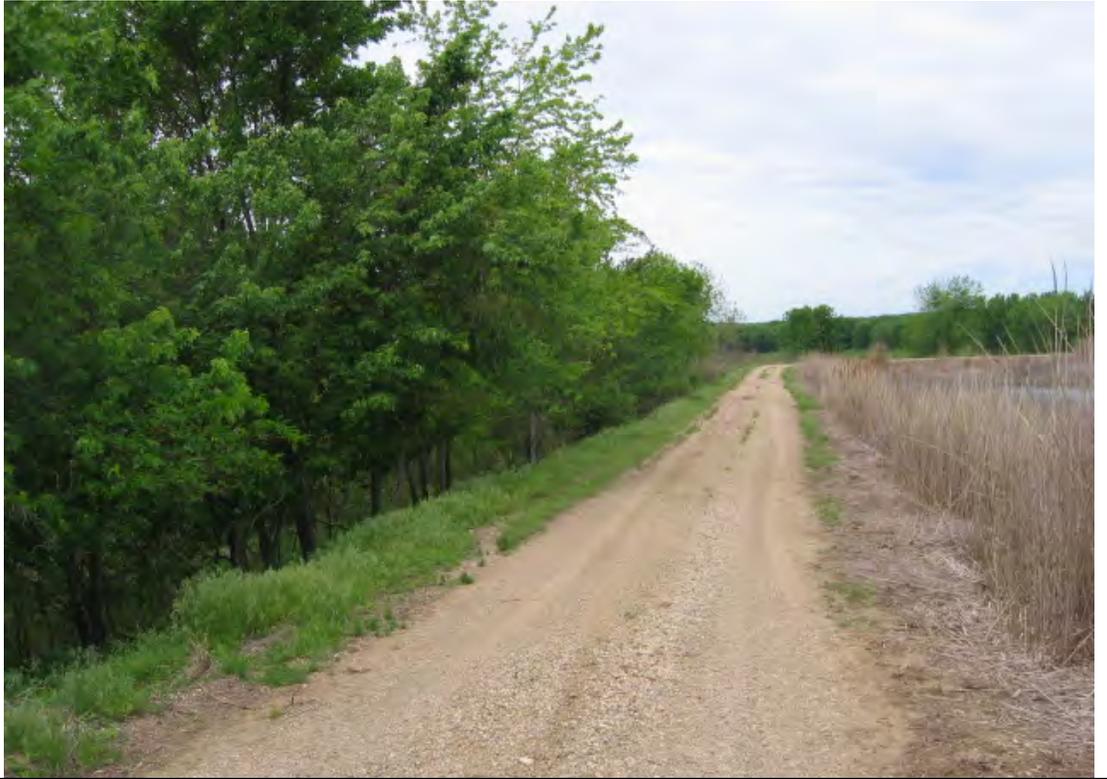
Description:
Crest and upstream slope of the WAPS.

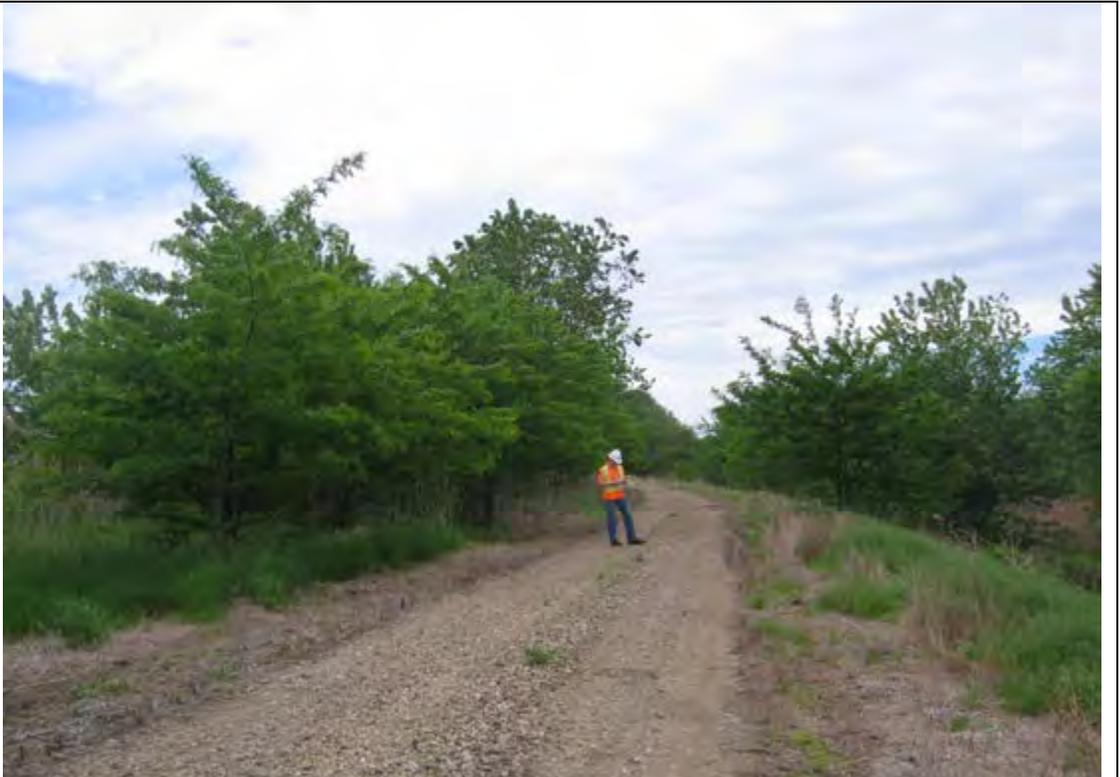
Photo No.
20

Description:
Crest and upstream slope of the WAPS.

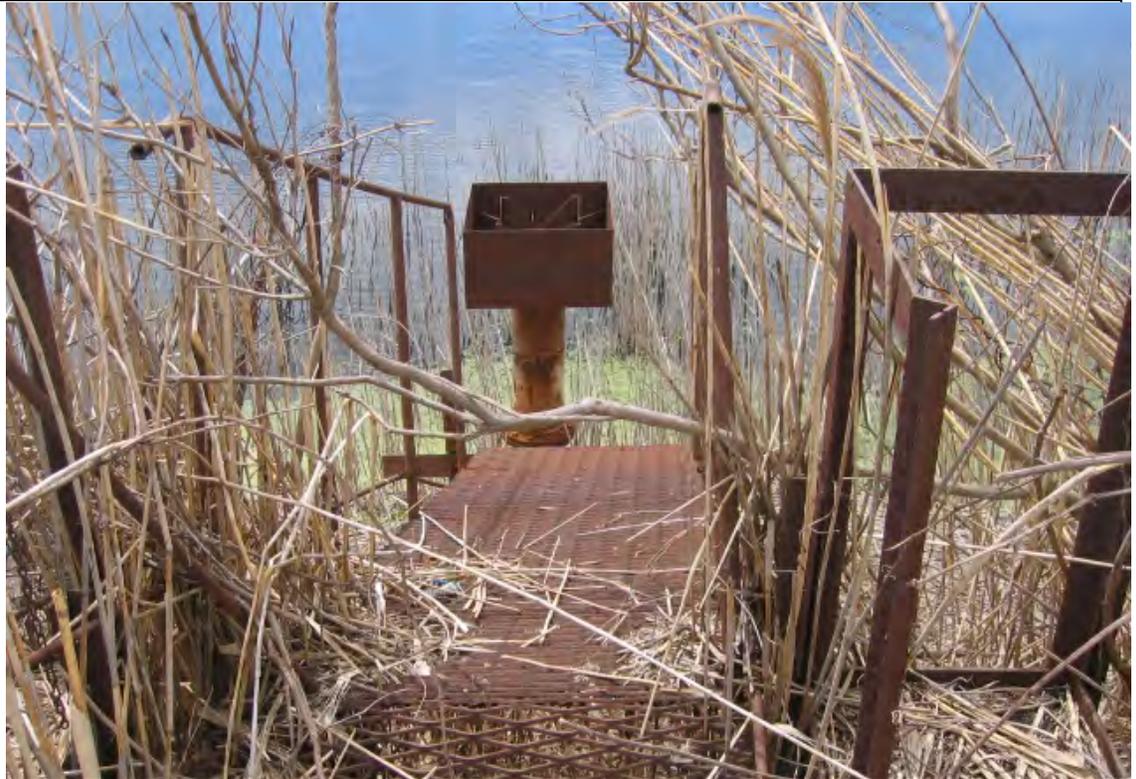
Photo No. 21	Date: 5/23/11
Direction Photo Taken: South

Description:
Decant structure in the WAPS.

The decant structure for the WAPS Impoundment consists of a 12-inch diameter steel pipe with a trash rack as shown in Photo 21. The pipe discharges into the Illinois River and the discharge pipe is shown in Photo 22. The decant and discharge portions of the pipe appeared to be in good condition at the time of our assessment.

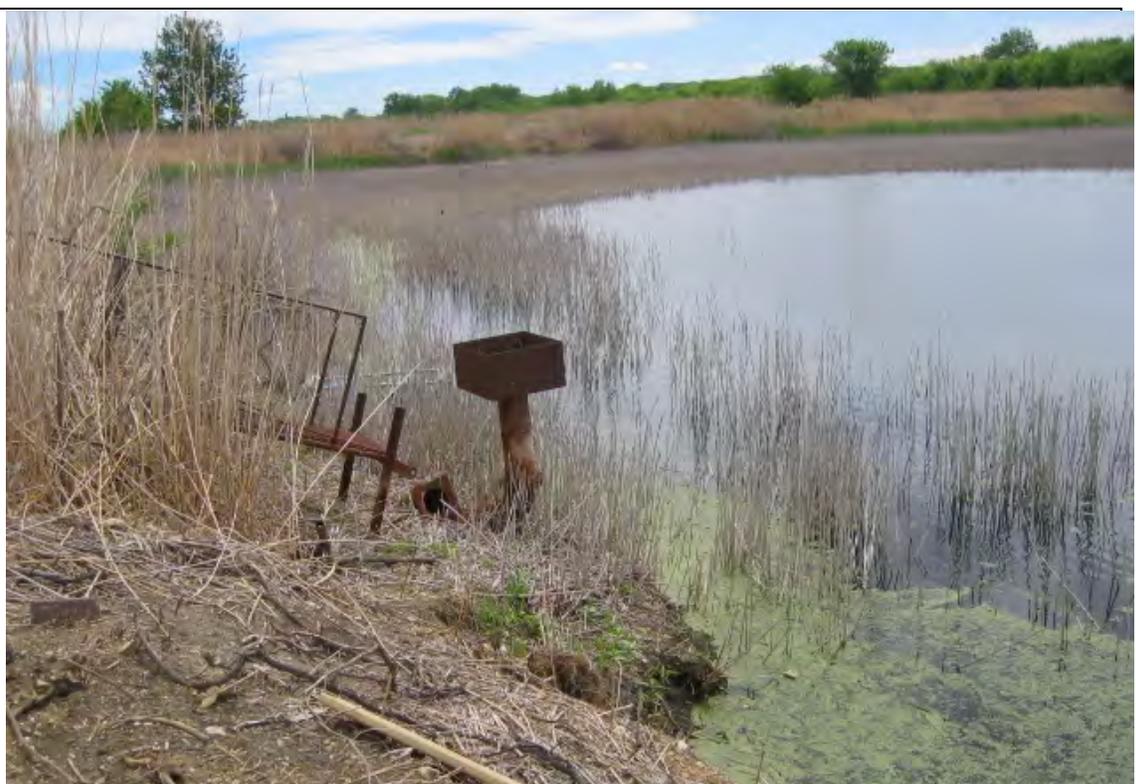
Photo No. 22	Date: 5/23/11
Direction Photo Taken: Southeast

Description:
Decant structure in the WAPS.

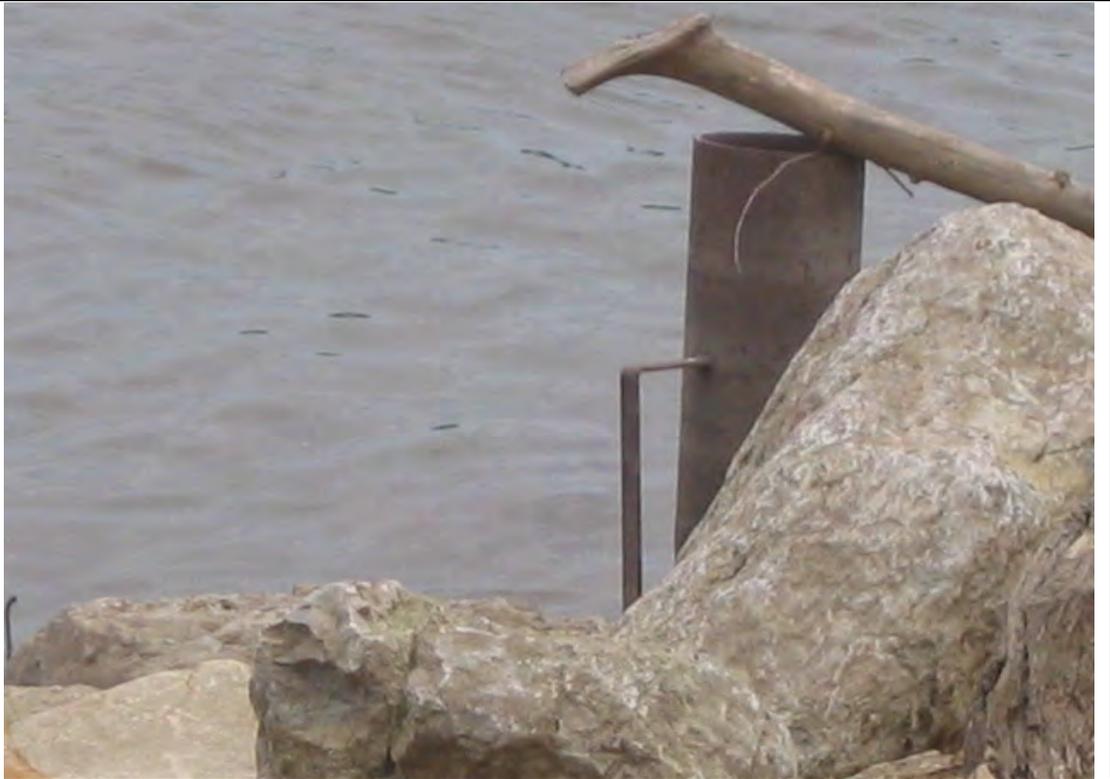
Photo No. 23	Date: 5/23/11
Direction Photo Taken: Northeast

Description:
Discharge pipe from the WAPS into the Illinois River.
