BEFORE THE ILLINOIS POLLUTION CONTROL BOARD

In the Matter of:)	
)	
)	
STANDARD FOR THE DISPOSAL OF)	
COAL COMBUSTION RESIDUALS)	PCB 2020-019
IN SURFACE IMPOUNDMENTS:)	(Rulemaking - Water)
PROPOSED NEW 35 ILL. ADMIN.)	
CODE 845)	
)	
)	
)	
)

Analysis is performed herein for the Initial Safety Factor Assessment of the existing ash ponds at Springfield City Water, Light and Power, Lakeside and Dallman Ash Ponds, Springfield, Illinois, as required per 40 CFR 257.73(e). Based upon historical geotechnical data and the existing conditions of the ash ponds, all factors of safety exceed the regulatory minimums as demonstrated within this report.

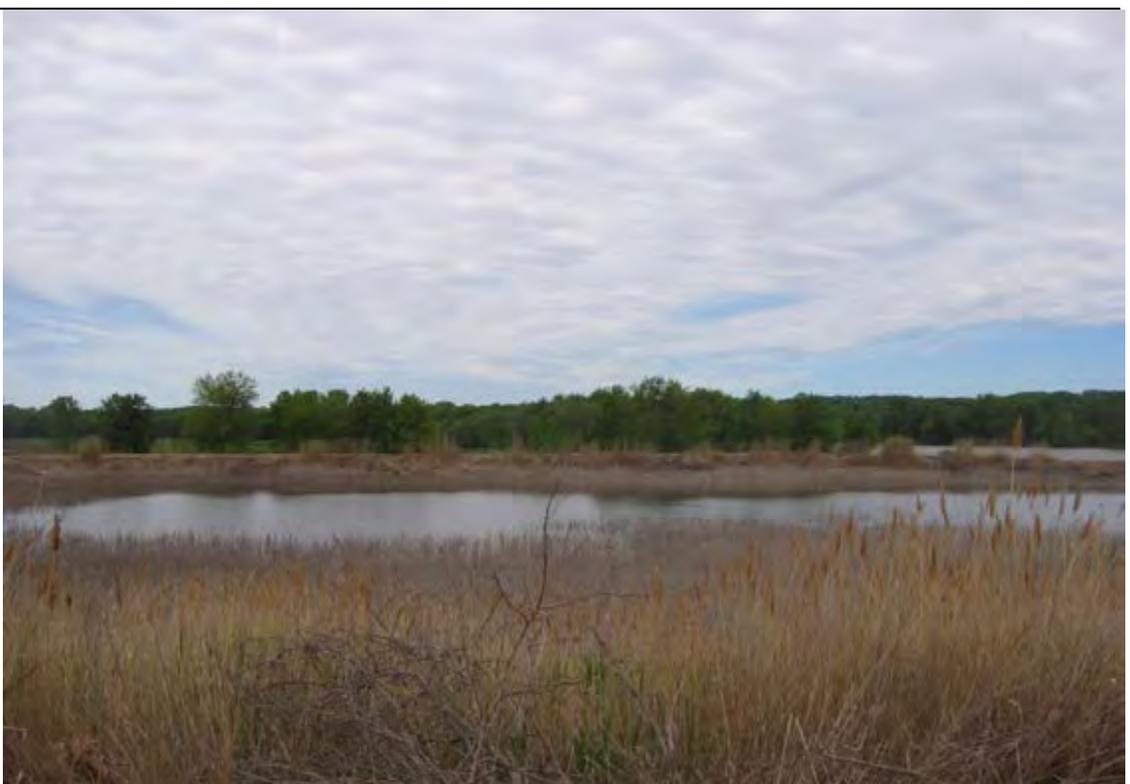
Photo No. 24	Date: 5/23/11
Direction Photo Taken: West

Description:
Upstream slope and ponded water in the WAPS.

2.1.12 WAPS Upstream Slope (Photos 18, 22, and 24)

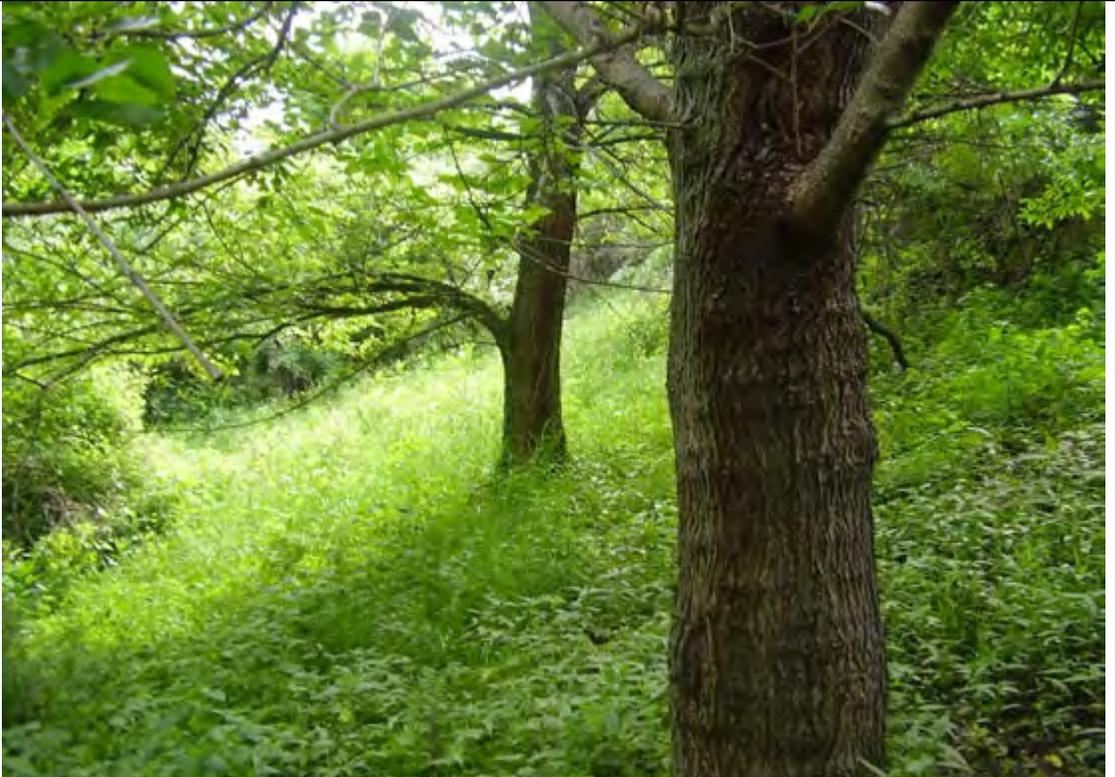
Photo No. 25	Date: 5/23/11
Direction Photo Taken: Northeast	
Description: Downstream slope of the EAPS.

2.1.4 EAPS Downstream Slope (Photos 25 through 28, 55 through 57, 69, and 70)

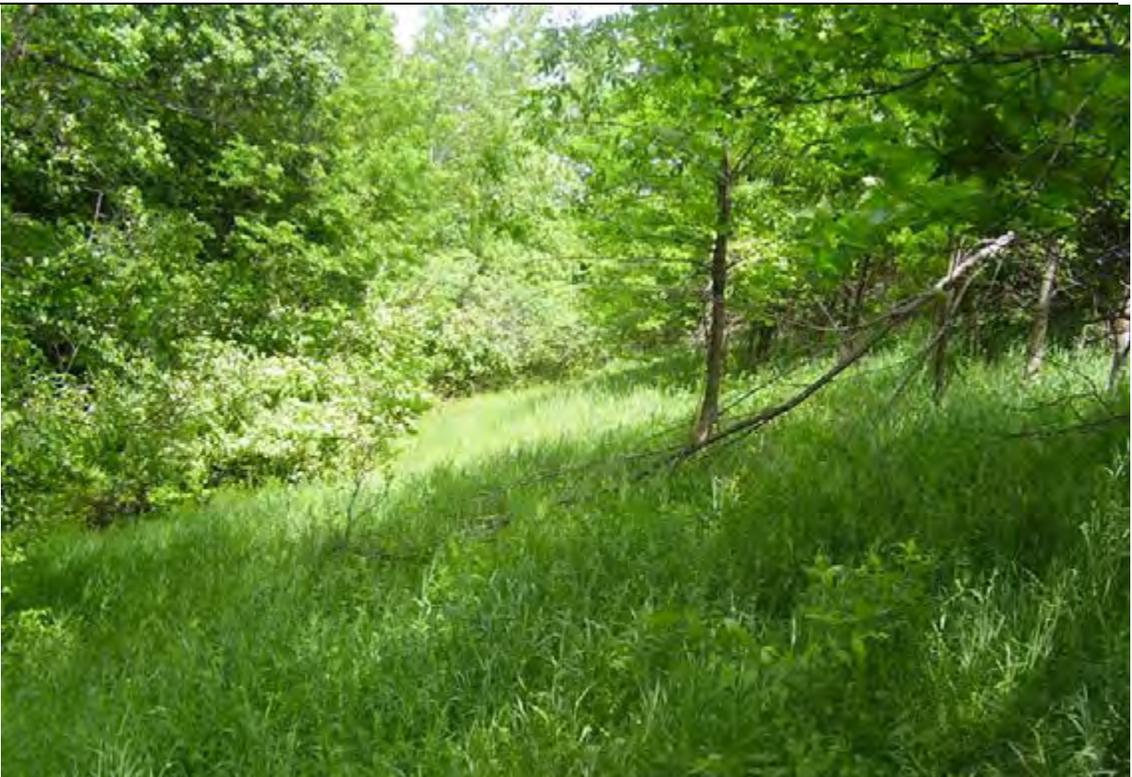
Photo No. 26	Date: 5/23/11
Direction Photo Taken: Northeast	
Description: Downstream slope of the EAPS.

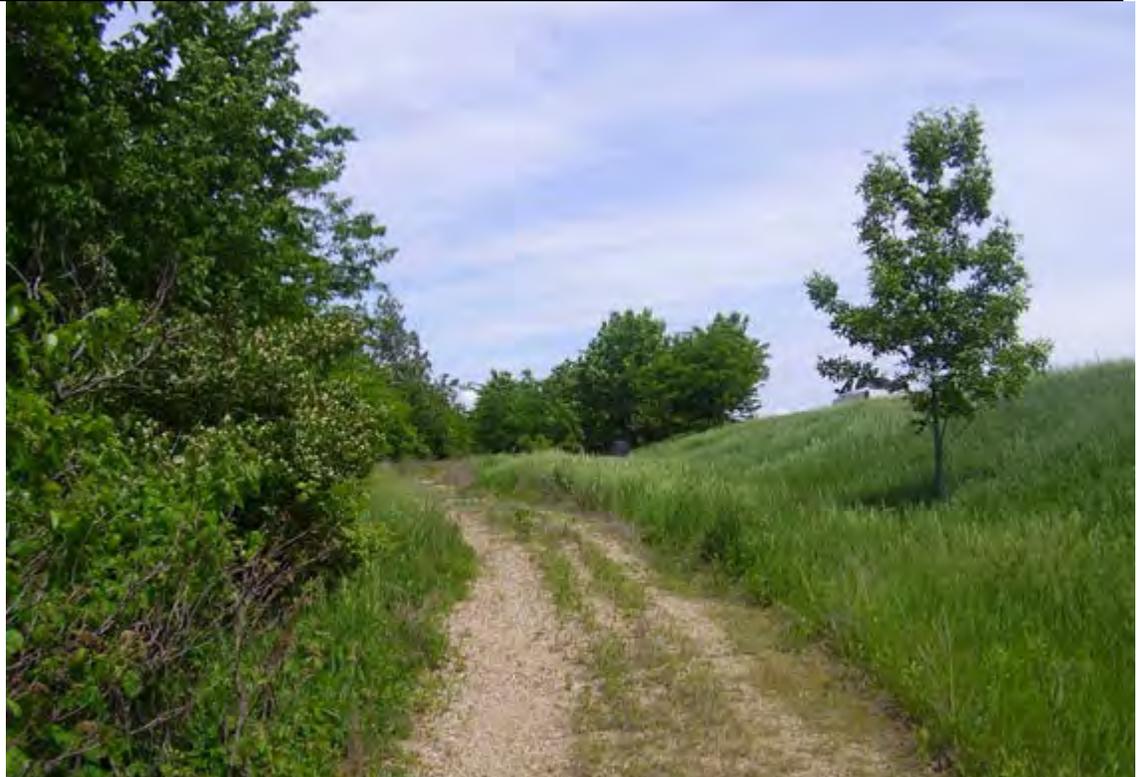
Photo No. 27	Date: 5/23/11
Direction Photo Taken: Northeast	
Description: Crest of the 1978 embankment and downstream slope of the 1995 embankment along the EAPS.

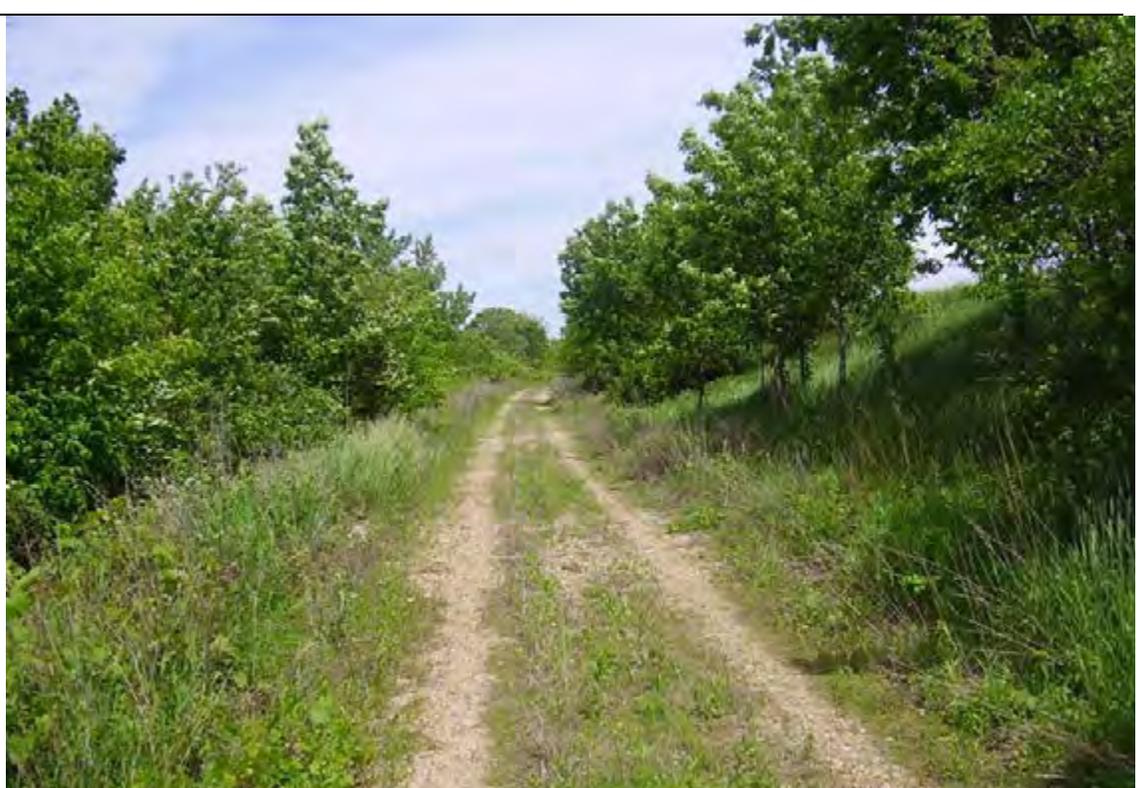
Photo No. 28	Date: 5/23/11
Direction Photo Taken: Northeast	
Description: Crest of the 1978 embankment and downstream slope of the 1995 embankment along the EAPS.

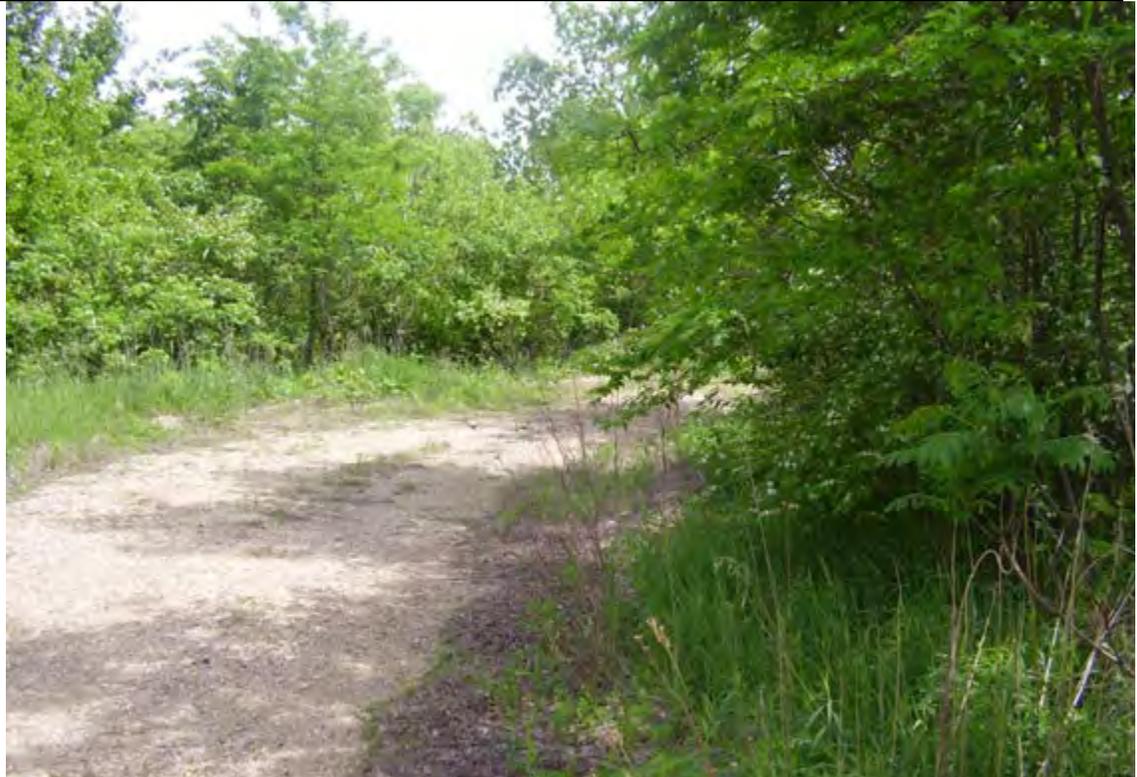
Description:
Crest of the 1978 embankment and downstream slope of the 1995 embankment near Pond 2E.

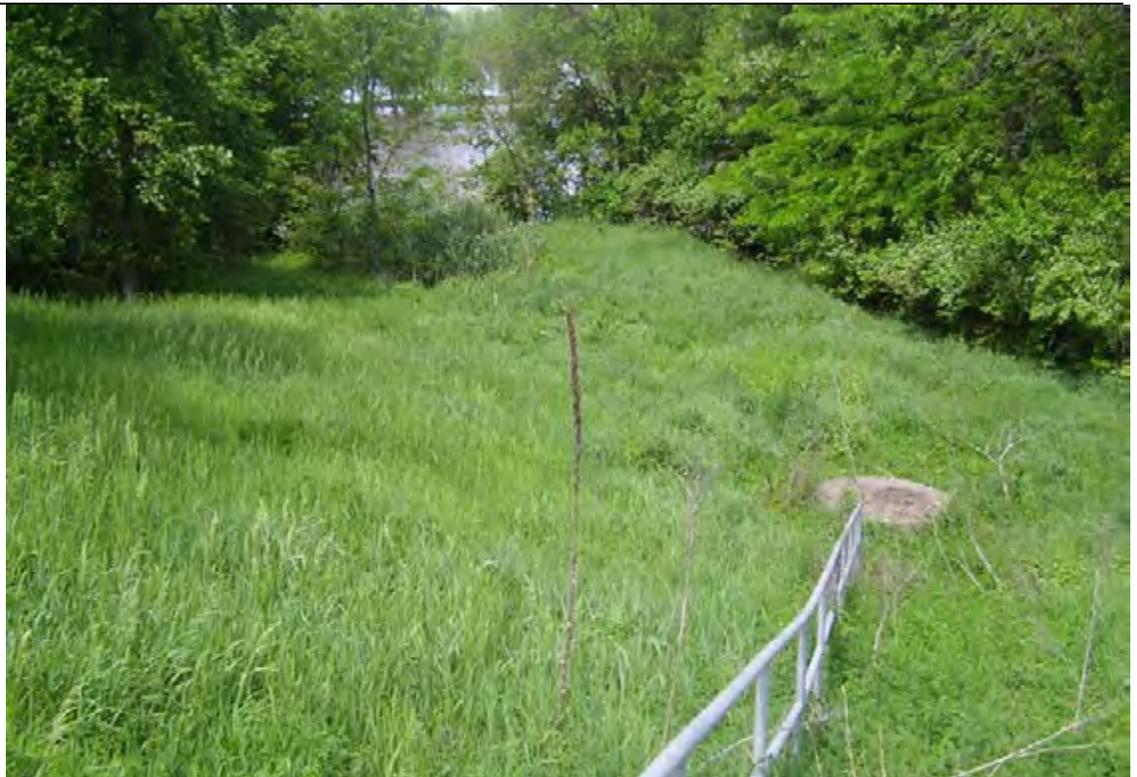
Photo No. 30	Date: 5/23/11
-------------------------------	-------------------------

Description:
Downstream slope of Pond 2E.

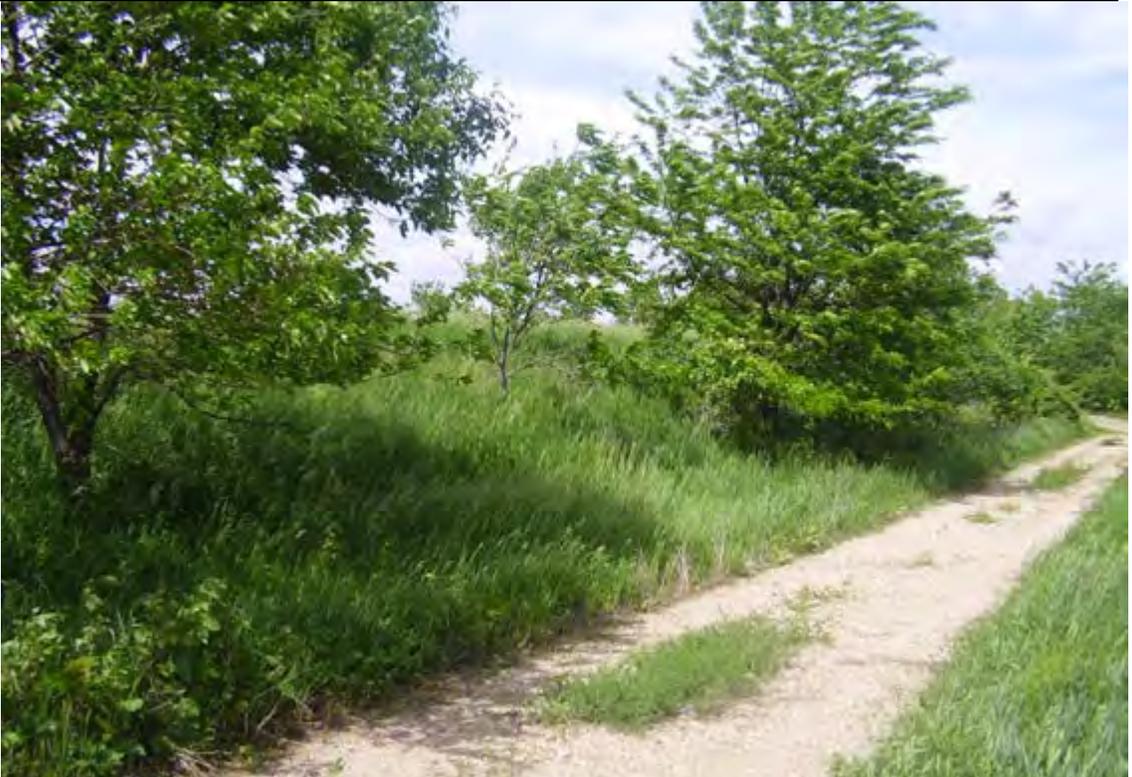
Photo No. 31	Date: 5/23/11
Direction Photo Taken: Northwest	
Description: Downstream slope of Pond 2E along crest of the 1978 embankment.

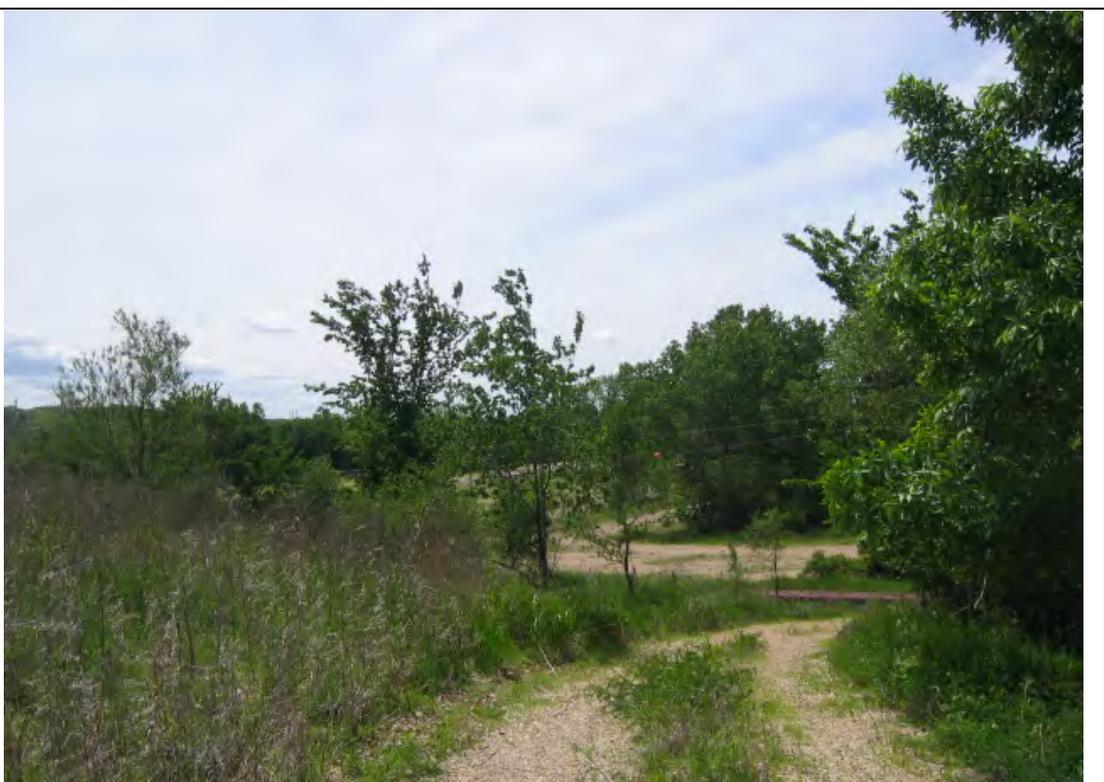
Photo No. 32	Date: 5/23/11
Direction Photo Taken: Southwest	
Description: Crest of the EAPS.

2.1.3 EAPS Crest of Impoundment (Photos 32 through 35, 45, 52, 71 through 73)

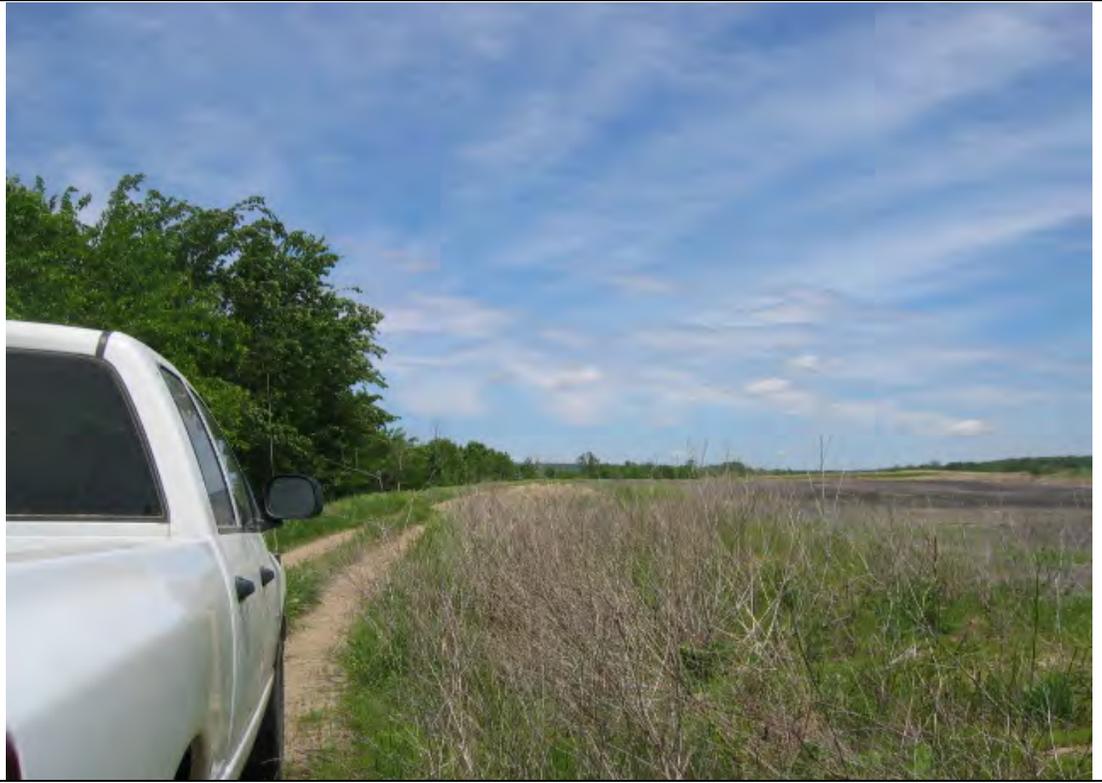
Photo No. 33	Date: 5/23/11
Direction Photo Taken: Northeast

Description:
Crest and upstream slope of the EAPS.

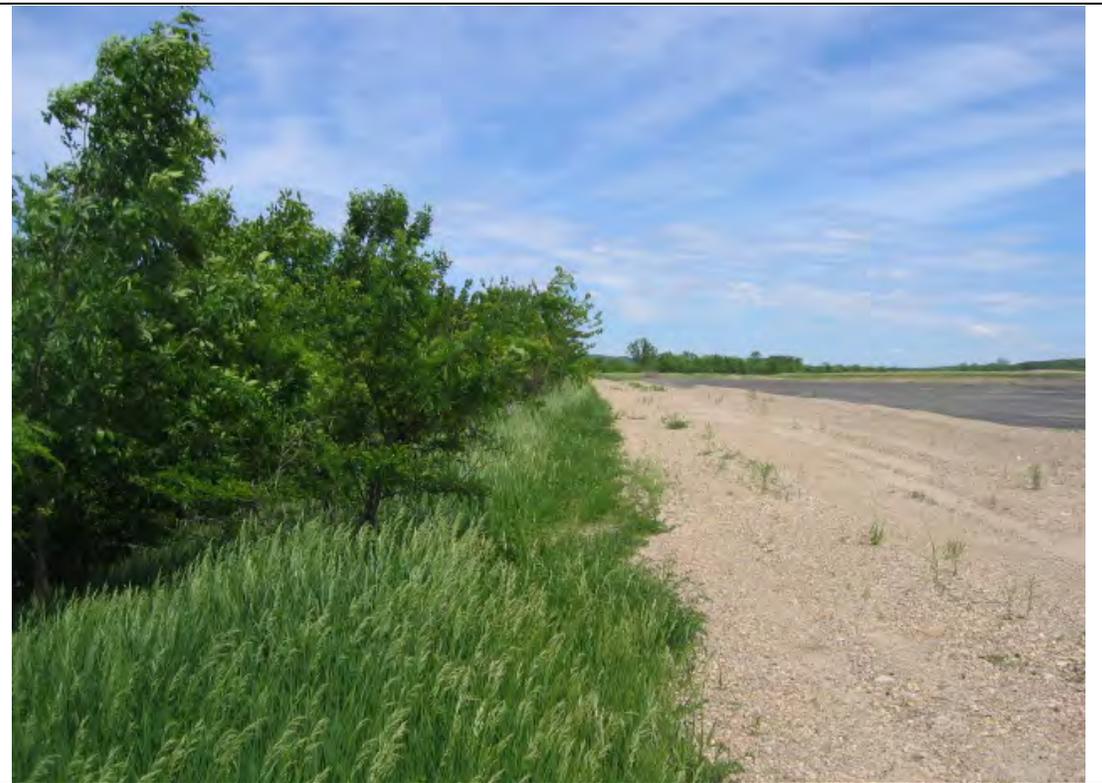
Photo No. 34	Date: 5/23/11
Direction Photo Taken: Northeast

Description:
Crest and upstream slope of the EAPS.

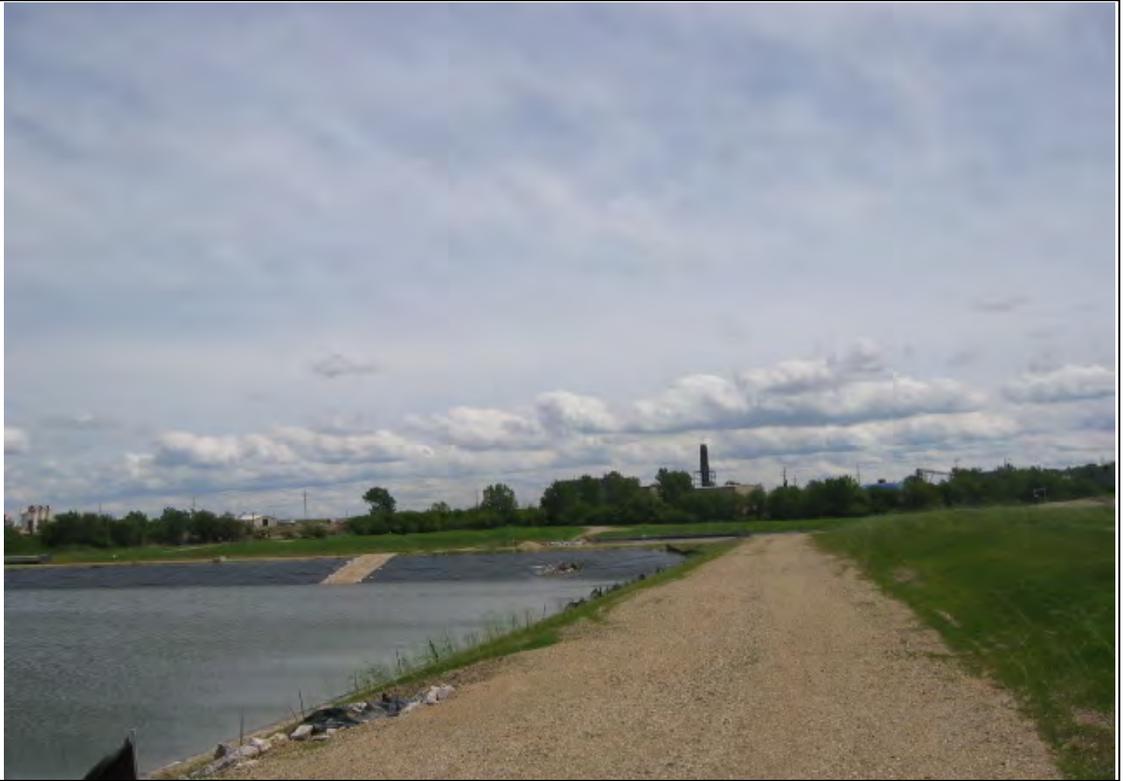
Crest of embankment between the EAPS and Pond 2E.

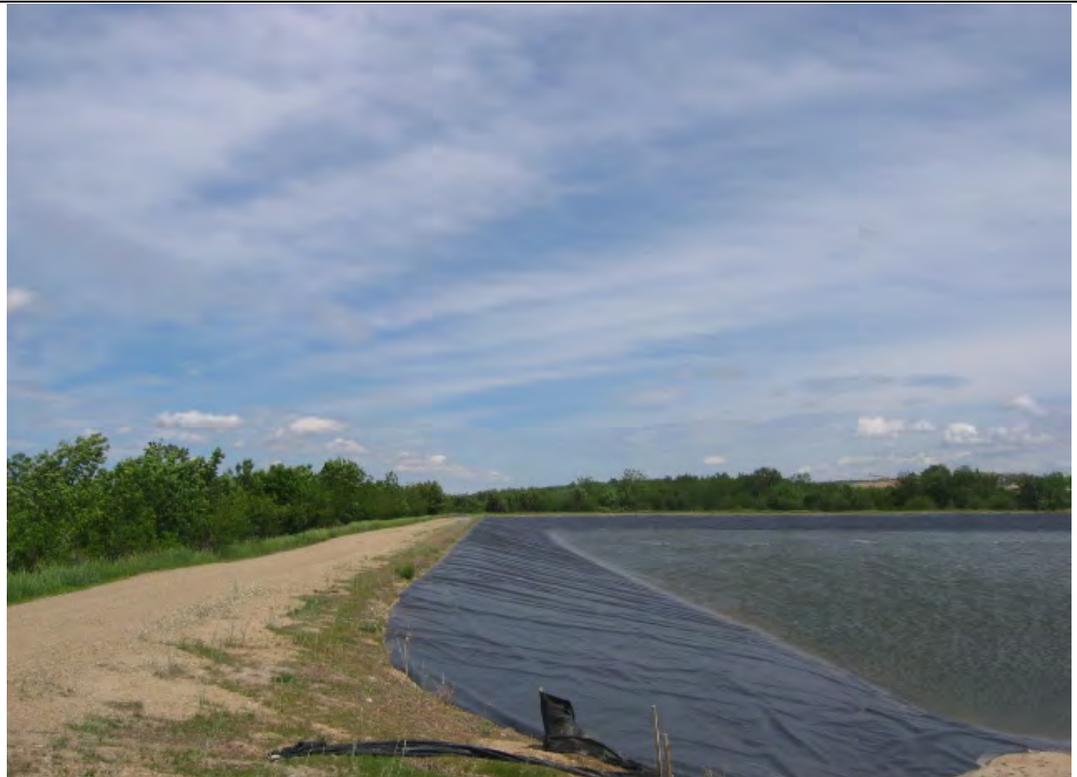
Photo No.
36

Crest and upstream slope of Pond 2E.

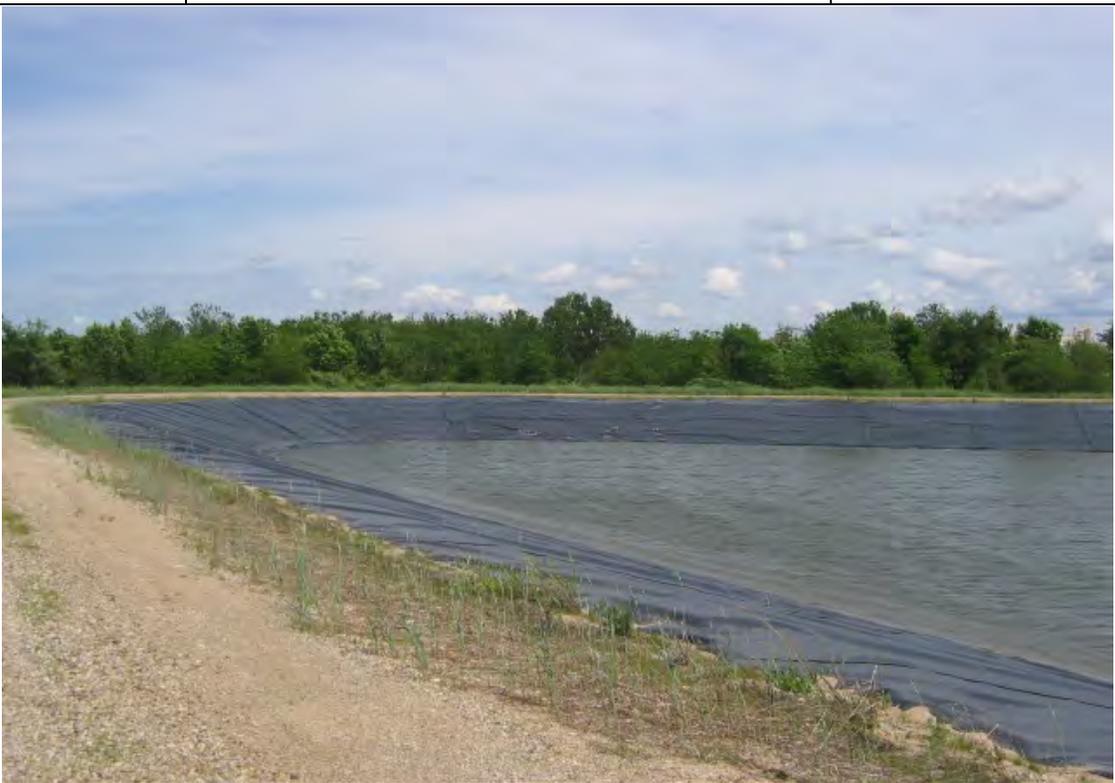
Photo No. 37	Date: 5/23/11
Direction Photo Taken: Southeast	
Description: Crest and upstream slope of Pond 2E.

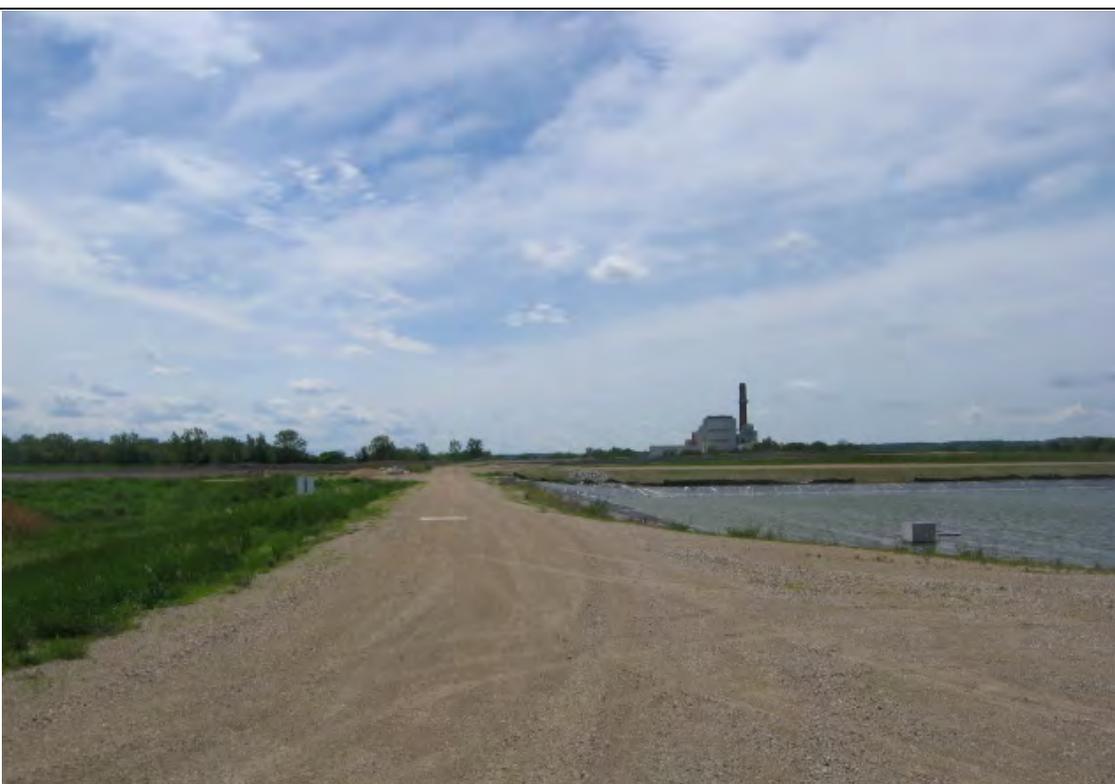
Photo No. 38	Date: 5/23/11
Direction Photo Taken: West	
Description: Crest of the embankment between Pond 2E and Secondary Cell.

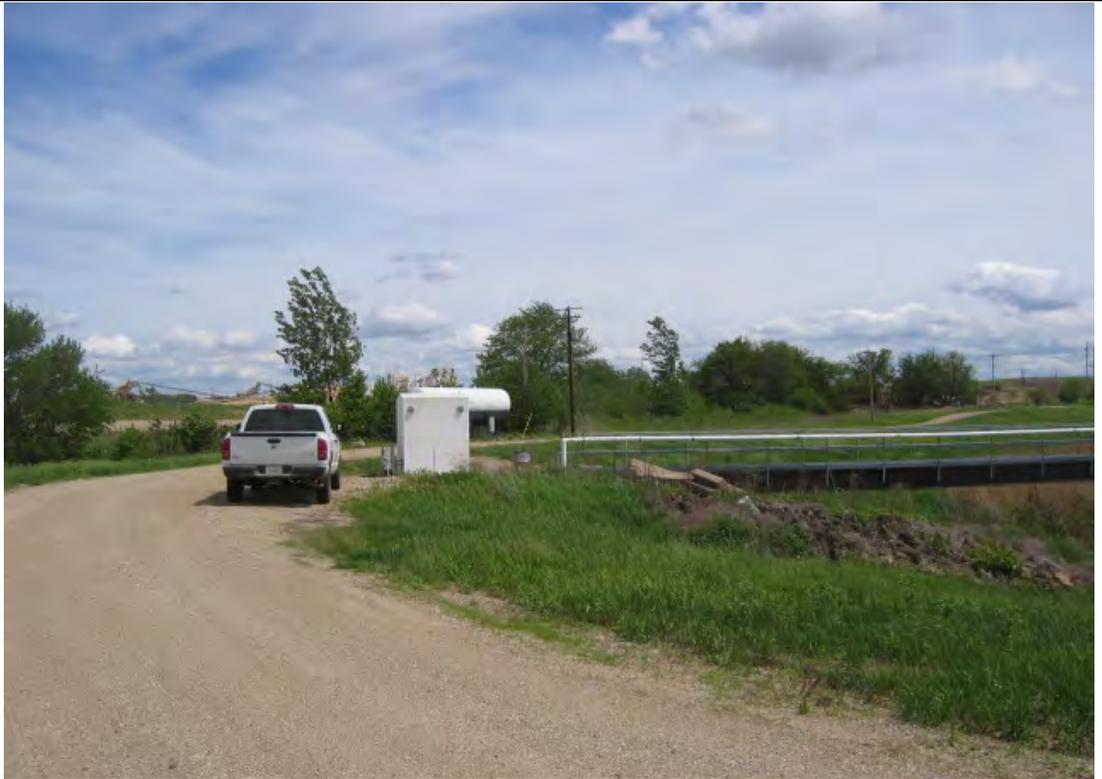
Description:
Crest and upstream slope of the Secondary Cell.

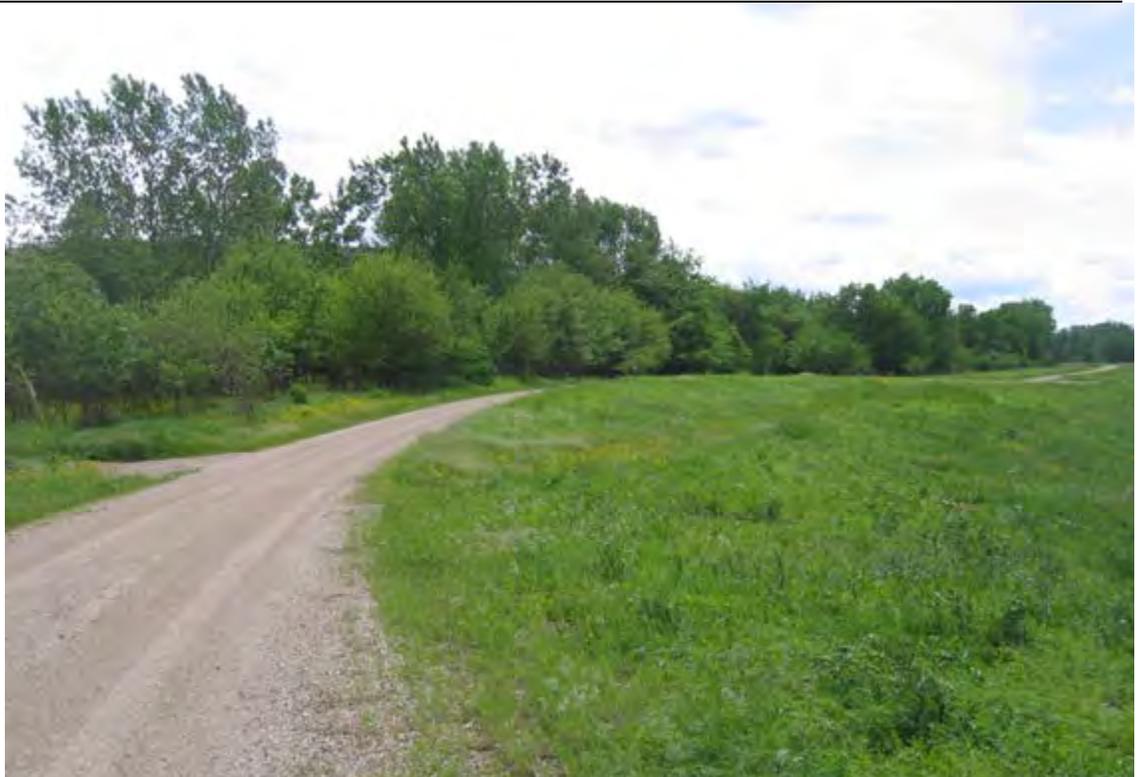
Photo No.
40

Description:
Crest and upstream slope of the Secondary Cell.

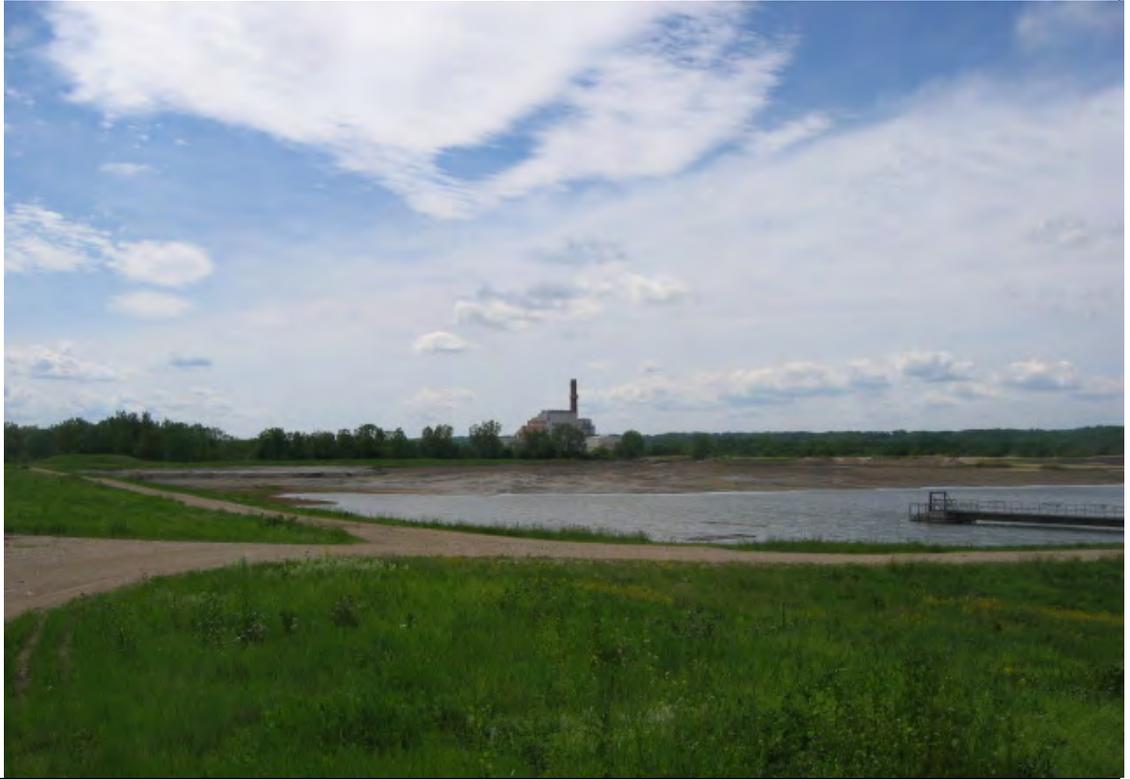
Description:
Crest and upstream slope of the Secondary Cell.

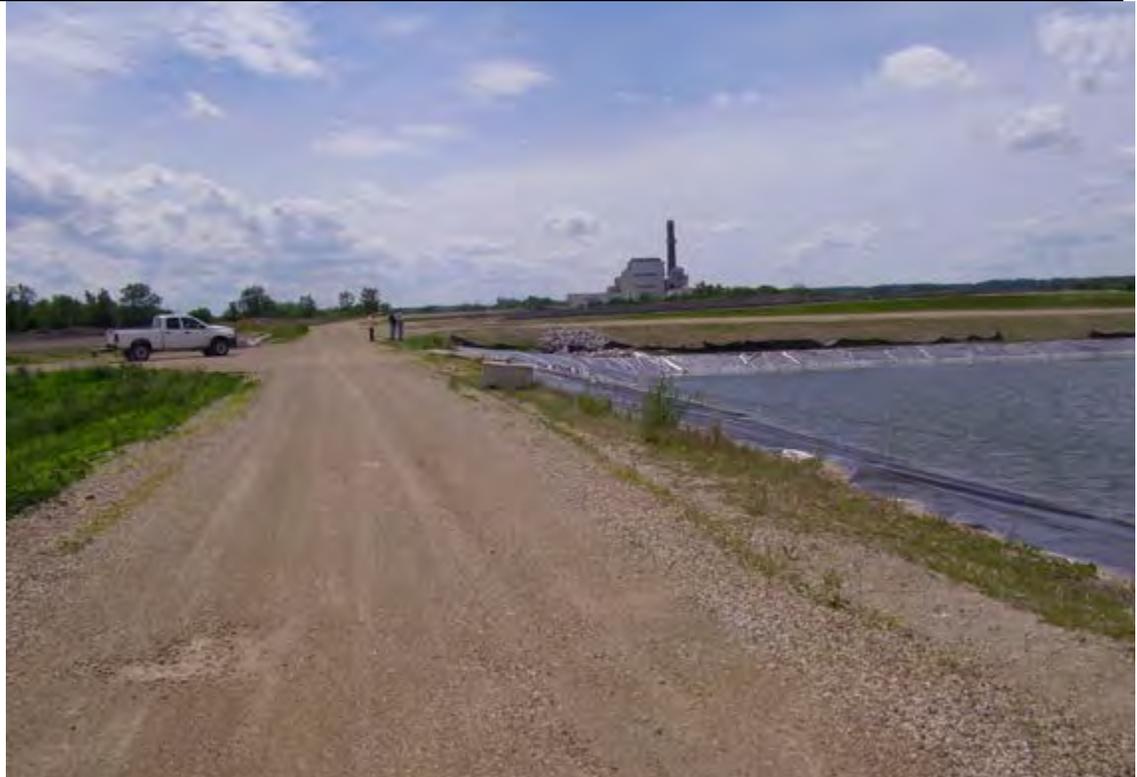
Photo No. 43	Date: 5/23/11
Direction Photo Taken: Southwest

Description:
Crest of the embankment between Pond 2E and the Secondary Cell.

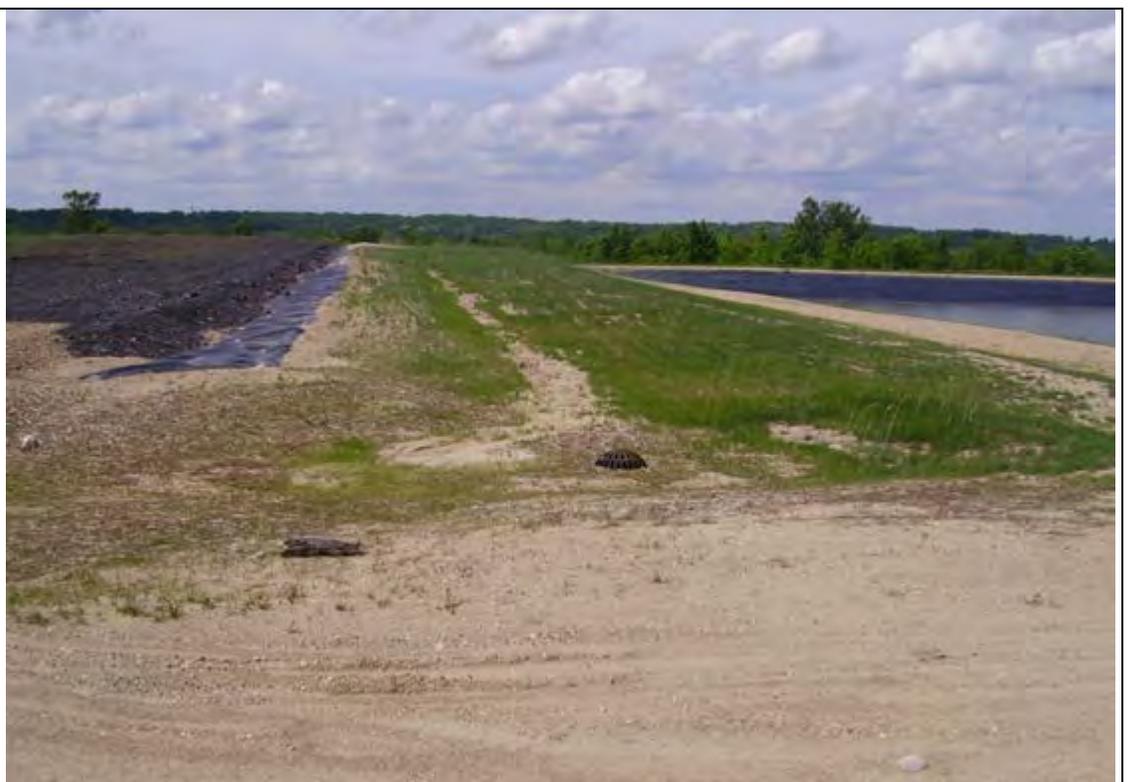
Photo No. 44	Date: 5/23/11
Direction Photo Taken: Northwest

Description:
Upstream slope of the EAPS.

The EAPS no longer functions as an active ash impoundment and no CCW sluice piping is present. Storm water drains have been installed along portions of the perimeter of the permitted landfill as shown in Photo 44. The drains appeared to be in good condition at the time of our assessment.

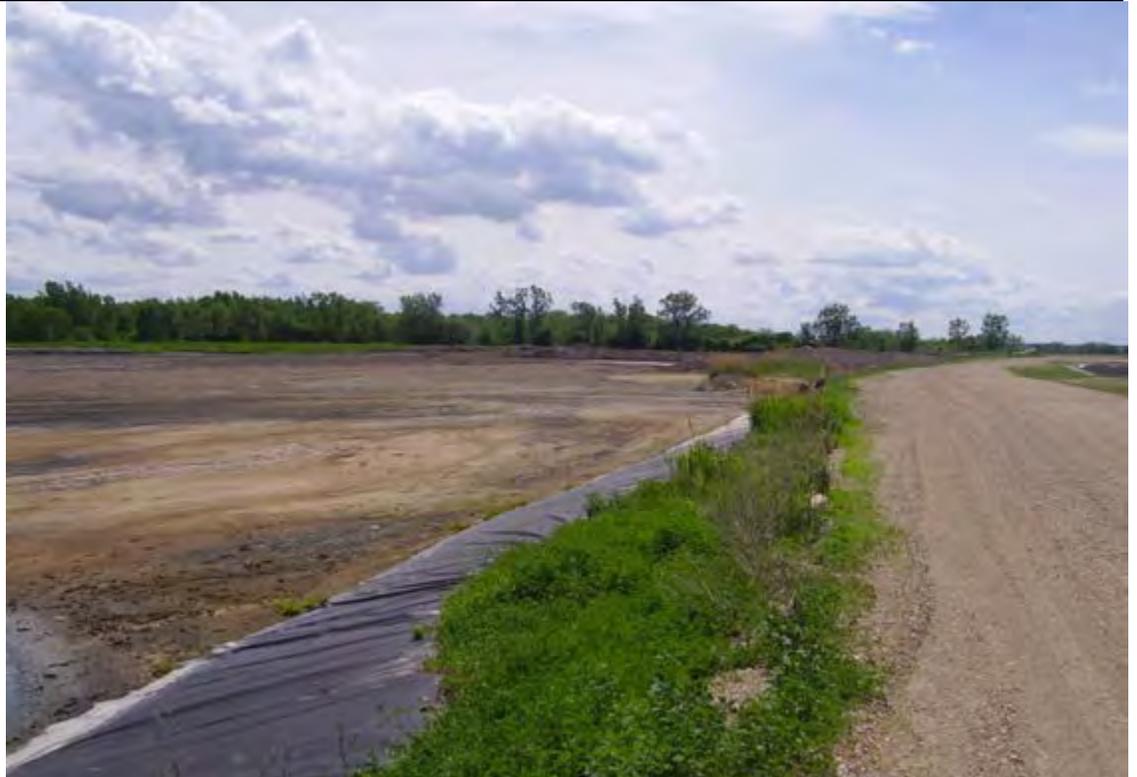
Photo No. 45	Date: 5/23/11
Direction Photo Taken: Southwest

Description:
Crest and upstream slope of the Primary Cell.

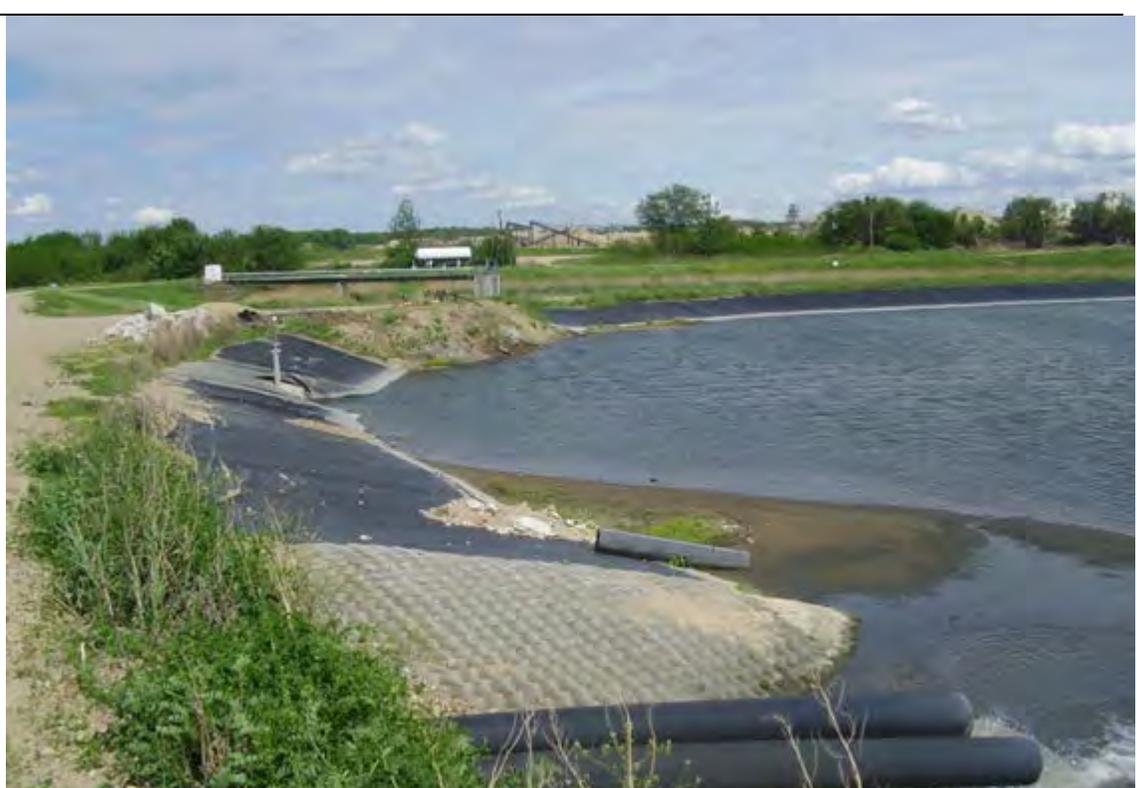
Photo No. 46	Date: 5/23/11
Direction Photo Taken: East

Description:
Upstream slope of the Primary Cell.

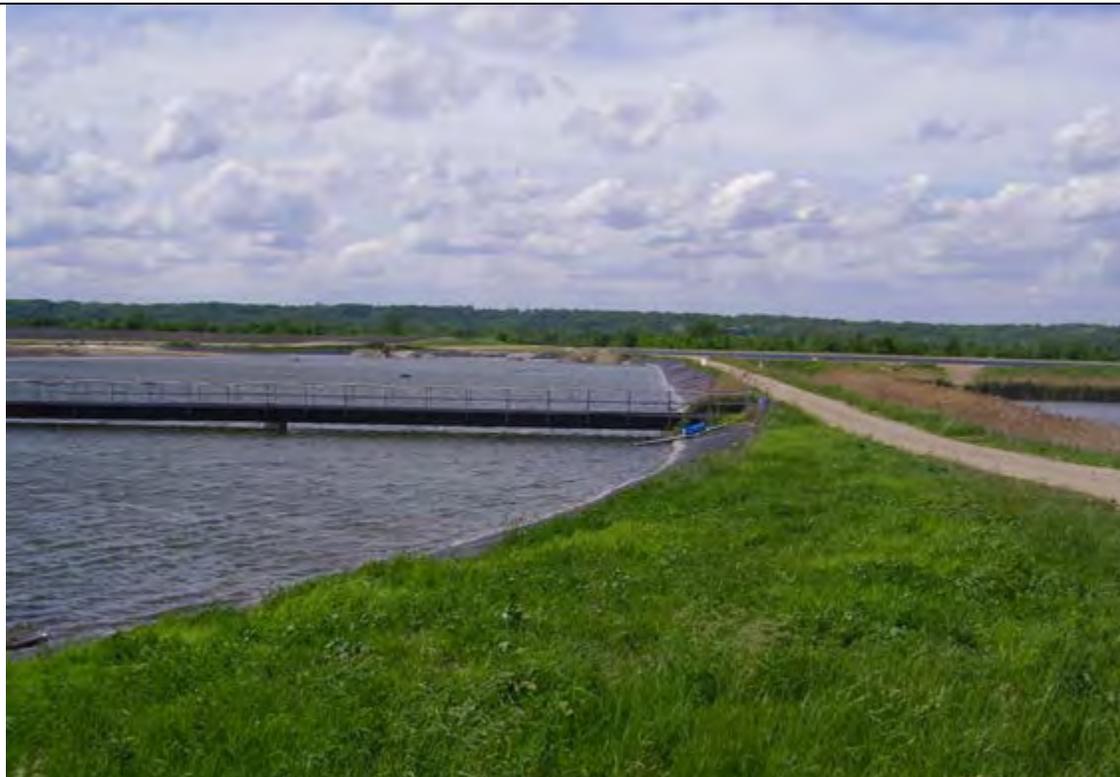
Photo No. 48	Date: 5/23/11
-------------------------------	-------------------------

Description:
Upstream slope of the Primary Cell near the decant structure.

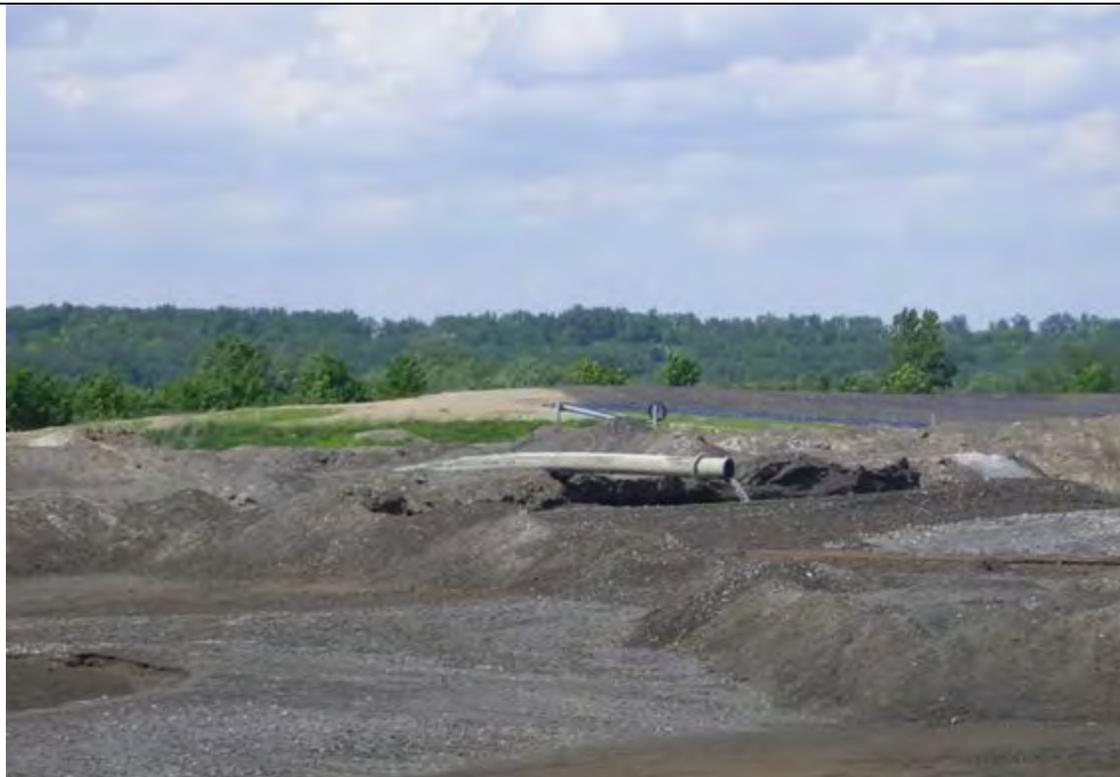
Photo No. 58	Date: 5/23/11
-------------------------------	-------------------------

Description:
Discharge pipe into the northwest portion of the Primary Cell.

2.1.10 AEAPS Discharge Structures (Photos 58 through 68)

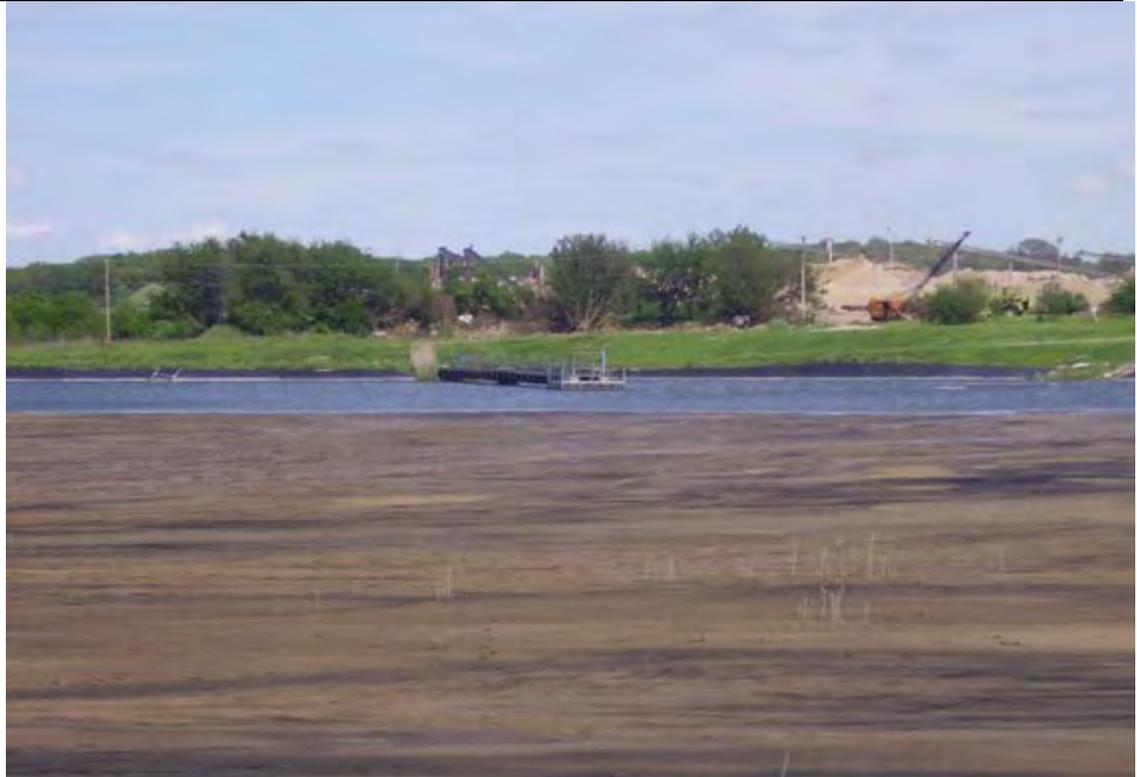
Photo No. 59	Date: 5/23/11
Direction Photo Taken: East

Description:
Old decant structure in the Primary Cell.
