BEFORE THE ILLINOIS POLLUTION CONTROL BOARD

In the Matter of:)	
)	
)	
STANDARD FOR THE DISPOSAL OF)	
COAL COMBUSTION RESIDUALS)	PCB 2020-019
IN SURFACE IMPOUNDMENTS:)	(Rulemaking - Water)
PROPOSED NEW 35 ILL. ADMIN.)	
CODE 845)	
)	
)	
)	
)

Analysis is performed herein for the Initial Safety Factor Assessment of the existing ash ponds at Springfield City Water, Light and Power, Lakeside and Dallman Ash Ponds, Springfield, Illinois, as required per 40 CFR 257.73(e). Based upon historical geotechnical data and the existing conditions of the ash ponds, all factors of safety exceed the regulatory minimums as demonstrated within this report.

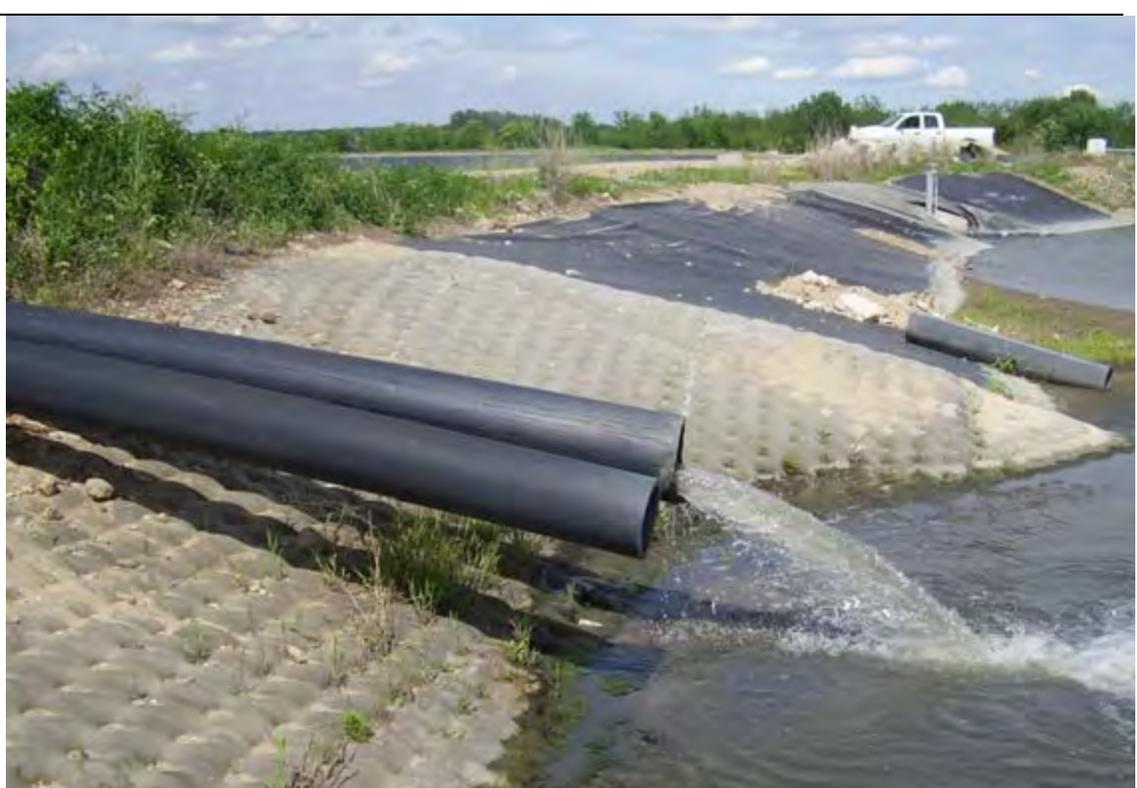
Photo No. 60	Date: 5/23/11
Direction Photo Taken: East

Description:
Discharge pipe into the Primary Cell near the northeast corner.

2.1.10 AEAPS Discharge Structures (Photos 58 through 68)

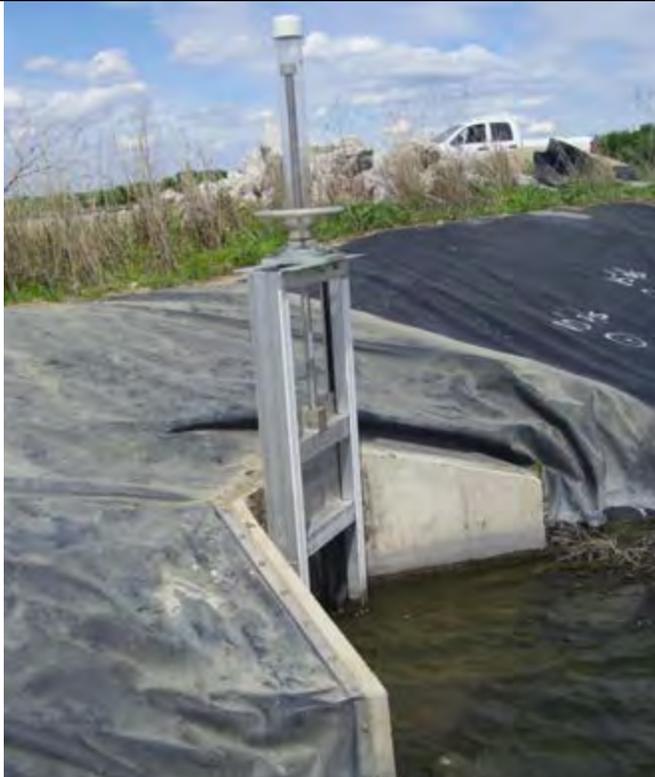
Photo No. 61	Date: 5/23/11
Direction Photo Taken: East

Description:
Decant structure in the Primary Cell.

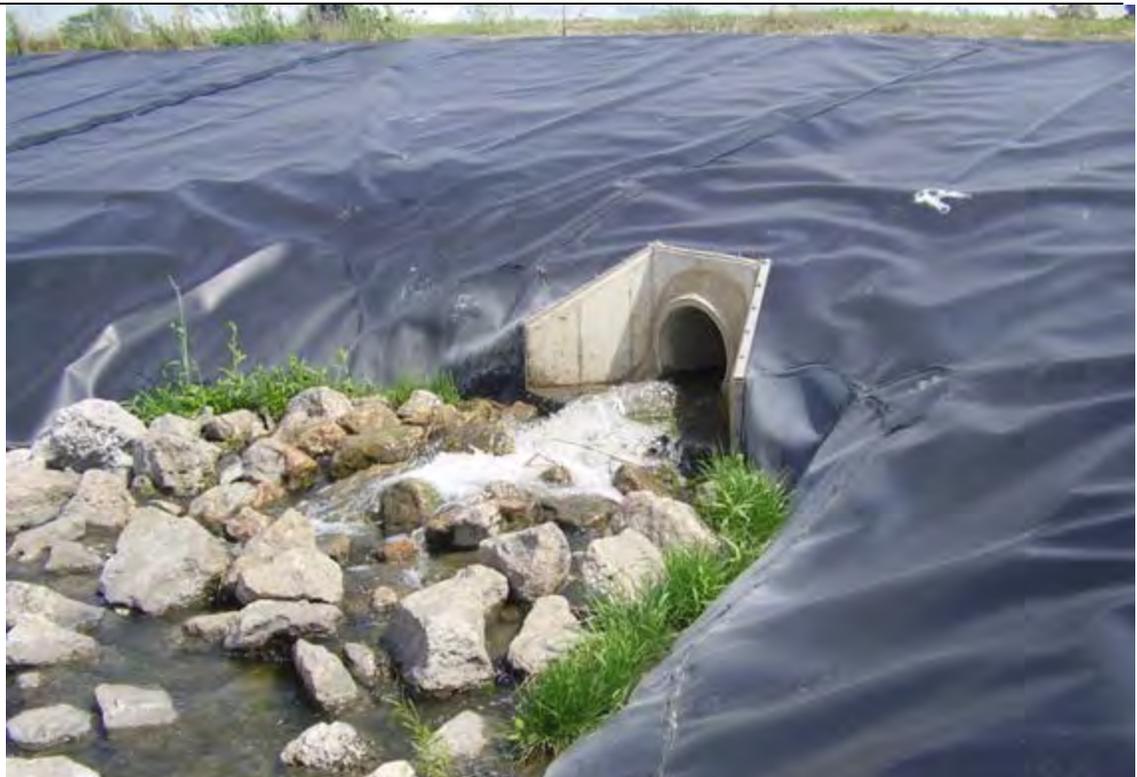
Photo No. 62	Date: 5/23/11
Direction Photo Taken: Southeast

Description:
Discharge pipe from the Primary Cell to Pond 2E.

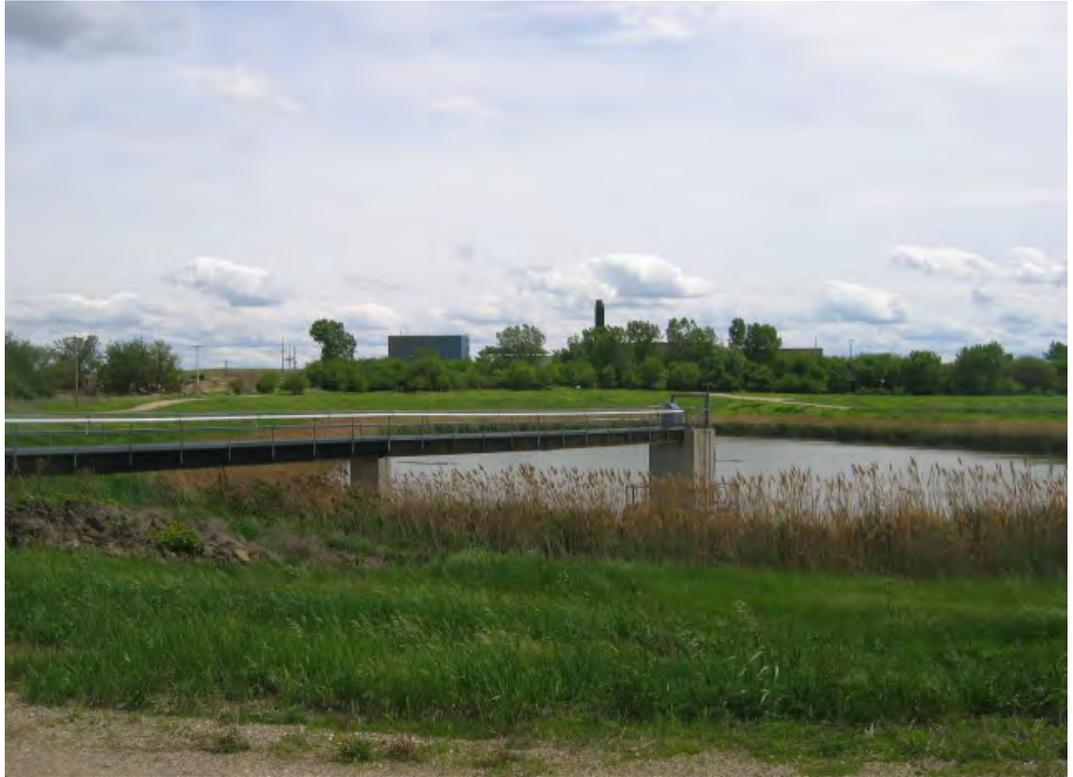
Description:
Decant structure in the Secondary Cell.

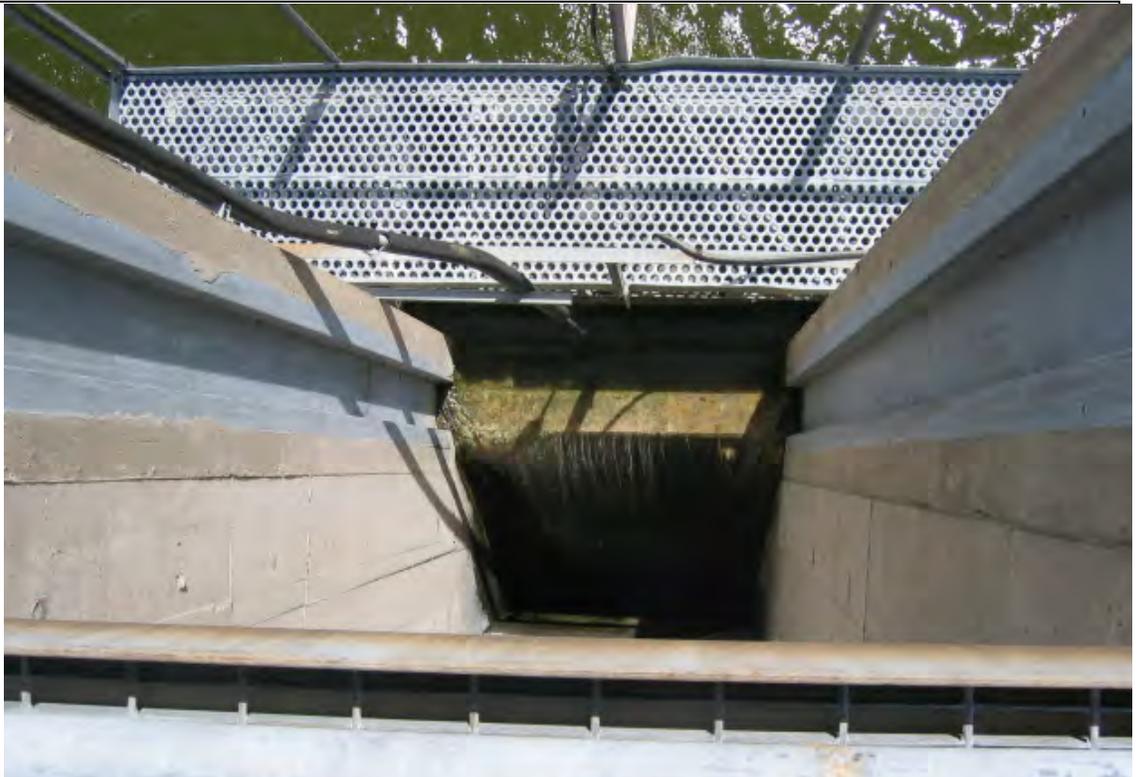
Photo No.
64

Description:
Decant structure in the Secondary Cell.

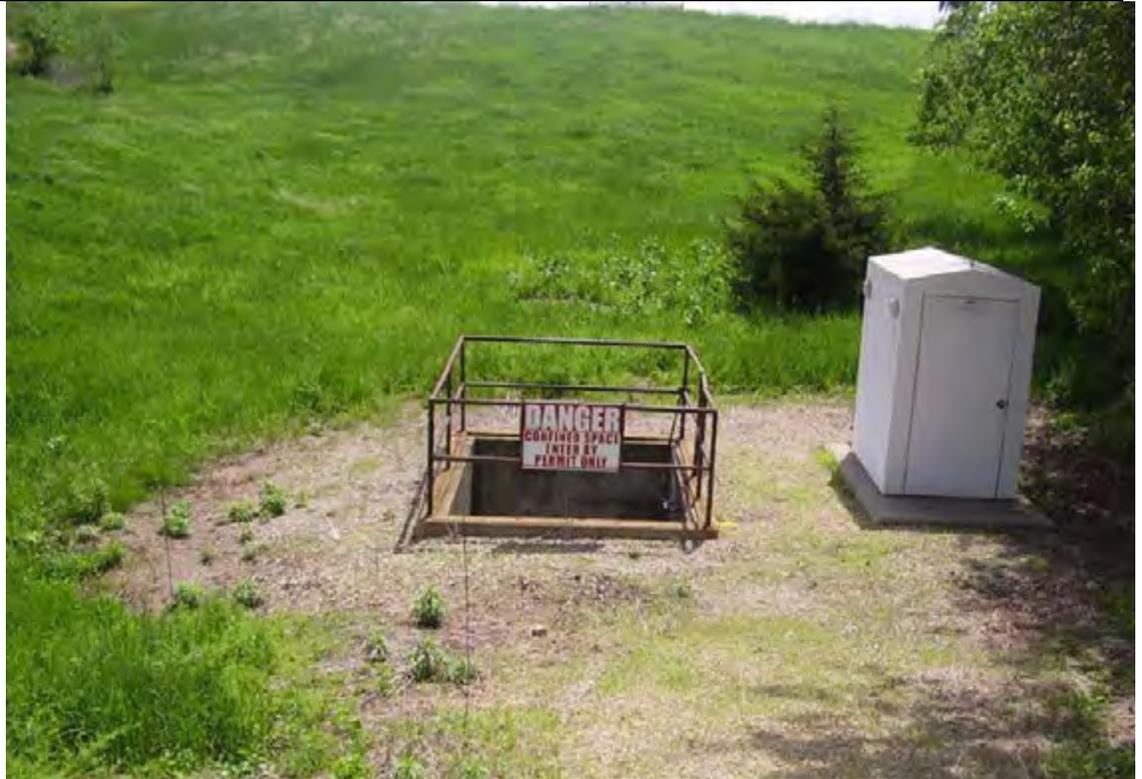
Surface features of the flume structure in the discharge line from the Secondary Cell to the Illinois River.

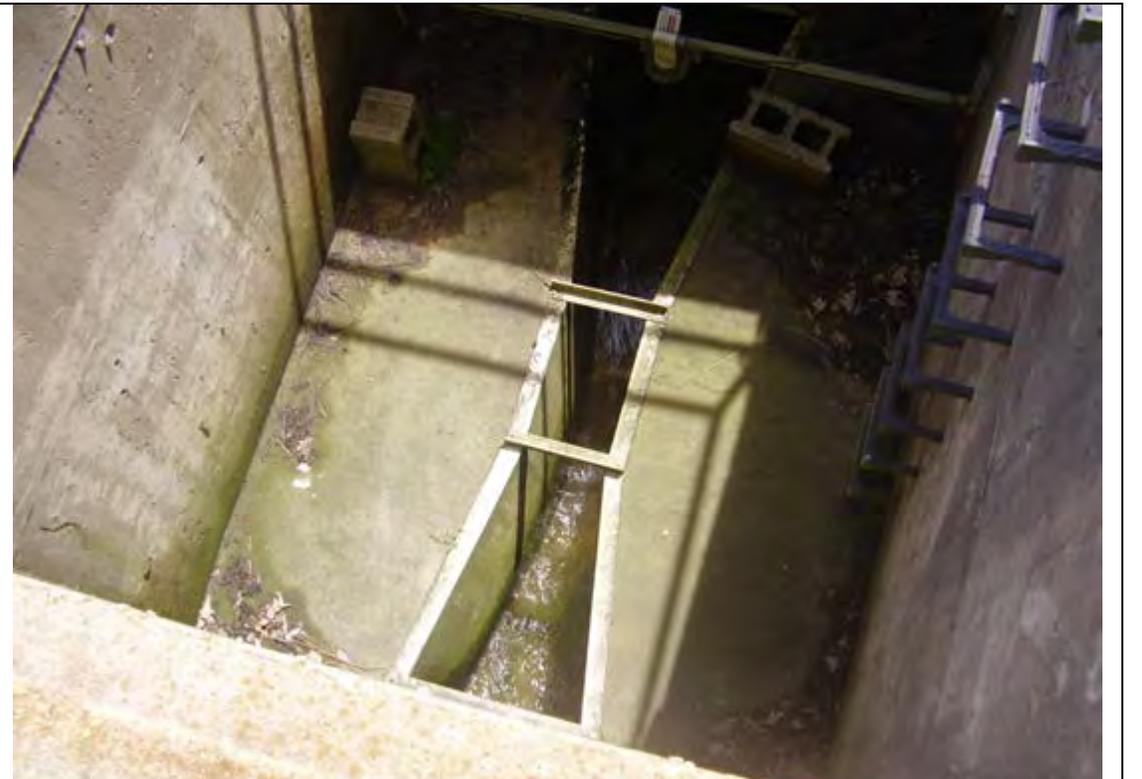
Photo No.
66

Flume structure in the discharge line from the Secondary Cell to the Illinois River.

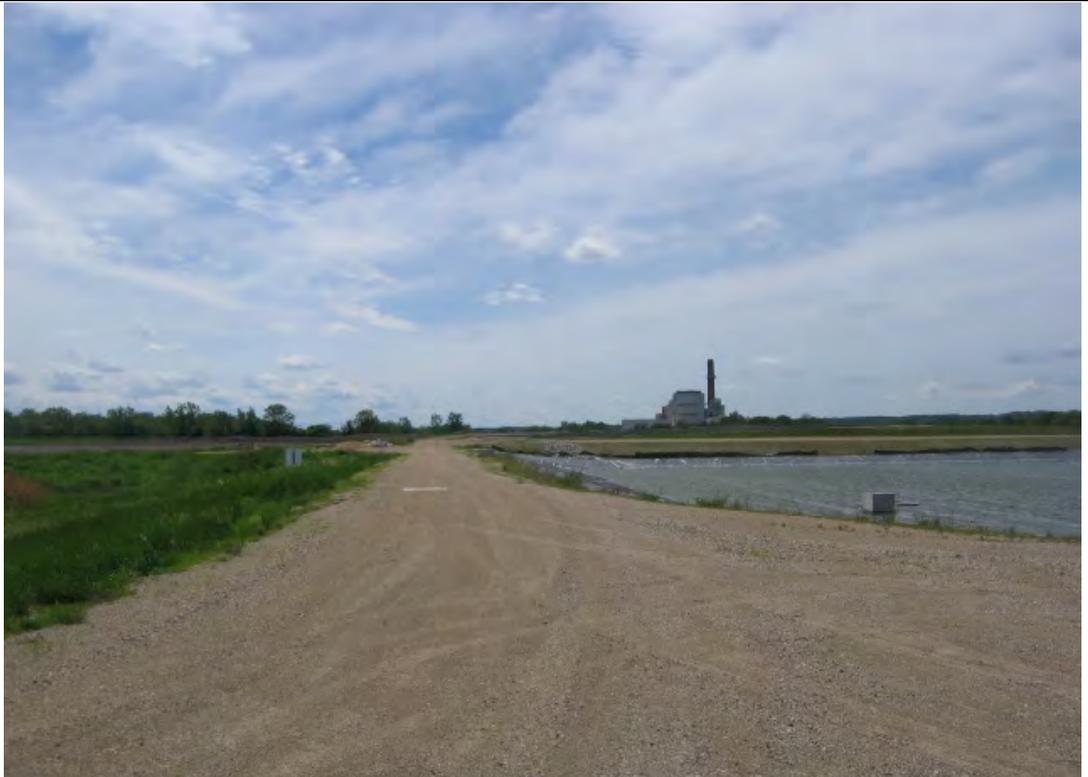
Photo No. 67	Date: 5/23/11
Direction Photo Taken: West

Description:
Crest of the interior embankment in the AEAPS with the Pond 2E decant structure shown.

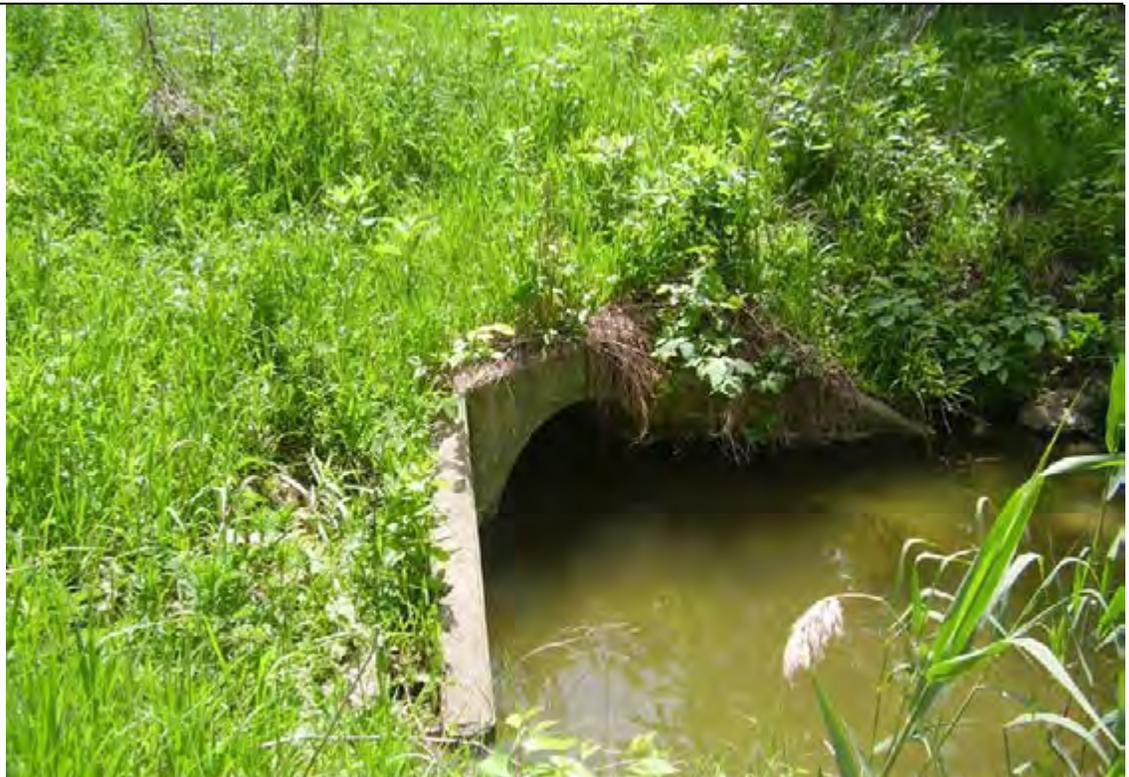
Photo No. 68	Date: 5/23/11
Direction Photo Taken: Southwest

Description:
Outfall at the Illinois River.
