BEFORE THE ILLINOIS POLLUTION CONTROL BOARD CLERK'S OFFICE
ADMINISTRATIVE CITATION

AC 09 - 9
Site Code: 0778035022

# Inspection Report Document: Open Dump Site Narrative

Site Name: DeSoto / Alvin Valdez Time: 1:40 p.m. –1:52 p.m.

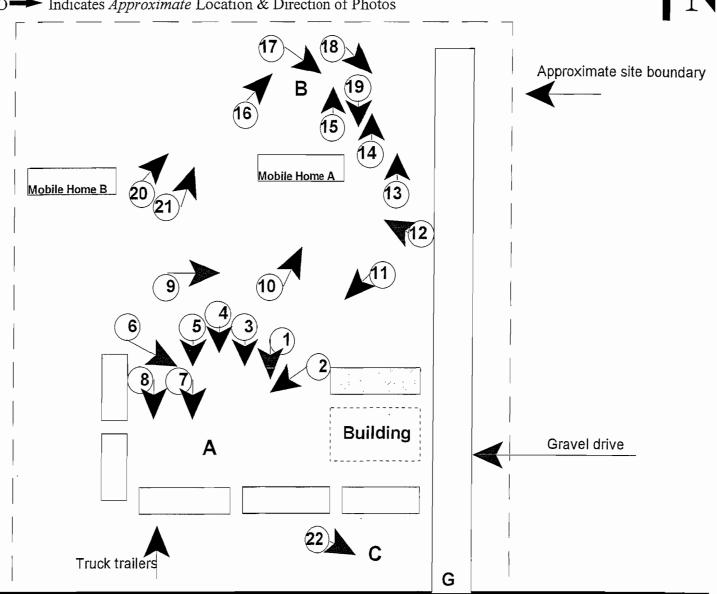
### **OPEN DUMP INSPECTION** SITE SKETCH

O Indicates *Approximate* Location & Direction of Photos

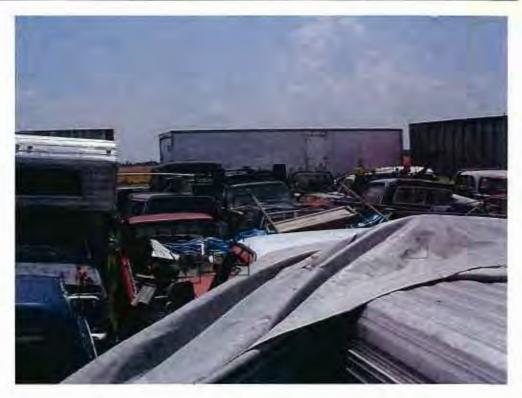
0778035022-06252008-01

I walked to a location west of the building at the site (Area A on Site Sketch). In this area I observed between thirty and forty abandoned vehicles (Photos #1 - #8, Site Sketch Area A). Several observations led this inspector to conclude that these vehicles were abandoned. These observations included: 1) vegetation was growing undisturbed, around and through the vehicles in this area, indicating that they had not been moved in at least seven days (Photos #3 -#4 & #6 - #8, Site Sketch Area A), 2) several trucks had waste material lying in their beds, uncovered and exposed to the elements (Photos #1 - #2 & #5 - #8, Site Sketch Area A), 3) no vehicles displayed current Illinois license plates (Two of which are shown in Photos #3 - #4, Site Sketch Area A), and 4) some of the vehicles were missing or had broken windows, allowing their interiors to be exposed to weathering. Also at the time of the inspection, these vehicles were not in use, were not useable in their current condition and were not stored in such a way as to protect any future use. Also, they were stored in an unorganized and unsightly manner.

As previously stated, I observed uncovered waste in the beds of many of the trucks located in the area labeled "A" on the site sketch (Photos #1 - #2 & #5 - #8, Site Sketch Area A). The waste in these vehicles included, but was not limited to: waste tires, scrap metal, vehicle parts, particle board that was falling apart, probably due to exposure to precipitation (Photo #6, Site Sketch Area A), dimensional lumber, an off-road recreational vehicle, and plastic items (Photos #1 - #8, Site Sketch Area A).

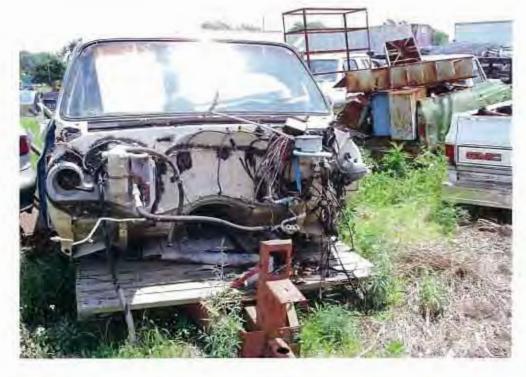
0778035022-06252008-09

North of the Area A, I observed several more abandoned vehicles (Photos #9 - #12, Site Sketch). At the time of the inspection, these vehicles were not in use, were not useable in their current condition and were not stored in such a way as to protect any future use. Also, they were stored in an unorganized and unsightly manner.

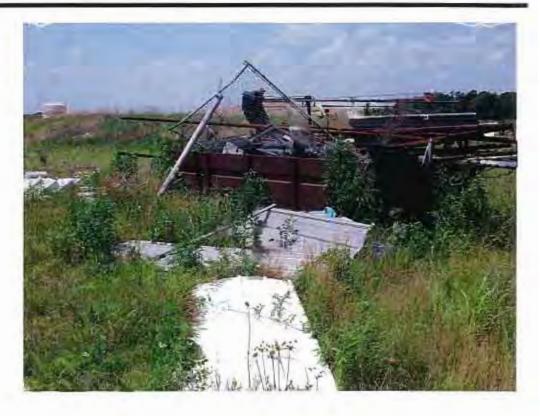
0778035022-06252008-13

I continued walking north and observed an area where metal siding and other scrap metal had been open dumped (Photo #13, Site Sketch). The materials in this area were over grown with vegetation, were not in use and were not stored in such a manner as to protect them for future use. Also these materials were stored in an unsightly manner.

I continued walking north and observed another area where waste had been open dumped (Photos #13 - #20, Site Sketch Area B). The waste in this area consisted of but was not limited to: abandoned vehicles, dimensional lumber, lawn mowers, vehicle parts, scrap metal, plastic items, and roofing shingles. The following observations led this inspector to conclude that the vehicles in this area were abandoned: 1) there were no tracks in the bare soil that would indicate the vehicles had been moved recently and 2) none of the vehicles were displaying current Illinois licence plates.

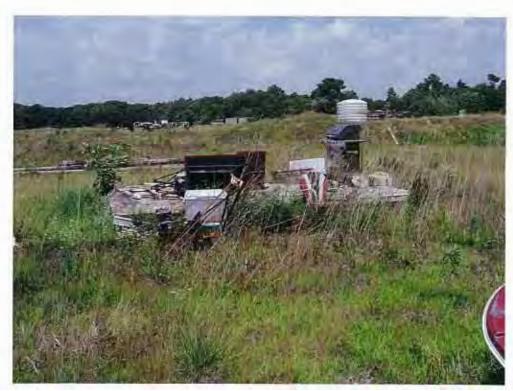
Photo Name: 0778035022-06252008-20

I walked south and observed another area of open dumped waste (Photos #20 & #21, Site Sketch). The waste in this area consisted of, but was not limited to: dimensional lumber, scrap metal, plastic items, a gas powered garden tiller and a motor boat. At the time of the inspection, these items were not in use, were not useable in their current condition and were not stored in such a way as to protect any future use.

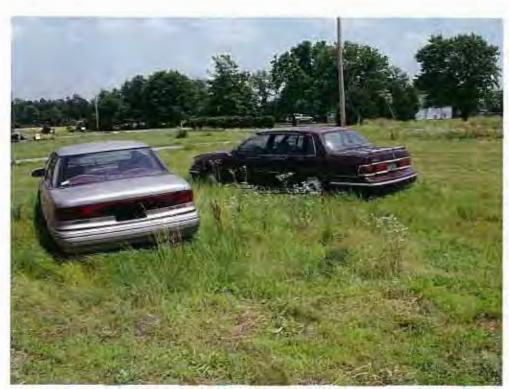
Photo Name: 0778035022-06252008-22

I then walked south to an area south of the truck trailers and observed two abandoned vehicles (Photo #22, Site Sketch). These vehicles appeared abandoned for the following reasons:

1) neither vehicle was displaying a current Illinois licence plate, 2) both vehicles were surrounded by vegetation that was at least 12 inches high and 3) I observed no tracks through the tall vegetation that would indicate the vehicles had been moved recently (Photo #22, Site Sketch).
