BEFORE THE ILLINOIS POLLUTION CONTROL BOARD

WATER QUALITY STANDARDS AND EFFLUENT LIMITATIONS FOR THE CHICAGO AREA WATERWAY SYSTEM AND LOWER DES PLAINES RIVER PROPOSED AMENDMENTS TO 35 ILL. ADM. CODE 301, 302, 303, and 304 R08-9 (Rulemaking – Water)

the Clerk of the Pollution Control Board PRE-FILED TESTIMONY OF G. ALLEN BURTON

AND GREG SEEGERT, by Midwest Generation, a copy of which is herewith served upon you.

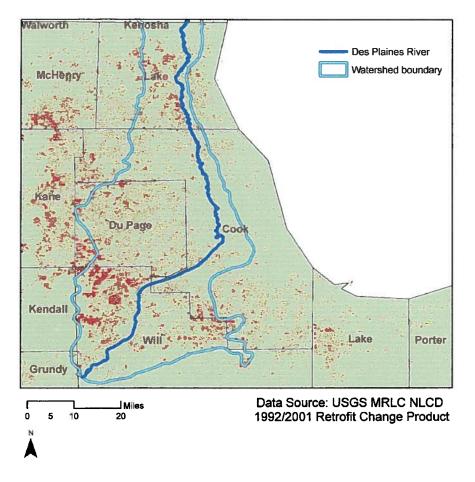
Area Converted to Urban Land Use 1992-2001

Figure B-1. Estimated land converted to urban land use between 1992 and 2001 based on a comparison of the NLCD 1992 and 2001 datasets (USGS, MRLC NLCD 1992/2001 Retrofit Change Product).

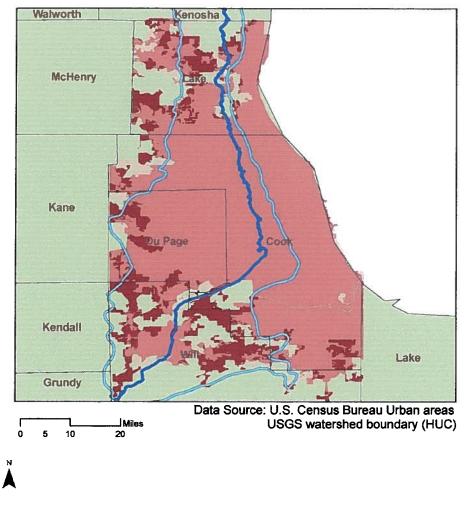
Urban Area Boundary Expansion 1990-2000 Cook, Dupage, Lake and Will Counties (IL)

Figure B-2. U.S. Census urban boundary change between 1990 and 2000 census for Cook, Du Page, Lake, and Will counties in Illinois.

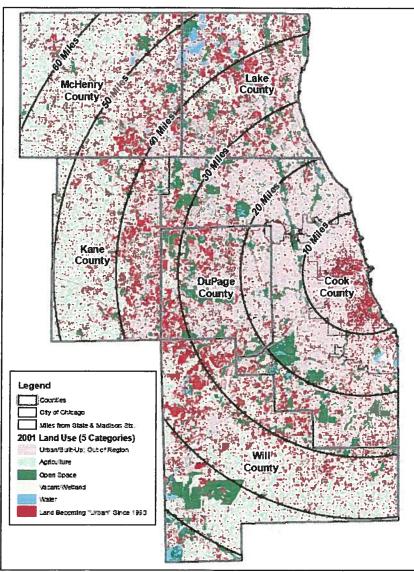
Map 10: "Urbanized" Lands (2001) Classified as "Agriculture" or "Vacant" in 1990

Figure B-5. Urban lands in 2001 that were agricultural or vacant in 1990. The 2001 land use data was compiled from interpretation of aerial photography and other sources).

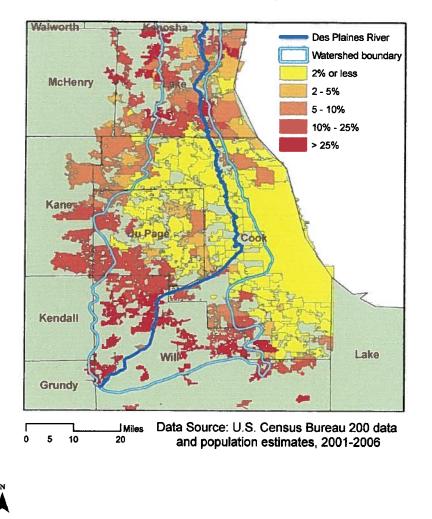
% Population Increase in Municipalities 2000-2006

Figure B-6. U.S. Census estimated population increase (%) in municipalities from year 2000 to 2006.

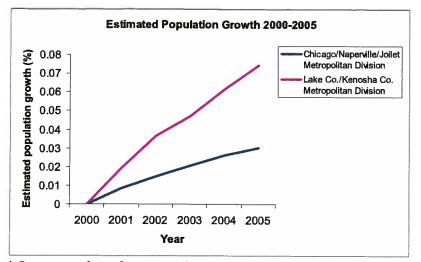
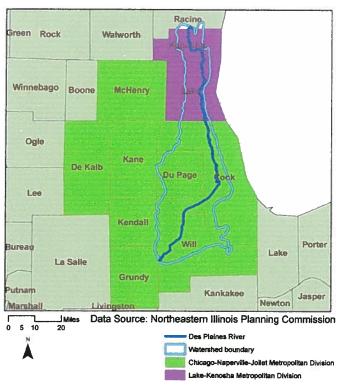
Metropolitan Division Areas

Figure B-7 (a+b). Estimated population growth (2000-2005, U.S. Census Bureau) by Metropolitan Division (Northeastern Illinois Planning Commission).

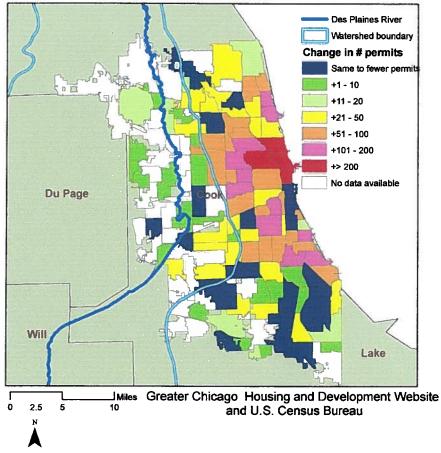
Figure B-8. Change in number of annual building permits (year 2000 versus 2003) for municipalities and communities of the Greater Chicago area.

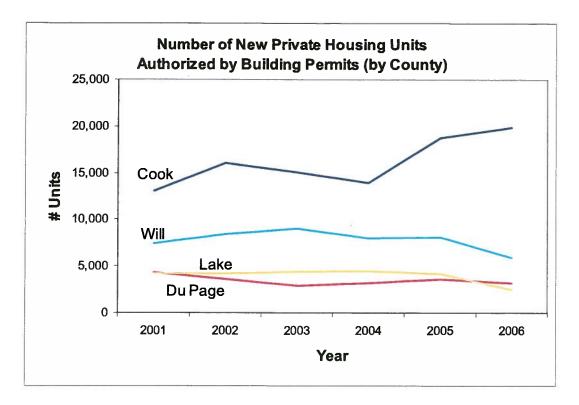
Figure B-9. Number of new private housing units authorized by building permits (2001-2006) for Cook, Du Page, Lake, and Will Counties (U.S. Census Bureau).

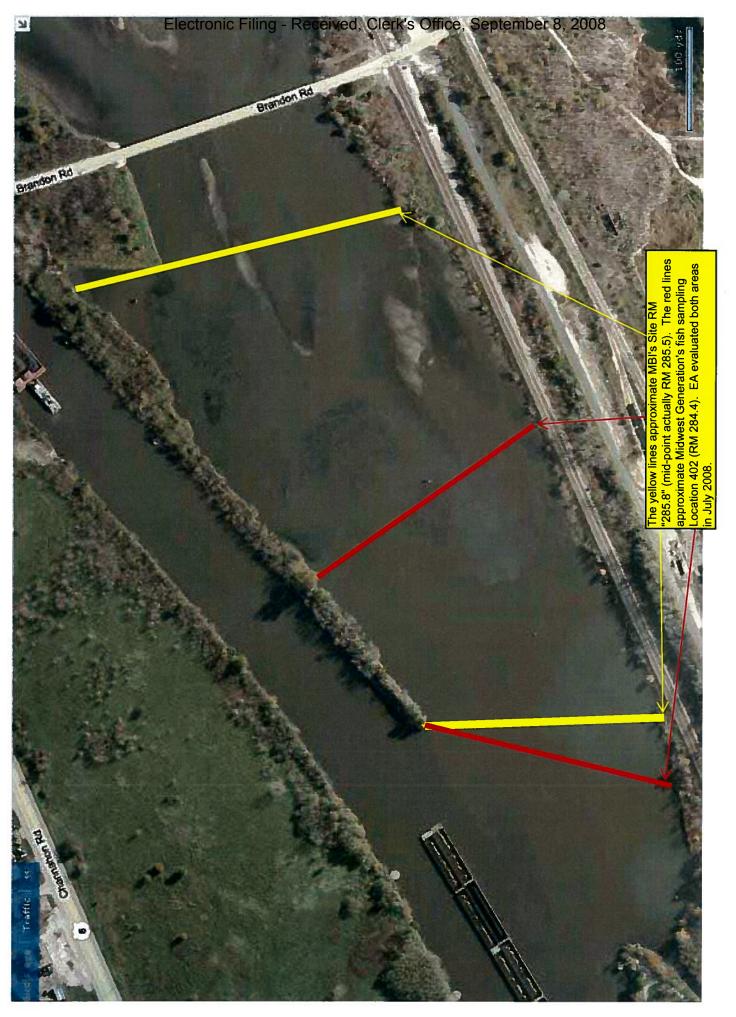
Areas within the Brandon Road Lock and Dam tailwater that were assessed with the QHEI during July 2008.

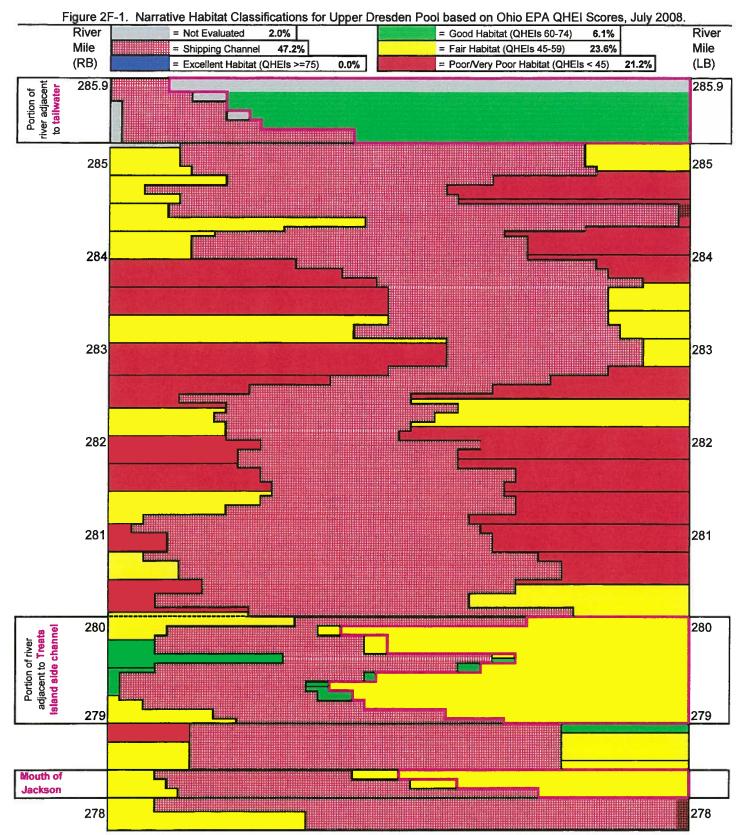
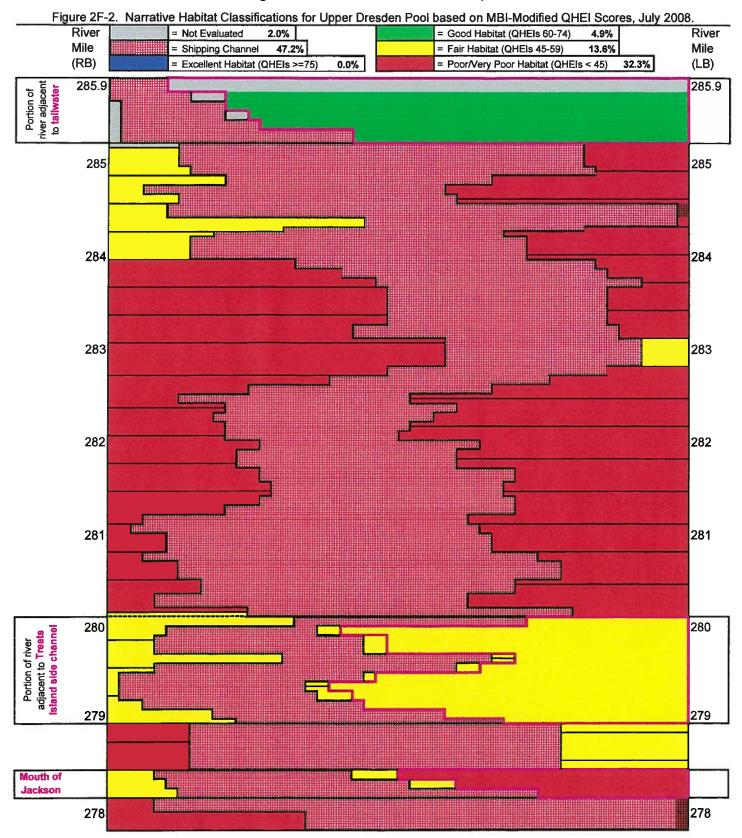
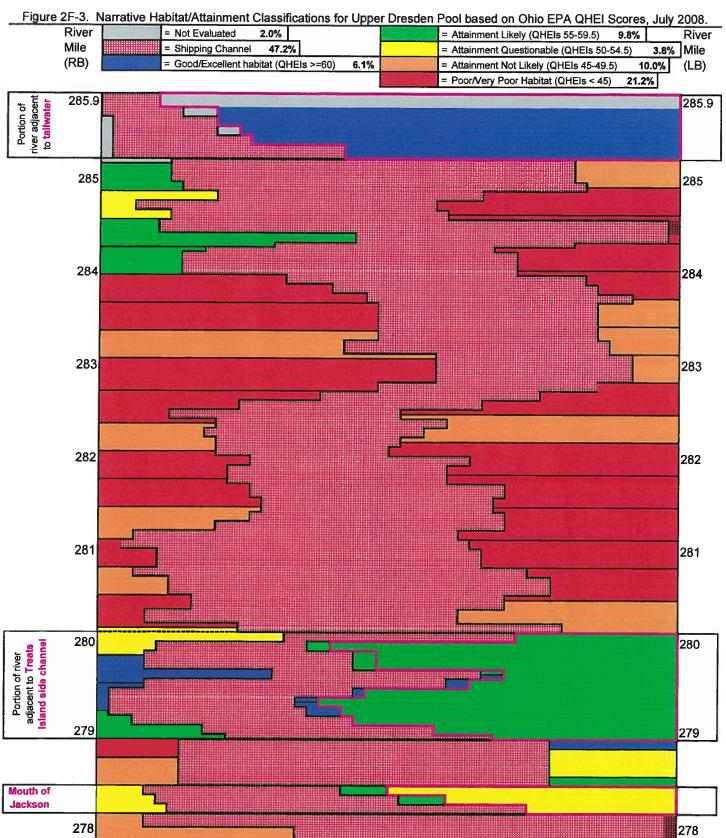
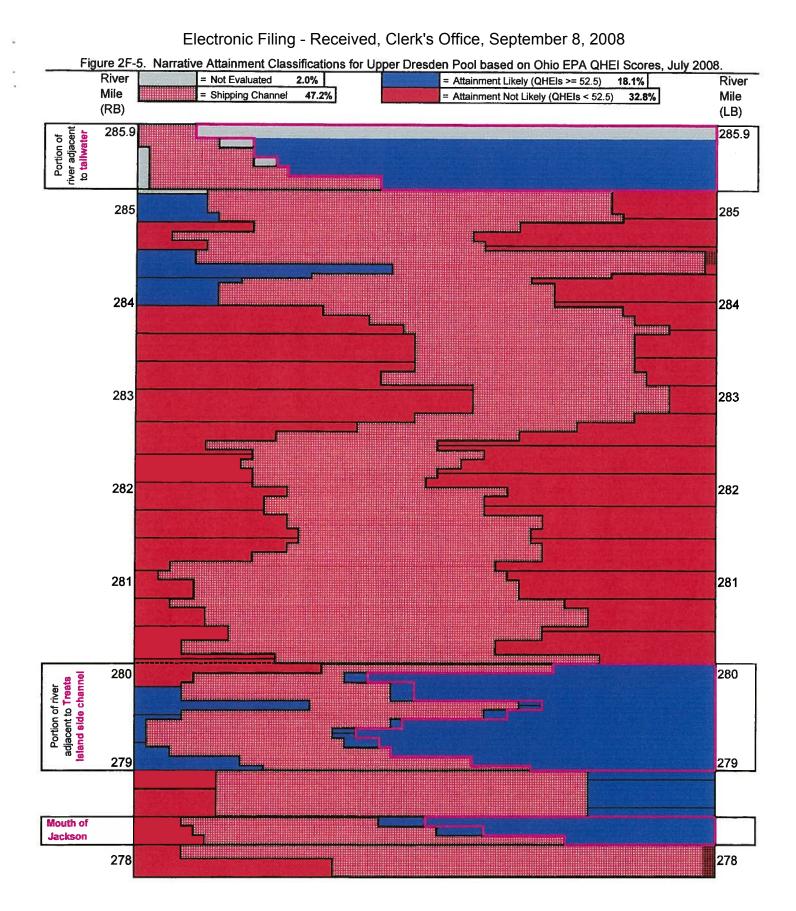
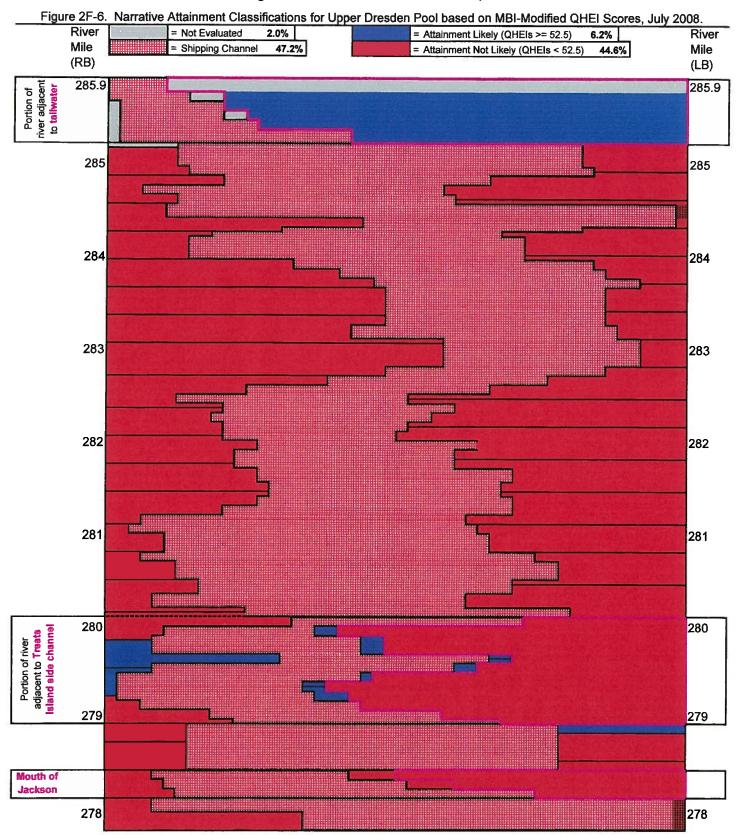
Figures showing QHEI score distributions for the July 2008 study

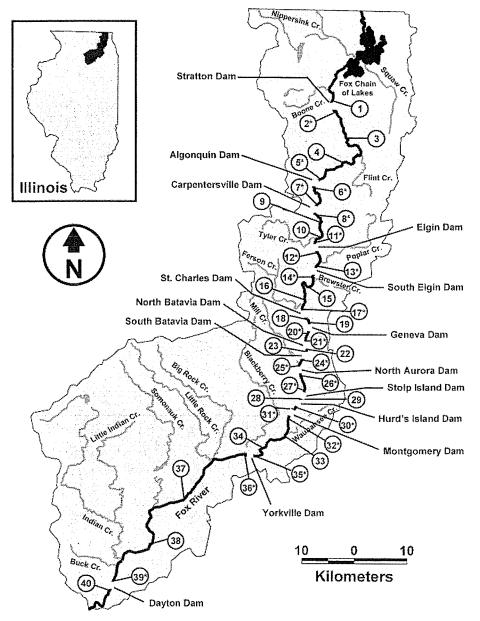
FIGURE 1.—Map of the Fox River watershed, Illinois, showing the locations of major tributaries (drainage area $> 50 \text{ km}^2$), main-stem and selected tributary dams (squares), and numbered stations that were sampled for fish, macroinvertebrates, and habitat during summer and fall 2000. Stations marked by asterisks were sampled for water quality during summer and fall 2001.

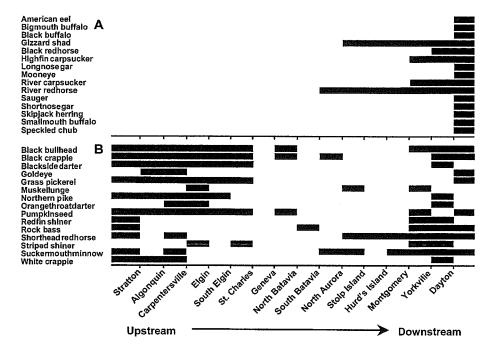
FIGURE 2.—Fox River (Illinois) fishes with (A) truncated distributions (restricted to the lower portion of the study area), namely American eel Anguilla rostrata, bigmouth buffalo Ictiobus cyprinellus, black buffalo I. niger, gizzard shad Dorosoma cepedianum, black redhorse Moxostoma duquesnei, highfin carpsucker Carpiodes velifer, longnose gar Lepisosteus osseus, mooneye Hiodon tergisus, river carpsucker C. carpio, river redhorse M. carinatum, sauger Sander canadensis, shortnose gar L. platostomus, skipjack herring Alosa chrysochloris, smallmouth buffalo I. hubalus, and speckled chub Macrhybopsis aestivalis and (B) discontinuous distributions (typically absent from the niddle portion of the study area), namely, black bullhead Ameiurus melas, black crappie Pomoxis nigromaculatus, blackside darter Percina maculata, goldeye H. alosoides, grass (redfin) pickerel Esox americanus, muskellunge E. masquinongy, northern pike E. lucius, orangethroat darter Etheostoma spectabile, pumpkinseed Lepomis gibbosus, redfin shiner Lythrurus umbratilis, suckermouth minnow Phenacobius mirabilis, and white crappie Pomoxis and relevant and tributary stations sampled from 1980 through 2000 (Bertrand et al. 1982; Sallee and Bergmann 1986; Day et al. 1992; Heidinger 1993; Santucci 1994; Pescitelli and Rung, unpublished data; present study). Note that distances between dams are not to scale.

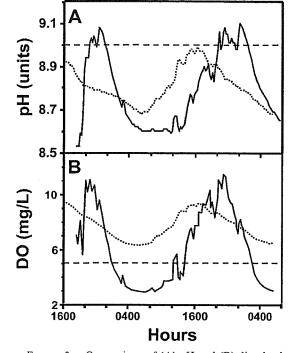
FIGURE 3.—Comparison of (A) pH and (B) dissolved oxygen (DO) between free-flowing (dotted lines) and impounded (solid lines) areas of the Fox River, Illinois, from the North Aurora Dam to the Stolp Island Dam. Similar patterns in DO and pH were observed between free-flowing and impounded reaches of 10 other between-dam river segments monitored during the study. Variables were measured with continuously recording Hydrolab Datasonde water quality monitors over a 40h period in August 2001. Horizontal dashed lines represent Illinois Environmental Protection Agency ambient water quality standards.

ANOVA: $F_{1,10} = 26.13$, P = 0.001), and DO minima were lower in impounded areas $(4.2 \pm 0.7 \text{ mg/L})$ L) than in free-flowing areas $(5.7 \pm 0.7 \text{ mg/L}; F_{1,10})$ = 6.88, P = 0.02). Mean maximum pH also was higher in impounded areas $(9.0 \pm 0.08 \text{ units})$ than in free-flowing areas $(8.8 \pm 0.07 \text{ mg/L})$ ($F_{1,10} =$ 7.35, P = 0.02), but minimum pH ($F_{1,10} = 0.03$, P = 0.86), maximum temperature ($F_{1,10} = 0.40$, P = 0.54), and minimum temperature ($F_{1,10} =$ 3.90, P = 0.54) were similar among impounded and free-flowing locations.

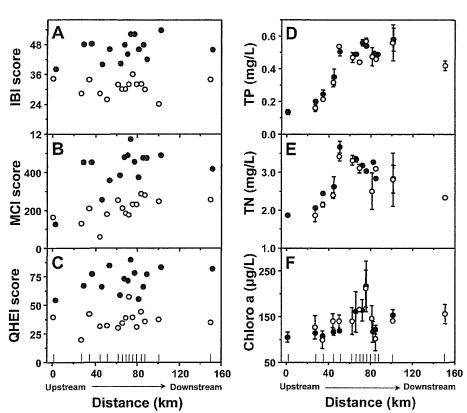
FIGURE 5.—Relations between upstream-downstream distance and (A) index of biotic integrity (IBI), (B) macroinvertebrate community index (MCI), (C) qualitative habitat evaluation index (QHEI), (D) total phosphorus (TP), (E) total nitrogen (TN), and (F) chlorophyll a (chloro a) for stations in free-flowing (solid circles) and impounded (open circles) areas in the Fox River, Illinois. Biota and habitat were sampled during July–September 2000, and water quality was sampled during August 2001. Values for chlorophyll a, TP, and TN are means ±SEs of morning and evening samples. Vertical lines above the x-axis indicate dam locations.
