ADMINISTRATIVE CITATION

AC 12-13
(IEPA No. 297-11-AC)

MEMORANDUM

Subject: I.PC# 1378615002 - Morgan County
Meredosia/Brown
Complaint C-12-017-C
FOS File

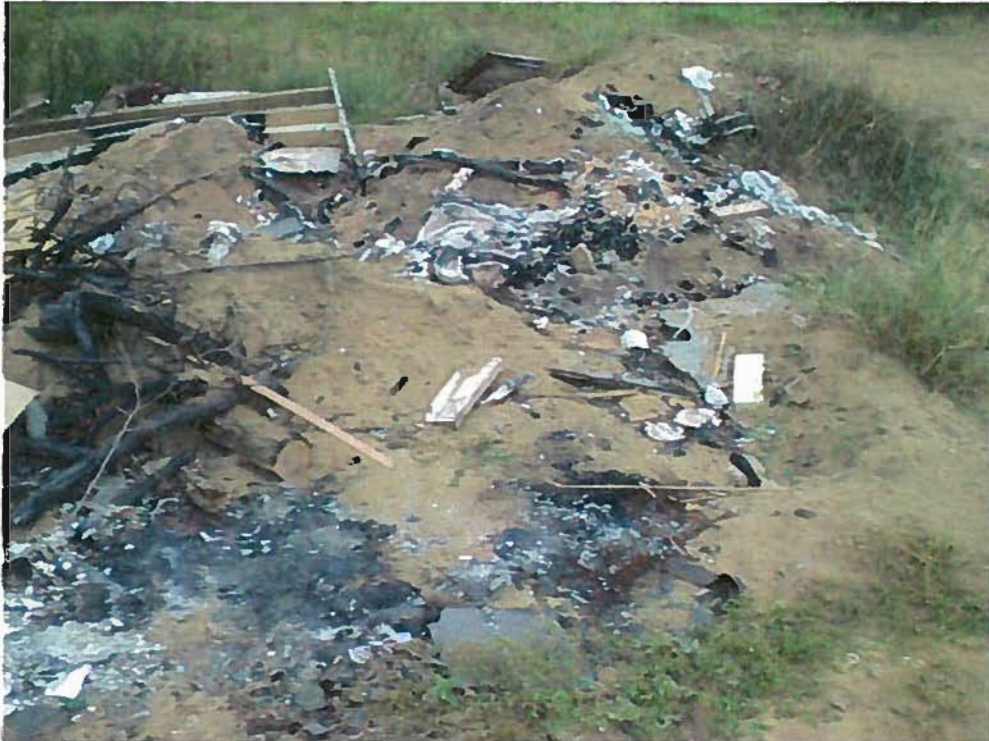
There was a pile of waste in the southwest part of the site. This pile is shown in photographs 001, 002 and 003. Most of the identifiable waste in this pile was wood demolition waste. This pile measured approximately 4 yards by 6 yards by up to 1 yd high. There was a considerable amount of ash in this pile. Since there were numerous individual pieces of wood waste in the pile that had previously been observed during the July 19, 2011 investigation and since none of the pieces of wood appeared to be burned or partially burned, it did not appear that the wastes in this pile had been burned since the ACWN had been received by Mr. Brown. There was no smoky smell in the area of this pile.

Date: September 14, 2011
Time: 12:08 PM
Direction: Southwest
Photo by: W Zierath
Exposure #: 001
Comments: Demolition waste and burned wastes in a pile in the southwest part of the site. Some of the unburned waste was observed on July 19, 2011.

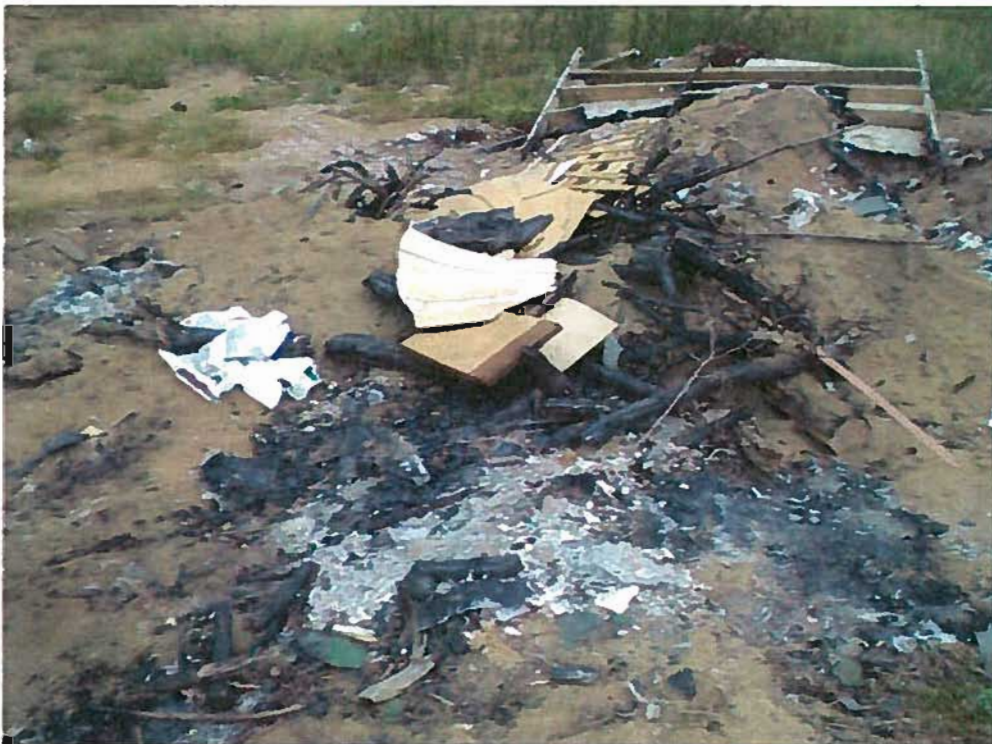
Date: September 14, 2011
Time: 12:09 PM
Direction: South
Photo by: W Zierath
Exposure #: 002
Comments: Demolition waste and burned wastes in a pile in the southwest part of the site. Some of the unburned waste was observed on July 19, 2011.

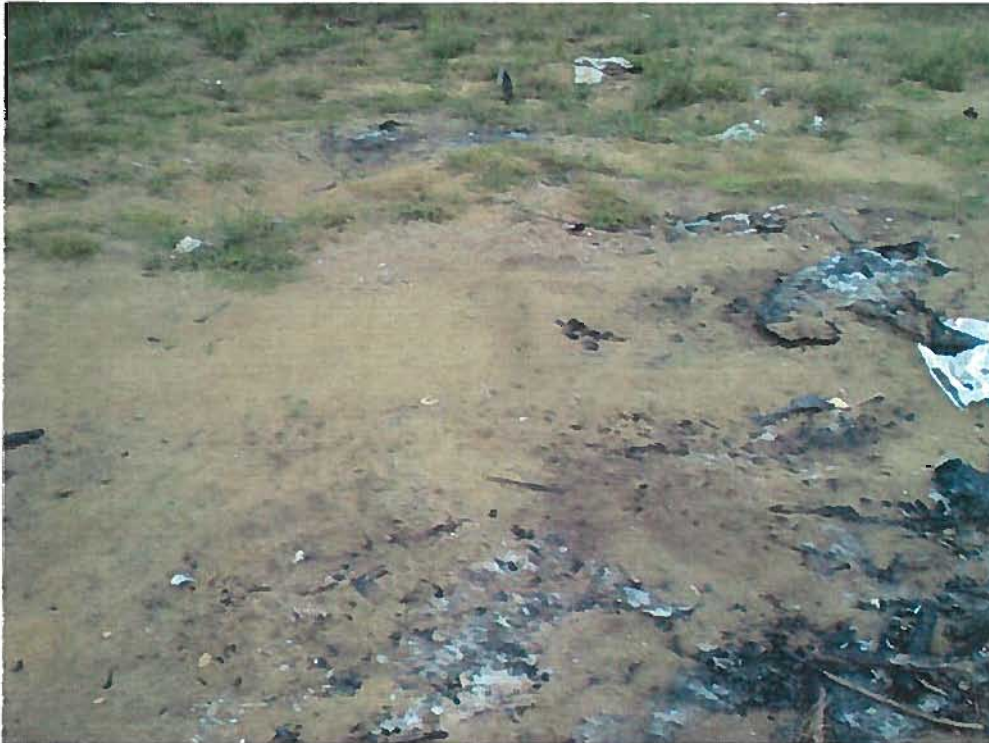
Date: September 14, 2011
Time: 12:09 PM
Direction: Southeast
Photo by: W Zierath
Exposure #: 003
Comments: Demolition waste and burned wastes in a pile in the southwest part of the site. Some of the unburned waste was observed on July 19, 2011.

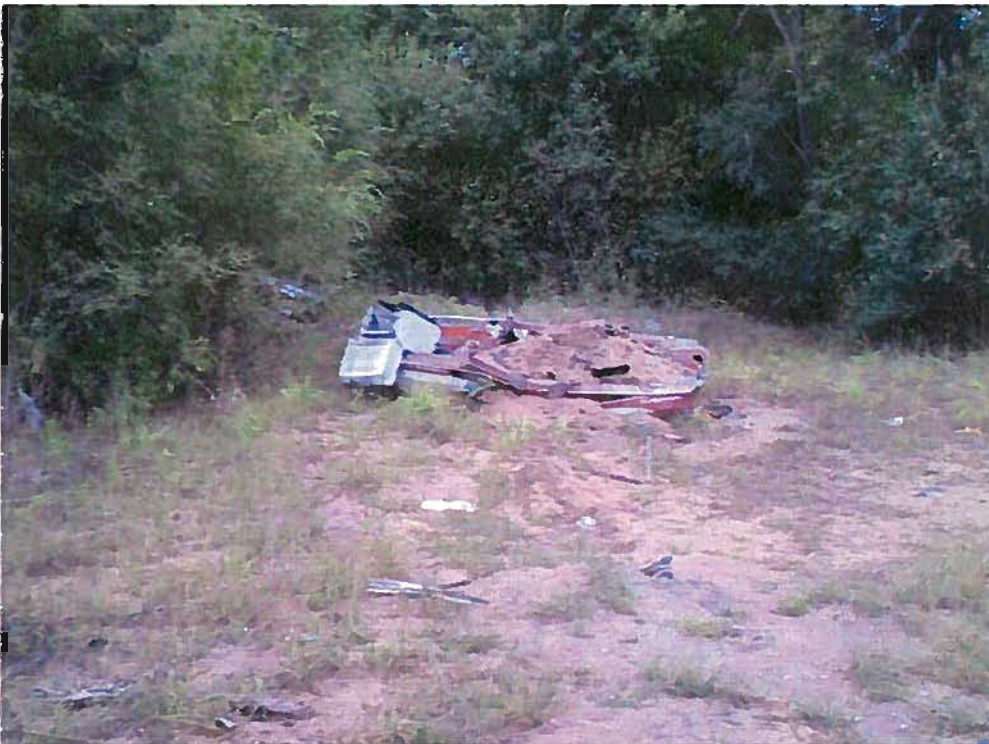
Southeast of the waste pile described above were two broken fiberglass boat hulls that had been dumped on the ground. These boat hulls are shown in photograph 004.

Date: September 14, 2011
Time: 12:09 PM
Direction: Southeast
Photo by: W Zierath
Exposure #: 004
Comments: Two broken fiberglass boats dumped at the south end of the site.

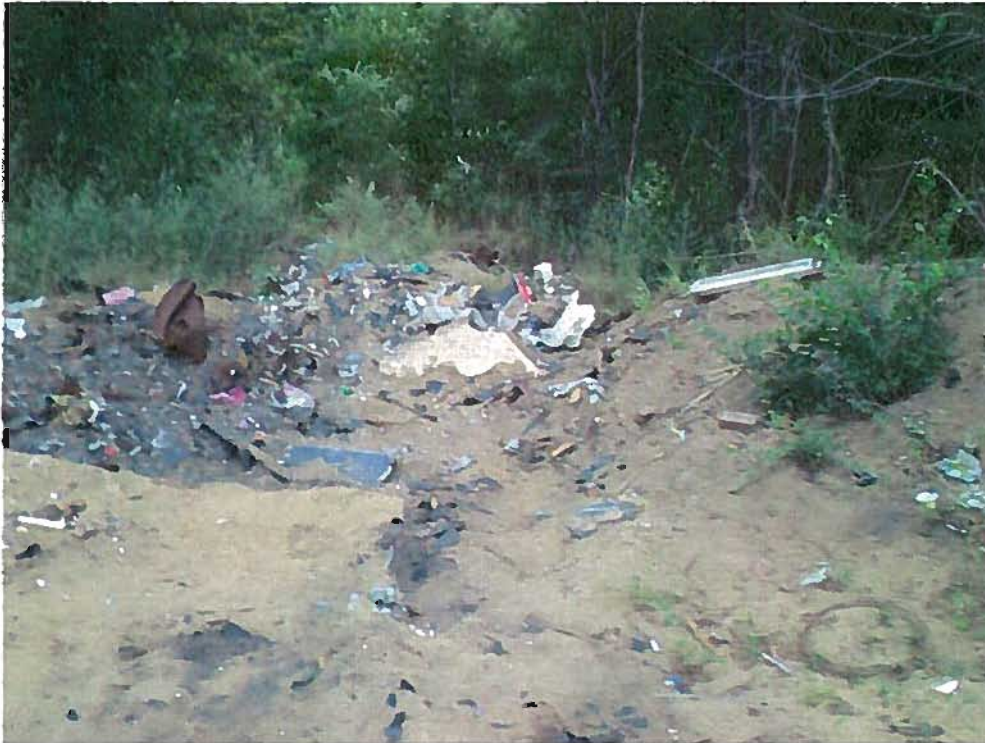
There was a pile of waste in the southeast part of the site. This pile is shown in photographs 005, 006, 007 and 008. The waste in this pile included wood demolition waste, scrap metal, the steel bands left from the burning of tires and assorted junk. This pile measured approximately 4 yards by 9 yards by up to a yard high. There was some ash around this pile. There was no smoky odor or smoke detectable near this pile.

Date: September 14, 2011
Time: 12:10 PM
Direction: Southwest
Photo by: W Zierath
Exposure #: 005
Comments: Unburned and burned wastes in the southeast part of the site. Wastes included demolition waste, scrap metal and the steel bands from burned tires.

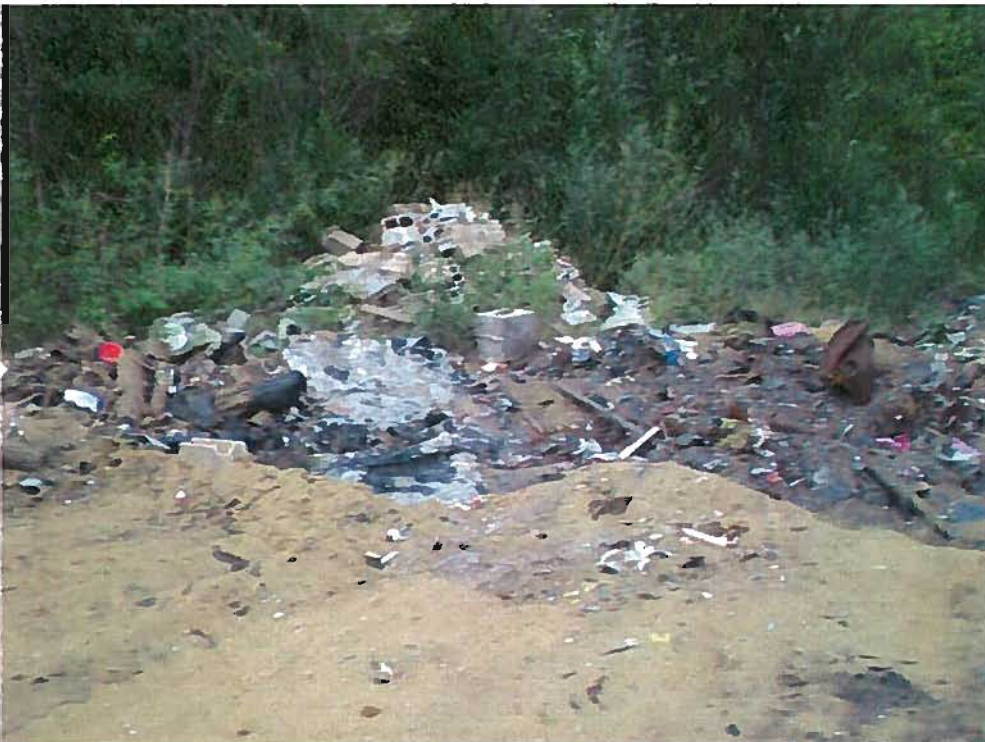
Date: September 14, 2011
Time: 12:10 PM
Direction: South
Photo by: W Zierath
Exposure #: 006
Comments: Unburned and burned wastes in the southeast part of the site. Wastes included demolition waste, scrap metal and the steel bands from burned tires.

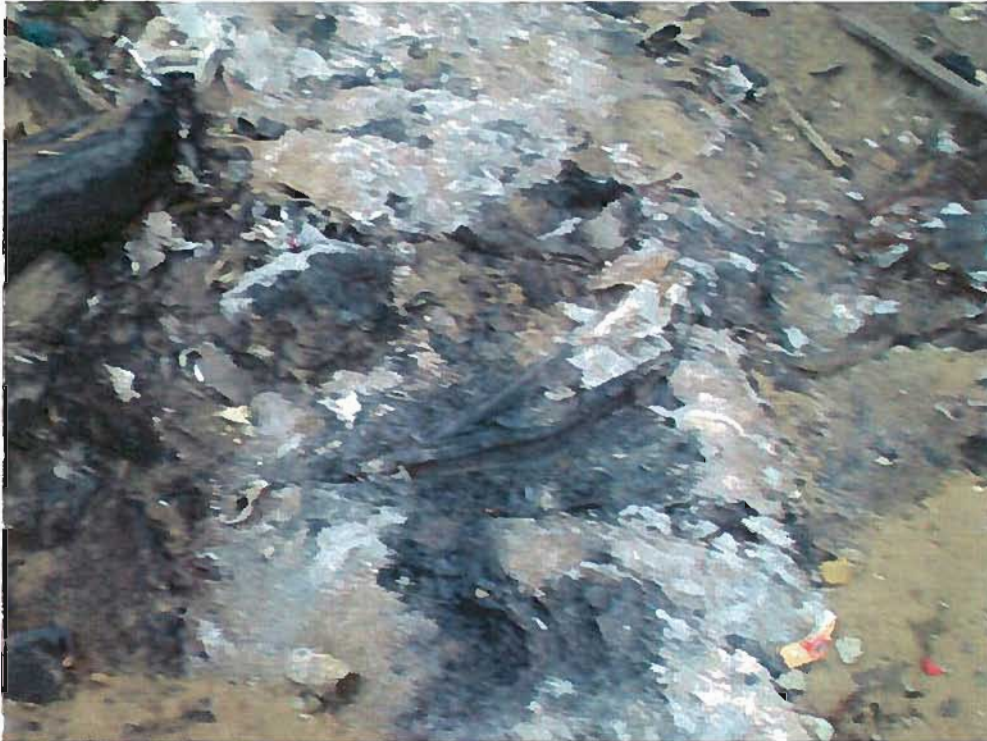
Date: September 14, 2011
Time: 12:11 PM
Direction: South
Photo by: W Zierath
Exposure #: 007
Comments: Close up of waste shown in photographs 005 and 006.

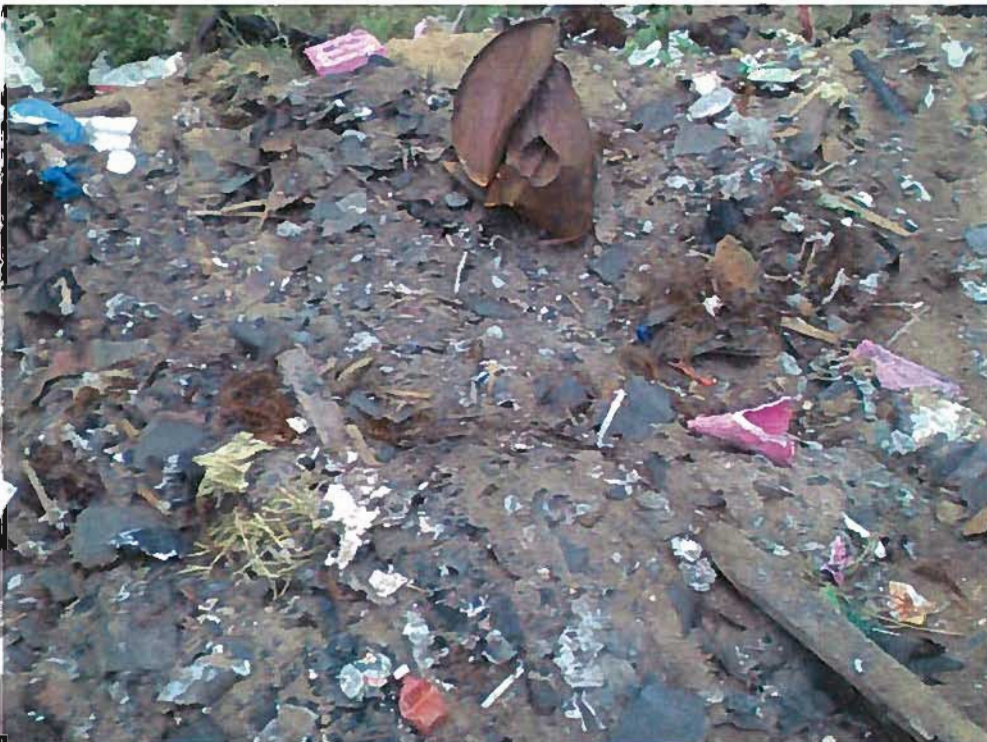
Date: September 14, 2011
Time: 12:11 PM
Direction: Southeast
Photo by: W Zierath
Exposure #: 008
Comments: Close up of waste shown in photographs 005 and 006.

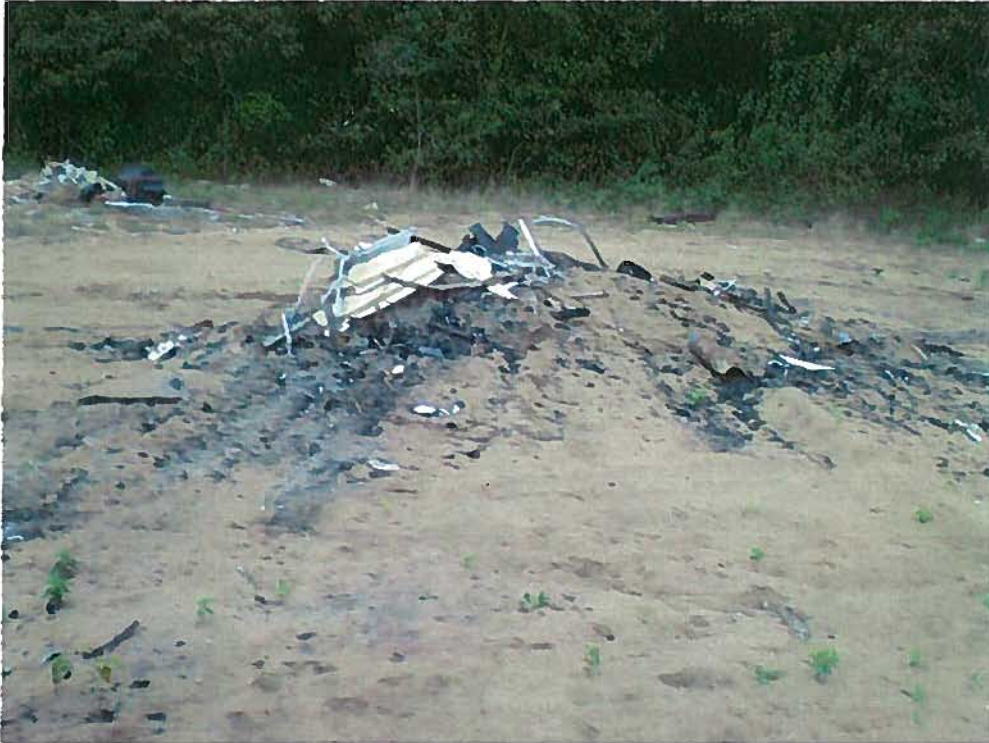
In the middle of the site was another pile of waste. This pile is shown in photograph 009. The wastes in this pile included used siding, scrap metal and numerous broken telephones. This pile measured approximately 3 yards by 3 yards by up to 1 yard high. There was a small amount of ash around this pile, but there was no indication of recent burning.

Date: September 14, 2011
Time: 12:13 PM
Direction: East
Photo by: W Zierath
Exposure #: 009
Comments: Unburned and burned wastes in a pile in the middle part of the site. Wastes included scrap metal, used siding and numerous old telephones.

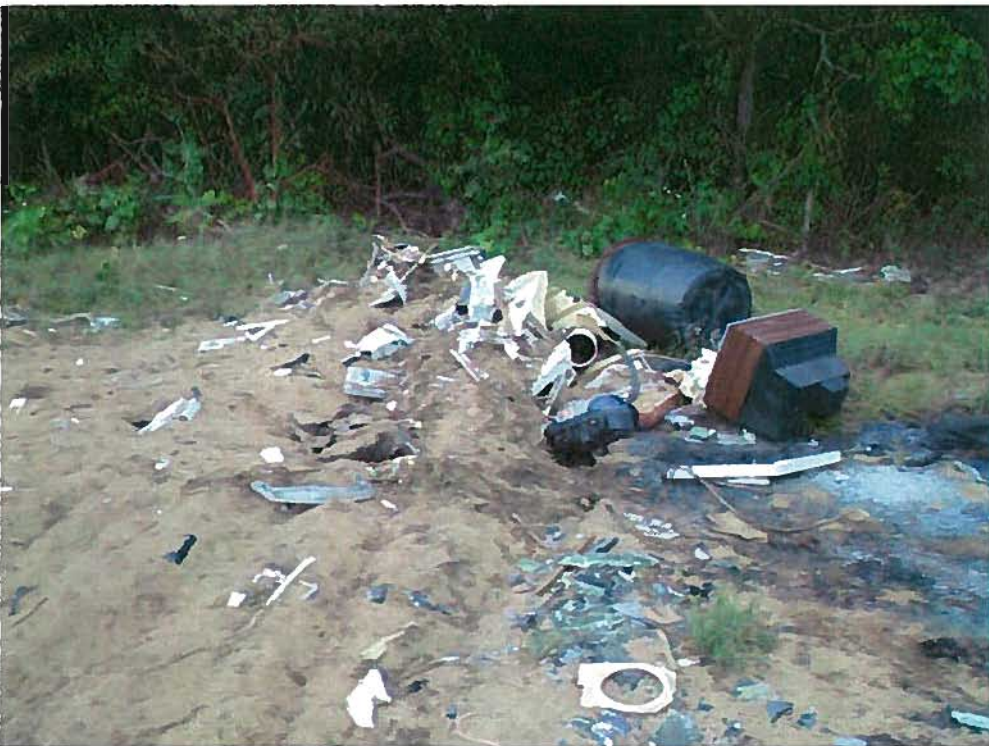
There was another waste pile northeast of the pile shown in photograph 009. This pile is shown in photograph 010. This pile contained scrap metal, an old television, numerous broken telephones, pieces of plastic and other junk. There were ashes south of this pile, but there was no indication of recent burning. This pile measured approximately 4 yards by 5 yards by up to 1 yard high.

Date: September 14, 2011
Time: 12:13 PM
Direction: East
Photo by: W Zierath
Exposure #: 010
Comments: Unburned and burned wastes in a pile on the east side of the site. Wastes included scrap metal, an old television and numerous old telephones.

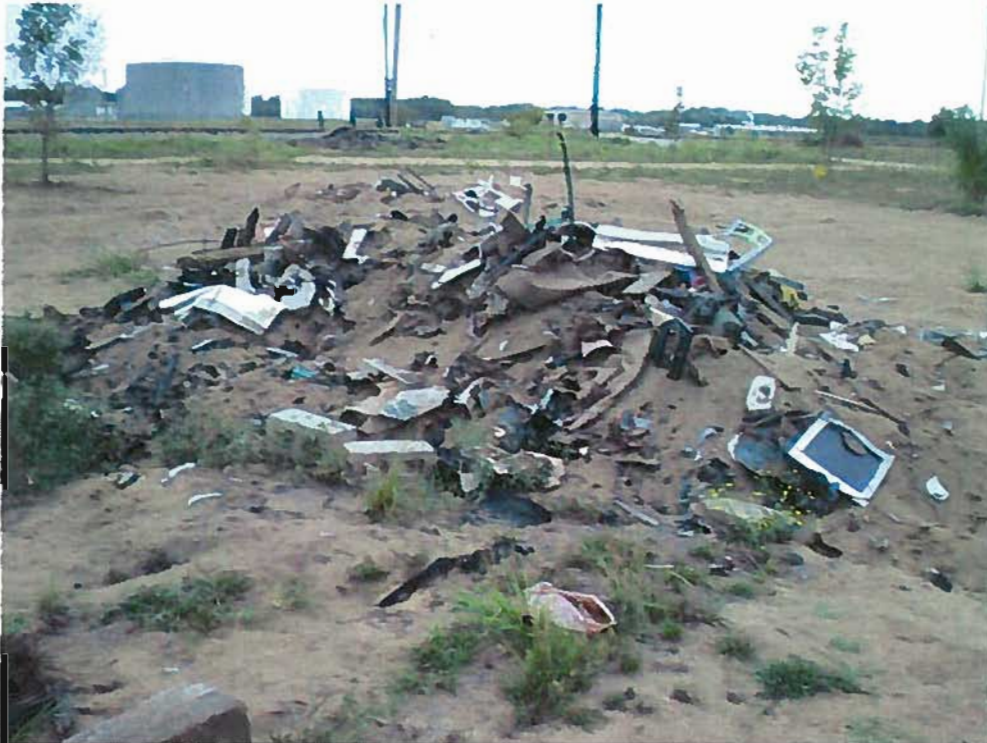
There was a pile of waste east of the former location of the building at this site. This pile is shown in photograph 011. The wastes observed in this pile included wood demolition waste, metal, plastic and assorted junk. This pile measured approximately 5 yards by 5 yards by over 1.5 yards high.

Date: September 14, 2011
Time: 12:15 PM
Direction: Northwest
Photo by: W Zierath
Exposure #: 011
Comments: A pile of waste east of the former location of the corrugated metal-sided building that had been demolished since the July 19, 2011 inspection. The waste included wood demolition waste, metal, plastic and assorted junk.

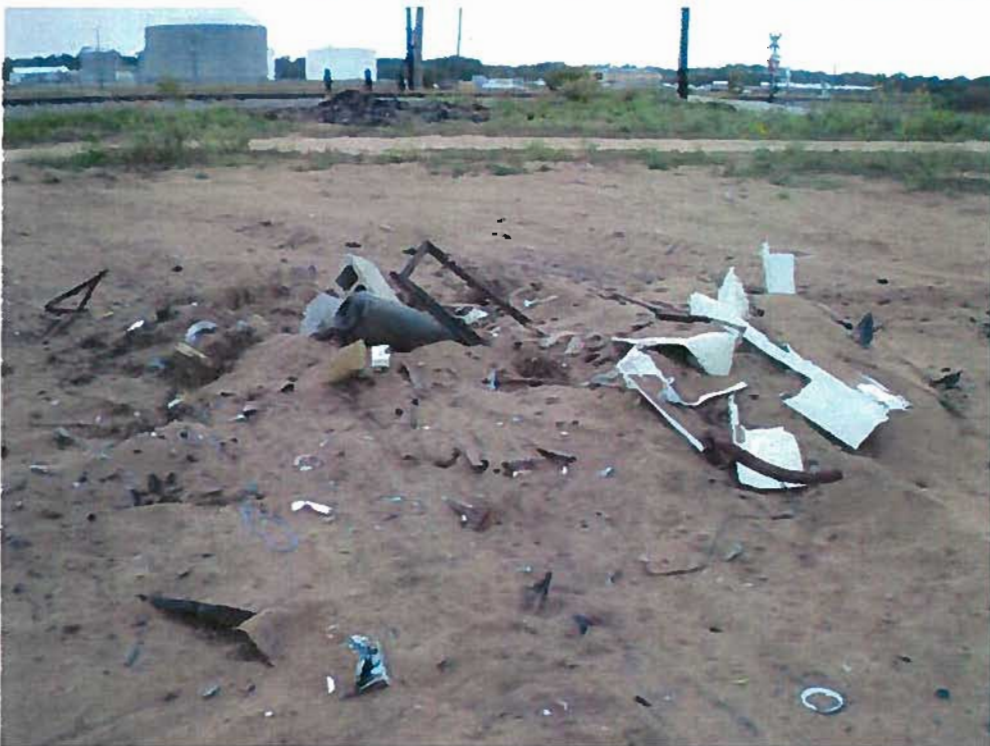
There was a small pile of waste located where the building used to be. This pile is shown in photograph 012. This pile measured approximately 3 yards by 4 yards by up to 1 yard high. Wastes in this pile included wood demolition waste, metal, and fiberglass siding.

Date: September 14, 2011
Time: 12:16 PM
Direction: Southwest
Photo by: W Zierath
Exposure #: 012
Comments: A small pile of waste on the former location of the corrugated metal-sided building that had been demolished since the July 19, 2011 inspection. The waste included wood demolition waste, metal, and fiberglass siding.

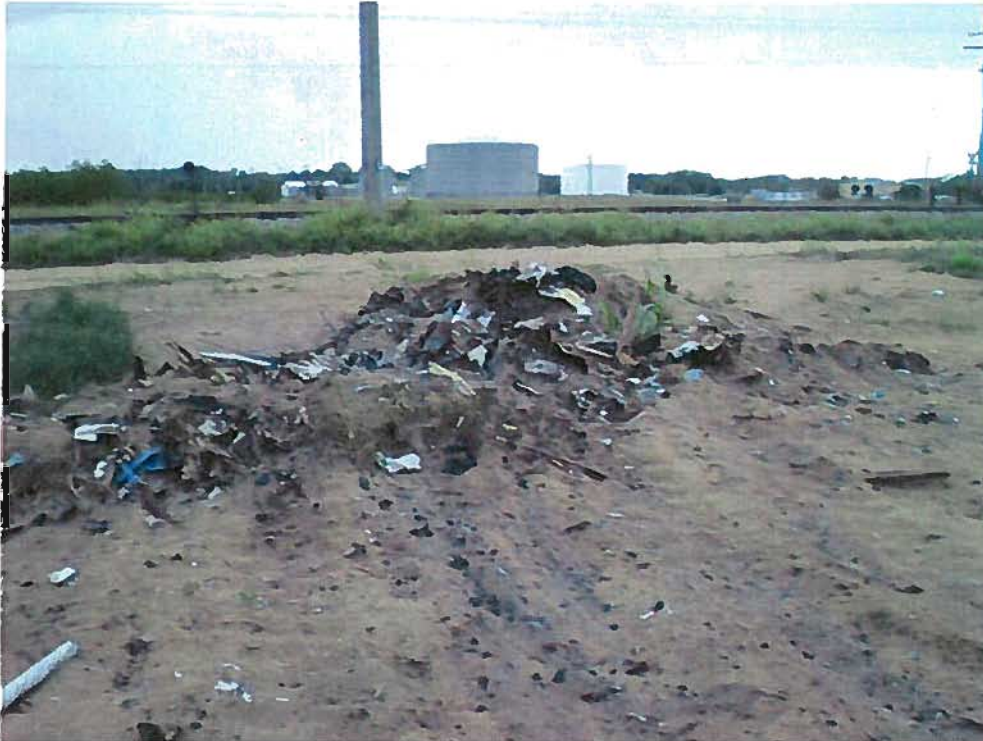
South of the former location of the building at this site was another pile of waste. This pile of waste is shown in photograph 013. Wastes in this pile included wood demolition waste, metal, paper and assorted junk. This pile measured approximately 3 yards by 5 yards by up to 1 yard high.

Date: September 14, 2011
Time: 12:17 PM
Direction: Northwest
Photo by: W Zierath
Exposure #: 013
Comments: A pile of waste south of the former location of the corrugated metal-sided building that had been demolished since the July 19, 2011 inspection. The waste included wood demolition waste, metal, paper and assorted junk.

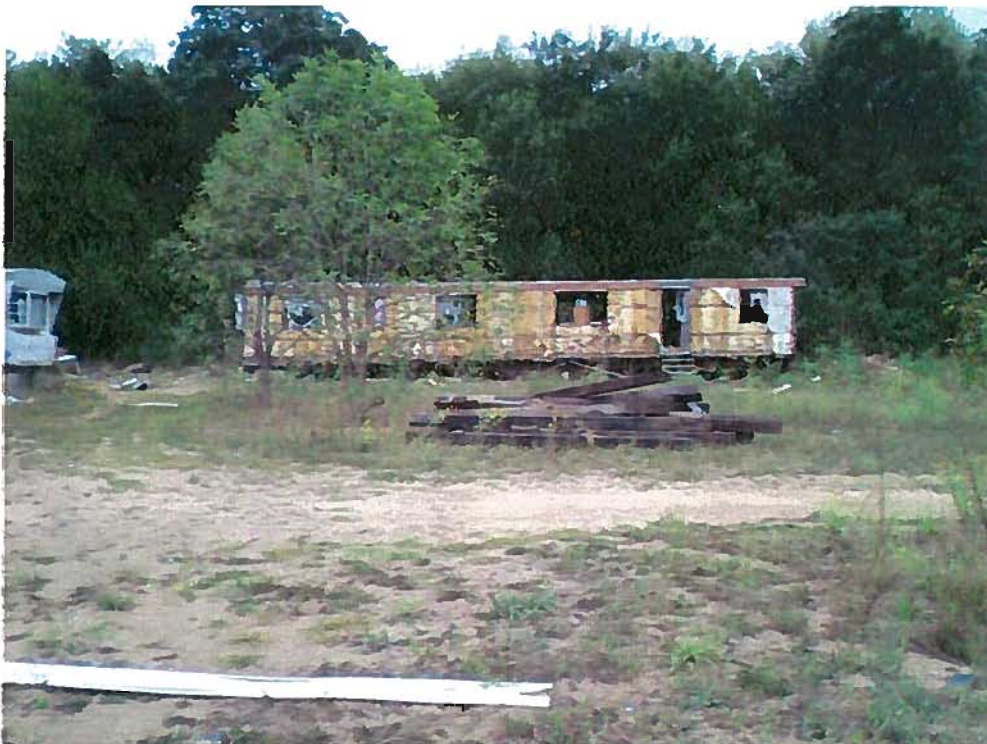
Date: September 14, 2011
Time: 12:17 PM
Direction: East
Photo by: W Zierath
Exposure #: 014
Comments: A stack of old railroad ties and a partially demolished mobile home in the northeast part of the site.

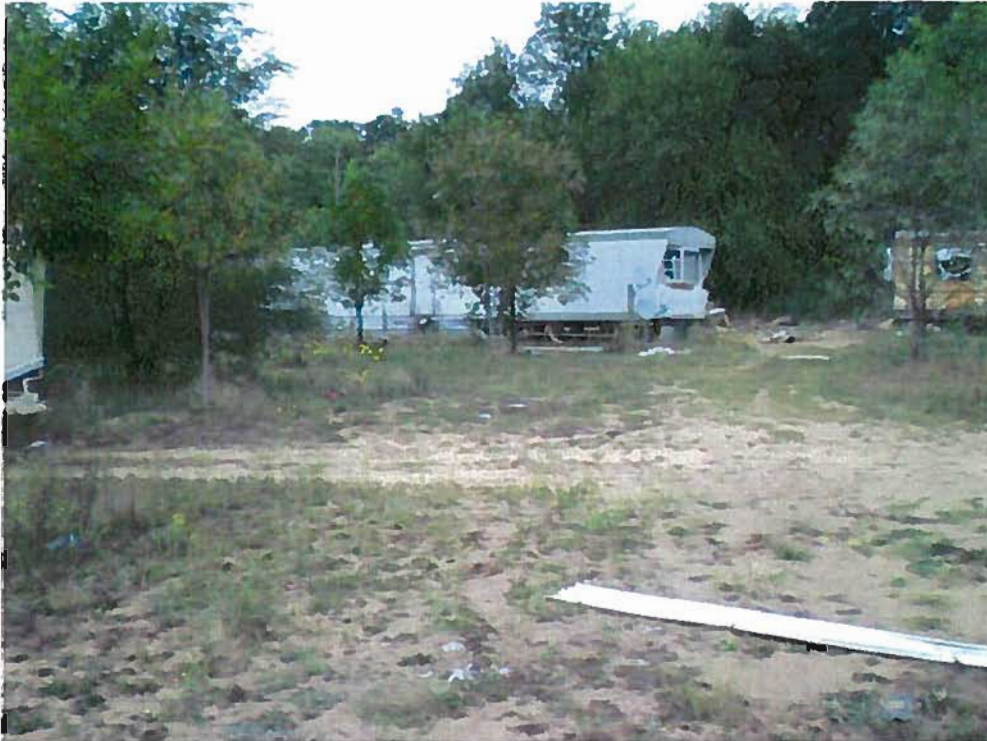
Date: September 14, 2011
Time: 12:17 PM
Direction: Northeast
Photo by: W Zierath
Exposure #: 015
Comments: An uninhabited mobile home in the northeast part of the site.

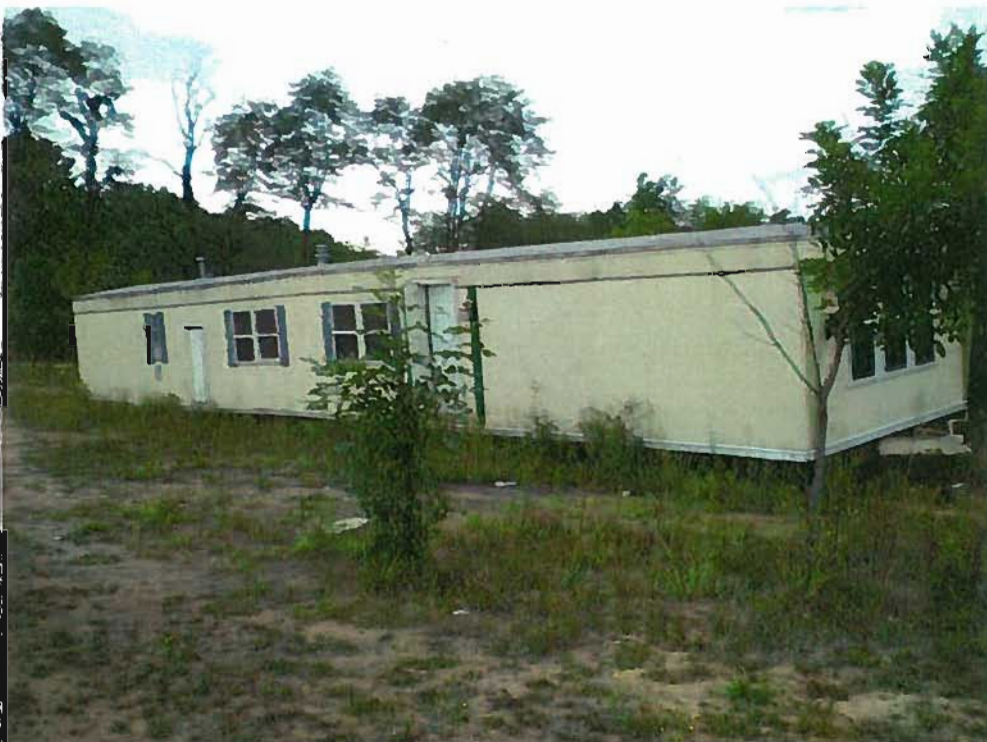
Date: September 14, 2011
Time: 12:17 PM
Direction: Northeast
Photo by: W Zierath
Exposure #: 016
Comments: An uninhabited mobile home in the north part of the site.

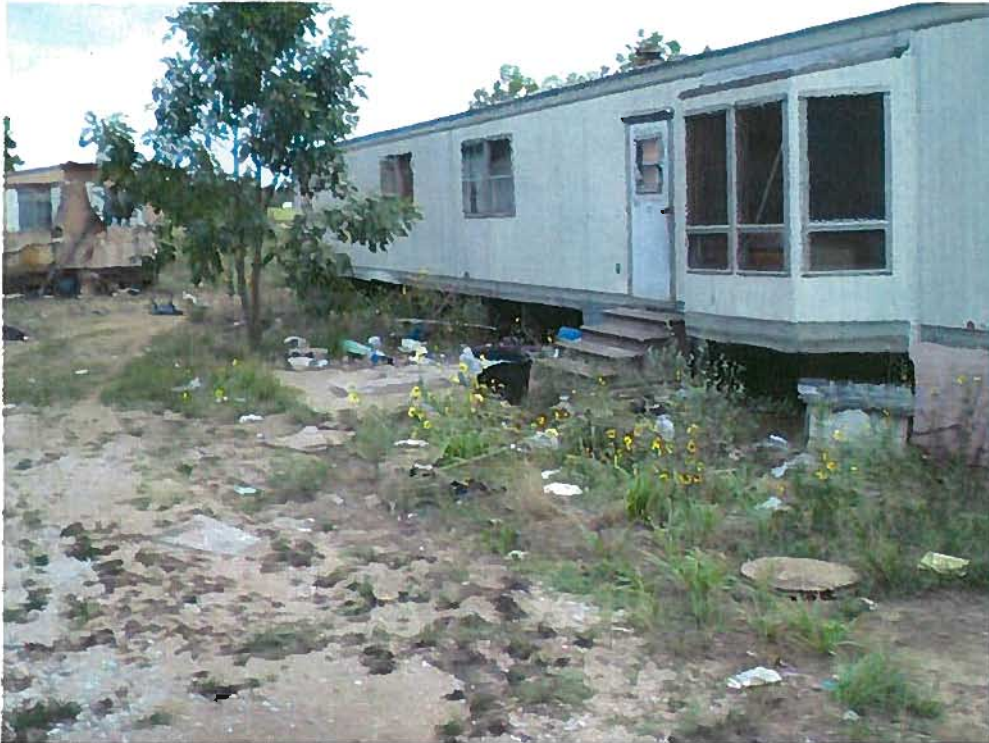
There was scattered waste on the ground east of the unoccupied mobile homes. Wastes included old furniture, old siding, pieces of old carpet, wood demolition waste and assorted trash. This waste is shown in photographs 017, 018 and 019.

Date: September 14, 2011
Time: 12:19 PM
Direction: Southwest
Photo by: W Zierath
Exposure #: 017
Comments: The east side of the mobile home shown in photograph 015 showing scattered trash.

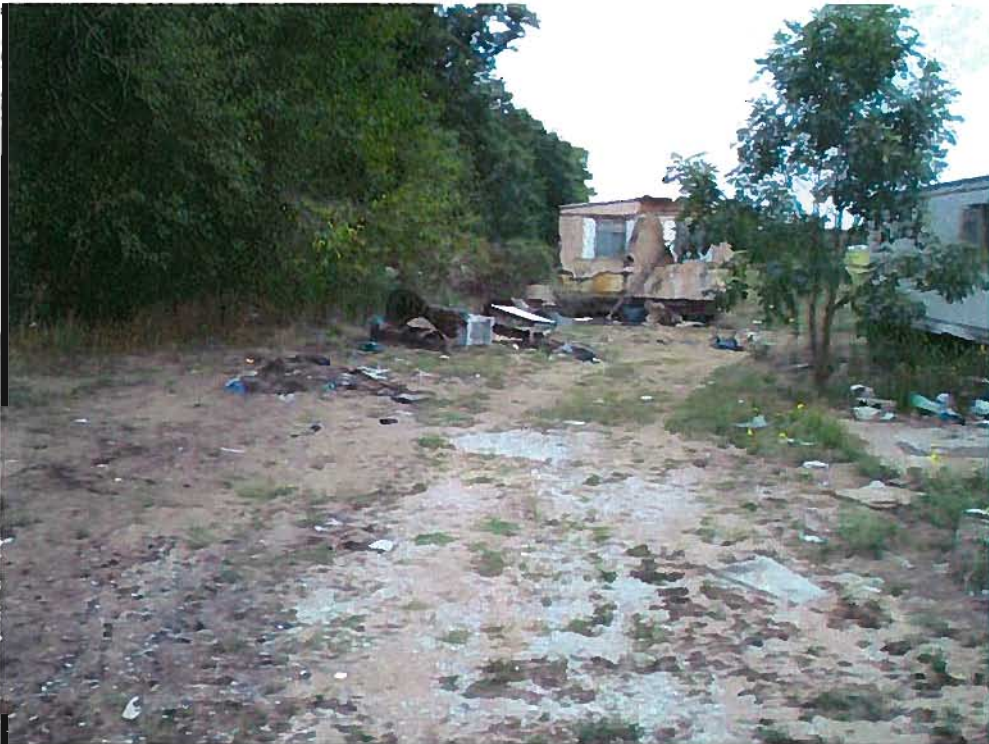
Date: September 14, 2011
Time: 12:19 PM
Direction: South
Photo by: W Zierath
Exposure #: 018
Comments: The north end of the mobile home shown in photograph 014 showing old furniture, demolition waste and a large amount of trash.

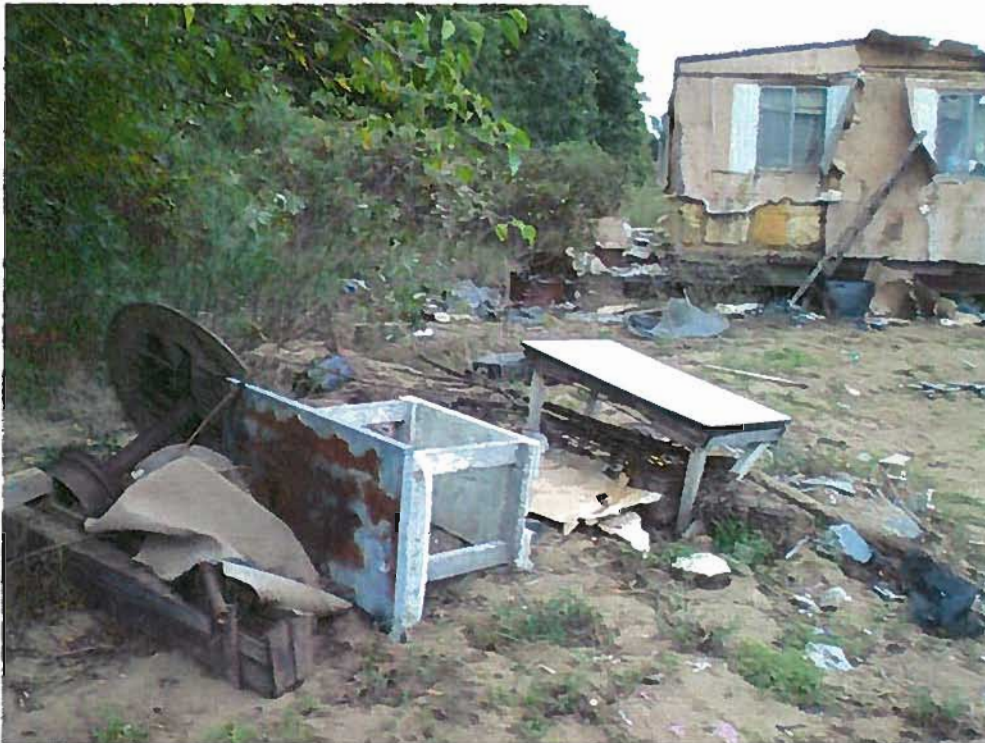
Date: September 14, 2011
Time: 12:20 PM
Direction: South
Photo by: W Zlerath
Exposure #: 019
Comments: The north end of the mobile home shown in photographs 014 and 018 showing old furniture, demolition waste and a large amount of trash.
