Re: Illinois Environmental Protection Agency v. Republic Services of Indiana, L.P
IEPA File No.6-12-AC: 1010100002—Lawrence County

BEFORE THE ILLINOIS POLLUTION CONTROL BOARD
ADMINISTRATIVE CITATION

FACILITY: Sumner/Republic Services-Sumner Landfill
SITE CODE NO.: 1010100002
COUNTY: Lawrence
CIVIL PENALTY: \$1,500.00
DATE OF INSPECTION: December 12, 2011

General Remarks: An 811 Solid Waste Landfill Inspection was conducted on Monday, December 12, 2011 at Republic Services – Sumner Landfill. Garrison Gross representing the Illinois EPA Bureau of Land conducted the inspection. The property is located at 10054 4-H Road on the south side of Route 250 east of Sumner, Illinois. The inspection was routine in nature and was performed to determine compliance with Part 811 Solid Waste Landfill Regulations. Weather conditions at the time of the inspection were 20° F, clear skies with a light breeze; surface conditions were frozen.

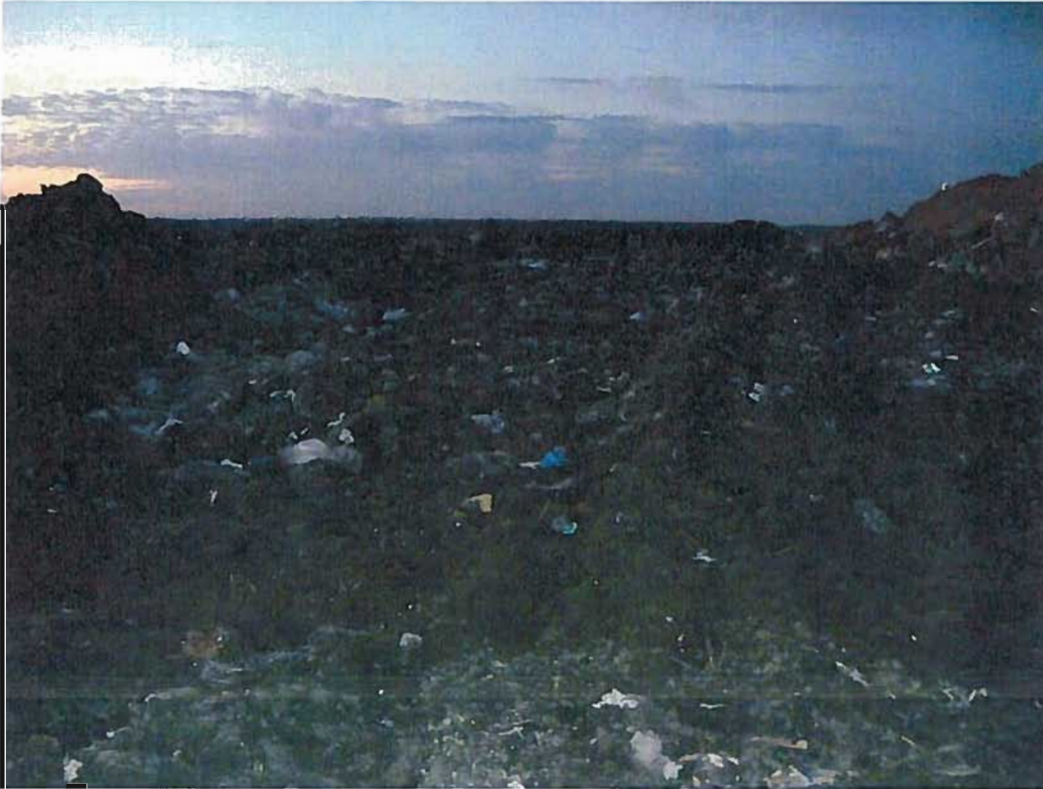
Date: 12/12/2011
Time: 6:41 a.m.
Direction: south
Photo by: Garrison Gross
Exposure #: 001
Comments: active face,
inadequate cover

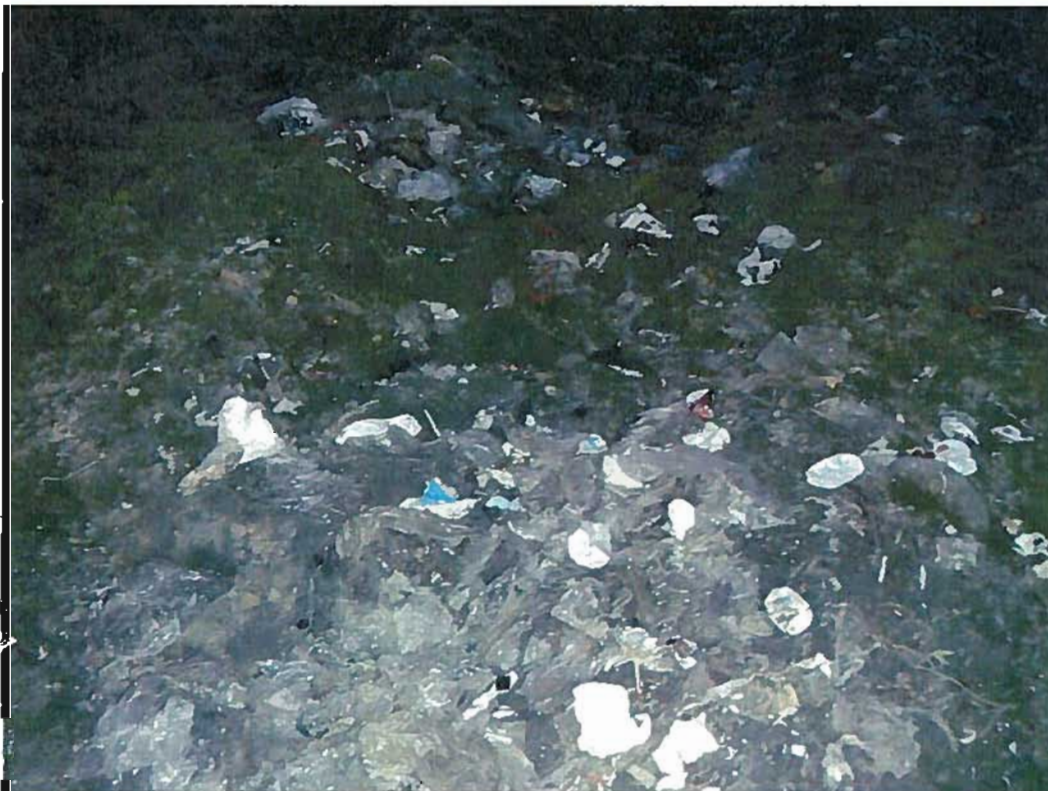
Date: 12/12/2011
Time: 6:41 a.m.
Direction: south
Photo by: Garrison Gross
Exposure #: 002
Comments: active face,
inadequate cover

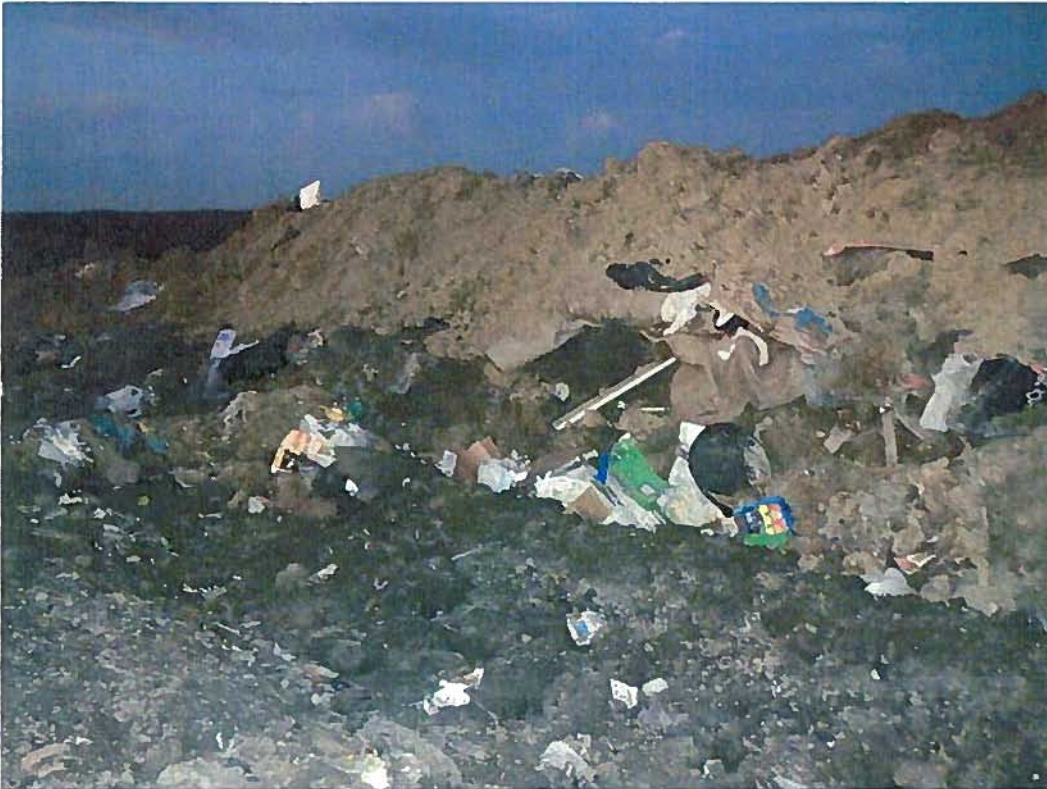
Date: 12/12/2011
Time: 6:41 a.m.
Direction: south
Photo by: Garrison Gross
Exposure #: 003
Comments: active face,
inadequate cover

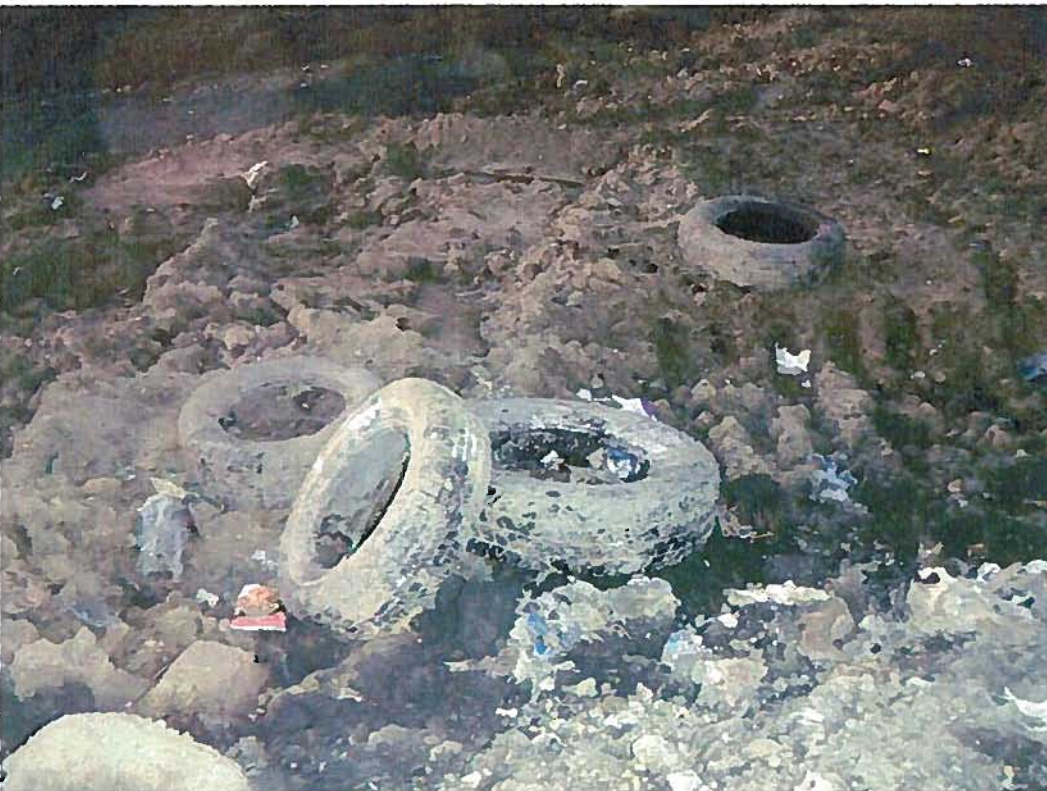
Five waste tires were observed below the active face along the haul road (photo 004). Six waste tires were observed near the face (photo 006). Mr. Michl explained that waste tires were removed from the face when they were discovered. I informed him that waste tires should be collected at the end of the day and placed in dry storage. Litter control fencing was not being used immediately adjacent to, or surrounding, the working level of the active face (photo 008 and 009). Litter control fencing and movable litter control panels were located below the active face near the haul road. Movable litter control panels were not being maintained properly. Litter had accumulated along the north slope of Cell 3 and 5 (photos 007 and 015). Litter had accumulated in the litter control fencing that was located below the active face and along the haul road (south slope of Cell 1 and 2) (photos 010 and 014).

Date: 12/12/2011
Time: 6:48 a.m.
Direction: south
Photo by: Garrison Gross
Exposure #: 004
Comments: waste tires

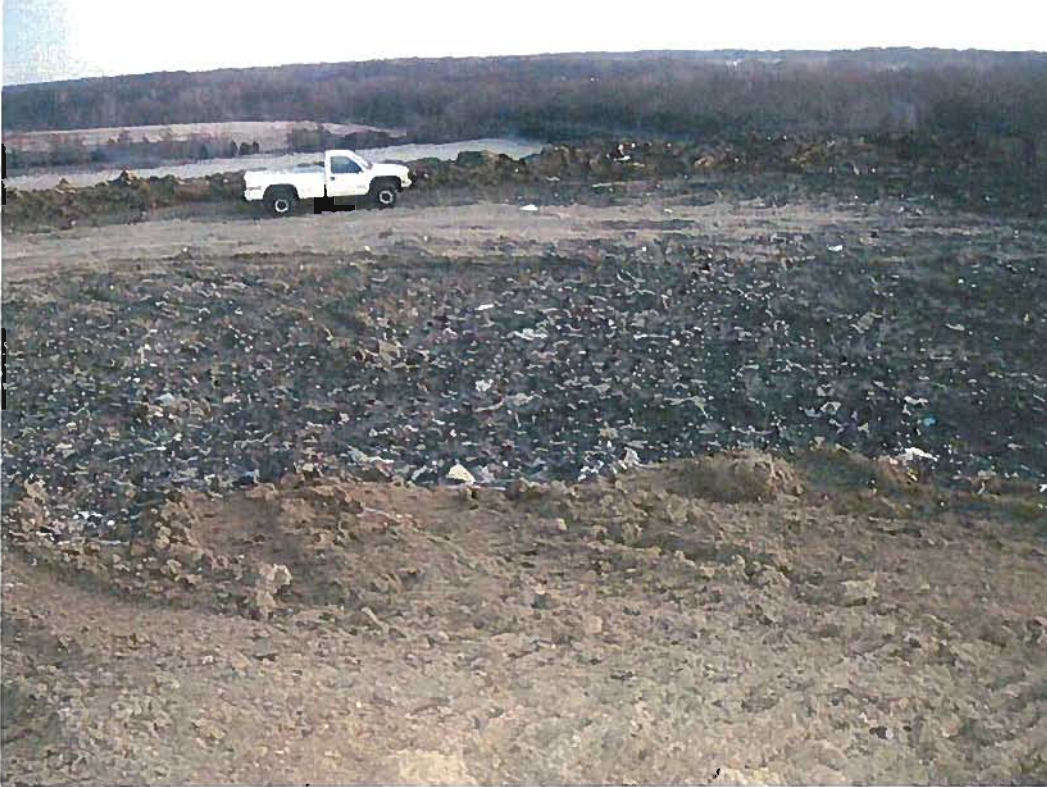
Date: 12/12/2011
Time: 6:49 a.m.
Direction: north
Photo by: Garrison Gross
Exposure #: 005
Comments: lift near face,
inadequate cover

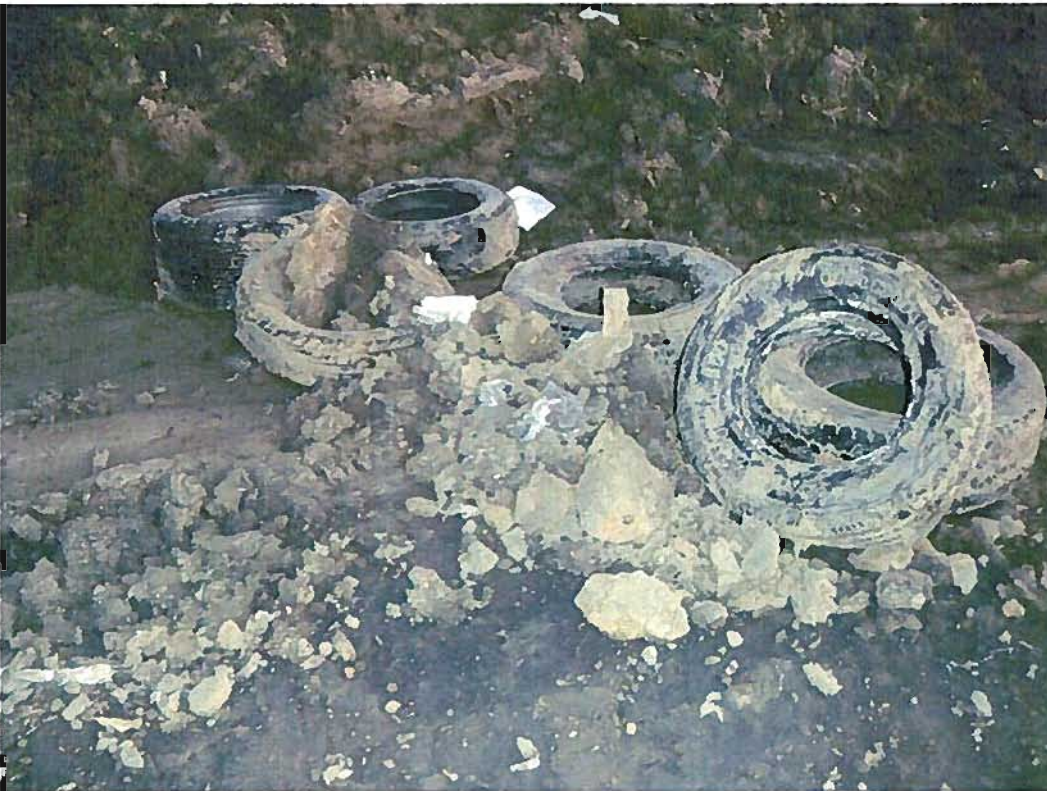
Date: 12/12/2011
Time: 6:50 a.m.
Direction: north
Photo by: Garrison Gross
Exposure #: 006
Comments: waste tires

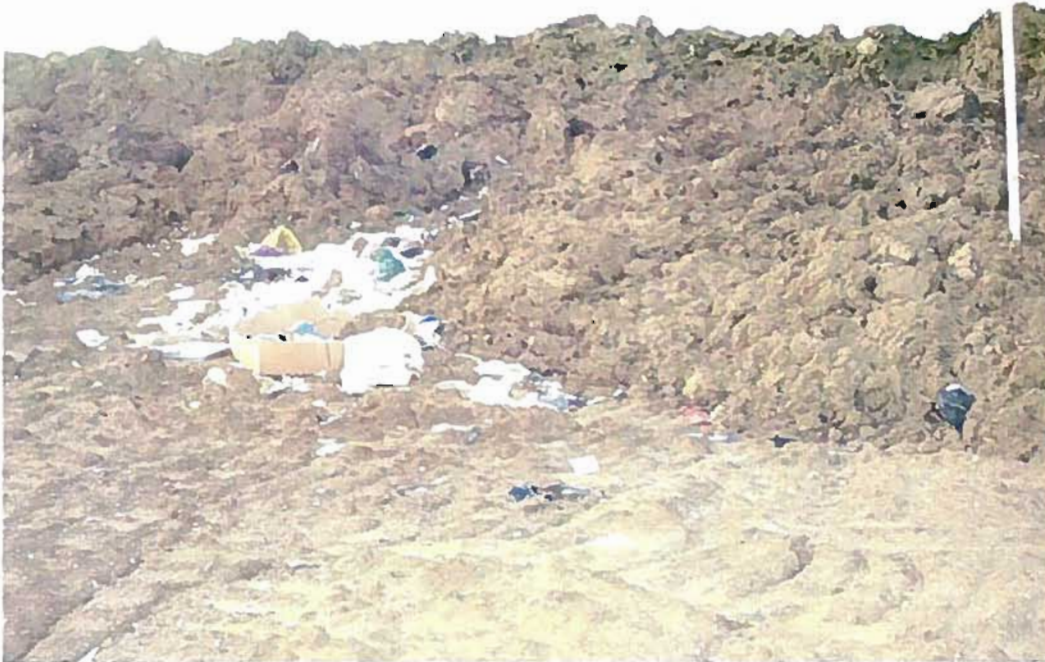
Date: 12/12/2011
Time: 6:53 a.m.
Direction: south
Photo by: Garrison Gross
Exposure #: 007
Comments: litter

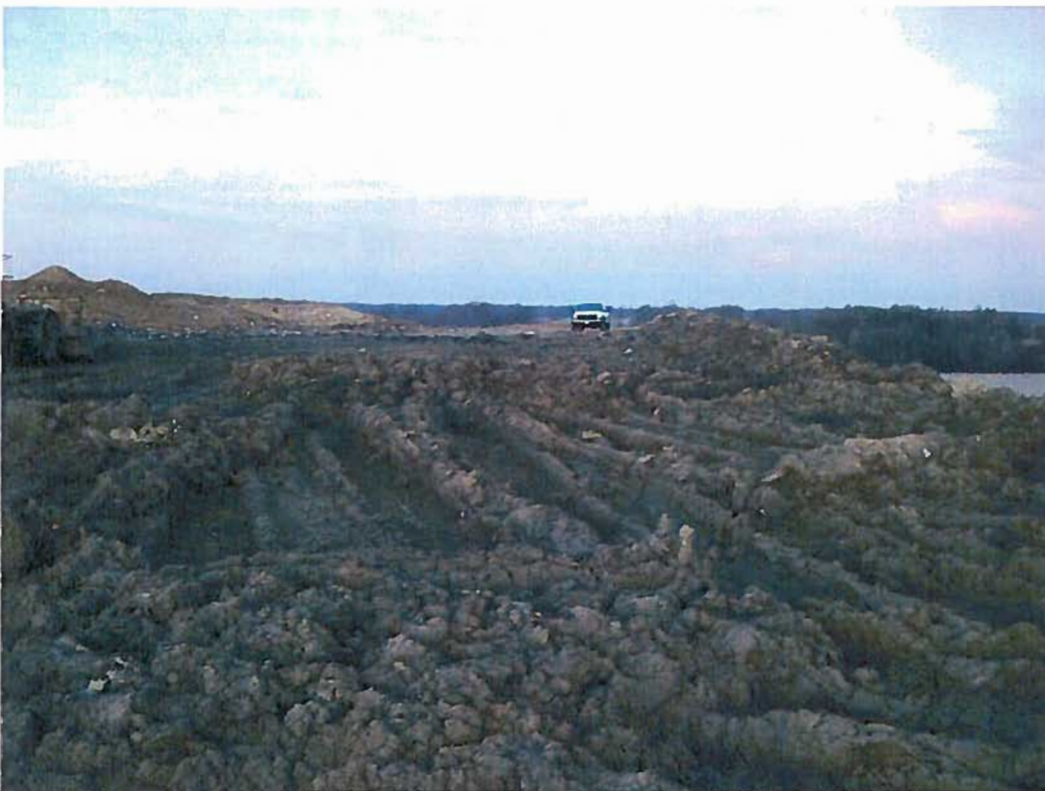
Date: 12/12/2011
Time: 6:59 a.m.
Direction: west
Photo by: Garrison Gross
Exposure #: 008
Comments: inadequate
litter control fencing

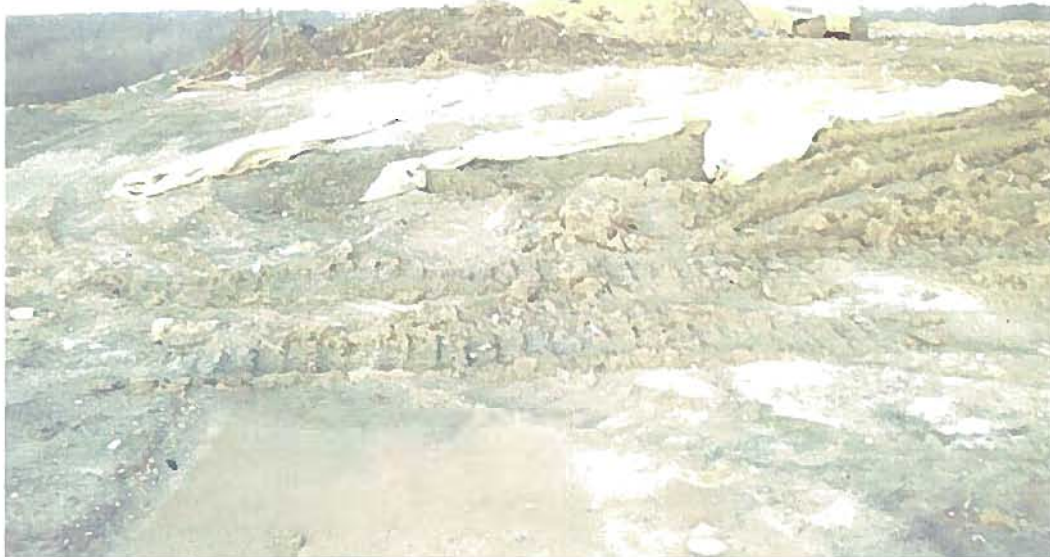
Date: 12/12/2011
Time: 7:00 a.m.
Direction: west
Photo by: Garrison Gross
Exposure #: 009
Comments: inadequate
litter control fencing

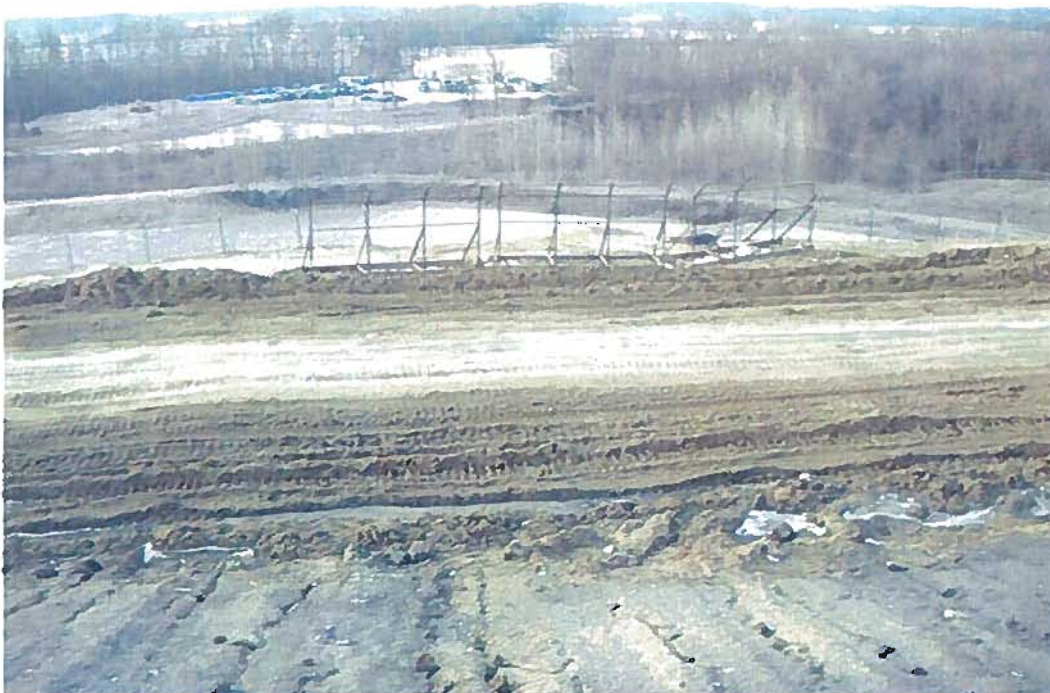
Date: 12/12/2011
Time: 7:02 a.m.
Direction: south
Photo by: Garrison Gross
Exposure #: 010
Comments: inadequate
litter control fencing

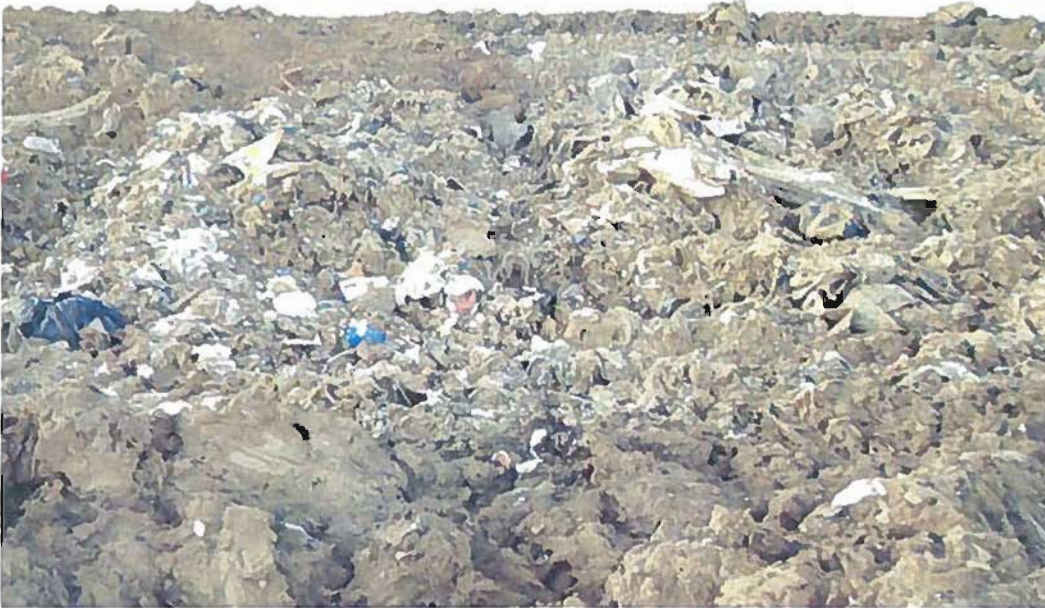
Date: 12/12/2011
Time: 7:05 a.m.
Direction: south
Photo by: Garrison Gross
Exposure #: 011
Comments: inadequate cover

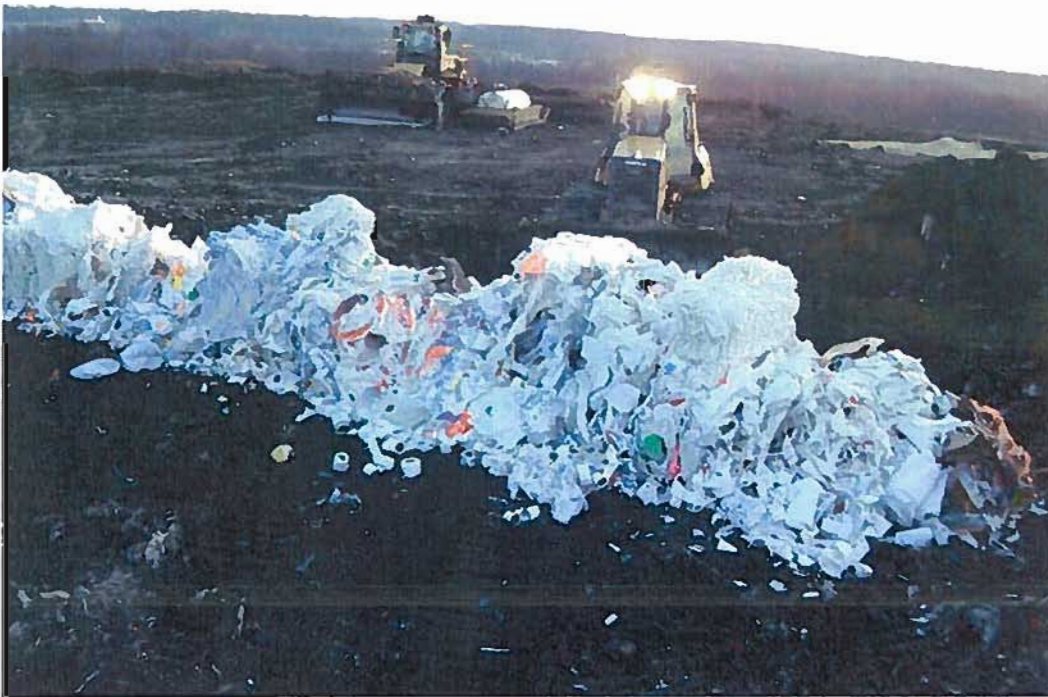
Date: 12/12/2011
Time: 7:11 a.m.
Direction: east
Photo by: Garrison Gross
Exposure #: 013
Comments: first load of
waste

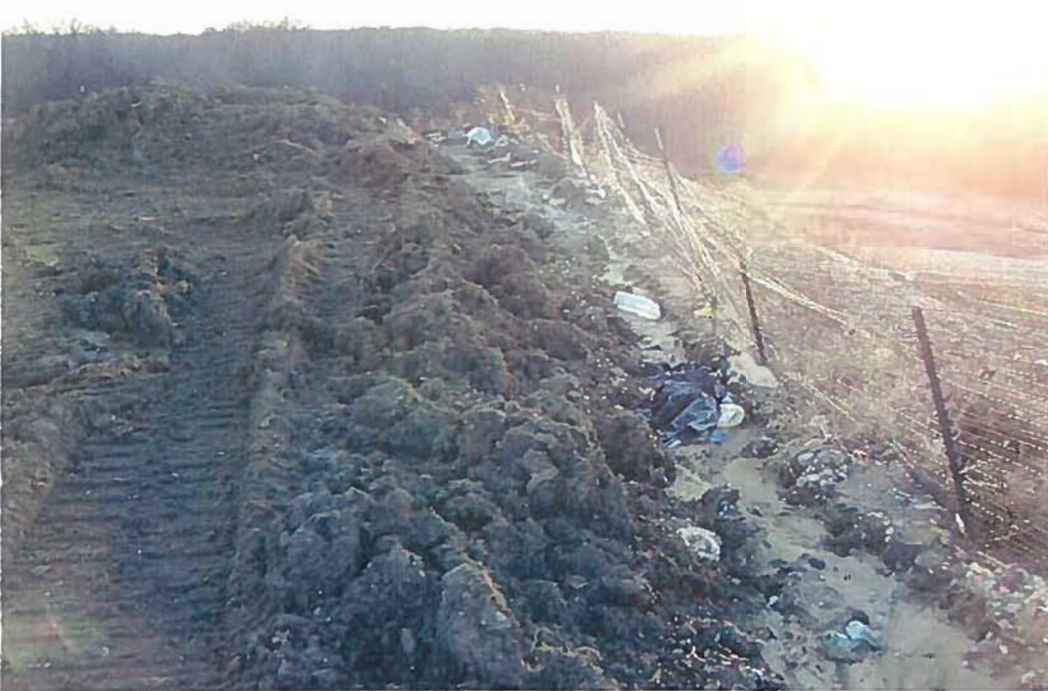
Date: 12/12/2011
Time: 7:26 a.m.
Direction: east
Photo by: Garrison Gross
Exposure #: 014
Comments: litter in
fencing

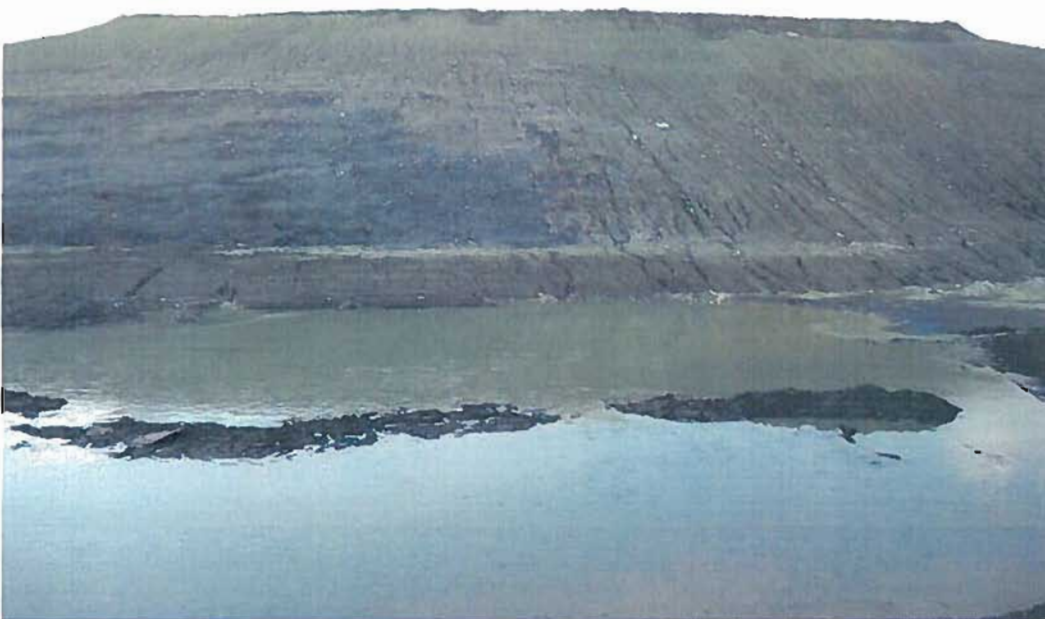
Date: 12/12/2011
Time: 7:31 a.m.
Direction: south
Photo by: Garrison Gross
Exposure #: 015
Comments: litter on slope

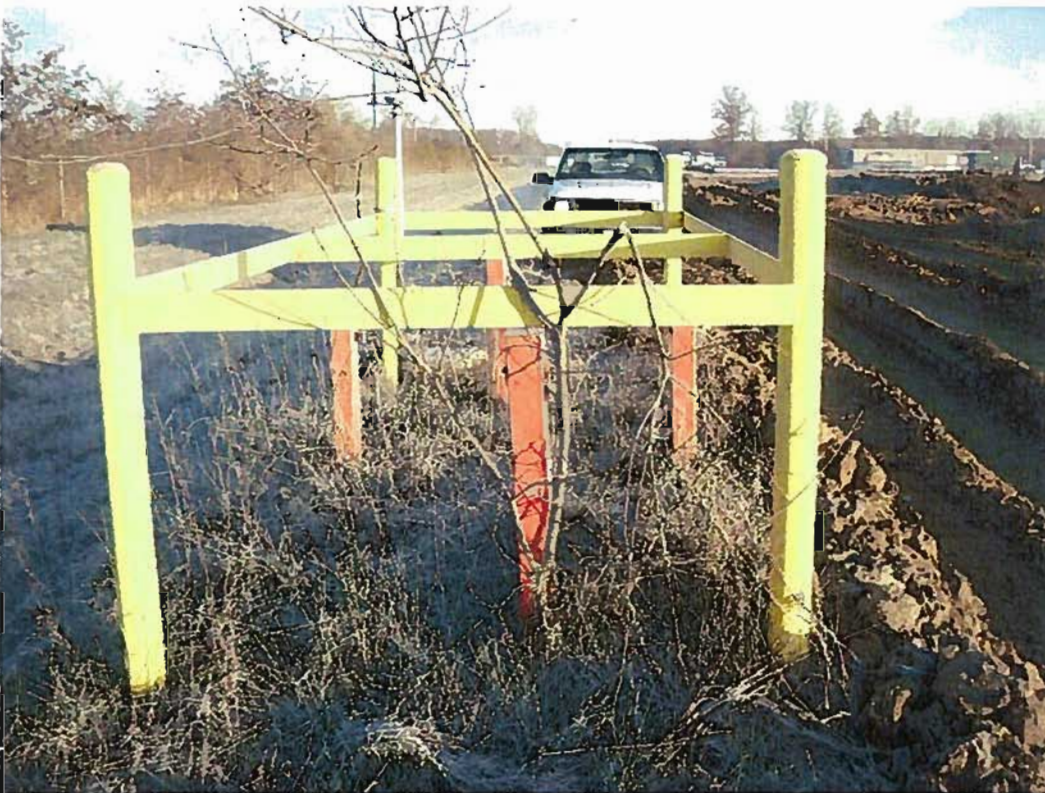
Monitoring Wells: We drove around the landfill and observed several monitoring wells along the west and south perimeter. Monitoring well P08D contained four wells and woody vegetation was growing up around one of the concrete bases (photo 016). One monitor well was observed that did not have proper labeling. Other monitoring wells G-121 and G-122 were labeled, locked and properly maintained. I informed Mr. Michl that all monitoring wells should be properly labeled with the appropriate IEPA designation, locked and properly maintained to prevent damage by woody vegetation and operational activities.

Date: 12/12/2011
Time: 7:37 a.m.
Direction: north
Photo by: Garrison Gross
Exposure #: 016
Comments: woody
vegetation growing near
monitoring well

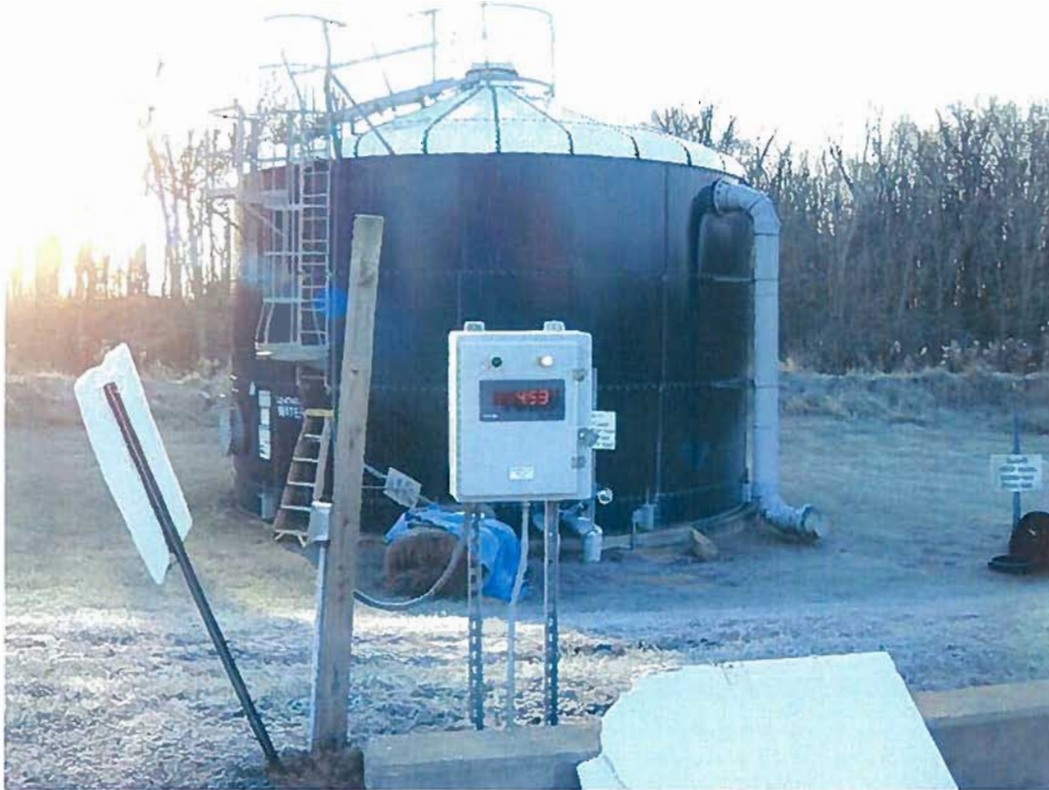
Leachate Storage Tank: The leachate storage tank and surrounding area were observed (photo 017). The tank, piping, load pad, and sump appeared to be in good condition. No woody vegetation was growing in or near the earthen secondary containment berm. Mr. Michl stated that leachate was being hauled off on a regular basis. He said he called the hauler when the leachate level reached 15 feet. The leachate tank is equipped with an electronic level gauge which read 4.59 feet. The nearby riser pipe and electronic control panel was observed (photo 018). The leachate level gauge read 23.7 inches. Mr. Michl stated that the system turns on automatically when the leachate level reaches 28 inches.

Date: 12/12/2011
Time: 7:47 a.m.
Direction: southeast
Photo by: Garrison Gross
Exposure #: 017
Comments: leachate tank

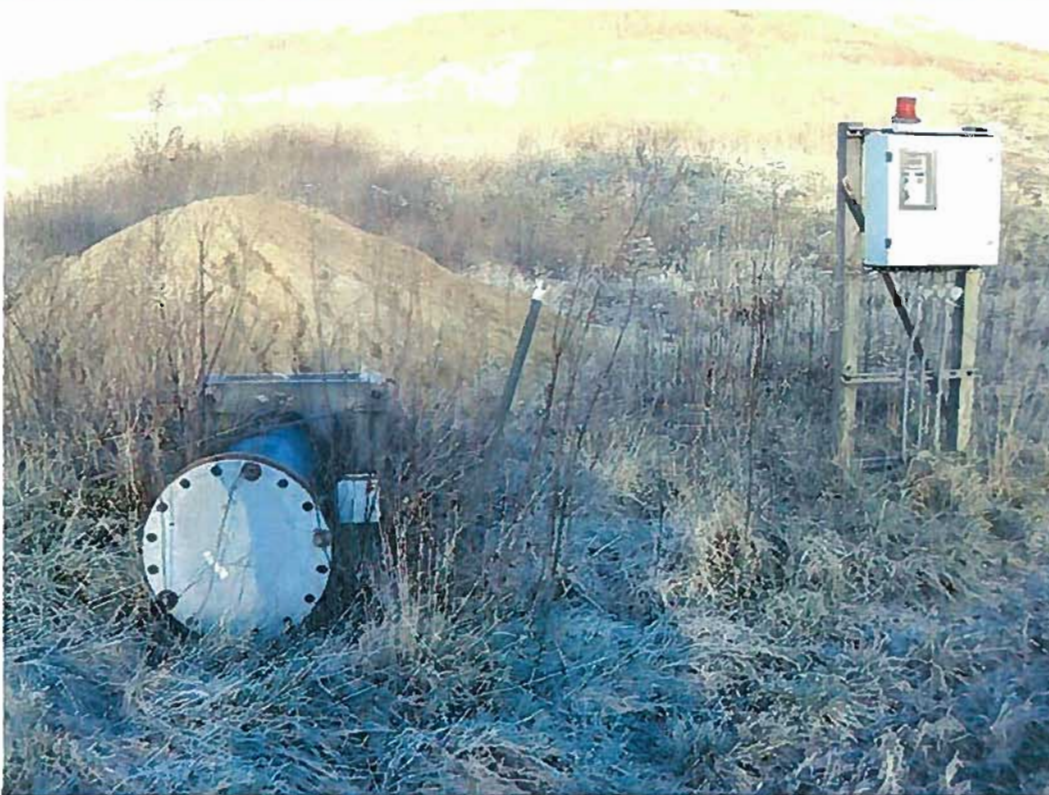
Date: 12/12/2011
Time: 7:54 a.m.
Direction: north
Photo by: Garrison Gross
Exposure #: 018
Comments: riser pipe

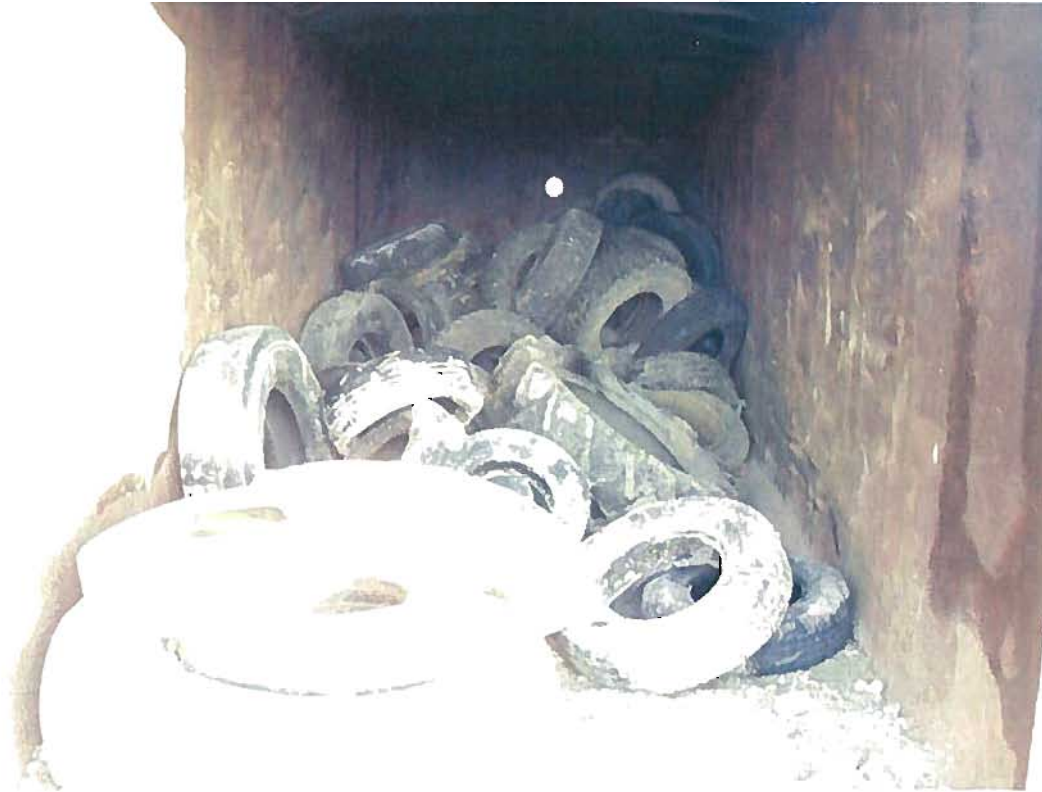
Maintenance Yard: We proceeded to the waste tire storage area (photo 019). Approximately 70 waste tires were present. Four large loader tires were outside and had accumulated water (ice). Mr. Michl said the waste tires are stored in the enclosed compactor box until Branna, LLC stops by to pick them up. He said they usually stop every two weeks but he said they missed their last regular pick up. I informed him of the tire storage regulations and that no more than 50 waste tires should be accumulated at the facility. We observed the small vehicle disposal area (photos 020 and 021). Both boxes contained waste from the previous week. Mr. Michl stated that the roll off boxes were emptied when they get full. One roll box did not have a tarp to cover it at night. The signage posted at the entrance was observed (photo 031).

Date: 12/12/2011
Time: 8:01 a.m.
Direction: north
Photo by: Garrison Gross
Exposure #: 019
Comments: waste tires

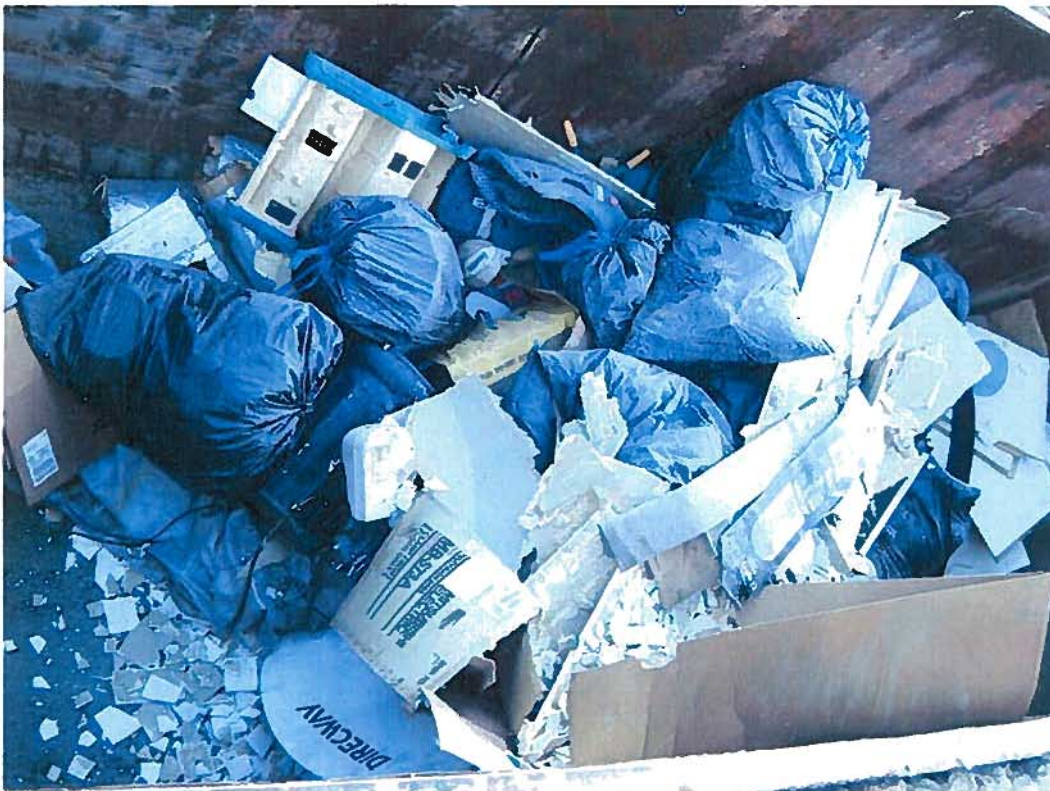
Date: 12/12/2011
Time: 8:03 a.m.
Direction: down
Photo by: Garrison Gross
Exposure #: 020
Comments: waste in roll off at small vehicle disposal area

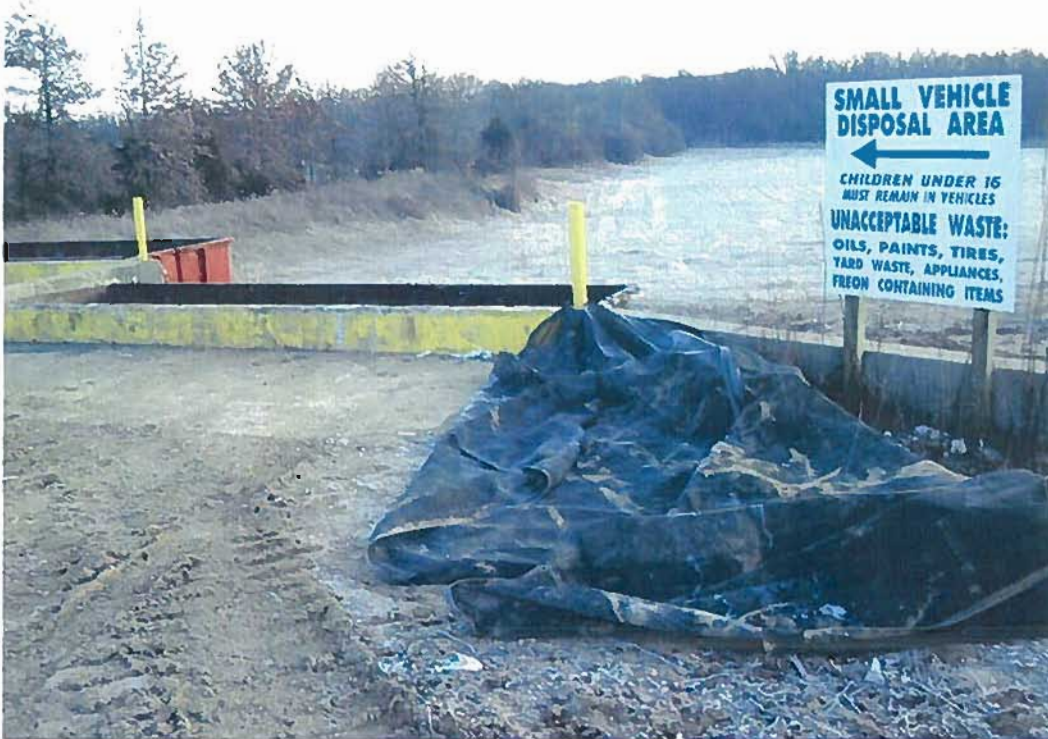
Date: 12/12/2011
 Time: 8:05 a.m.
 Direction: east
 Photo by: Garrison Gross
 Exposure #: 021
 Comments: small vehicle disposal area

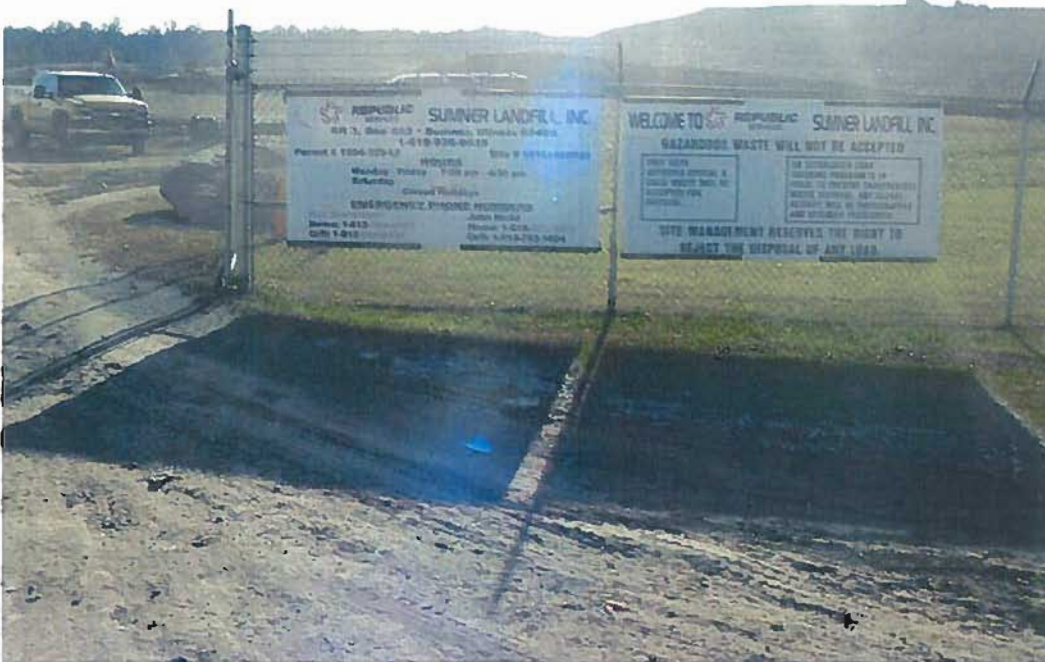
Date: 12/12/2011
Time: 9:20 a.m.
Direction: east
Photo by: Garrison Gross
Exposure #: 031
Comments: signage

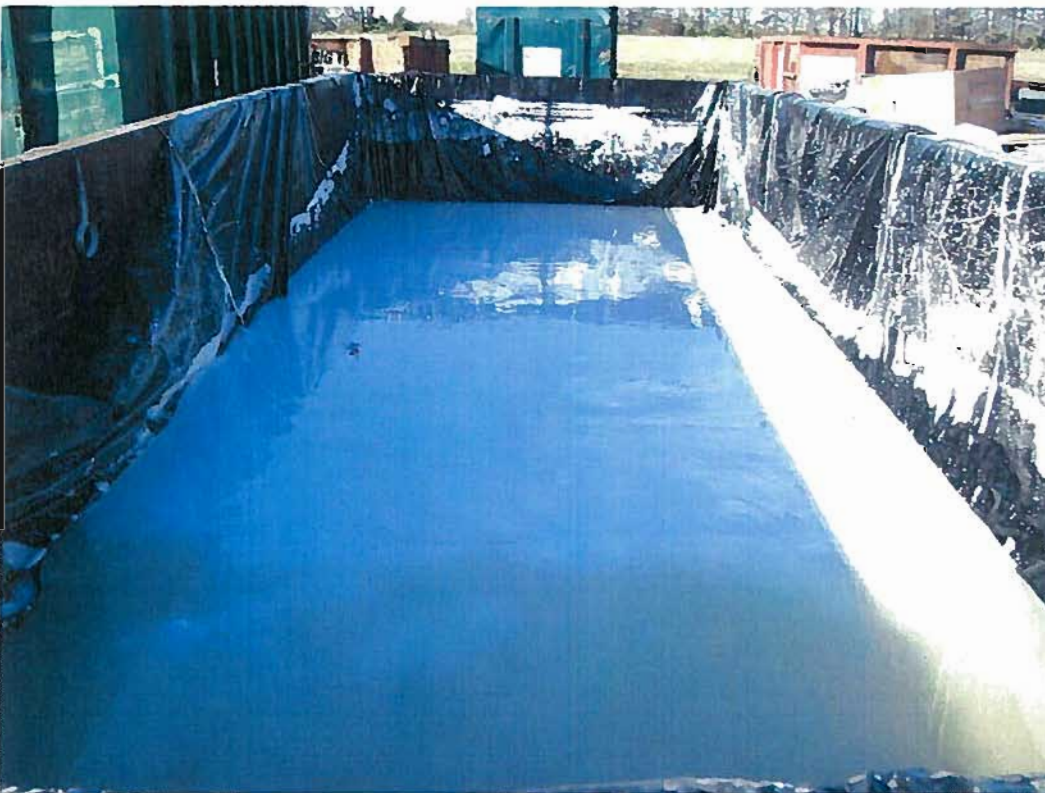
Roll Off Storage and Landscape Disposal Area: A roll off storage is located outside of the fenced facility. Three uncovered containers were observed at the site that contained waste. One roll off box of a gray paint-like waste was observed (photo 032). Free liquid was observed on the surface of the waste. The roll off box was lined with black plastic sheeting. The second roll off box contained cardboard boxes (photo 033). The third roll off box contained landscape waste. Mr. Michl informed me later that haul trucks drop off containers of waste and pick up empty containers during hours that the landfill is not operating. The full containers are weighed and dumped at the active face later that day. The gray paint-like waste was identified as a special waste glass sludge generated by Schott Gemtron Corporation. Mr. Michl stated that the landscape waste is disposed at the landscape disposal site which is not part of the landfill (photo 039). The landscape waste is piled into windrows and spread out at a later time.

Date: 12/12/2011
Time: 9:22 a.m.
Direction: west
Photo by: Garrison Gross
Exposure #: 032
Comments: uncovered
 Gemtron waste

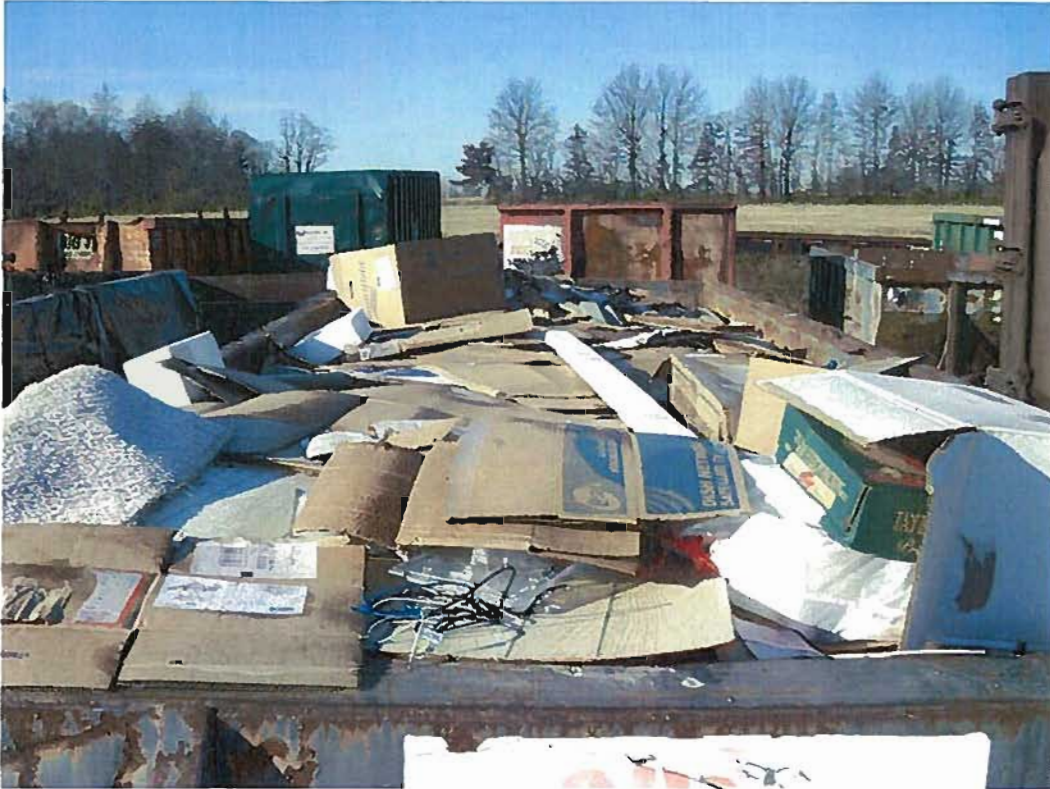
Date: 12/12/2011
Time: 9:22 a.m.
Direction: west
Photo by: Garrison Gross
Exposure #: 033
Comments: uncovered
waste

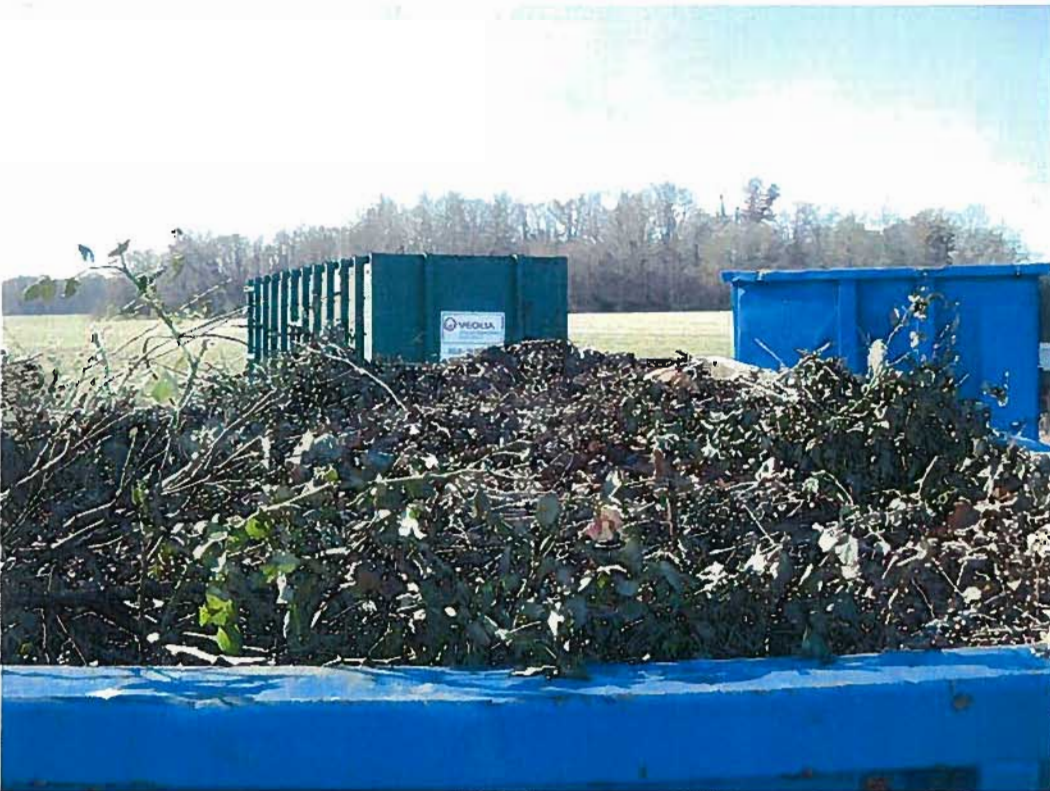
Date: 12/12/2011
Time: 9:22 a.m.
Direction: west
Photo by: Garrison Gross
Exposure #: 034
Comments: uncovered
landscape waste

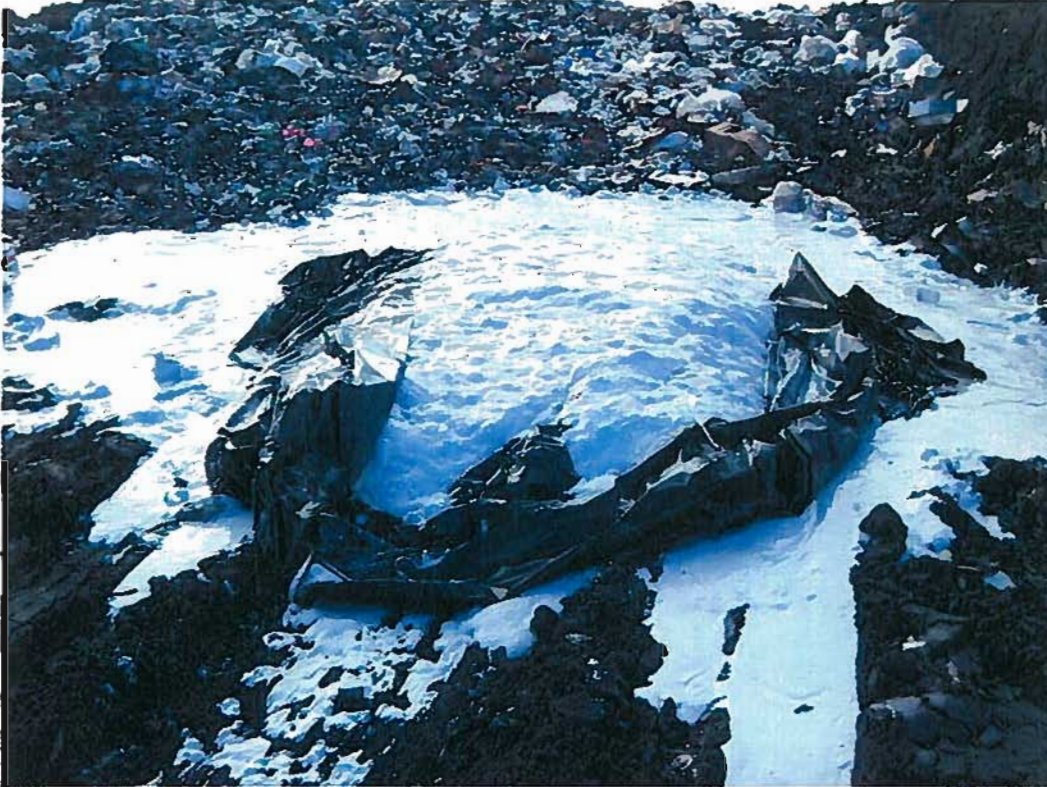
Date: 12/12/2011
Time: 10:03 a.m.
Direction: south
Photo by: Garrison Gross
Exposure #: 036
Comments: Gemtron waste

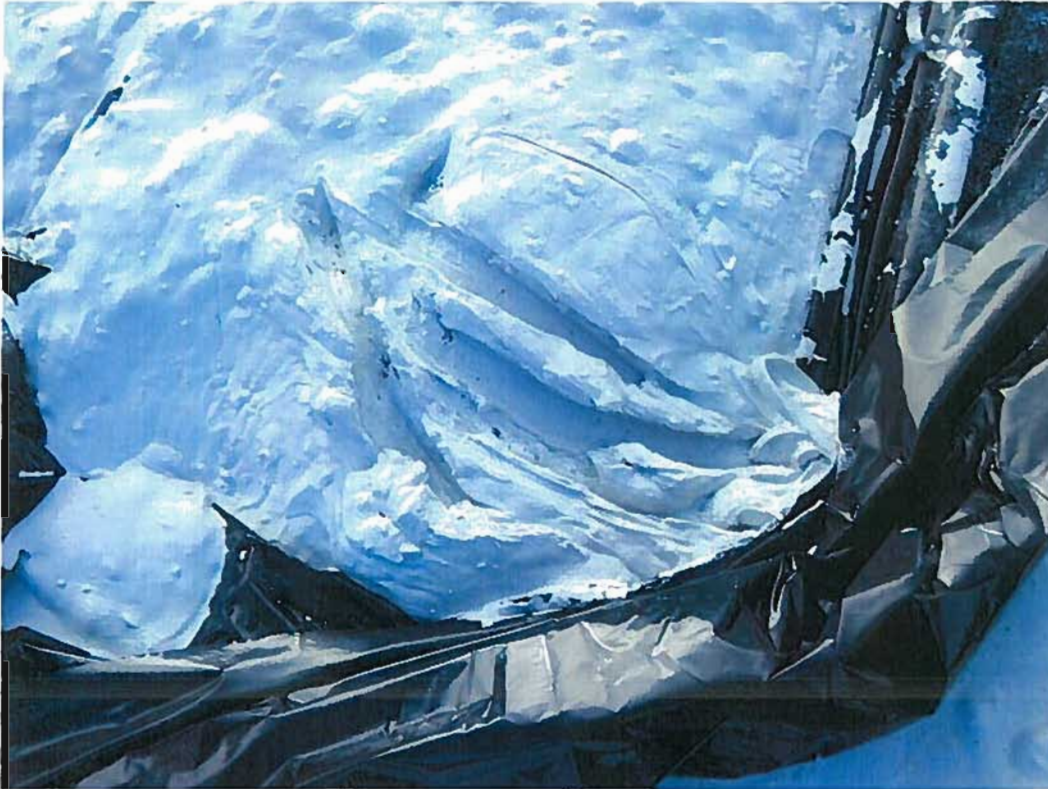
Date: 12/12/2011
Time: 10:04 a.m.
Direction: south
Photo by: Garrison Gross
Exposure #: 037
Comments: Gemtron waste
