Re: Illinois Environmental Protection Agency v. Republic Services of Indiana, L.P
IEPA File No.6-12-AC: 1010100002—Lawrence County

BEFORE THE ILLINOIS POLLUTION CONTROL BOARD
ADMINISTRATIVE CITATION

FACILITY: Sumner/Republic Services-Sumner Landfill
SITE CODE NO.: 1010100002
COUNTY: Lawrence
CIVIL PENALTY: \$1,500.00
DATE OF INSPECTION: December 12, 2011

General Remarks: An 811 Solid Waste Landfill Inspection was conducted on Monday, December 12, 2011 at Republic Services – Sumner Landfill. Garrison Gross representing the Illinois EPA Bureau of Land conducted the inspection. The property is located at 10054 4-H Road on the south side of Route 250 east of Sumner, Illinois. The inspection was routine in nature and was performed to determine compliance with Part 811 Solid Waste Landfill Regulations. Weather conditions at the time of the inspection were 20° F, clear skies with a light breeze; surface conditions were frozen.

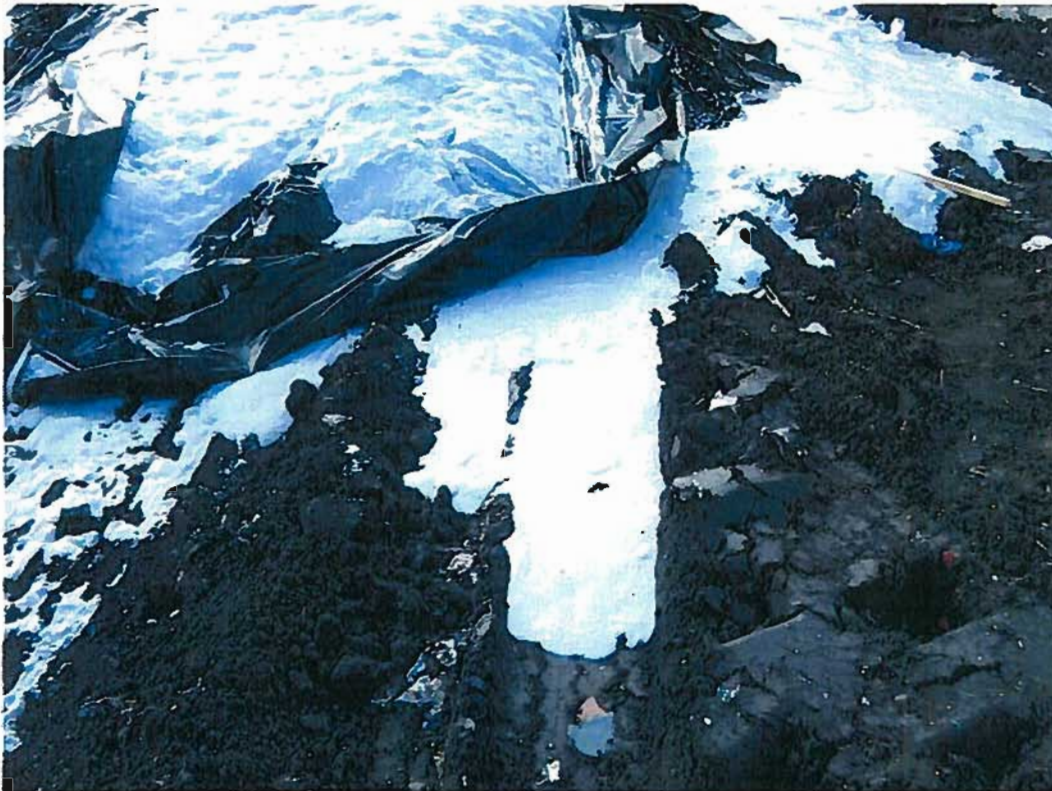
Date: 12/12/2011
Time: 10:04 a.m.
Direction: south
Photo by: Garrison Gross
Exposure #: 038
Comments: Gemtron waste

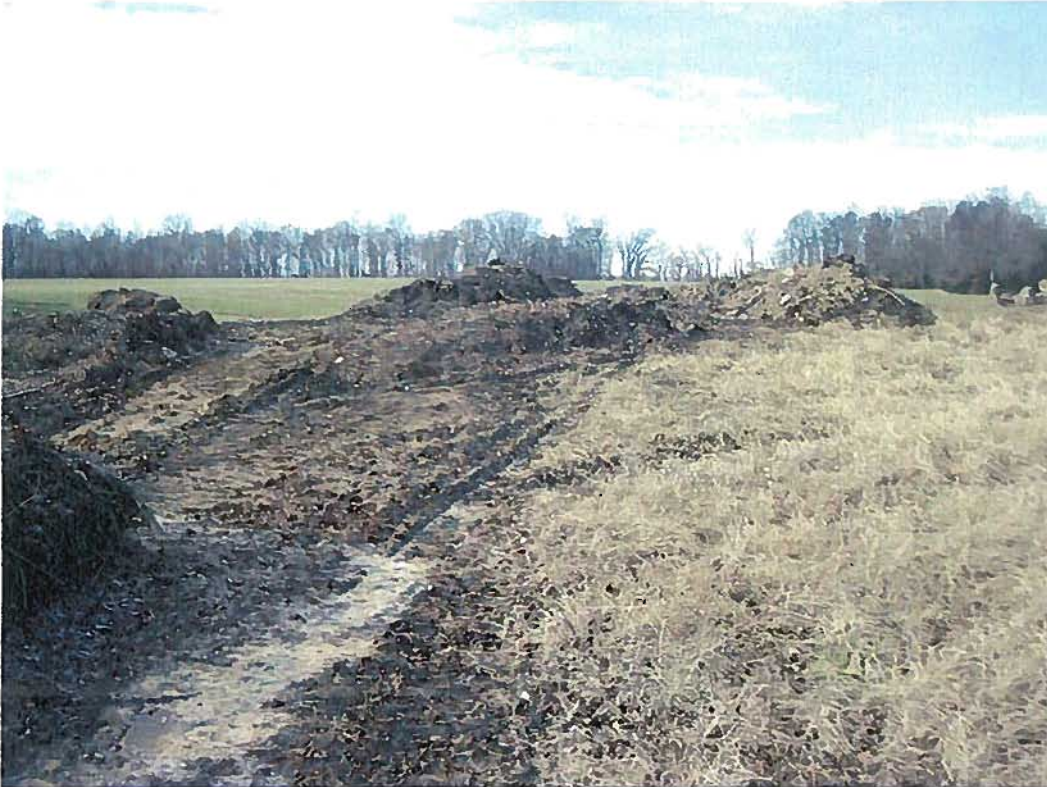
Roll Off Storage and Landscape Disposal Area: A roll off storage is located outside of the fenced facility. Three uncovered containers were observed at the site that contained waste. One roll off box of a gray paint-like waste was observed (photo 032). Free liquid was observed on the surface of the waste. The roll off box was lined with black plastic sheeting. The second roll off box contained cardboard boxes (photo 033). The third roll off box contained landscape waste. Mr. Michl informed me later that haul trucks drop off containers of waste and pick up empty containers during hours that the landfill is not operating. The full containers are weighed and dumped at the active face later that day. The gray paint-like waste was identified as a special waste glass sludge generated by Schott Gemtron Corporation. Mr. Michl stated that the landscape waste is disposed at the landscape disposal site which is not part of the landfill (photo 039). The landscape waste is piled into windrows and spread out at a later time.

Date: 12/12/2011
Time: 10:10 a.m.
Direction: west
Photo by: Garrison Gross
Exposure #: 039
Comments: landscape
waste
