BEFORE THE ILLINOIS POLLUTION CONTROL BOARD

ADMINISTRATIVE CITATION

AC 13-3
(IEPA No. 173-12-AC)

PLEASE TAKE NOTICE that on this date I mailed for filing with the Clerk of the Pollution Control Board of the State of Illinois the following instrument(s) entitled ADMINISTRATIVE CITATION, AFFIDAVIT, and TIRE STORAGE SITE INSPECTION CHECKLIST.

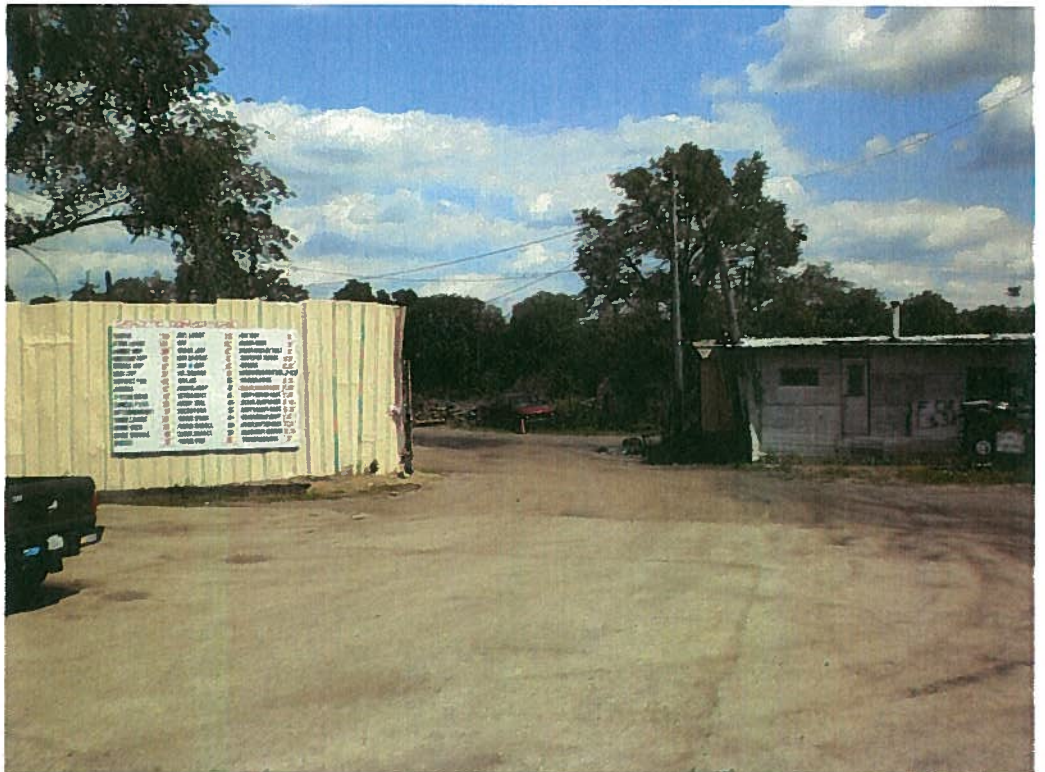
PHOTOGRAPH FILE NAME:
1430655817~06052012-002.jpg

COMMENTS: Public drive
through the opening around to the
back of the building with recyclable
metals including rims with used
tires.

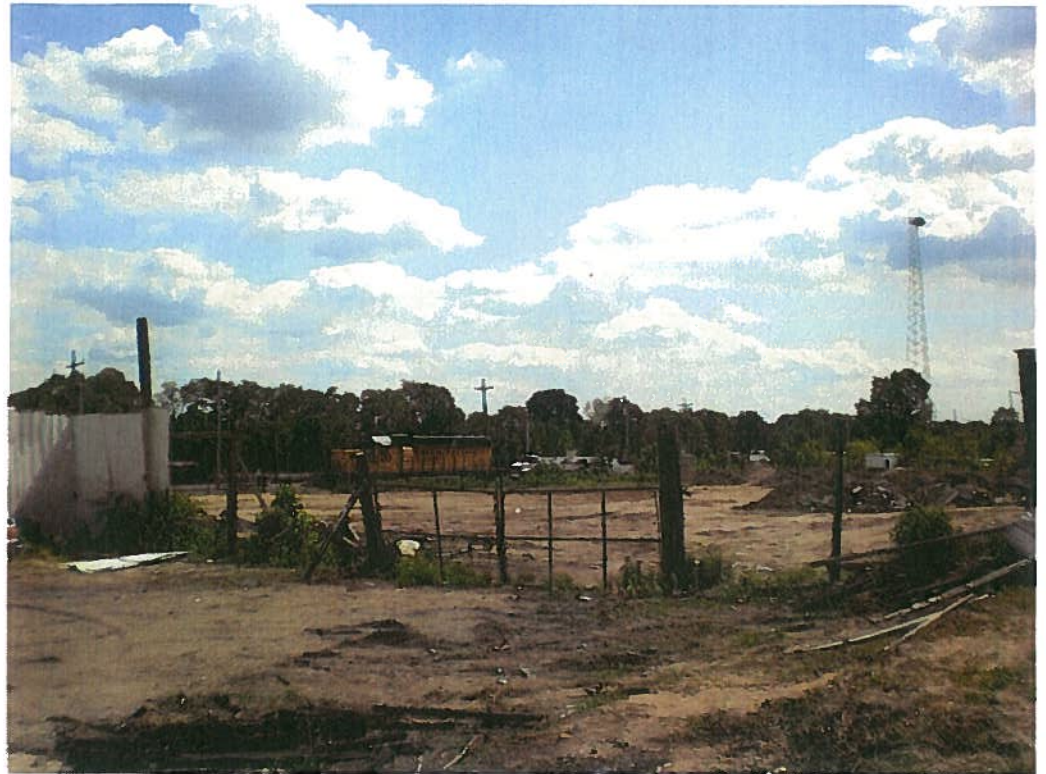
PHOTOGRAPH FILE NAME:
1430655817~06052012-003.jpg

COMMENTS: The security fence
is gone.

I observed that a security fence present during the previous inspection on February 21, 2012 is no longer in place at the facility. See photographs 3, 4, 29, 30, and 35. Mr. Schafer explained that it was destroyed by wind.

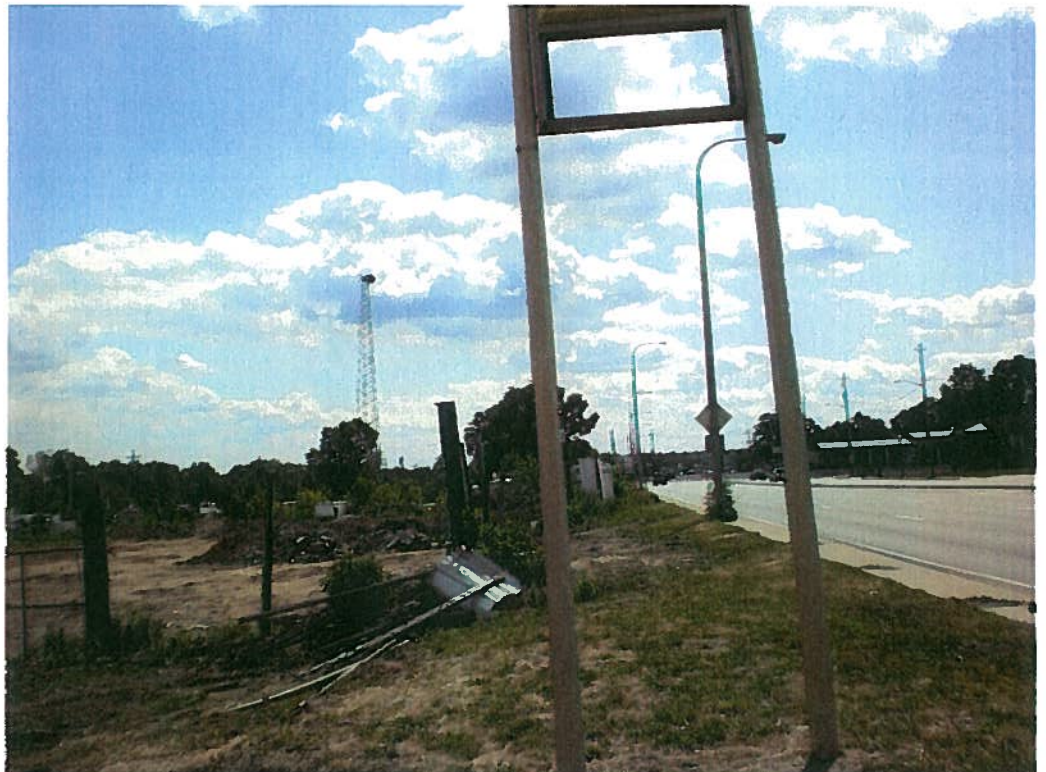
PHOTOGRAPH FILE NAME:
1430655817~06052012-004.jpg

COMMENTS: The security fence
is gone.

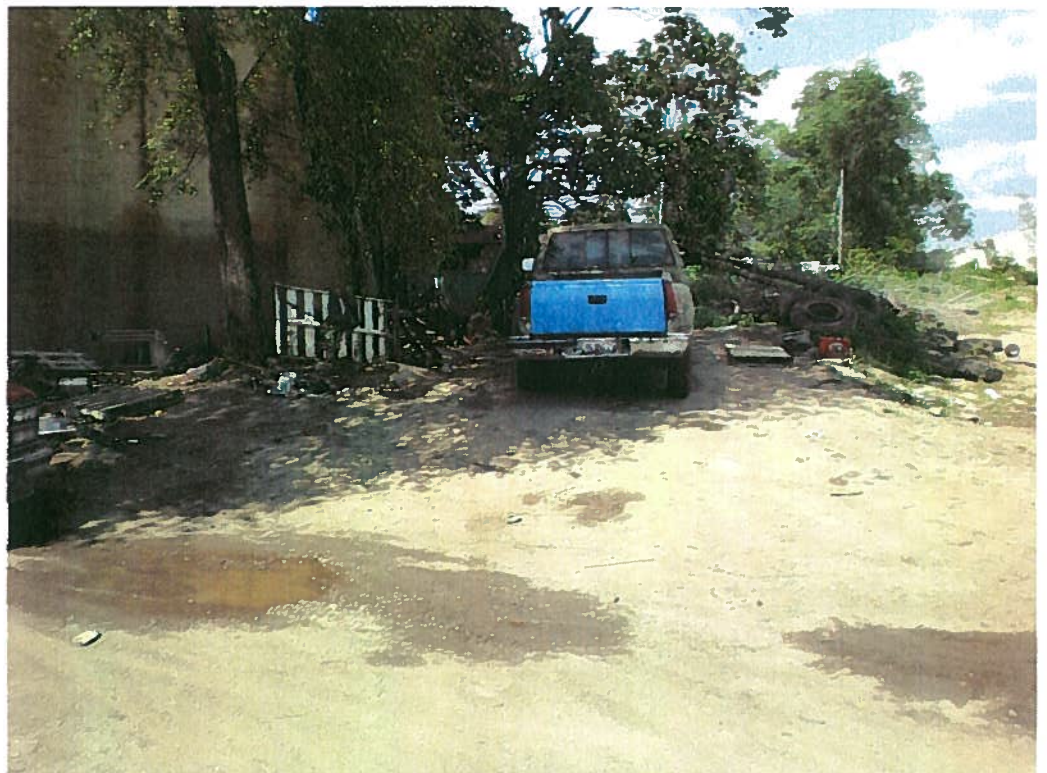
PHOTOGRAPH FILE NAME:
1430655817~06052012-006.jpg

COMMENTS: A pile of used tires
within 50 feet of overhanging
limbs, grass, and weeds.

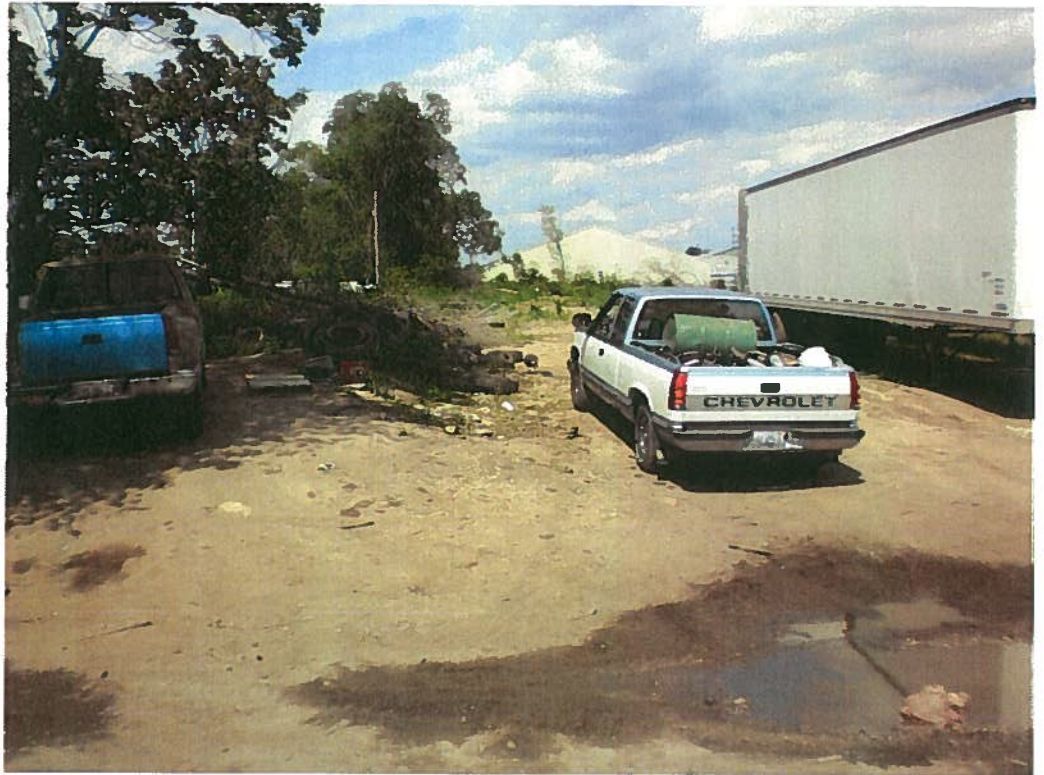
PHOTOGRAPH FILE NAME:
1430655817~06052012-007.jpg

COMMENTS: A Liberty
Transport trailer. (T8141)

I observed a Liberty Tire Recycling (T8141) transport trailer on site. Mr. Schafer explained that the trailer is the same trailer observed during a previous inspection conducted on February 21, 2012. (See photographs 7, 8, 13, 21, 22, and 23).

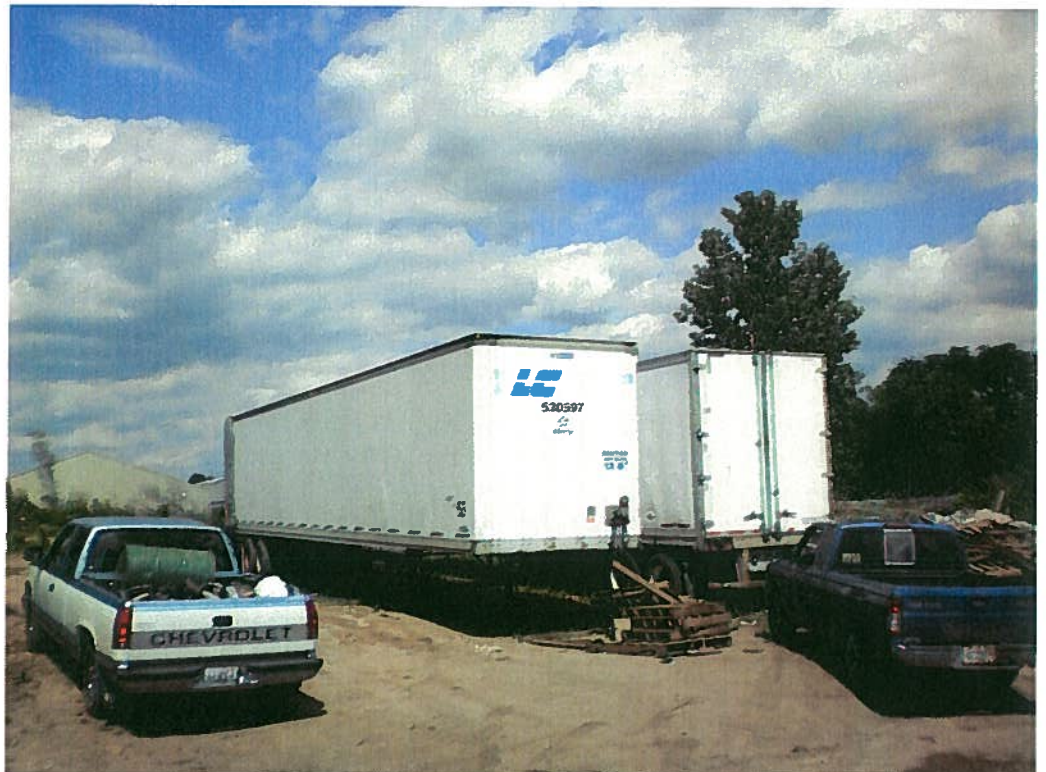
PHOTOGRAPH FILE NAME:
1430655817~06052012-008.jpg

COMMENTS: A Liberty Trailer
next to a trailer containing prepared
steel.

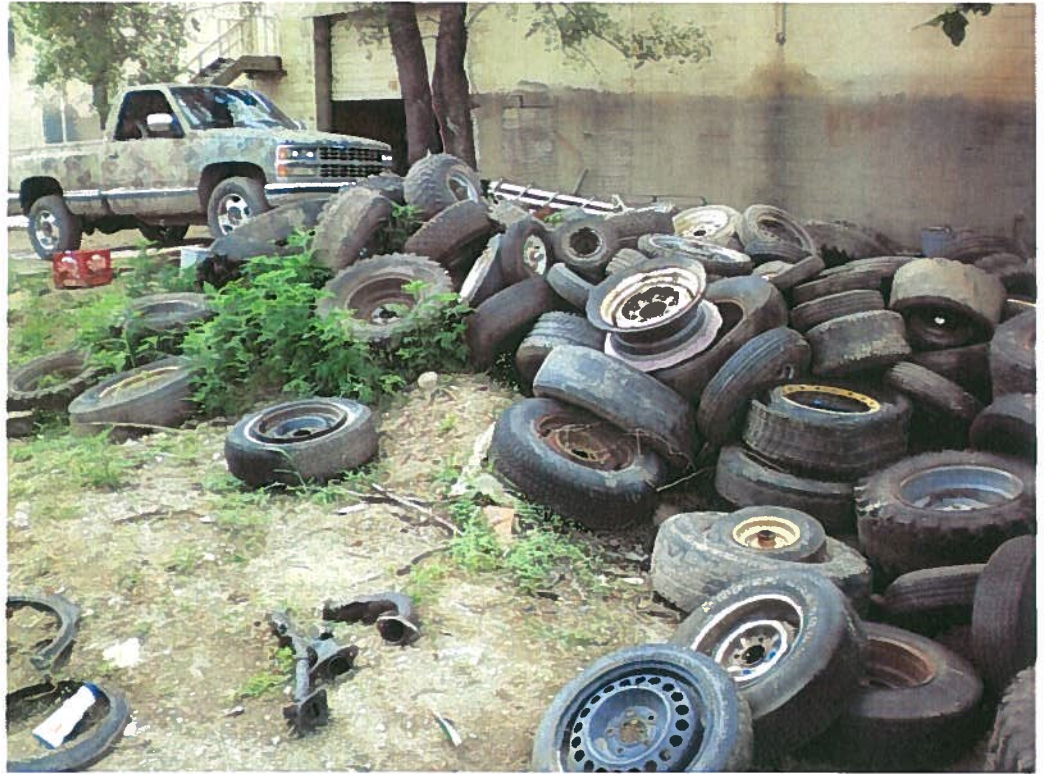
PHOTOGRAPH FILE NAME:
1430655817~06052012-009.jpg

COMMENTS: Used tires on rims
are stored here within 50 feet of
overhanging limbs, grass, and
weeds.

I observed about 250 used tires mostly on the ground in a pile within 50 feet of overhanging tree limbs, grass, weeds, and brush as seen in photographs 9, 10, and 11.

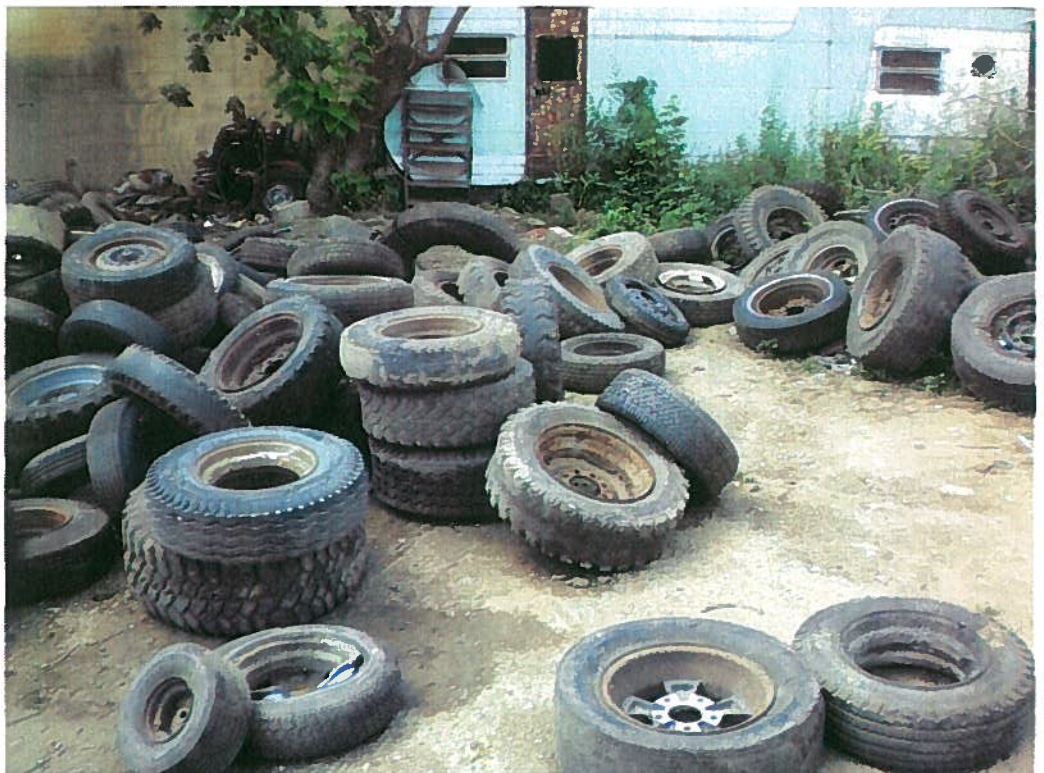
PHOTOGRAPH FILE NAME:
1430655817~06052012-010.jpg

COMMENTS: Used tires on rims
are stored here within 50 feet of
overhanging limbs, grass, and
weeds.

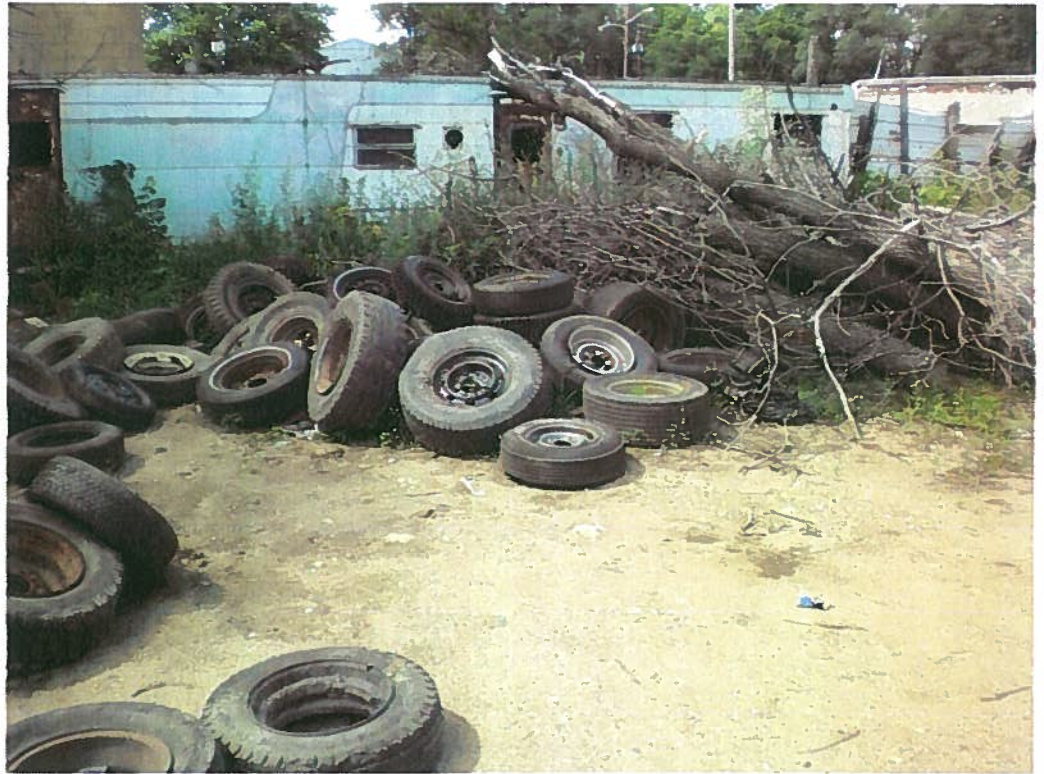
PHOTOGRAPH FILE NAME:
1430655817~06052012-011.jpg

COMMENTS: Used tires on rims
are stored here within 50 feet of
overhanging limbs, grass, and
weeds.

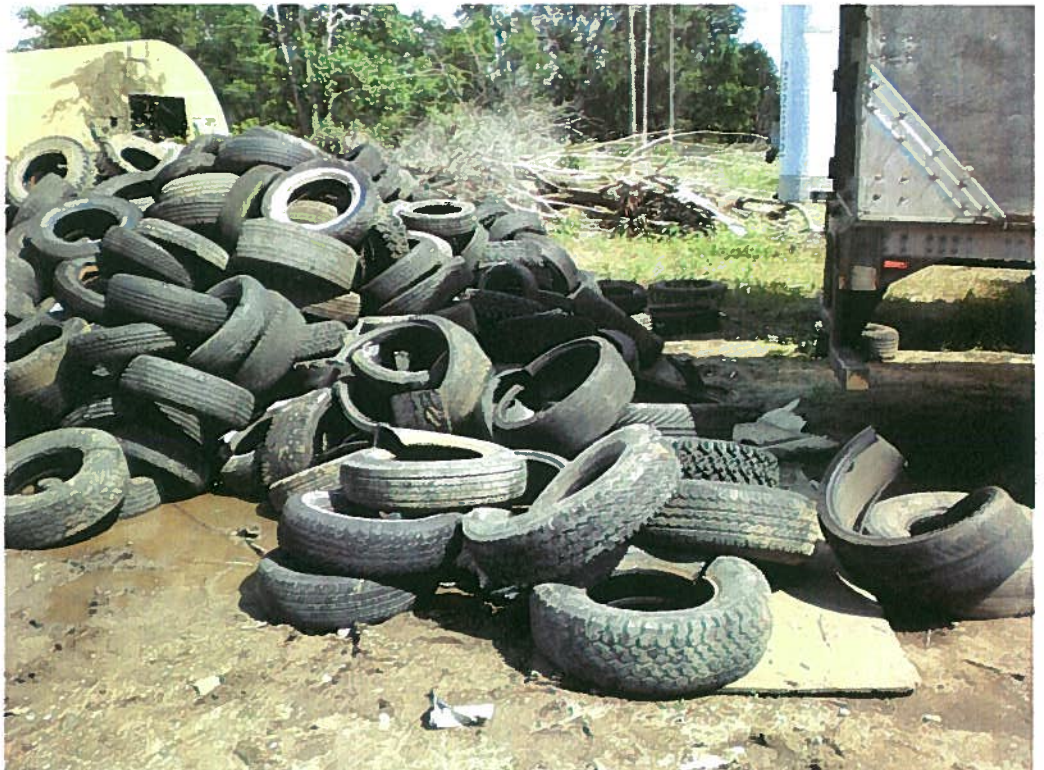
PHOTOGRAPH FILE NAME:
1430655817~06052012-012.jpg

COMMENTS: When a used tire is
separated from the rim inside the
building, it is stored outside here.
Used tires are not prevented from
accumulating water. Most of the
tires observed in this pile contain
water. Sampling revealed the
presence of larval mosquitos.

I observed about 400 used tires on the ground at the back of the Liberty Transport Trailer. The used tires have been separated from the wheel rim and have not been placed in the trailer. Most of the used tires on the ground in front of the trailer are holding water. Sampling revealed the presence of larval mosquitos. (See photographs 13, 14, and 15).

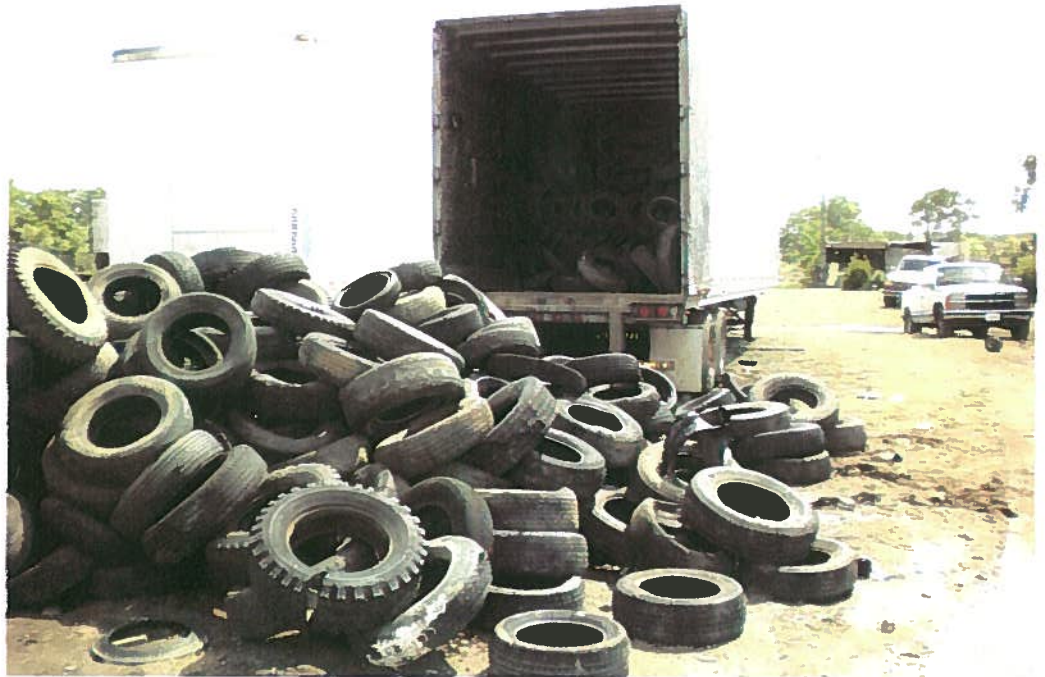
PHOTOGRAPH FILE NAME:
1430655817~06052012-013.jpg

COMMENTS: When a used tire is separated from the rim inside the building, it is stored outside here. Used tires are not prevented from accumulating water. Most of the tires observed in this pile contain water. Sampling revealed the presence of larval mosquitos. About 1,000 used tires in the trailer.

I observed that the transport trailer (T8141) on site contained about 1000 used tires as seen in photographs 13 and 21.

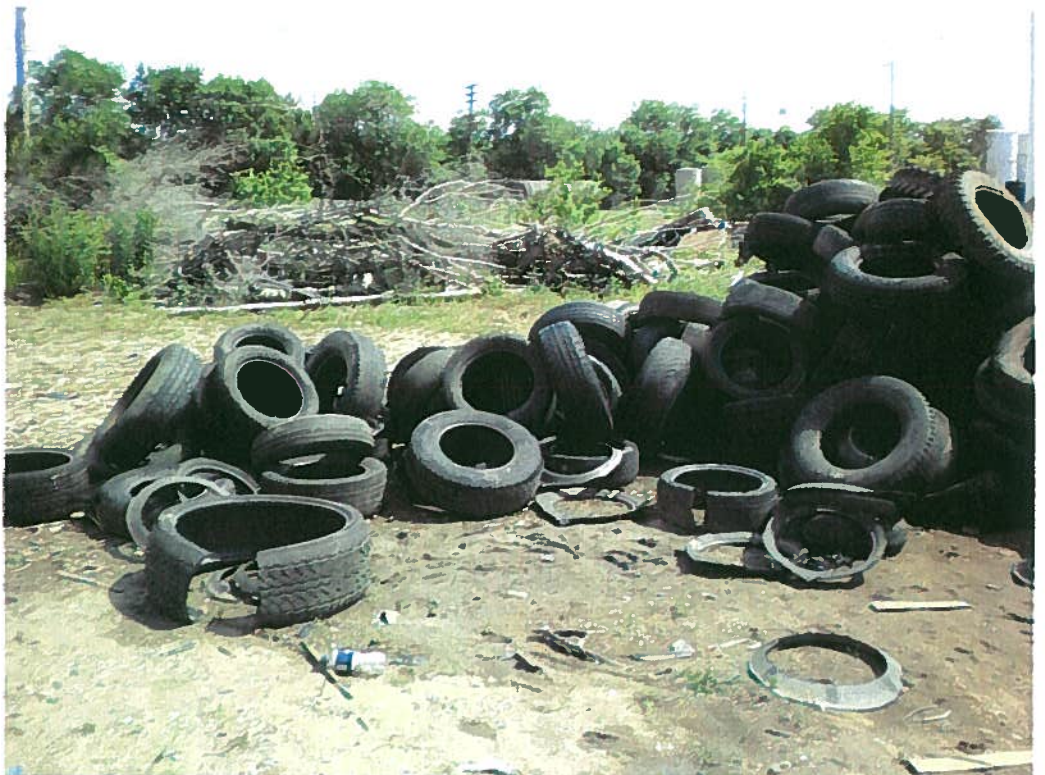
PHOTOGRAPH FILE NAME:
1430655817~06052012-014.jpg

COMMENTS: When a used tire is separated from the rim inside the building, it is stored outside here. Used tires are not prevented from accumulating water. Most of the tires observed in this pile contain water. Sampling revealed the presence of larval mosquitos.

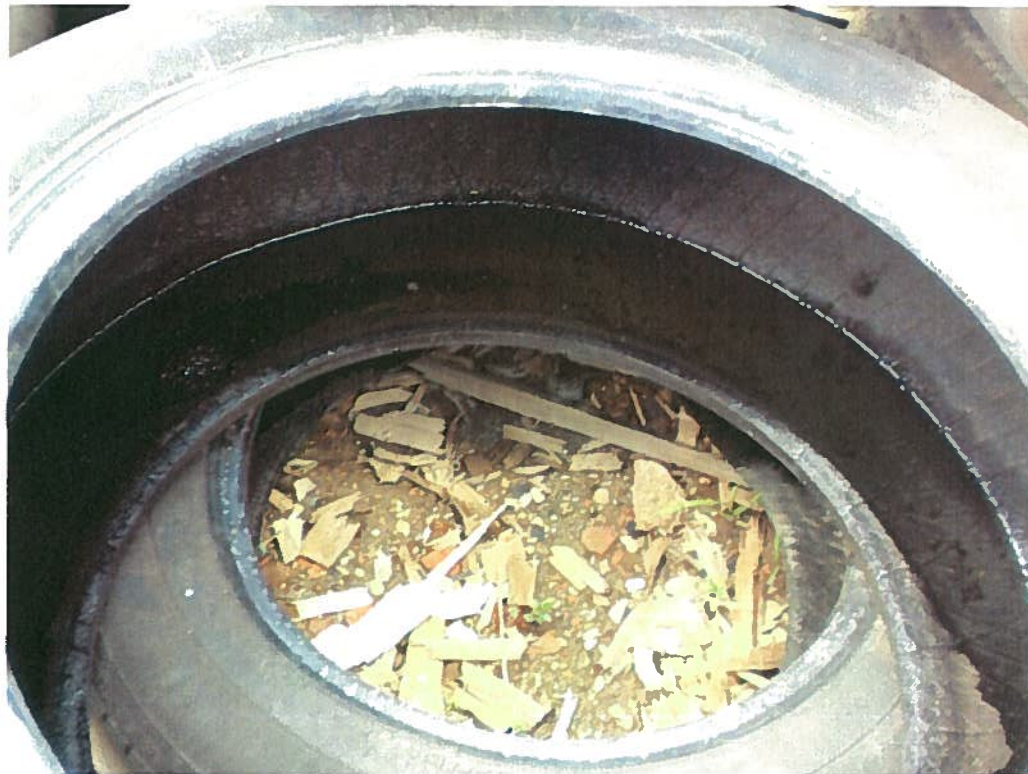
PHOTOGRAPH FILE NAME:
1430655817~06052012-015.jpg

COMMENTS: Many of the used
tires observed contained water like
this one.

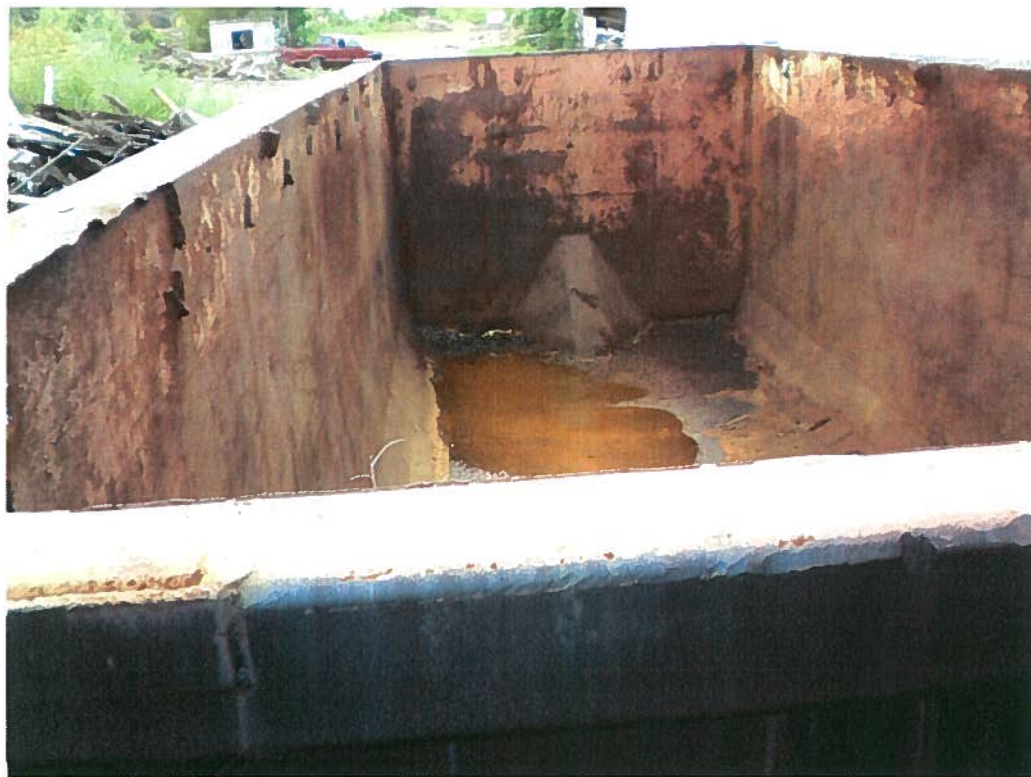
PHOTOGRAPH FILE NAME:
1430655817~06052012-016.jpg

COMMENTS: An empty waste
box.

I observed an open dump consisting of, but not limited to, household waste, landscape waste, wood pallets, construction/demolition debris, automotive waste, plastics, metal, and some furniture that appeared to be burned. See photographs 17, 18, 19, 20, 24, and 25. The wood pallets and shelving observed in photographs 24 and 25 were not observed in the previous inspection conducted on February 21, 2012. There is an empty waste drop box within 30 feet of the open dump. See photograph 16.

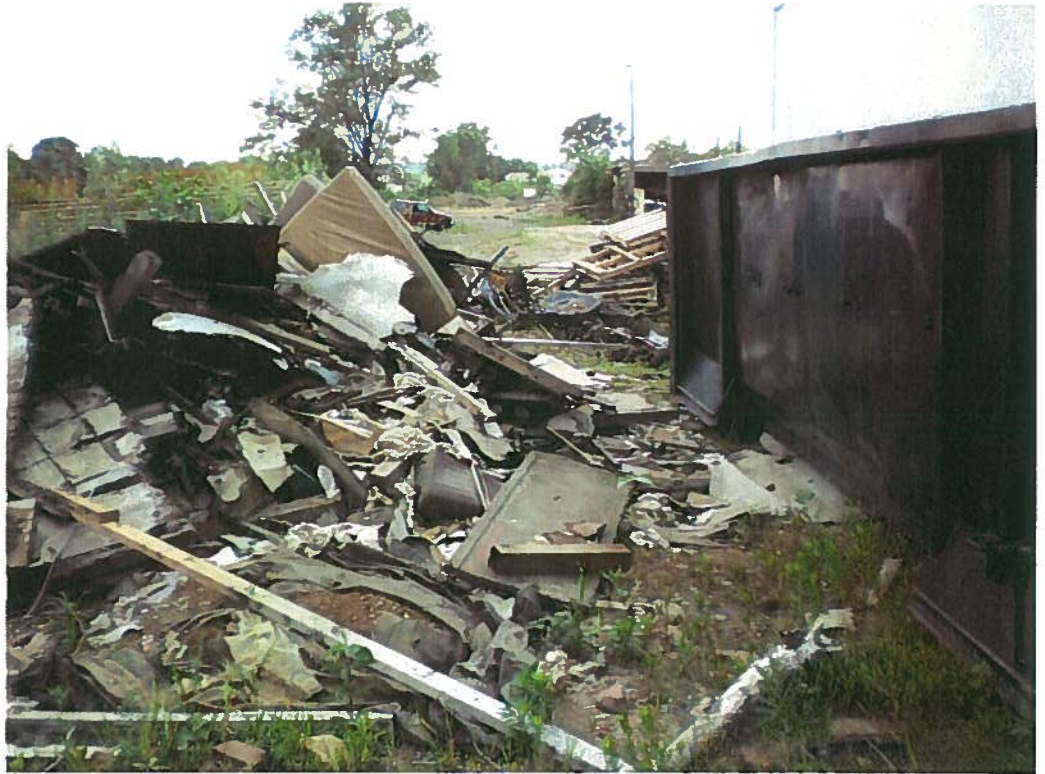
PHOTOGRAPH FILE NAME:
1430655817~06052012-017.jpg

COMMENTS: Next to the empty
drop box is an open dump
containing, but not limited to,
household waste, landscape waste,
automotive waste,
construction/demolition debris,
plastics, metal and furniture.

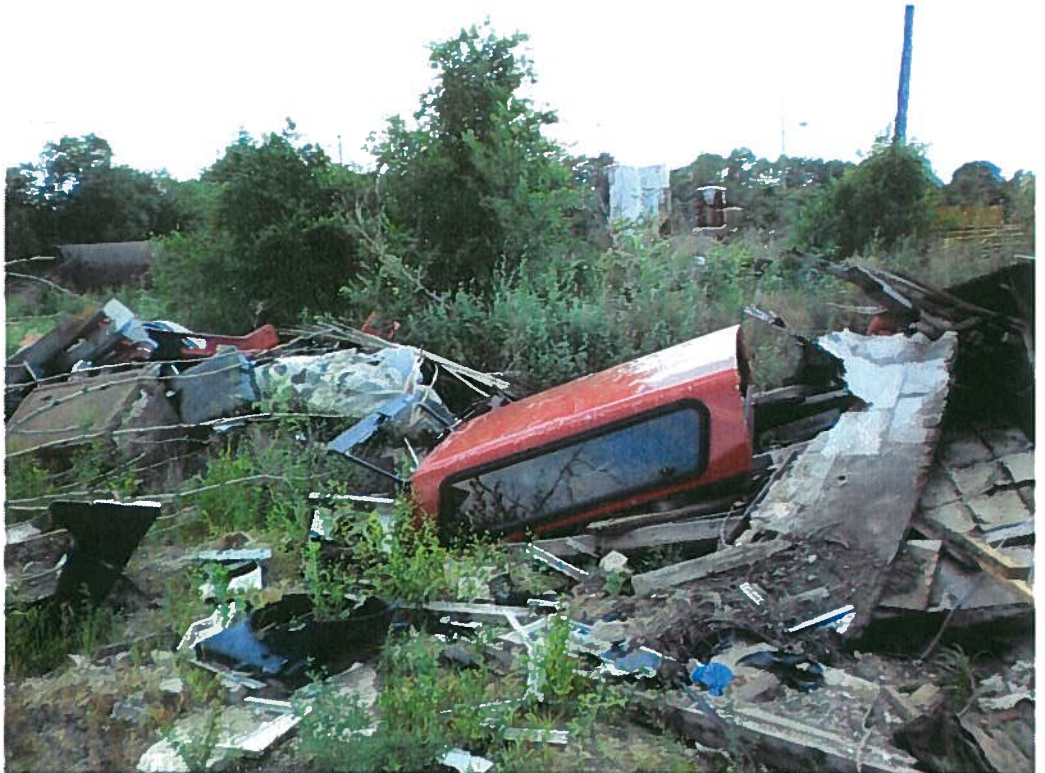
PHOTOGRAPH FILE NAME:
1430655817~06052012-018.jpg

COMMENTS: An open dump
containing, but not limited to,
household waste, landscape waste,
automotive waste,
construction/demolition debris,
plastics, metal and furniture.

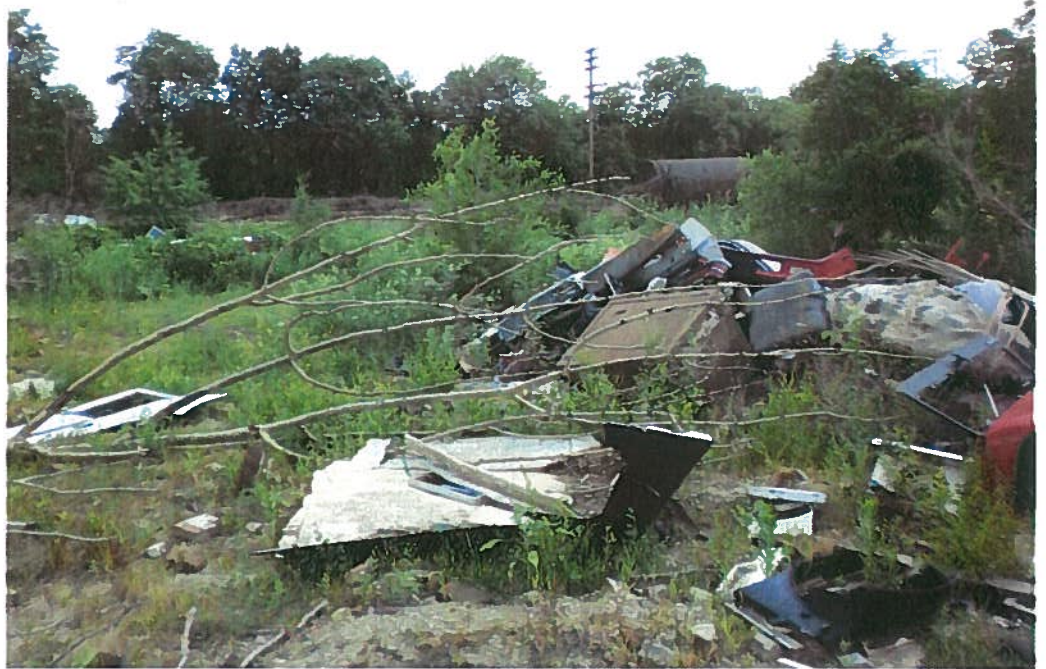
PHOTOGRAPH FILE NAME:
1430655817~06052012-019.jpg

COMMENTS: An open dump
containing, but not limited to,
household waste, landscape waste,
automotive waste,
construction/demolition debris,
plastics, metal and furniture.

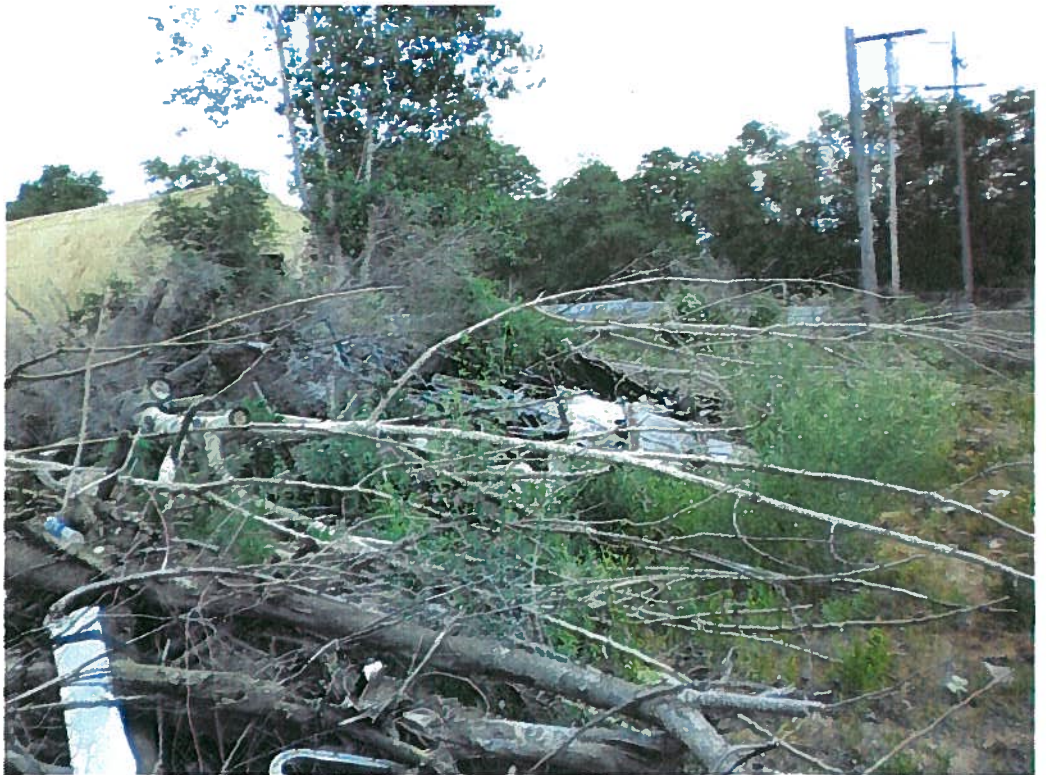
PHOTOGRAPH FILE NAME:
1430655817~06052012-020.jpg

COMMENTS: an open dump
containing, but not limited to,
household waste, landscape waste,
automotive waste,
construction/demolition debris,
plastics, metal and furniture.

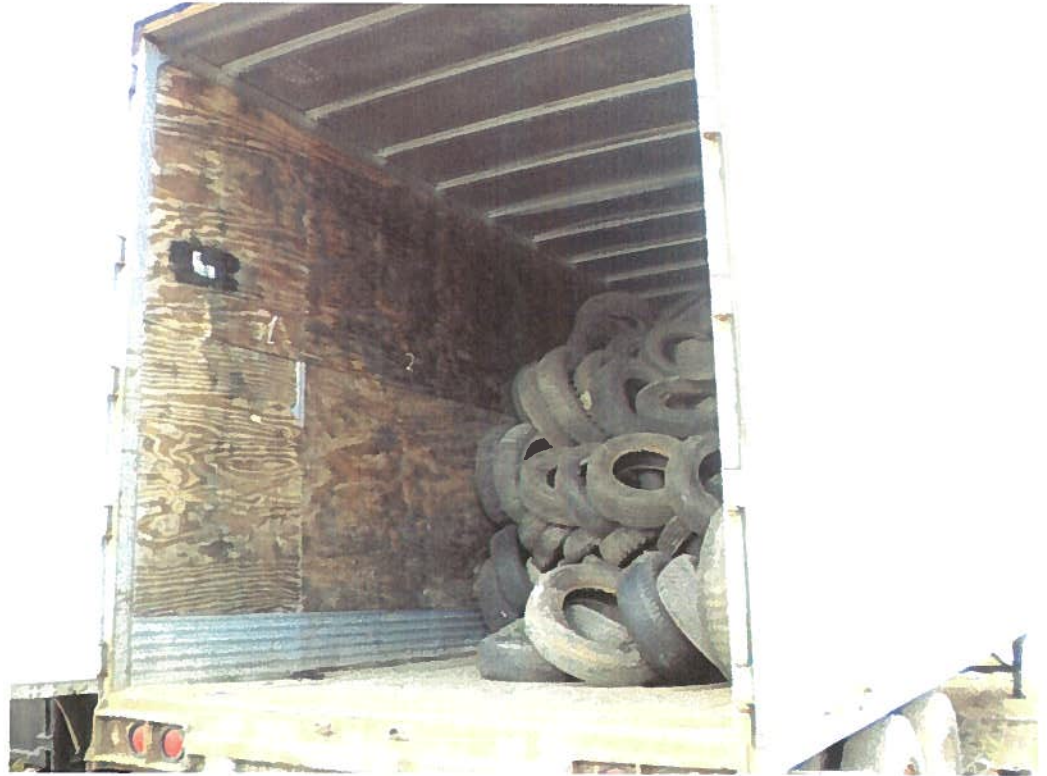
PHOTOGRAPH FILE NAME:
1430655817~06052012-021.jpg

COMMENTS: The trailer has
room for about 300 more used tires.

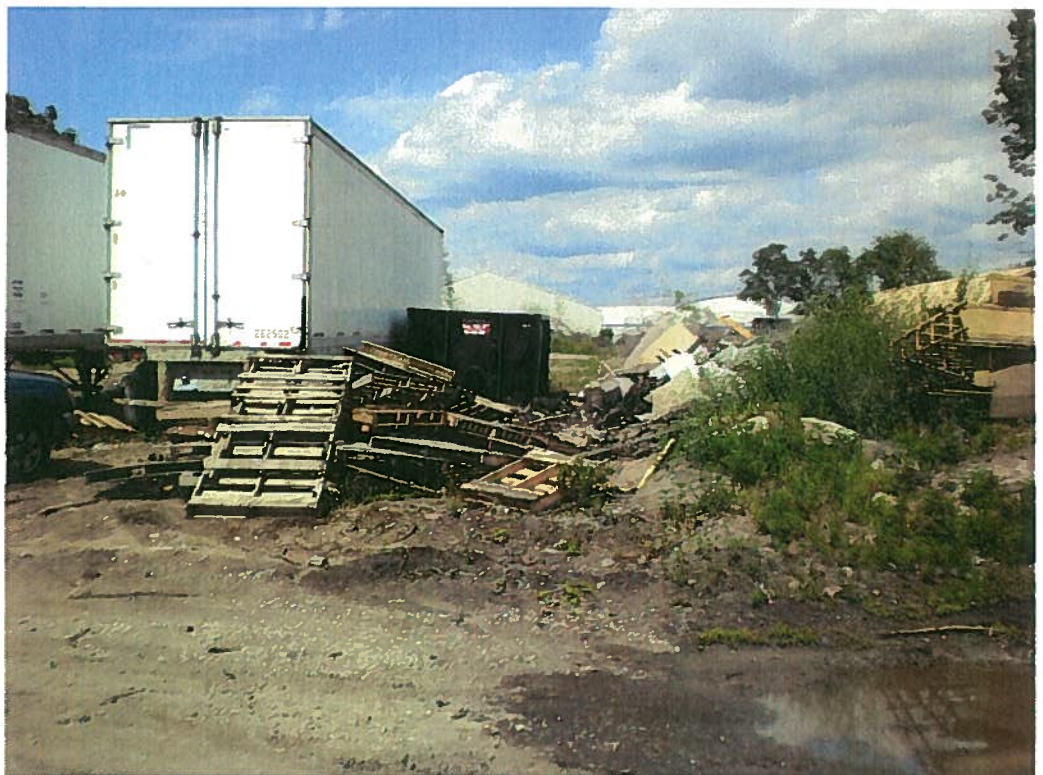
PHOTOGRAPH FILE NAME:
1430655817~06052012-024.jpg

COMMENTS: Pallets that Daniel
Schafer claims are used for
shipment of prepared metals.
Drums of metal on the pallets.
Pallets stacked on top of pallets
loaded into the trailer next to the
drop box.

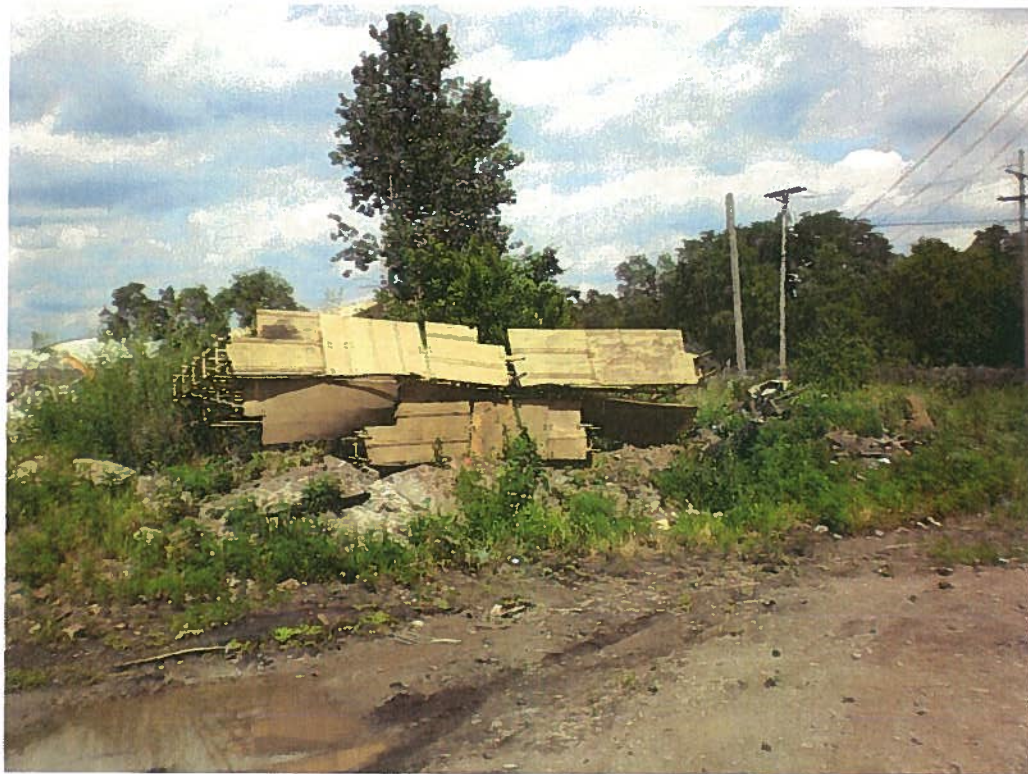
PHOTOGRAPH FILE NAME:
1430655817~06052012-025.jpg

COMMENTS: Shelves from
inside the building are now open
dumped. The drop box is empty.

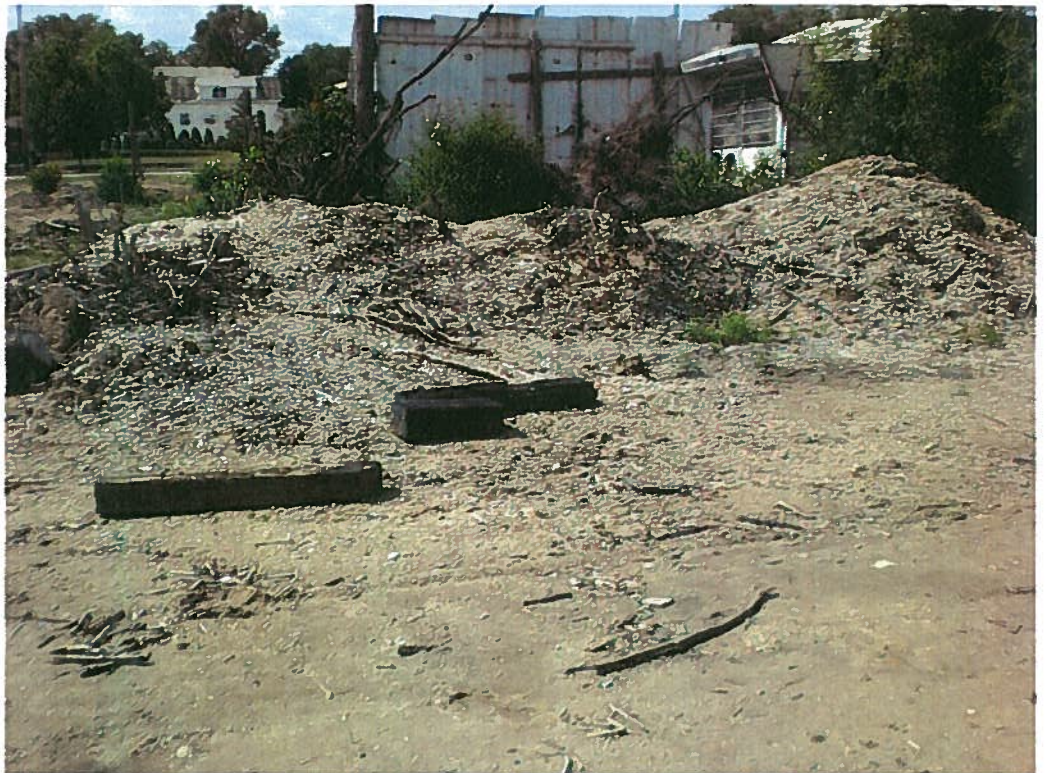
PHOTOGRAPH FILE NAME:
1430655817-06052012-028.jpg

COMMENTS: Landscape waste
from on site has been ground into
mulch and placed here.

I also observed a pile of wood chips (mulch) shown in photograph 28. Mr. Schafer explained that the mulch came from landscape waste on site that was ground into chips. According to

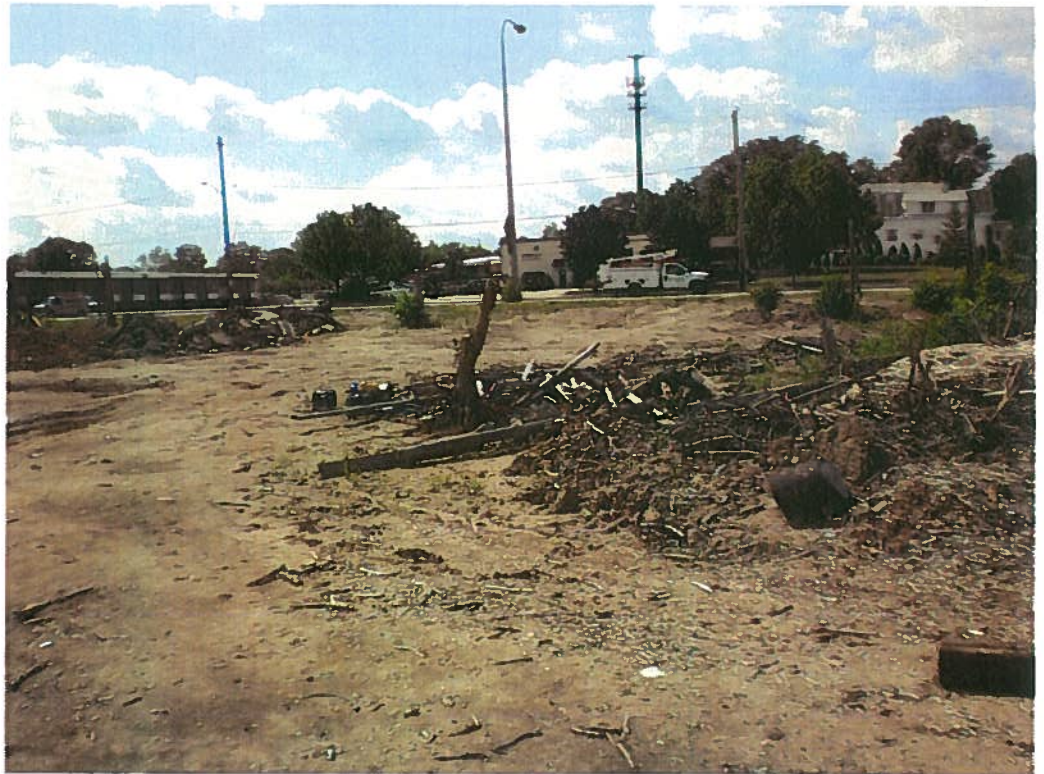
PHOTOGRAPH FILE NAME:
1430655817~06052012-029.jpg

COMMENTS: The security fence
is gone. An open dump consisting
of, but not limited to,
construction/demolition debris, a
battery, and some empty plastic
jugs.

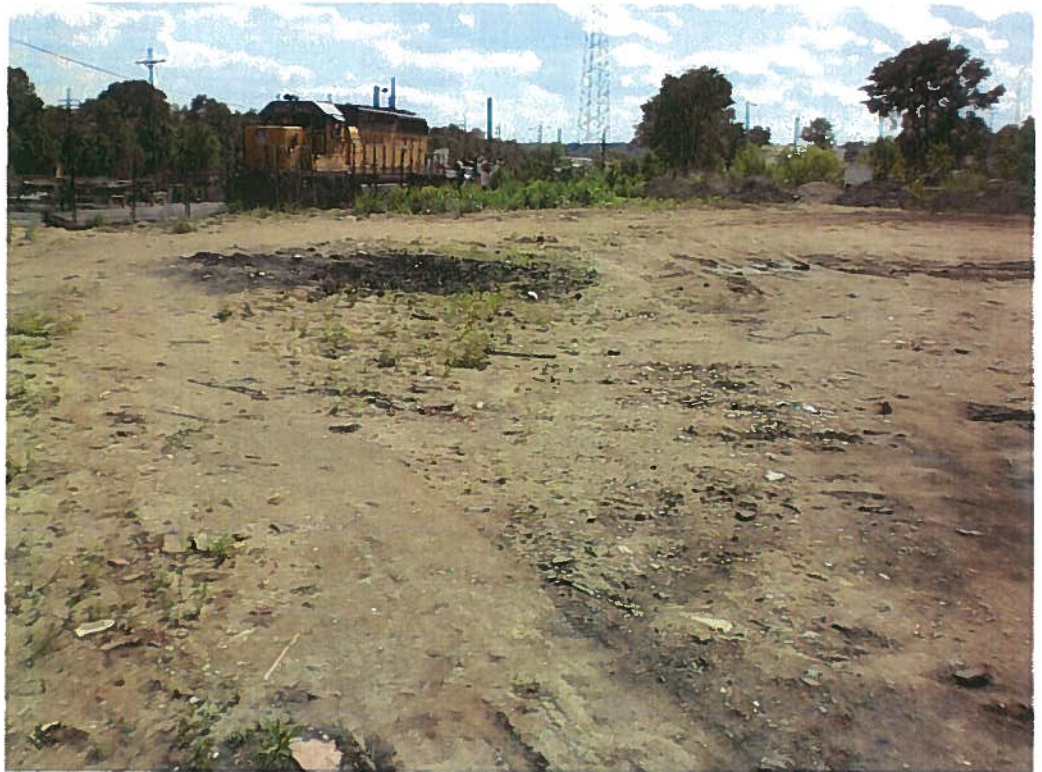
PHOTOGRAPH FILE NAME:
1430655817~06052012-031.jpg

COMMENTS: The remnants of
an open burn pile.

I observed remnants of an open burn pile not previously observed during the first inspection. (See photograph 31). Mr. Schafer explained that because the security fence is no longer in place, an unauthorized homeless person was able to enter the facility at night and started a fire with landscape material in efforts to stay warm.

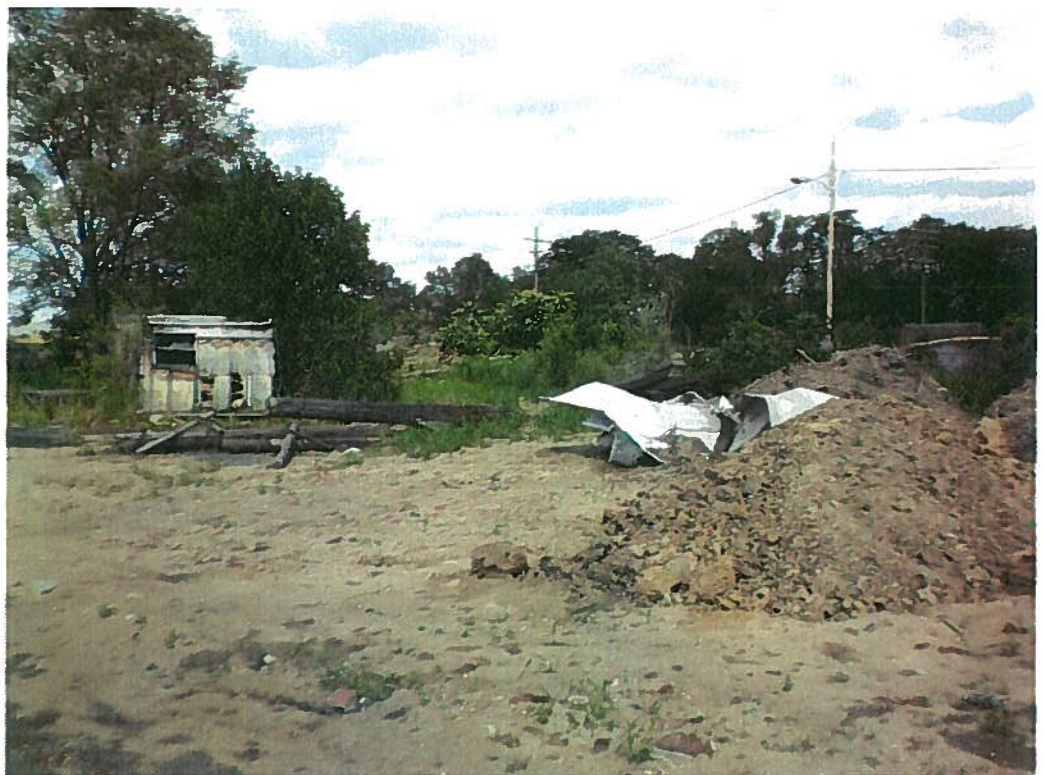
PHOTOGRAPH FILE NAME:
1430655817~06052012-032.jpg

COMMENTS: Metal and wood
debris from the security fence that
used to be in place.

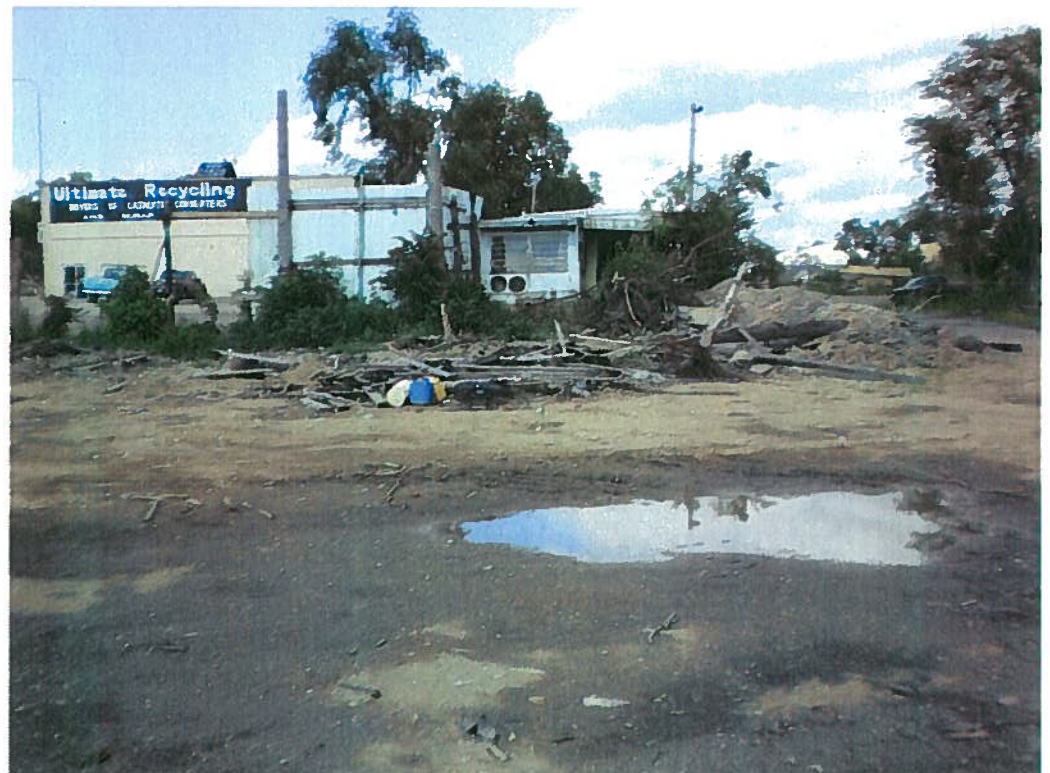
PHOTOGRAPH FILE NAME:
1430655817-06052012-034.jpg

COMMENTS: The open dump
observed in photograph 29. Behind
it on the right is the landscape waste
that was ground to mulch.
