BEFORE THE ILLINOIS POLLUTION CONTROL BOARD

ADMINISTRATIVE CITATION

AC 13-3
(IEPA No. 173-12-AC)

PLEASE TAKE NOTICE that on this date I mailed for filing with the Clerk of the Pollution Control Board of the State of Illinois the following instrument(s) entitled ADMINISTRATIVE CITATION, AFFIDAVIT, and TIRE STORAGE SITE INSPECTION CHECKLIST.

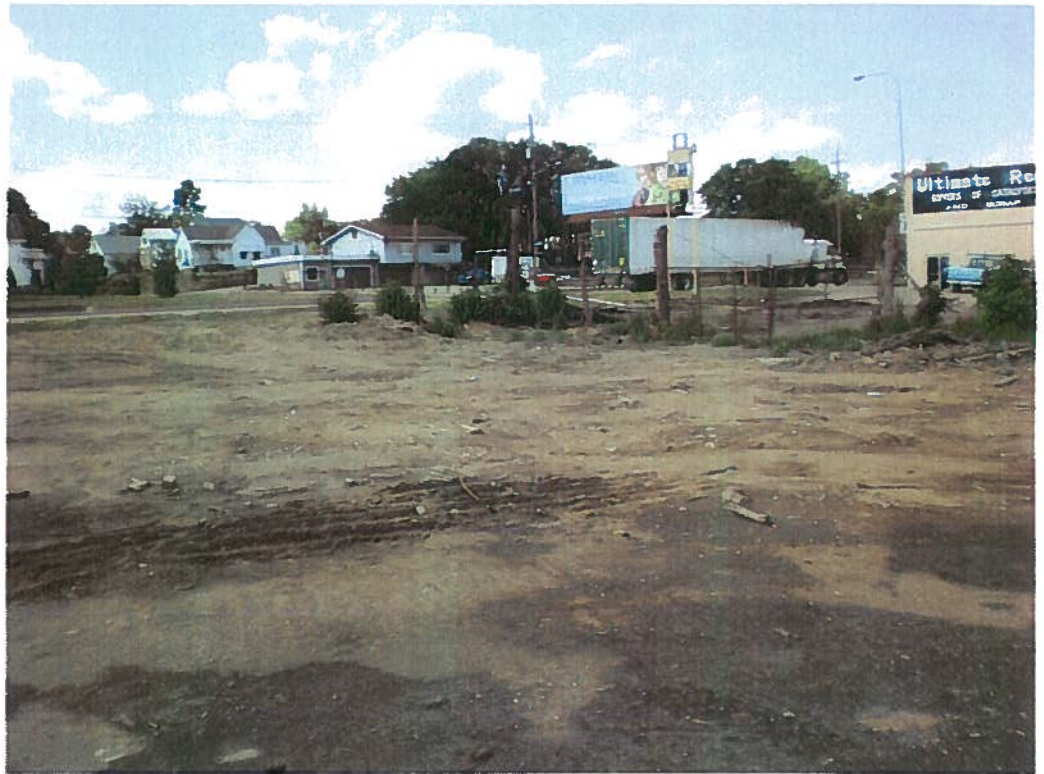
PHOTOGRAPH FILE NAME:
1430655817~06052012-035.jpg

COMMENTS: The security fence
is gone. The street is higher in
elevation than where I stand.

I observed that a security fence present during the previous inspection on February 21, 2012 is no longer in place at the facility. See photographs 3, 4, 29, 30, and 35. Mr. Schafer explained that it was destroyed by wind.

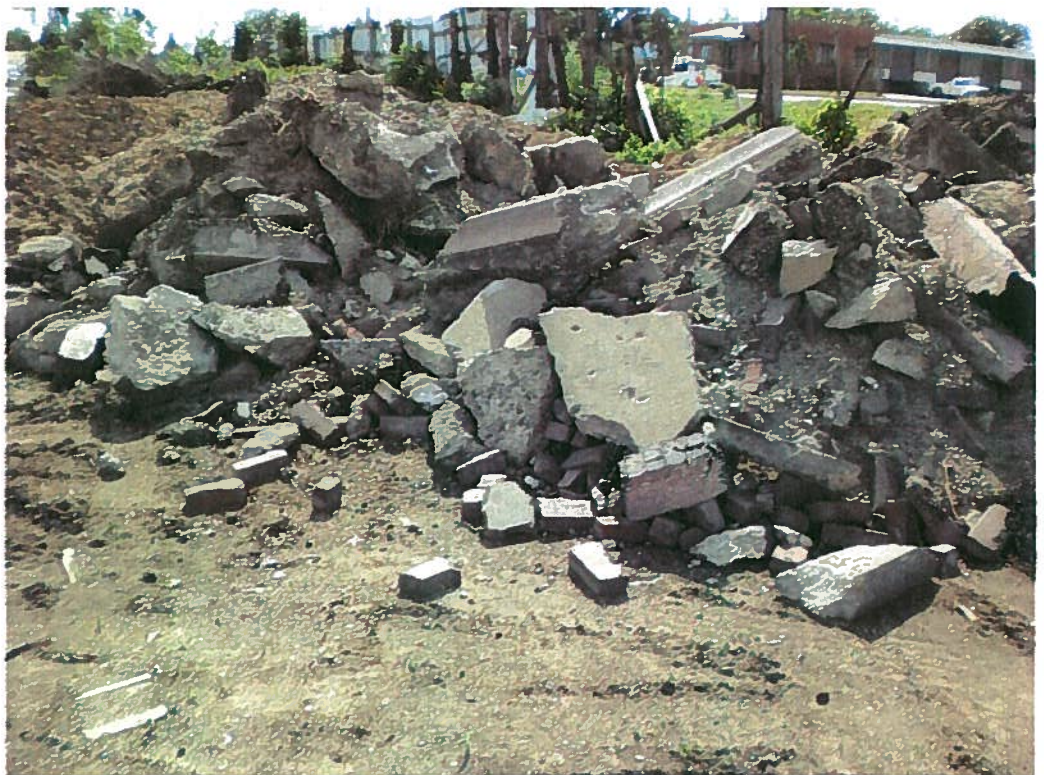
PHOTOGRAPH FILE NAME:
1430655817~06052012-036.jpg

COMMENTS: A pile of concrete,
bricks and asphalt to be used as fill
and covered with dirt.

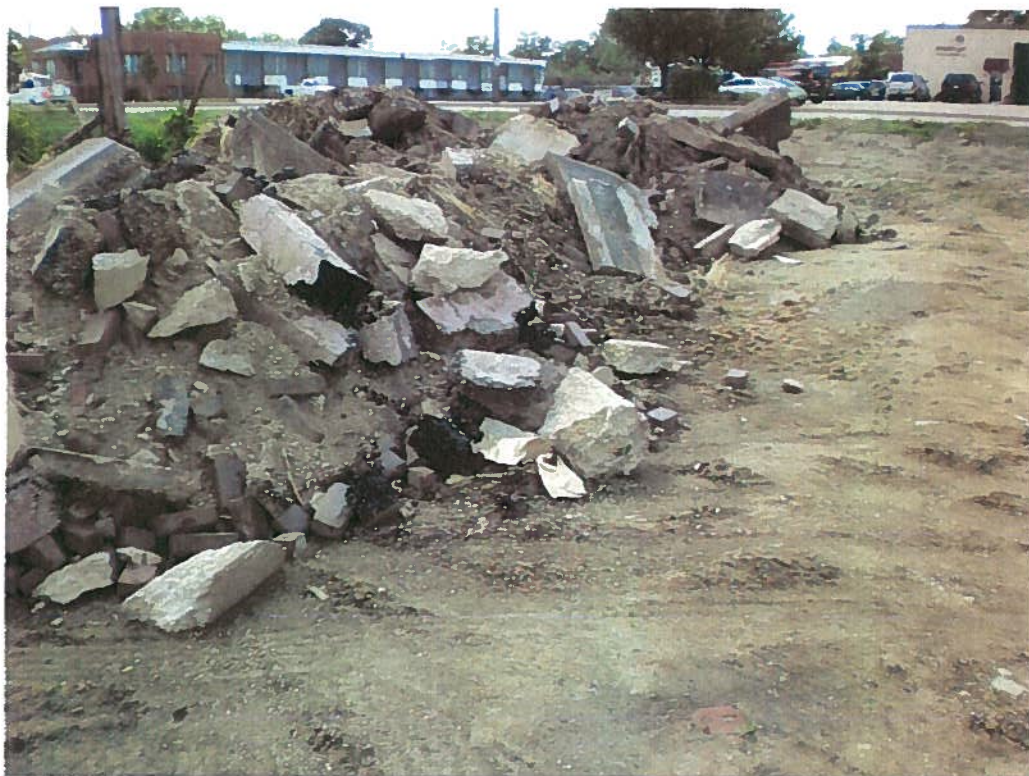
PHOTOGRAPH FILE NAME:
1430655817~06052012-037.jpg

COMMENTS: A pile of concrete,
bricks and asphalt to be used as fill
and covered with dirt.

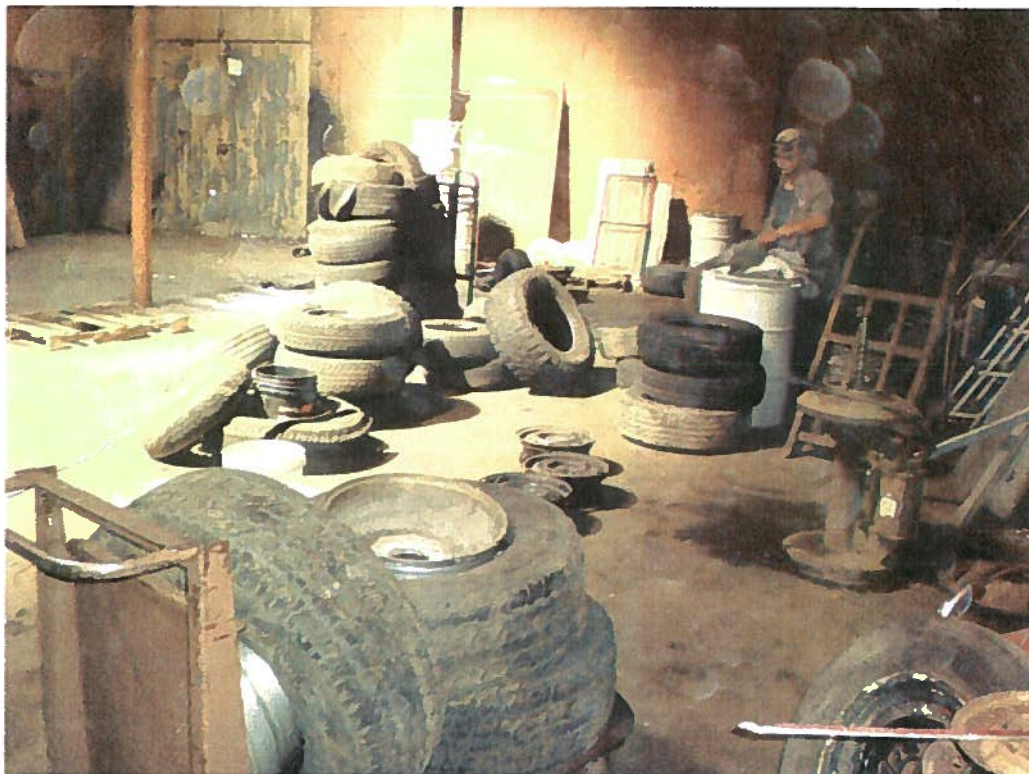
PHOTOGRAPH FILE NAME:
1430655817~06052012-038.jpg

COMMENTS: Used tires inside
are separated from the rim. Metal
drums are used to ship prepared
metals for recycling.

I observed about 50 used tires inside the building. See photographs 38 and 39.

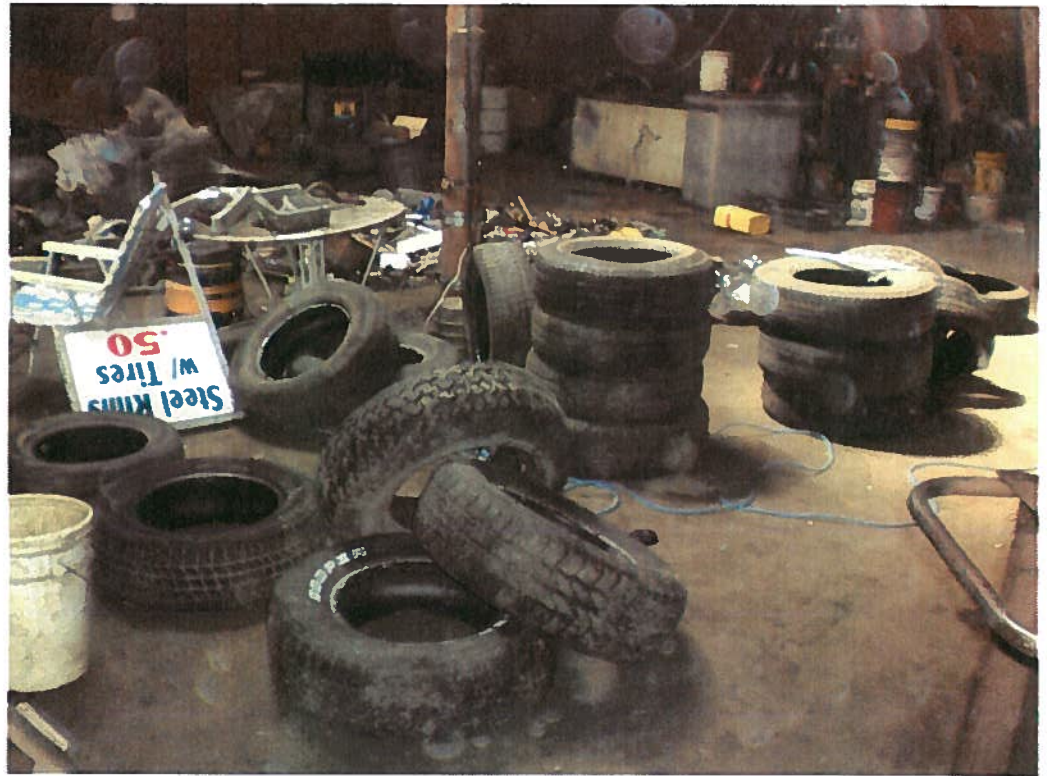
PHOTOGRAPH FILE NAME:
1430655817~06052012-039.jpg

COMMENTS: Used tires
separated from the rims. The sign
reads “Steel Rims w/ Tires .50” was
posted outside along S.W. Adams
St where the public can see it.
