BEFORE THE ILLINOIS POLLUTION CONTROL BOARD
ADMINISTRATIVE CITATION

AC 16-5
(IEPA No. 333-15-AC)

Open Dump Inspection Checklist

LPC #: 1990155032 – Williamson County
Site Name: Falmier's Auto Salvage & Towing
Date of Inspection: September 24, 2015
Inspector: Garrison Gross – Bureau of Land Field Operations
Subject: Open Dumping Inspection at Falmier's Auto Salvage & Towing

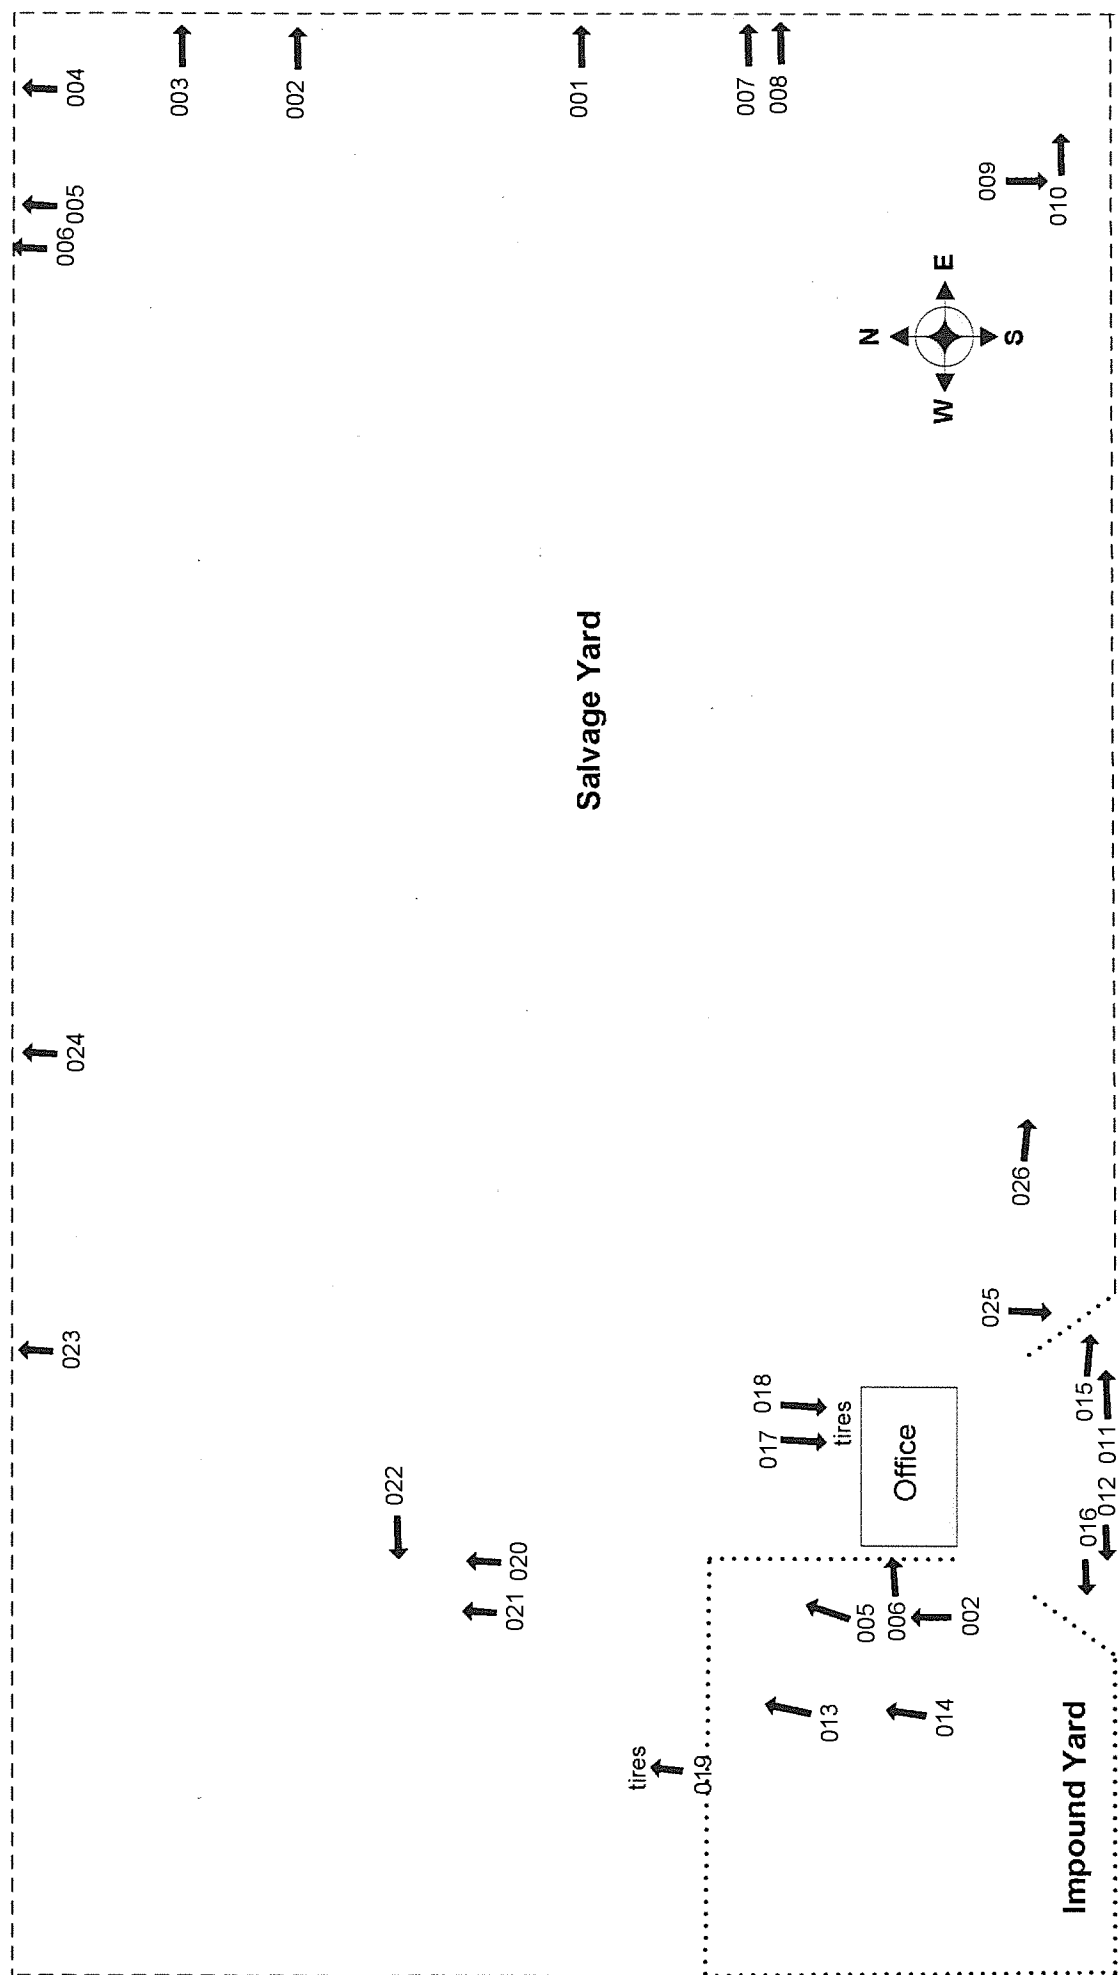
State of Illinois
ENVIRONMENTAL PROTECTION AGENCY
Inspection Site Sketch

Date: September 24, 2015
BOL ID #: 1990155032 – Williamson County
Site Name: Falmier's Auto Salvage & Towing
Inspector: Garrison Gross
Not Drawn to Scale: All Locations Are Approximate

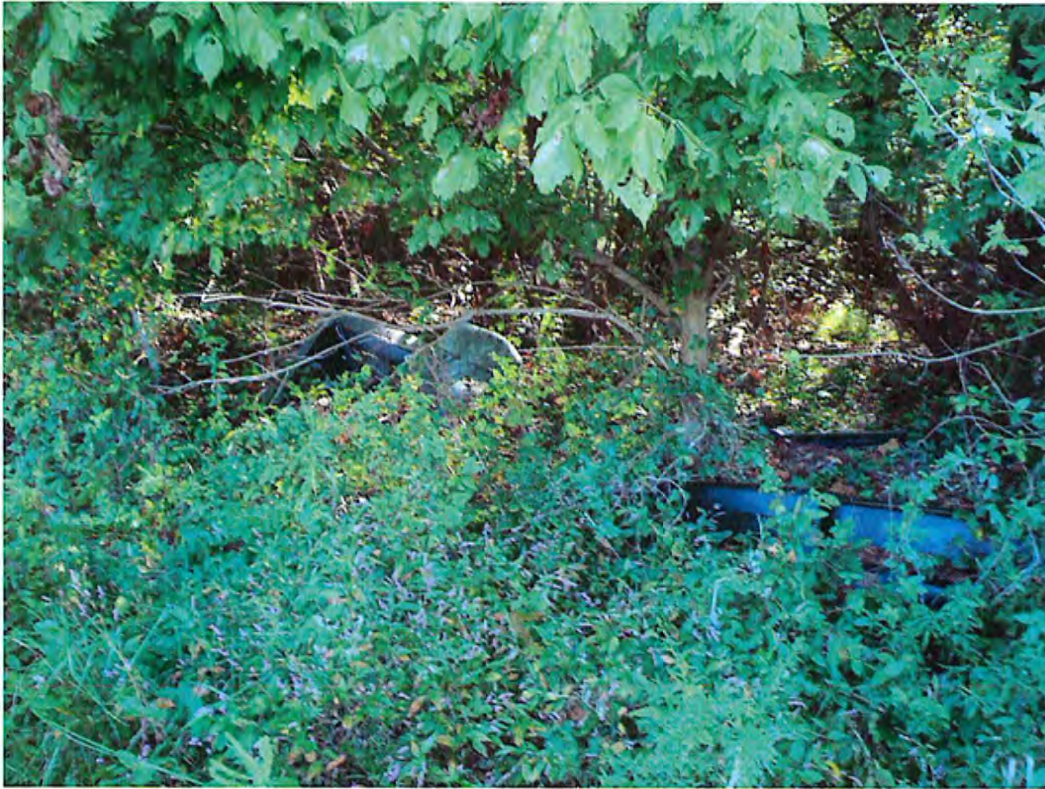
Date: 09/24/2015
Time: 9:50 A.M.
Direction: east
Photo by: G. Gross
Exposure #: 001
Comments: waste
automotive parts;
observed during
previous inspection

Open Dumped Waste: Numerous non-metal and mixed-metal automotive parts were observed along the north and west property boundaries (photo 001-005, 007, 008, 020, 023-025). These included but were not limited to fuel tanks, interior door panels, seats, insulation, carpeting, fiberglass truck bedcovers and plastic bed liners. Some of these waste items were observed during the previous inspection.

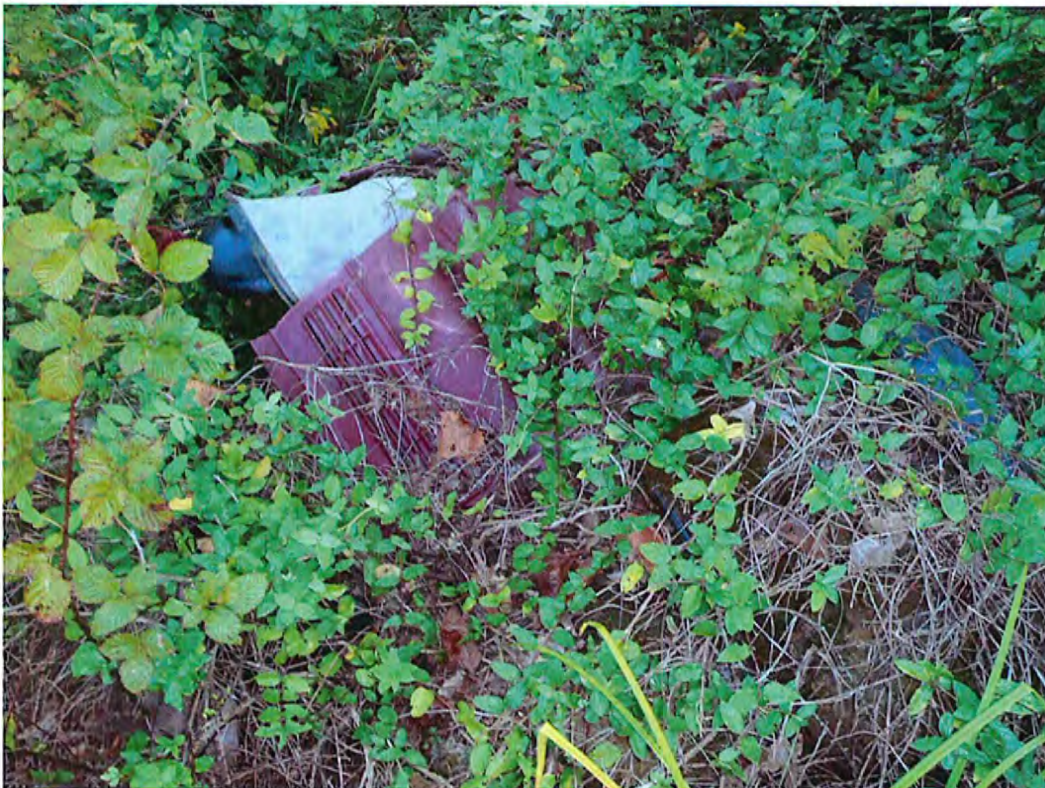
Date: 9/24/2015
Time: 9:51 A.M.
Direction: east
Photo by: G. Gross
Exposure #: 002
Comments: waste
automotive parts;
observed during the
previous inspection

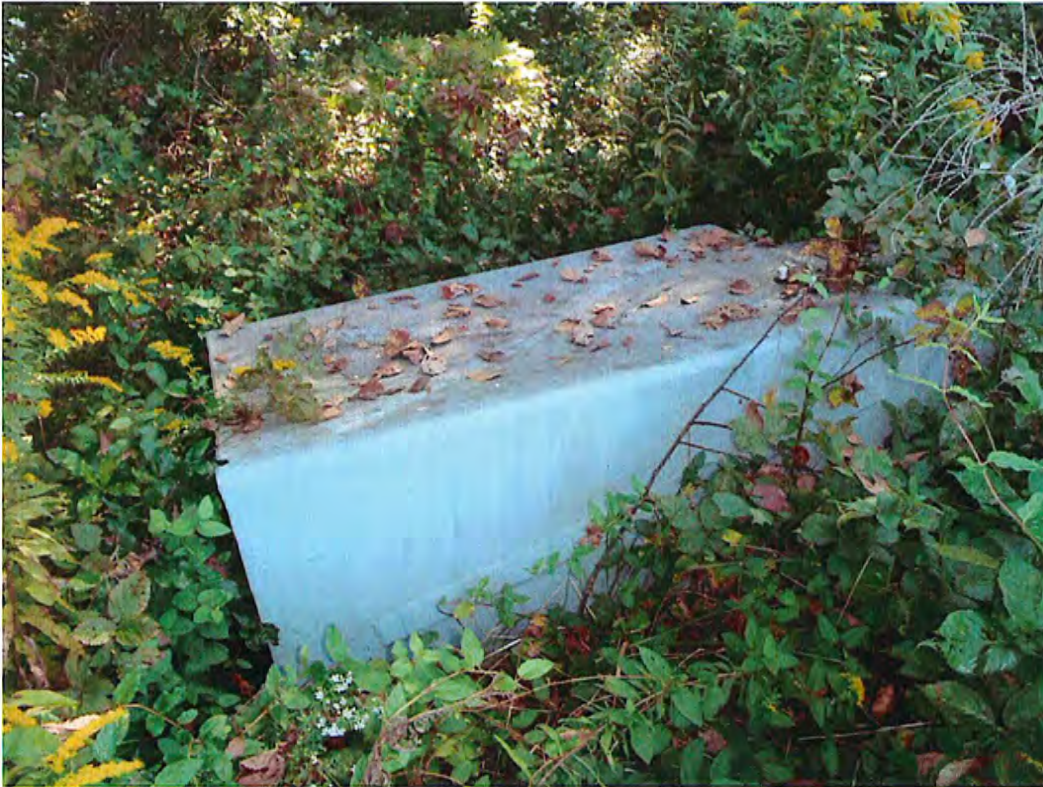
Date: 09/24/2015
Time: 9:52 A.M.
Direction: east
Photo by: G. Gross
Exposure #: 003
Comments: waste
shower stall

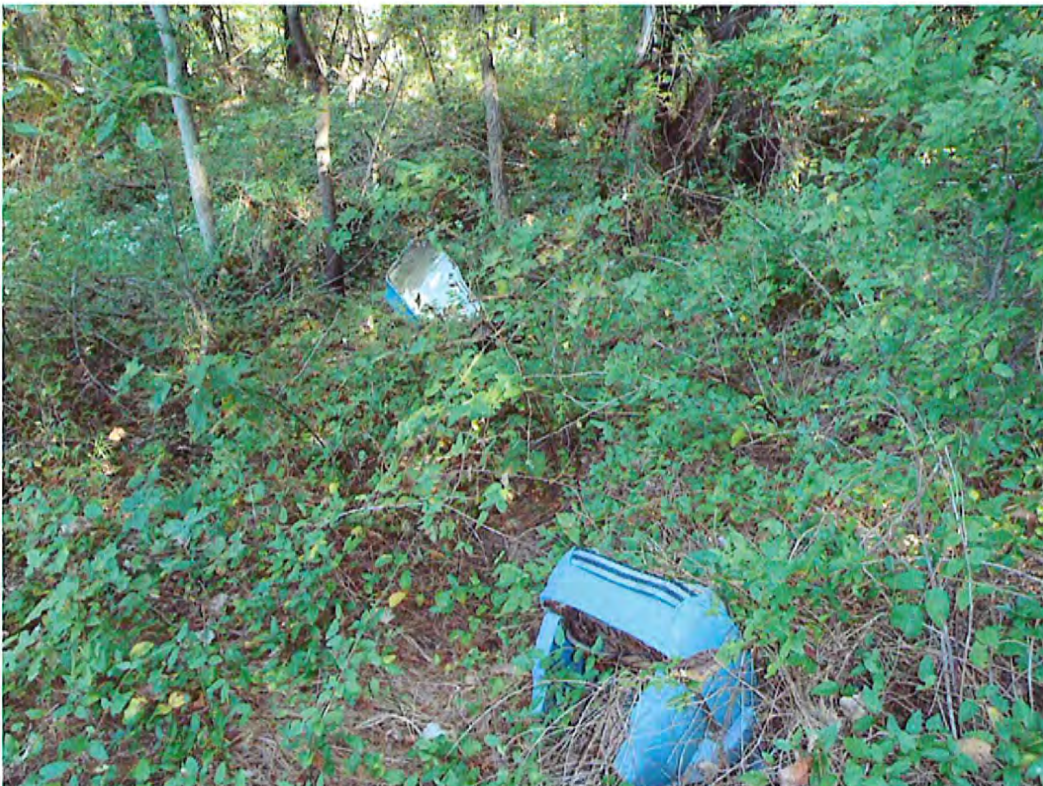
Date: 9/24/2015
Time: 9:53 A.M.
Direction: north
Photo by: G. Gross
Exposure #: 004
Comments: waste
automotive parts;
observed during
previous inspection

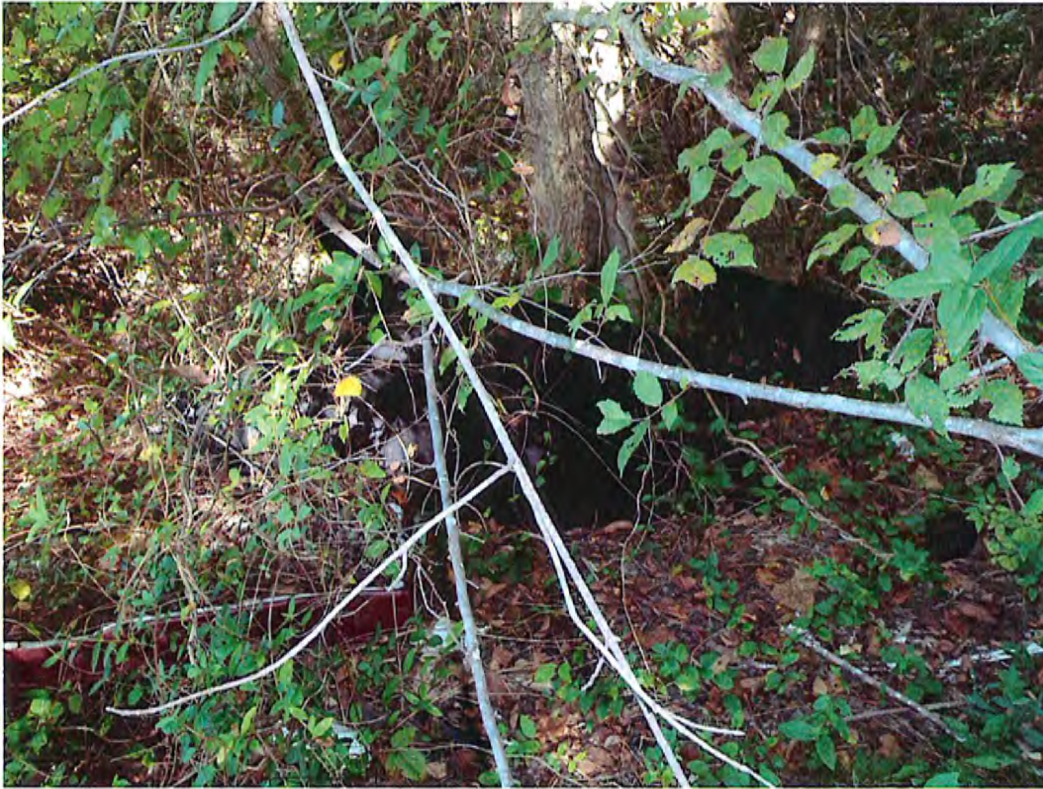
Date: 09/24/2015
Time: 9:54 A.M.
Direction: north
Photo by: G. Gross
Exposure #: 005
Comments: waste
automotive parts,
observed during
previous inspection

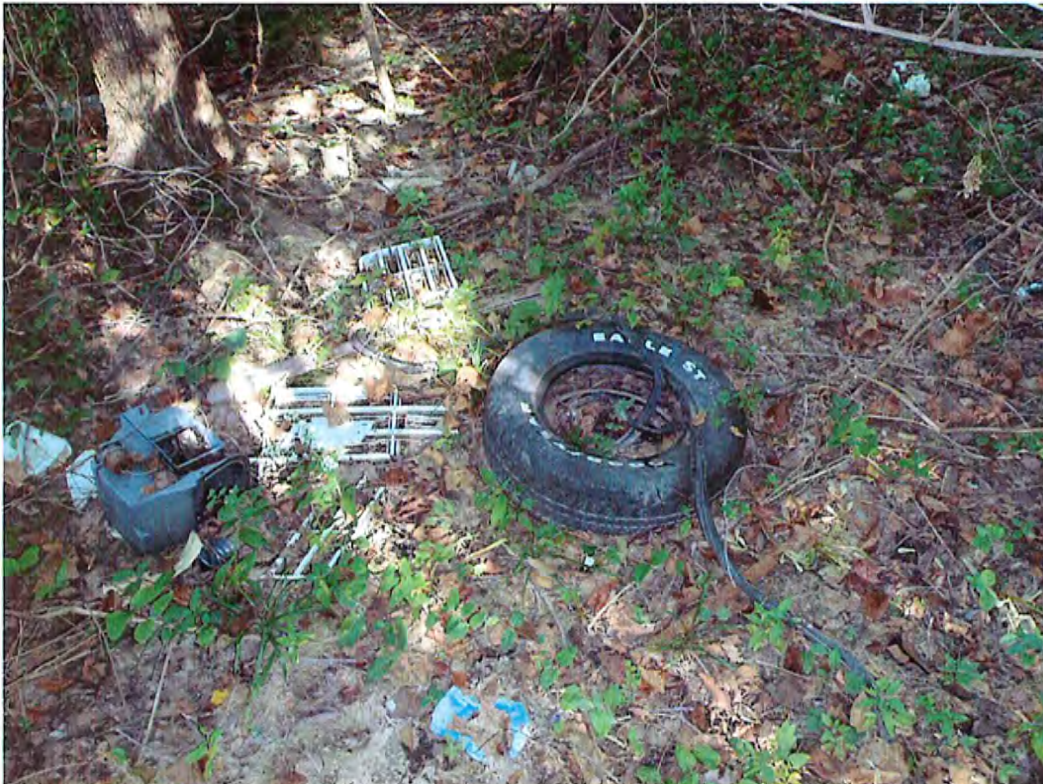
Date: 9/24/2015
Time: 9:54 A.M.
Direction: north
Photo by: G. Gross
Exposure #: 006
Comments: waste tire;
off the rim; observed
during the previous
inspection

Tire Storage / Disposal: Seventeen (17) used / waste tires were observed at the site. Due to the tall vegetation, it is likely that additional tires are located at the site. All of the previously inspected areas were not observed due to overgrowth in vegetation. Small tire piles remained in some of the areas observed during the last inspection (photos 006, 013, 017, 019 and 026). Recently acquired tires were stored in the back of recently acquired vehicles (photo 009). Tires were not protected from accumulating water. Some of the tires were on rim and holding air. Others were not holding air or were off rim. Off rim tires had accumulated water, organic material (leaves) and mosquito larvae were present in some of the tires (photos 010 and 018).

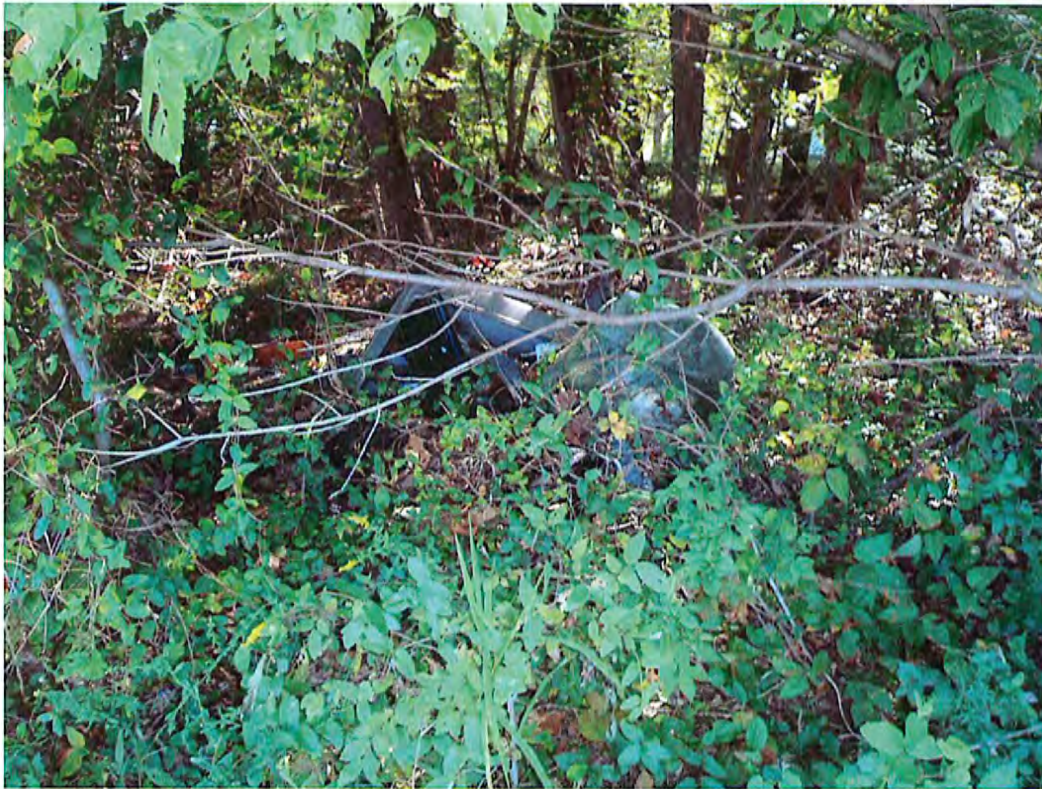
Date: 09/24/2015
Time: 9:56 A.M.
Direction: east
Photo by: G. Gross
Exposure #: 007
Comments: waste
automotive parts

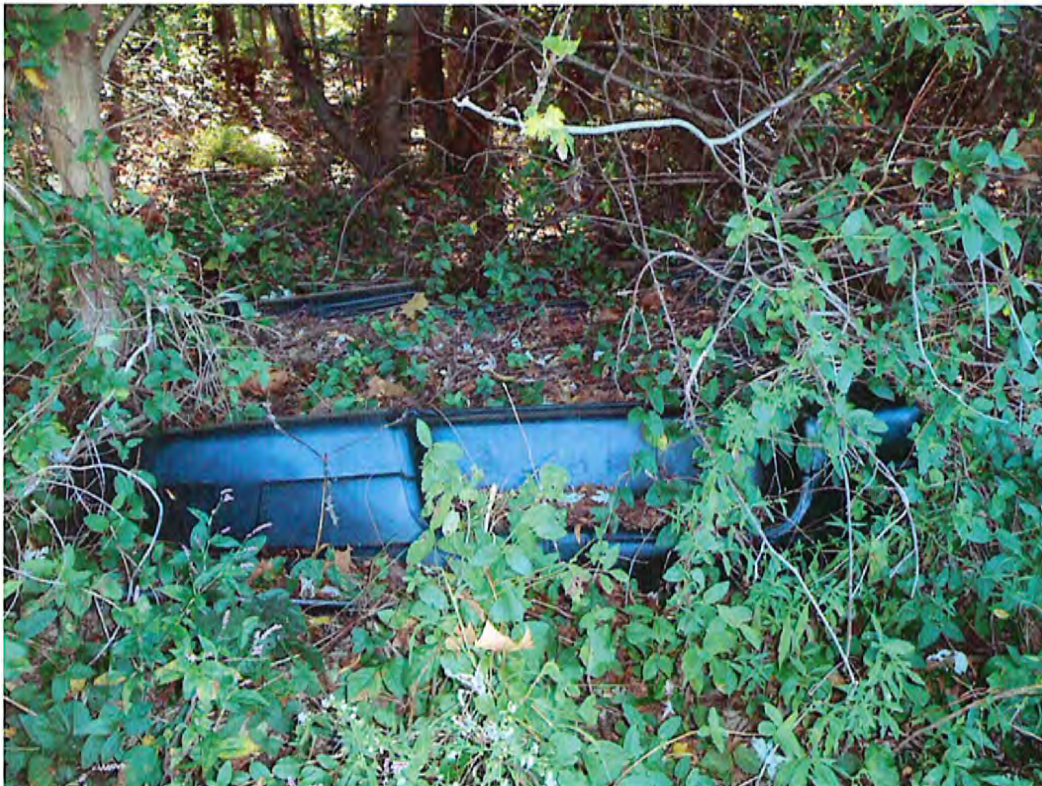
Date: 9/24/2015
Time: 9:56 A.M.
Direction: east
Photo by: G. Gross
Exposure #: 008
Comments: waste
automotive parts

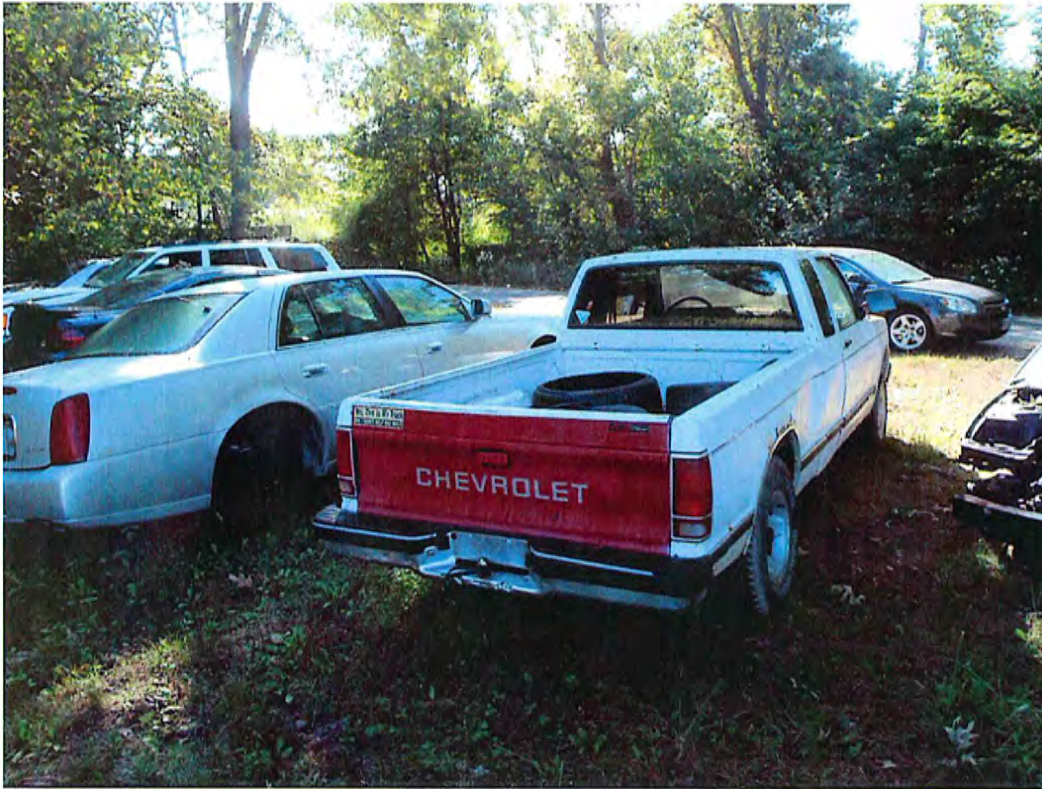
Date: 09/24/2015
Time: 9:58 A.M.
Direction: south
Photo by: G. Gross
Exposure #: 009
Comments: used /
waste tires in back of
salvage / impound
vehicle

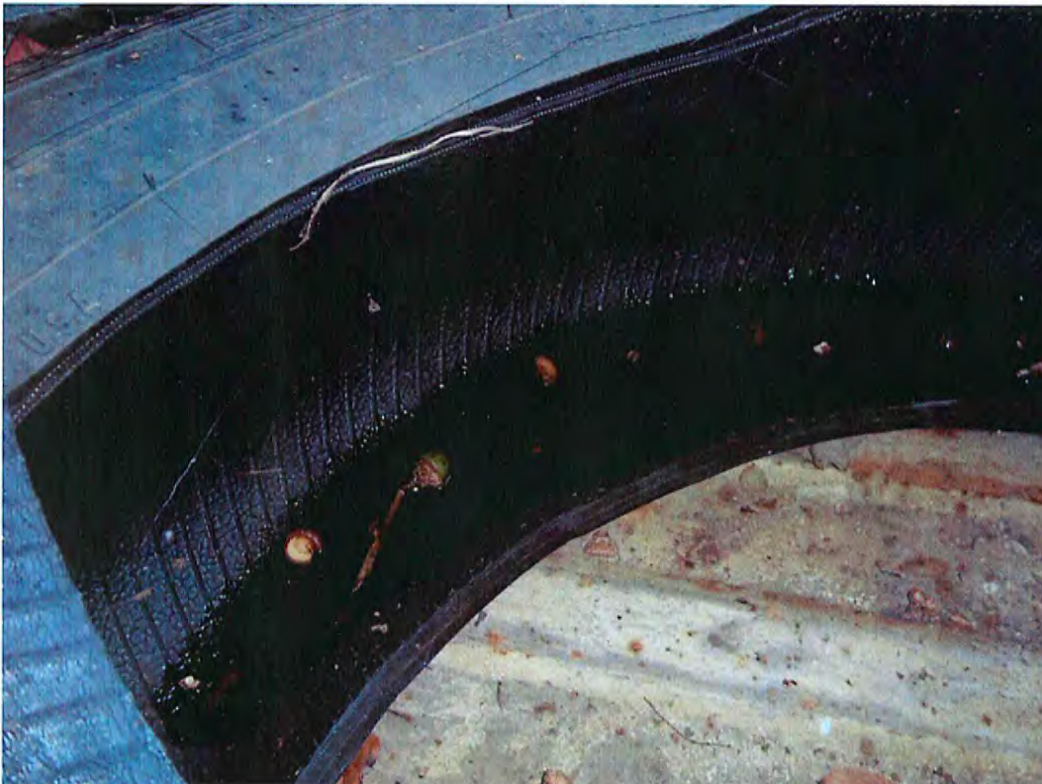
Date: 9/24/2015
Time: 9:59 A.M.
Direction: east
Photo by: G. Gross
Exposure #: 010
Comments: used /
waste tires in back of
salvage / impound
vehicle; tires had
been cut to remove
side wall; one was
still capable of
holding water and
mosquito larvae and
adult mosquitoes
were present

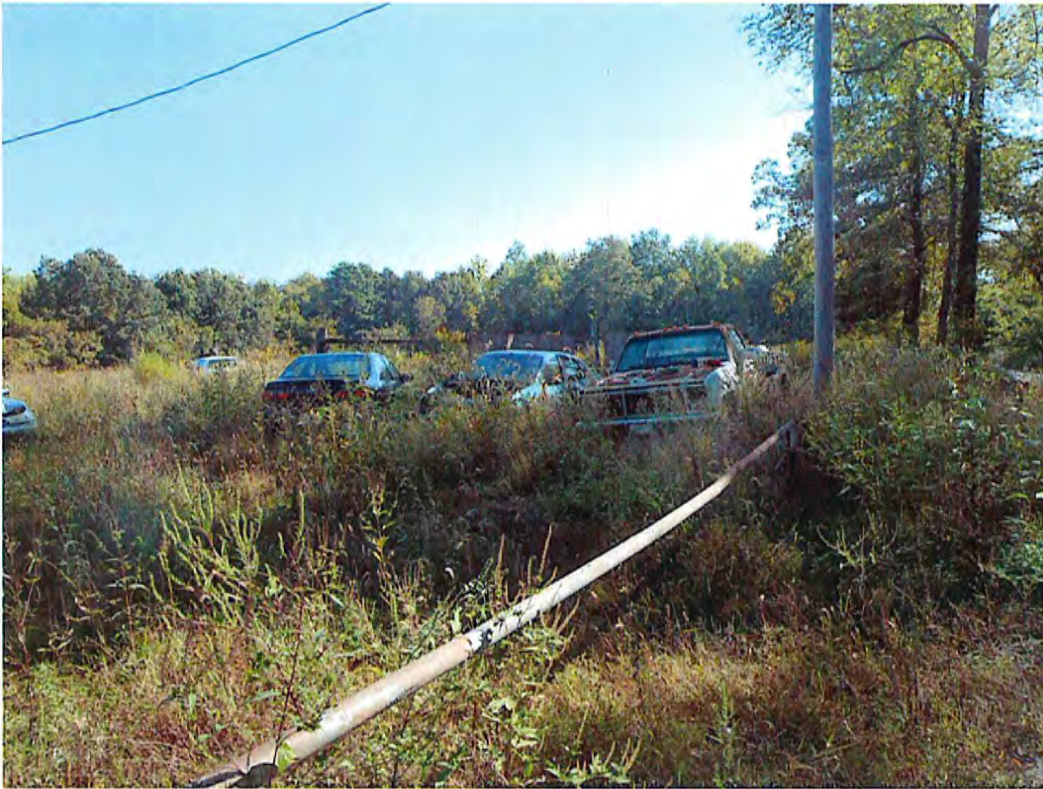
Vehicles: Approximately forty-six (46) vehicles were located at the site. At least six (6) vehicles had been obtained since the last inspection. Eight (8) waste / end-of-life vehicles were observed at the site (photos 011, 012, 015 and 016). Five of these vehicles were vintage, three were unused tow trucks. These vehicles did not appear to be in use, useable in their current condition, or protected for future use. It did not appear they were being parted out or an integral part of the automotive parts operation.

Date: 09/24/2015
Time: 10:01 A.M.
Direction: east
Photo by: G. Gross
Exposure #: 011
Comments: view of site
from main entrance;
waste vehicle (truck)
observed during
previous inspection
(see photo 015)

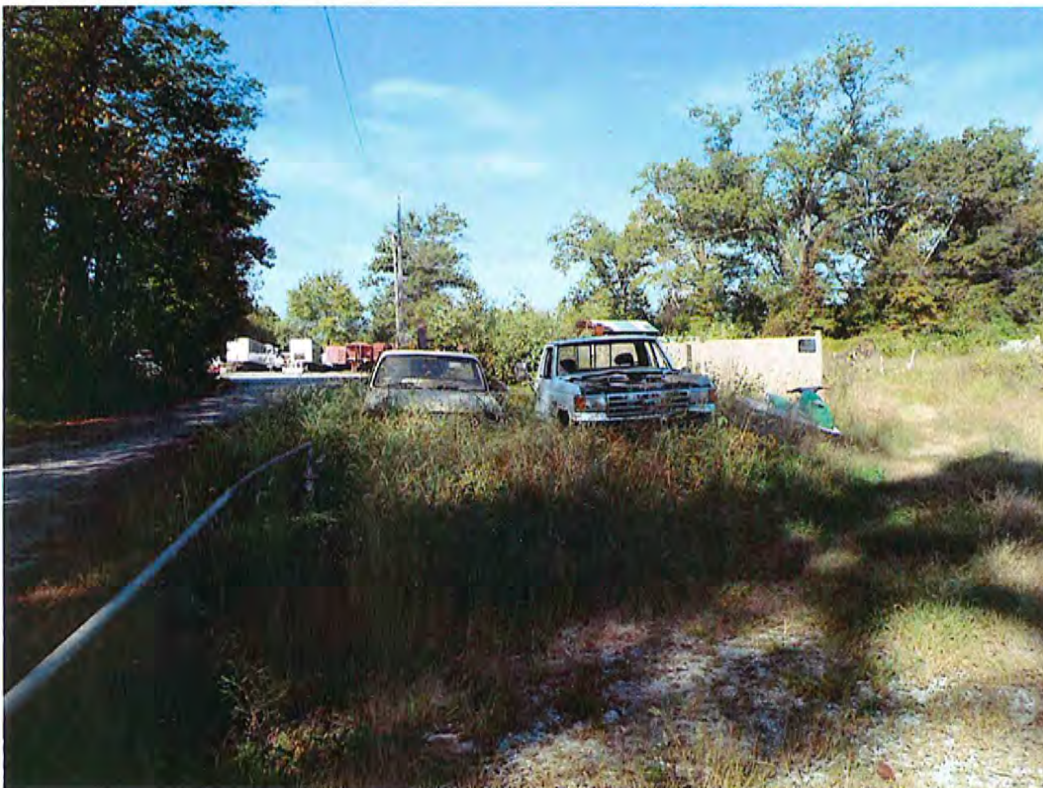
Date: 9/24/2015
Time: 10:01 A.M.
Direction: west
Photo by: G. Gross
Exposure #: 012
Comments: view of site
from main entrance;
waste vehicles
(trucks) observed
during previous
inspection (see photo
016)

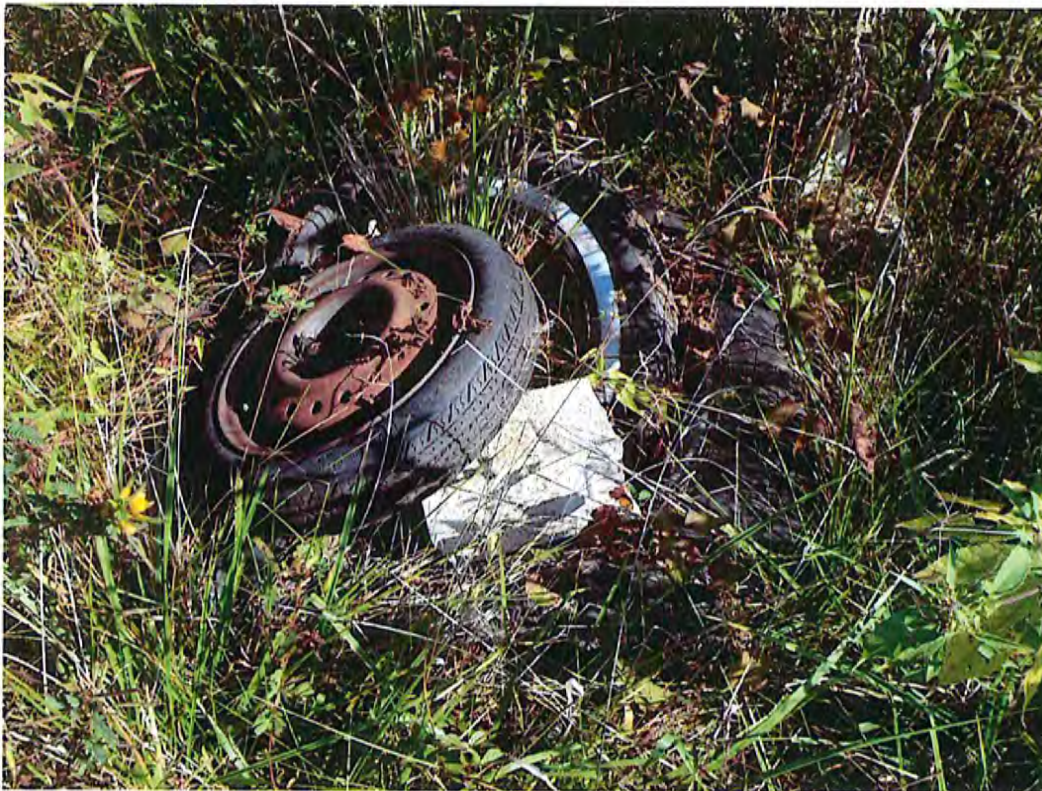
Date: 09/24/2015
Time: 10:02 A.M.
Direction: north
Photo by: G. Gross
Exposure #: 013
Comments: waste tires
observed during
previous inspection

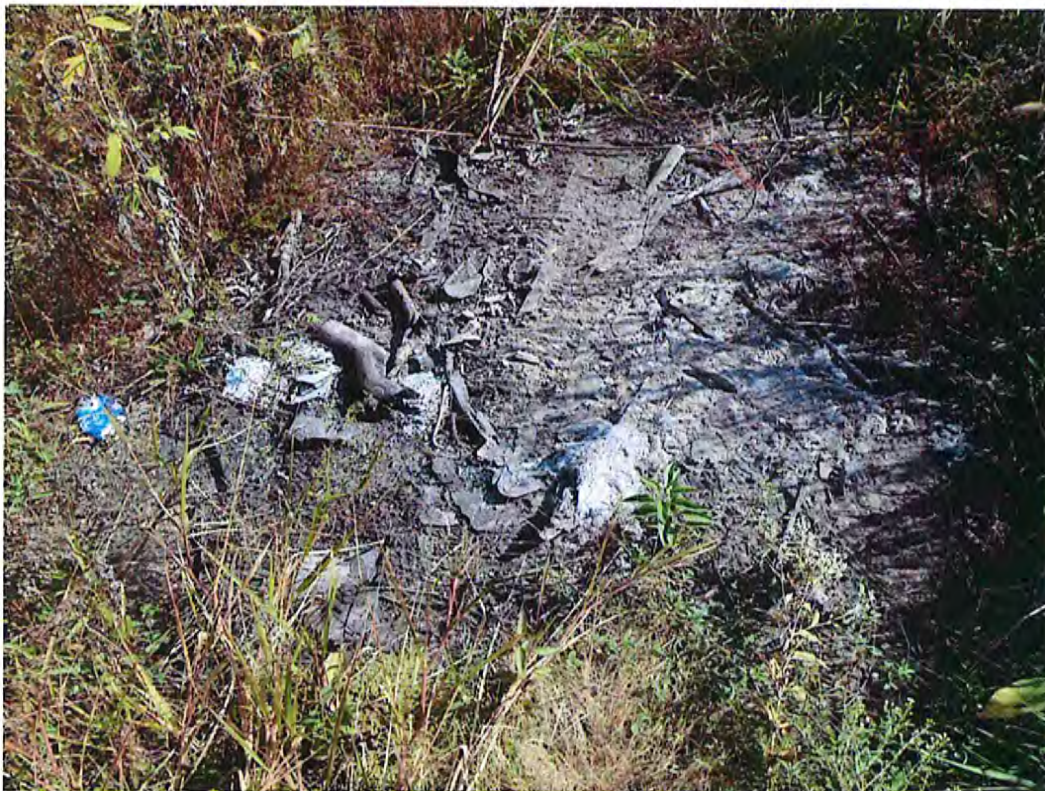
Open Burning: Evidence of continued open burning was observed at three (3) locations (photos 014, 021 and 022). The ash and debris piles measured 2 feet in diameter up to 6 feet in diameter. It appeared that recent open burning consisted of bias ply tires that did not contain steel belting. Numerous small white fibers were observed in the ash consistent with burning those types of tires. The ash also contained landscape waste, non-metal and mixed-metal automotive parts, fiberglass and trash.

Date: 9/24/2015
Time: 10:03 A.M.
Direction: north
Photo by: G. Gross
Exposure #: 014
Comments: evidence of
open burning;
appeared to be open
burning of bias tires;
no steel belting
observed

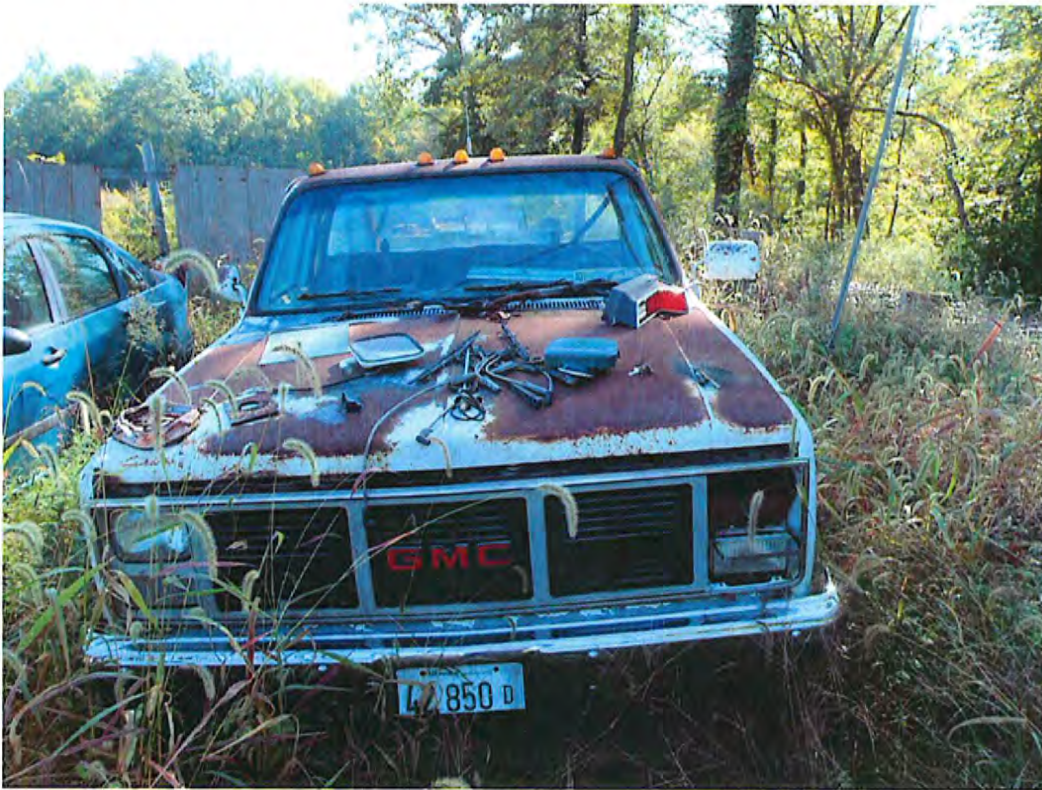
Date: 09/24/2015
Time: 10:04 A.M.
Direction: east
Photo by: G. Gross
Exposure #: 015
Comments: waste
vehicle; observed
during previous
inspection

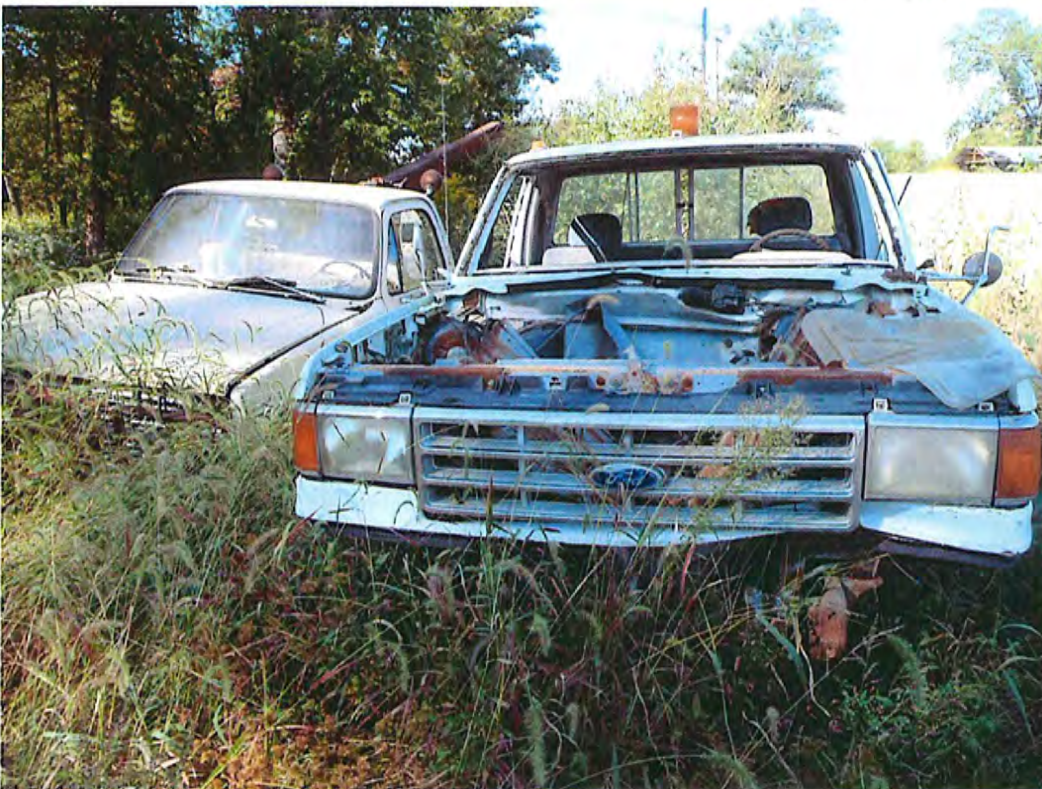
Date: 9/24/2015
Time: 10:04 A.M.
Direction: west
Photo by: G. Gross
Exposure #: 016
Comments: waste
vehicles; observed
during previous
inspection

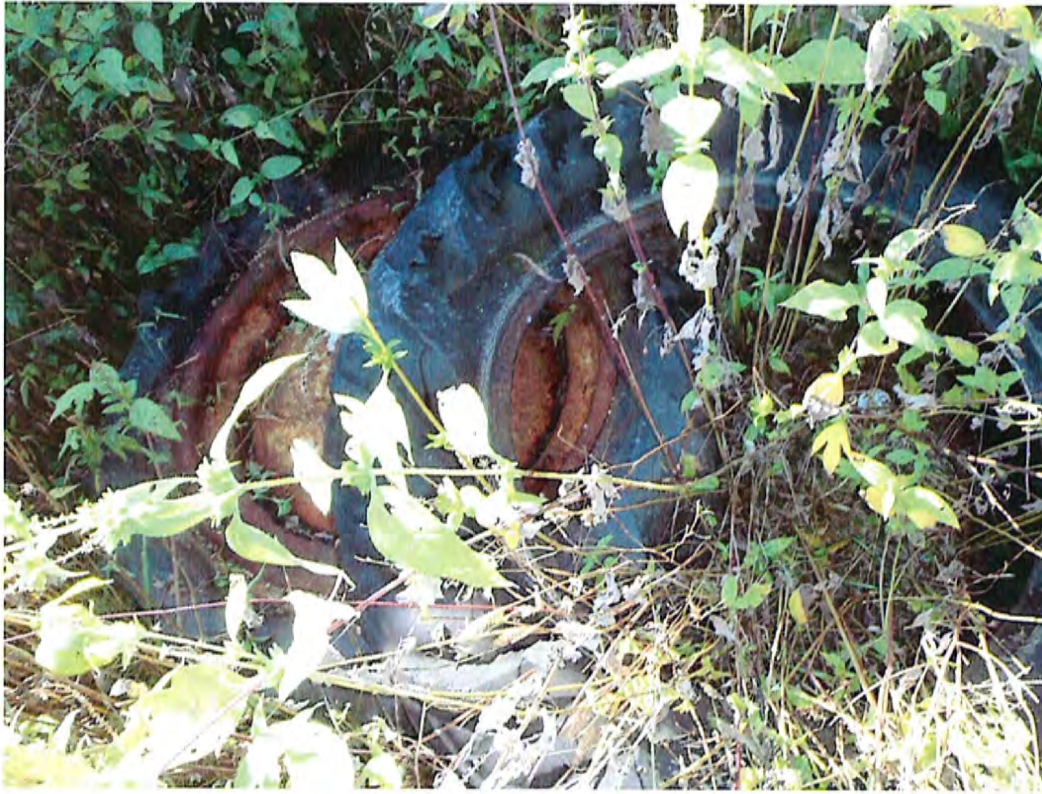
Date: 09/24/2015
Time: 10:06 A.M.
Direction: south
Photo by: G. Gross
Exposure #: 017
Comments: waste tires;
some were off the
rim

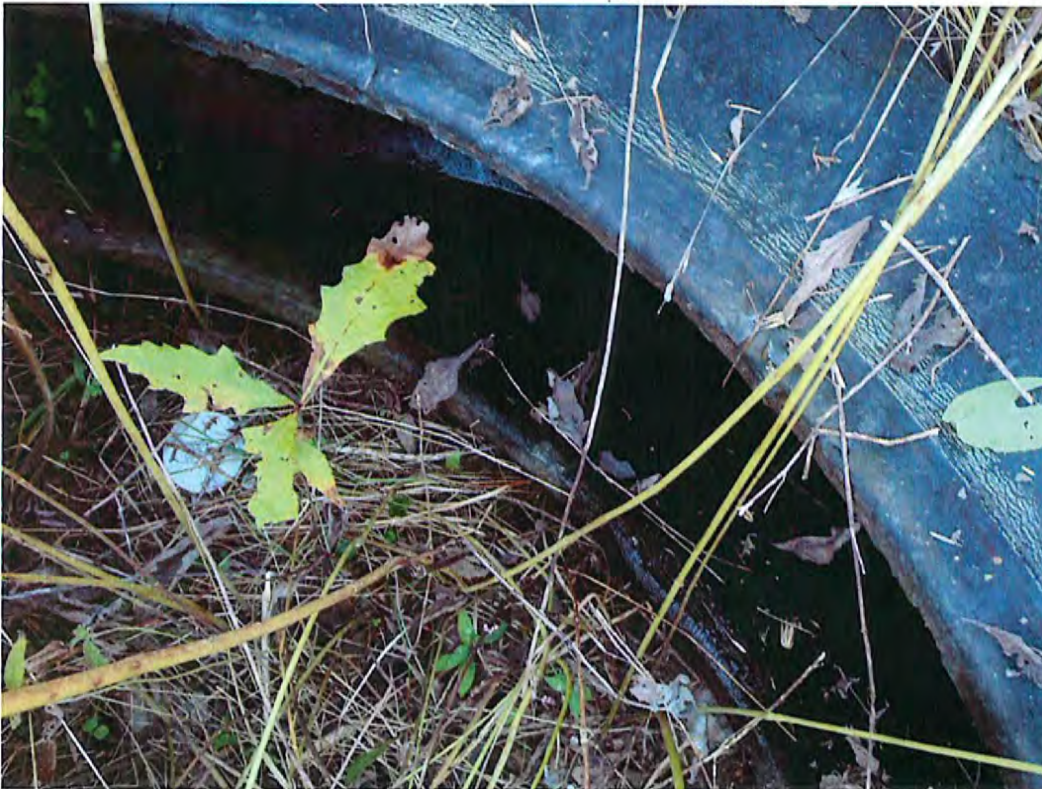
Date: 9/24/2015
Time: 10:06 A.M.
Direction: south
Photo by: G. Gross
Exposure #: 018
Comments: water in
tires; mosquito larvae
and adult mosquitoes
were present

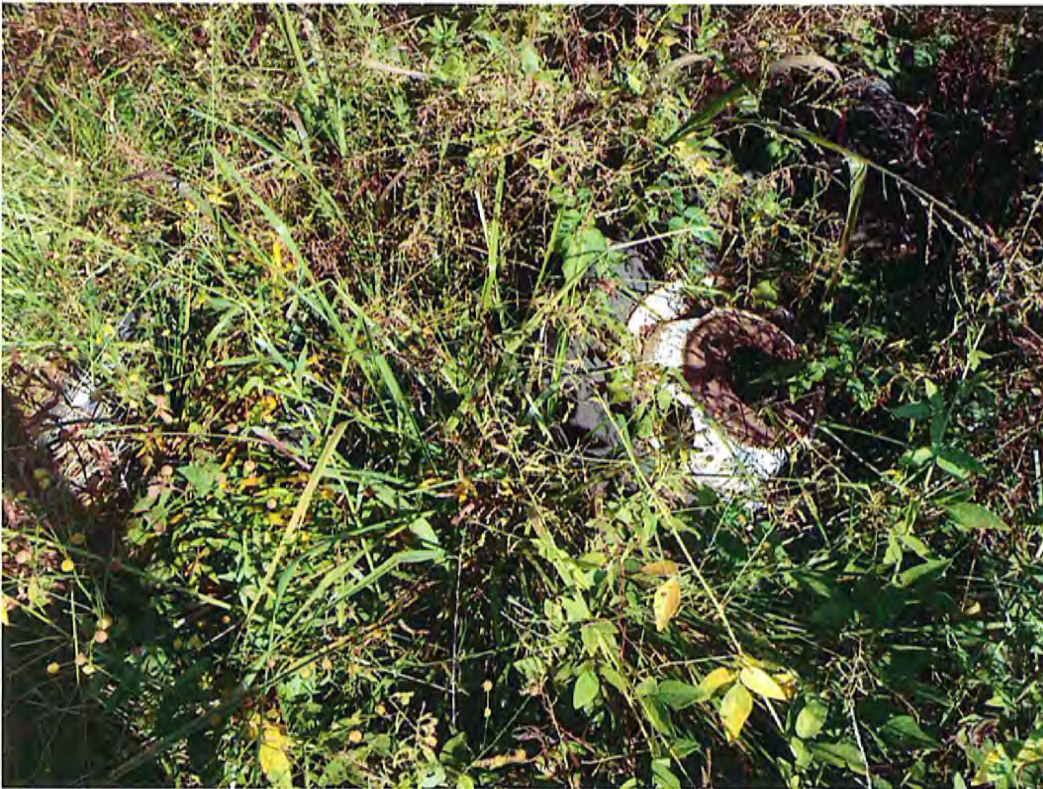
Date: 09/24/2015
Time: 10:08 A.M.
Direction: north
Photo by: G. Gross
Exposure #: 019
Comments: waste tires

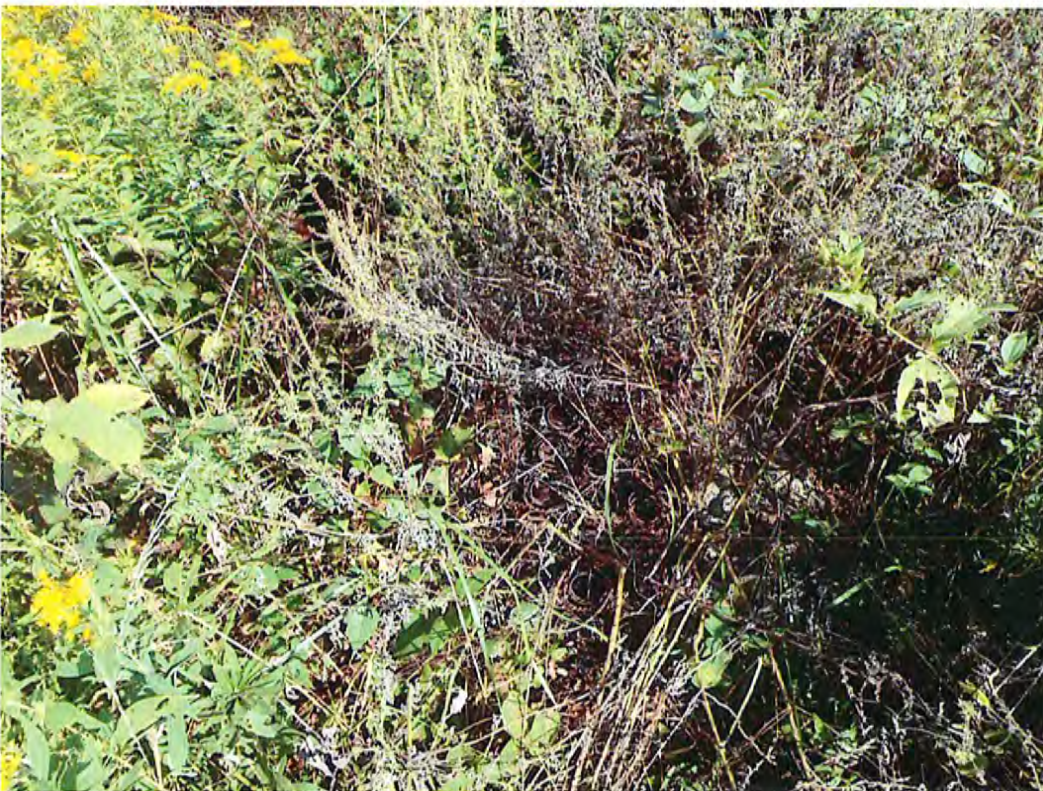
Date: 9/24/2015
Time: 10:10 A.M.
Direction: north
Photo by: G. Gross
Exposure #: 020
Comments: open burn
area photographed
during previous
inspection; wastes
(mattress spring) now
overgrown in
vegetation

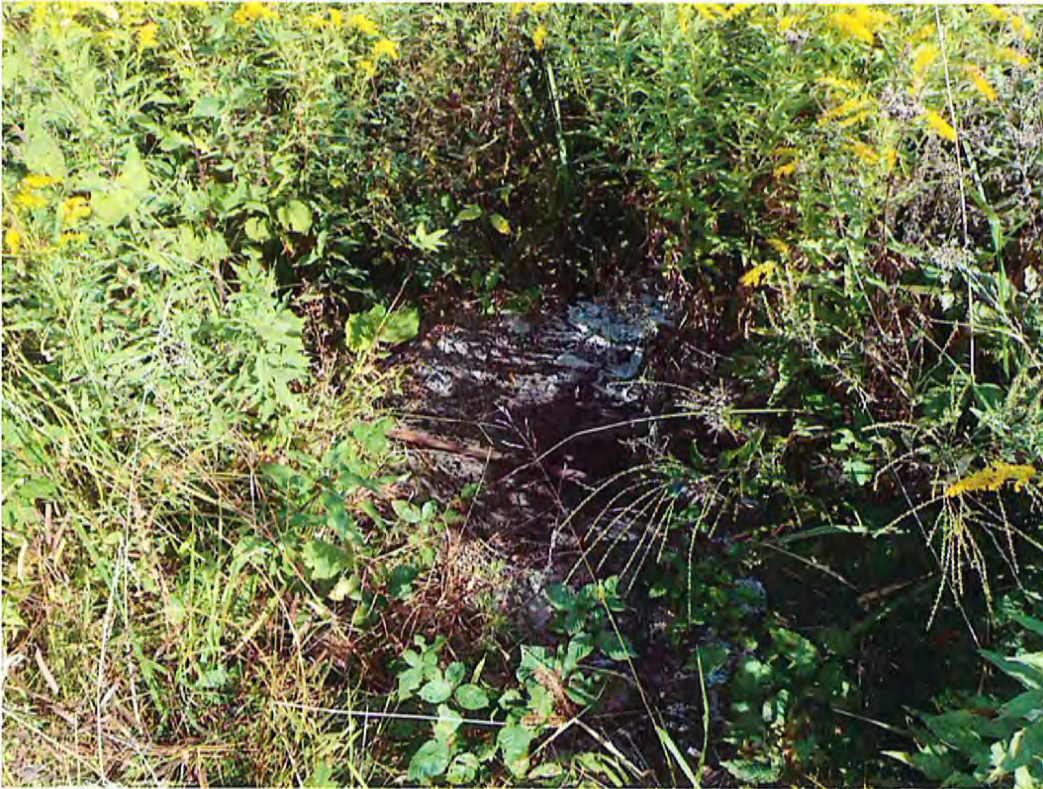
Date: 09/24/2015
Time: 10:10 A.M.
Direction: north
Photo by: G. Gross
Exposure #: 021
Comments: evidence of open burning; area adjacent to area in photo 020; appeared to be open burning of bias tires; no steel belting observed

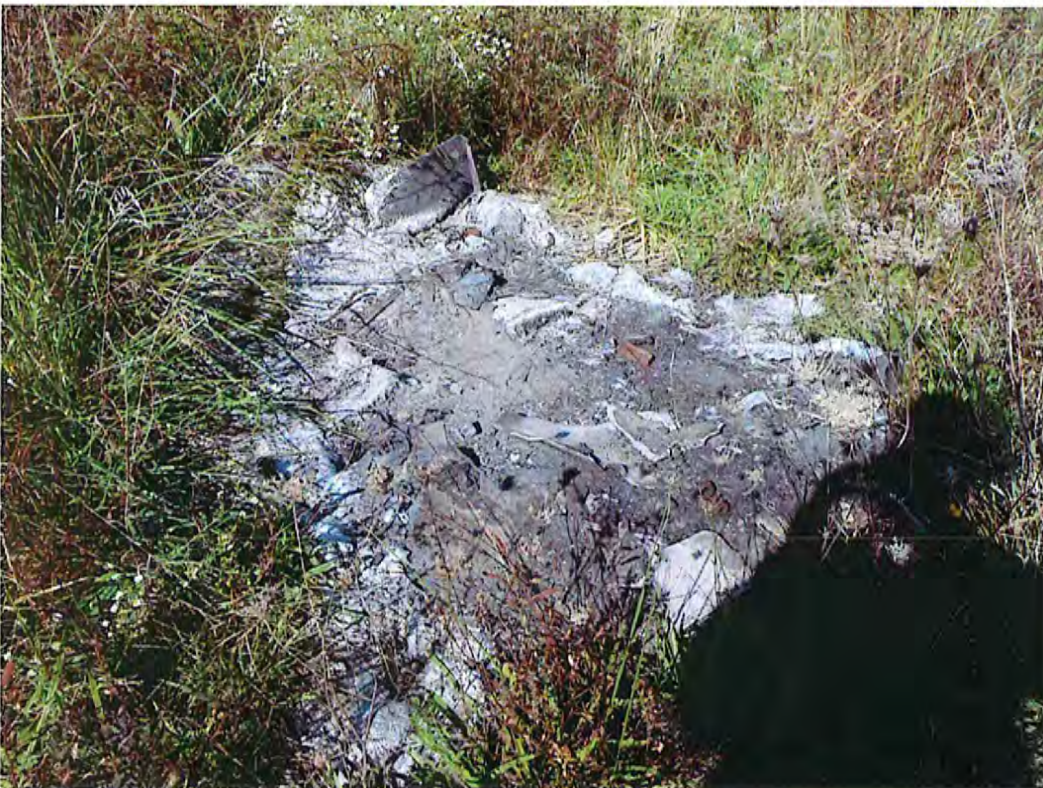
Date: 9/24/2015
Time: 10:11 A.M.
Direction: west
Photo by: G. Gross
Exposure #: 022
Comments: evidence of open burning; another area adjacent to area in photo 020; appeared to open burning of bias tires; no steel belting observed

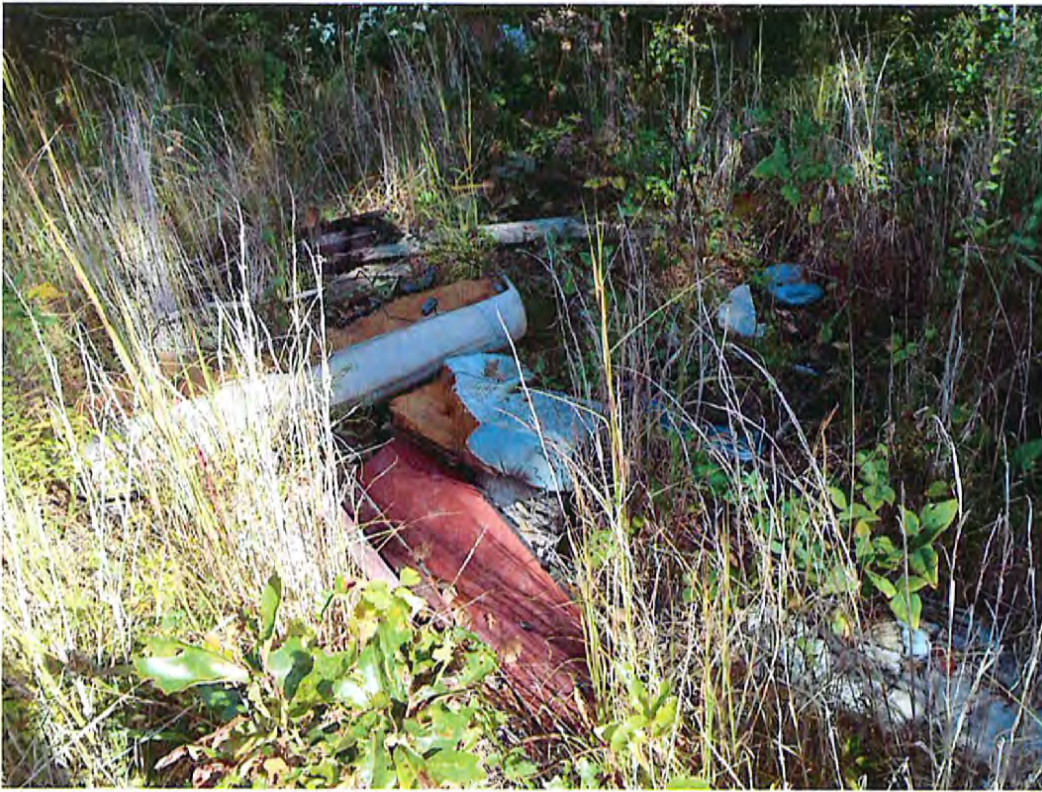
Date: 09/24/2015
Time: 10:13 A.M.
Direction: north
Photo by: G. Gross
Exposure #: 023
Comments: waste
automotive parts
