BEFORE THE ILLINOIS POLLUTION CONTROL BOARD
ADMINISTRATIVE CITATION

AC 16-5
(IEPA No. 333-15-AC)

Open Dump Inspection Checklist

LPC #: 1990155032 – Williamson County
Site Name: Falmier's Auto Salvage & Towing
Date of Inspection: September 24, 2015
Inspector: Garrison Gross – Bureau of Land Field Operations
Subject: Open Dumping Inspection at Falmier's Auto Salvage & Towing

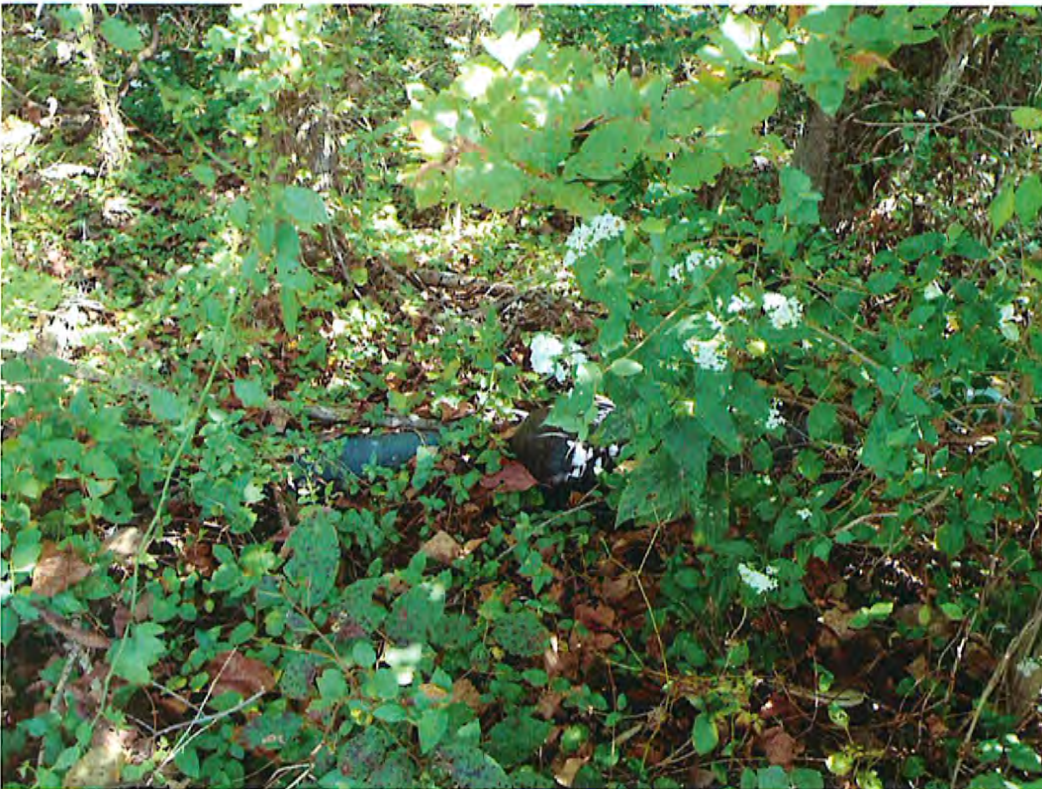
Open Dumped Waste: Numerous non-metal and mixed-metal automotive parts were observed along the north and west property boundaries (photo 001-005, 007, 008, 020, 023-025). These included but were not limited to fuel tanks, interior door panels, seats, insulation, carpeting, fiberglass truck bedcovers and plastic bed liners. Some of these waste items were observed during the previous inspection.

Date: 9/24/2015
Time: 10:14 A.M.
Direction: north
Photo by: G. Gross
Exposure #: 024
Comments: waste
automotive parts

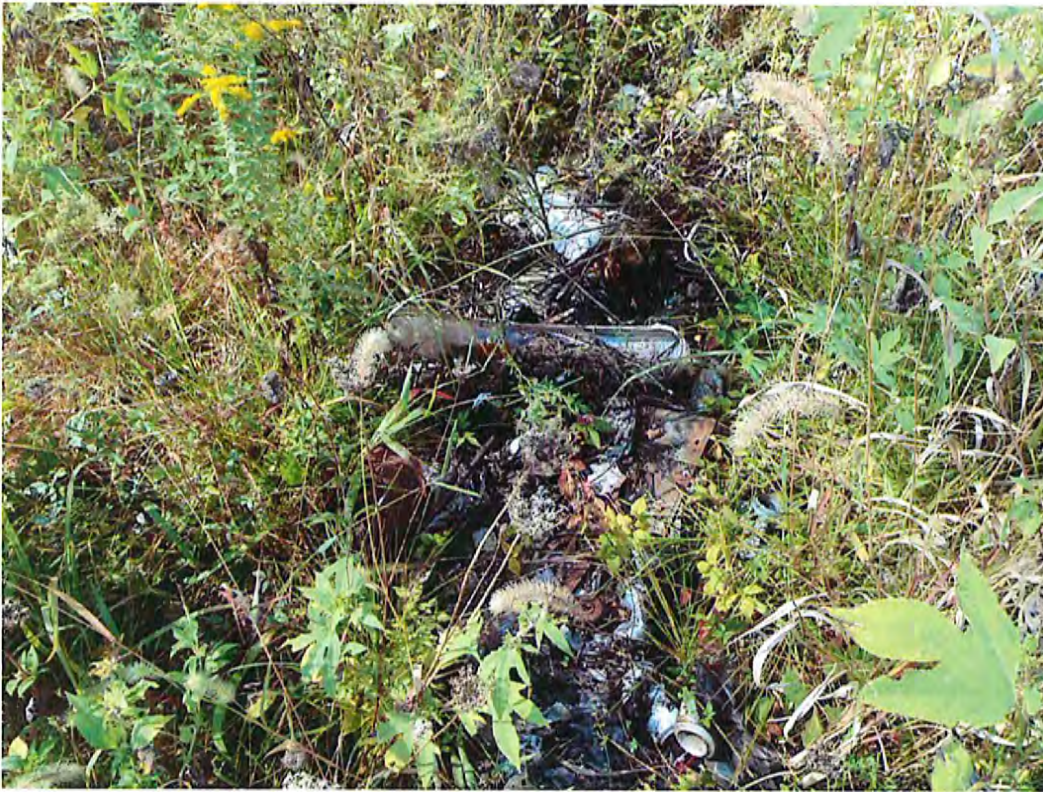
Date: 09/24/2015
Time: 10:16 A.M.
Direction: south
Photo by: G. Gross
Exposure #: 025
Comments: open burn
area photographed
during previous
inspection; waste
now overgrown in
vegetation

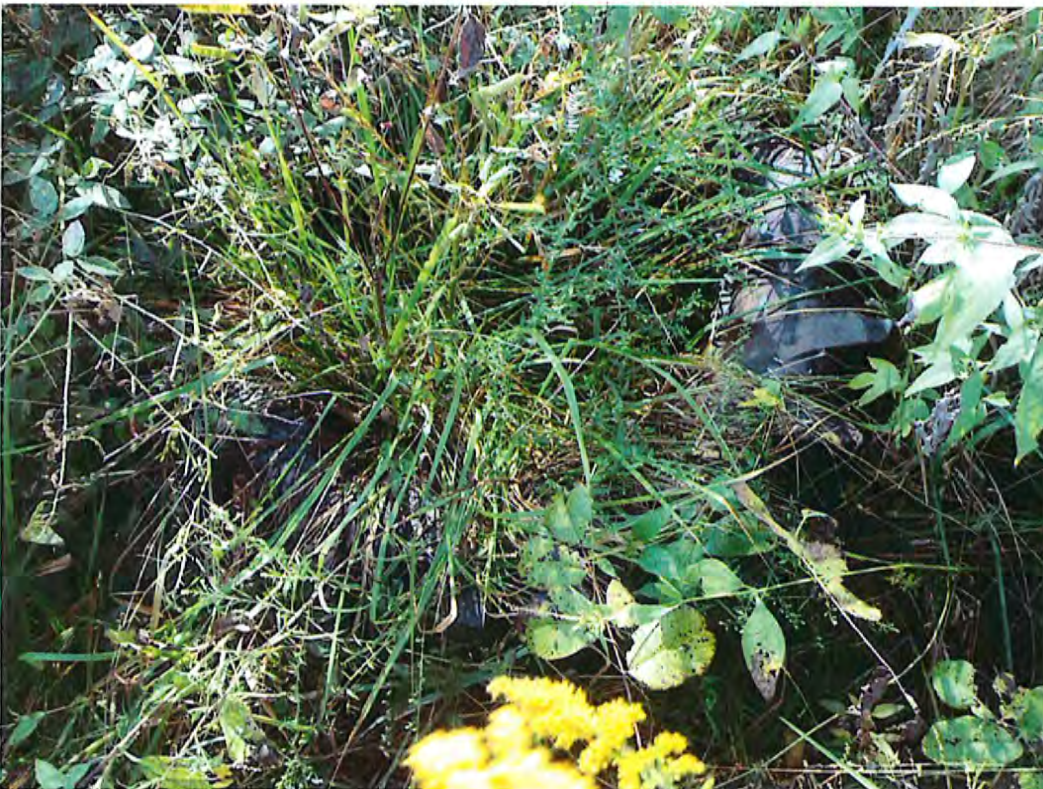
Date: 9/24/2015
Time: 10:16 A.M.
Direction: east
Photo by: G. Gross
Exposure #: 026
Comments: waste tire
off the rim

Tire Storage / Disposal: Seventeen (17) used / waste tires were observed at the site. Due to the tall vegetation, it is likely that additional tires are located at the site. All of the previously inspected areas were not observed due to overgrowth in vegetation. Small tire piles remained in some of the areas observed during the last inspection (photos 006, 013, 017, 019 and 026). Recently acquired tires were stored in the back of recently acquired vehicles (photo 009). Tires were not protected from accumulating water. Some of the tires were on rim and holding air. Others were not holding air or were off rim. Off rim tires had accumulated water, organic material (leaves) and mosquito larvae were present in some of the tires (photos 010 and 018).
