Re: County of Macon v. Matthew Lawrence
Administrative Citation: ACL-2017-MC-003
MCEMD File No. AC2017-003: LPC1158000001 – Macon County

ADMINISTRATIVE CITATION

Inspection Photographs

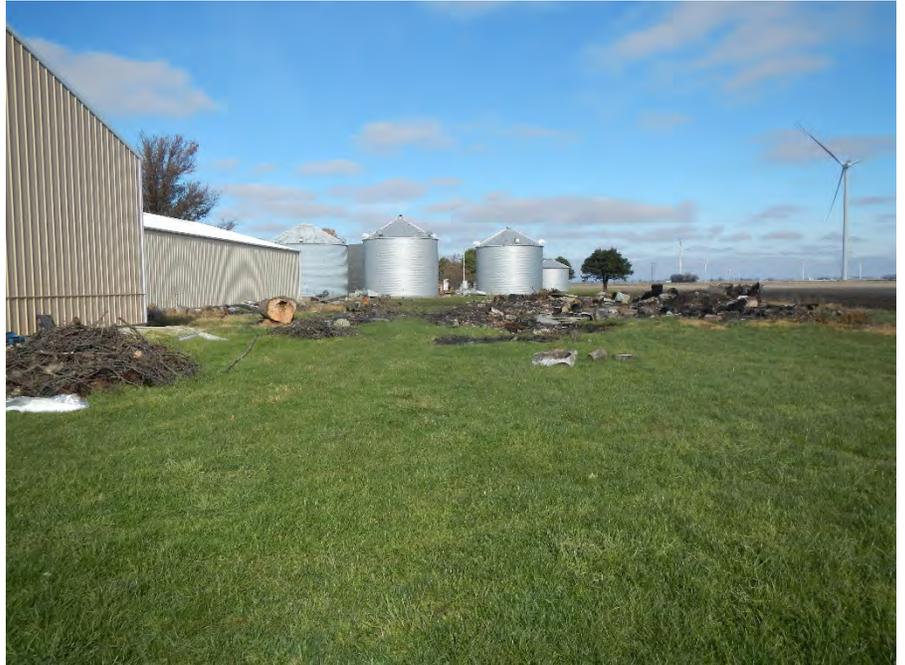
Site: 1158000001
County: Macon
Site Name: Austin Twp/Lawrence
Date: Nov. 16, 2017
Time: 11:52 a.m. - 12:09 p.m.
Photographer: Laurie Rasmus
Photograph: 01
Direction of subject: N
Comments:

I observed an area east of the sheds but west of the west margin of the field, which was approximately 60 feet east-west by 150 feet north south that appeared to be a burn site for construction and demolition debris, off-site generated landscape waste and other waste items (photos 01 – 04, 06 – 16, 22 - 24). The area had patches of scorched earth with remnants of blackened vegetation in the marginal areas of the patches. Waste items that were observed on the ground in these areas included what appeared to be rusted tire beads from tires that had been burned (photo 03), charred and uncharred dimensional lumber, numerous rusty nails, debris that appeared to be burned drywall board, vinyl siding of which some appeared to be partially melted and charred, rusty hardware, ash, fines, charred and uncharred landscape waste that appeared to be generated from off-site, charred and uncharred bricks and brick pieces, charred and uncharred pieces of concrete, food packaging and what appeared to be charred remnants of fiber glass of the type that is used for insulation.

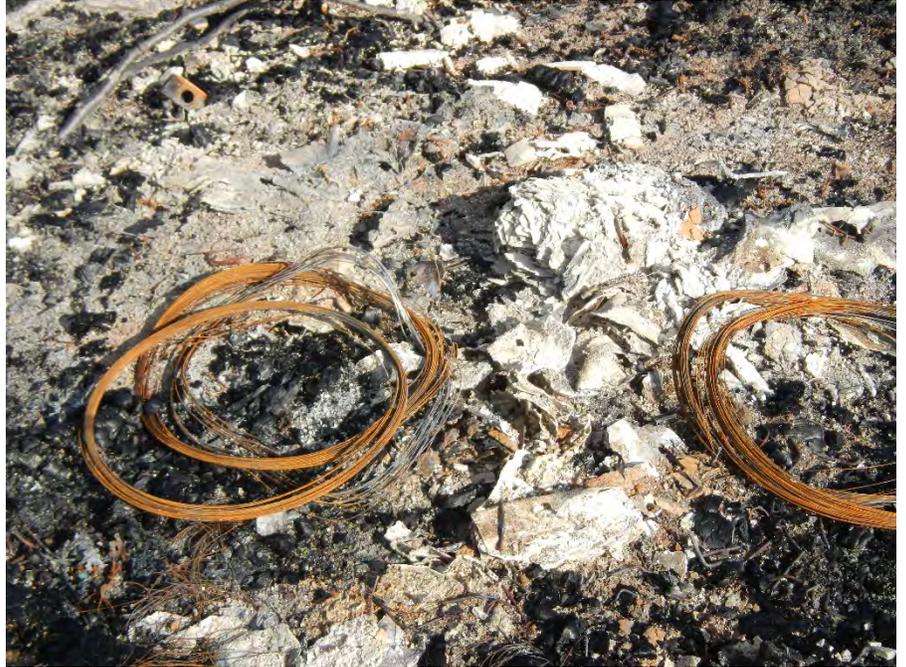
Comments: Zoomed in on subject matter in center of frame of photo 02; remnants of items that apparently had been burned including tires

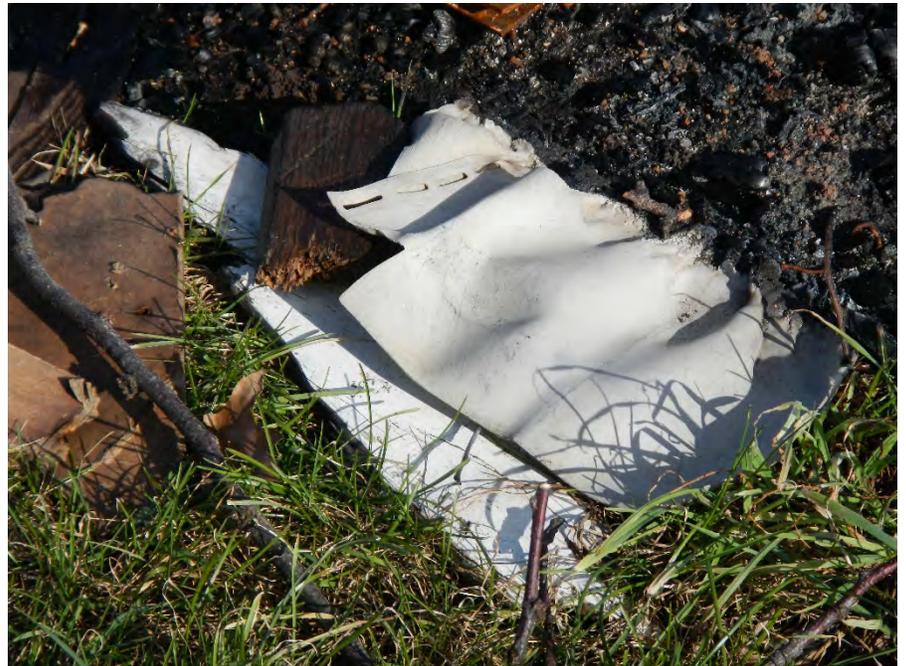
Comments: Panned camera left from subject matter in photo 03

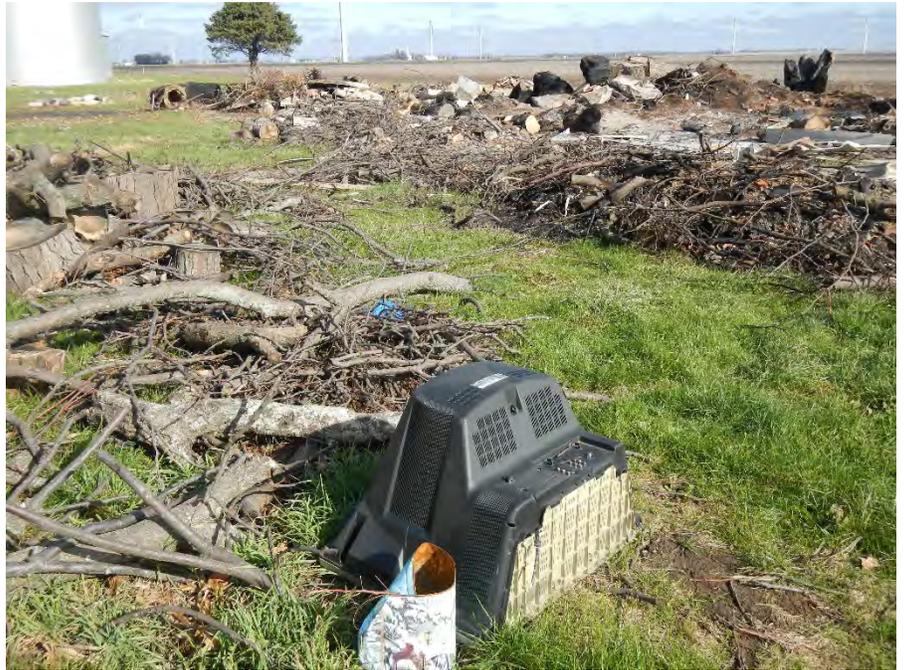
Site: 1158000001
County: Macon
Site Name: Austin Twp/Lawrence
Date: Nov. 16, 2017
Time: 11:52 a.m. - 12:09 p.m.
Photographer: Laurie Rasmus
Photograph: 05
Direction of subject: NE
Comments:

Along the west margin of the apparent burn site, various waste items appeared to be open dumped on the ground (photo 21). Waste items observed included a television set (photo 05) and a cash register (photos 18, 19). Accumulations of landscape waste, which appeared to be off-site generated, were also on the ground in this area. Containers, such as buckets, contained waste items that appeared to be disposed of including rusty cans and various metal parts of which some appeared to be charred and/or rusted (photo 20). Other containers in the area, all of which appeared to be empty, included a red, plastic container of the type used for gasoline, a five-gallon bucket labeled as “hydraulic oil”, and a hinged box (photo 17).

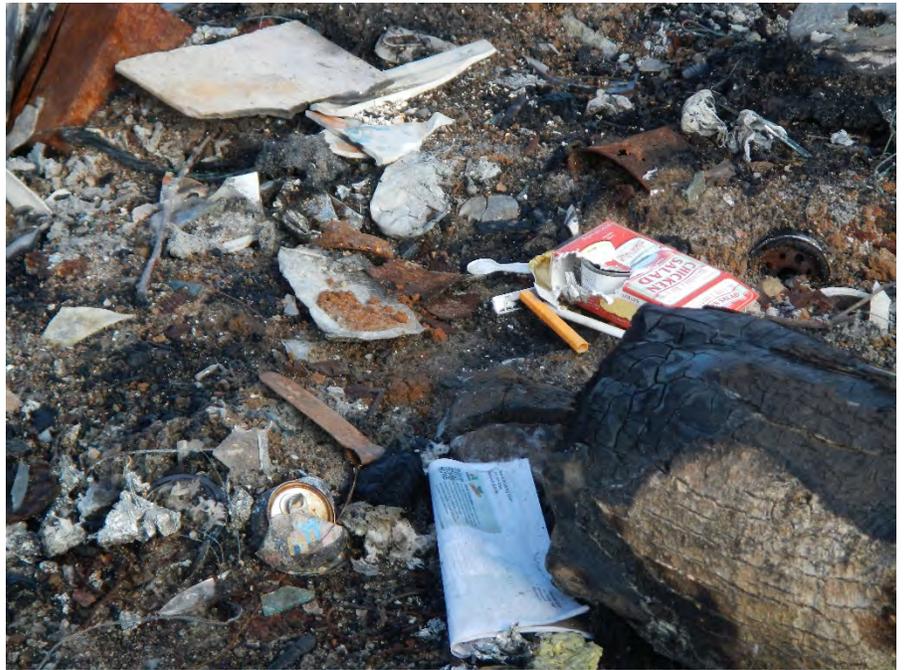
Site: 1158000001
County: Macon
Site Name: Austin Twp/Lawrence
Date: Nov. 16, 2017
Time: 11:52 a.m. - 12:09 p.m.
Photographer: Laurie Rasmus
Photograph: 09
Direction of subject: NE
Comments: Zoomed in from same viewpoint as photo 08

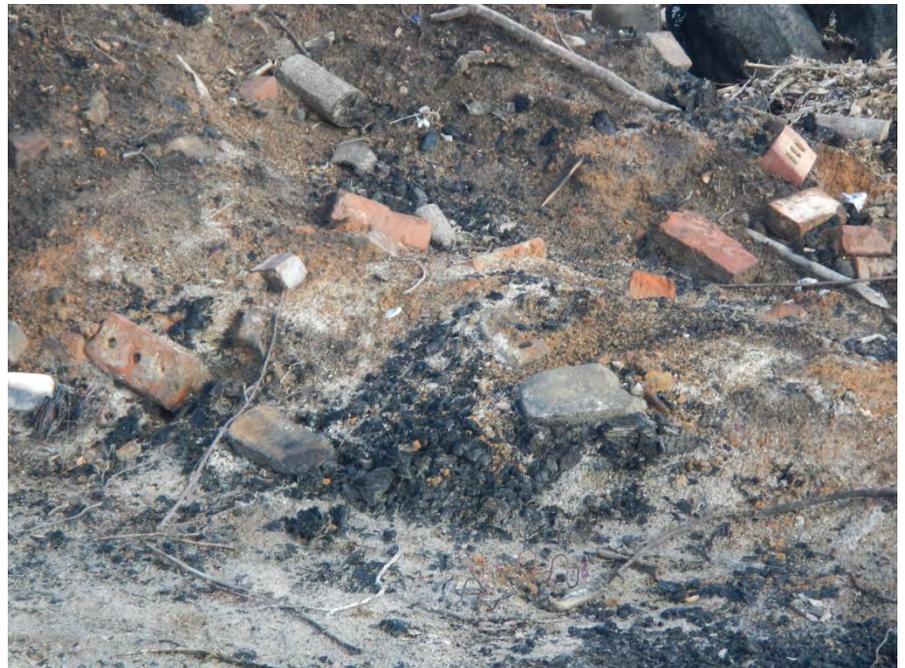
Site: 1158000001
County: Macon
Site Name: Austin Twp/Lawrence
Date: Nov. 16, 2017
Time: 11:52 a.m. - 12:09 p.m.
Photographer: Laurie Rasmus
Photograph: 10
Direction of subject: NE
Comments: Zoomed in from same viewpoint as photo 08

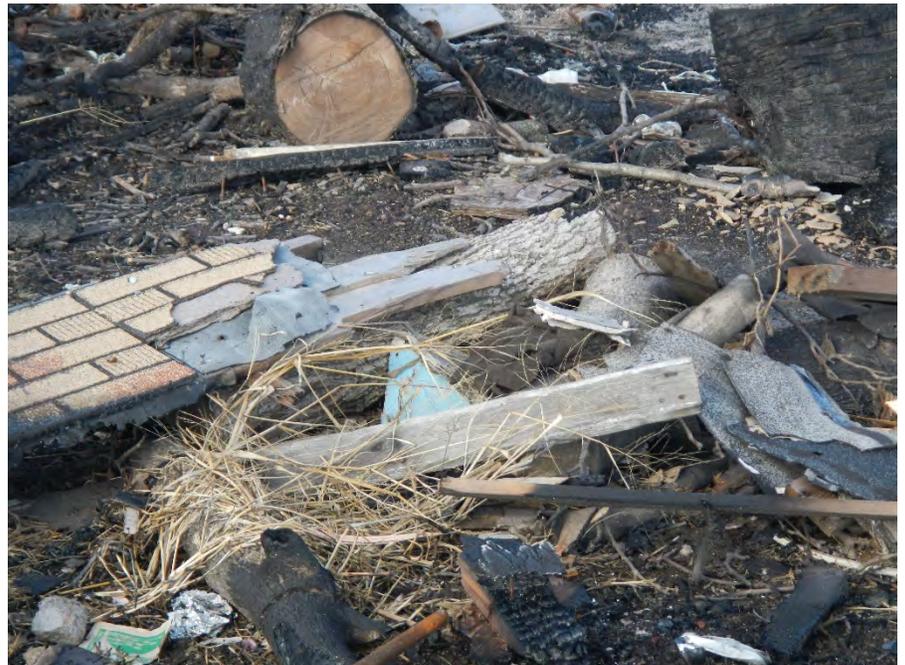
Site: 1158000001
County: Macon
Site Name: Austin Twp/Lawrence
Date: Nov. 16, 2017
Time: 11:52 a.m. - 12:09 p.m.
Photographer: Laurie Rasmus
Photograph: 12
Direction of subject: NW
Comments: Zoomed in on subject matter in photo 11

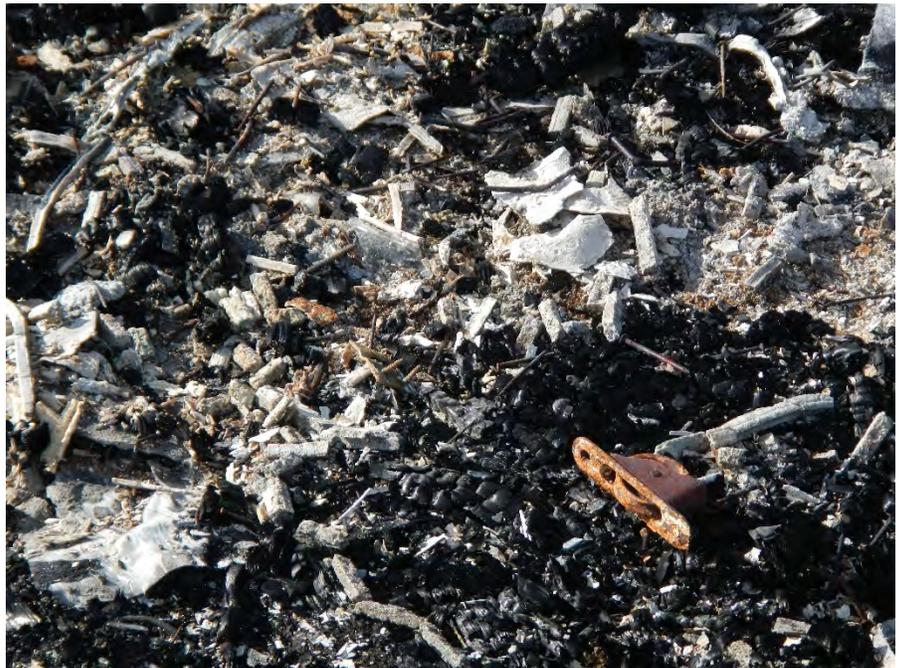
Site: 1158000001
County: Macon
Site Name: Austin Twp/Lawrence
Date: Nov. 16, 2017
Time: 11:52 a.m. - 12:09 p.m.
Photographer: Laurie Rasmus
Photograph: 14
Direction of subject: SW
Comments: Zoomed in on subject matter in photo 13

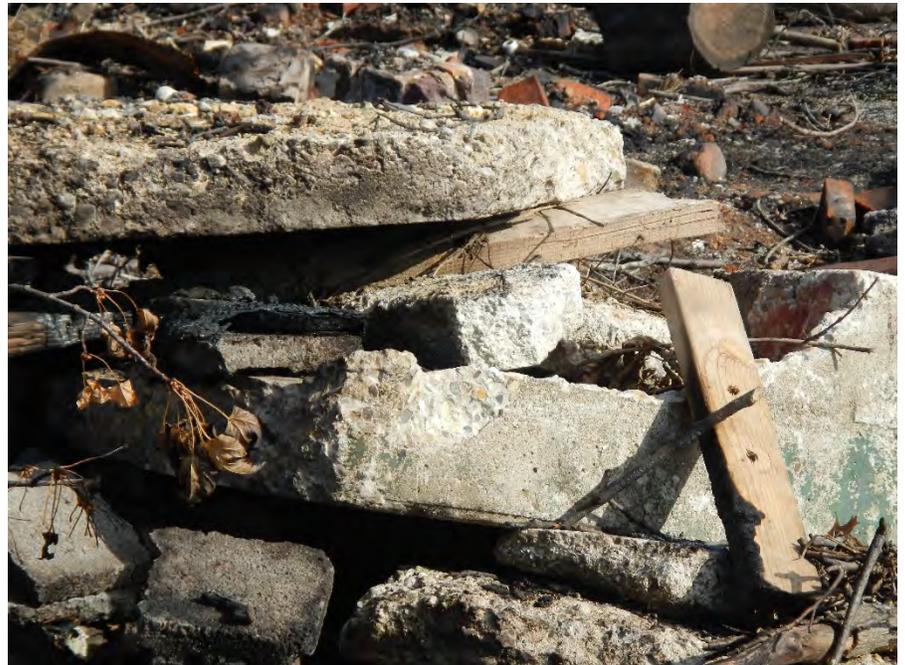
Site: 1158000001
County: Macon
Site Name: Austin Twp/Lawrence
Date: Nov. 16, 2017
Time: 11:52 a.m. - 12:09 p.m.
Photographer: Laurie Rasmus
Photograph: 16
Direction of subject: NE
Comments: Zoomed in on subject matter in photo 15

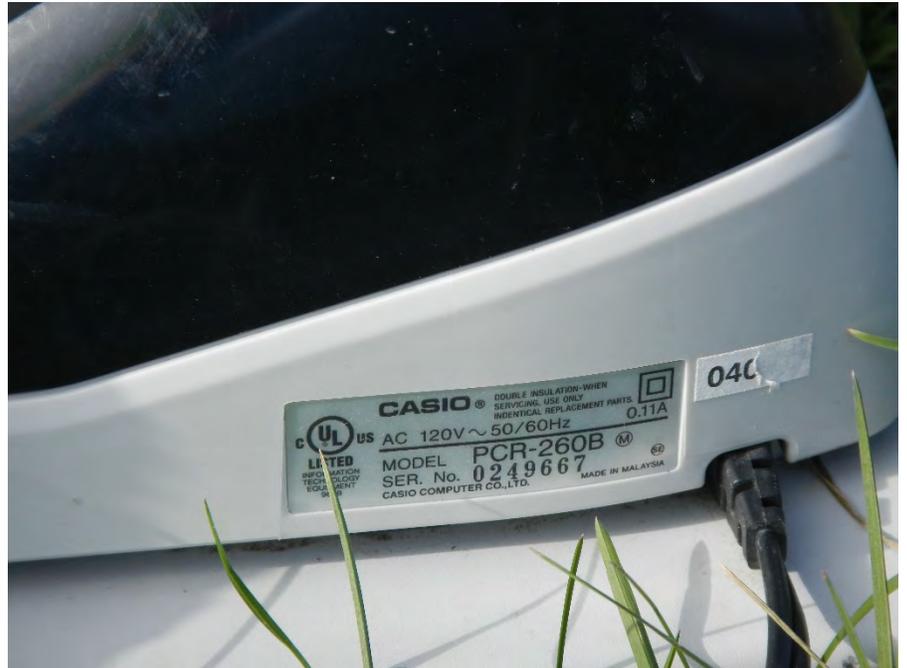
Site: 1158000001
County: Macon
Site Name: Austin Twp/Lawrence
Date: Nov. 16, 2017
Time: 11:52 a.m. - 12:09 p.m.
Photographer: Laurie Rasmus
Photograph: 19
Direction of subject: WNW
Comments: Label on side of cash register in photo 18

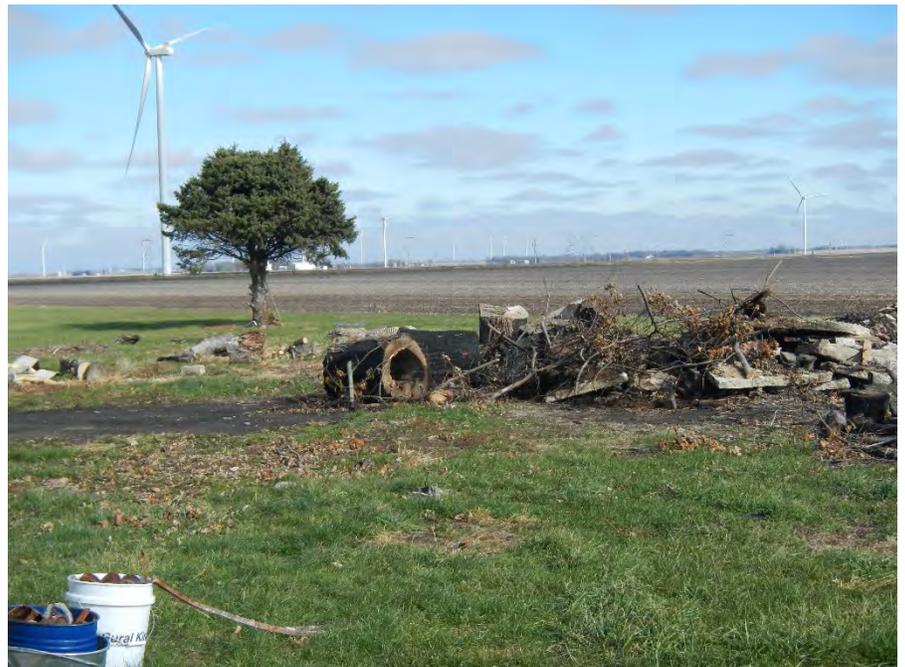
Site: 1158000001
County: Macon
Site Name: Austin Twp/Lawrence
Date: Nov. 16, 2017
Time: 11:52 a.m. - 12:09 p.m.
Photographer: Laurie Rasmus
Photograph: 22
Direction of subject: NE
Comments: First of three photos,
panning left to right

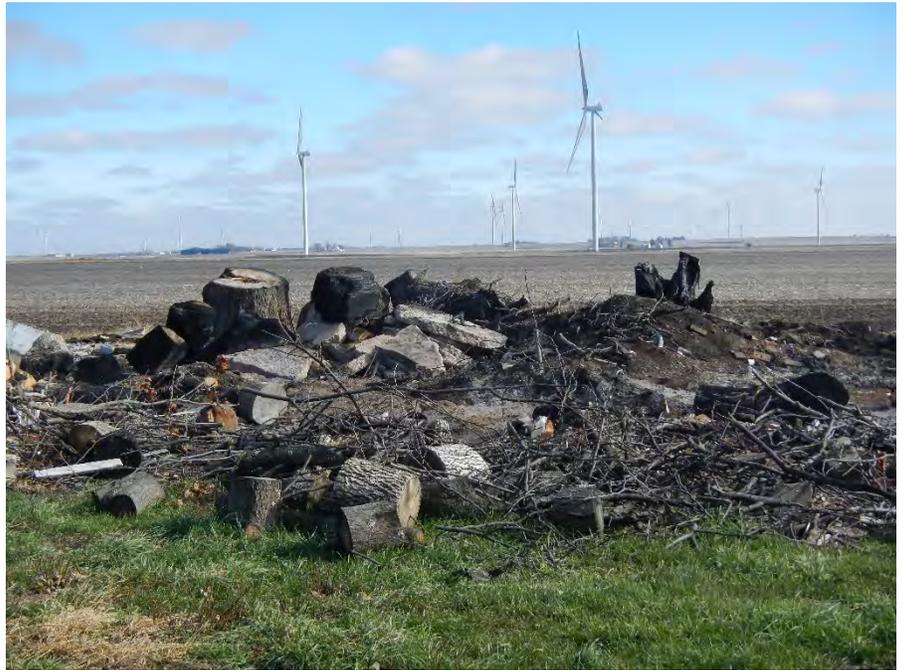
Site: 1158000001
County: Macon
Site Name: Austin Twp/Lawrence
Date: Nov. 16, 2017
Time: 11:52 a.m. - 12:09 p.m.
Photographer: Laurie Rasmus
Photograph: 23
Direction of subject: E
Comments: Comments: Second of three photos, panning left to right

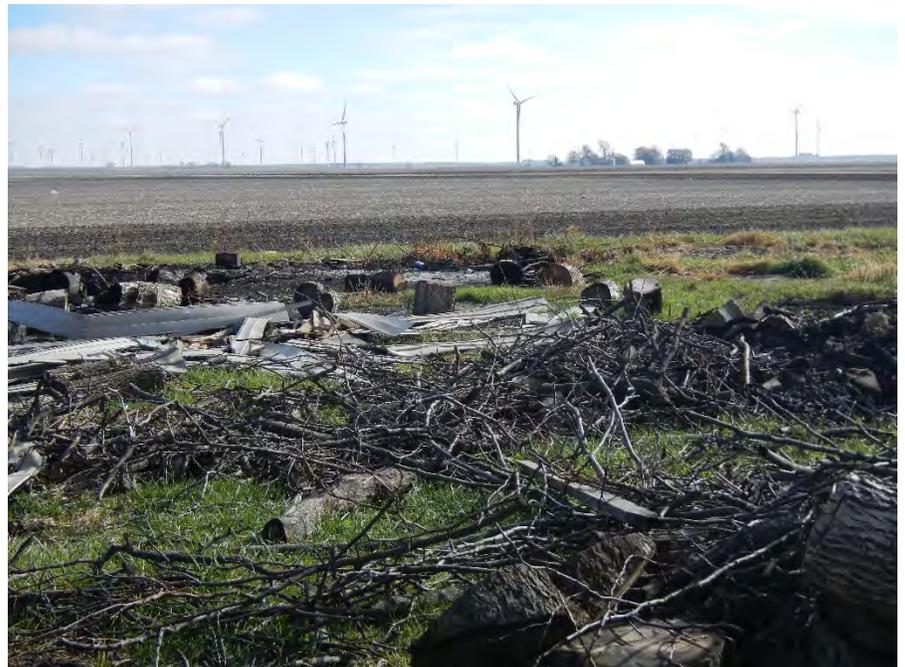
Site: 1158000001
County: Macon
Site Name: Austin Twp/Lawrence
Date: Nov. 16, 2017
Time: 11:52 a.m. - 12:09 p.m.
Photographer: Laurie Rasmus
Photograph: 24
Direction of subject: SE
Comments: Third of three photos, panning left to right
