**Brickyard Disposal & Recycling, Inc.  
Danville, Vermilion County, Illinois**

**EXHIBIT C**  
**Extraneous Materials**  
**Cover Plan**

**June 2014**

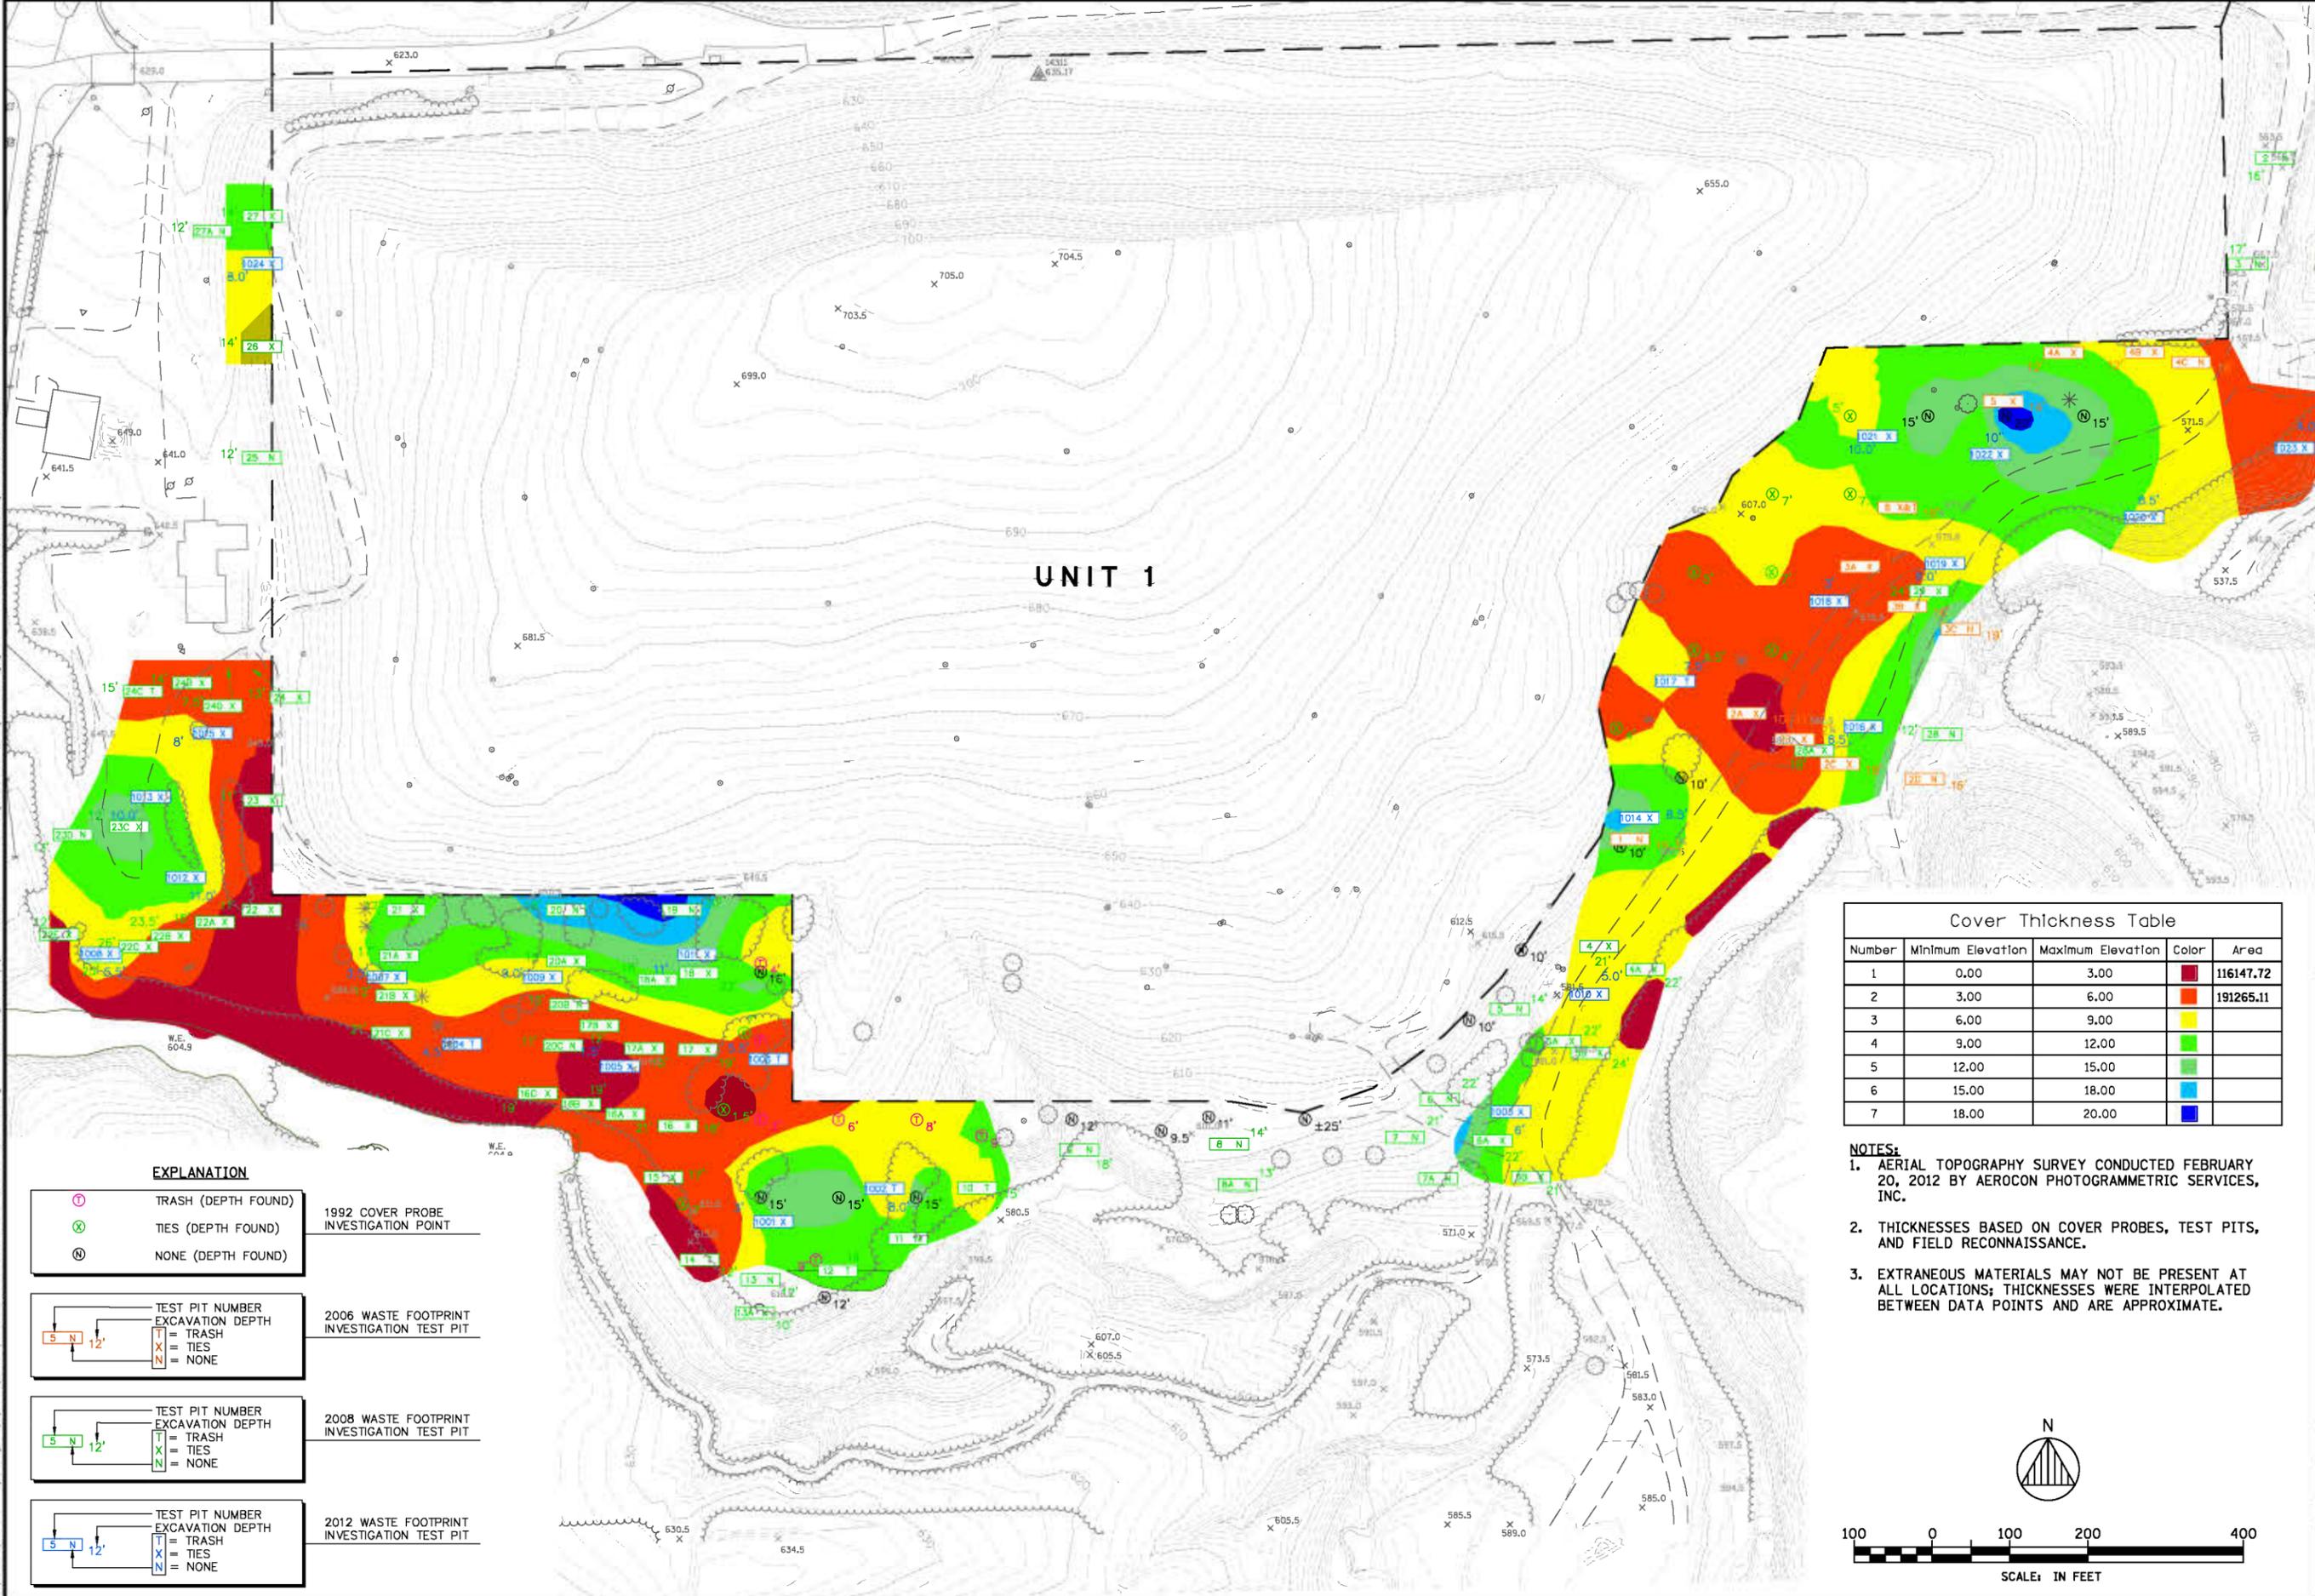
FIG. 2

Cover Thickness Table

Number	Minimum Elevation	Maximum Elevation	Color	Area
1	0.00	3.00	Red	116147.72
2	3.00	6.00	Orange	191265.11
3	6.00	9.00	Yellow	
4	9.00	12.00	Light Green	
5	12.00	15.00	Green	
6	15.00	18.00	Light Blue	
7	18.00	20.00	Blue

- NOTES:**
- AERIAL TOPOGRAPHY SURVEY CONDUCTED FEBRUARY 20, 2012 BY AEROCON PHOTOGRAMMETRIC SERVICES, INC.
  - THICKNESSES BASED ON COVER PROBES, TEST PITS, AND FIELD RECONNAISSANCE.
  - EXTRANEIOUS MATERIALS MAY NOT BE PRESENT AT ALL LOCATIONS; THICKNESSES WERE INTERPOLATED BETWEEN DATA POINTS AND ARE APPROXIMATE.

COVER THICKNESS MAP

As stated above, test pits were conducted at 24 locations. Field logs were created for each of the excavations describing the material encountered; the subject logs are provided in Appendix A. The test excavations were located over known areas containing extraneous materials. The cover thickness ranged from 1.5 feet (Station 1005) to 11.0 feet (Stations 1011 and 1012), with an average thickness for the investigation of 6.9 feet. Of the 24 locations tested, only one contained less than 2.5 feet of cover; all other locations contained at least 3.0 feet of cover. The data obtained from the October 2012 investigation have been combined with the data derived during previous investigations to create a comprehensive cover thickness map (Figure 2). As shown, nearly all areas contain at least 3 feet of cover over the extraneous materials. Only very small areas contain less than 3 feet of cover. Table 1 summarizes the data from the test pit investigations from 1992, 2006, 2008, and 2012.

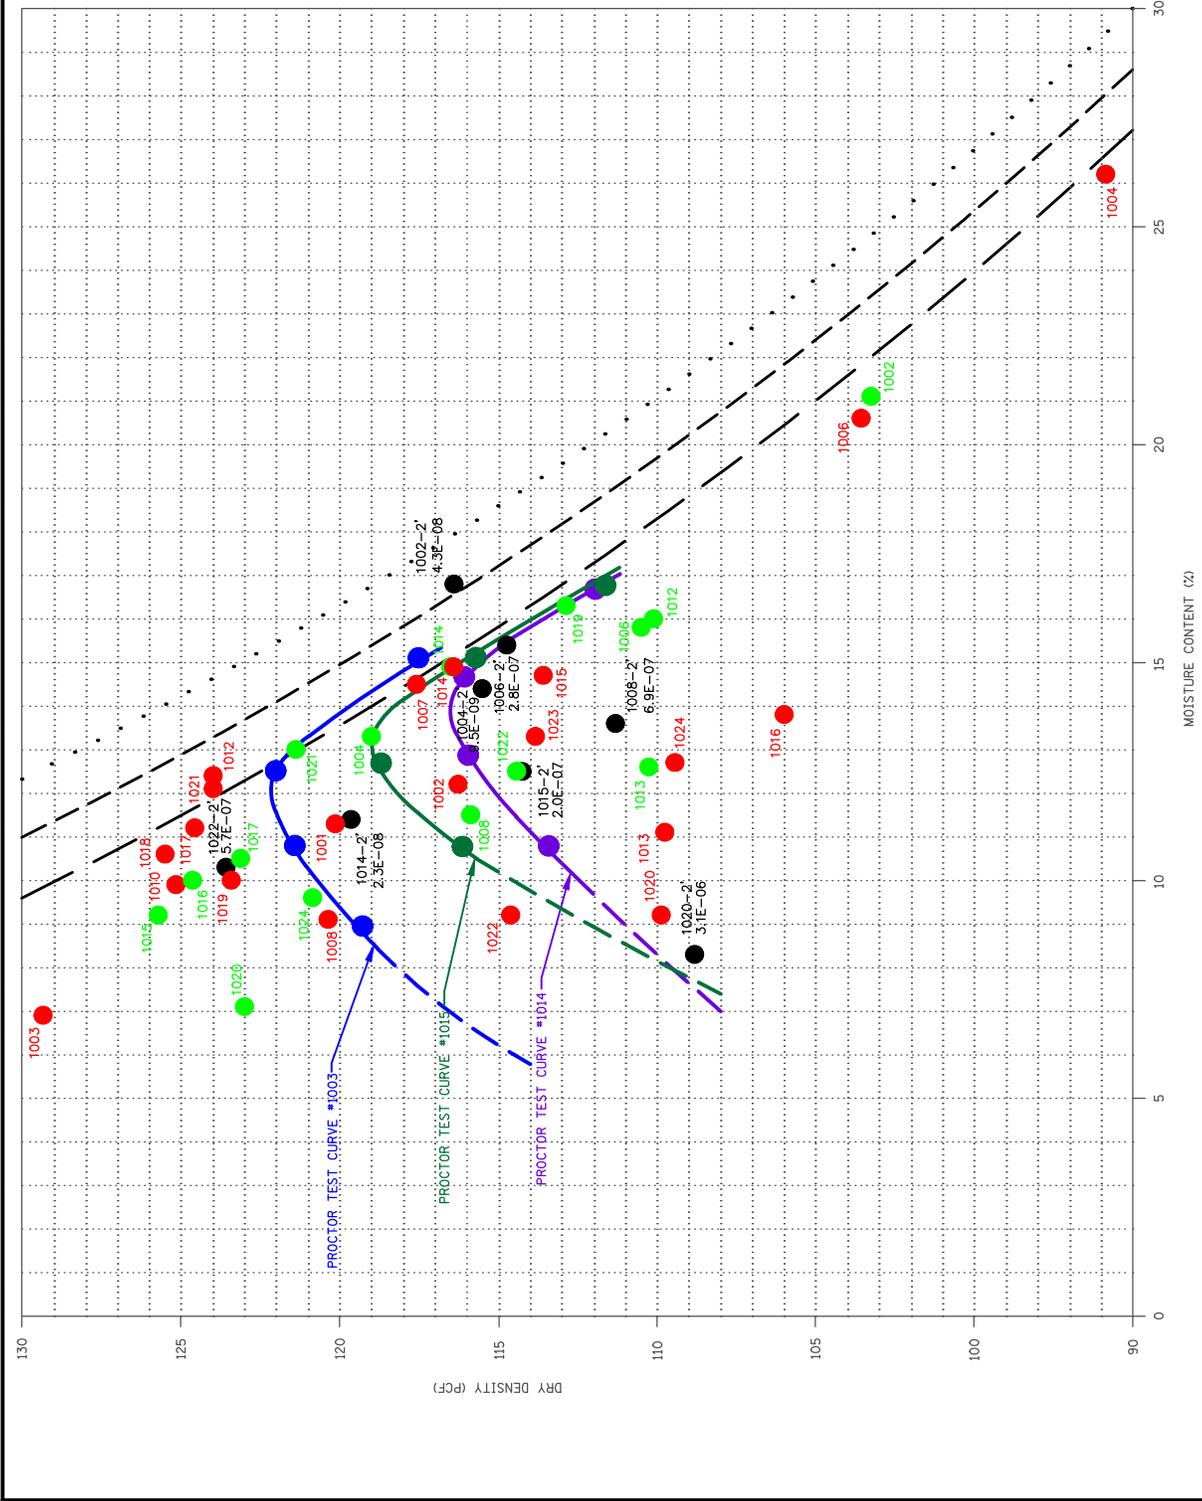
MOISTURE-DENSITY GRAPH

Standard Proctor curves, nuclear density tests and hydraulic conductivity test results were plotted together on the same graph to identify the range of values and illustrate the correlation. Figure 3 contains the moisture density and hydraulic conductivity information from this investigation of the cover soils. Detailed results from the hydraulic conductivity tests are provided in Appendix B.

As discussed above, the maximum dry density utilized in derivation of the in-place density (nuclear moisture density gauge) was obtained from the Proctor tests. The subject values used to determine the percent compaction were 122.1, 116.5, and 120.0 pounds per cubic foot for the varying soil types. The percent compaction is then determined by dividing the maximum dry density into the dry density given by the nuclear moisture-density gauge. An experienced construction quality assurance field technician from Andrews Engineering determined which maximum dry density value was appropriate for each field moisture density test. As shown in Table 3, the compaction of the cover ranged from 75.8 to 107 percent Standard Proctor. The average compaction was 97.4 percent Standard Proctor. The compaction/density requirement in a typical permitted construction quality assurance plan for the low permeable clay layer (final cover and liner) is 95 percent Standard Proctor. The average density of the cover over the extraneous materials exceeds this value. The high soil density does correlate with the low hydraulic conductivity for the extraneous materials cover.

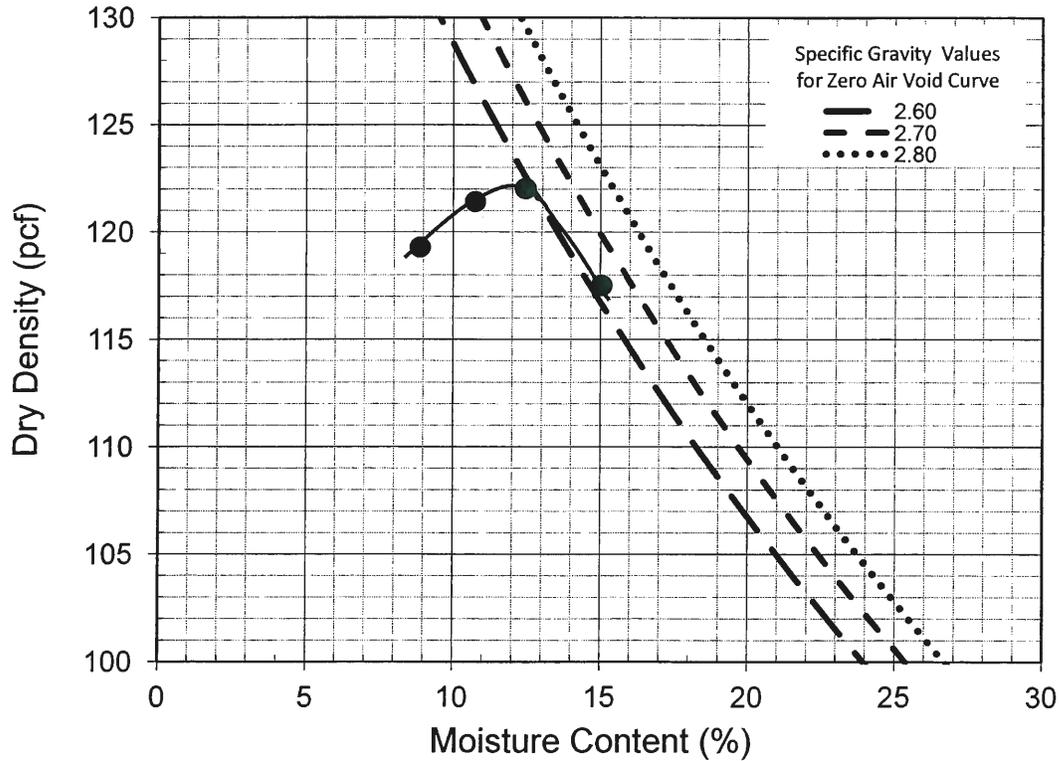
### Proctor Compaction Test

Maximum Dry Density (pcf): 122.1  
 Optimum Water Content (%): 12.3

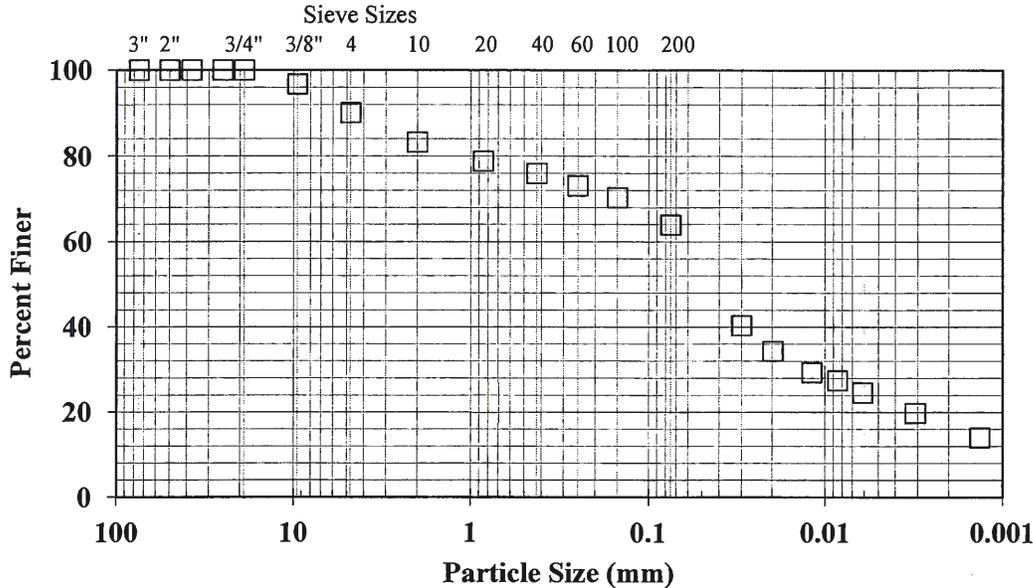
Client: Andrews Engineering, Inc.  
 Project: Brickyard  
 Sample: 1003

TRI Log#: E2373-06-01  
 Test Method: ASTM D 422  
 Test Date: 11/12/12

Sieve Analysis	
Sieve Size	Percent Passing
3 in.	100.0
2 in.	100.0
1.5 in.	100.0
1 in.	100.0
3/4 in.	100.0
3/8 in.	96.7
No. 4 (4.75 mm)	90.1
No. 10 (2.00 mm)	83.2
No. 20 (850 µm)	78.8
No. 40 (425 µm)	76.0
No. 60 (250 µm)	73.1
No. 100 (150 µm)	70.3
No. 200 (75 µm)	63.9
Hydrometer Analysis	
Particle Size	Percent Passing
0.074 mm	63.4
0.005 mm	22.8
0.001 mm	12.9

Notes: Soil classifies as a sandy lean clay (CL) in accordance with ASTM D2487.

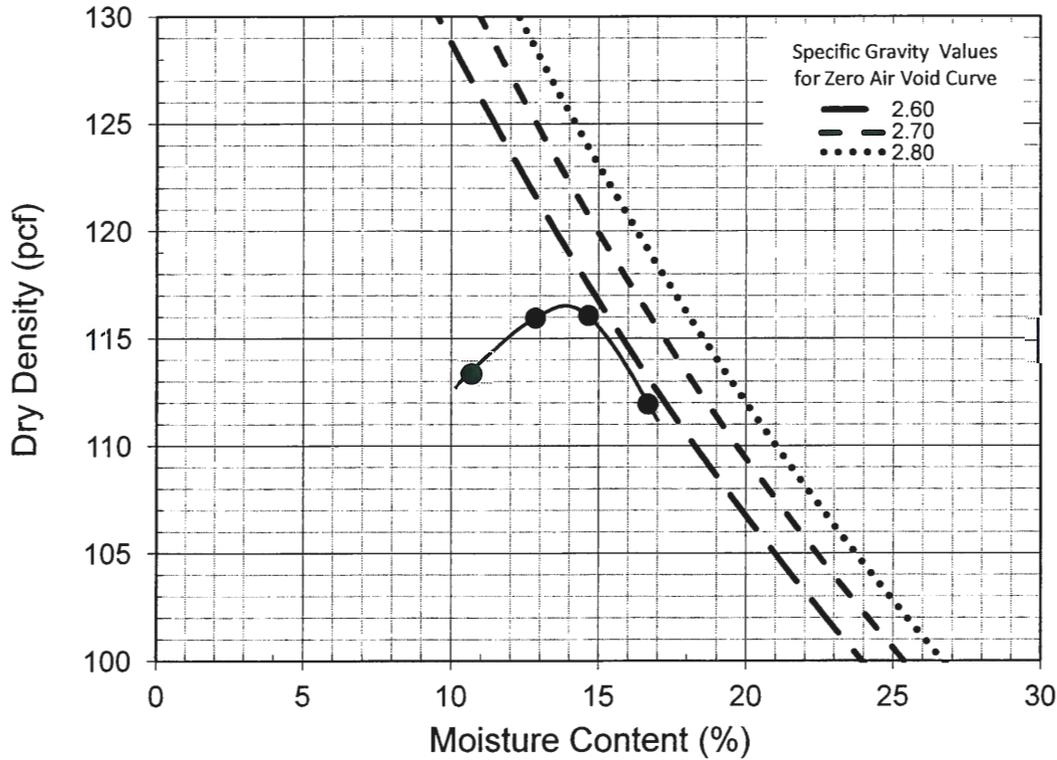
### Proctor Compaction Test

Maximum Dry Density (pcf): 116.5  
 Optimum Water Content (%): 13.9

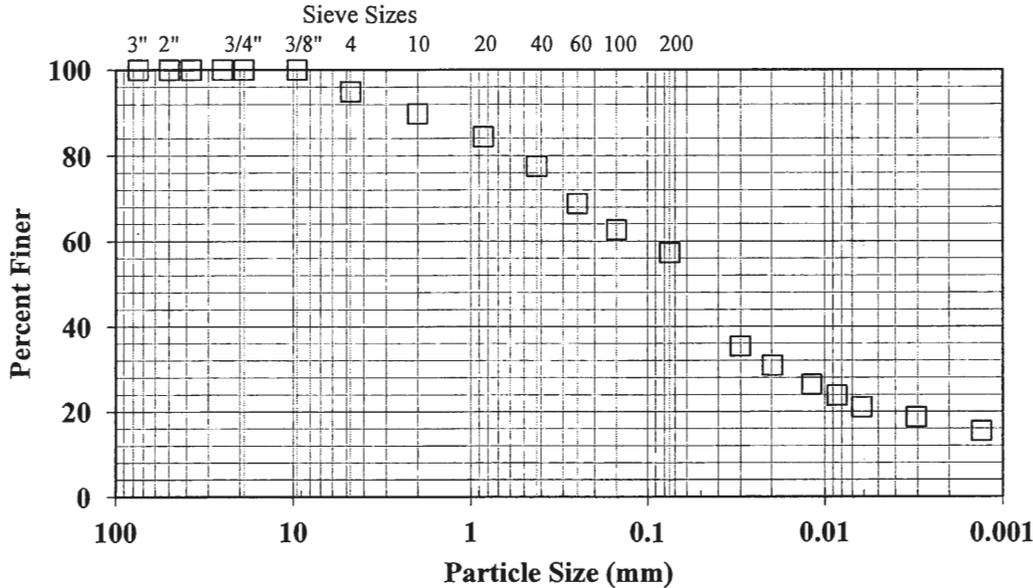
Client: Andrews Engineering, Inc.  
 Project: Brickyard  
 Sample: 1014

TRI Log#: E2373-06-01  
 Test Method: ASTM D 422  
 Test Date: 11/12/12

Sieve Analysis	
Sieve Size	Percent Passing
3 in.	100.0
2 in.	100.0
1.5 in.	100.0
1 in.	100.0
3/4 in.	100.0
3/8 in.	100.0
No. 4 (4.75 mm)	94.9
No. 10 (2.00 mm)	89.8
No. 20 (850 µm)	84.4
No. 40 (425 µm)	77.5
No. 60 (250 µm)	68.8
No. 100 (150 µm)	62.7
No. 200 (75 µm)	57.3
Hydrometer Analysis	
Particle Size	Percent Passing
0.074 mm	56.8
0.005 mm	20.2
0.001 mm	14.9

Notes: Soil classifies as a sandy lean clay (CL) in accordance with ASTM D2487.

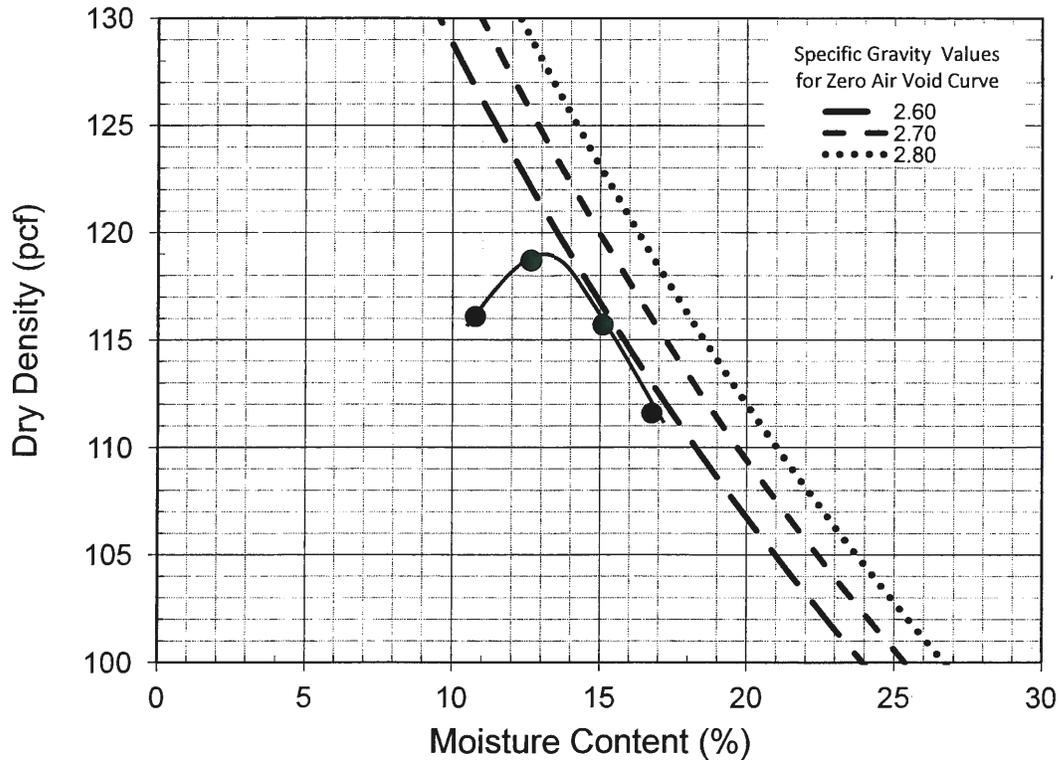
### Proctor Compaction Test

Maximum Dry Density (pcf): 120.0  
 Optimum Water Content (%): 13.1

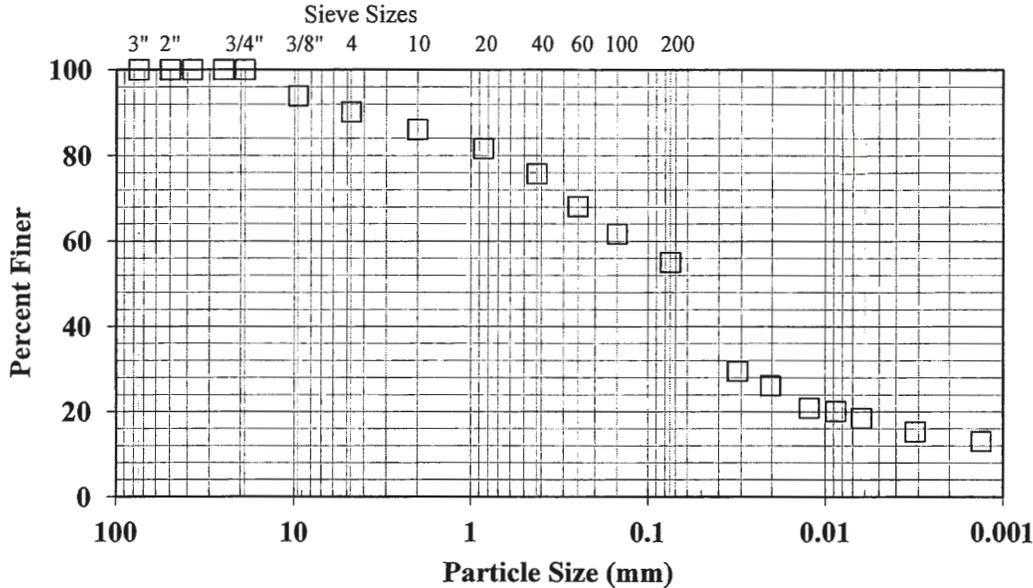
Client: Andrews Engineering, Inc.  
 Project: Brickyard  
 Sample: 1015

TRI Log#: E2373-06-01  
 Test Method: ASTM D 422  
 Test Date: 11/12/12

Sieve Analysis	
Sieve Size	Percent Passing
3 in.	100.0
2 in.	100.0
1.5 in.	100.0
1 in.	100.0
3/4 in.	100.0
3/8 in.	93.9
No. 4 (4.75 mm)	90.1
No. 10 (2.00 mm)	86.1
No. 20 (850 µm)	81.7
No. 40 (425 µm)	75.8
No. 60 (250 µm)	68.1
No. 100 (150 µm)	61.7
No. 200 (75 µm)	55.1
Hydrometer Analysis	
Particle Size	Percent Passing
0.074 mm	54.5
0.005 mm	17.2
0.001 mm	12.6

Notes: Soil classifies as a sandy lean clay (CL) in accordance with ASTM D2487.

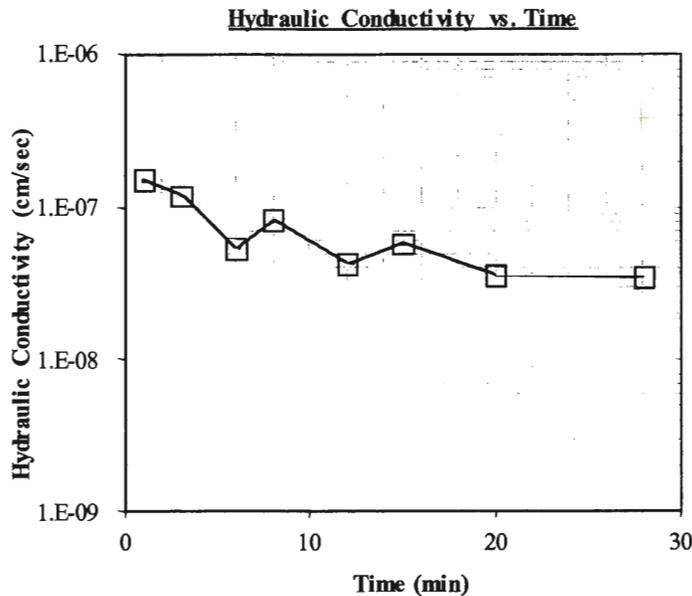
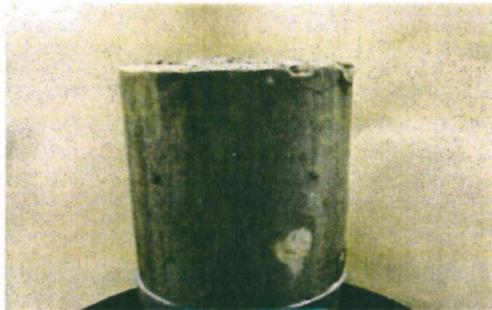
Client: Andrews Engineering, Inc.  
 Project: Brickyard  
 Sample: 1002

TRI Log#: E2373-06-01  
 Test Method: ASTM D 5084, Method F  
 Test Date: 11/09/12

INITIAL VALUES	
Avg. Sample Height (in)	2.79
Avg. Sample Diameter (in)	2.84
Wet Weight (g)	630.1
Area (in <sup>2</sup> )	6.32
Volume (cc)	289.3
Initial Water Content (%)	16.8
Total Density (pcf)	136.0
Dry Density (pcf)	116.4
G <sub>s</sub> (assumed)	2.65
Degree of Saturation (%)	100.0
Void Ratio	0.42
Porosity	0.30
1 Pore Volume (cc)	85.6

Time (min)	k at 20 deg C (cm/sec)
1	1.53E-07
3	1.20E-07
6	5.41E-08
8	8.31E-08
12	4.26E-08
15	5.82E-08
20	3.58E-08
28	3.51E-08

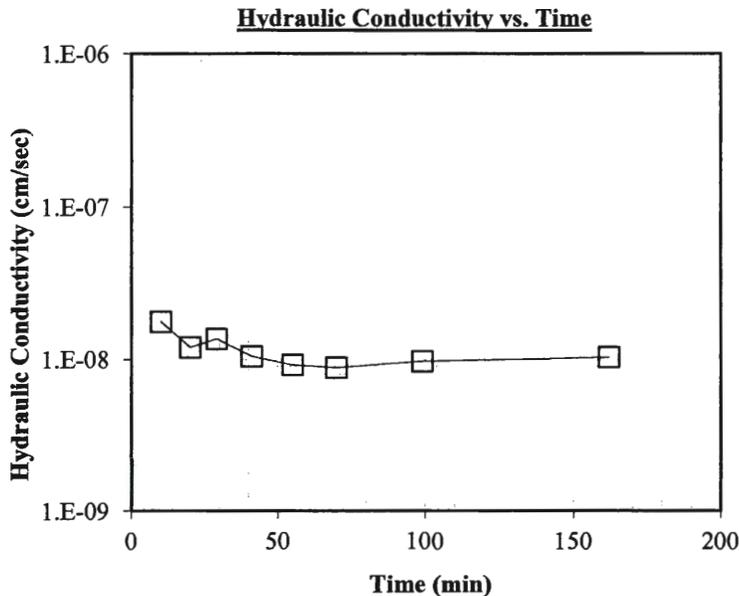
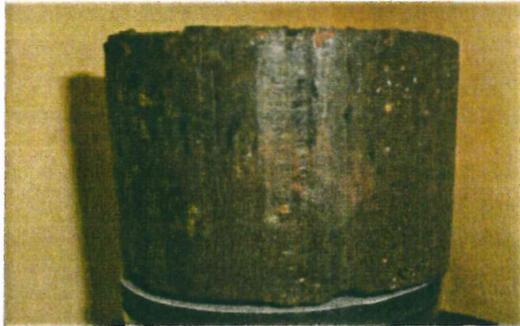
Client: Andrews Engineering, Inc.  
 Project: Brickyard  
 Sample: 1004

TRI Log#: E2373-06-01  
 Test Method: ASTM D 5084, Method F  
 Test Date: 11/09/12

INITIAL VALUES	
Avg. Sample Height (in)	2.14
Avg. Sample Diameter (in)	2.85
Wet Weight (g)	473.8
Area (in <sup>2</sup> )	6.39
Volume (cc)	224.0
Initial Water Content (%)	14.4
Total Density (pcf)	132.1
Dry Density (pcf)	115.5
G <sub>s</sub> (assumed)	2.65
Degree of Saturation (%)	88.2
Void Ratio	0.43
Porosity	0.30
1 Pore Volume (cc)	67.6

Hydraulic Conductivity	
Time (min)	k at 20 deg C (cm/sec)
10	1.77E-08
20	1.20E-08
29	1.37E-08
41	1.05E-08
55	9.21E-09
70	8.81E-09
99	9.73E-09
162	1.03E-08

Average<sup>1</sup>: **9.5E-09**

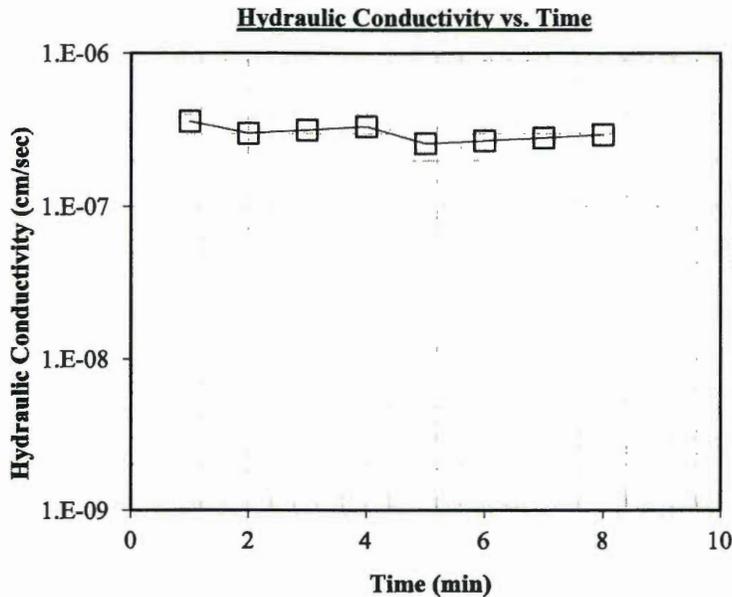
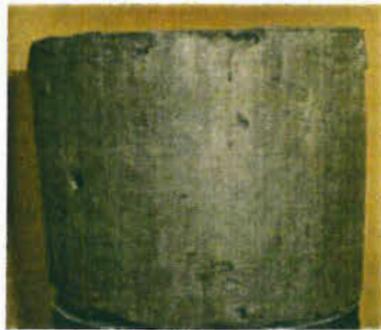
Client: Andrews Engineering, Inc.  
 Project: Brickyard  
 Sample: 1006

TRI Log#: E2373-06-01  
 Test Method: ASTM D 5084, Method F  
 Test Date: 11/09/12

Note: A B-value of 0.97 was achieved for the undisturbed specimen. Permeation measurements were made with a mercury U-tube. The effective confining pressure was 5 psi per test request.

INITIAL VALUES	
Avg. Sample Height (in)	2.49
Avg. Sample Diameter (in)	2.84
Wet Weight (g)	547.3
Area (in <sup>2</sup> )	6.32
Volume (cc)	257.8
Initial Water Content (%)	15.4
Total Density (pcf)	132.5
Dry Density (pcf)	114.8
G <sub>s</sub> (assumed)	2.65
Degree of Saturation (%)	92.9
Void Ratio	0.44
Porosity	0.31
1 Pore Volume (cc)	78.8

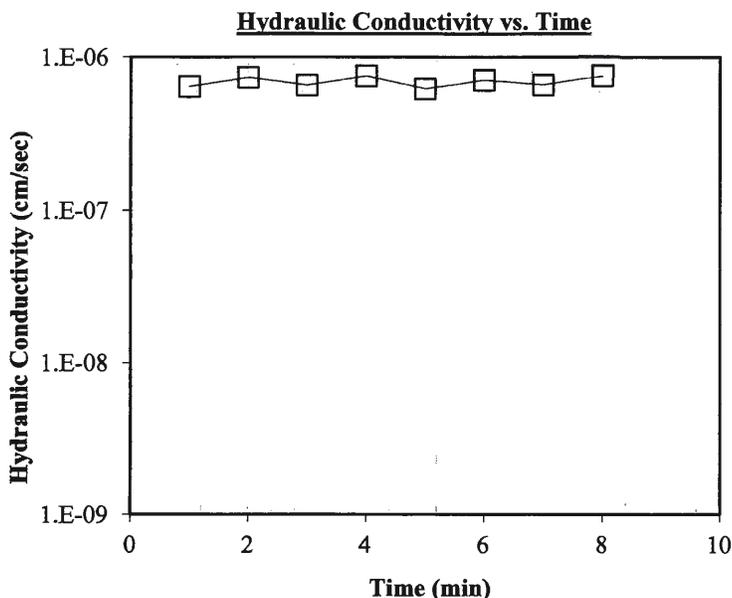
Client: Andrews Engineering, Inc.  
 Project: Brickyard  
 Sample: 1008

TRI Log#: E2373-06-01  
 Test Method: ASTM D 5084, Method F  
 Test Date: 11/09/12

INITIAL VALUES	
Avg. Sample Height (in)	2.06
Avg. Sample Diameter (in)	2.86
Wet Weight (g)	437.5
Area (in <sup>2</sup> )	6.41
Volume (cc)	216.1
Initial Water Content (%)	13.6
Total Density (pcf)	126.4
Dry Density (pcf)	111.3
G <sub>s</sub> (assumed)	2.65
Degree of Saturation (%)	74.0
Void Ratio	0.49
Porosity	0.33
1 Pore Volume (cc)	70.7

Hydraulic Conductivity	
Time (min)	k at 20 deg C (cm/sec)
1	6.43E-07
2	7.36E-07
3	6.55E-07
4	7.52E-07
5	6.22E-07
6	7.08E-07
7	6.59E-07
8	7.58E-07
Average <sup>1</sup> :	<b>6.9E-07</b>

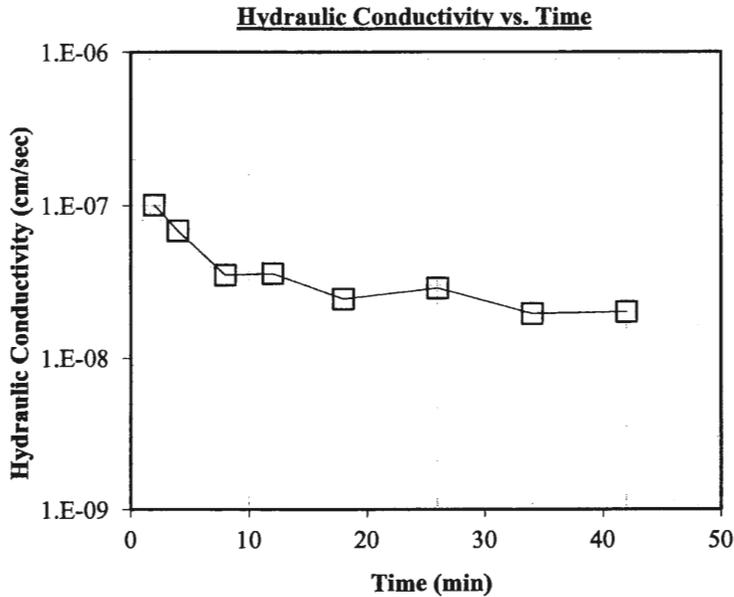
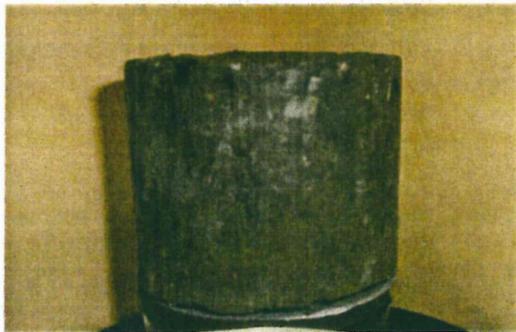
Client: Andrews Engineering, Inc.  
 Project: Brickyard  
 Sample: 1014

TRI Log#: E2373-06-01  
 Test Method: ASTM D 5084, Method F  
 Test Date: 11/09/12

INITIAL VALUES	
Avg. Sample Height (in)	2.44
Avg. Sample Diameter (in)	2.85
Wet Weight (g)	545.2
Area (in <sup>2</sup> )	6.39
Volume (cc)	255.2
Initial Water Content (%)	11.4
Total Density (pcf)	133.3
Dry Density (pcf)	119.7
G <sub>s</sub> (assumed)	2.65
Degree of Saturation (%)	79.2
Void Ratio	0.38
Porosity	0.28
1 Pore Volume (cc)	70.5

Note: A B-value of 0.95 was achieved for the undisturbed specimen. Permeation measurements were made with a mercury U-tube. The effective confining pressure was 5 psi per test request.

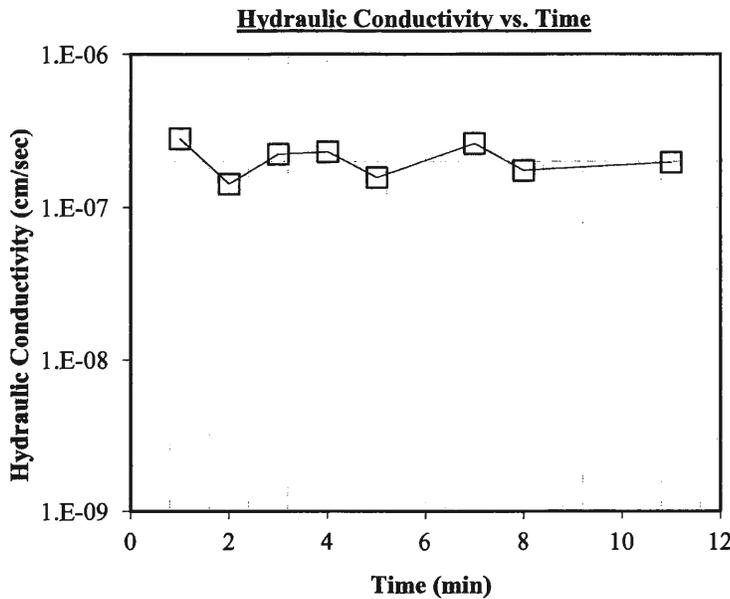
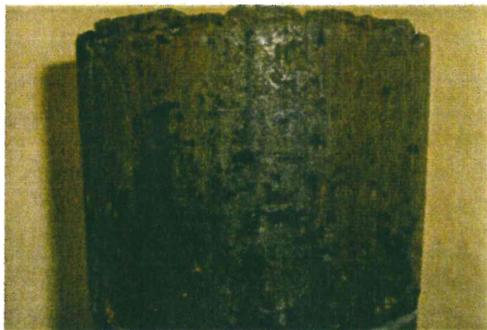
Client: Andrews Engineering, Inc.  
 Project: Brickyard  
 Sample: 1015

TRI Log#: E2373-06-01  
 Test Method: ASTM D 5084, Method F  
 Test Date: 11/09/12

INITIAL VALUES	
Avg. Sample Height (in)	2.50
Avg. Sample Diameter (in)	2.85
Wet Weight (g)	536.2
Area (in <sup>2</sup> )	6.36
Volume (cc)	260.5
Initial Water Content (%)	12.5
Total Density (pcf)	128.5
Dry Density (pcf)	114.2
G <sub>s</sub> (assumed)	2.65
Degree of Saturation (%)	74.2
Void Ratio	0.45
Porosity	0.31
1 Pore Volume (cc)	80.6

Note: A B-value of 0.97 was achieved for the undisturbed specimen. Permeation measurements were made with a mercury U-tube. The effective confining pressure was 5 psi per test request.

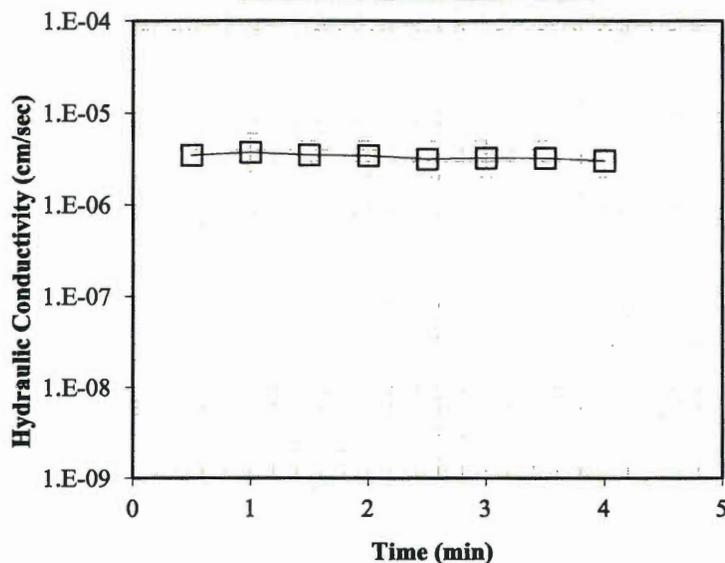
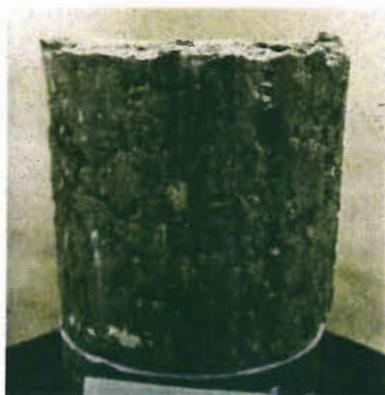
**Hydraulic Conductivity vs. Time**

TRI Log#: E2373-06-01  
 Test Method: ASTM D 5084, Method F  
 Test Date: 11/13/12

Note: A B-value of 0.96 was achieved for the undisturbed specimen. Permeation measurements were made with a mercury U-tube. The effective confining pressure was 5 psi per test request.

INITIAL VALUES	
Avg. Sample Height (in)	2.93
Avg. Sample Diameter (in)	2.80
Wet Weight (g)	559.2
Area (in <sup>2</sup> )	6.16
Volume (cc)	296.0
Initial Water Content (%)	8.3
Total Density (pcf)	117.9
Dry Density (pcf)	108.9
G <sub>s</sub> (assumed)	2.65
Degree of Saturation (%)	42.4
Void Ratio	0.52
Porosity	0.34
1 Pore Volume (cc)	101.2

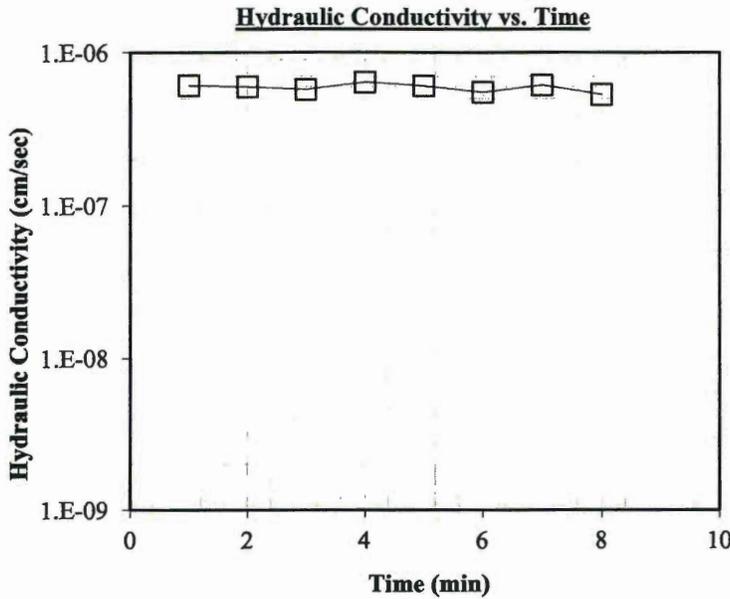
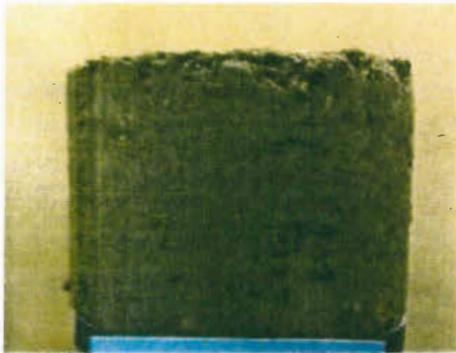
Client: Andrews Engineering, Inc.  
 Project: Brickyard  
 Sample: 1022

TRI Log#: E2373-06-01  
 Test Method: ASTM D 5084, Method F  
 Test Date: 11/09/12

INITIAL VALUES	
Avg. Sample Height (in)	2.23
Avg. Sample Diameter (in)	2.87
Wet Weight (g)	515.6
Area (in <sup>2</sup> )	6.47
Volume (cc)	236.1
Initial Water Content (%)	10.3
Total Density (pcf)	136.3
Dry Density (pcf)	123.6
G <sub>s</sub> (assumed)	2.65
Degree of Saturation (%)	80.8
Void Ratio	0.34
Porosity	0.25
1 Pore Volume (cc)	59.6

Note: A B-value of 0.97 was achieved for the undisturbed specimen. Permeation measurements were made with a mercury U-tube. The effective confining pressure was 5 psi per test request.

Hydraulic Conductivity	
Time (min)	k at 20 deg C (cm/sec)
1	6.09E-07
2	5.97E-07
3	5.73E-07
4	6.40E-07
5	6.05E-07
6	5.50E-07
7	6.12E-07
8	5.31E-07
Average <sup>1</sup> :	5.7E-07
