BEFORE THE ILLINOIS POLLUTION CONTROL BOARD
ADMINISTRATIVE CITATION

AFFIDAVIT

The purpose of this memorandum is to serve as the Narrative Inspection Report Document of an inspection conducted at the subject site, RCS Inc., Landfill (RCS) on September 9, 2003 from approximately 6:50 a.m. until 11:40 a.m., by this author. I was not accompanied by anyone else from the Illinois EPA on the inspection. While at the landfill, I conducted the physical inspection, the Document Review and Exit Interview portions of the landfill inspection. Each of these main areas is discussed herein. As shown in this report, there are apparent violations being alleged as a result of this inspection.

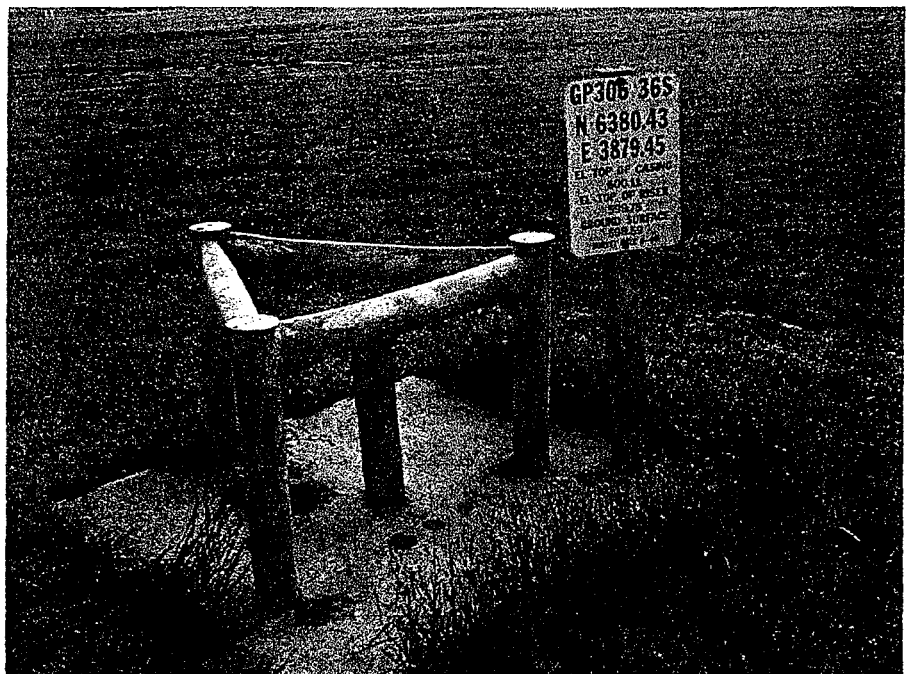
0830250012~09092003-002

Comments: Gas probe GP306 is
shown. The casing was in good
shape and the well is properly
marked. Protective steel posts
surround the well.

inspected the concrete bases, which were intact with no visible cracks. I checked the above ground portion of the casings, which were also intact. The wells and probes were properly locked and marked. Nothing out of the ordinary was observed and the surrounding vegetation had been recently mowed at many of the wells and probes. Throughout the physical inspection of the facility, all of the groundwater monitoring wells and gas probes appeared to be properly cared for as well.

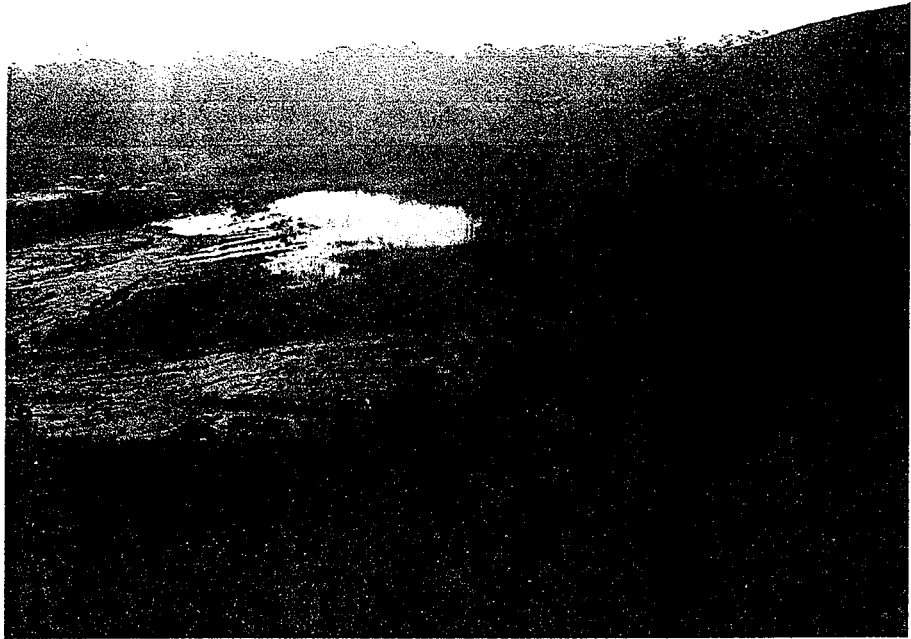
0830250012~09092003-005

Comments: Yet to be permitted
Cell # 3 with ponded water.

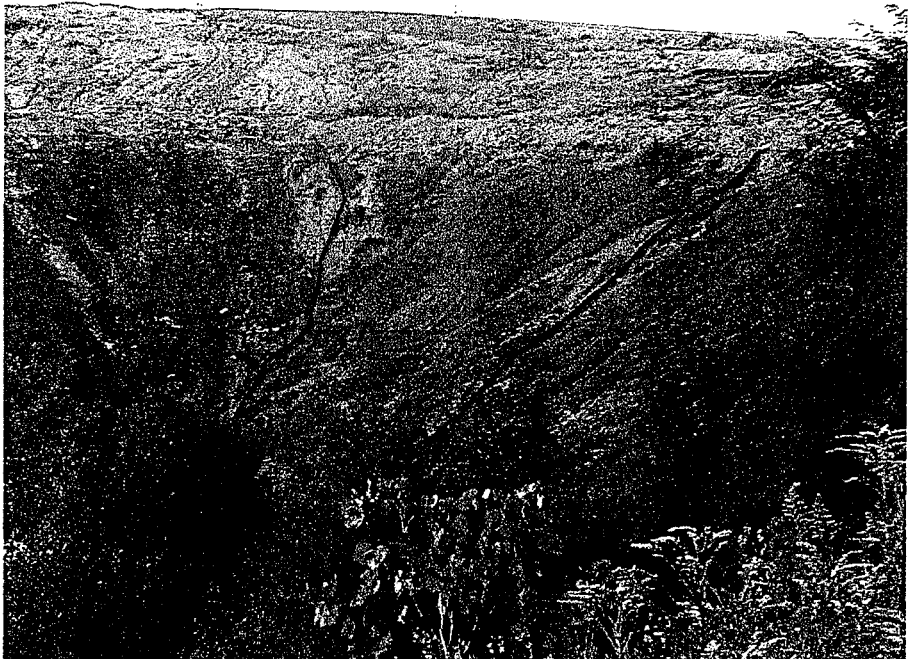
0830250012~09092003-006

The permitted landfill slope at the northwest corner of Cell # 2 appeared to once again have some exposed refuse. As mentioned, this is why Mr. Robbins had placed the flexible black pipes as he had, as shown in photo #s 006, 007 and 008. However, many areas along the lower portion of the entire northern face had small areas of exposed refuse (also see photo #s 009, 010 and 011). These exposed refuse areas show evidence of inadequate intermediate cover, an apparent violation of the regulations, Title 35, Illinois Administrative Code, Subtitle G (35 IAC), Section 811.313(c). This then also shows an apparent violation of the Illinois Environmental Protection Act (Act), Section 21(o)(5), as does some exposed refuse, albeit minor, in the active fill area, as shown in photo #s 012 and 013. Associated apparent violations of the permit also exist. These are all explained in greater detail, later in this report. It is understandable that intermediate cover would be broken down by erosion when one considers the intense rainfall of the Labor Day weekend, previously discussed. However, that was over a week prior to the inspection, during which the weather was mostly sunny, or with no or minimal rain. However, additional soil cover was necessary to comply with the regulations. In addition to informing Messrs. Ross and Robbins of the apparent violations, I also recommended them to keep a daily watch over that situation at that location, the entire north face, and anywhere else in cells with buried waste.

Comments: Two flexible plastic
pipes were placed at the northwest
area of Cell # 2 to help control
storm water runoff and erosion.

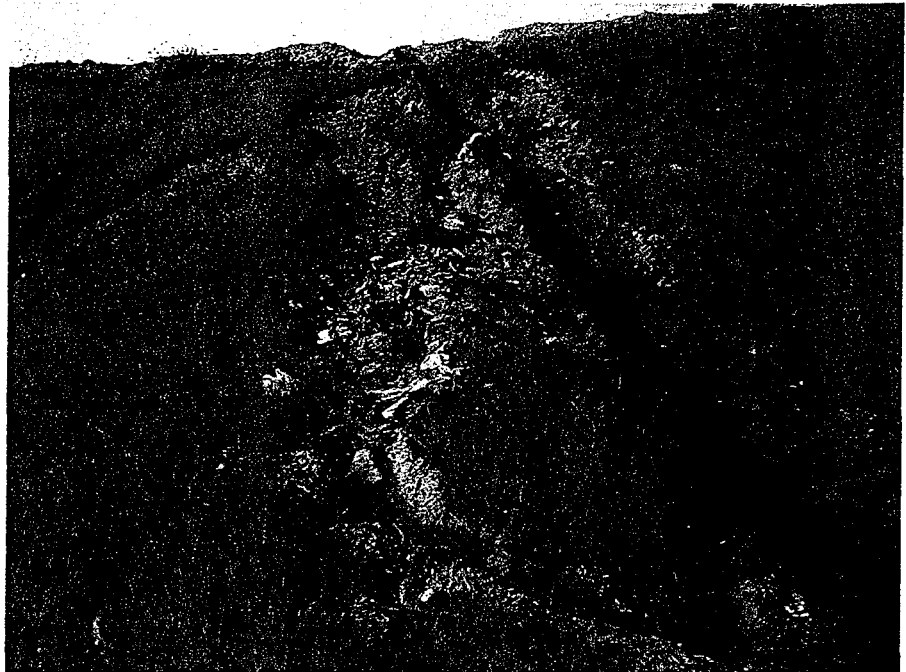
0830250012~09092003-007

Comments: Exposed refuse in an area measuring approximately 10' x 3', adjacent to the western most black flexible pipe in the northwestern part of Cell # 2 shown in photo # 006, is shown here.

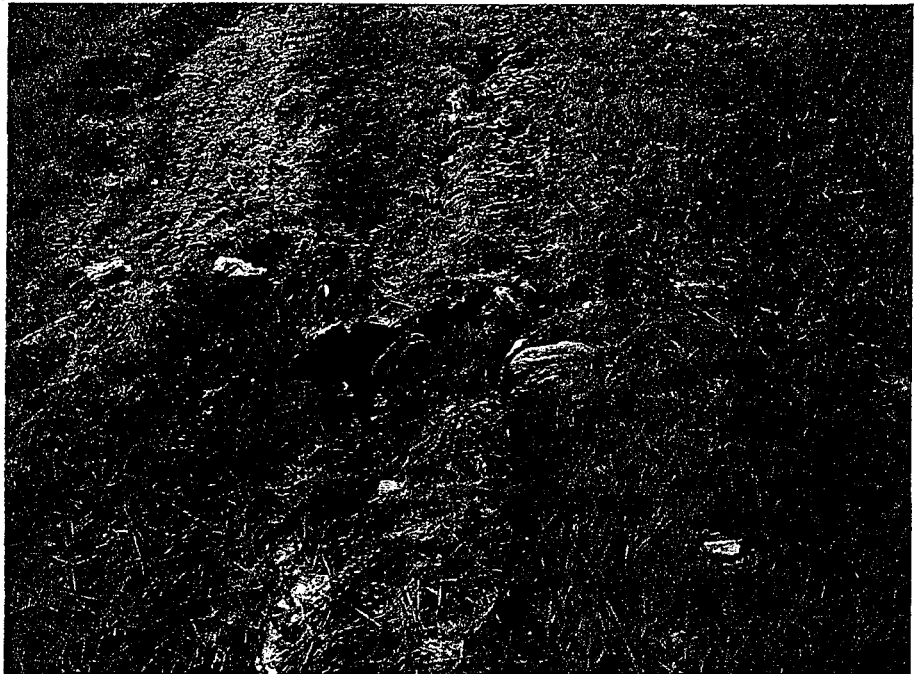
0830250012~09092003-009

Comments: A small area of
exposed refuse is shown on the
north face of Cell # 2.

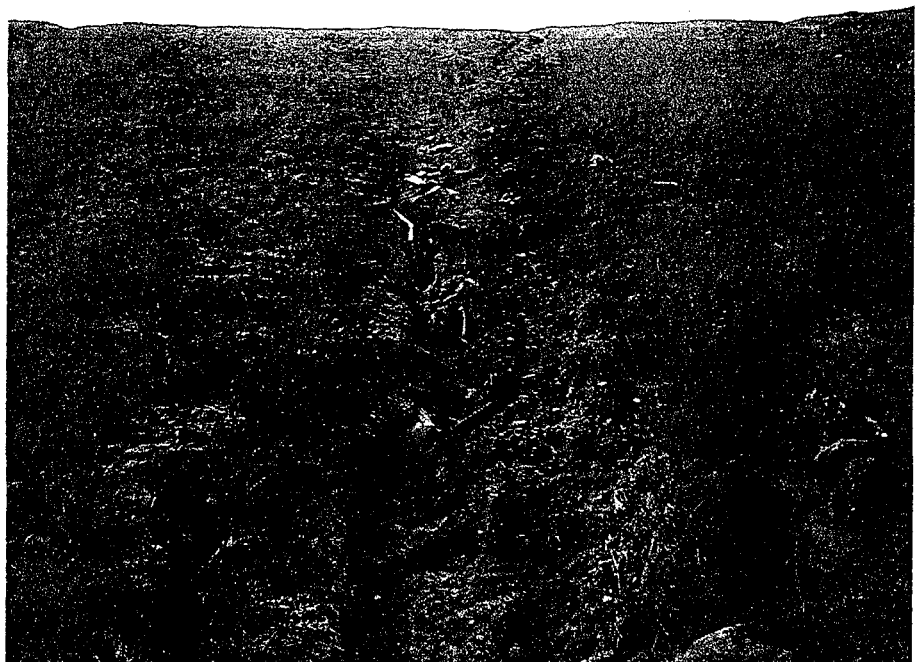
0830250012~09092003-010

Comments: Exposed refuse in an
area measuring approximately 15'
x 2' is shown.

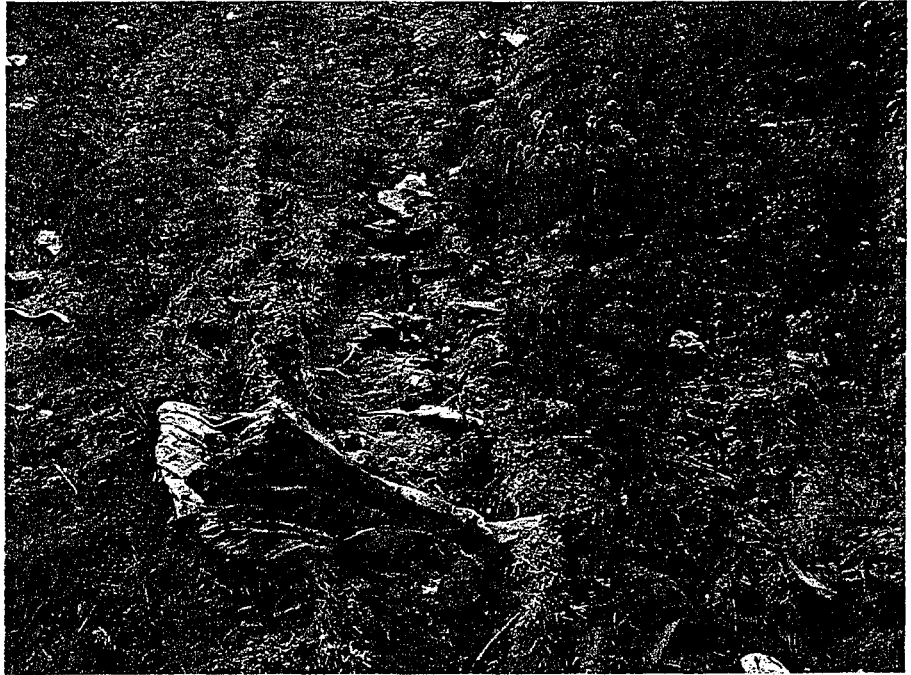
0830250012~09092003-011

Comments: Exposed refuse in an area measuring approximately 20' x 2' is shown.

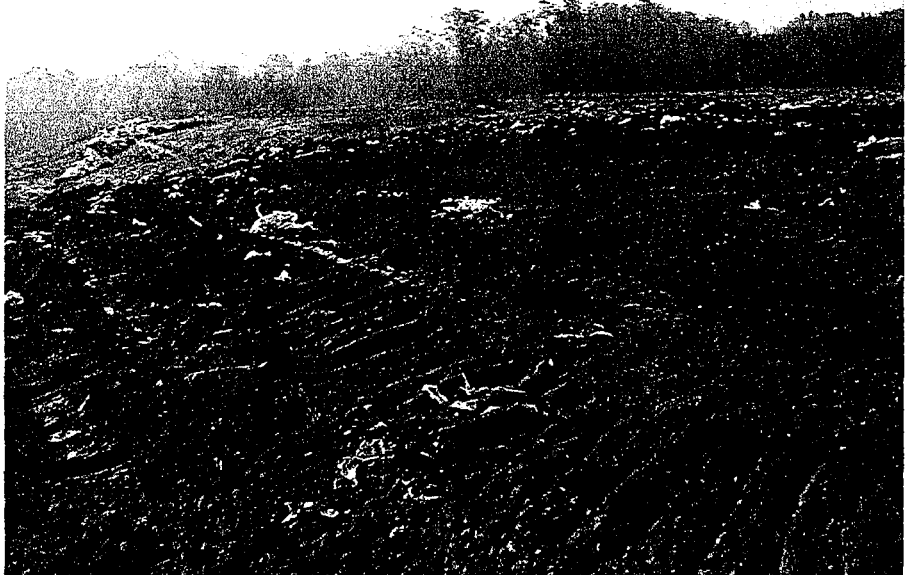
0830250012~09092003-012

Comments: A small amount of exposed refuse is shown in the soil used as daily cover.

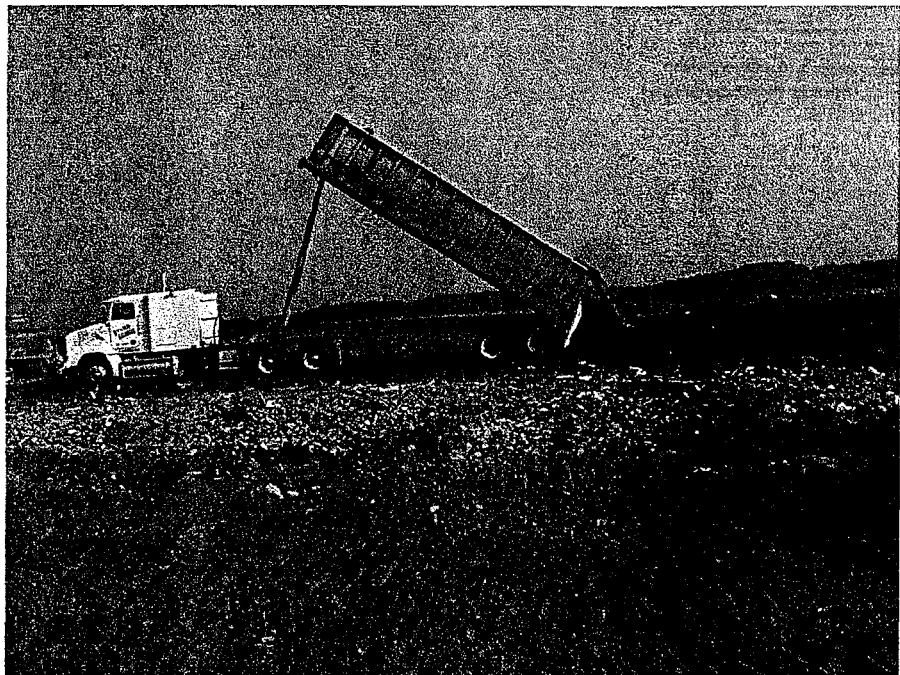
0830250012~09092003-014

Comments: Underground Storage Tank (UST) soil from an excavation in White Hall is shown being dumped at the active fill area.

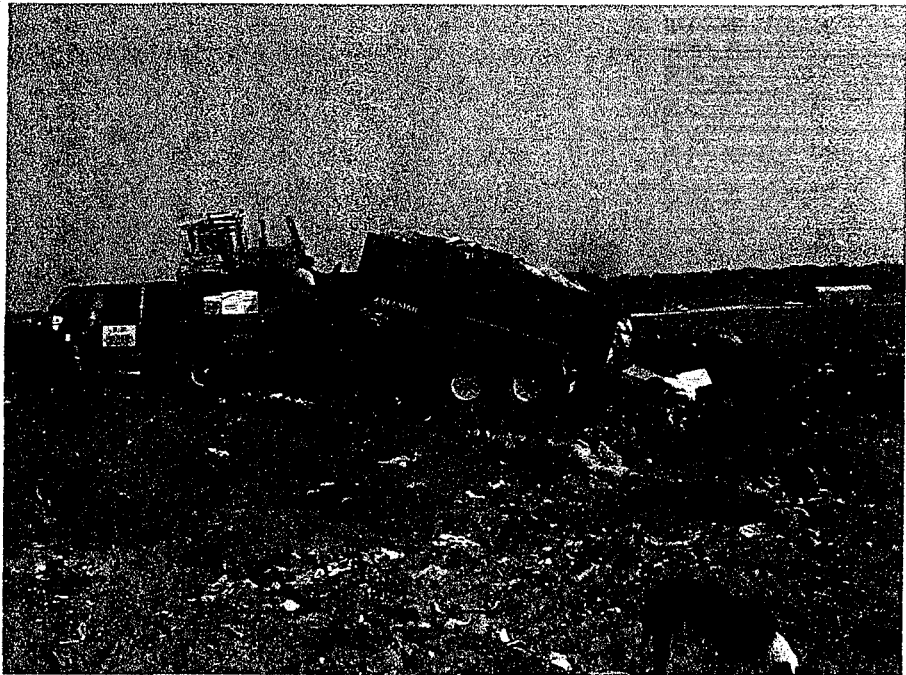
0830250012~09092003-015

Comments: F & F Construction is shown dumping a small load of demolished house debris

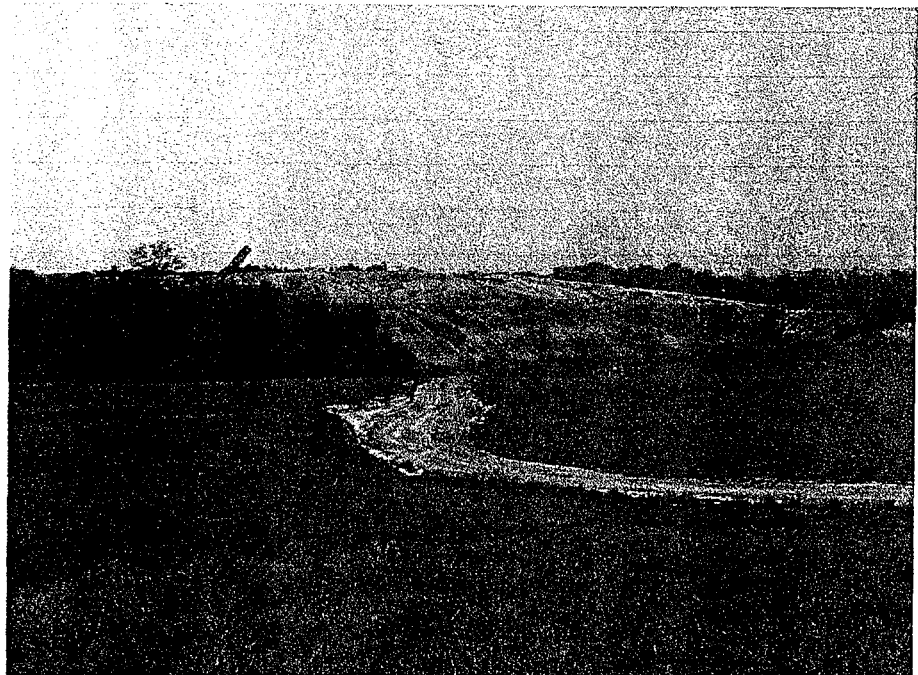
0830250012~09092003-018

Comments: The landfill, shown from the hill at the northeast corner of the landfill.

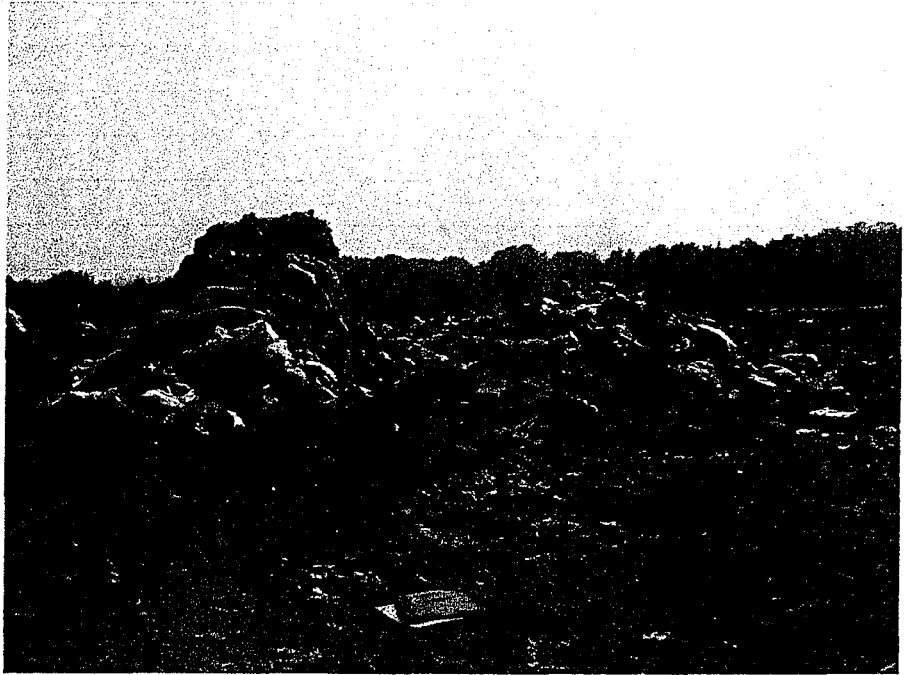
0830250012~09092003-019

active fill area, because the first two Merritt Hauling local refuse hauling trucks arrived and dumped their loads. I requested Mr. Ross to call Mr. Robbins on his radio to catch the name on the trucks and to not touch those specific waste piles until I could get up there to inspect the loads. Mr. Robbins asked if he should have the driver wait, and I said no, so long as he had the trucking company identified. Once back at the active fill area, both loads were inspected and found to contain nothing unusual or unacceptable. These loads are shown in photo # 019.

Comments: Waste piles from Merritt Hauling, reportedly out of Shipman, Illinois. They reportedly pick up residential refuse in Jerseyville, smaller communities and rural areas. These loads were inspected by this Inspector and found to be acceptable.

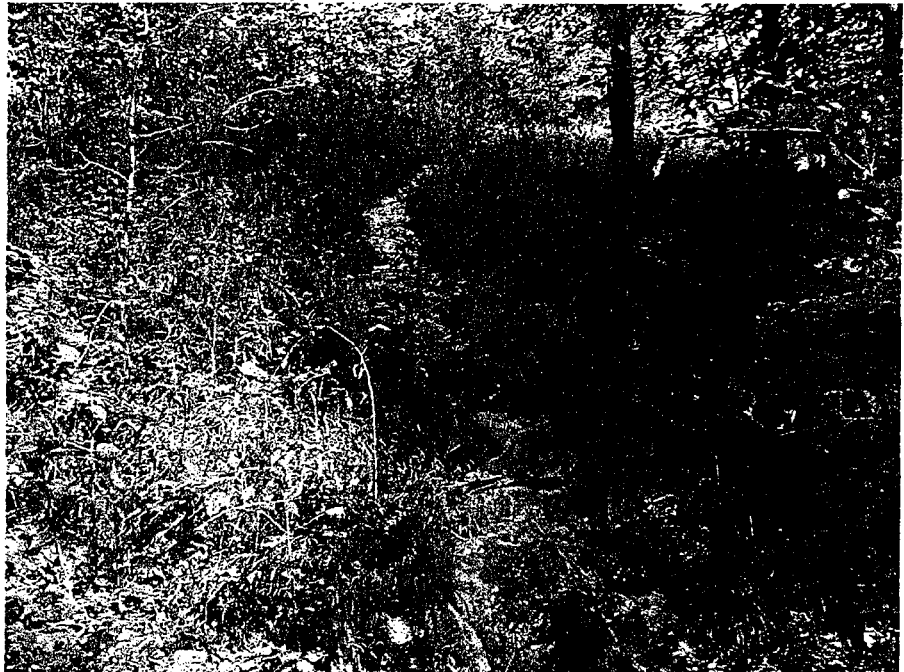
0830250012~09092003-020

approximately six-feet long with new couplings that he stated had just arrived so that repairs could be made to the system that removes storm water from yet to be permitted Cell # 3. That repair was made during the morning of the inspection and the pump was operating and removing storm flow to the detention pond south of the landfill, as shown in photo #s 020 and 021.

Comments: A babbling brook or stream of storm water from yet to be permitted Cell # 3 is shown flowing through a wooded area south of the south haul road, leading to the storm water detention pond.

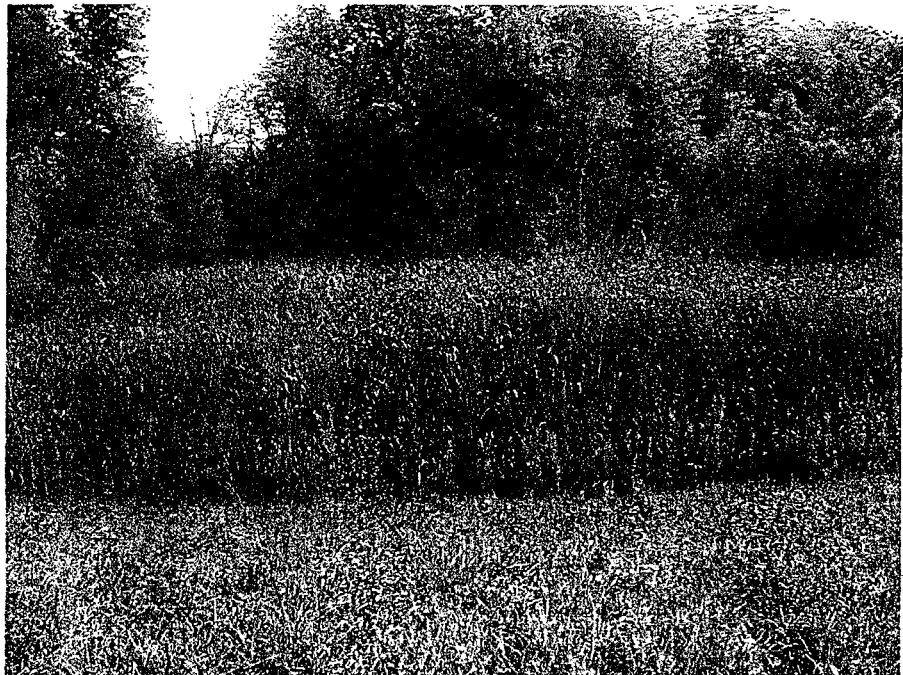
0830250012~09092003-022

Comments: Marsh grass and cat tails are all that can be seen in this storm water detention pond. The water flow in the previous two photograph #s, 020 and 021, had been accumulating in the pond for approximately a half-hour. A pipe under the berm that this photographer stood on, exited to a tributary stream to Sandy Creek in the next photo, # 022.
