Re: Livestock Waste Regulations
35 Ill. Adm. Code 506
R01-28 (Rulemaking-Land)

LEAKAGE AND SINKHOLE COLLAPSES UNDER HOG WASTE LAGOONS IN KENTUCKY

Nicholas C. Crawford, Ph.D.
Western Kentucky University

CONSTRUCTING NEW MANURE STORAGE SYSTEMS IN THE KARST REGION

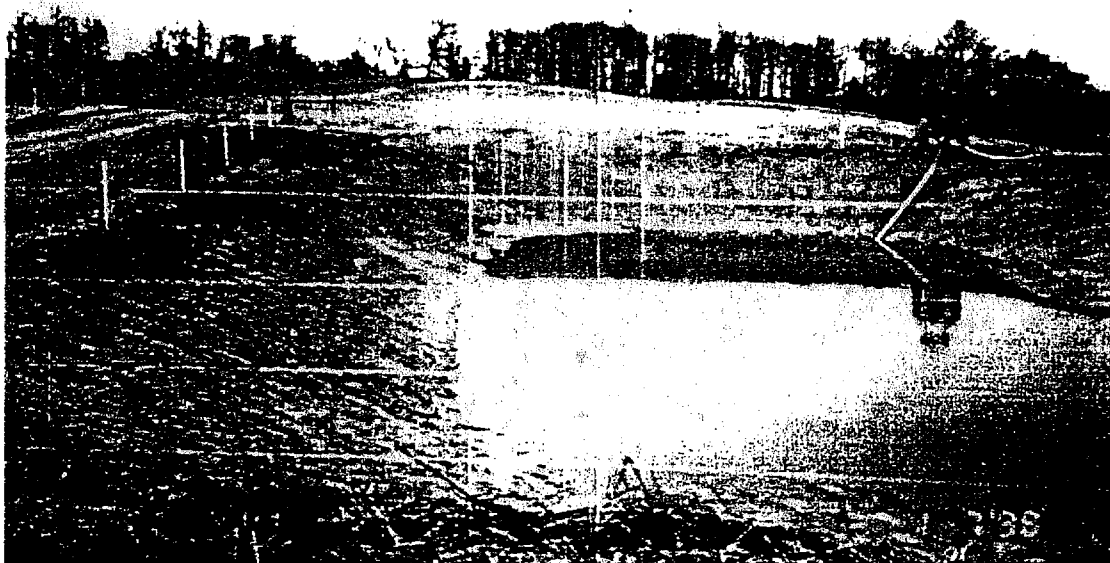
FIGURE 5. Sinkhole collapse under a hog waste lagoon in Warren County, Kentucky on January 6, 1998. Photo by Kentucky Division of Water.

Figures 5, 6 and 7 are photographs of sinkhole collapse under a hog waste lagoon that occurred in Warren County on January 6, 1998. The estimated loss of settled hog waste was approximately 15,000 gallons. The Kentucky Division of Water recommended that a synthetic liner be placed under the lagoon. Figures 8, 9 and 10 are photographs of a sinkhole collapse under a hog waste lagoon that occurred in Logan County on April 29, 1991. The pond was 125 feet by 100 feet and 12.8 feet deep with hog waste when the collapse occurred. The entire pond drained quickly into the karst Aquifer for an estimated loss of 1,050,000 gallons of hog waste. This pond had a synthetic liner that extended across the bottom and 4 feet up the sides. The collapse occurred where the

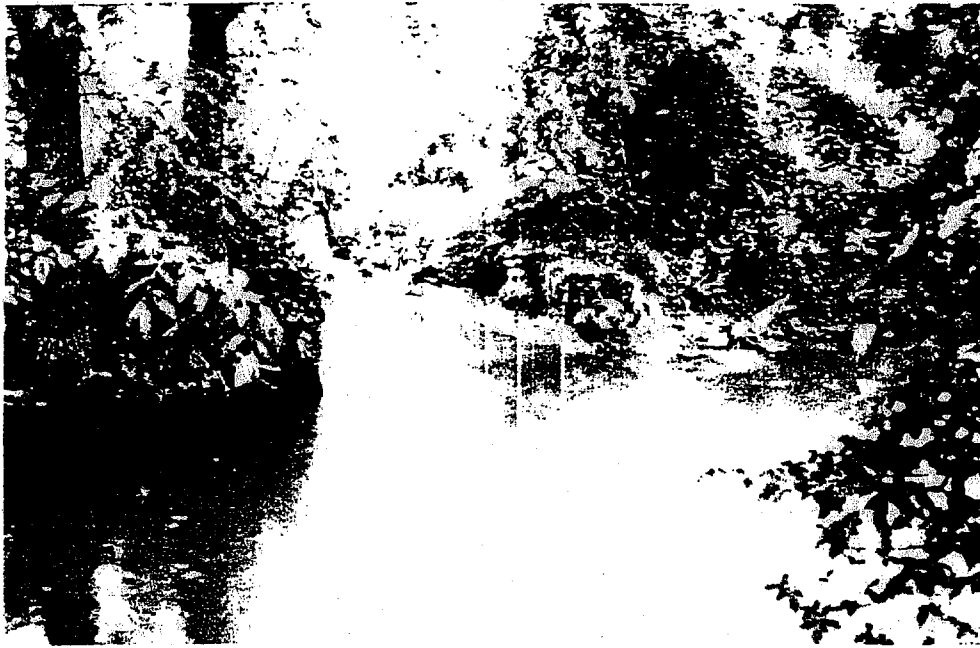
FIGURE 10. A Rhodamine WT dye trace performed by the Kentucky Division of Water was visually positive at the above spring on Sinking Creek.
